Joshua Tree Survey

of a 68.8-acre lot on the NE C/O Mesa Linda Ave. and Mojave Dr.
City of Victorville, San Bernardino County, California

Prepared by: **CalPacific Sciences**
George J Wirtes, MS, RCA #738
ISA Certified Arborist

Report Date: November 11, 2022

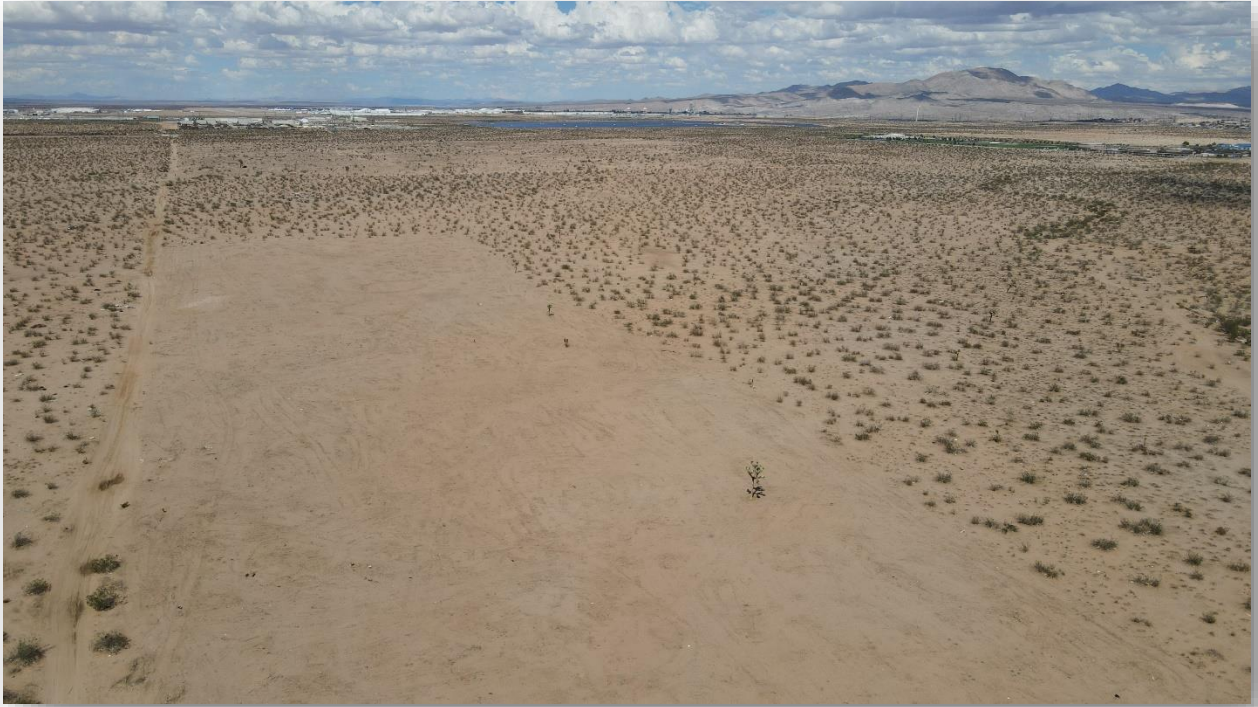
Plate 1. This is a view to the northeast from the southwestern corner of the site.

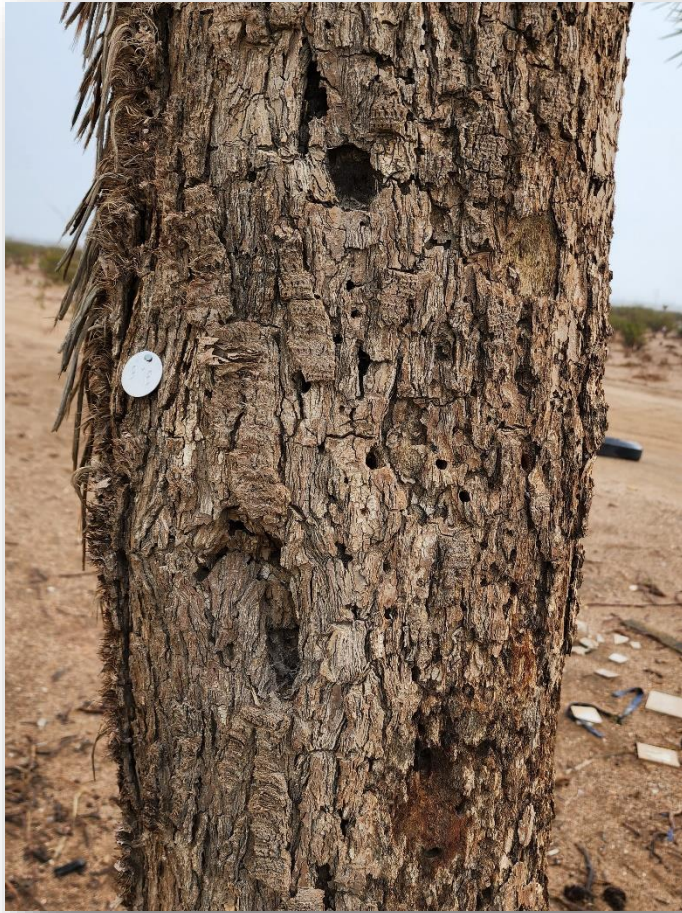
Plate 3. This is a view of boreholes and peridermal cavities in a stem (tree #916).

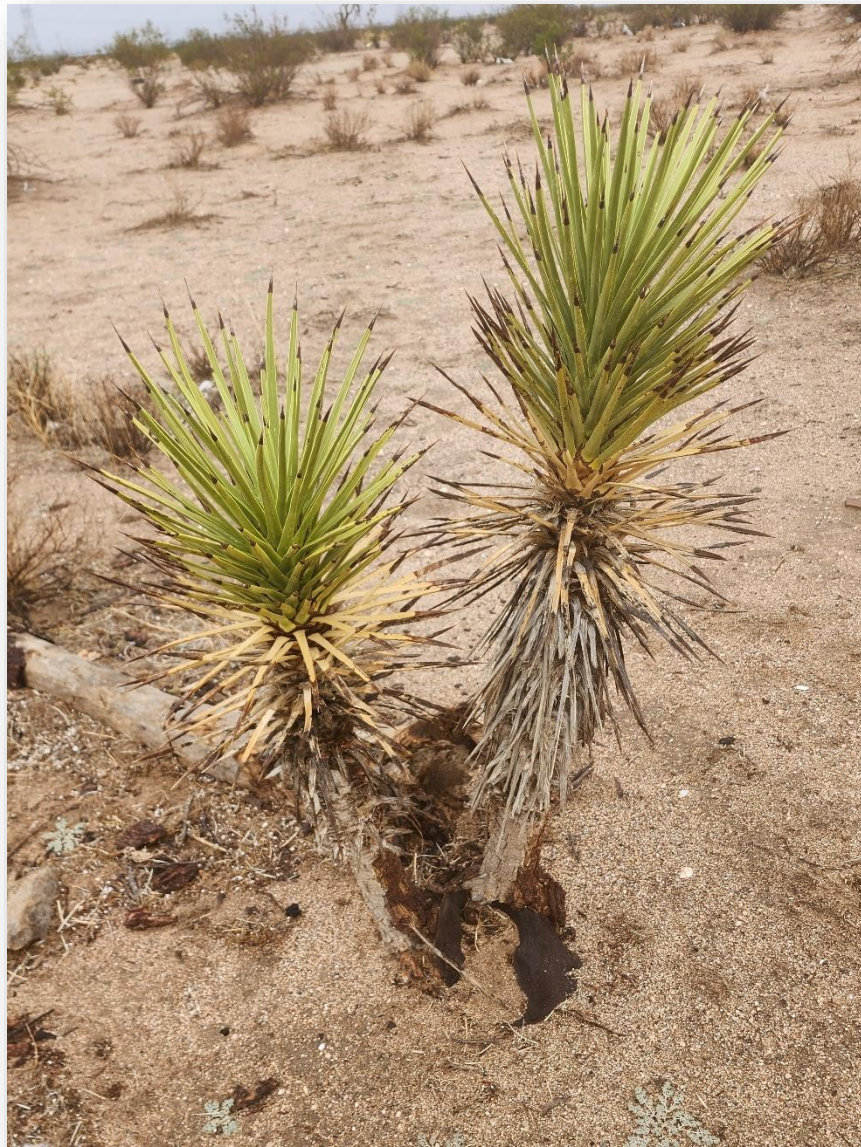
Plate 4. This is a view of epicormic, clonal growth at the base of a dead WJT (tree #919).

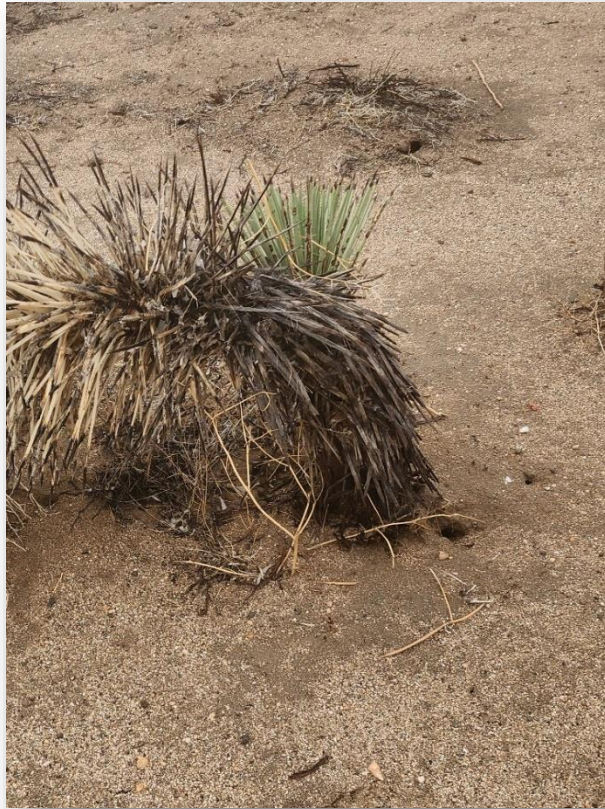
Plate 5. This is a view of a diseased stem with basal epicormic growth (tree UT 2).

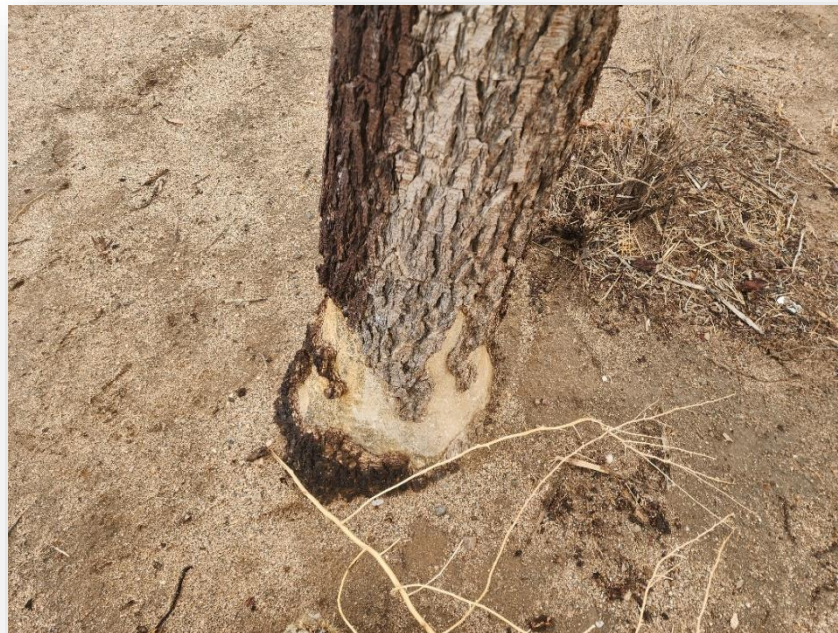
Plate 6. This is a view of a peridermal exfoliation (tree # 921).

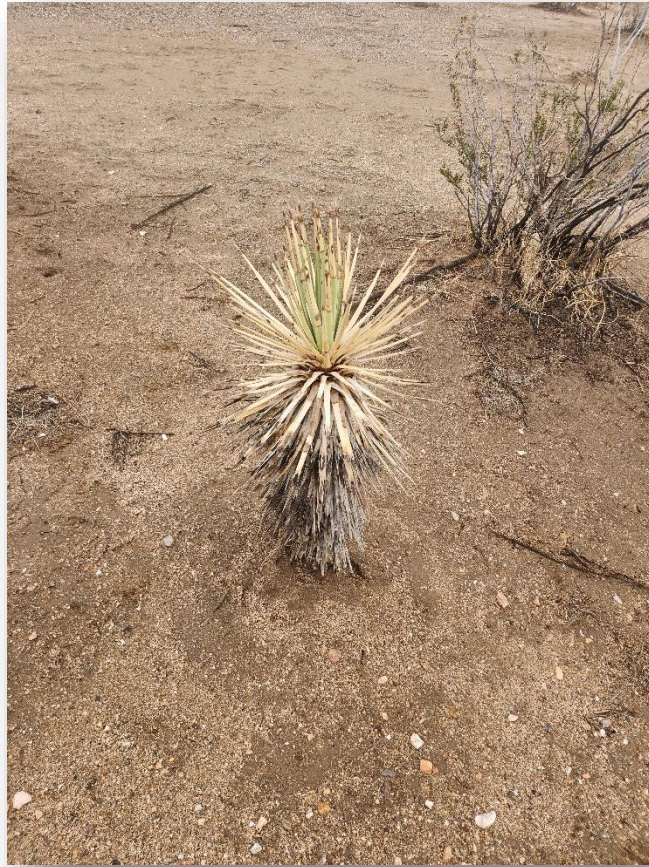
Plate 7. This is a view of a juvenile in decline (UT 3).

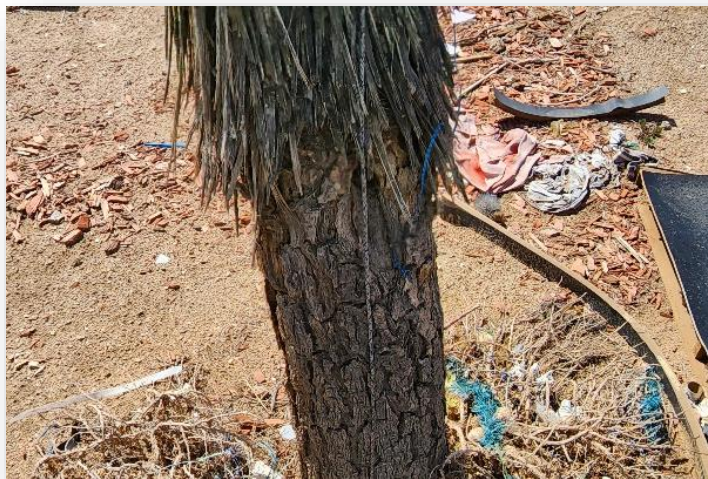
Plate 8. This is a view of a large cavity in the stem of a tree (#926).

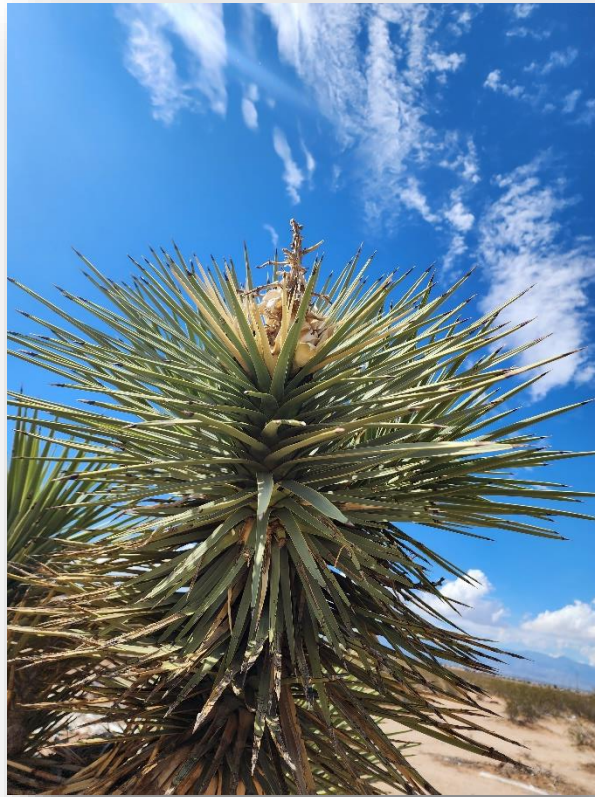
Plate 9. This is a view of an expended fruiting panicle (#926).

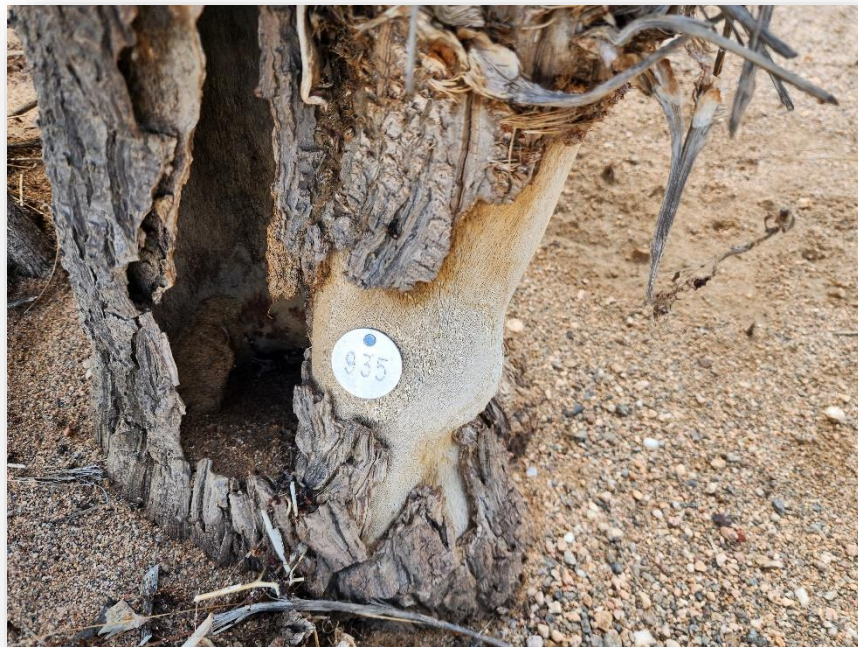
Plate 10. This is a view of extensive internal decay within a stem (#935).

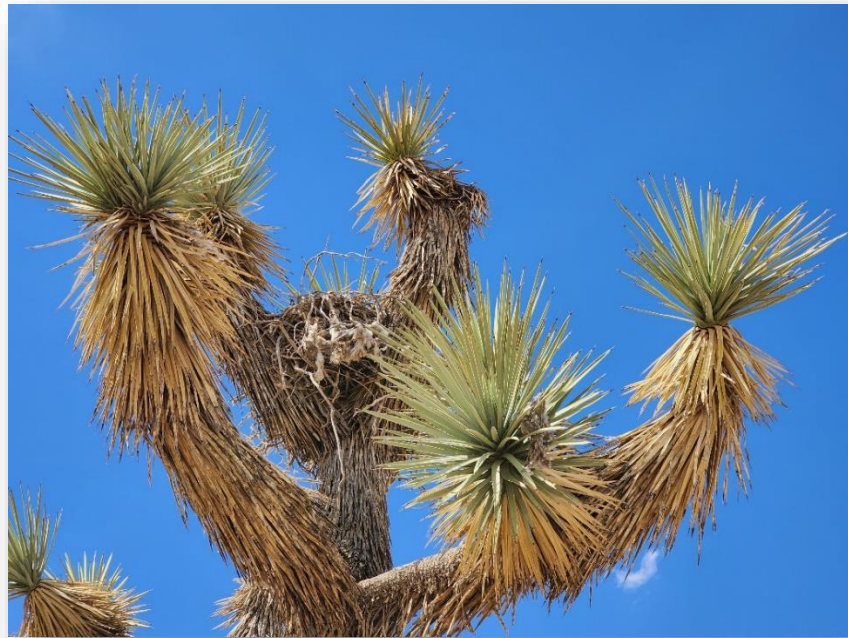
Plate 11. This is a view of a nest within the canopy of a tree (tree #936).

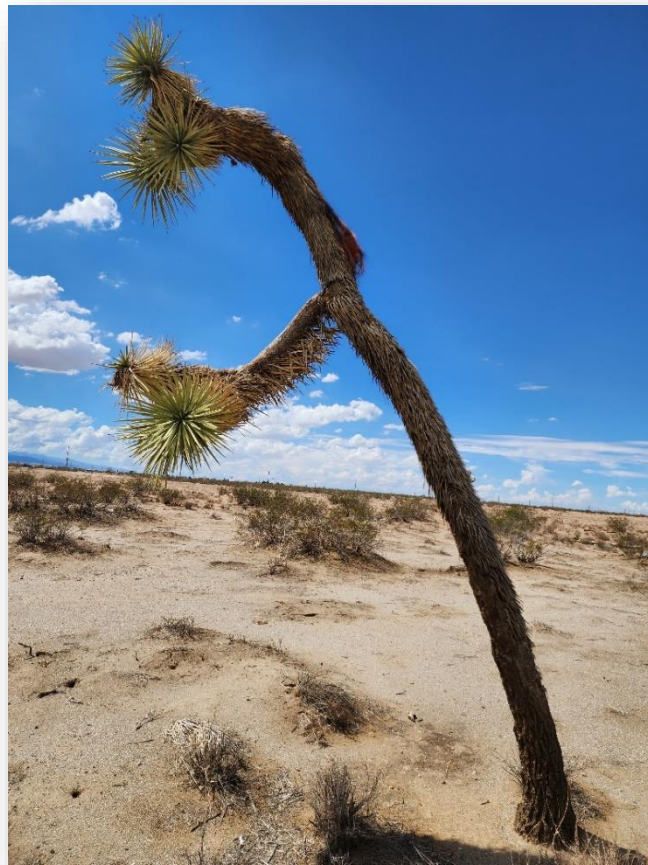
Plate 12. This is a view of a WJT with a lean and offset canopy mass (tree #939).

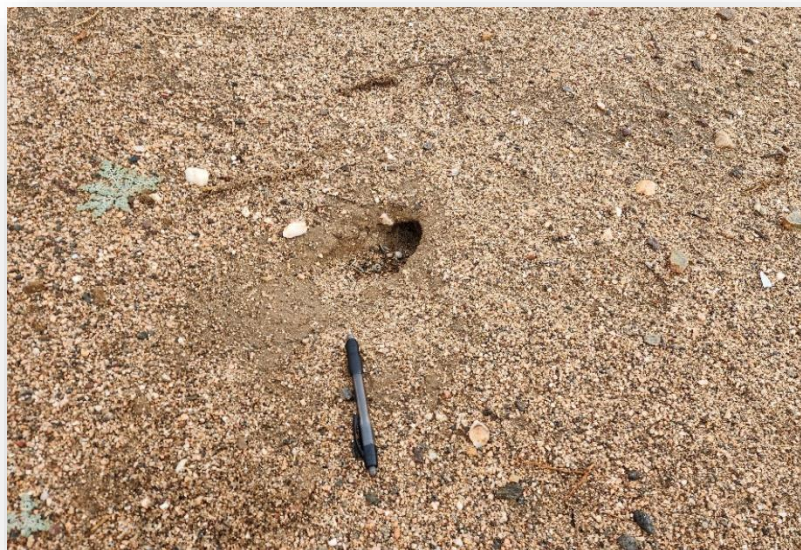
Plate 13. This is a view of a possible kangaroo rat burrow (tree buffer #916).

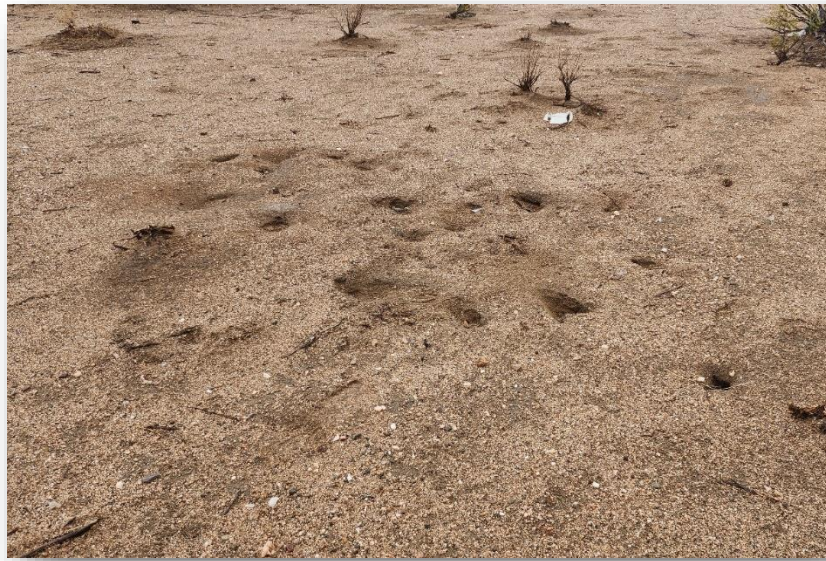
Plate 14. This is a view of a possible kangaroo rat burrow complex (tree #917).

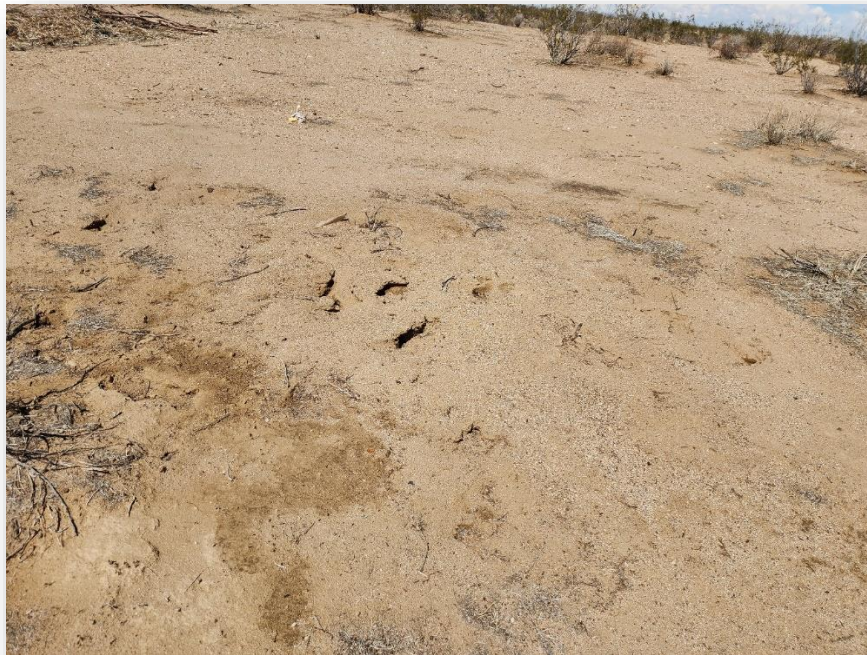
Plate 15. This is a view of a possible seed cache excavations and nearby burrows (tree #930).

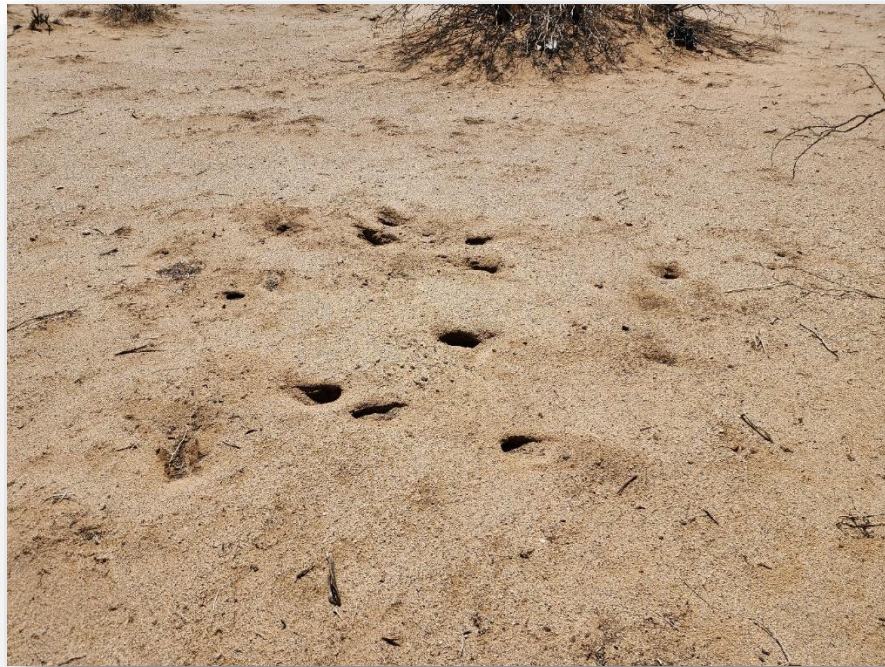
Plate 16. This is a view of a possible kangaroo rat burrow complex (tree #932).

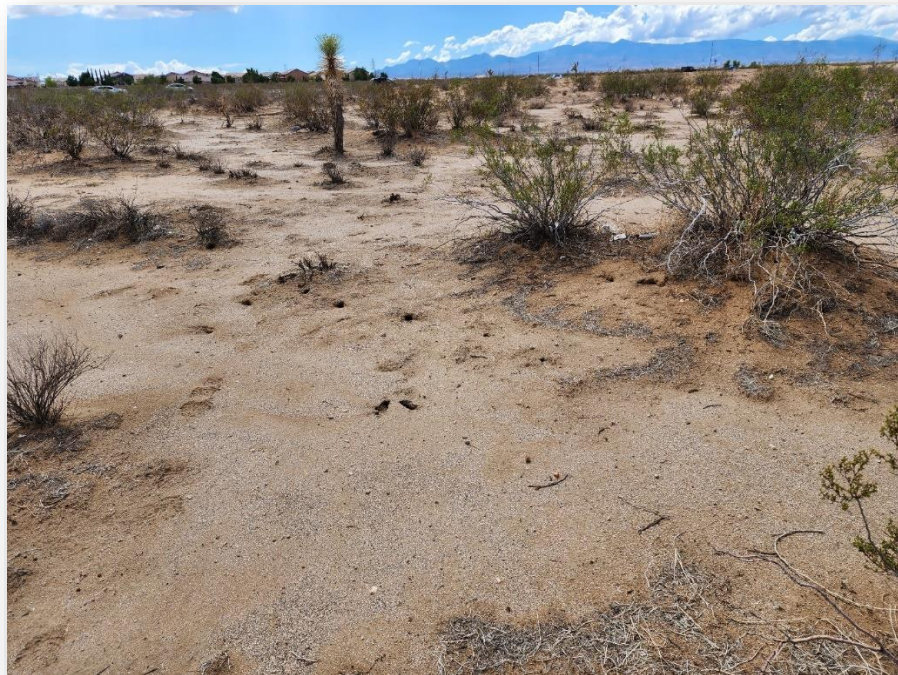
Plate 17. This is a view of burrow complex occupied by a white-tailed antelope ground squirrel (*Ammospermophilus leucurus*) (tree #939).
