REVISED: TREE ASSESSMENT AND PROTECTION PLAN

Project Site: 749 San Ysidro Rd., San Barbara 93108

November 15, 2021

Bill Spiewak Consulting Arborist

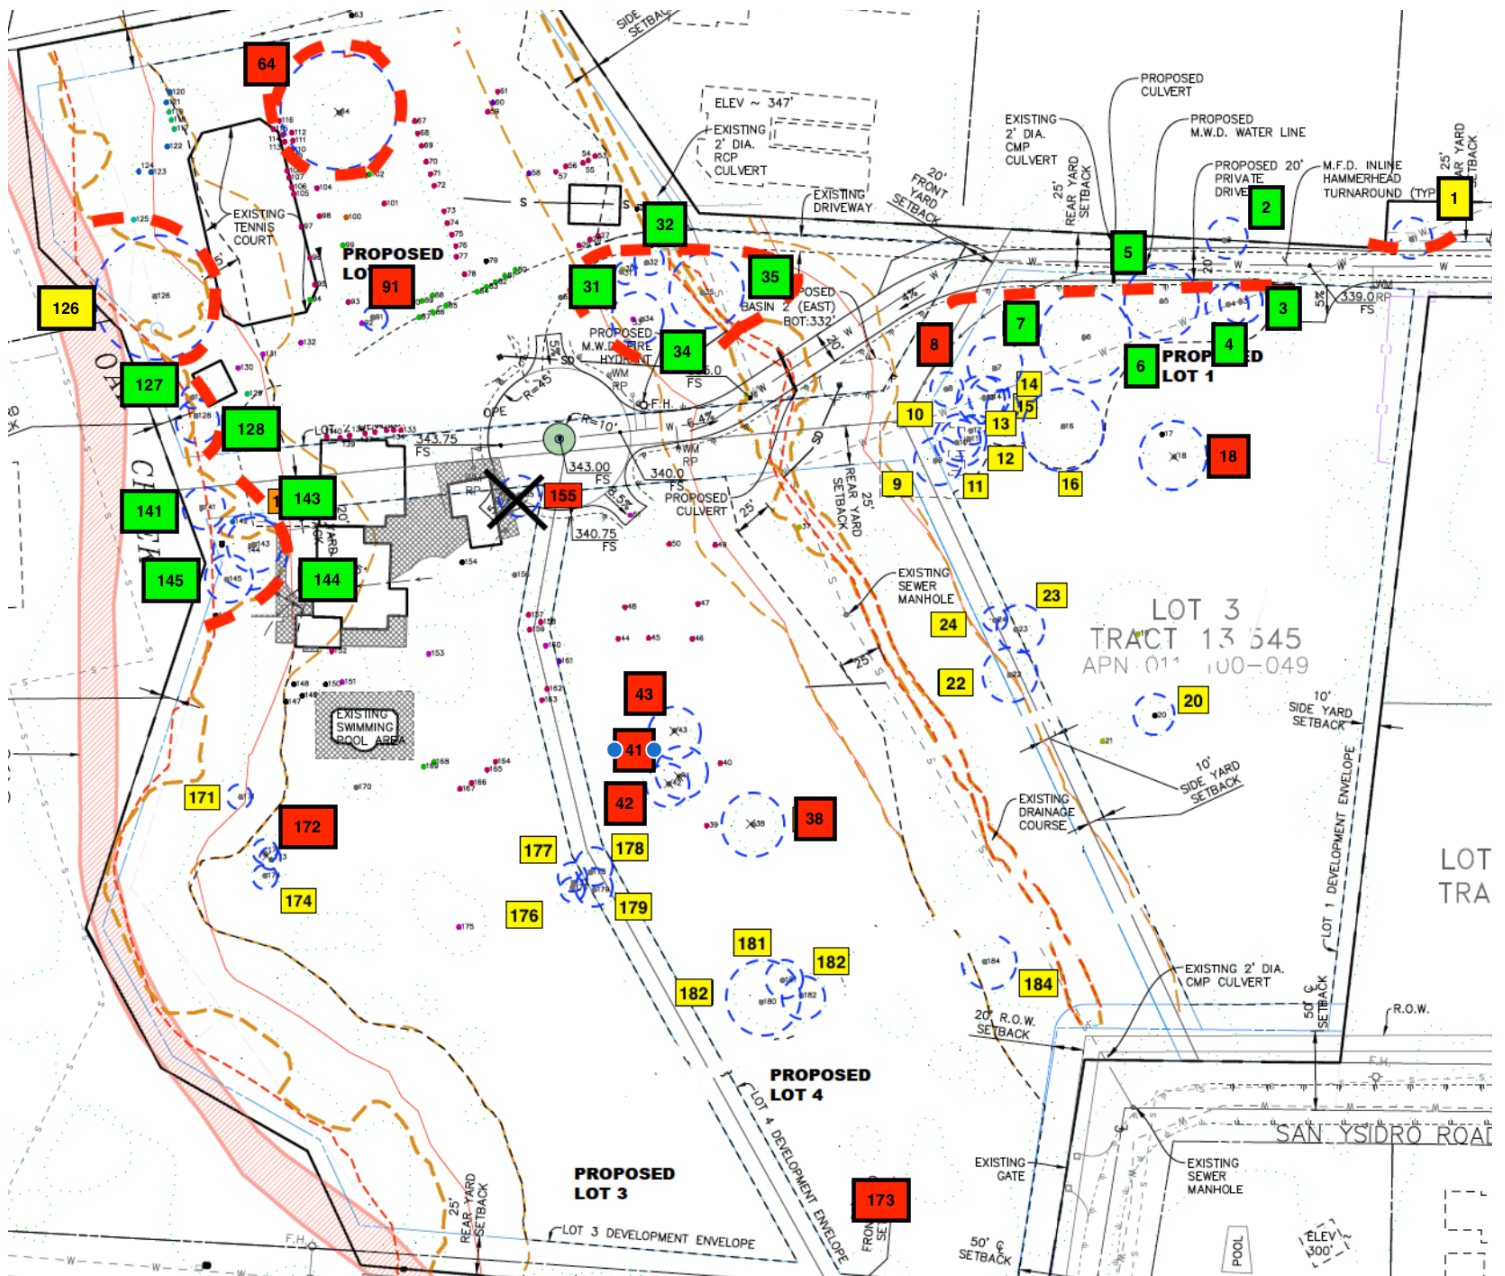
ORIGINAL SITE PLAN: All Trees (See updated plan on page 9)

1. Two oak trees (#8 & #155) will be removed for the initial phase of the project. Nine additional oaks (#18, #38, #41-#43, #64, #91, #172 & #173), are anticipated to be removed in the future by individual property owners. These are highlighted in red on the spreadsheet and site plan.
2. No other oaks or sycamores will be impacted from the initial phase of the project, provided fencing is in place as depicted in the site plan. The green highlighted numbers on the plan identify these native trees. Red dashed lines illustrate protection fencing locations.
3. Thirty three (33) 15-gallon oaks should be planted on site to mitigate the removal of the eleven oaks.
4. The project biologist will opine on any impacts to willows from work in the drainage and riparian areas and provide planting locations for mitigation trees.

1. In designated areas, install fences to establish TPZs (tree protection zones).
2. TPZs are necessary to keep out construction activities, equipment, storage of materials, and dumping of spoils.
3. Chain-link fencing on movable stands is recommended. These fences should be 5'-6' in height.
4. Fences must remain upright and secure throughout the duration of the project.
