Project No. G2755-42-01
November 15, 2021

Subject: SUPPLEMENTAL GEOTECHNICAL FAULT INVESTIGATION
NIRVANA PROPERTY
821 MAIN STREET
CHULA VISTA, CALIFORNIA

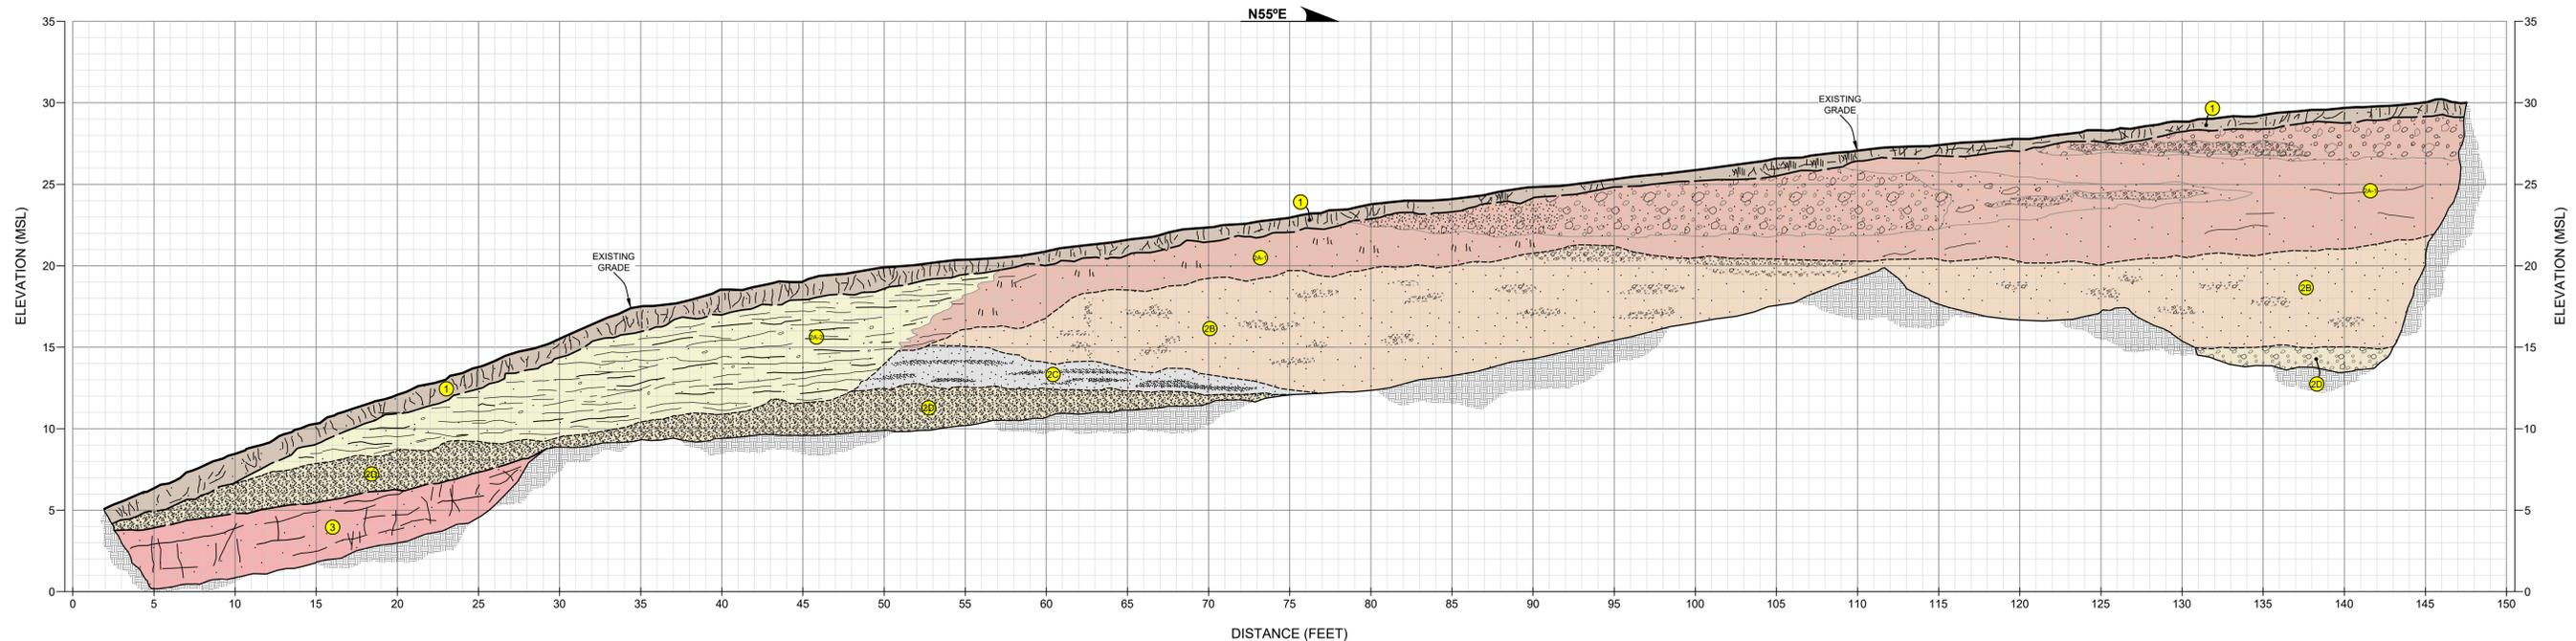
FAULT TRENCH FT-1
SCALE: 1" = 5' (Vert. = Horiz.)

Based on our field logging, there is no evidence of faulting or offset in the Pleistocene age Terrace Deposits exposed in our fault trench excavation. Our field observations support the conclusions presented in the referenced geotechnical reports. Therefore, we opine that the La Nacion fault segment depicted on regional maps and fault databases is not active as no evidence of faulting in Pleistocene age sediments has been observed on the site. The La Nacion fault segment, if present at the site, is confined to the Oligocene age Otay Formation (approximately 23 to 34 million years old) that underlies the Quaternary Terrace Deposits at the site and will not impact site development. A fault setback for the proposed development is not required.

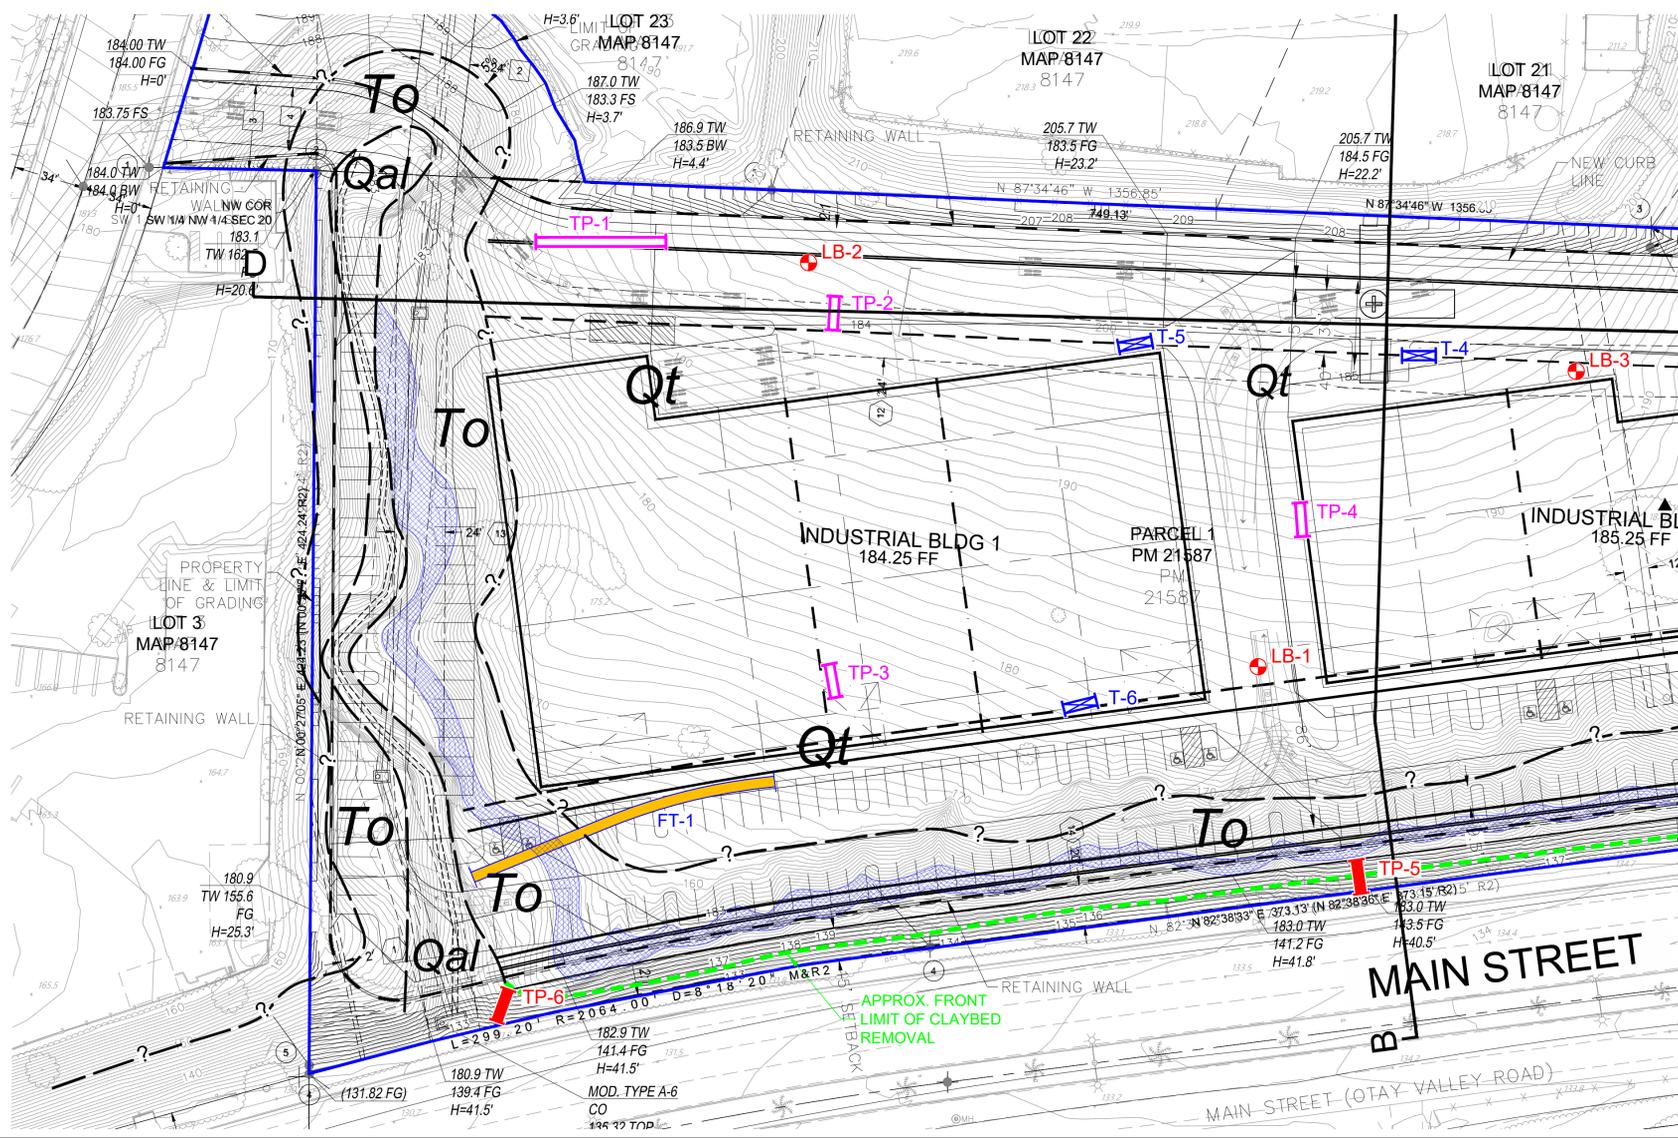
GEOLOGIC MAP AND FAULT TRENCH LOG
NIRVANA INDUSTRIAL BUILDINGS AND SELF STORAGE COMPLEX
821 MAIN STREET
CHULA VISTA, CALIFORNIA

Figure 1 shows the locations of fault trenches performed by Advanced Geotechnical Solutions (AGS; Reference 1; TP-1), and by Geocon Incorporated (FT-1; excavated on November 4, 2021). Fault trench locations and the fault trench log for FT-1 are presented on Figure 1. AGS did not provide a fault trench log in Reference 1.
