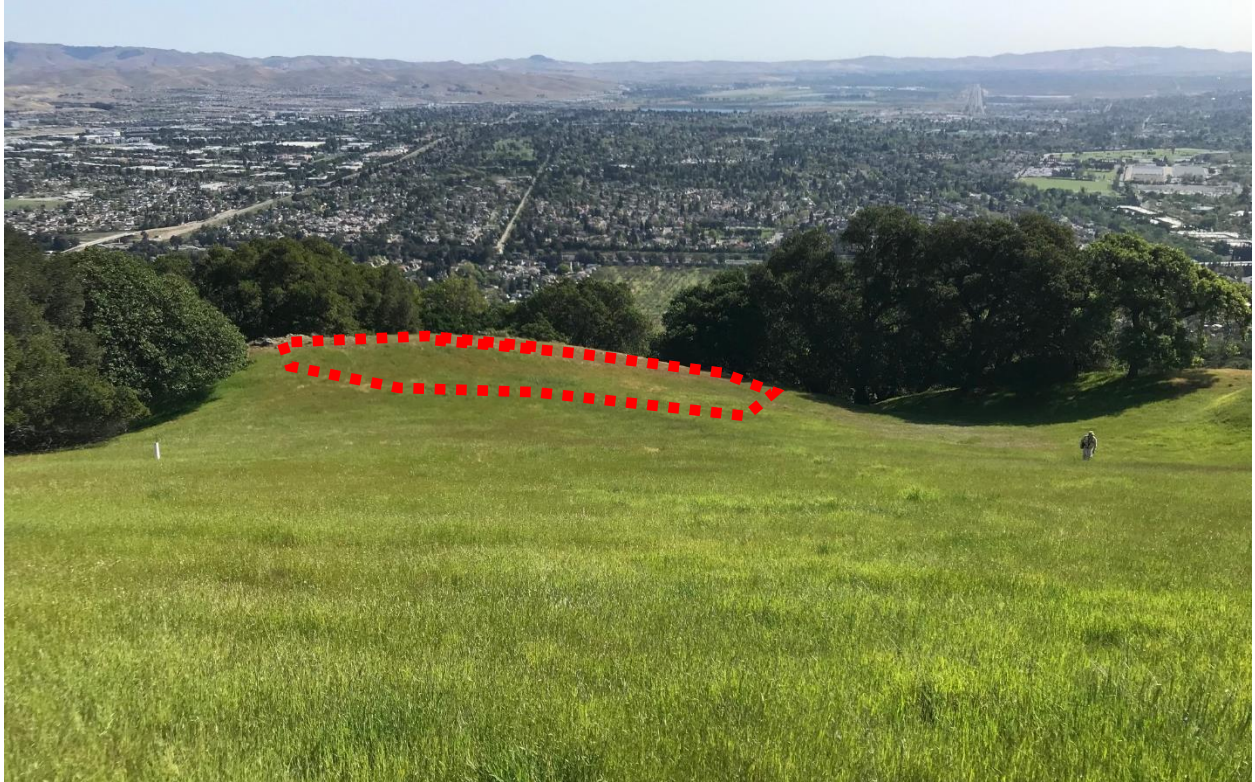
Photo 1. Non-native grassland with view to the east. Homesite location is outlined in red dots. Coast live oak woodland surrounds the homesite (4/6/2022).

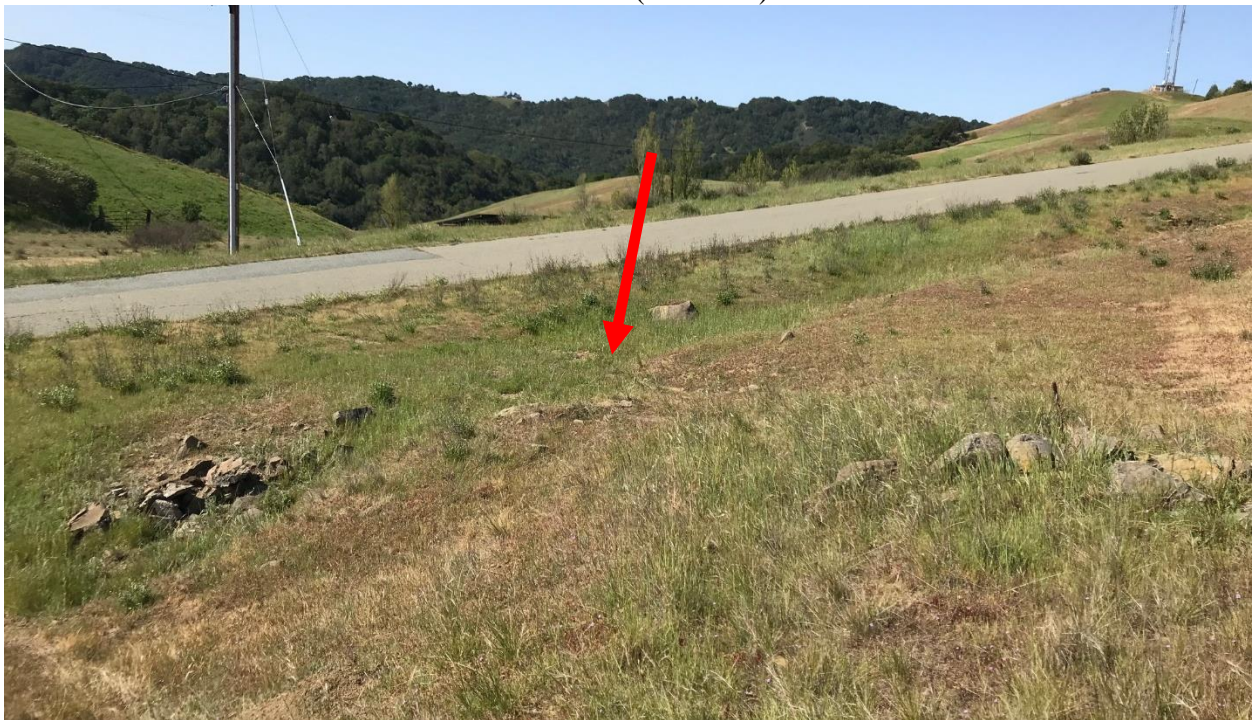
Photo 2. Roadside ditch that will be crossed by driveway is indicated by red arrow, with Santos Ranch Road behind. View is to the southwest (4/6/2022)

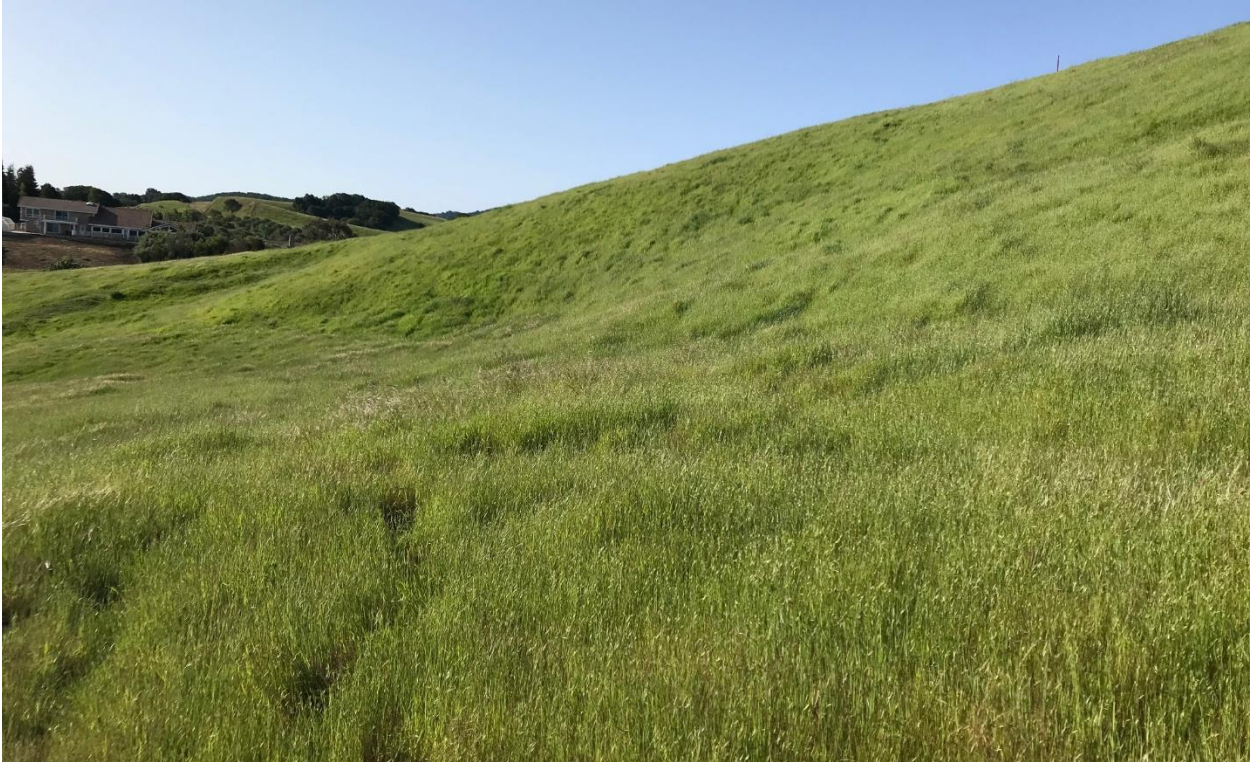
Photo 3. Non-native grassland to be traversed by driveway. View is to the south (4/6/2022).

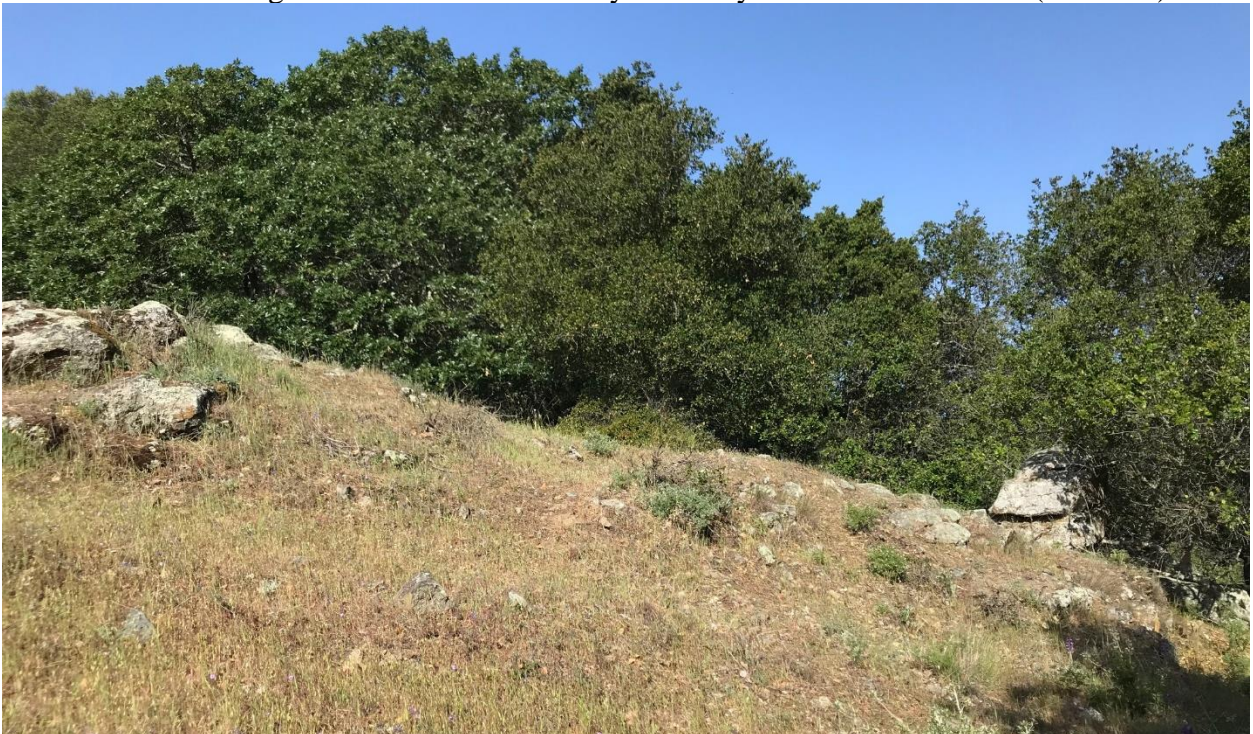
Photo 4. The rock outcroppings surrounding the area to be developed during homesite construction will not be disturbed. Coast live oak woodland lies to the north, east and south of the homesite. View is to the north (4/5/2022)

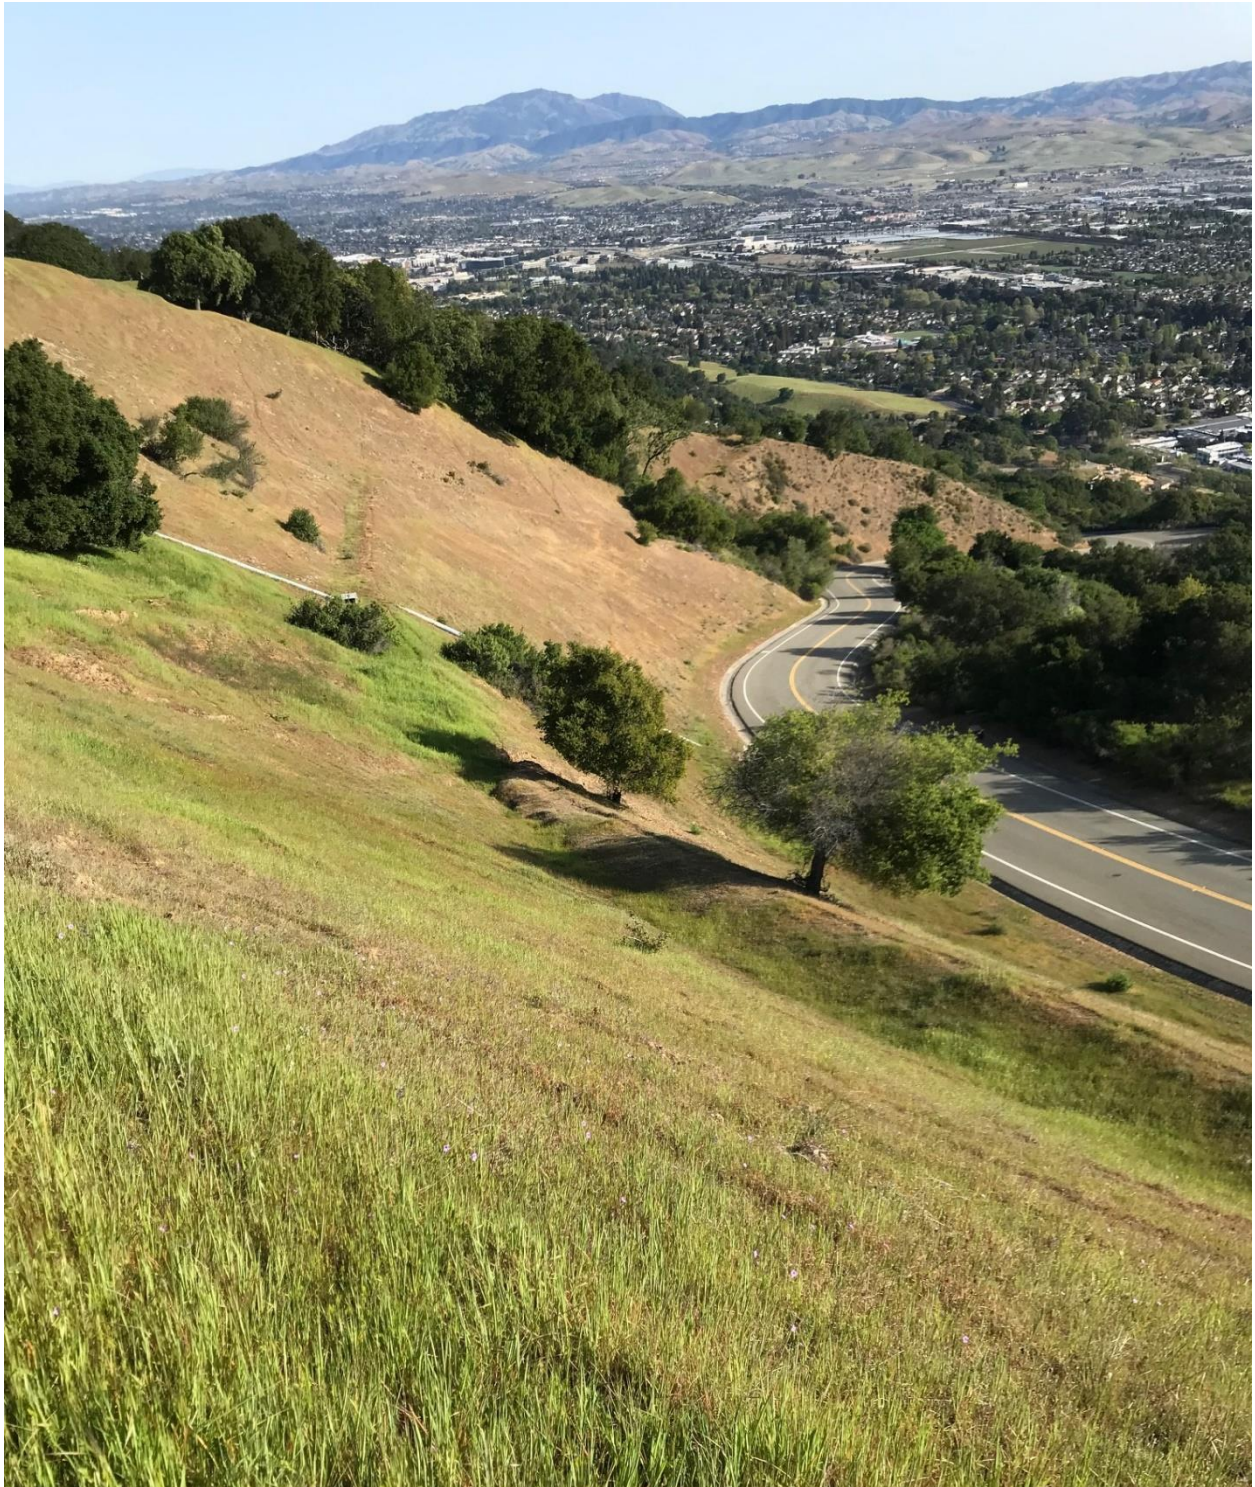
Photo 5. This east-facing slope in the Study Area, dominated by ruderal herbaceous species was disturbed during construction of Santos Ranch Road (4/6/2022).
