Arborist Survey Report for the Nicholas Elementary School Replacement Project

Sacramento County, California

February 21, 2023

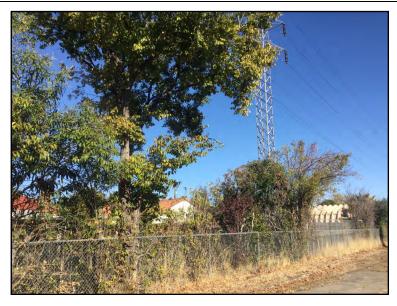
Photo 1. View of trees along northern boundary, looking northeast. Photo taken November 10, 2022.

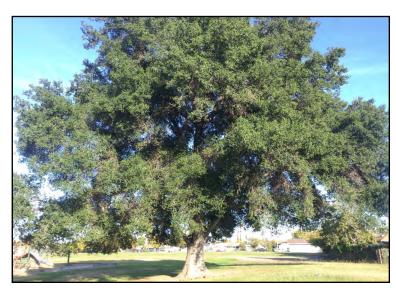
number 964 is a heritage tree. Tree number 15, the valley oak, is unknown whether it is a heritage tree as it is in a residential backyard and the trunk was not visible during the survey.

Tree number 964 will be retained and protected within the Study Area. The recommendations in Section 6.0 apply to this tree.

Photo 3. View of large interior live oak that will be preserved, looking east. Photo taken November 10, 2022.

- a. Avoid grade cuts greater than 1 foot within the driplines of oak trees, and within 5 feet of their trunks.
- b. Avoid fill greater than 1 foot within the driplines of oak trees and any placement of fill within 5 feet of their trunks.
- c. Avoid trenching within the driplines of oak trees. If it is absolutely necessary to install underground utilities within the driplines of an oak tree, it is recommended that the trench be either bored or drilled.
- d. Avoid installing irrigation systems within the driplines of oak tree(s) as it may be detrimental to the long term survival of the oak tree(s).

- a. Major roots 2 inches or greater in diameter encountered within the tree's dripline in the course of excavation from beneath trees that are not to be removed should be kept moist and covered with earth as soon as feasible. Roots 1 inch to 2 inches in diameter that are severed should be trimmed, treated with pruning compound, and covered with earth as soon as possible.
- Support roots that are inside the dripline of the tree should be protected to the extent feasible.
 Hand-digging is recommended in the vicinity of major trees to prevent root cutting and mangling by heavy equipment.

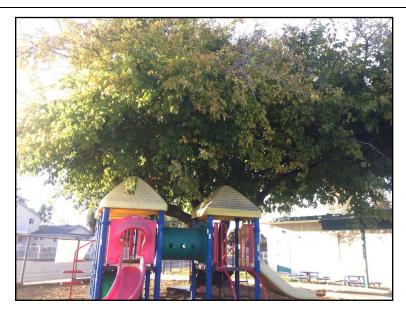
Photo 2. View of mulberry in playground, looking northwest. Photo taken November 10, 2022.

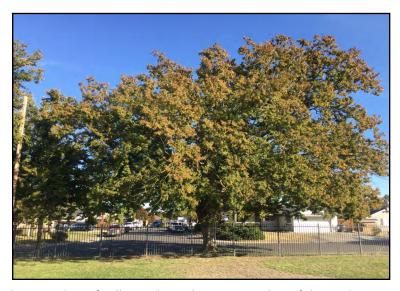
Photo 4. View of zelkova along the eastern edge of the project, looking east. Photo taken November 10, 2022.
