Rubio Wash Channel Improvements
Project Arborist Report

ARBORIST REPORT

RUBIO WASH CHANNEL IMPROVEMENTS PROJECT, COUNTY OF LOS ANGELES, CALIFORNIA

SEPTEMBER 2018

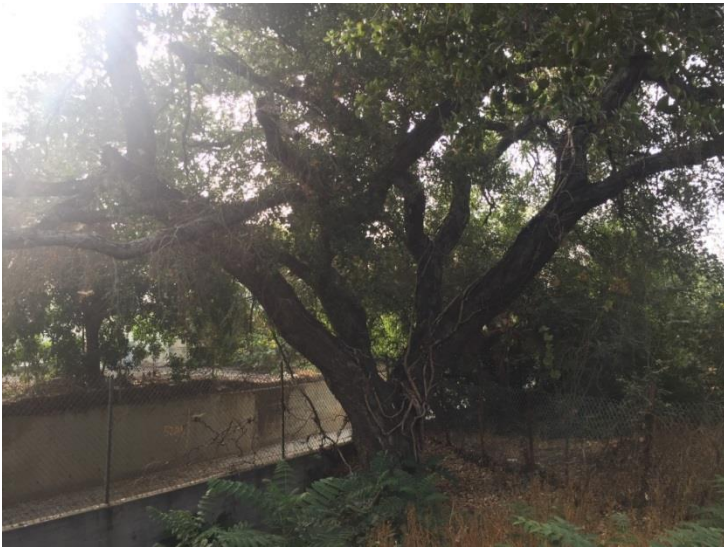
1. Overview photo of Tree Number 1, coast live oak proposed for removal, as viewed facing southeast.

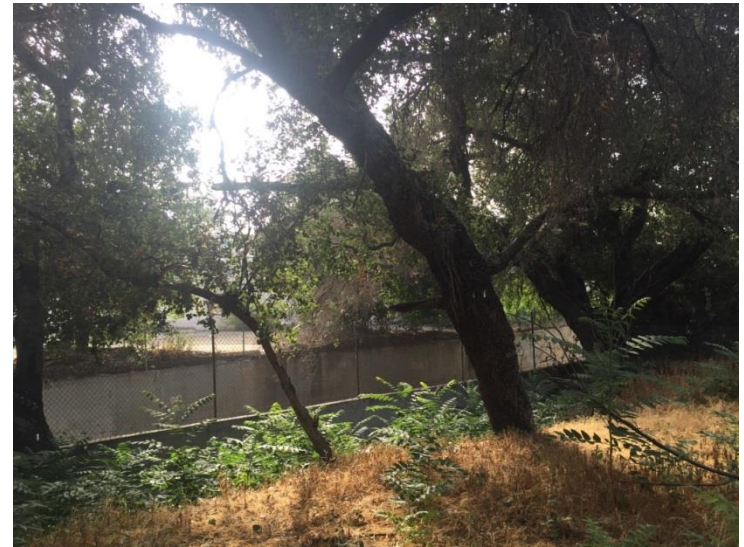
2. Overview photo of Tree Numbers 2 and 3 (R to L), coast live oaks proposed for removal, as viewed facing southeast.

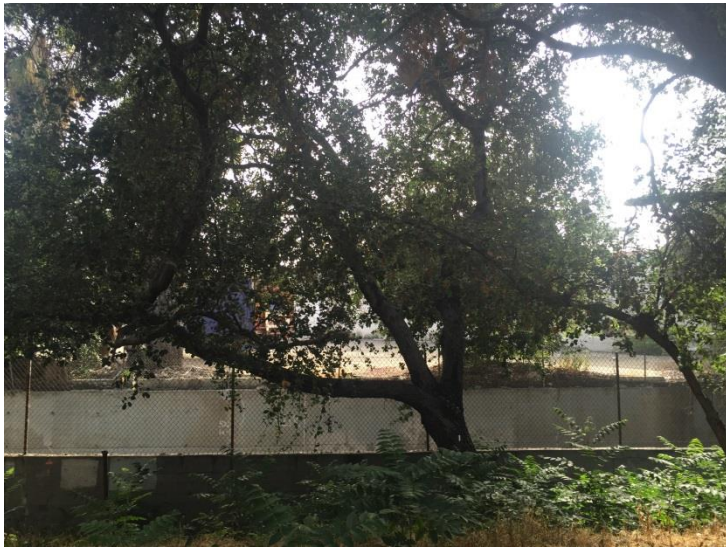
3. Overview photo of Tree Number 4, coast live oak proposed for removal, as viewed facing east.

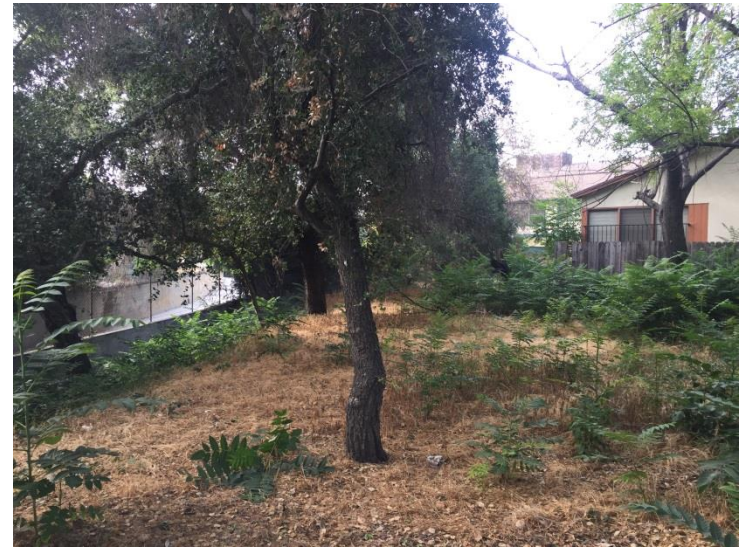
4. Overview photo of Tree Number 5, coast live oak proposed for encroachment, as viewed facing southeast.

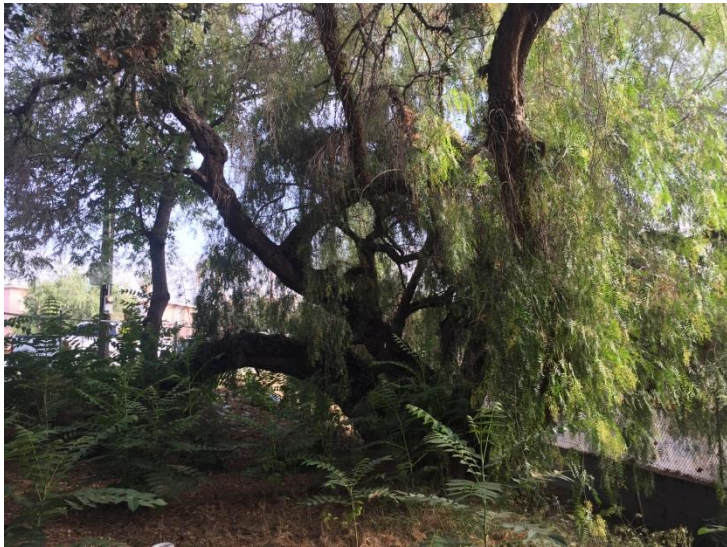
5. Overview photo of Tree Number 6, Peruvian pepper tree proposed for removal, as viewed facing northeast.

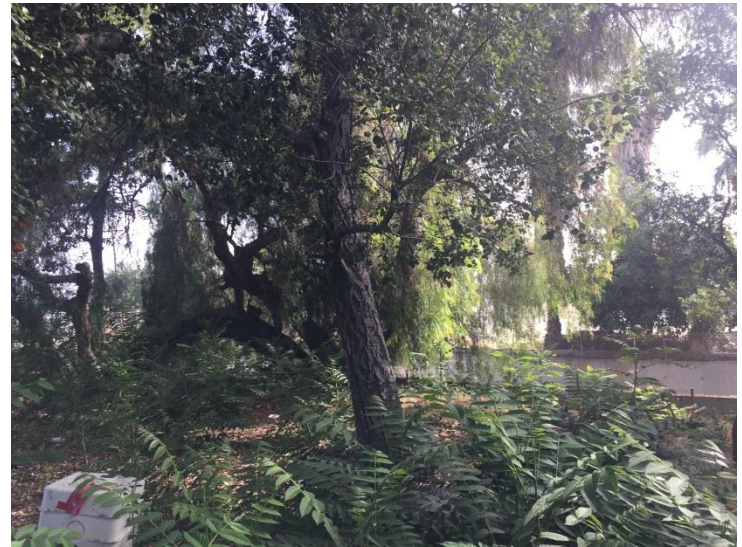
6. Overview photo of Tree Number 8, coast live oak proposed for indirect impact, as viewed facing east.

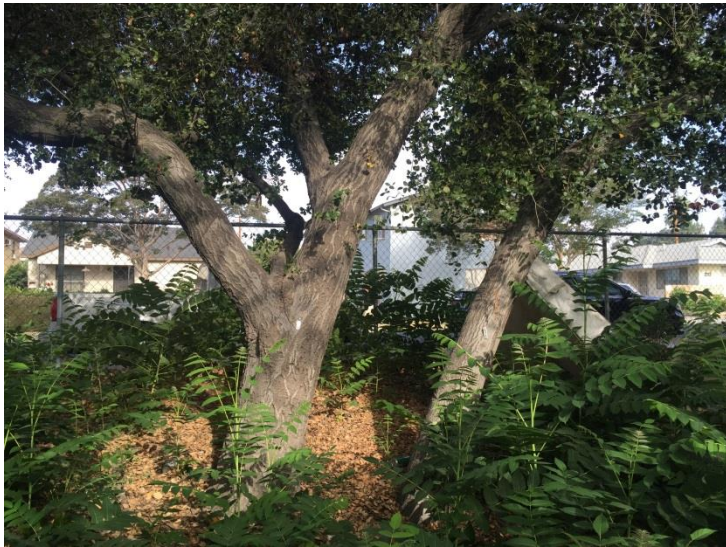
7. Overview photo of Tree Numbers 9 and 10 (R to L), coast live oaks proposed for protection in place, as viewed facing west.

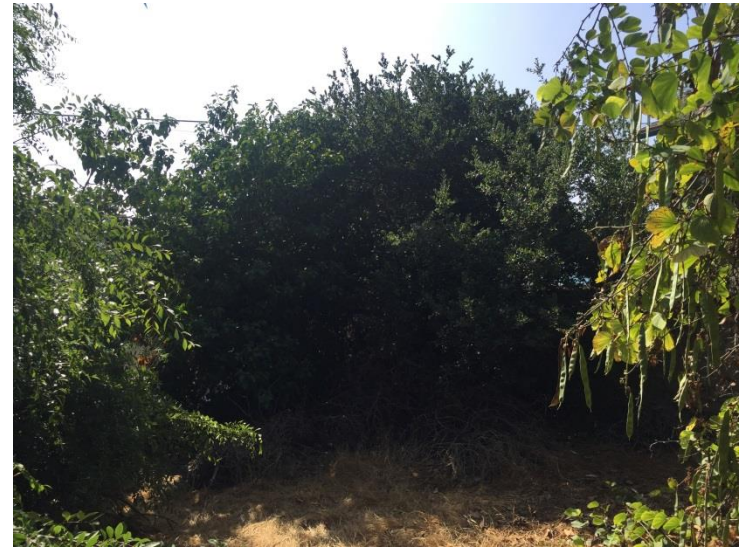
8. Overview photo of Tree Number 41, coast live oak proposed for removal, as viewed facing east.

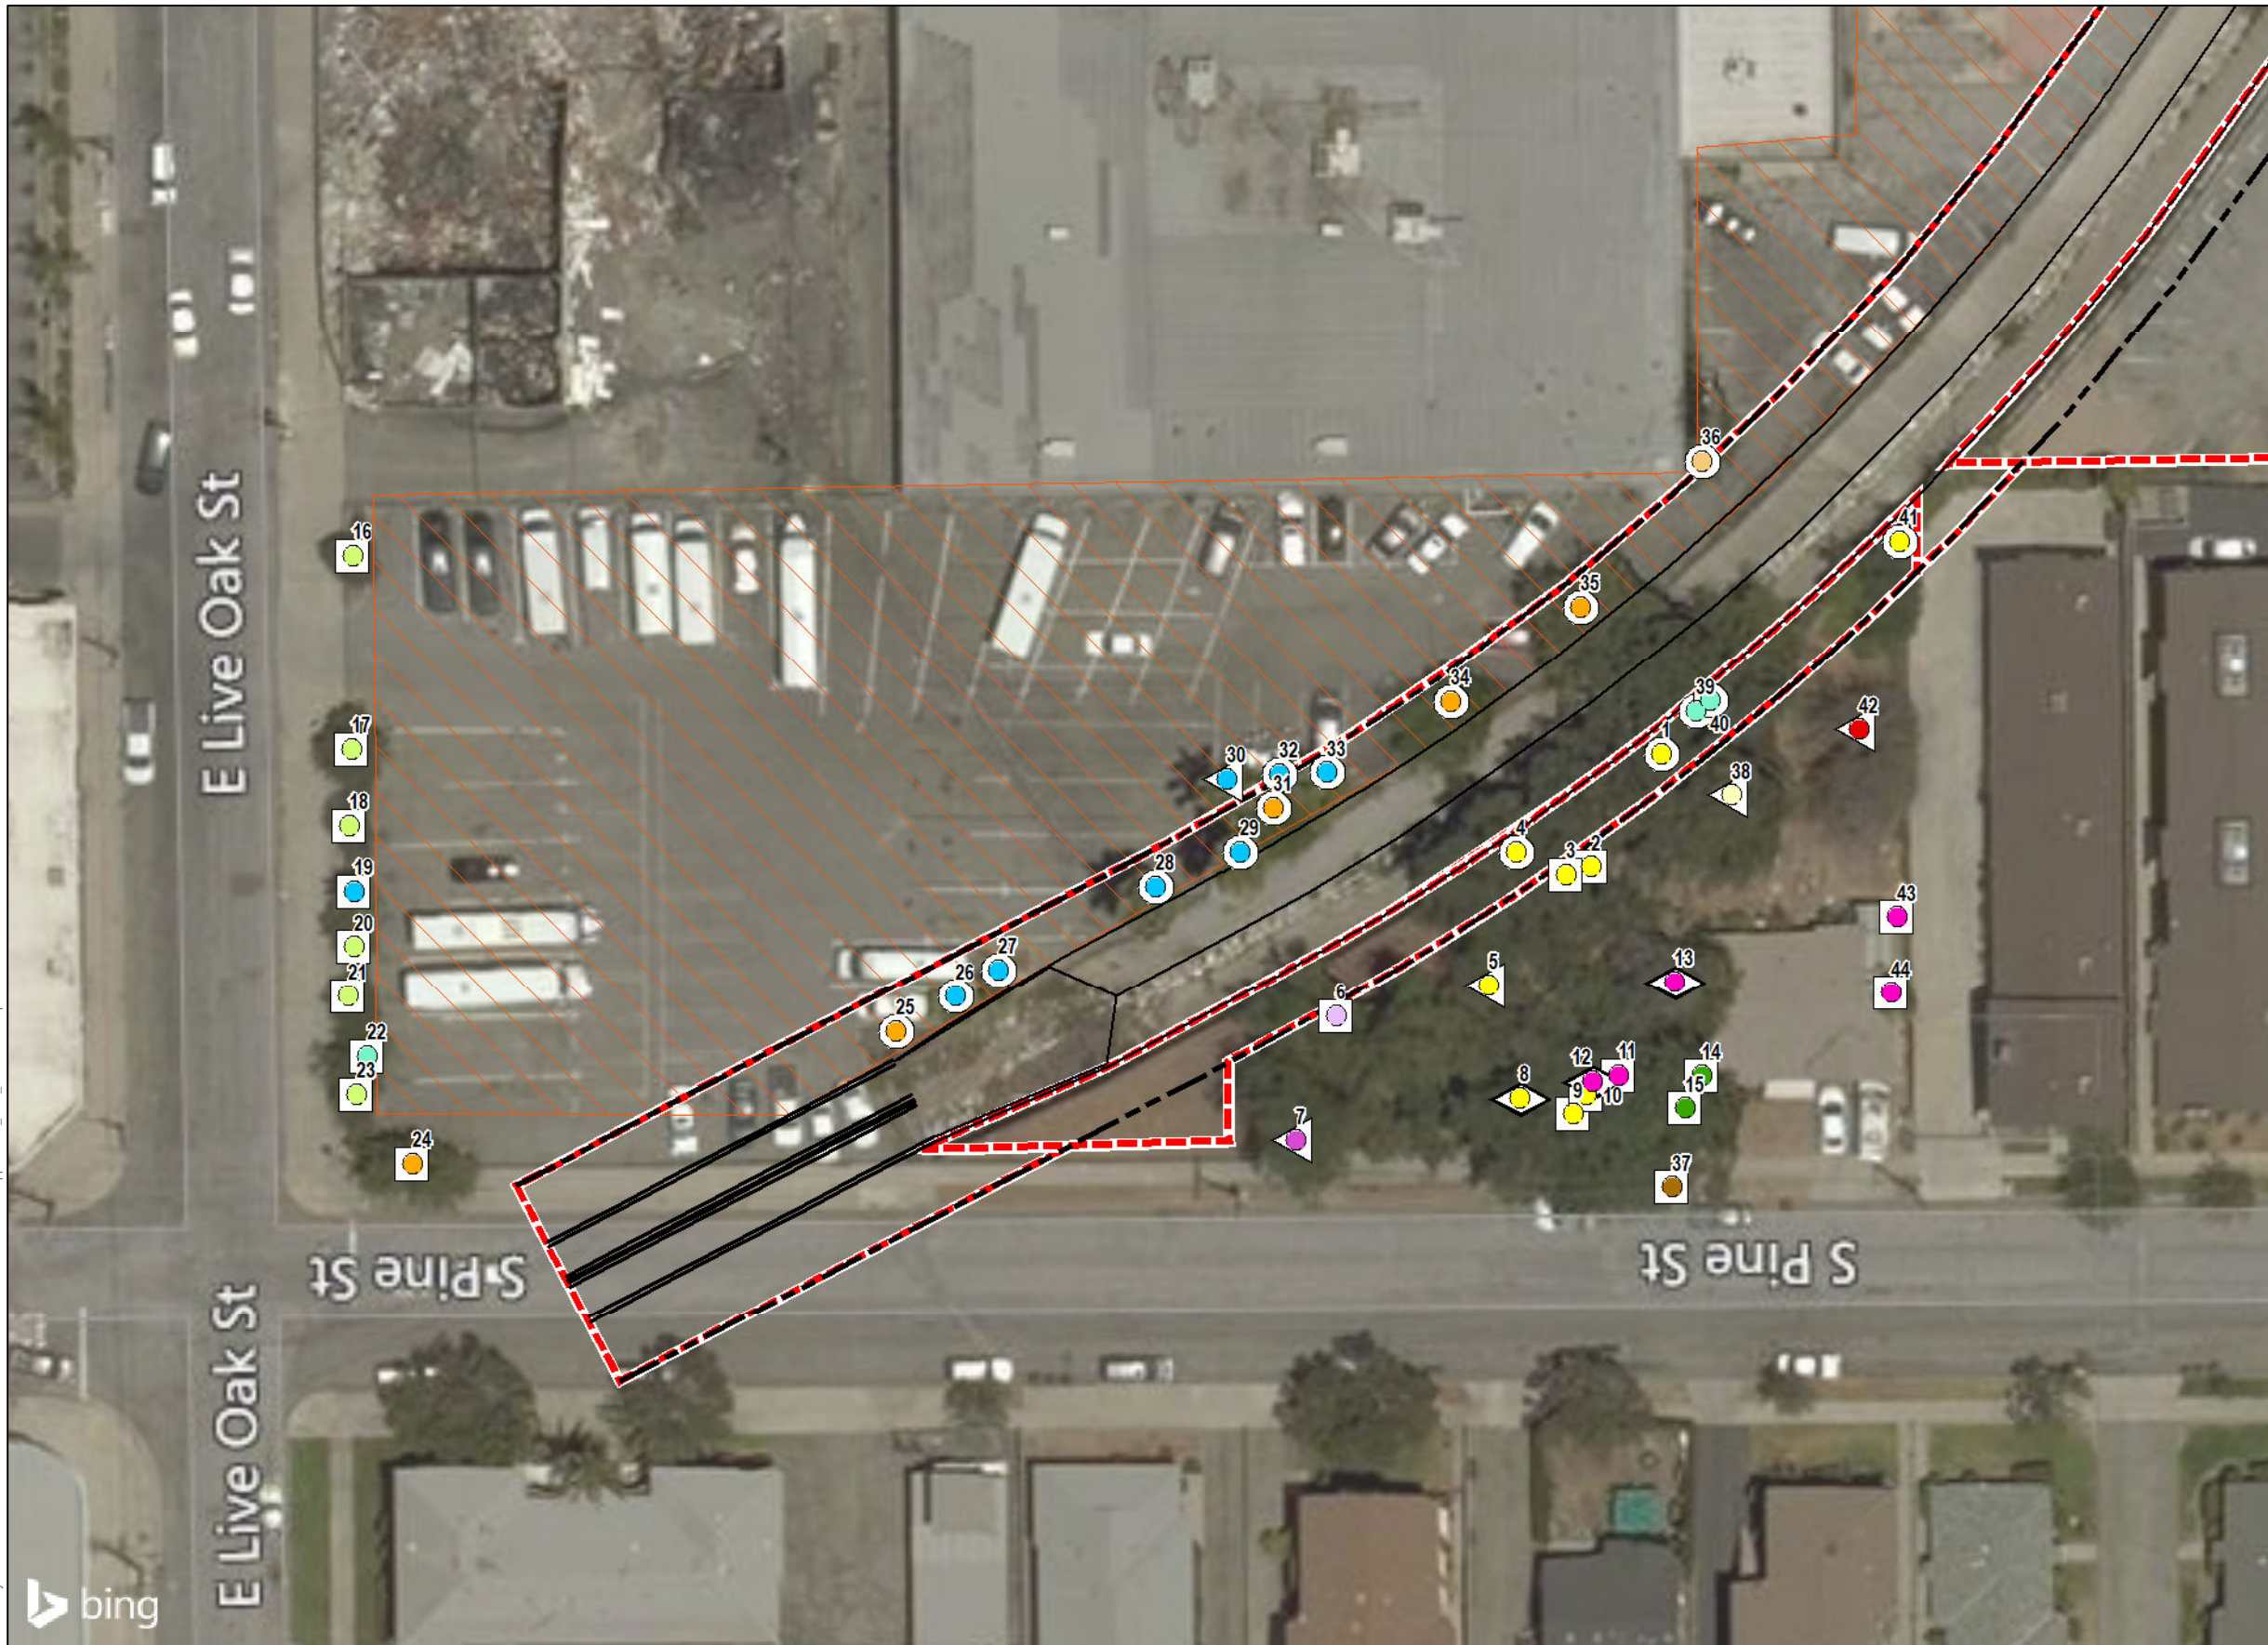
Tree Location and Disposition Exhibit

The location of each tree identified in the project site is depicted in Appendix C.

Eight trees will experience encroachment into the tree protection zone, six of which are considered protected by the City; three trees will experience indirect impacts and are considered protected by the City; and 17 will be preserved in place with no direct impacts. The locations of impacted trees, by impact type, are presented in Appendix C. Measures to minimize the extent of impact to preserved trees are provided in Appendix D.
