February 15, 2017

Job No. 1-216-0670

**SUBJECT: ADDITIONAL SOIL PROFILE LOGS AND PERCOLATION TESTS RESULTS /ADDENDUM #1
 PROPOSED ON-SITE SEPTIC SYSTEM
 7548 HENNESS RIDGE DRIVE
 YOSEMITE NP, MARIPOSA COUNTY, CALIFORNIA 95389**

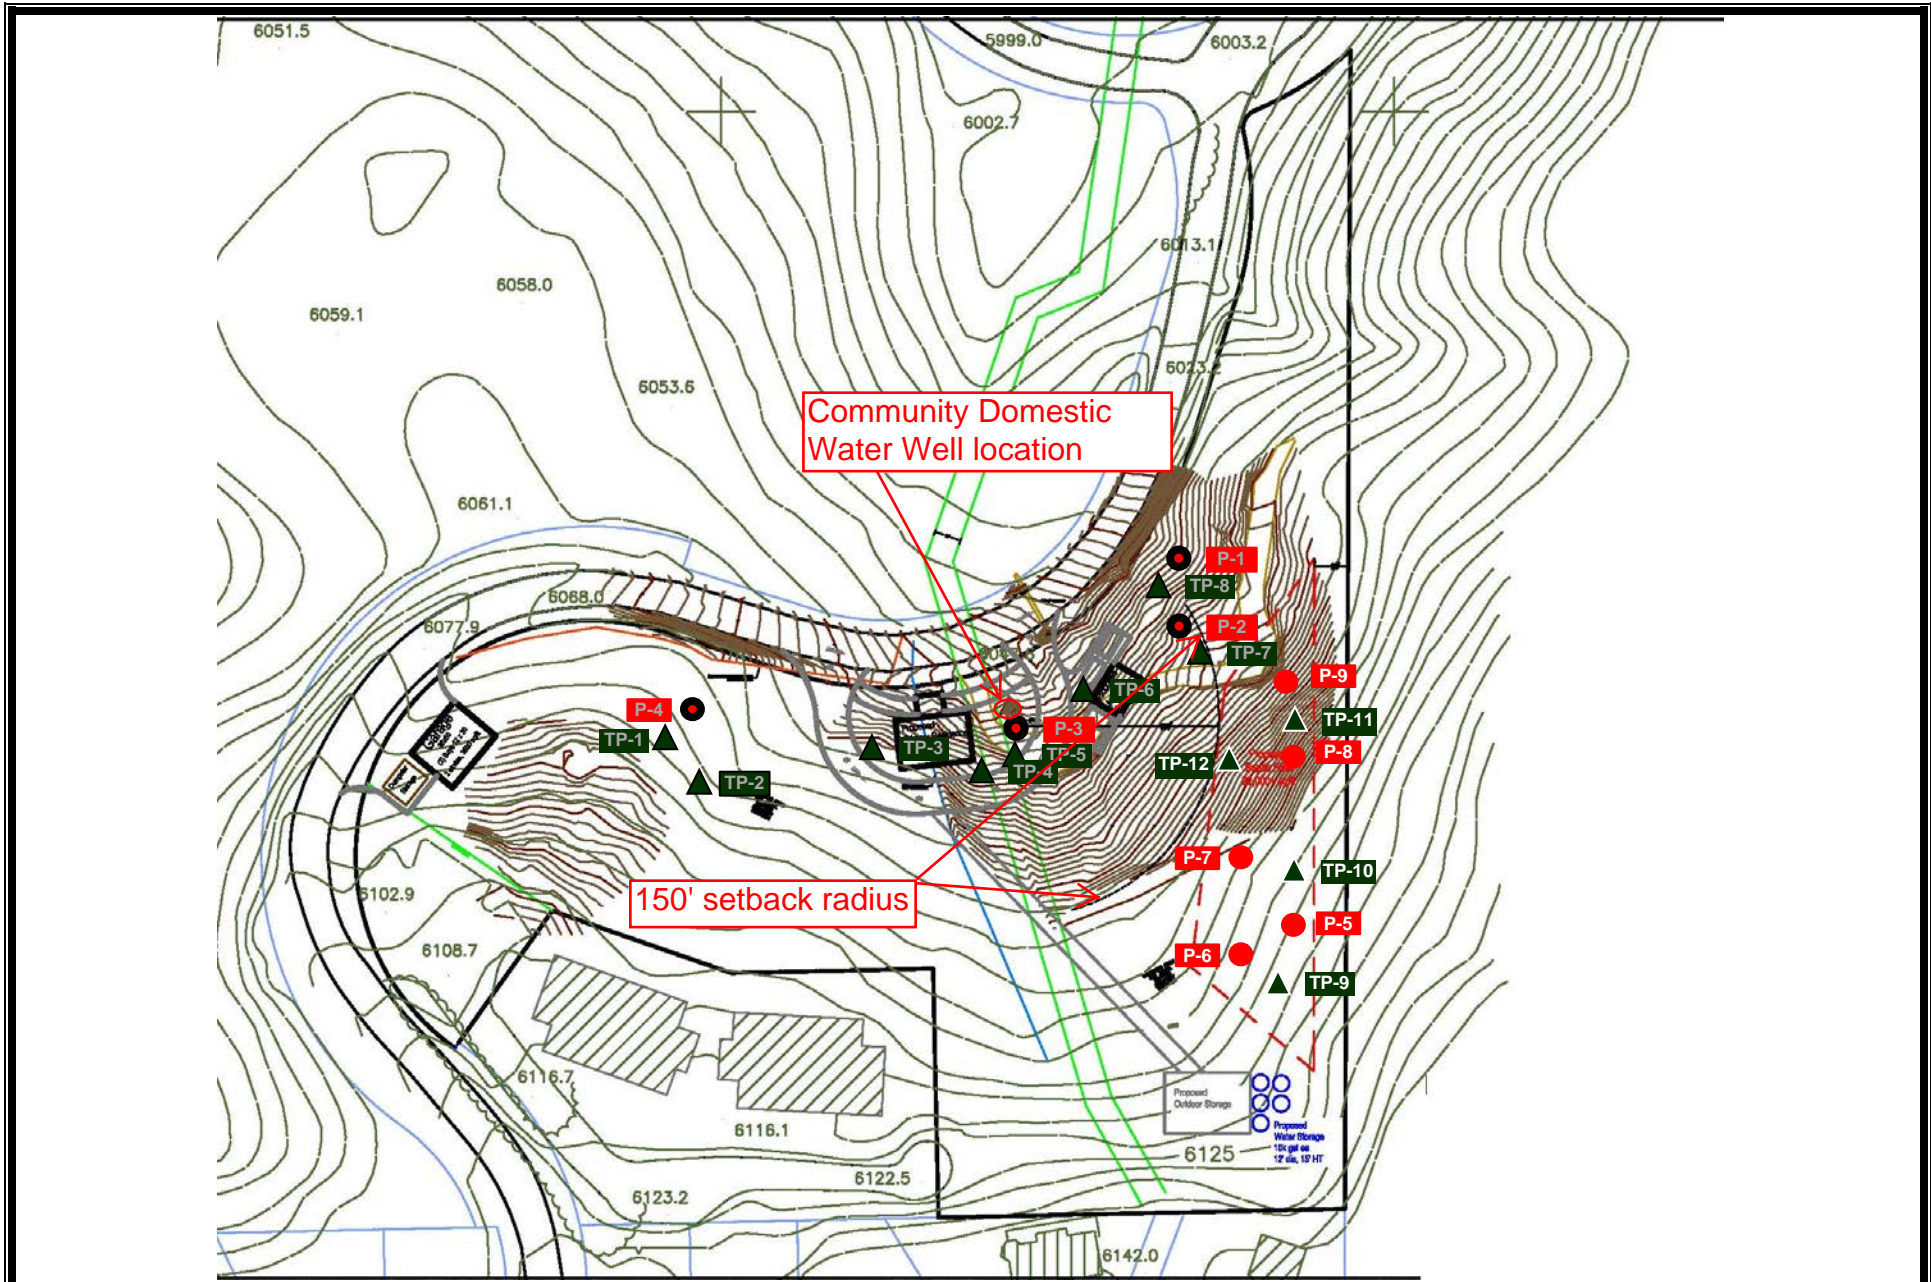
indicated on the Site Map, Figure 2. The field investigation was carried out/planned according to a site plan relevant at the time of exploration. The current Site Plan (Figure 2), as well as the test pit logs and percolation test data is included at the end of this report.

On December 22nd and 23rd, 2016, SALEM observed the soil conditions within four (4) test pits and conducted five (5) percolation tests. The purpose of the soil profile test pits was to visually classify and record a continuous log of the native soils encountered. Utilizing the soil profile, five (5) locations were selected to perform percolation testing. In general, due to varying site conditions, the percolation tests were performed at locations throughout the site between depths of 1.7, 2.2, 2.3, 4.3, and 4.9 feet, as advised by Mariposa County Environmental Health Department personnel. The testing and profile boring were conducted in accordance with guidelines established by the U.S. EPA Method of Septic Tank Practices, as well as Mariposa County Environmental Health Department requirements. The approximate location of the percolation tests and profile boring are shown on the attached Site Plan, Figure 2.
