Arborist Report

Jim Borer, Certified Arborist #496

Re: Summary of Field Inspection and Inventory of Existing Trees, Nov. 12, 2023
TTM 83528
3700 Monterey Avenue
El Monte, Ca.

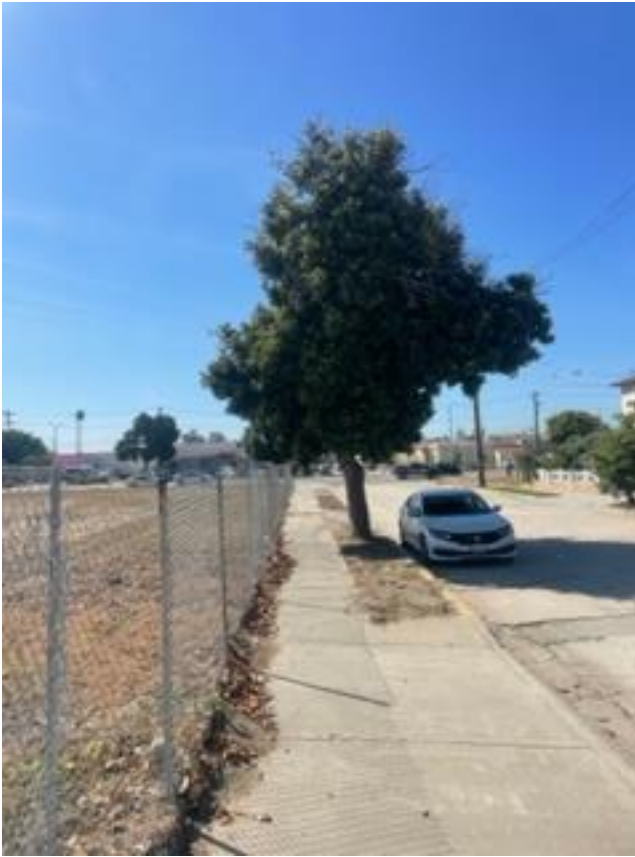
Tree #1, *Magnolia grandiflora*, southern magnolia

The magnolias are mostly vigorous specimens that are growing as mature specimens of a species that has a widely dispersed surface root network that is not drought tolerant and which would be adversely affected by any encroachment during the operations.

The magnolias are considered to meet the standard that makes them 'Heritage Trees. They generally exhibit good canopy densities but poor form and structures that include significant defects, wounds, that would expose them to poor dispositions for long-term conservation in place. The site grading would expose these magnolias to widespread root system encroachment. They are quite mature and are supported by widespread, shallow root systems that would be wounded, expected to under-perform, and unlikely to survive with archetypal vigor or viability after encroachment.

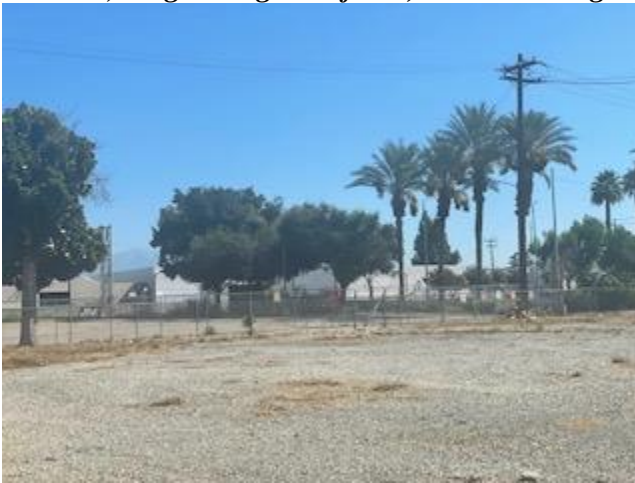
Tree #s 2, and three left to right, and palms 4-7, right to left beyond the utility pole.

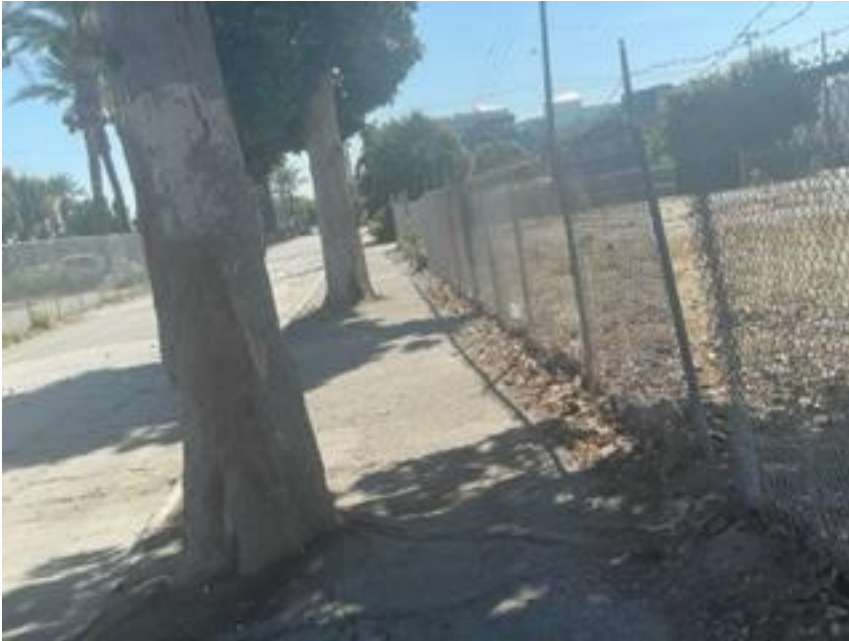
The three magnolias are growing within the central portion, street frontage, of the project site and would be encroached and exposed to injury by the site demolition and grading operations. The magnolias would be expected to be significantly encroached in the grading process given the remedial grading requirements defined by civil engineers in their report relating to the alluvial soils.

Trunks of tree numbers 2 and 3 with their root crowns paved up to with concrete sidewalks and curbs.

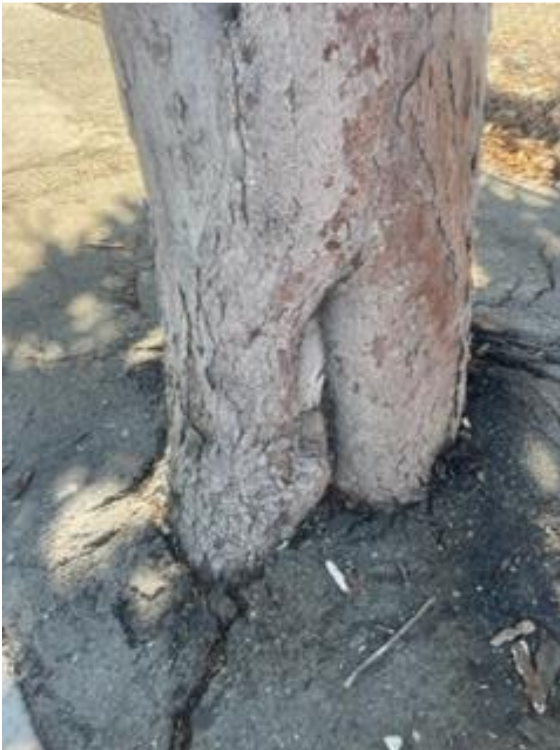
Tree # 2 with basal wound on trunk, comparable to other wounds on magnolias.

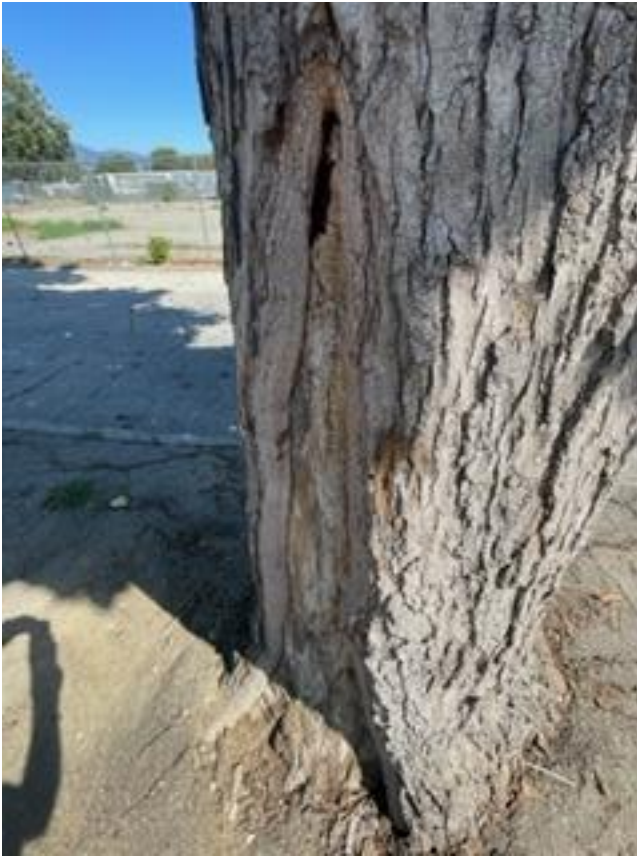
Magnolia tree # 3, larger basal wound.

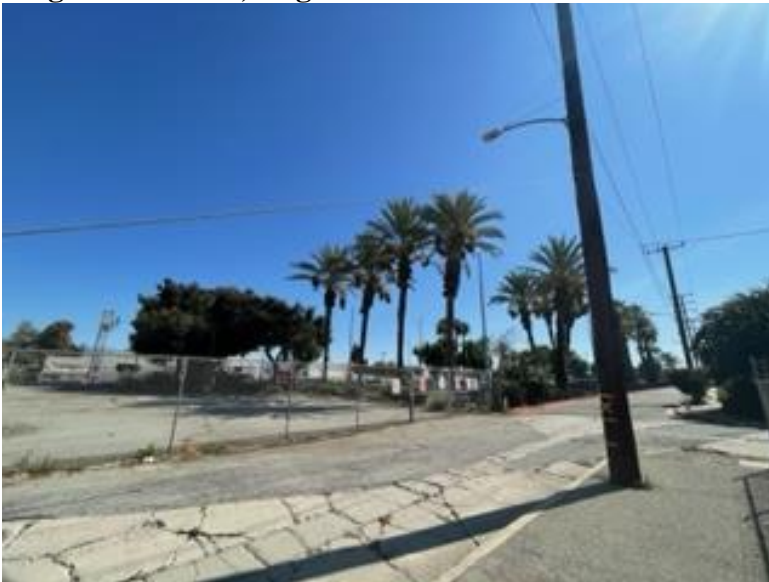
Palm numbers 4-7 are growing offsite on the boundary with the property to the east of the site. The palms are growing at the southern end of the eastern property boundary where the Metrolink communication station is located. They are typical mature specimens that are archetypal in vigor, form, and character, and well-disposed to performing vigorously no matter what happens within the proposed development site.

Tree numbers 8-12, growing offsite on property boundary to the east of the site boundary fence. They are vigorous maturing specimens that are well-disposed to perform vigorously for the long-term given their existing conditions.

Closer view of off-site date palms, numbers 4-7, and coast live oaks to left, numbers 8-12.

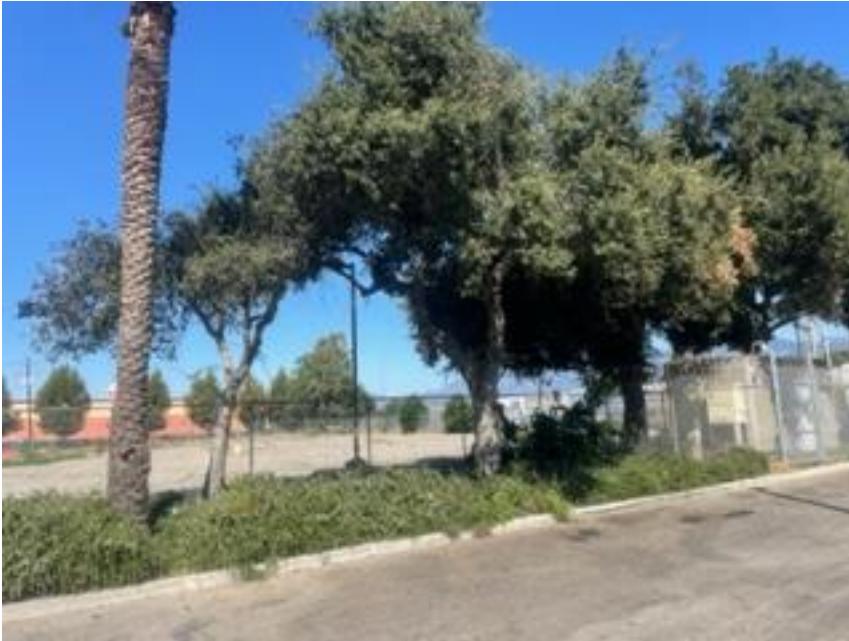
It is my opinion that tree numbers 8, 9, and 12 are reasonably well enough removed from the nearest encroachments, boundary wall to be effectively conserved without too much special care or attention in the development process. Oak tree numbers 10 and 11 would be exposed to much more effects of encroachment given their closer proximity, as close as two feet away, to the boundary location. These trees would require deliberate, simple, conservation methods to limit the effects of grading and permanent barrier boundary wall development upon their root systems and systemic viability. Phil Malcomson discussed the limits of grading being setback from the property boundary grading and that the boundary wall construction would be in the general location of the existing fence.

Tree numbers 7, date palm, 8 and 9, coast live oaks on adjacent property to the east of the project site. Boundary fence can be seen beyond the oak trunks to establish proximity to the site.

The construction of a wall in the existing fence location would require alternative construction methods adjacent to oak tree numbers 10 and 11 to ensure that their root systems are not unduly impacted. The alternate fencing methods could include the use of a wrought iron fence that relies on pier footings that would be centered away from the two oaks trunks or construction of a block wall using grade beams in the sections adjacent to tree number 10 and 11 instead of a conventional linear footing adjacent to their trunks and root crowns.

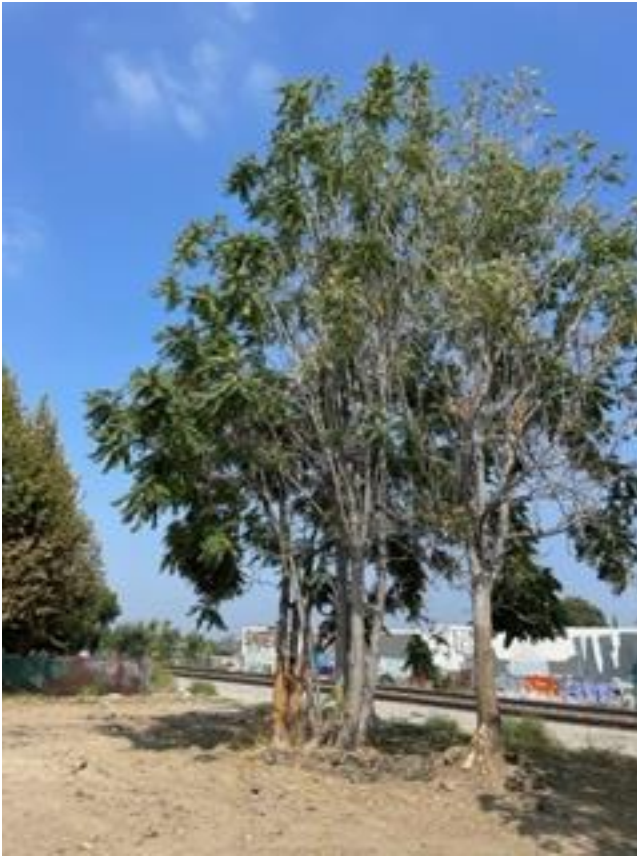
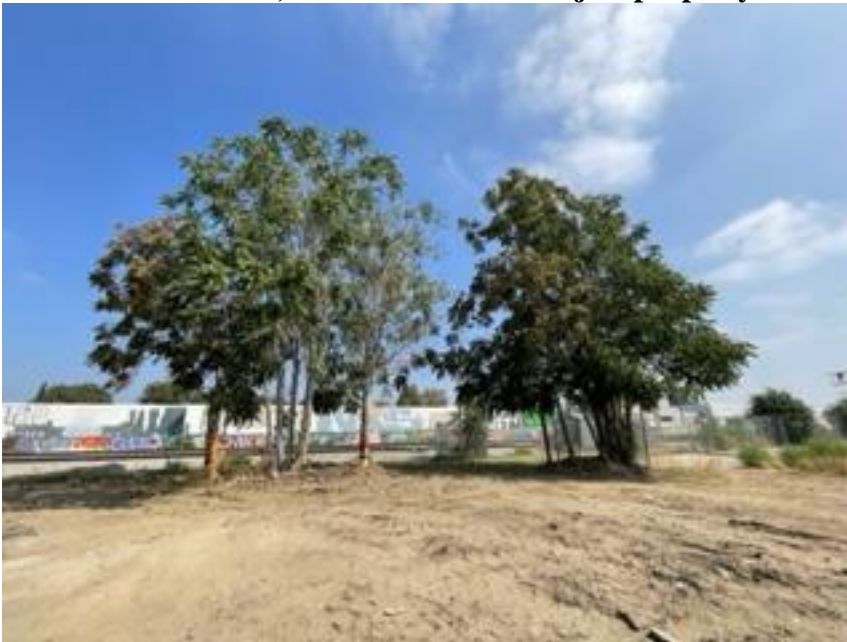
'Tree of heaven' numbers 13, 15, 16, and 17 are all Heritage Trees as defined by the Heritage Tree Ordinance. Tree number 14 does not meet the minimum size requirements to be considered a Heritage Tree. The 'trees of heaven' are within a portion of the project site that would be subject to grading, significantly impacted, and are proposed for removal.

The individuals are vigorous specimens of a species that is considered by the California Department of Agriculture to be a noxious weed given their ability to volunteer seed freely and aggressively. These specimens' structures are mechanically wounded on their exposed lower trunks and are proposed for removal.

Tree numbers 15-17, *Ailanthus alt.* on subject property.

Tree numbers 13-17, *Ailanthus altissima*, right to left as seen herein.

'Tree of Heaven' number 13, 15, 17, and 17 are considered to meet the standard that makes them 'Heritage Trees. Tree number 14 does not meet the criteria. The 'trees of heaven' have many adverse qualities both individually and as a species, are poor candidates for conservation in any circumstance, and are subject to severe encroachment by site grading operations. **The 'Tree of Heaven' are proposed for removal.**

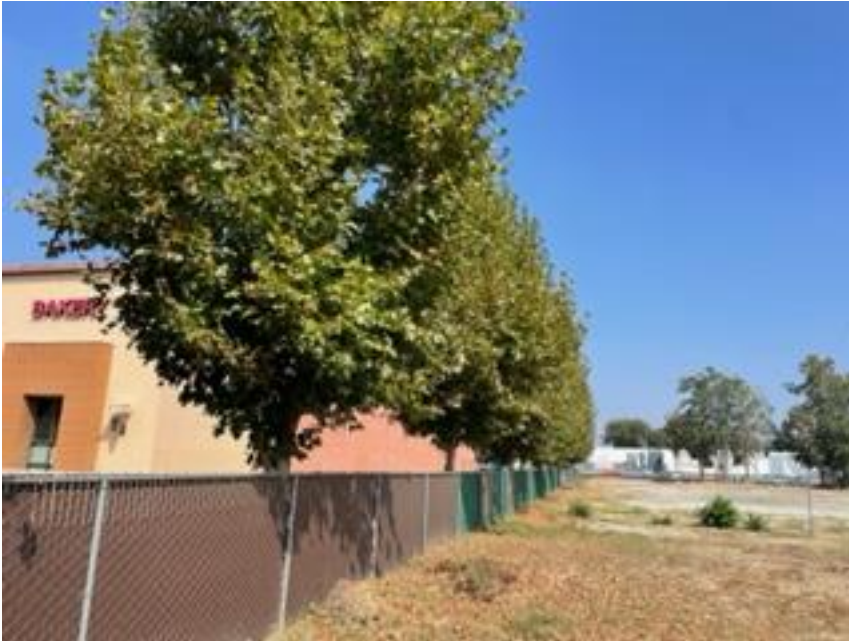
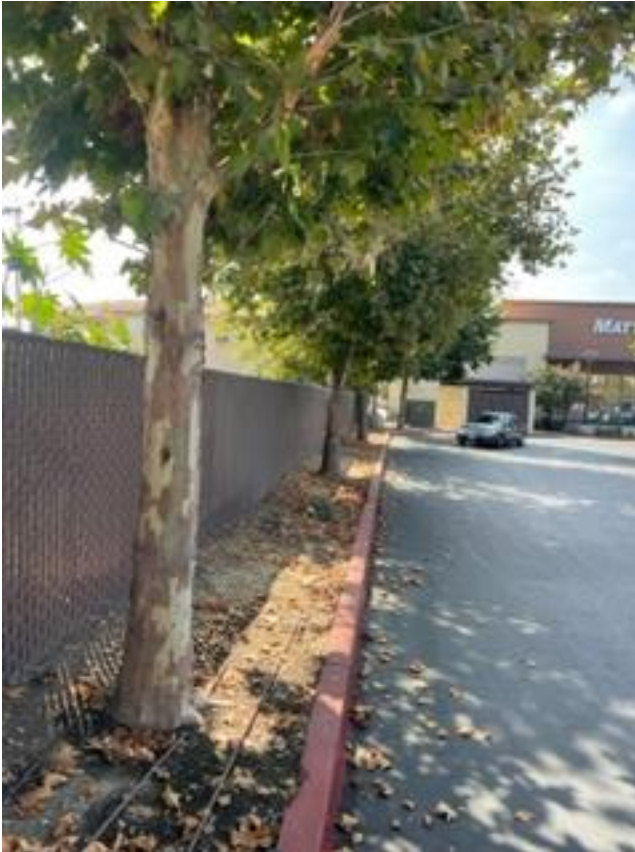
The London plane trees all meet the criteria to be considered Heritage Trees, are growing in a linear row on the adjacent retail property to the west of the subject property. They are growing between two and four feet from the existing property boundary fence that appears to be the boundary between the two properties. The individual trees are performing vigorously, support good archetypal form and character, and are well-disposed to long-term conservation given their existing conditions and the existing site usages.

The London plane tree proximities to the property boundary could expose their root systems to mechanical damage if a standard wall is constructed in the location of the existing chain link boundary fence. As an alternative to the construction of a standard block wall along the boundary supported by a continuous footing either the construction of a wrought iron fence with pier footings adjacent to the trees or else a block wall build using pier footings and grade beams would inflict less damage to the London plane trees root systems.

Typical for tree numbers 18-32 from property side of boundary fence.

Typical tree numbers 18-32 as seen from adjacent side of property boundary fence.

the use of sympathetic alternative methods of enclosing the property boundaries, either using wrought iron fencing with supporting piers or walls supported by grade beam footings adjacent to the individual offsite trees' trunks.
