### Tree Inventory Report

**CITY OF LOS ANGELES TREE REPORT  
1811 SACRAMENTO STREET  
LOS ANGELES, CALIFORNIA 90021**

**MARCH 21, 2023**

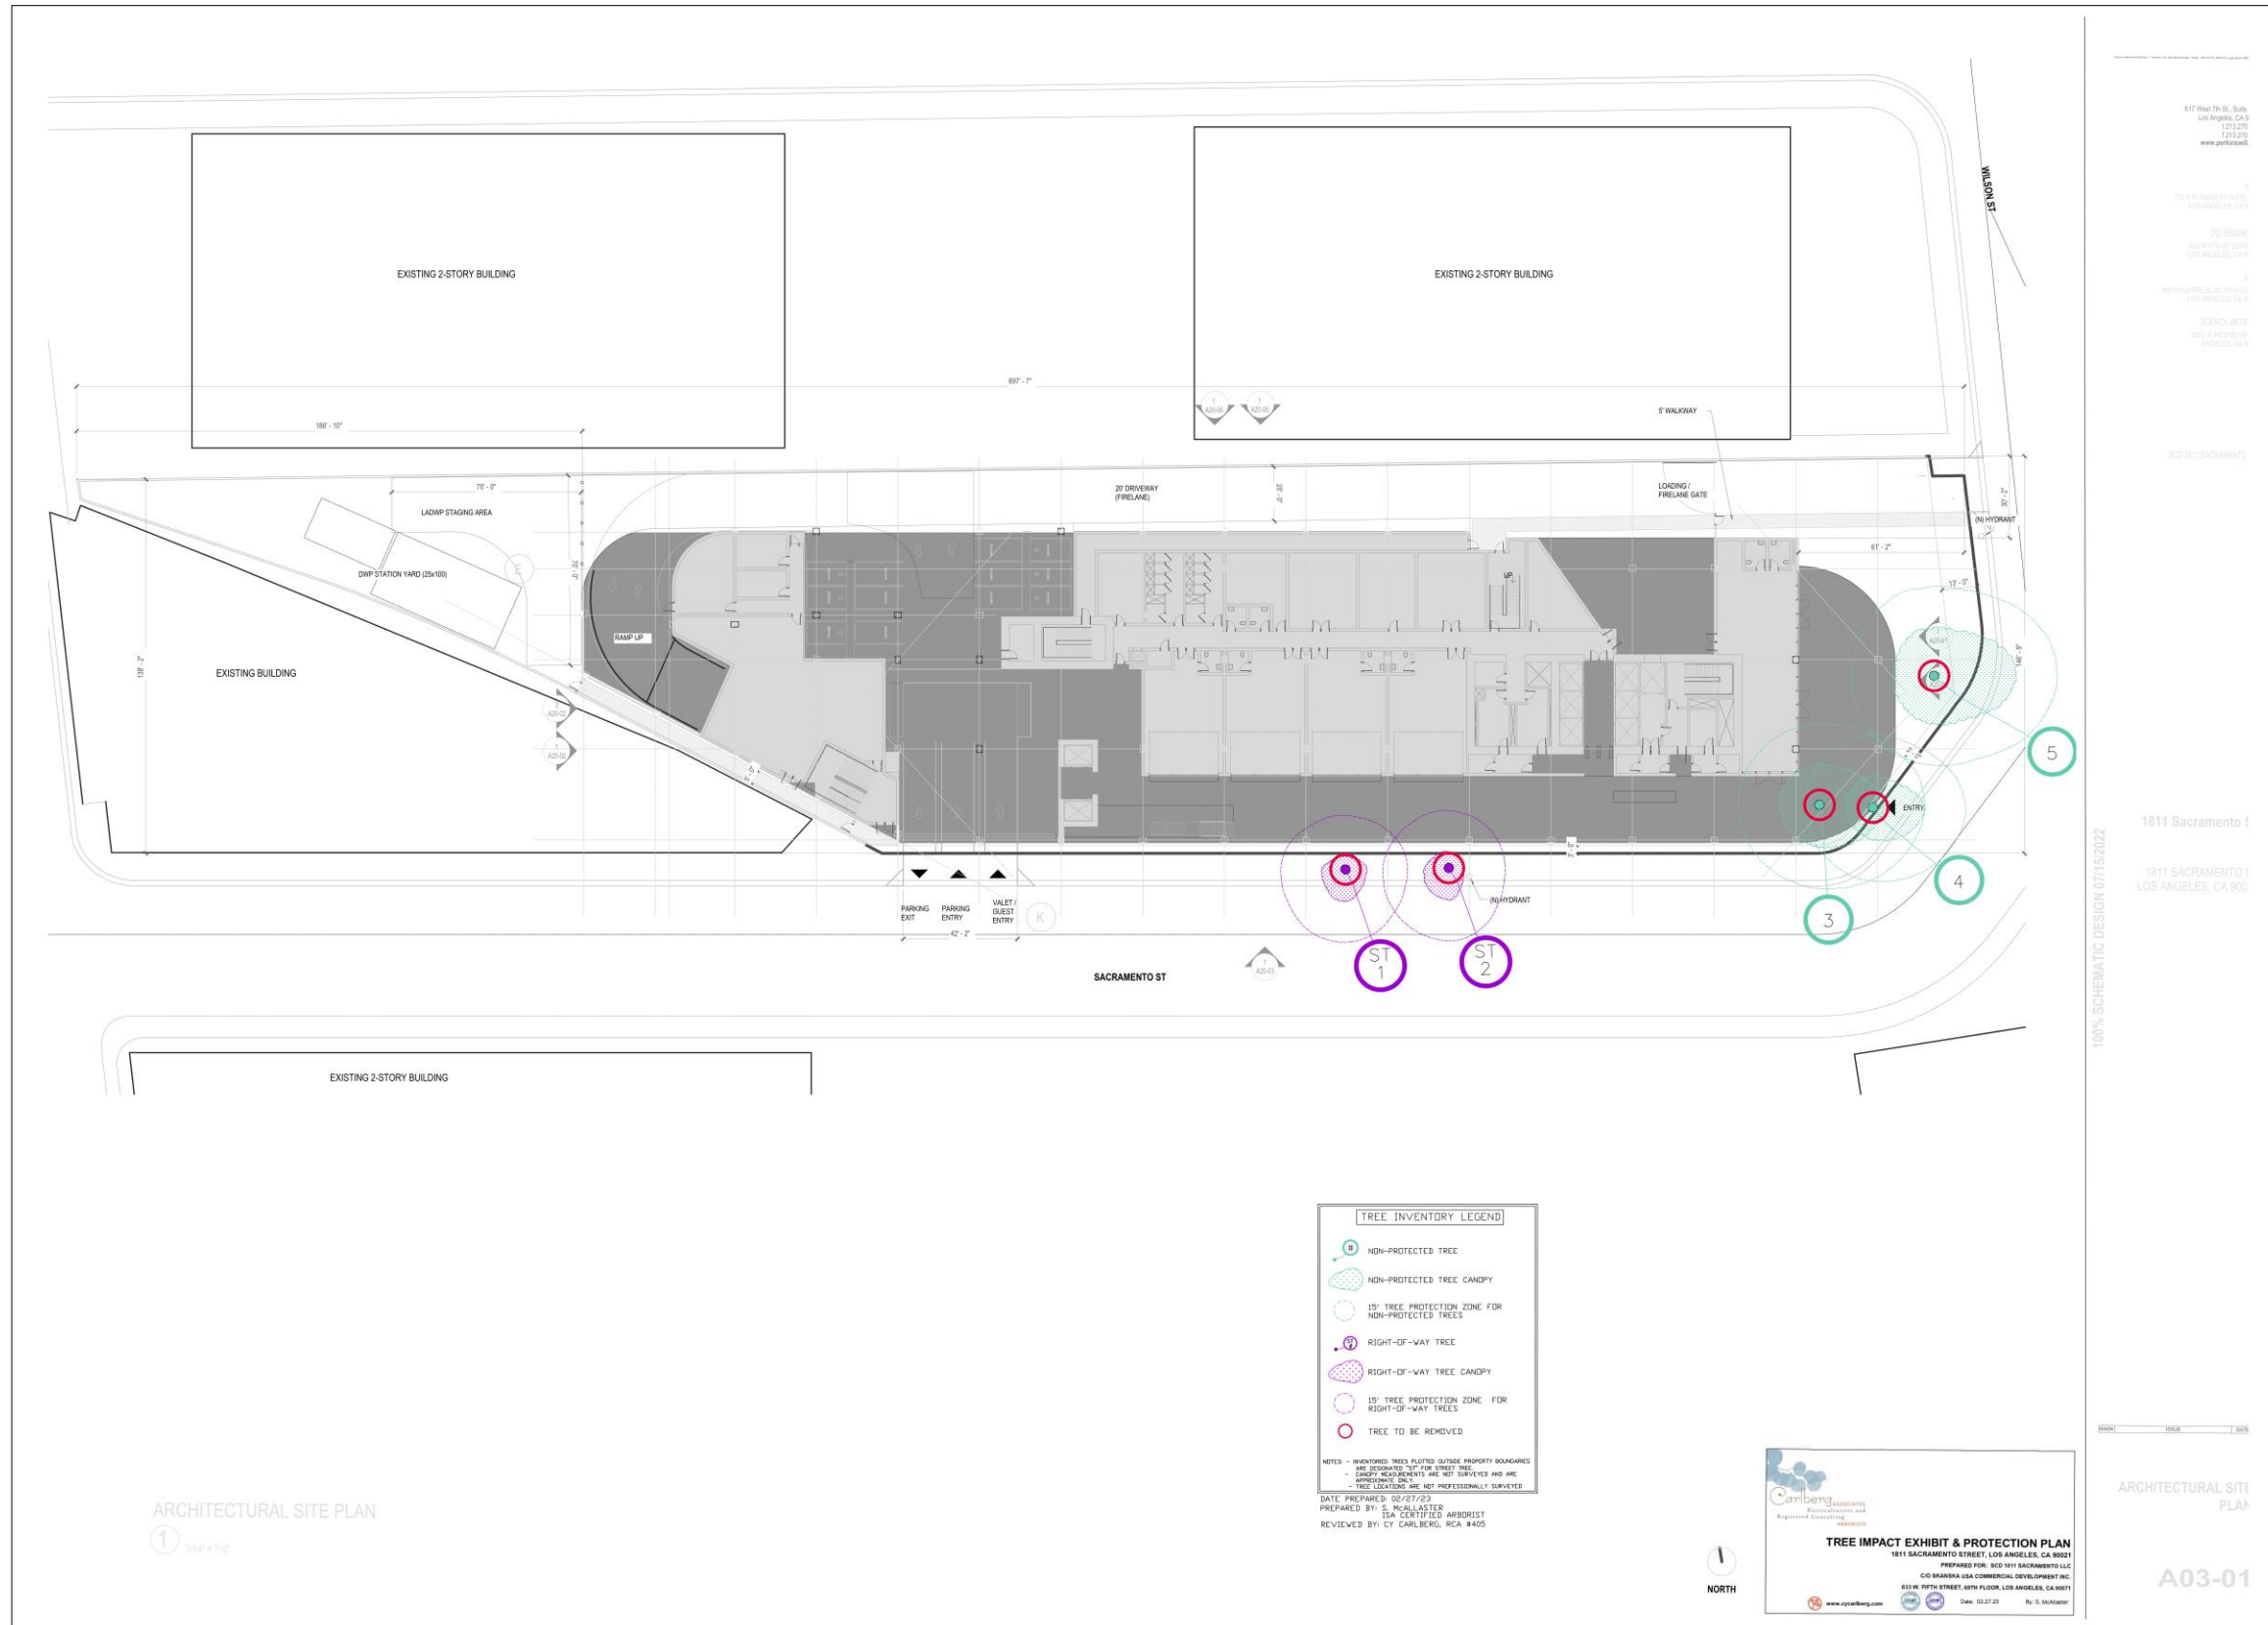
EXHIBIT E – TREE IMPACT EXHIBIT AND PROTECTION PLAN

Trees to be preserved or removed, along with the proposed location of recommended protective fencing, are illustrated on the reduced and full-sized copies of the Tree Impact Exhibit and Protection Plan. The reduced copies are included as **Exhibit E** on page 10. Full-size copies of the Tree Impact Exhibit and Protection Plan (10 sheets) are included in pockets at the end of this report.

As listed, two City street trees are proposed for removal. The Project proposes to replace the two trees with 12 new street tree plantings.

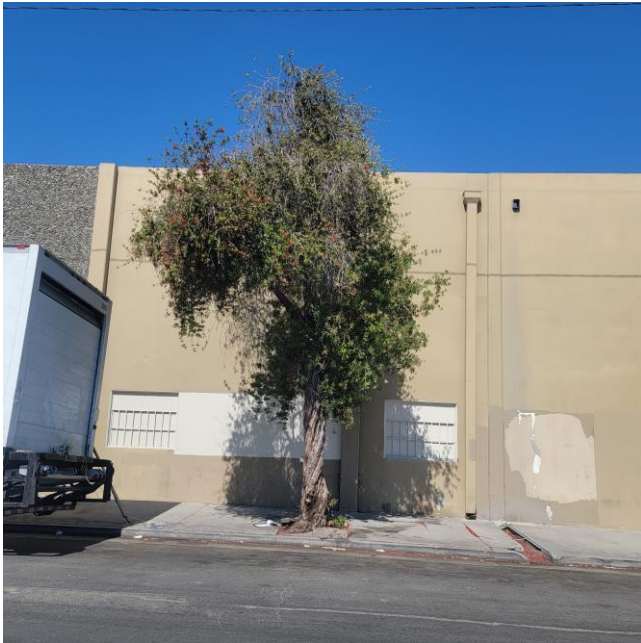
Tree ST1 – *Callistemon citrinus*  
facing north

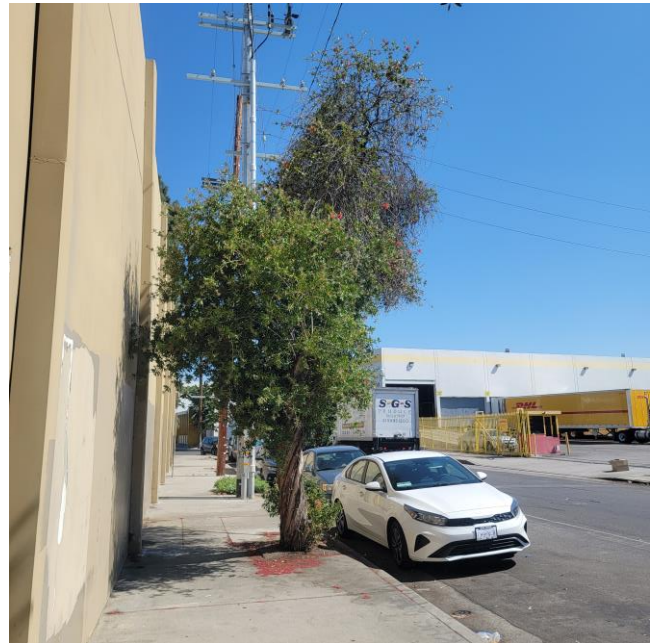
Tree ST2 – *Callistemon citrinus*  
facing east

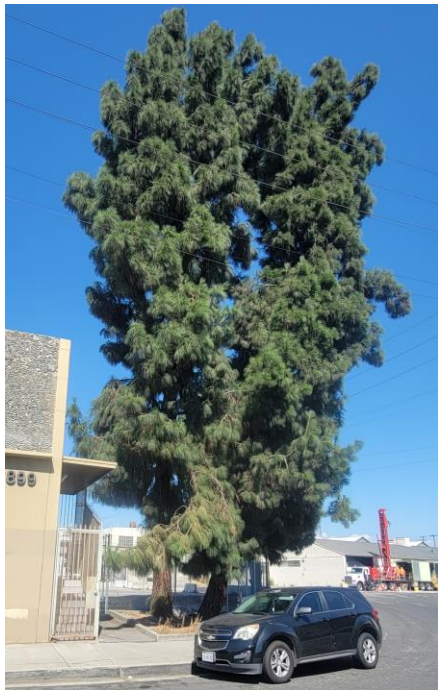
Trees 3-4 (left to right) – *Pinus canariensis*  
facing northeast

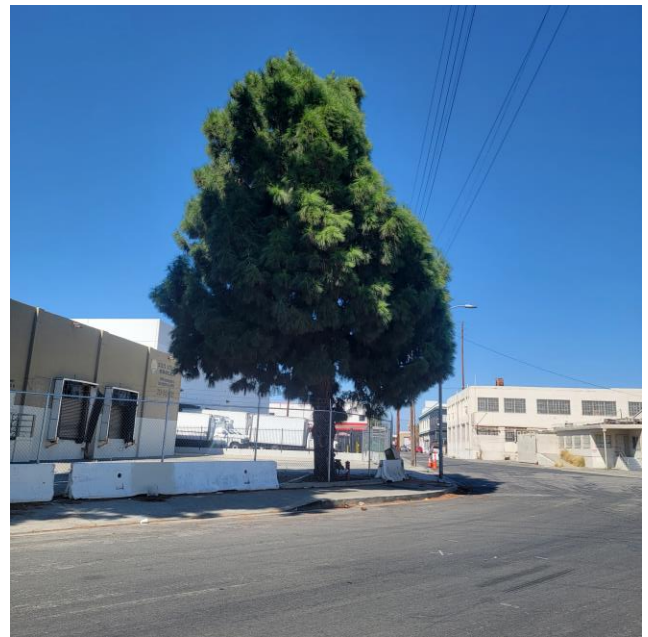
Tree 5 – *Pinus canariensis*  
facing north

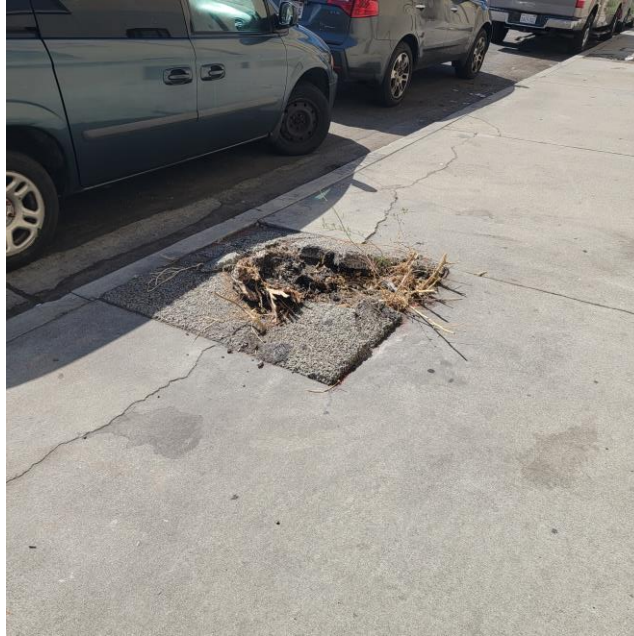
Shown is the remaining stump from a previously removed street tree
