GEOTECHNICAL ENGINEERING INVESTIGATION
THE NEIGHBORHOODS AT LUGONIA VILLAGE
NORTHWEST CORNER OF WEST LUGONIA AVENUE
AND KARON STREET
REDLANDS, CALIFORNIA
Project Number: H02901.01

**Subject: Geotechnical Engineering Investigation
The Neighborhoods at Lugonia Village
Northwest Corner of West Lugonia Avenue and Karon Street
Redlands, California**

**Geotechnical Engineering Investigation
The Neighborhoods at Lugonia Village
NWC of West Lugonia Avenue and Karon Street, Redlands, California
February 11, 2022**

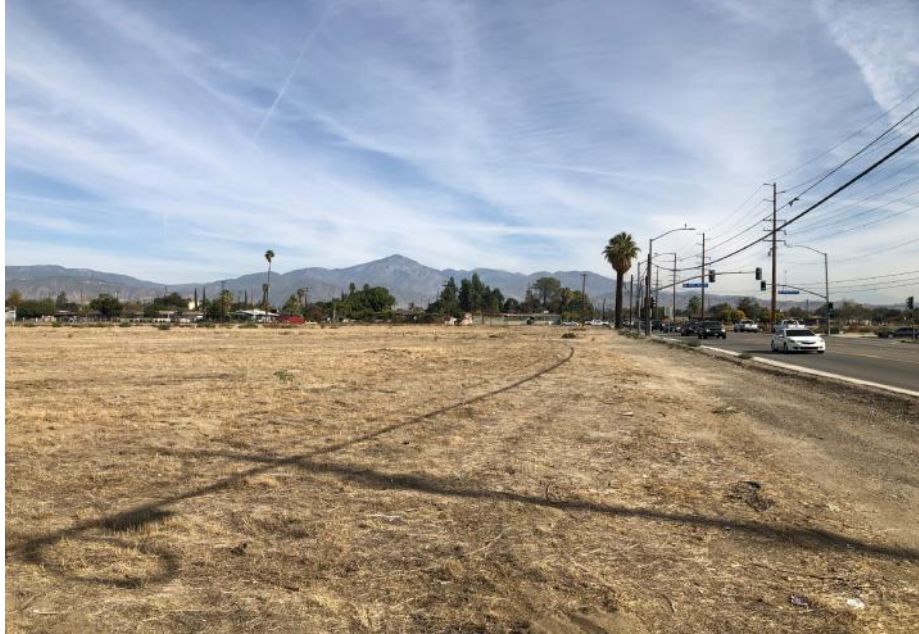
Photograph No. 1: Viewing east along south side of site adjacent to West Lugonia Avenue

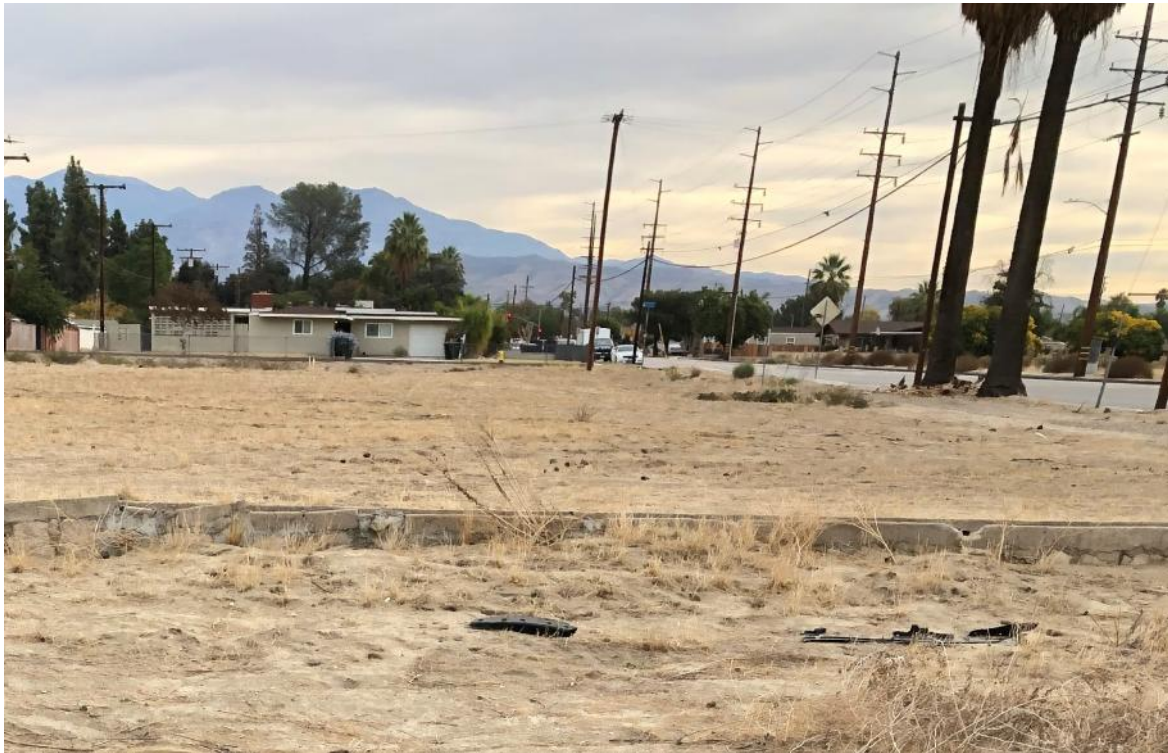
Photograph No. 2: Viewing east at U-shaped concrete structure (electrical easement) that trends in a north-south orientation across the south-central portion of the site

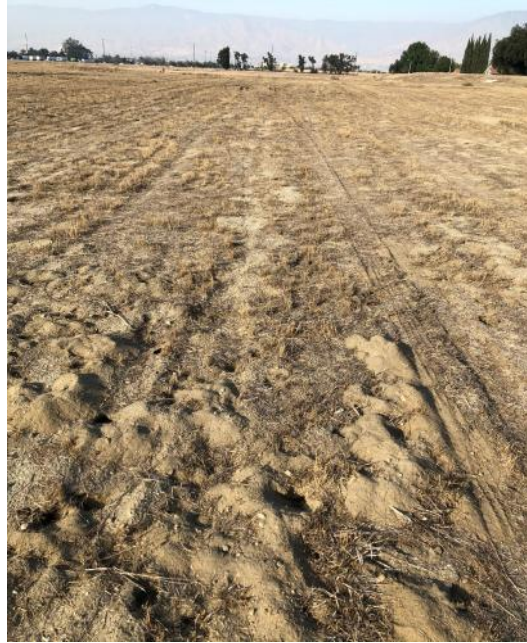
Rodent burrows were also noted throughout the site, some of which extended about 12 inches, and deeper, below site grade.

Photograph No. 3: Viewing north along east side of site; small rodent burrows in foreground

Drainage/irrigation structures were noted on the north and west sides of the site. A debris pit was noted in the northeastern corner of the site, and a dry well was noted in the southwestern portion of the site. In addition, an electrical easement exists at the site. These on-site features should be completely removed and any piping or underground utilities (if any) should be removed from the site and not mixed with soils to be used as engineered fill. Recycled materials including asphalt, concrete and brick should not be mixed in with soils to be used as engineered fill below buildings; however, these materials may be processed to less than 6 inches in size and mixed in with soils to be used as engineered fill outside of building areas. Rodent burrows were also noted throughout the site, some of which extended about 12 inches in depth. The rodent burrows should be over-excavated until undisturbed soils are encountered.

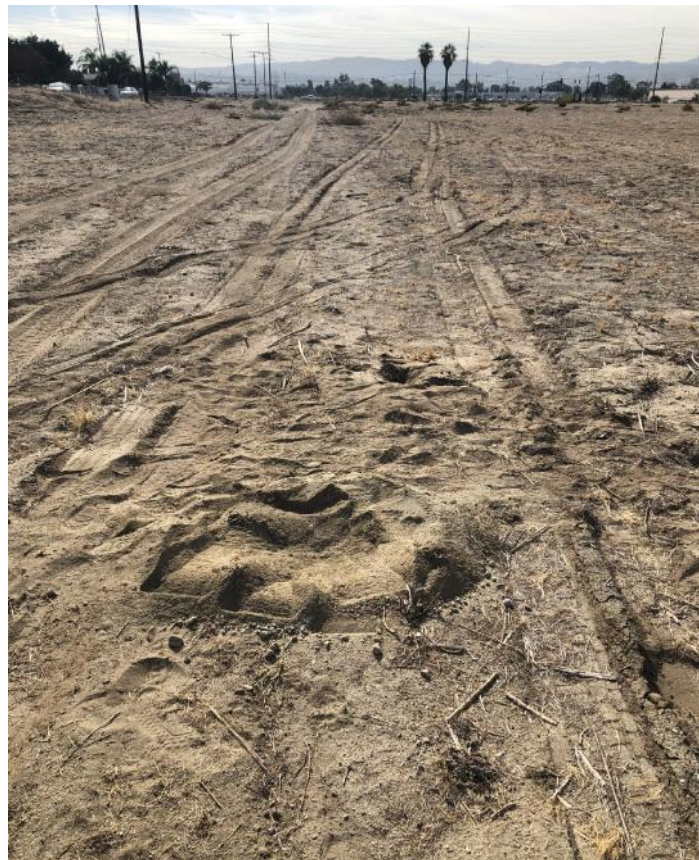
Photograph No. 4: Viewing south along east side of site; west-facing slope adjacent to Karon Street shown in background on left side of picture

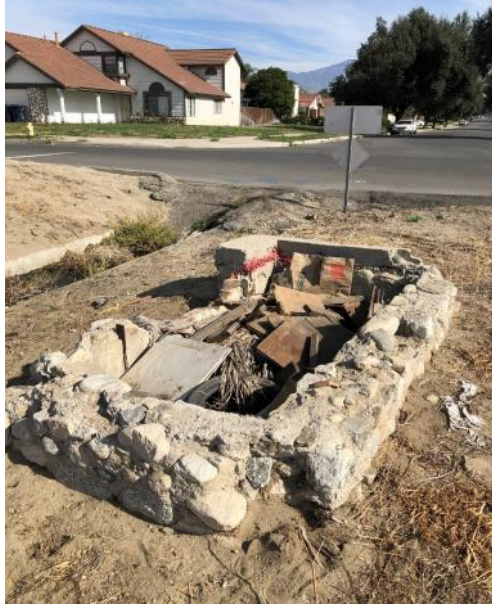
Photograph No. 5: Rectangular-shaped concrete structure filled with debris in northeast corner of site near the intersection of Karon Street and Pennsylvania Avenue

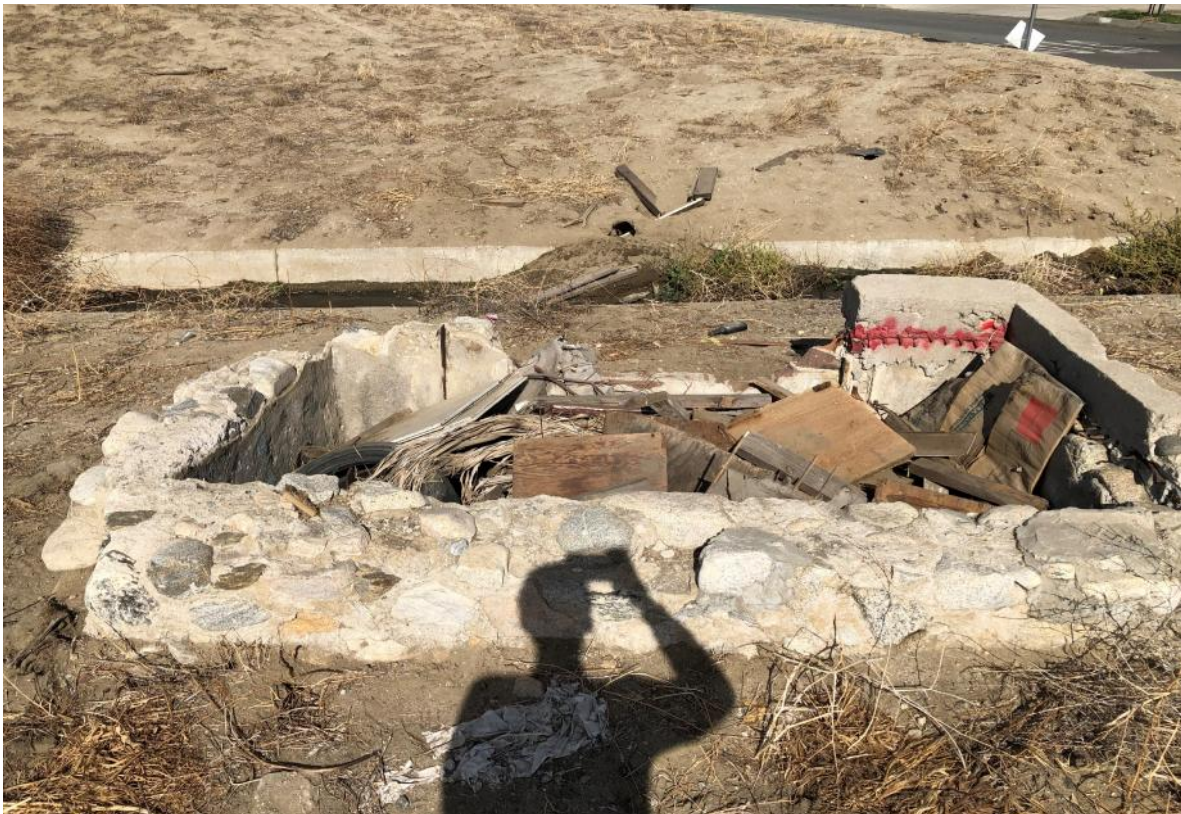
Photograph No. 6: Rectangular-shaped structure in northeast corner of site and U-shaped concrete drainage structure in background trending east-west along center line of future extension of Pennsylvania Avenue

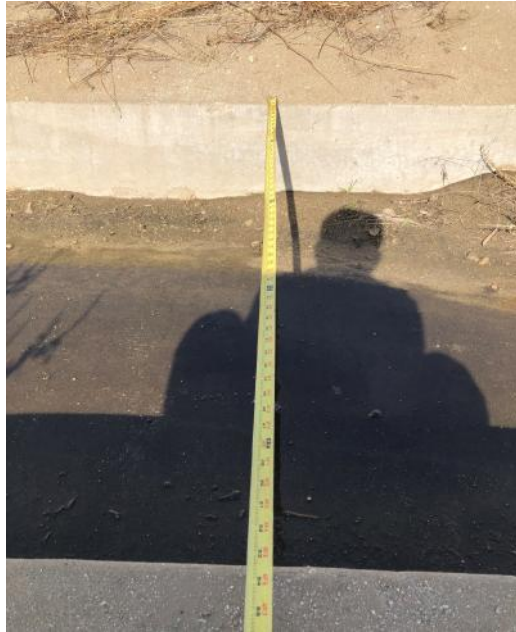
Photograph No. 7: U-shaped concrete structure trending east-west along center line of future extension of Pennsylvania Avenue is about 4.5 feet wide and 12 inches in height

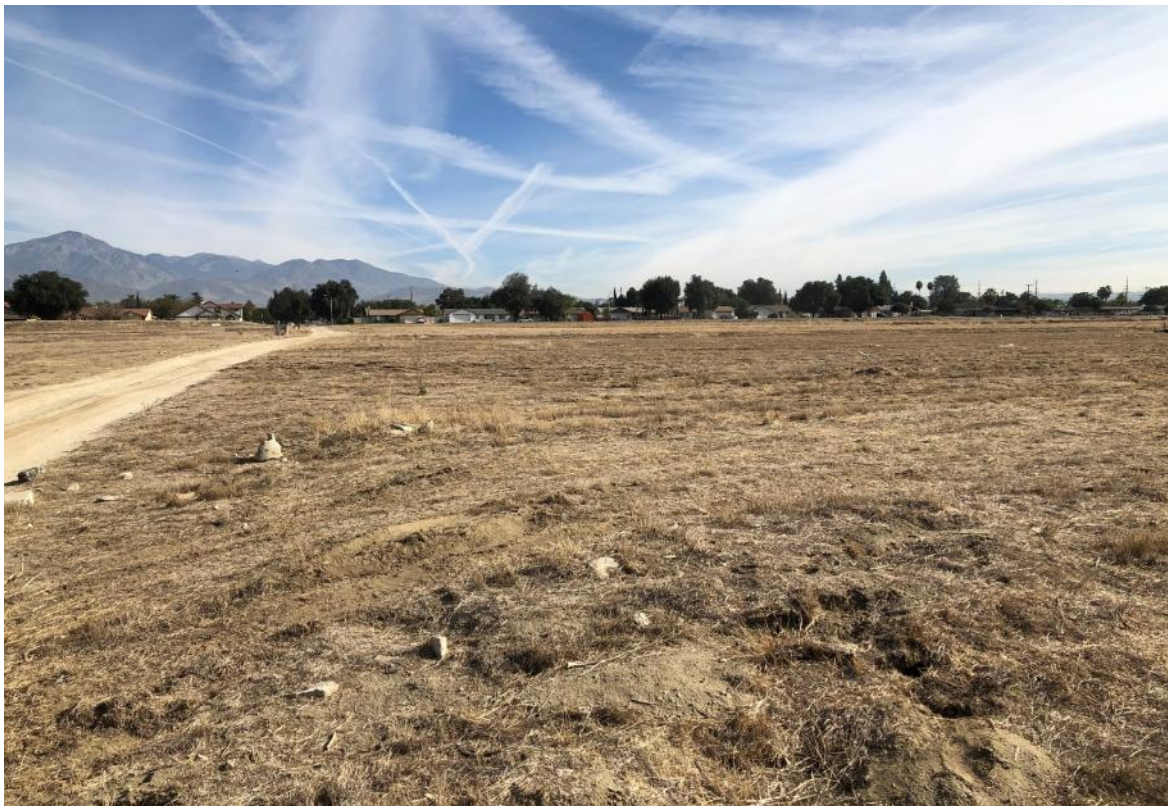
Photograph No. 8: Viewing east from northwest corner of site showing scattered concrete debris in foreground

At the time of our investigation, the site was generally vacant land covered by scattered dead grasses and weeds. Some scattered concrete debris was also noted throughout the site. Where existing vegetation and landscaping is present, these areas should be stripped of all vegetation and top soil, and removal of vegetation should remove all roots greater than ¼ inch in diameter. Debris such as concrete debris should be removed from the site and not mixed with on-site soils.

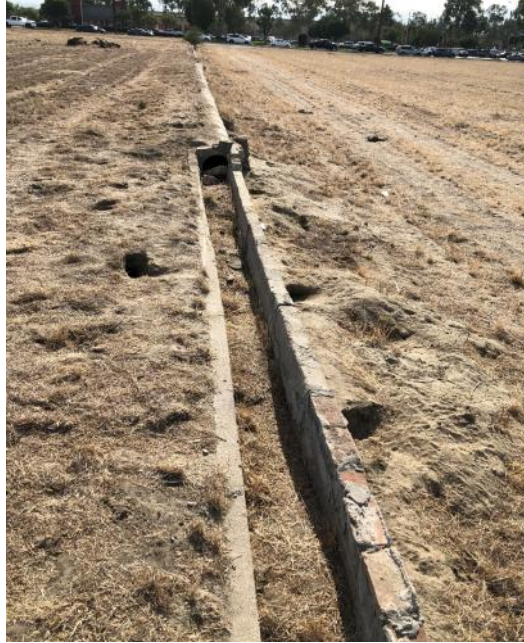
Photograph No. 9: Viewing south along west side of site showing concrete drainage structure (U-shaped structure in foreground and circular concrete pipe in background)

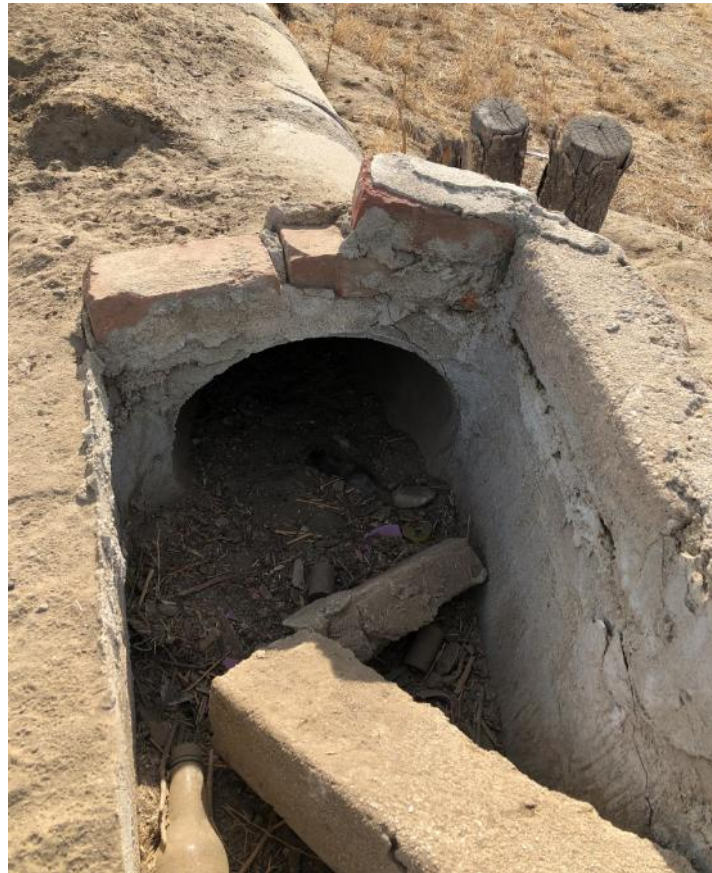
Photograph No. 10: Close-up of concrete drainage structure on west side of site

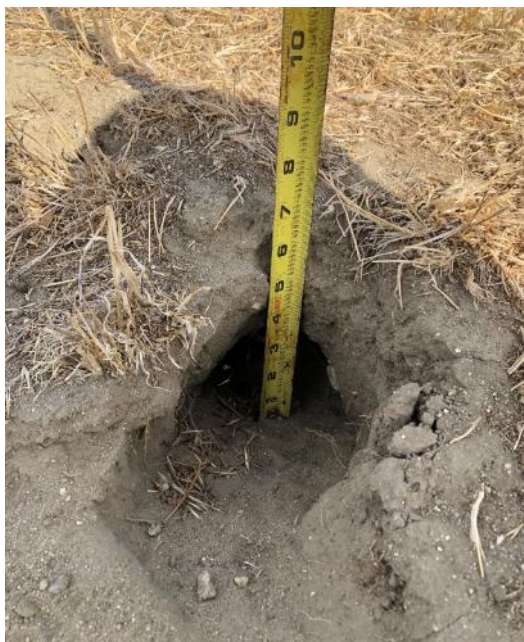
Photograph No. 11: Seven-inch deep rodent burrow on west side of site

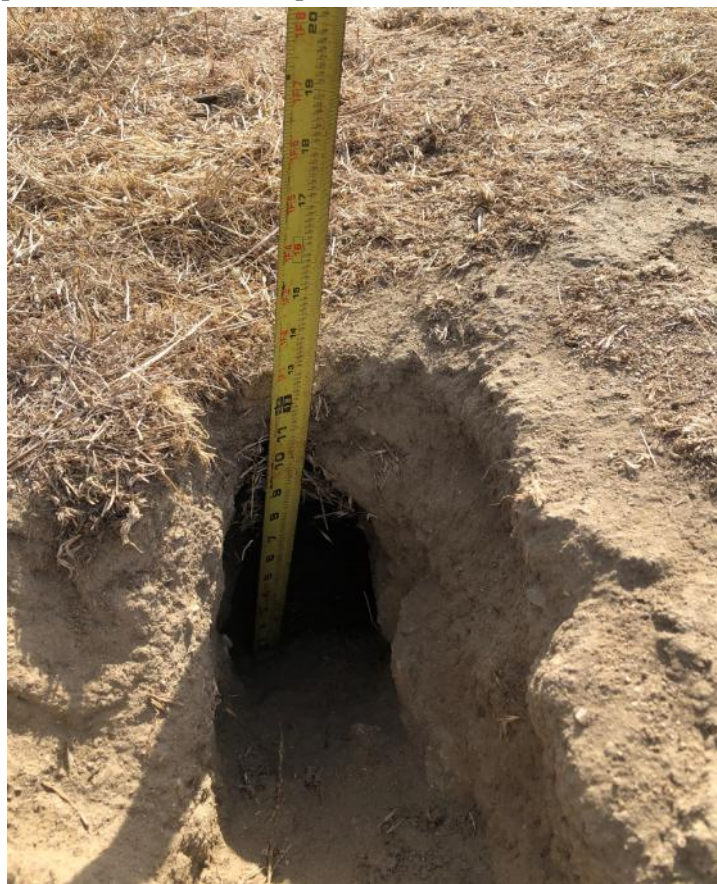
Photograph No.12: Thirteen-inch deep rodent burrow on west side of site

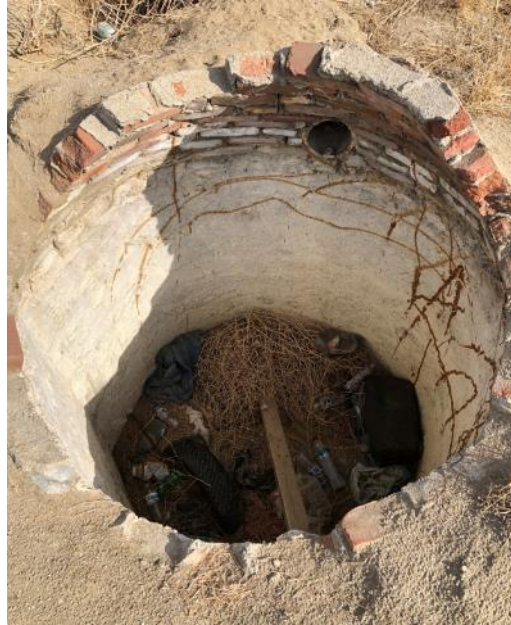
An open cylindrical excavation (thought to be a dry well) was noted in the southwestern portion of the site. The dry well was about 5 feet in diameter and the sides of the structure was lined with brick

and concrete. The dry well was filled with concrete debris; thus, the depth of the hole could not be determined. The depth to the top of the debris was about 4.5 to 5 feet below grade. An approximate 12 to 18-inch diameter pipe was noted as extending perpendicular away from the shaft near the bottom just above the debris. A smaller, approximate 4-inch diameter pipe was noted as extending perpendicular away from the dry well near the top of the well. It is assumed that the dry well may be associated with some of the past improvements noted at the site.

Photograph No. 13: Open cylindrical excavation (shaft) made of brick, concrete and filled with debris in the southwest portion of the site

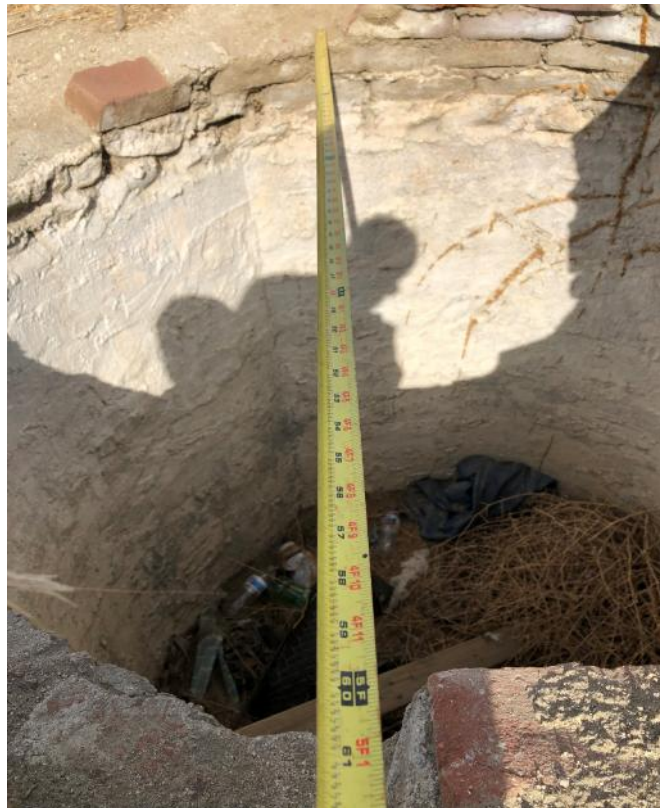
Photograph No. 14: Open cylindrical excavation (shaft) in southwest portion of site is about 5 feet in diameter
