Preliminary Arborist Report

4590 Patrick Henry Drive
Santa Clara, CA

June 2023

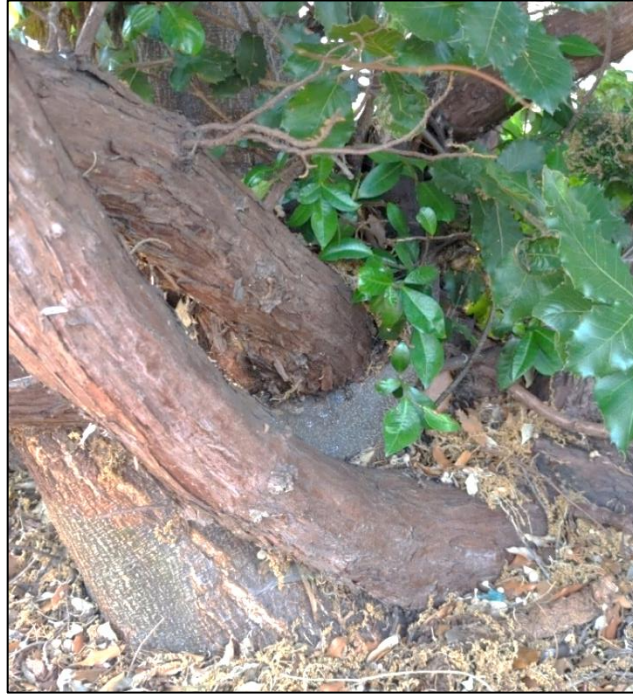
Photo 1. The bases of holly oak #315 and Chinese juniper #312 were so close that their trunks were embedded in one another.

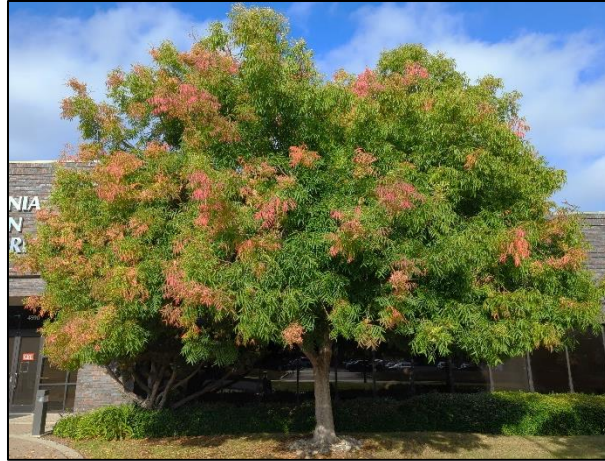
Photo 3. Chinese pistache #310 had an exceptionally wide, dense crown.

310	Chinese pistache	12	No	3	Moderate	Multiple attachments at 5 and 7 ft; 2 ft by 1 ft wound at base on S; dense rounded crown; rocks around base.
311	Chinese pistache	8	No	4	Moderate	Multiple attachments at 5 and 8 ft; very slightly sparse rounded crown; raised bark at lowest branch attachment; rocks around base.
312	Chinese juniper	7,6,5,5,5	No	3	Low	Multiple attachments at base; growing around and engulfing holly oak 316; topped.
313	Purpleleaf plum	8	No	4	Moderate	Good upright form; full round crown; sapsucker damage in trunk; rocks around base.
315	Holly oak	11	No	3	Low	Good upright form; sapsucker damage; base engulfing juniper.
316	Crape myrtle	4	No	3	Low	Good upright form; sparse; crown heavier on N.
317	Crape myrtle	5	No	2	Low	Good upright form; very sparse.
318	Crape myrtle	5	No	2	Low	Good upright form; very sparse.
