Visual Hazardous Building Materials Survey

47–57 South B Street, San Mateo, California 94103

August 9, 2022

Project Number 0397.002.001

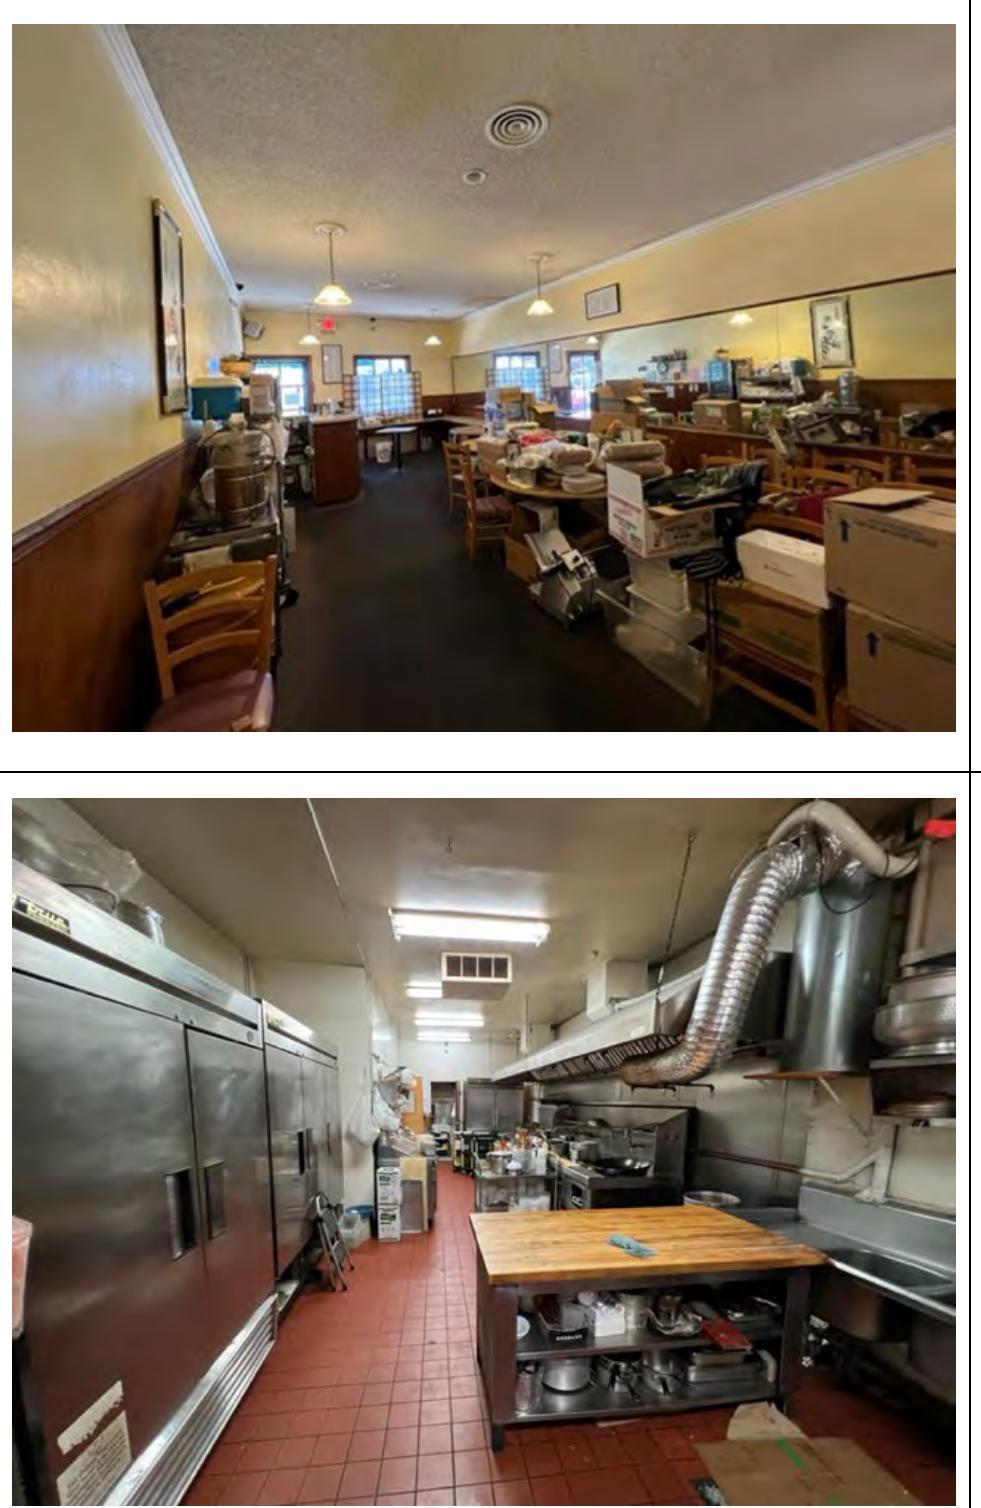
Photograph 3:

View depicting the typical interior of 31 South B Street – China Bee Restaurant.

Photograph 4:

View depicting the kitchen of 31 South B Street – China Bee Restaurant.
