Tree Inventory Report

REXFORD L.A.X. INDUSTRIAL
9000 Airport Boulevard
Los Angeles, California

February 21, 2024

**Subject: Arborist tree survey and Report for Rexford LAX Industrial Project 9000 Airport Boulevard
Los Angeles, California**

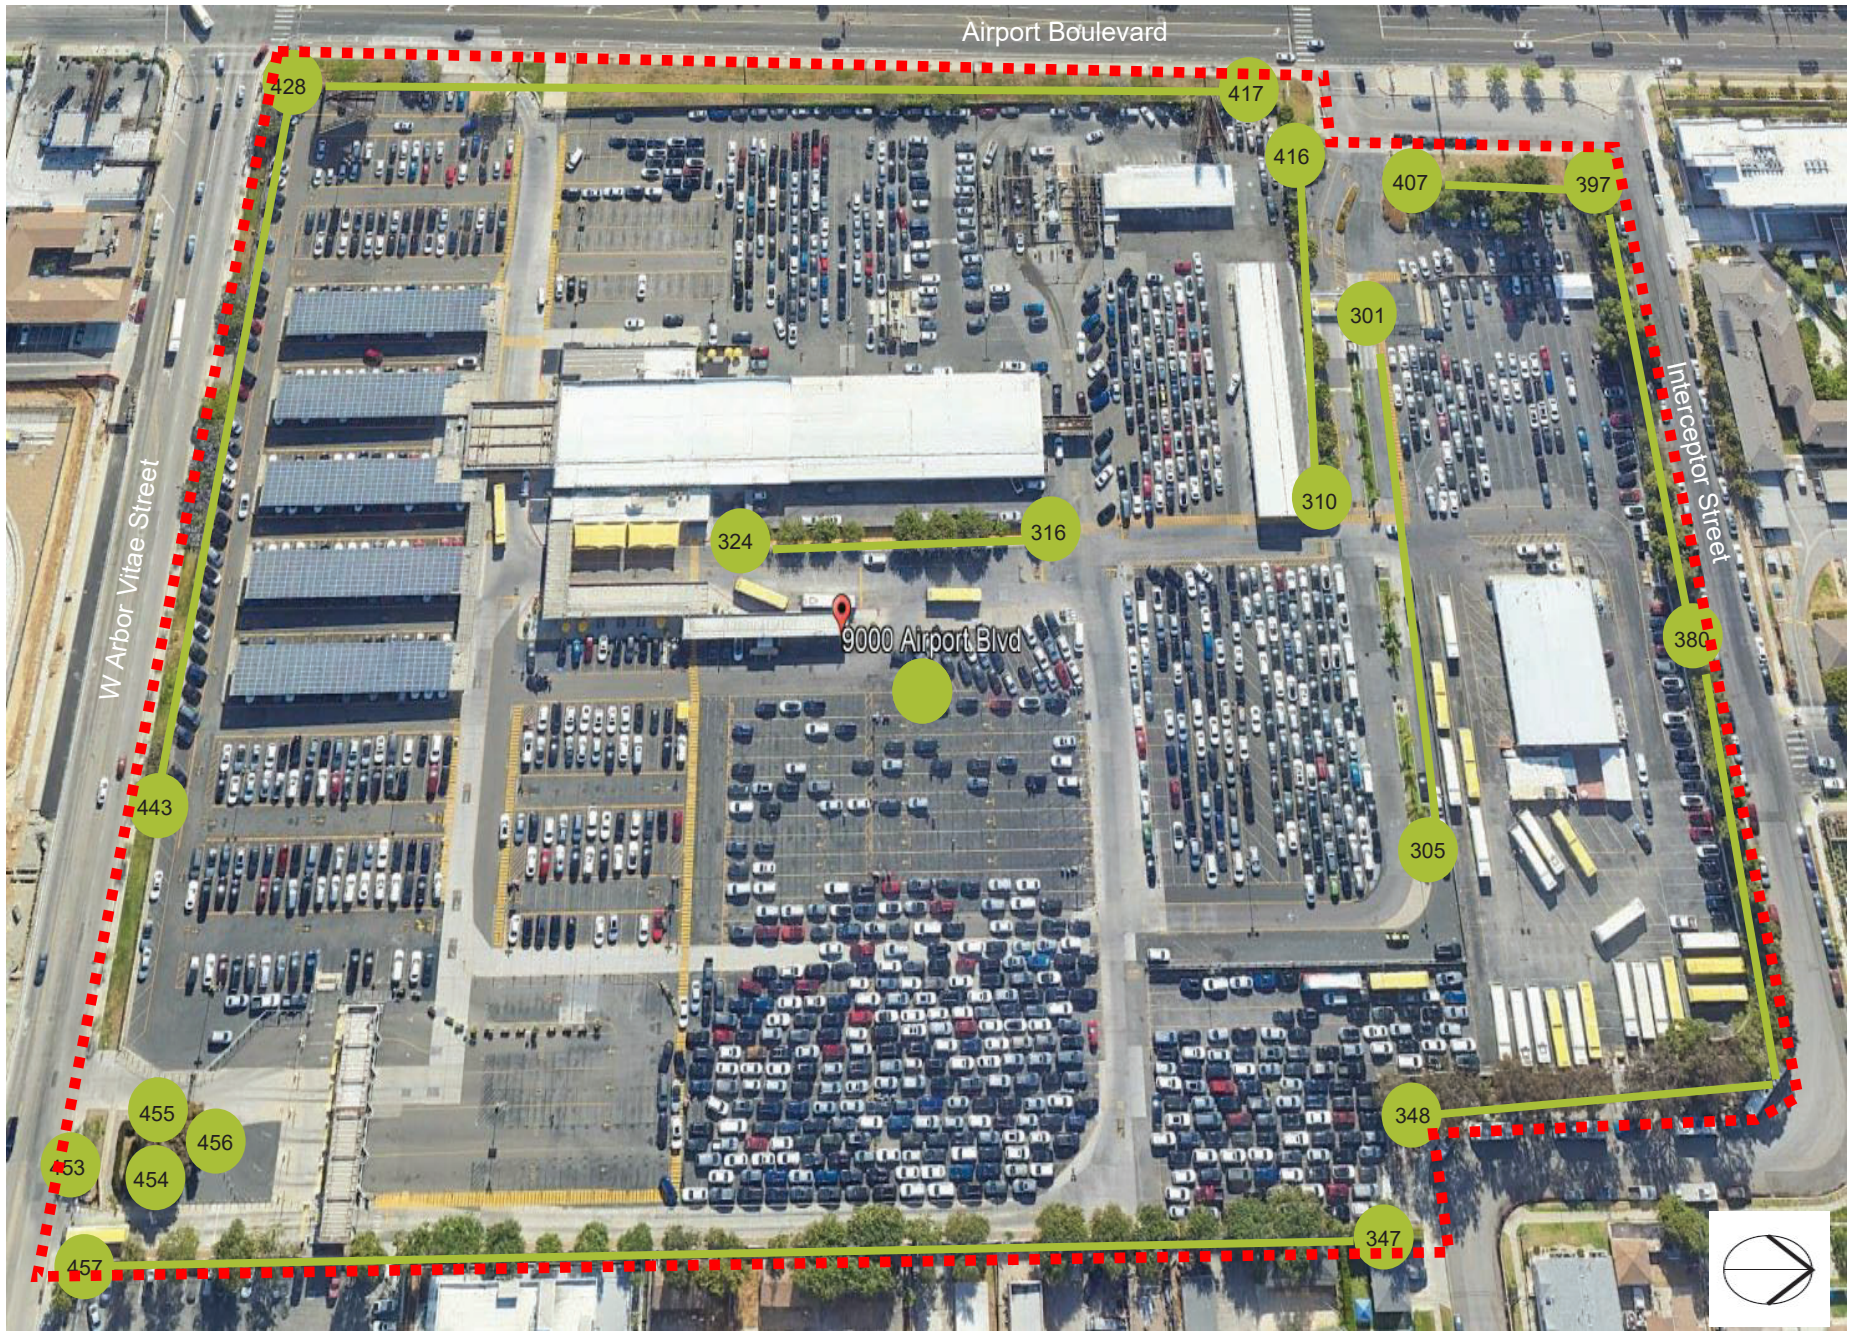
Tree location map / number tags affixed to each tree / August 2023

All tree locations are approximate to allow reader to locate and inspect specific trees growing at the project site

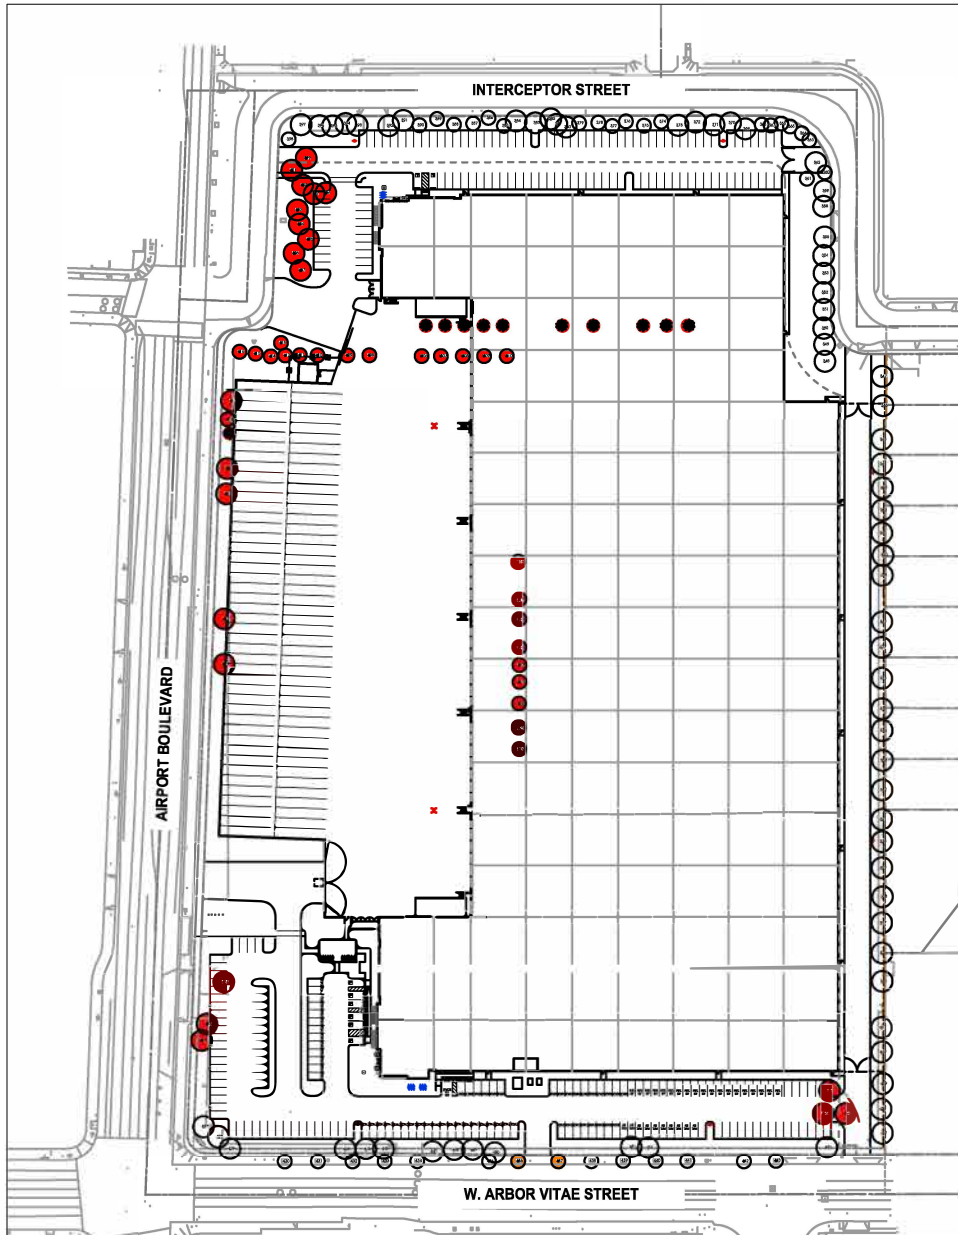
OPTION 1 PLAN

- (45) ONSITE TREES TO BE REMOVED
 - NO TREE REMOVAL RATIO
- (11) ONSITE PALMS TO BE REMOVED
 - NO TREE REMOVAL RATIO
 - REFER TO TREE TABLE FOR SPECIES TYPE
- (2) STREET TREES TO BE REMOVED (#436, 437)
 - TREE REMOVAL RATIO 2:1
 - REFER TO TREE TABLE FOR SPECIES TYPE

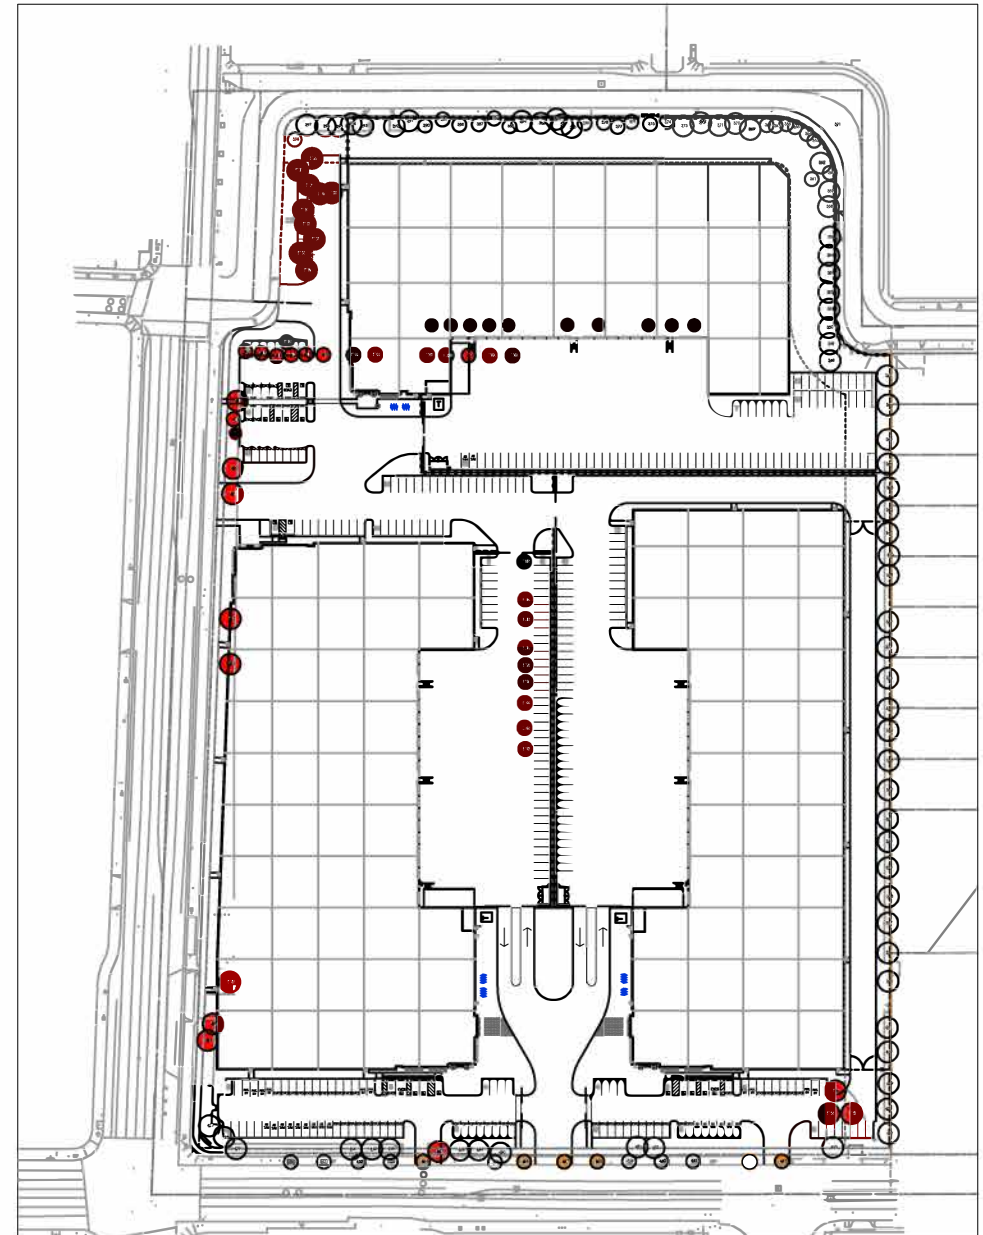
OPTION 2 PLAN

- (46) ONSITE TREES TO BE REMOVED
 - NO TREE REMOVAL RATIO
- (11) ONSITE PALMS TO BE REMOVED
 - NO TREE REMOVAL RATIO
 - REFER TO TREE TABLE FOR SPECIES TYPE
- (5) STREET TREES TO BE REMOVED (#434, 436, 437, 438, 443)
 - TREE REMOVAL RATIO 2:1
 - REFER TO TREE TABLE FOR SPECIES TYPE
