Arborist Report

**2303 Gianera Street
Santa Clara, CA**

October 2023

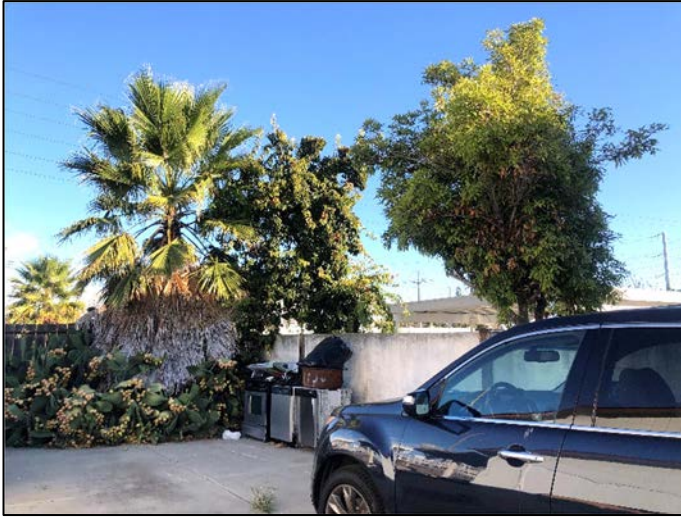
- Four Mexican fan palms were present; two (#166 and 167) were off-site at the east and west sides of the property. Condition was good (3 palms) and fair (palm #157). The three palms in good condition: #160 (Photo 1) and off-site palms #166 and 166 were the only trees in good condition at the site. Diameters ranged from 16 to 21 inches, with brown trunk heights from 7 to 30 feet.

Photo 1. Palm #160 and off-site trees #164 and 165 were growing at the north corner of the site.

The proposed project would demolish the existing buildings and replace them with eight lots containing 2-story residences. Based on my assessment of the proposed plan and evaluation of the trees, I recommend the removal of all 14 trees on the site (#150 – 163) and preservation of off-site trees #164 – 167. None of the trees proposed for removal are *Protected*.

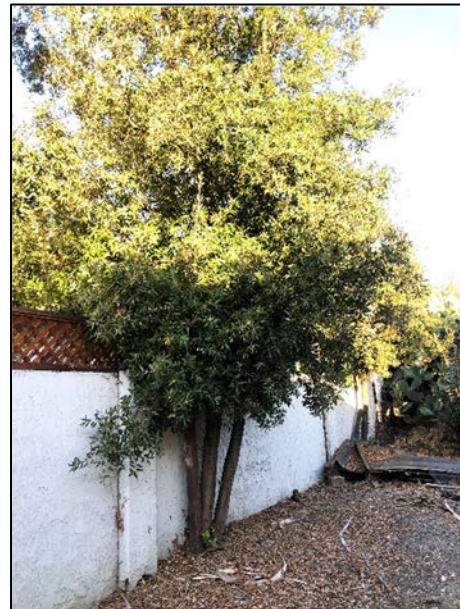
- Three holly oaks were growing on the west side. All were young and in fair condition, with stem diameters from 3 to 6 inches. The oaks were growing at or close to either building walls or the property line (Photo 2).

Photo 2. Holly oak #150 was growing near a wall at the west property line.

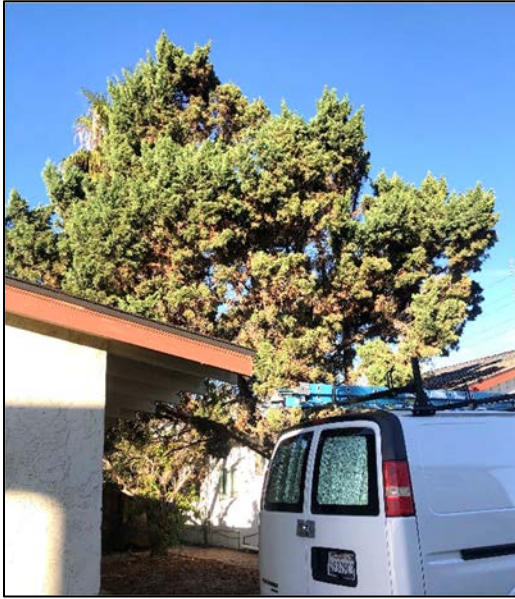
- Monterey cypress #159 had codominant stems of 12 and 7 inches. It had a full crown and was in fair condition (Photo 3).

Photo 3. Monterey cypress #159 was in fair condition with a full crown.
