California Tree and Landscape Consulting, Inc.

PRE-DEVELOPMENT REPORT & TREE INVENTORY

RE: 6001 Beech Avenue & 6018 Roloff Way, APN 261-0250-032 & APN 261-0250-033, County of Sacramento jurisdiction, California

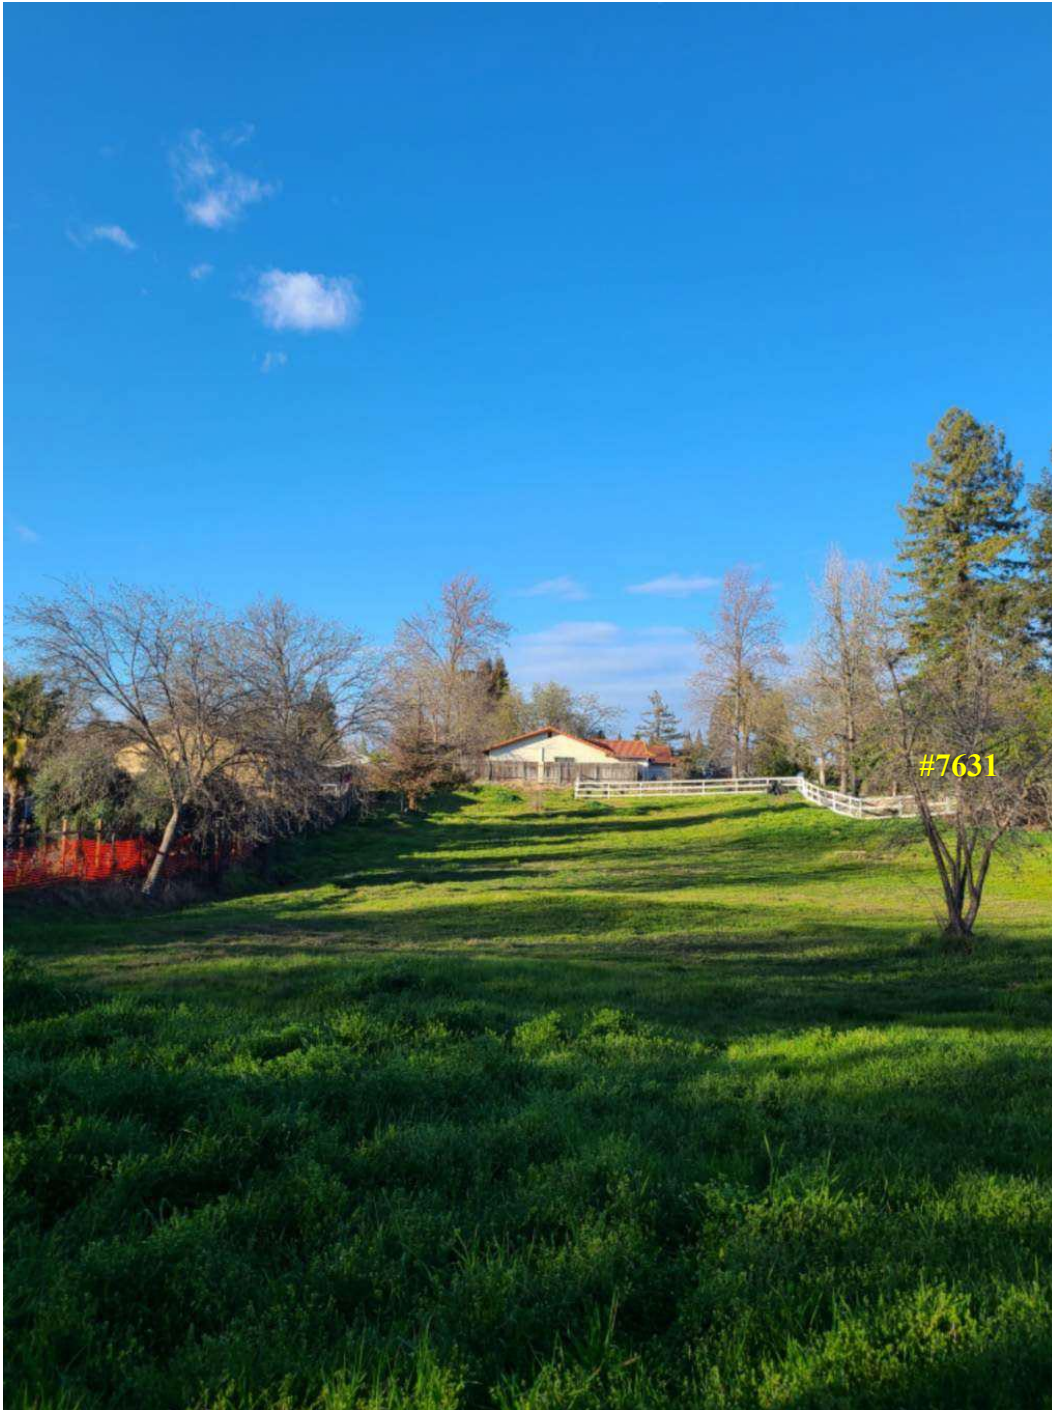
View from the southwest corner of parcel facing north.

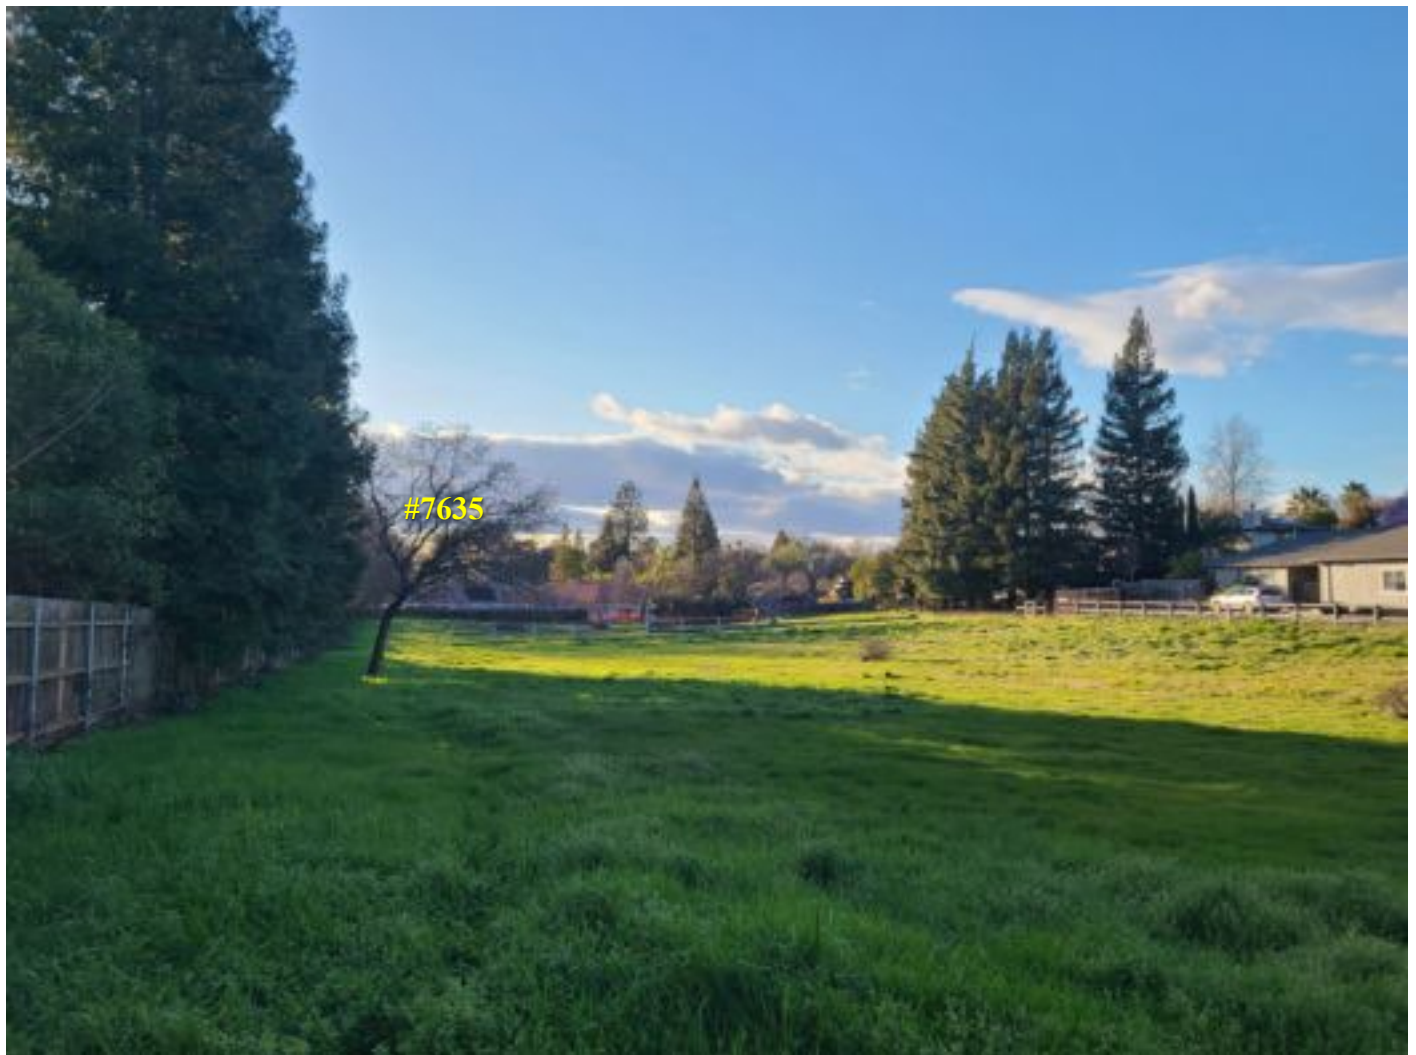
View from the southeast corner of parcel facing west.

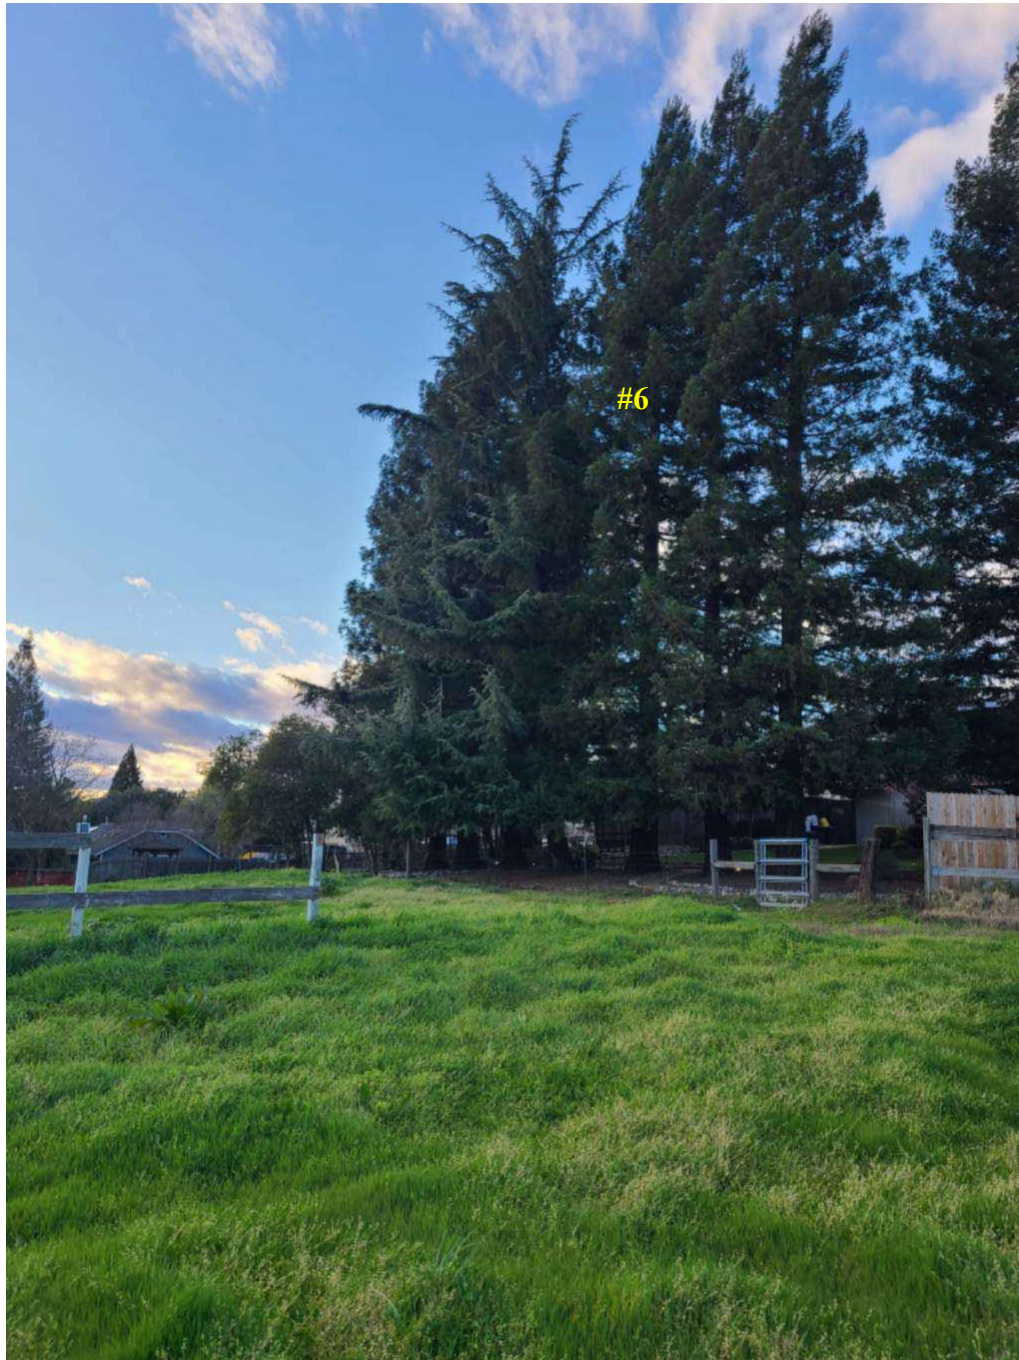
View of off-site stand of trees on the north property line.
