**Google West Borregas Campus
100 Caribbean
Biological Resources Report**

Project #3475-49

Google Caribbean Campus

Arborist Report

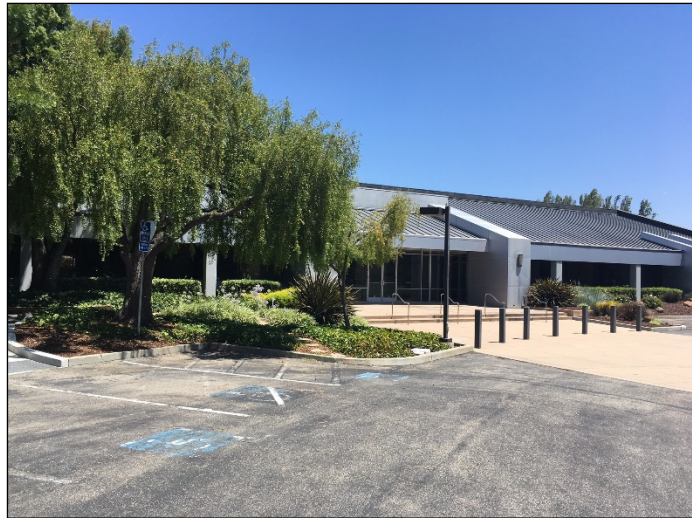
Photo 1. Developed/Landscaped Land Cover Type on the Project Site

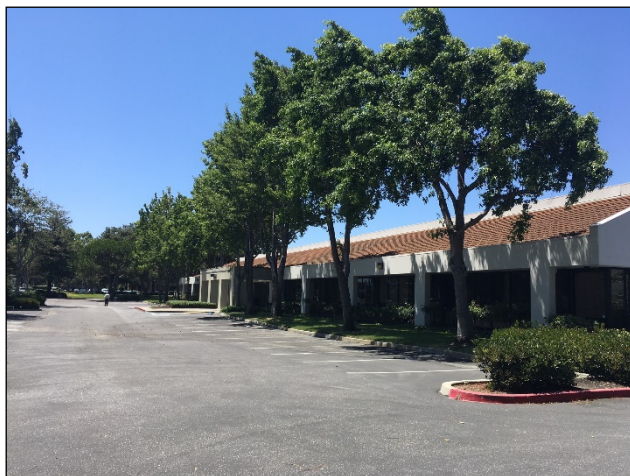
Photo 2. Typical Non-Native Trees on the Site

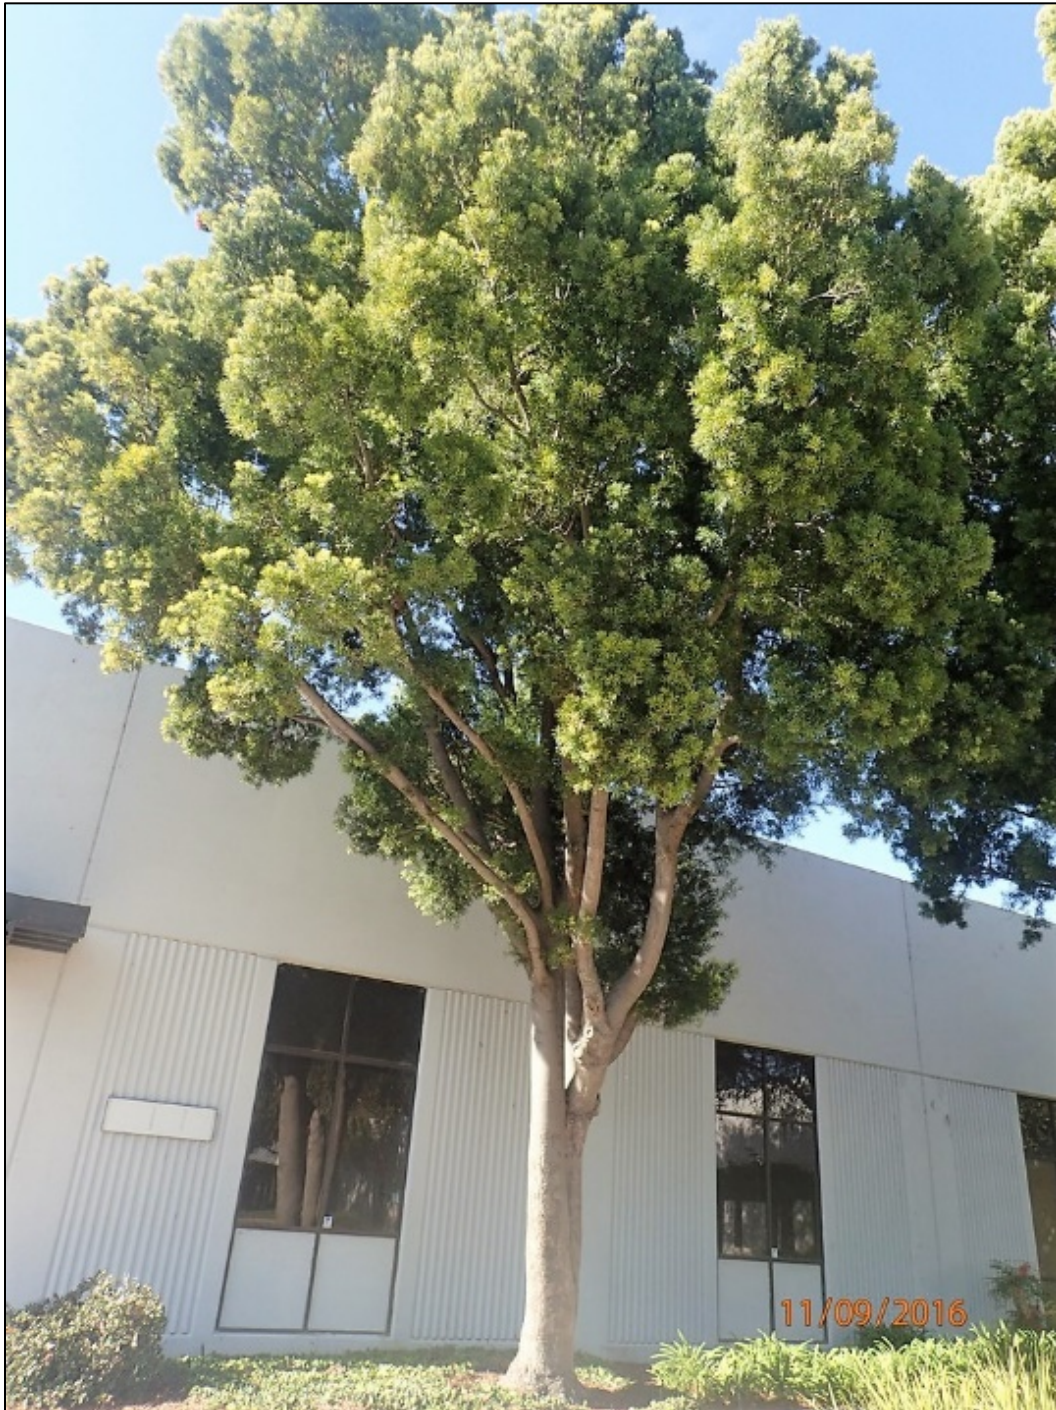
Photo 1. Tree #1043, African fern pine (*Afrocarpus falcatus*).

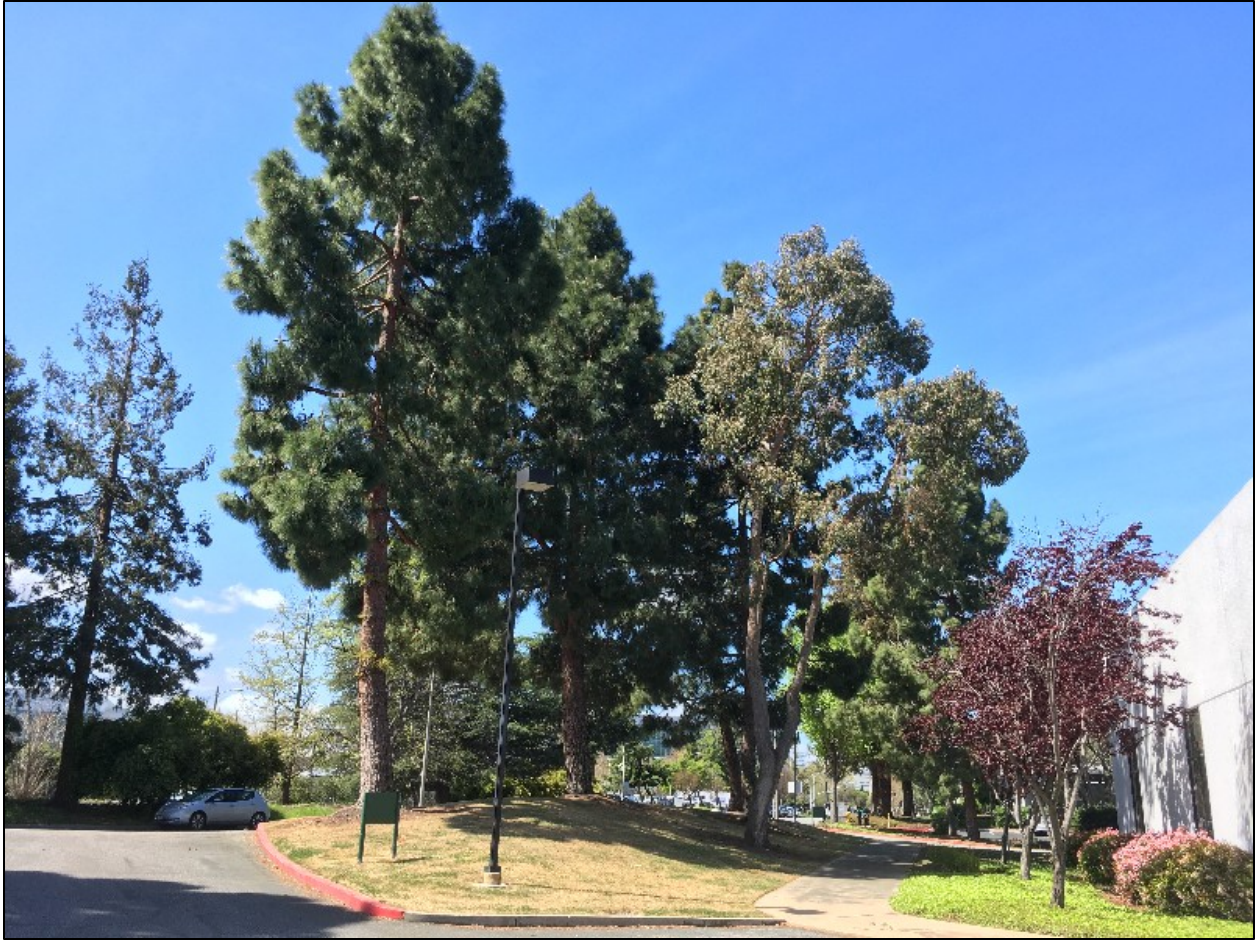
Photo 2. Tree 1006 (left side), Canary Island pine (*Pinus canariensis*). Tree #1011 (right side), purple leaf plum (*Prunus cerasifera*).

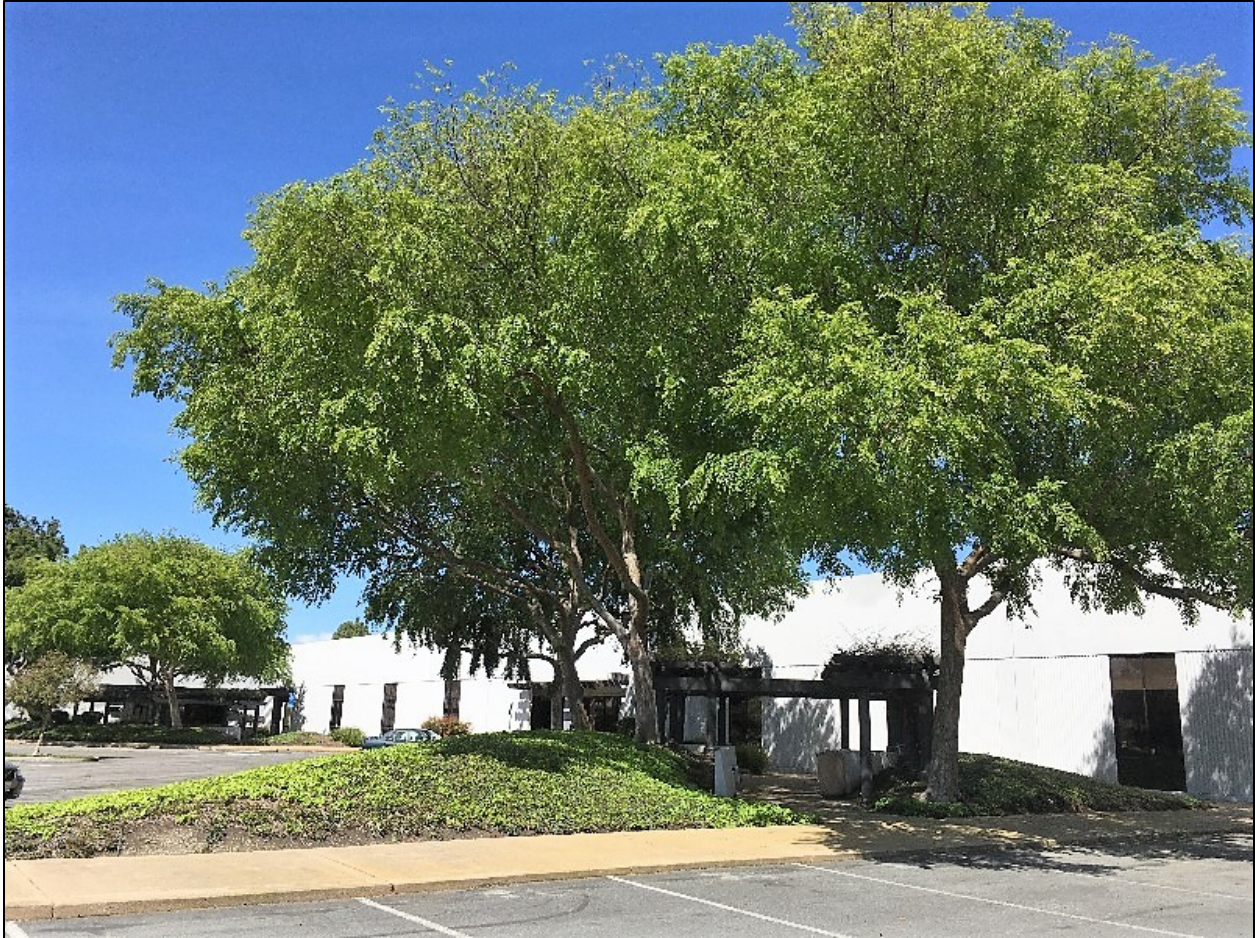
Photo 3. Tress 1048-1051 (left to right), all are Chinese elm (*Ulmus parvifolia*).

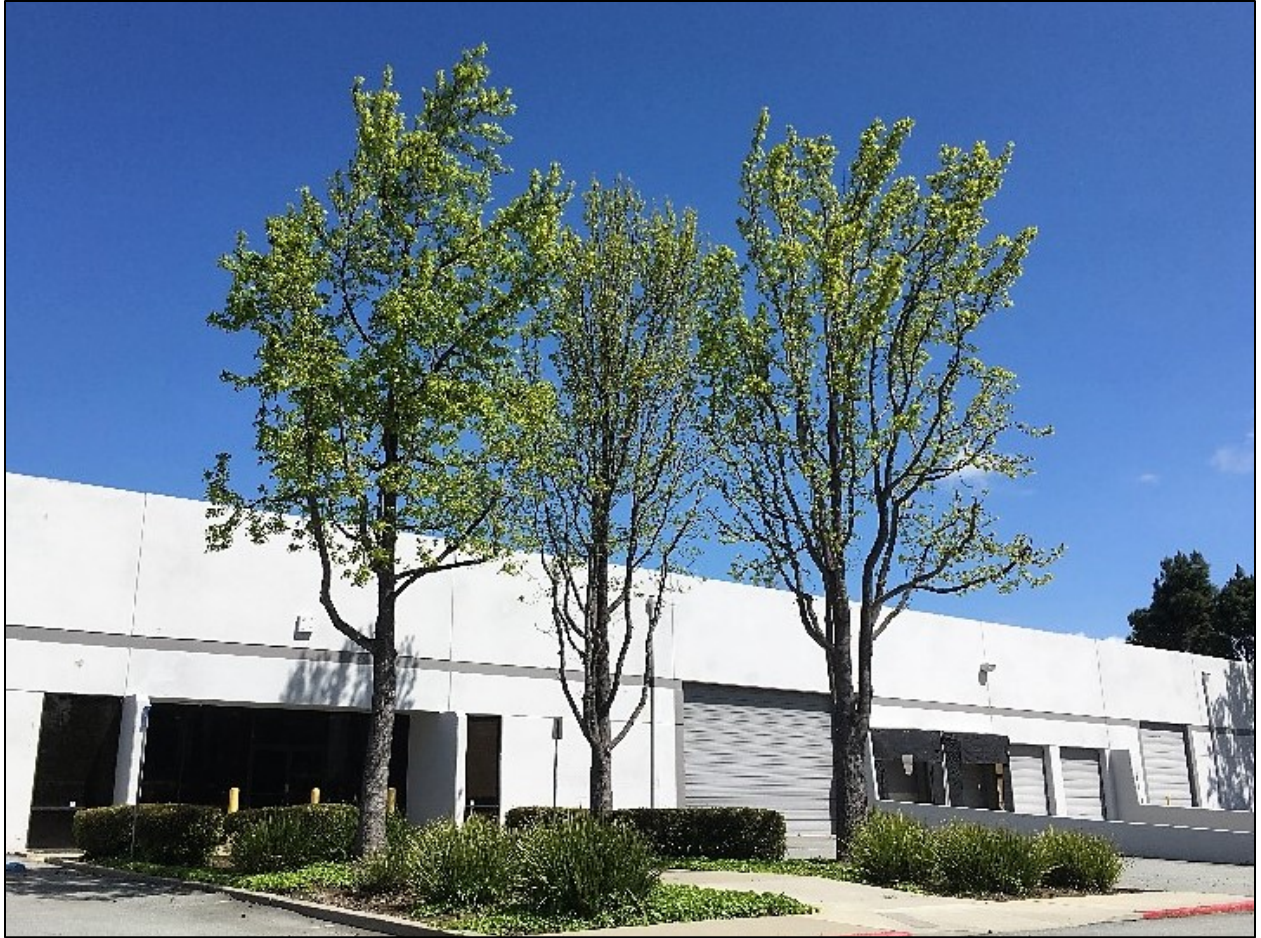
Photo 4. Trees 2124-2126 (left to right), all are sweetgum (*Liquidambar styraciflua*).

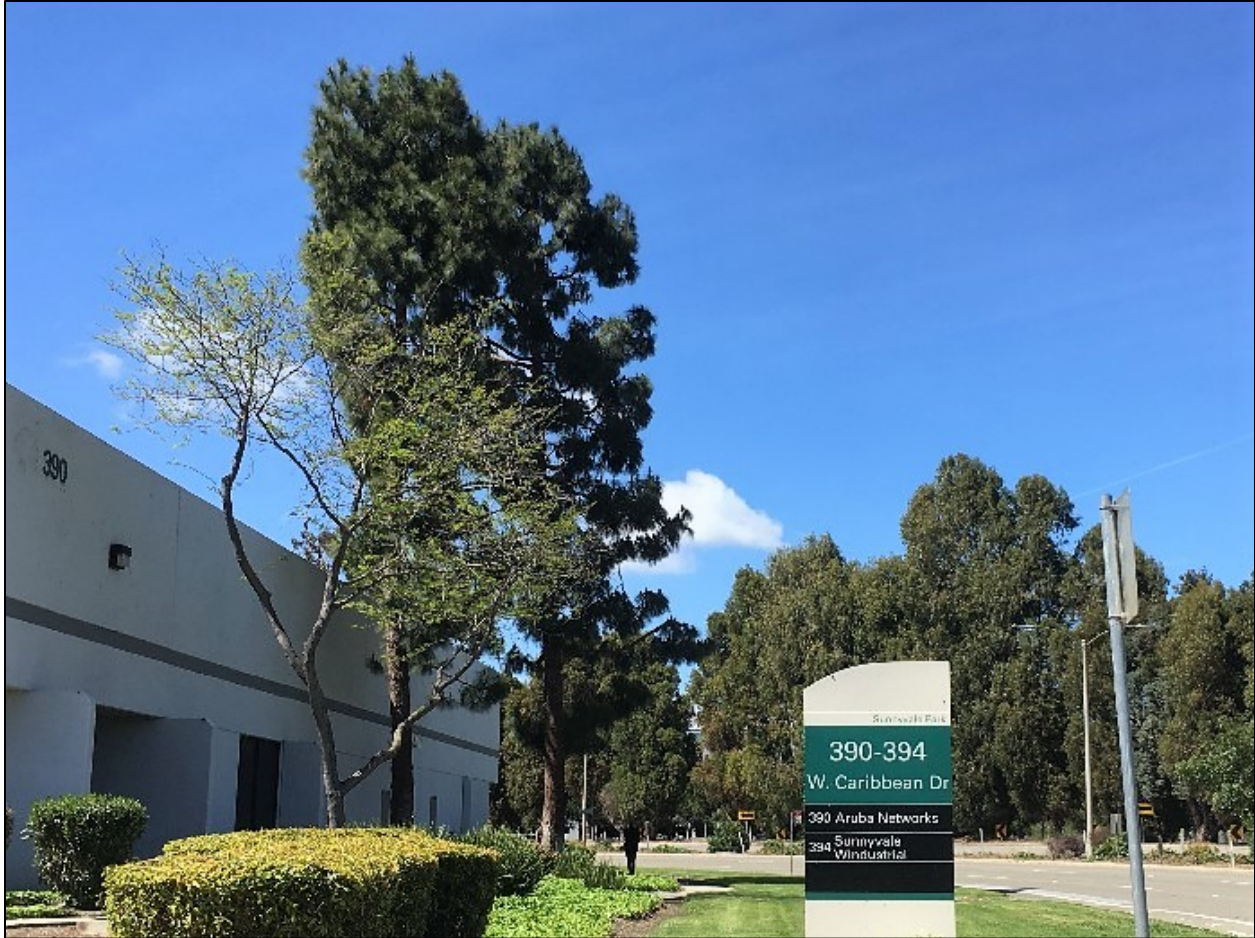
Photo 5. Tree 2144 (foreground), jacaranda (*Jacaranda mimosifolia*) and Trees 2142-2143 (background), Canary Island pine (*Pinus canariensis*).
