**Humboldt  
Redwood™**

March 17, 2014

#### **Geologic Evaluation of the McDoe Timber Harvesting Plan Humboldt County, California**

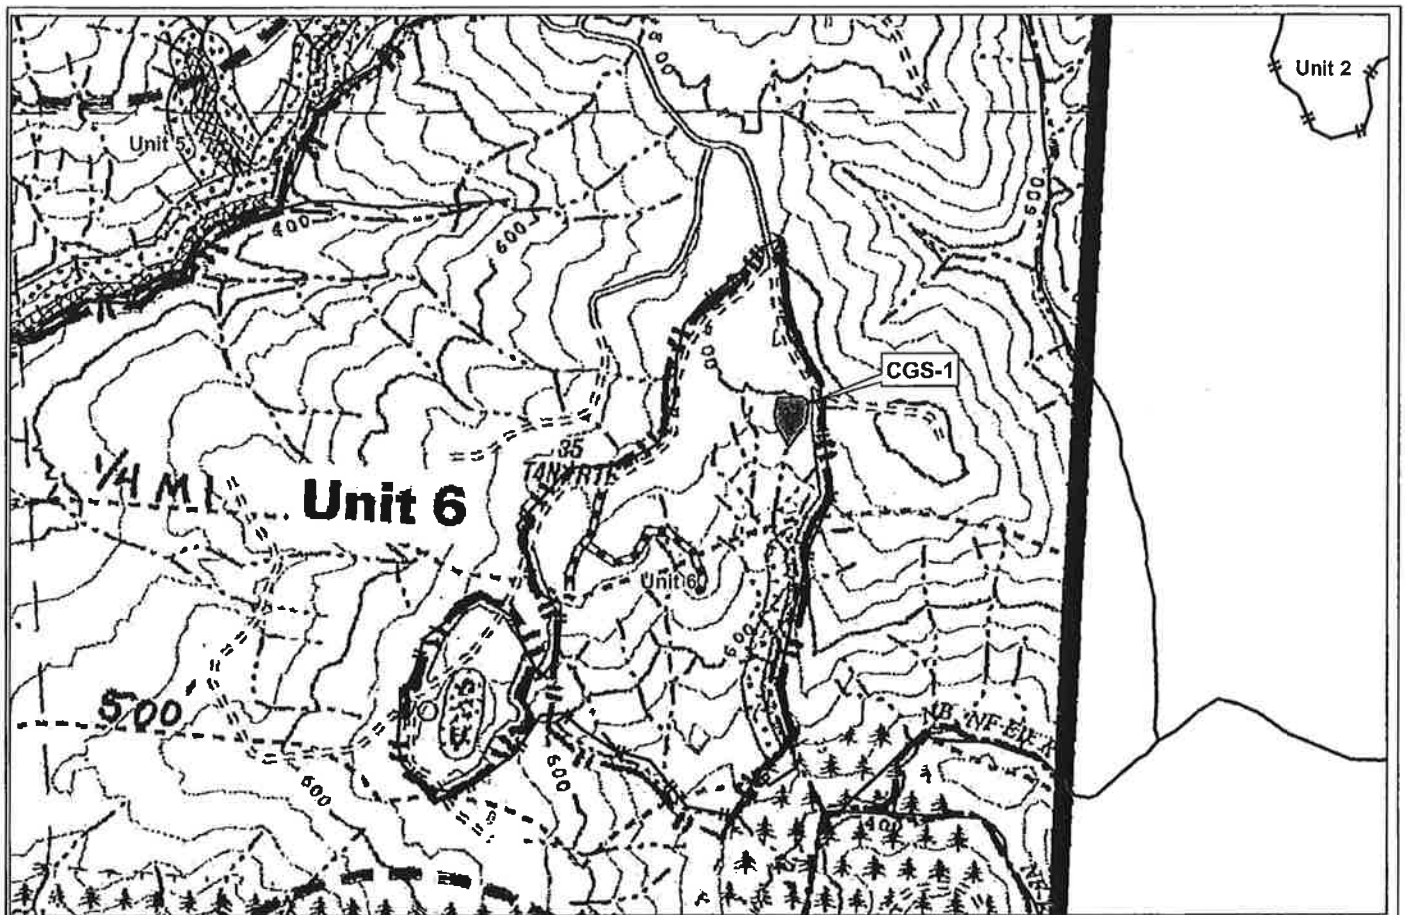
CGS-1, unstable area described in text
