## **Appendix E      Specimen Tree Report**

November 2, 2018

***Subject: Specimen Tree Report for the 6501-6513 Serrano Avenue Project, Anaheim, California***

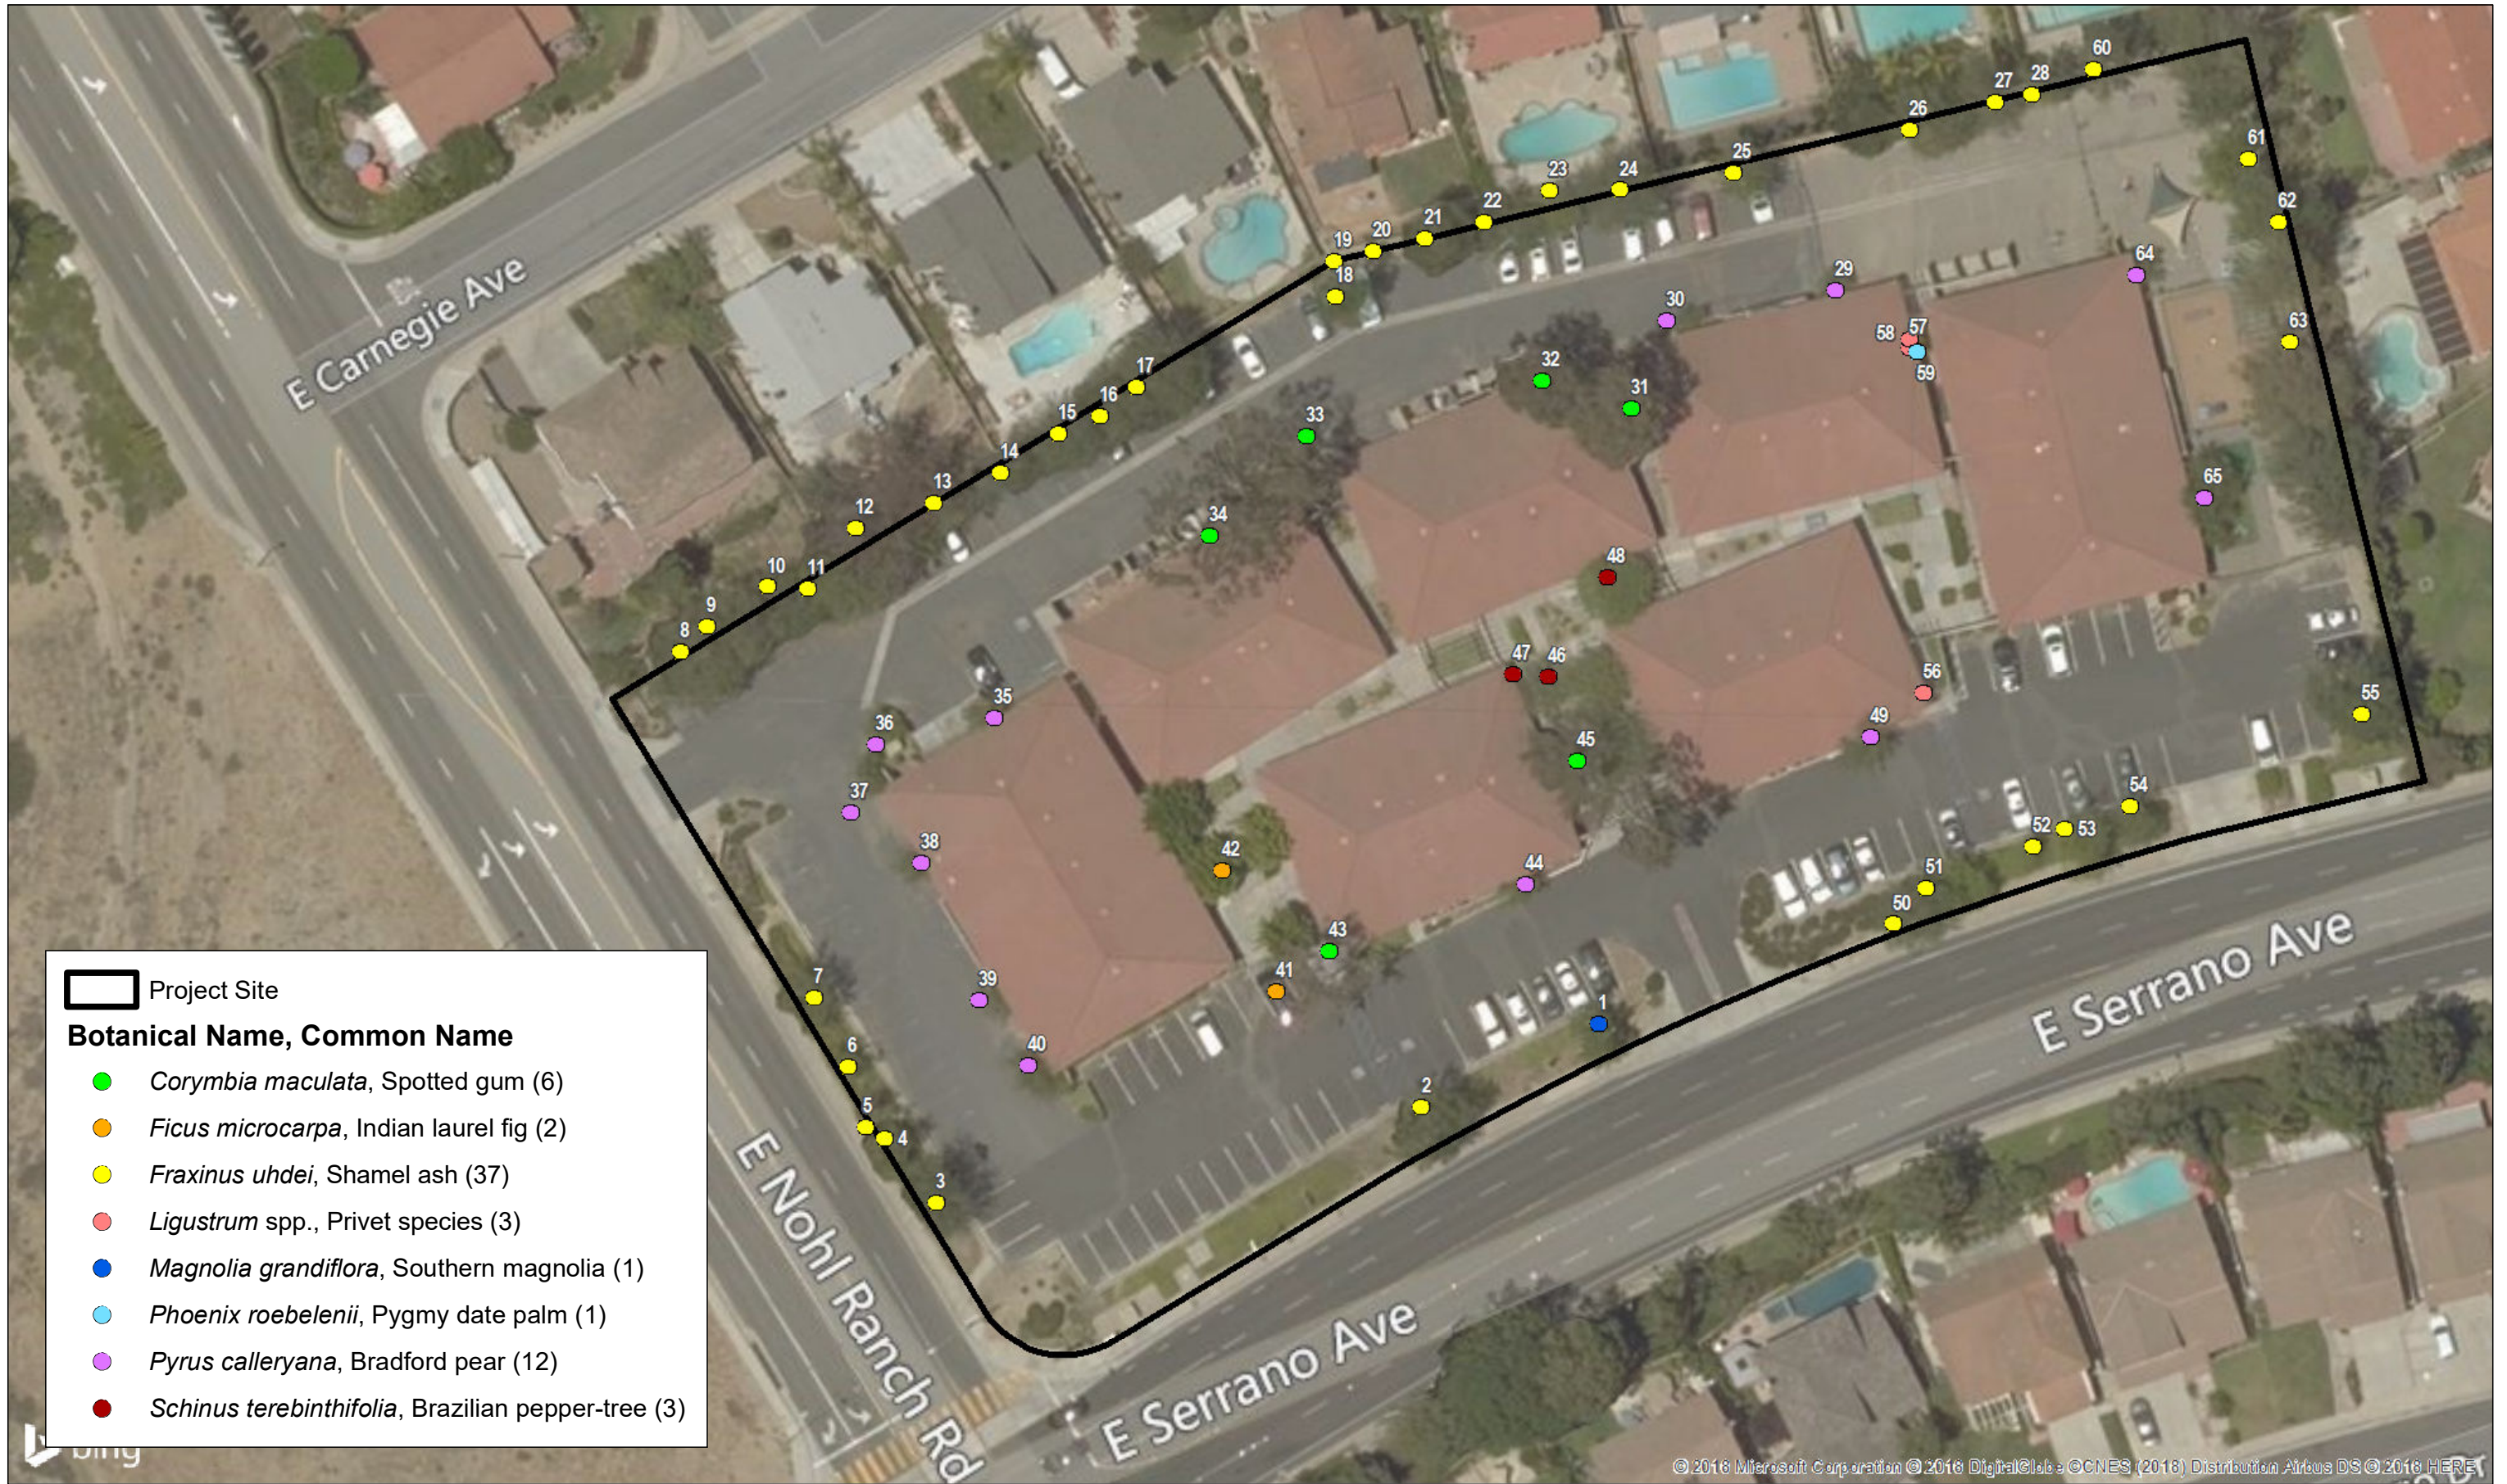
**ATTACHMENT 1**  
*Specimen Tree Location Exhibit*

Overall, the trees exhibit growth and structural conditions that are typical of their planting locations as urban landscape trees. As presented in Attachment 2, approximately 33 (51%) of the trees are in fair condition; 23 (35%) are in good condition; and the remaining 9 (14%) are in poor condition. Table 1 provides a summary of the 8 species mapped and evaluated within the survey area. Attachment 1 – Specimen Tree Location Exhibit presents the location of the trees documented and assessed on the property.
