PROTECTED TREE REPORT

1830 N. Blue Heights Drive
Los Angeles, CA 90069

March 1, 2018

LISA SMITH, THE TREE RESOURCE
REGISTERED CONSULTING ARBORIST #464
ISA CERTIFIED ARBORIST #WE3782
ISA TREE RISK ASSESSOR QUALIFIED
MEMBER OF AMERICAN SOCIETY OF CONSULTING ARBORISTS
P.O. BOX 49314, LOS ANGELES, CA 90049
T 310-663-2290 E queenpalm@earthlink.net

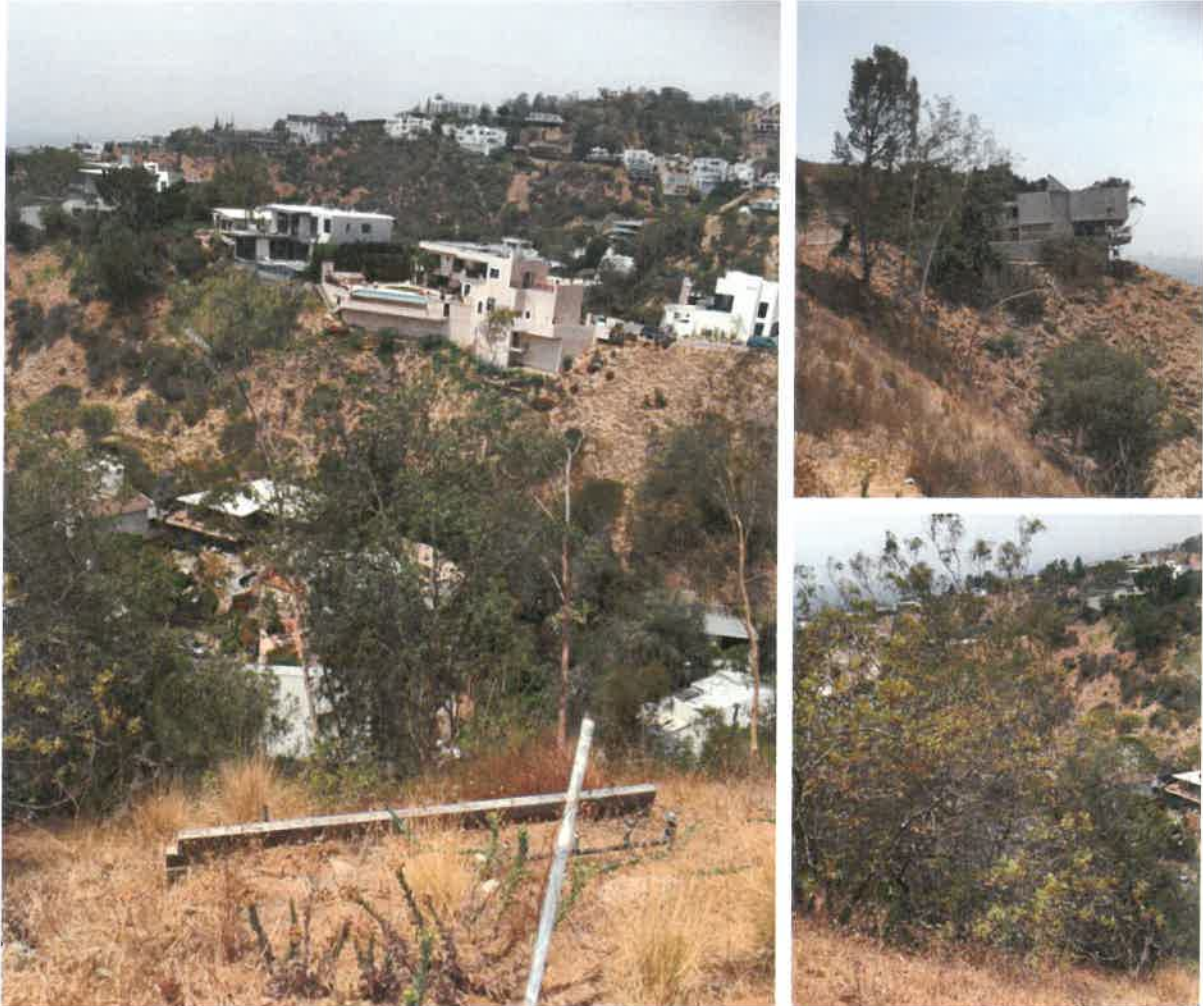
PHOTO 1. Shows views of the subject property. Clockwise from left: looking southwest down the central slope, with the main collection of eucalyptus and Brazilian pepper visible; looking to the eastern limit, to a collection of offsite trees adjacent to the neighboring residence; and a view of the two Protected black walnut (*Juglans californica*) trees at the top of the slope near the main peninsula of the property. The seven (7) Non-Protected Trees and two (2) Protected black walnut trees on site will be significantly impacted by the proposed construction and are recommended for removal.

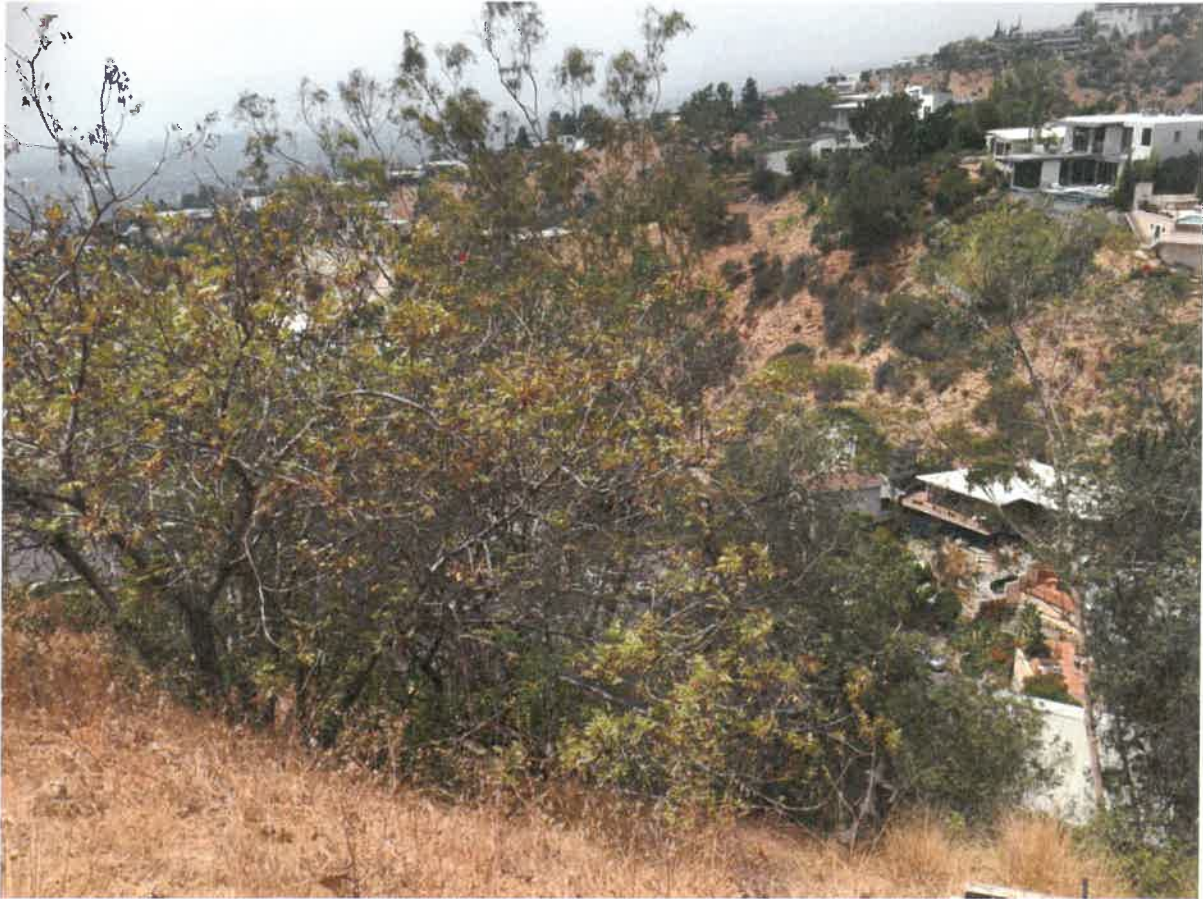
At this time, I observed two (2) black walnut (*Juglans californica*) trees on the property. These two trees are on the upper portion of this steeply sloping lot well within the construction zone. These trees are drought stressed and in poor condition. They will both be significantly impacted by the proposed construction and are located in the footprint of the proposed residence. They are recommended for removal and replacement to the satisfaction of the Urban Forestry Division. Due to the steep hillside terrain, they are not tagged, however they are located on the tree location map provided within this report.

PHOTO 2. Shows Protected black walnut (*Juglans californica*) #1 and #2 at the top of the slope near the main peninsula of the property. These two (2) Protected black walnut trees will be significantly impacted by the proposed construction and are recommended for removal and replacement at a four to one (4:1) ratio, 24" box minimum size, to the satisfaction of the Urban Forestry Division.

The two (2) protected black walnut trees at the top of the slope are within the footprint of the new residence and are recommended for removal and replacement to the satisfaction of the City of Los Angeles, Urban Forestry Division, at a four to one (4:1) ratio, minimum 24 inch box size. A total of eight (8) native trees will be planted on site.
