# **NATIONAL CITY CARMAX PROJECT BIOLOGICAL TECHNICAL REPORT**

**November 2019**

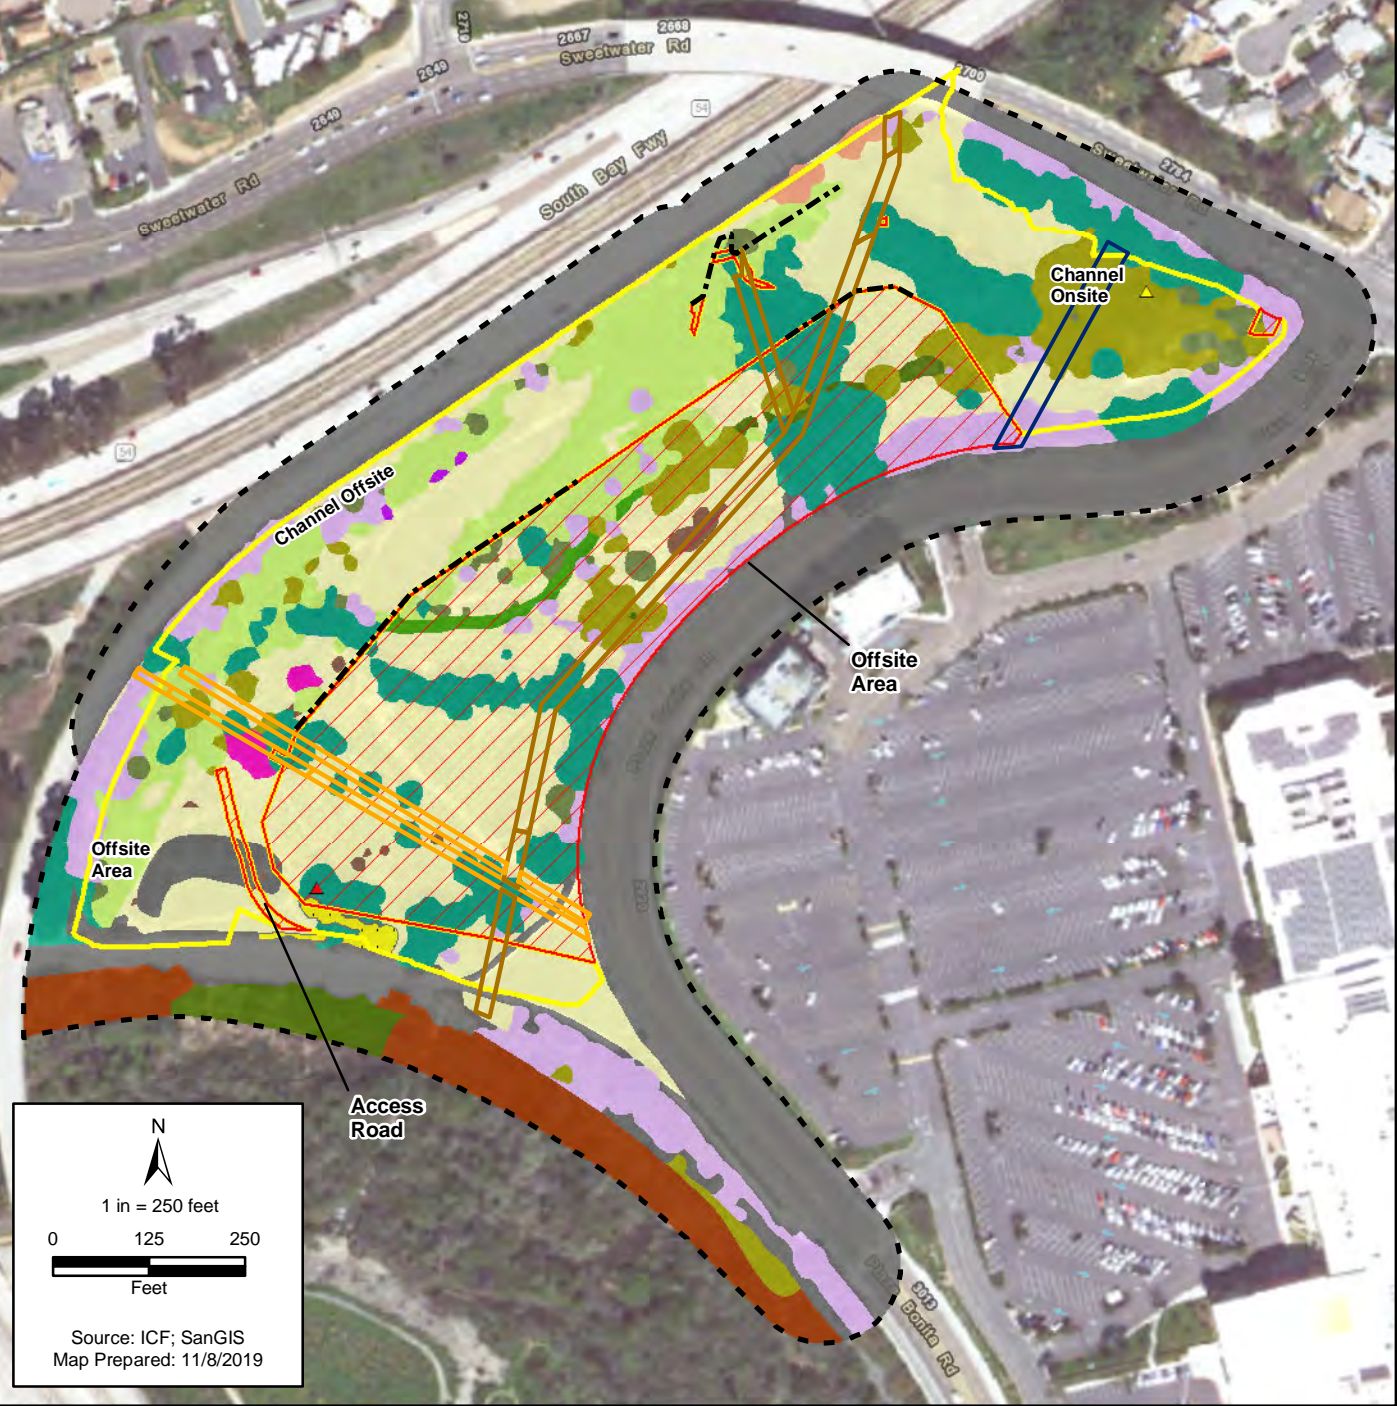
**Figure 10**  
**Project Impacts to Vegetation**  
**National City CarMax Project**

Legend						
	Study Area	<b>Rare Plant Observation</b>		Coyote Brush Scrub		Nonnative Riparian
	SDG&E Easement		Walnut trees (2 individuals)			Disturbed Habitat
	Sewer Easement		Juncus acutus			Eucalyptus Groves
	Water Easement	<b>Vegetation Communities</b>		Giant Reed Breaks		Mule-Fat Thickets
	Permanent Impact		Arroyo Willow Thickets			Naturalized Warm-Temperate
	Temporary Impact		Cattail Marshes			Riparian and Wetland Semi-Natural Stands
	Retaining Wall		Cottonwood Tree			San Diego Sunflower Scrub
						Sycamore Tree
						Urban/Developed

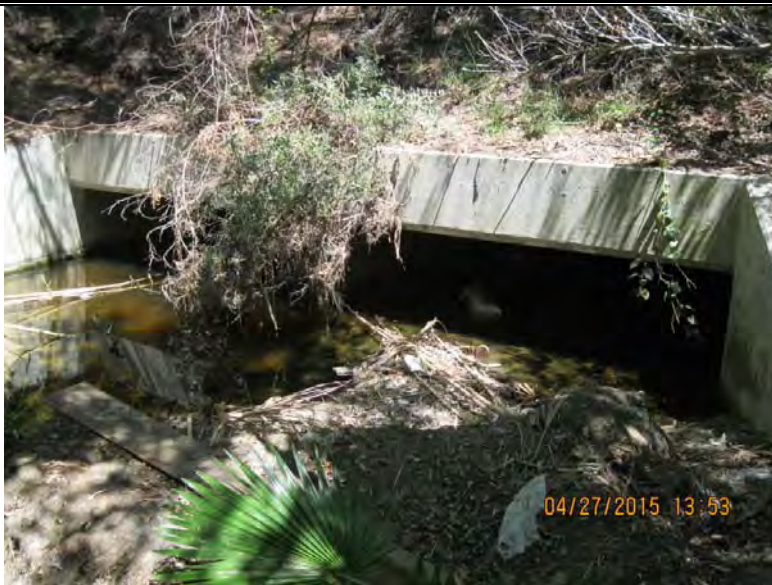
**Photograph: 1**

**Comment:** Photo depicts a 25-foot wide box culvert located at the upstream end of Feature 1.

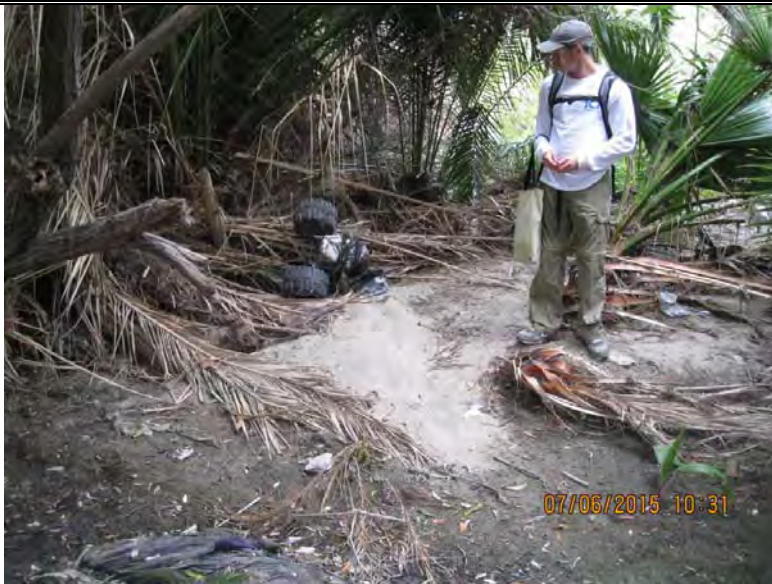
**Photograph: 2**

**Comment:** Photo depicts large sediment deposits and debris at the upper portion of Feature 1.

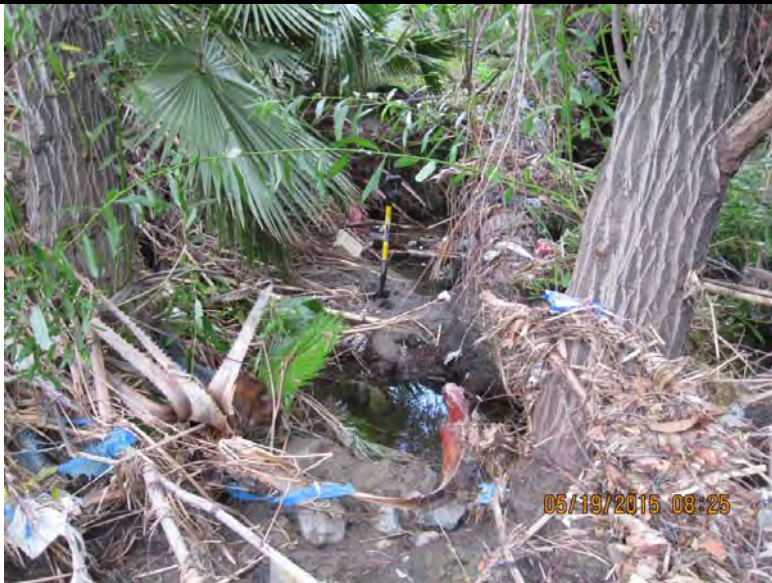
**Direction:** Photo looking east (across the channel).

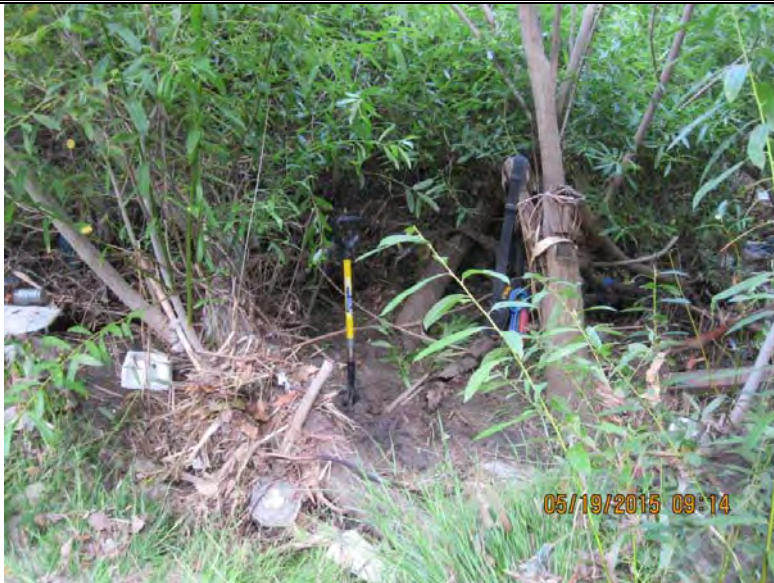
**Photograph: 3**

**Direction:** Photo looking south (downstream).

**Comment:** Photo depicts Sample Point 1.

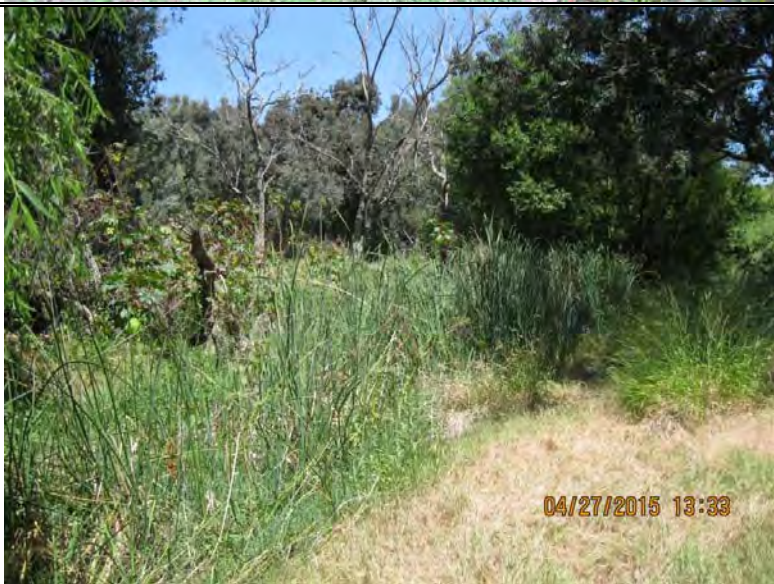
**Photograph:** 5

**Comment:** Photo depicts cat-tail and club-rush vegetation with Feature 1.

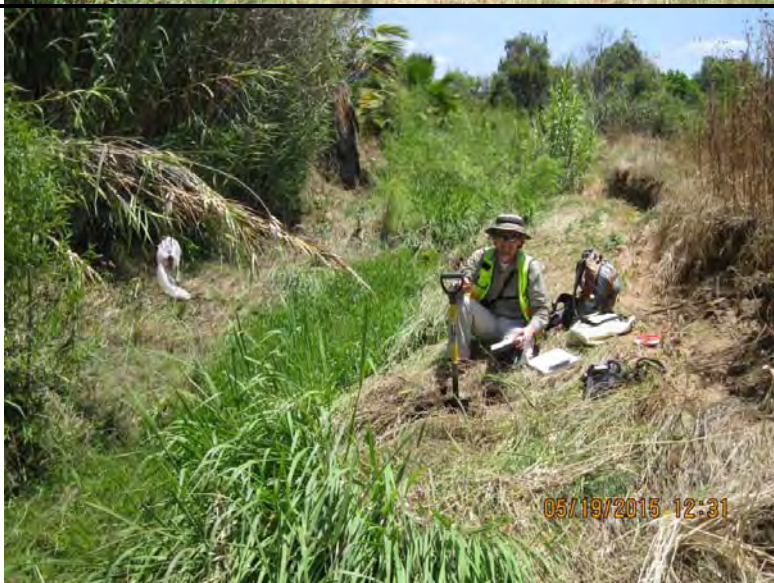
**Direction:** Photo looking northwest (upstream).

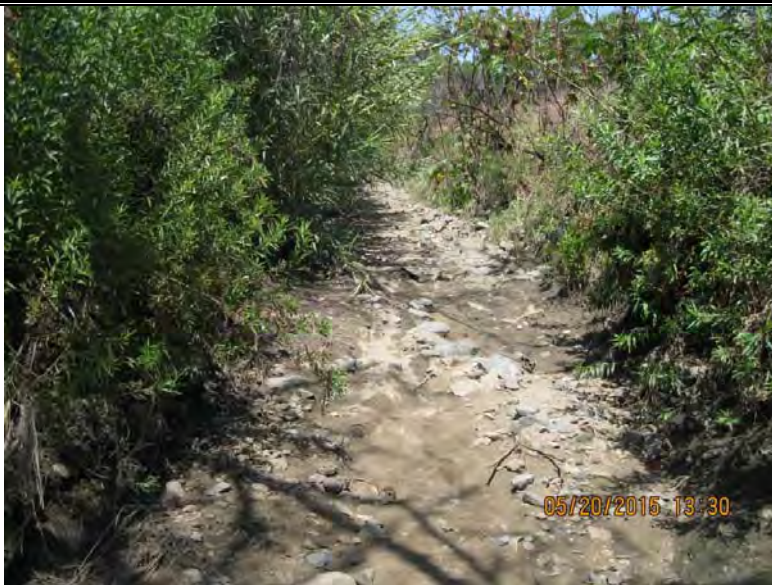
**Photograph: 7**

**Comment:** Photo depicts the channel bottom and adjacent vegetation at the lower portion of Feature 1.

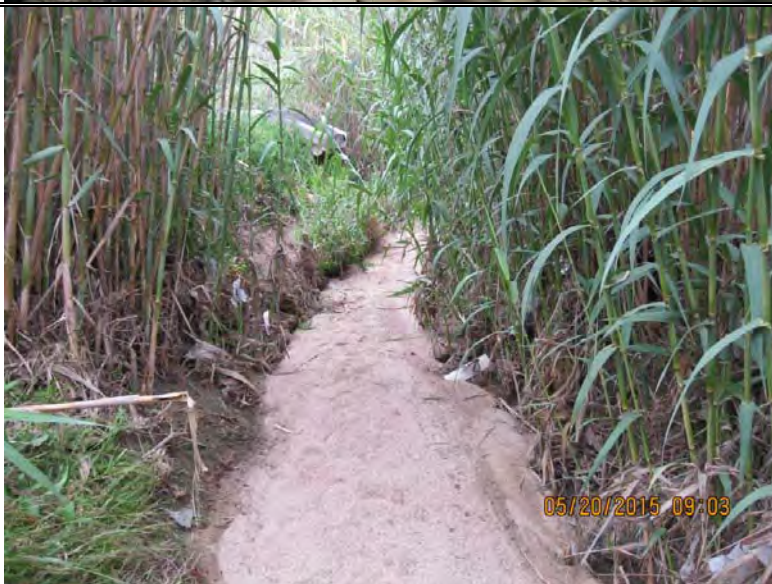
**Photograph: 8**

**Comment:** Photo depicts the channel and vegetation associated with the upper portion of Feature 2.

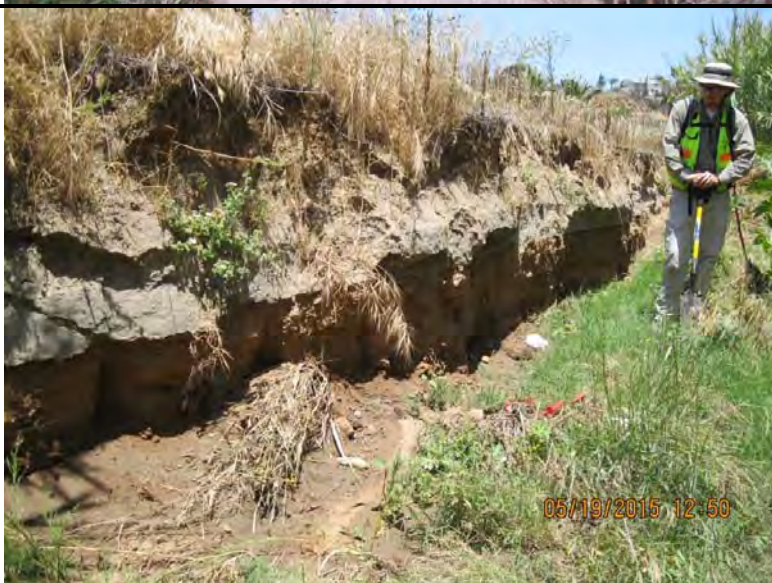
**Direction:** Photo looking south (downstream).

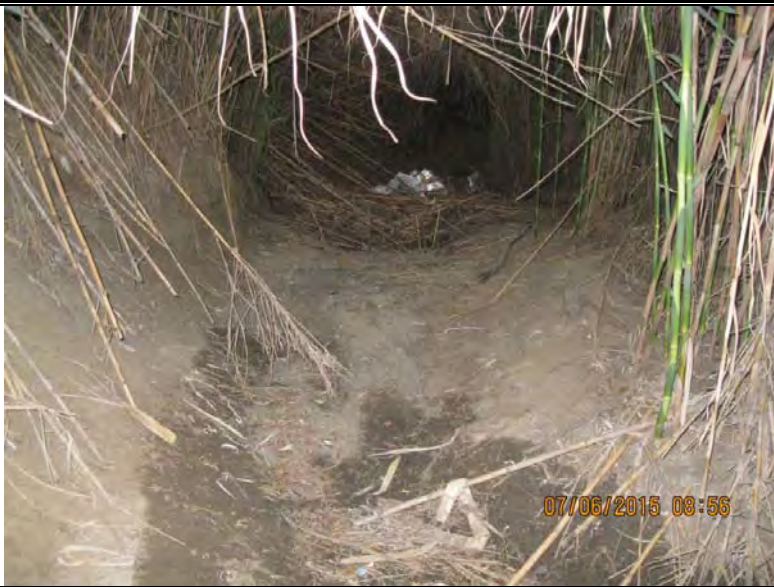
**Direction:** Photo looking northwest (upstream).

**Comment:** Photo depicts the conditions present in the lower portion of Feature 2.

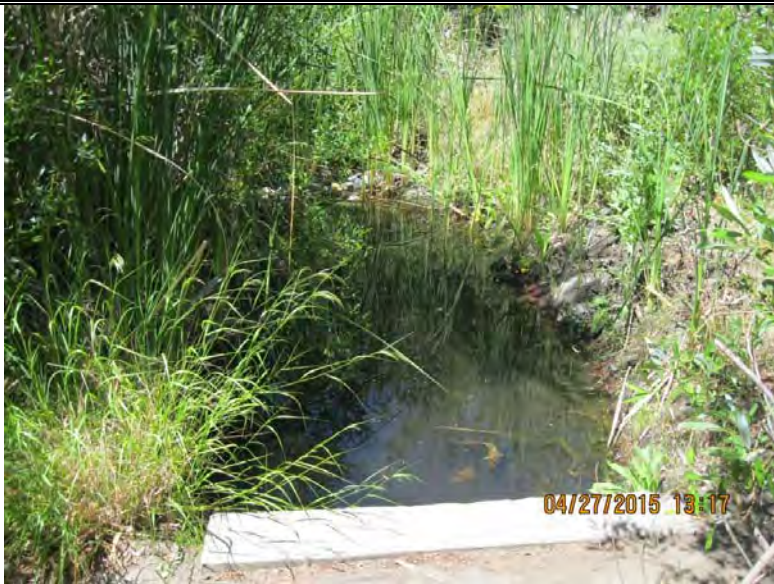
**Photograph: 11**  
**Photo Date:** April 27, 2015  
**Location:** Feature 1b.  
**Direction:** Photo looking west (downstream).  
**Comment:** Photo depicts cat-tail and vegetation and standing water just below the culvert at the top of Feature 1b.

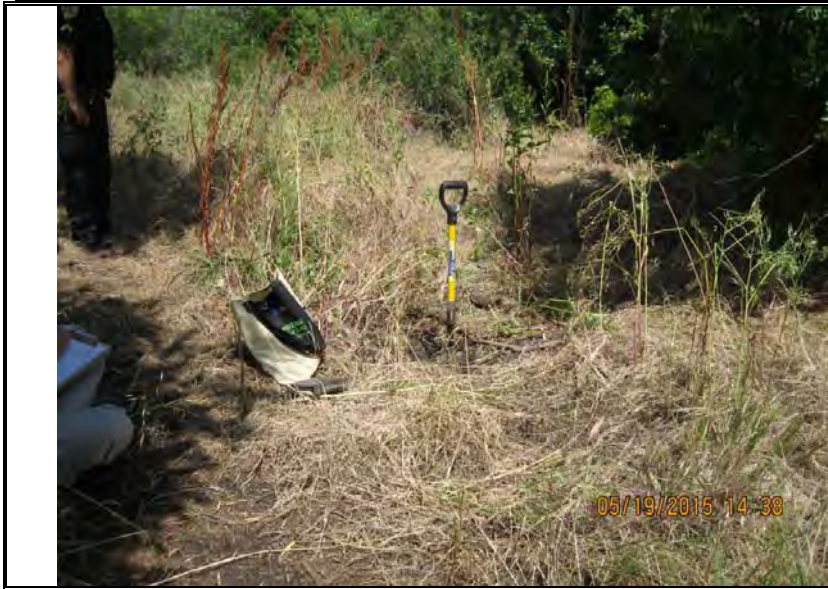
**Photograph: 12**  
**Photo Date:** May 19, 2015  
**Location:** Feature 1b.  
**Direction:** Photo looking south (across the channel).  
**Comment:** Photo depicts Wetland Sample Point #4.

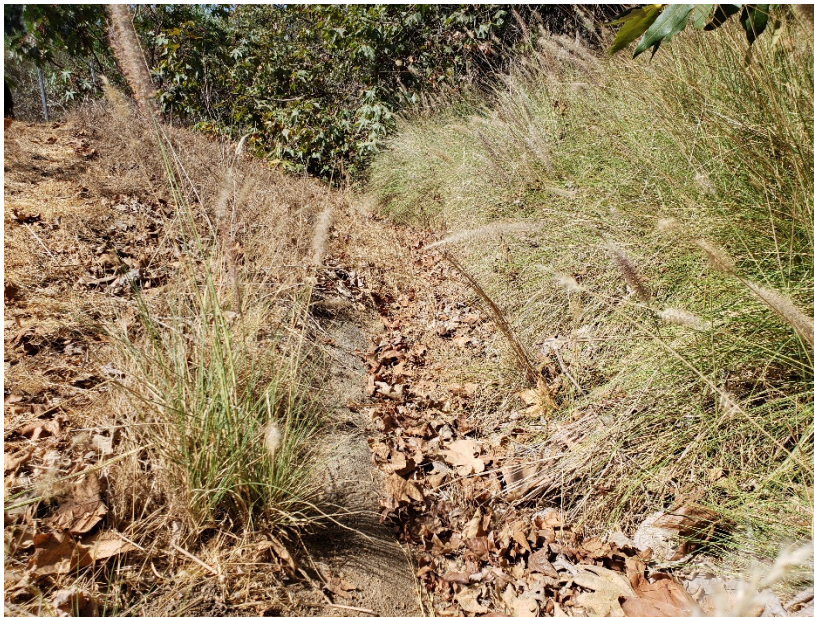
Feature 2c, newly mapped feature. Blue line indicated the channel bottom added.

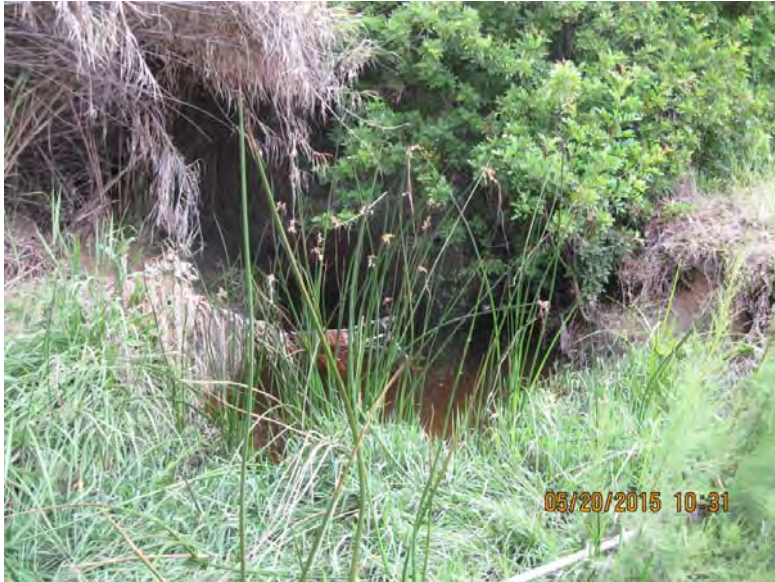
**Photograph: 1**  
**Photo Date:** May 20, 2015  
**Location:** AA 1  
**Direction:** Downstream end of AA 1 looking upstream.  
**Comment:** Photo of deep pool with debris at the downstream end of AA 1.

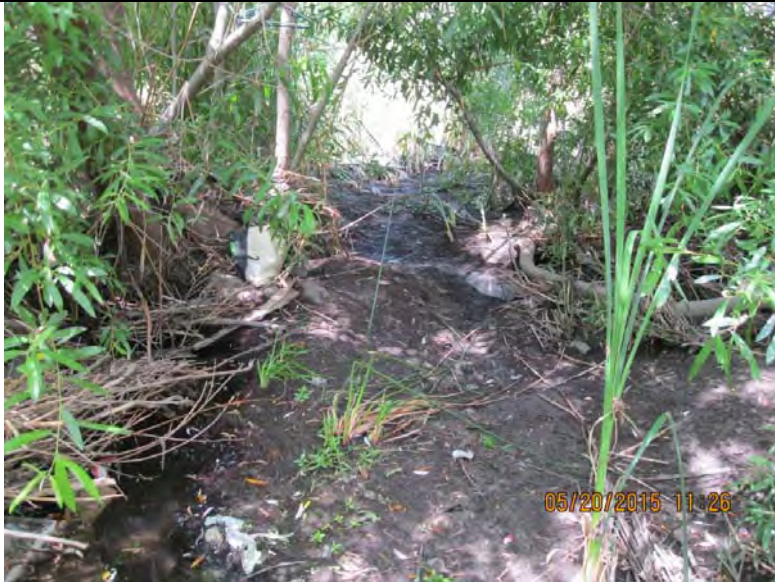
**Photograph: 2**  
**Photo Date:** May 20, 2015  
**Location:** AA 1  
**Direction:** Upstream end of AA 1 looking downstream.  
**Comment:** Photo of channel and riparian vegetation located at the upstream end of AA 1.

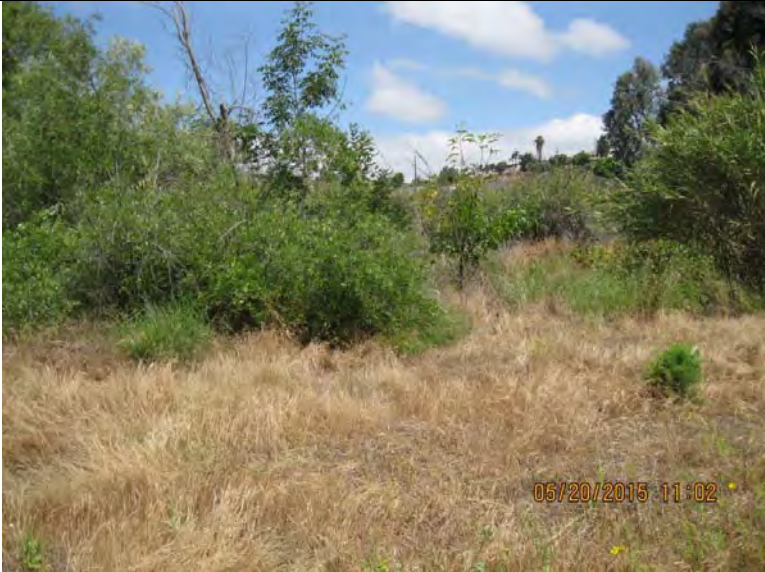
**Photograph: 3**  
**Photo Date:** May 20, 2015  
**Location:** AA 1  
**Direction:** Middle of AA 1 looking east.  
**Comment:** Photo of vegetation within and adjacent to the middle portion of AA 1.

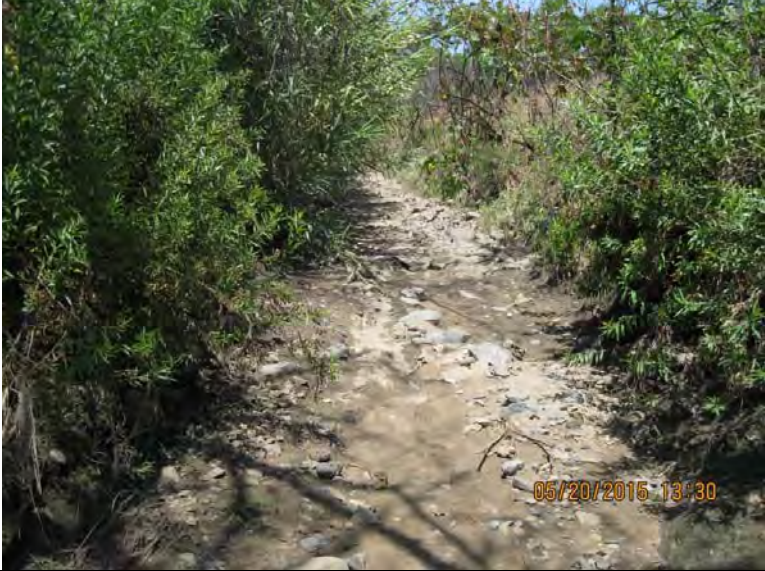
<p><b>Photograph:</b> 4</p> <p><b>Photo Date:</b> May 20, 2015</p> <p><b>Location:</b> AA 1</p> <p><b>Direction:</b> Middle of AA 1 looking west.</p> <p><b>Comment:</b> Photo of vegetation within and adjacent to the middle portion of AA 1.</p>

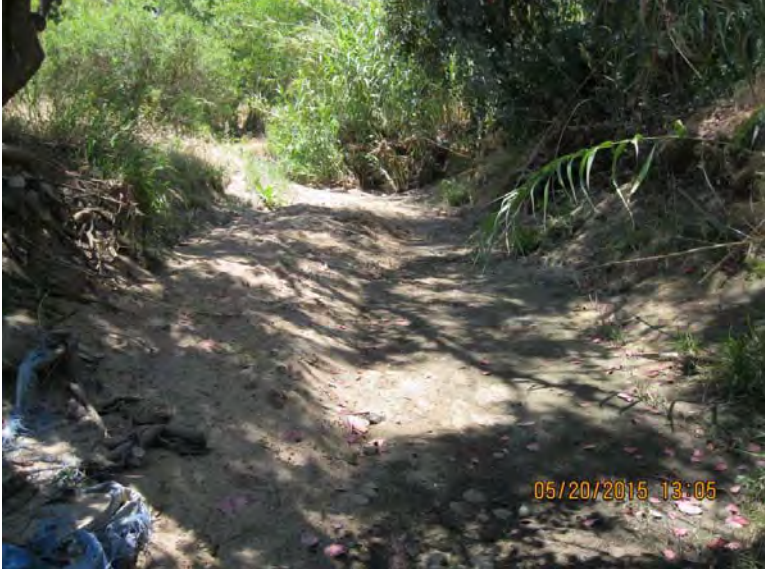
<p><b>Photograph:</b> 5</p> <p><b>Photo Date:</b> May 20, 2015</p> <p><b>Location:</b> AA 2</p> <p><b>Direction:</b> Downstream end of AA 2 looking upstream.</p> <p><b>Comment:</b> Photo of channel and vegetation present at the downstream end of AA 2.</p>

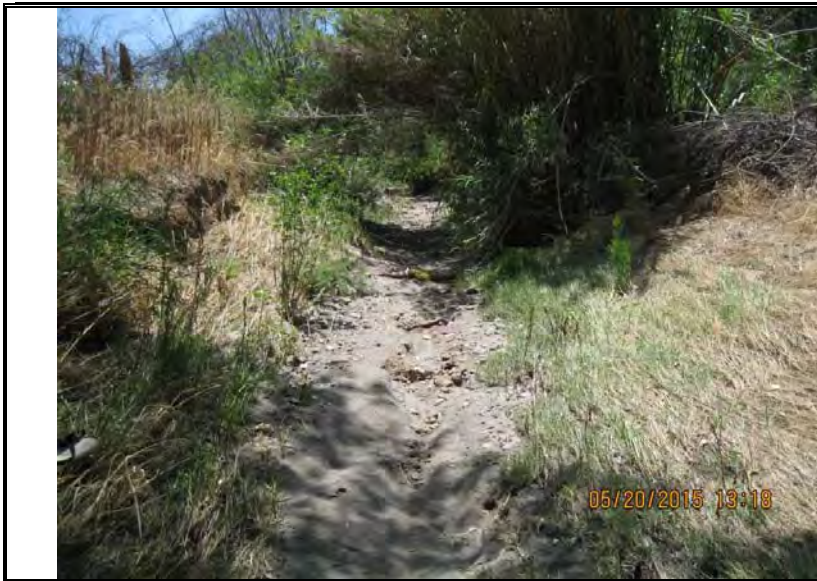
<p><b>Photograph:</b> 6</p> <p><b>Photo Date:</b> May 20, 2015</p> <p><b>Location:</b> AA 2</p> <p><b>Direction:</b> Upstream end of AA 2 looking downstream.</p> <p><b>Comment:</b> Photo of channel and vegetation present at the upstream end of AA 2.</p>

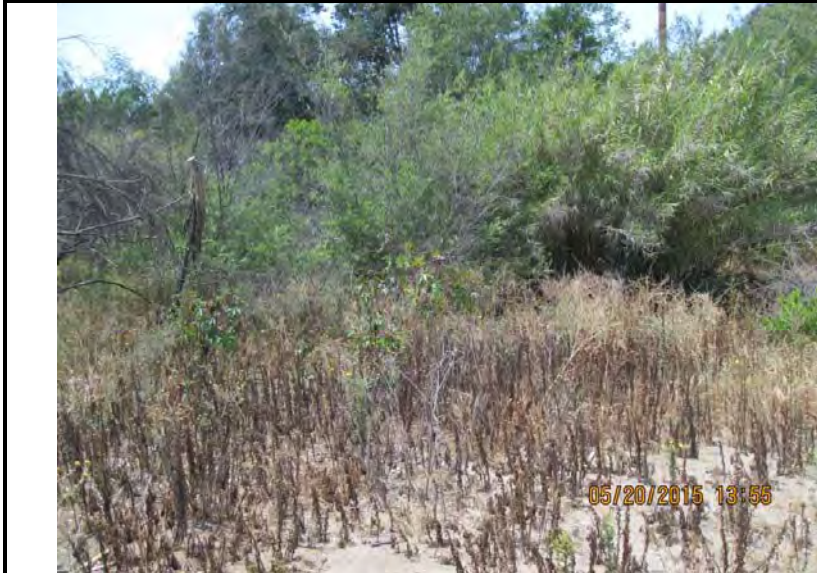
**Photograph:** 8

**Direction:** Middle of AA 2 looking downstream.  
*No middle of AA photo looking east photo was taken as there was a large homeless encampment on the western edge of AA 2.*

**Comment:** Photo of vegetation within and adjacent to the middle portion of AA 2.

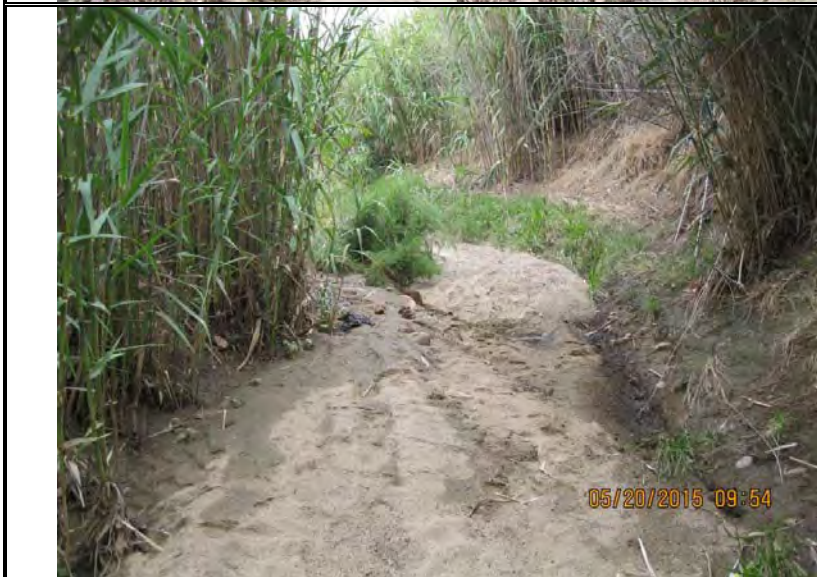
**Photograph:** 9

**Direction:** Middle of AA 2 looking west.

**Comment:** Photo of vegetation within and adjacent to the middle portion of AA 2.

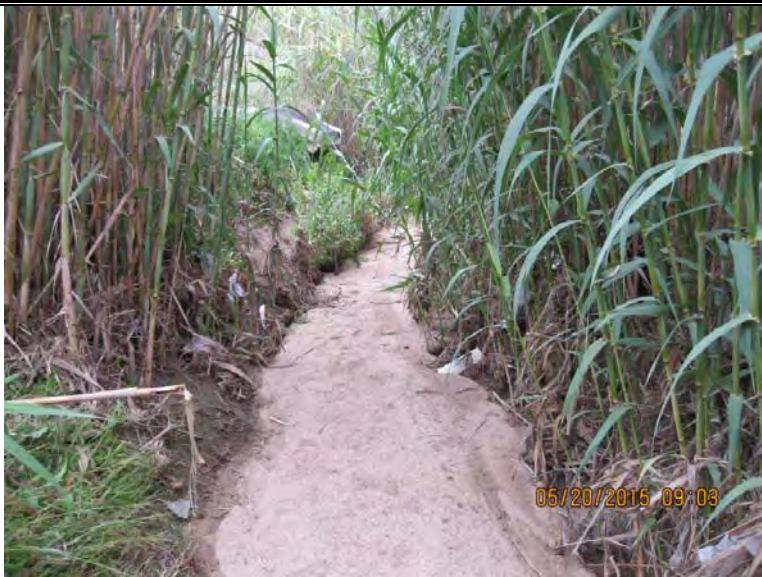
**Direction:** Downstream end of AA 3 looking upstream.

**Comment:** Photo of channel and vegetation present at the downstream end of AA 3.

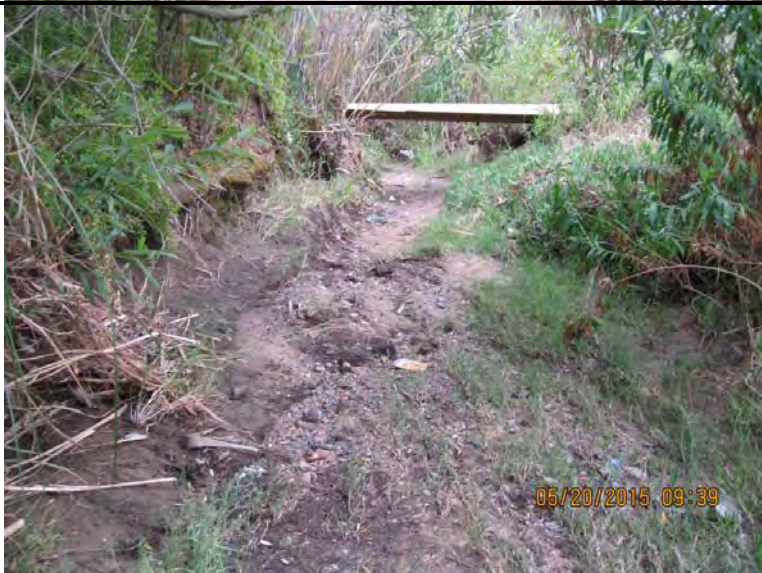
**Photograph:** 10  
**Photo Date:** May 20, 2015  
**Location:** AA 3  
**Direction:** Upstream end of AA 3 looking downstream.  
**Comment:** Photo of channel and vegetation present at the upstream end of AA 3.

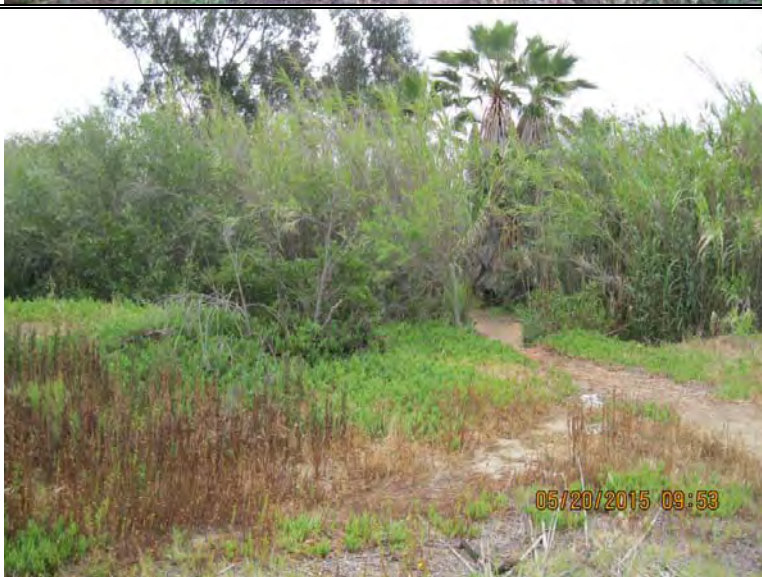
**Photograph:** 11  
**Photo Date:** May 20, 2015  
**Location:** AA 3  
**Direction:** Middle of AA 3 looking downstream. No middle of AA photo looking west photo was taken as there was a large homeless encampment on the eastern edge of AA 3.  
**Comment:** Photo of vegetation within and adjacent to the middle portion of AA 3.

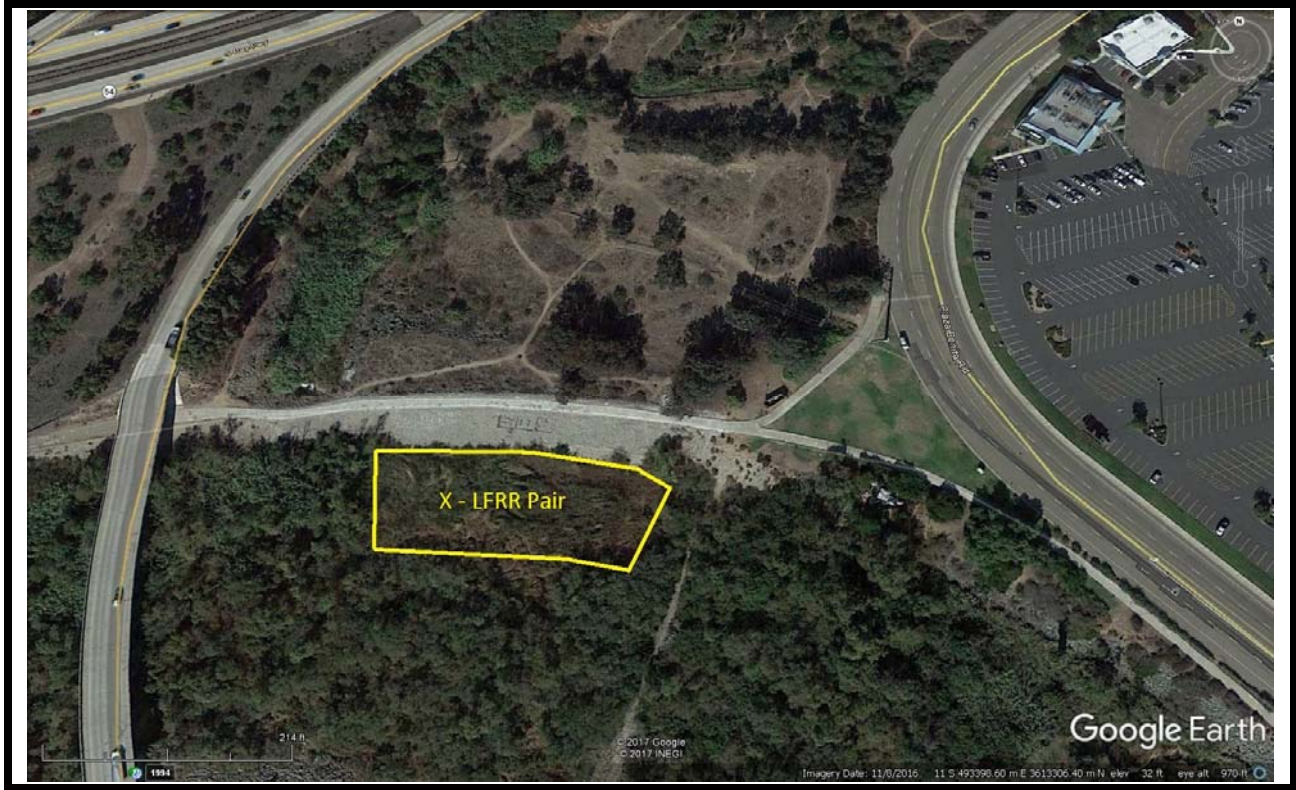
Figure 3. Location (Google Earth photo) of the Light-footed Ridgway's Rail Pair Detected (yellow X) adjacent to the Proposed CarMax Site, City of National City, San Diego County, California, 2017.

In 2017, a protocol survey for light-footed Ridgway's rail was conducted and one pair of federally and state-listed light-footed Ridgway's rail was detected in southern cattail marsh patch located southwest of the project area within the Sweetwater River. No other federally or state-listed wildlife species were detected in 2015 within the survey area. In 2015, focused protocol-level surveys were conducted for LBV, SWFL, and CAGN, and no LBV, SWFL, or CAGN were observed. Two California SSC avian species were observed incidentally during surveys in 2015: yellow warbler and the yellow-breasted chat. One observation of yellow warbler occurred outside of the survey area within the Sweetwater River in 2015, and four observations of yellow-breasted chat occurred (two onsite within the proposed limits of grading and two offsite outside the survey area within Sweetwater River) in 2015. Portions of the project are within the County's Multiple Species Conservation Plan (MSCP) Subarea Plan and MSCP Linkage Area. No wildlife corridors and habitat linkages occur within the project limits, and no USFWS-designated critical habitat for any plant or wildlife species exists within the project limits.
