**Supplement 03 to**

**Final Mitigated Negative Declaration**

**BIG RIVER WATERSHED RESTORATION**  
**PROPOSITION 40 –**  
**RIVER PARKWAYS GRANT PROJECT**  
**State Clearinghouse # 2006072012**

## **SUPPLEMENT TO A MITIGATED NEGATIVE DECLARATION**

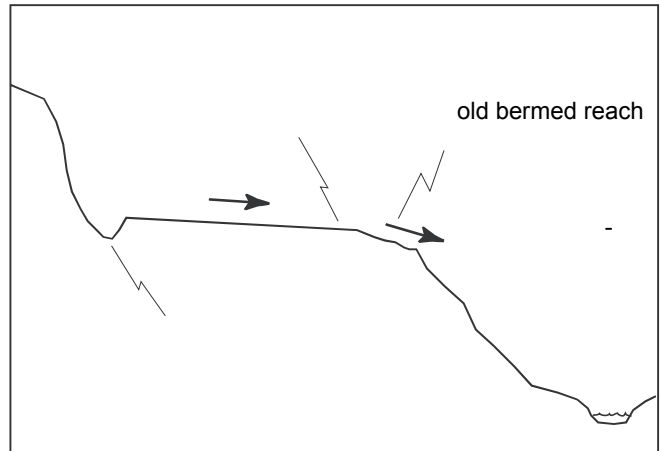
1. On gentle road segments berms can be removed continuously (see B-B').
2. On steep road segments, where safety is a concern, the berm can be frequently breached (see A-A' & B-B')

while maintaining a semi-continuous berm for vehicle safety.
