**Subject: Geotechnical Report for Environmental Impact Report  
The Park at Live Oak [APN8532-001-002 & -004]  
1220 - 1270 Arrow Highway  
Irwindale, California  
HDGI Project No. 70917**

**GEOTECHNICAL REPORT  
FOR ENVIRONMENTAL IMPACT REPORT  
THE PARK AT LIVE OAK [APN 8532-001-002 & -004]  
1220 - 1270 ARROW HIGHWAY  
IRWINDALE, CALIFORNIA**

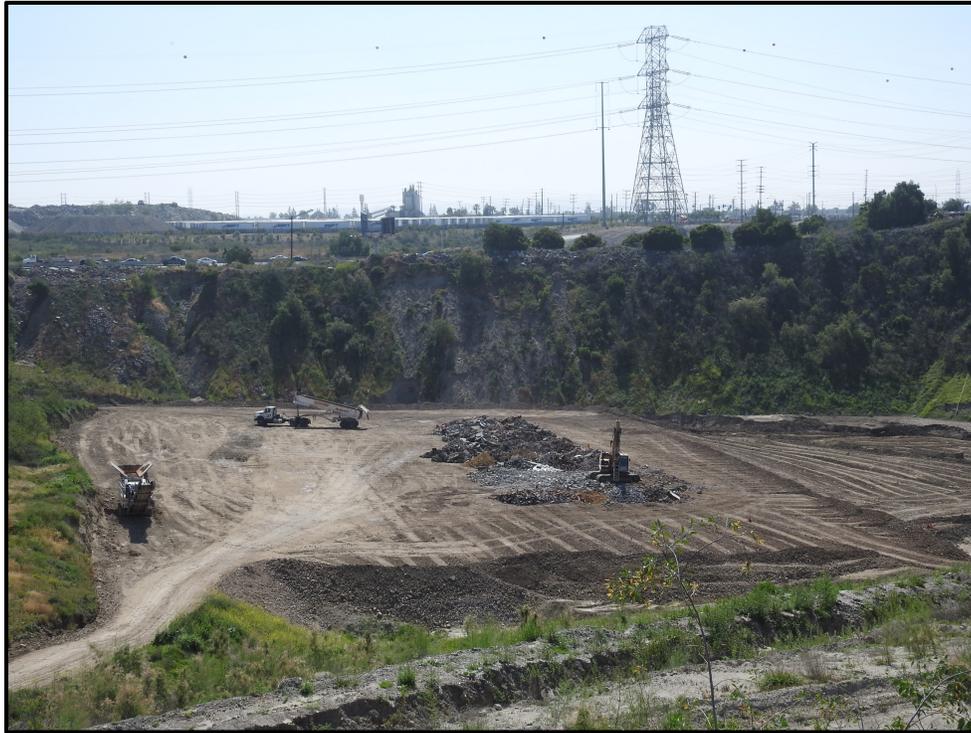
**2017 April** – Southeast Pit (Area 3S). Truck discharging inert debris and pulverization of oversized material. View to east; I-605 Freeway in background.

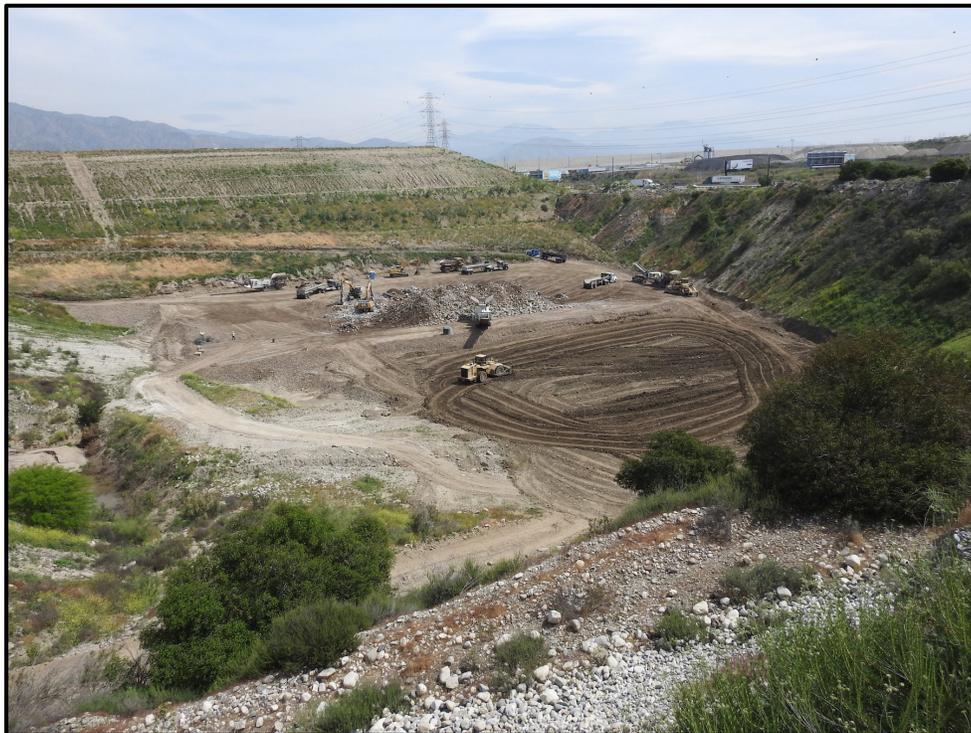
**2017 April** – Southeast Pit (Area 3S). Compaction of blended rubble fill. Area 3N surcharge fill in background. View to northeast.

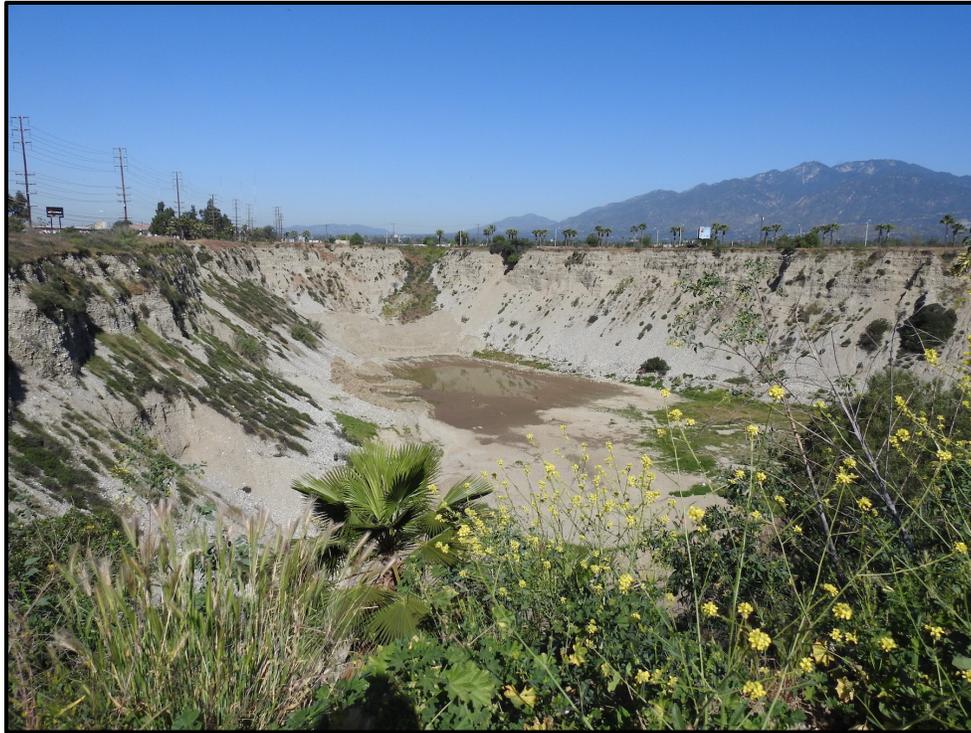
**2017 April** – West Pit (Area 1). Prior to the 2017 earthwork and after precipitation. View to west.

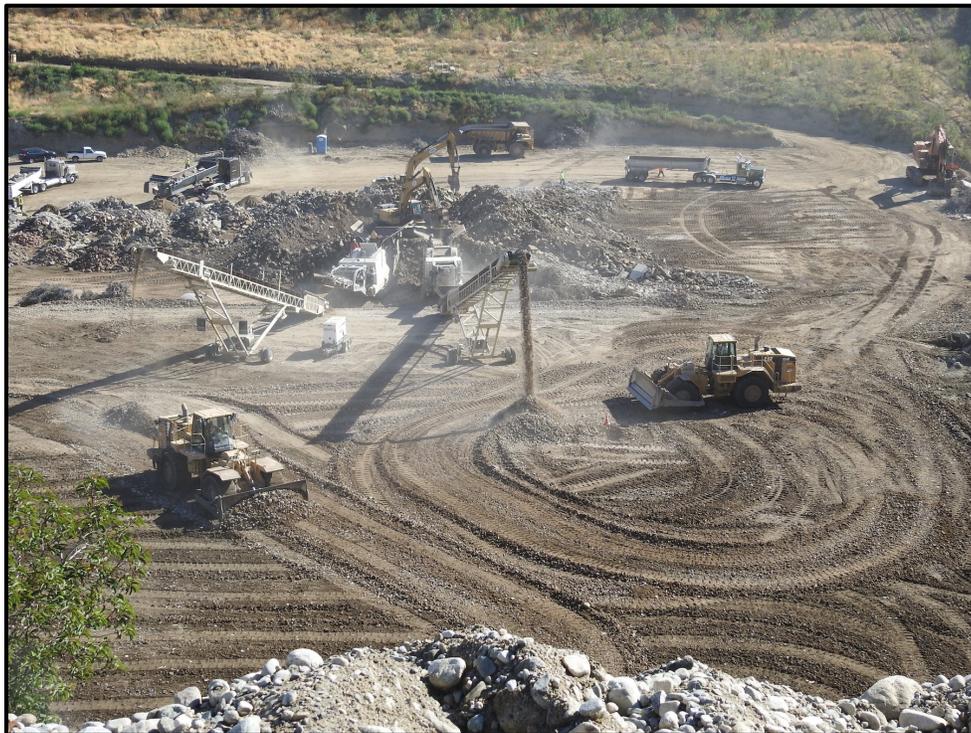
**2017 May** – Southeast Pit (Area 3S). Production and compaction of blended rubble. View to north.

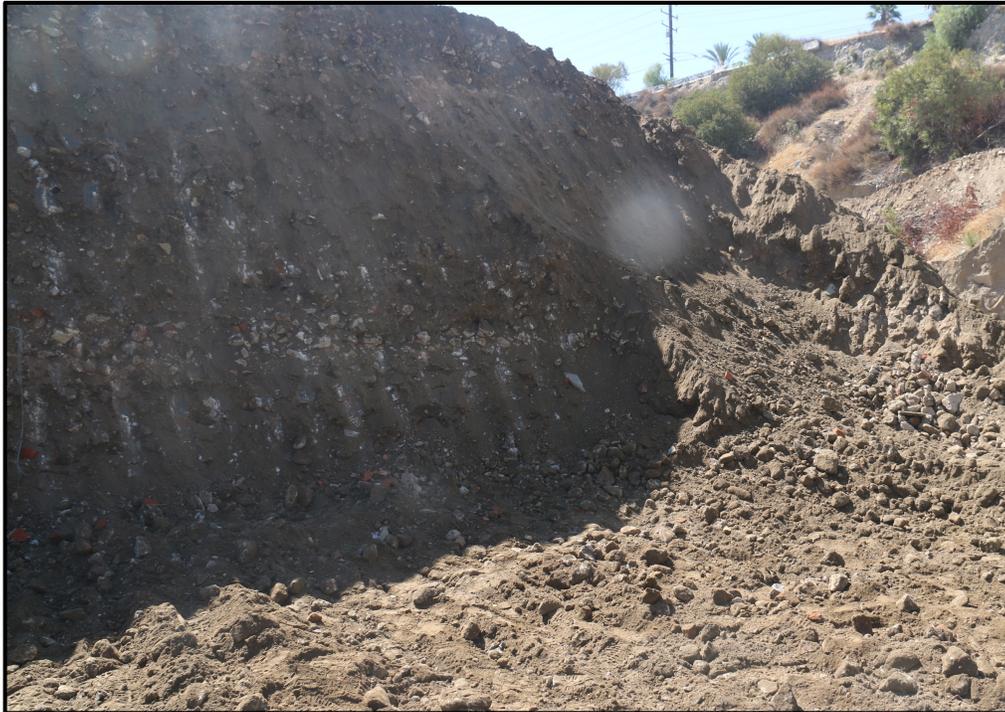
**2017 April** – Southeast Pit (Area 3S). Face of new engineered fill slope cleaned of slough. View to southeast.

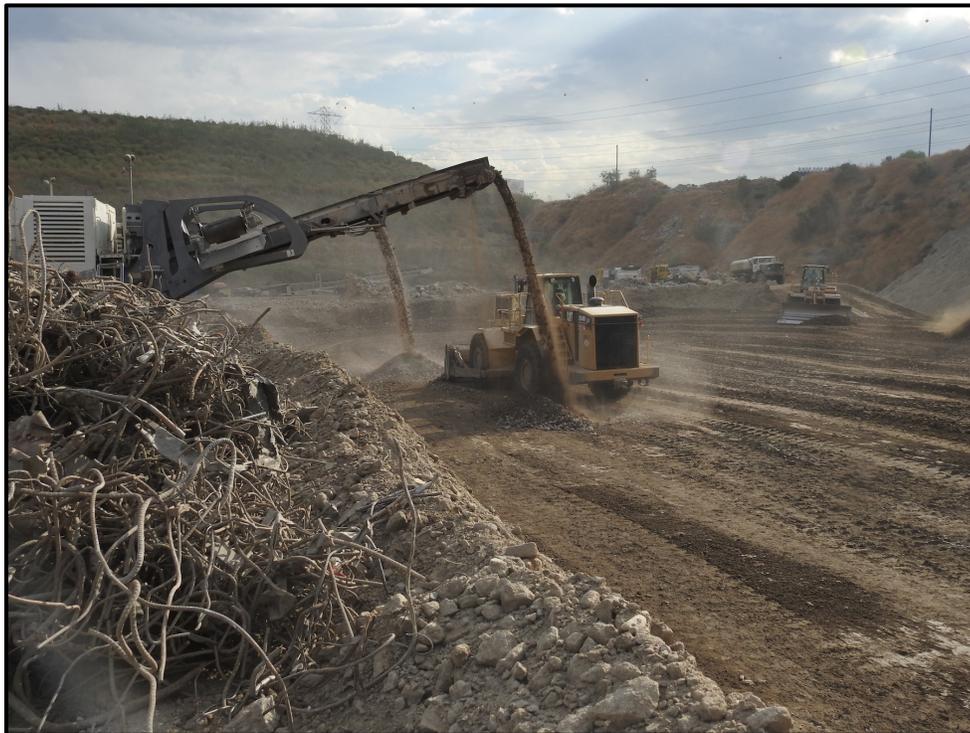
**2017 August** – Southeast Pit (Area 3S). Crushing of pulverized inert debris, and compaction of blended rubble fill. View to northeast.

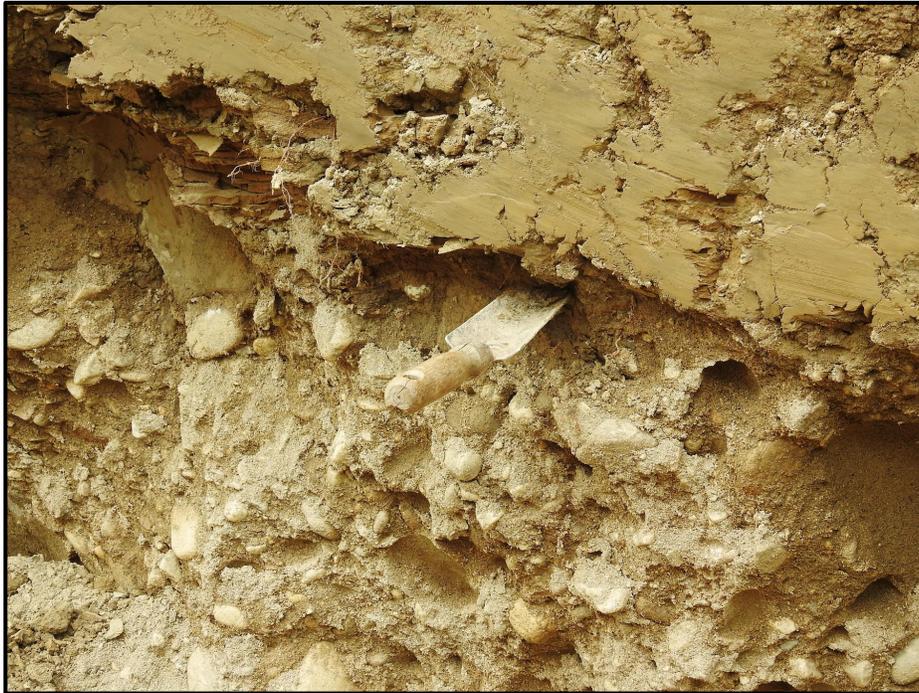
**2017 August** – West Pit (Area 1). Geologic characterization of West Pit bottom materials. Trowel is stuck into side wall at contact of previously-placed silt and clay wash products and the underlying native sands and gravels. The wash products were removed in preparation for placement of engineered fill.

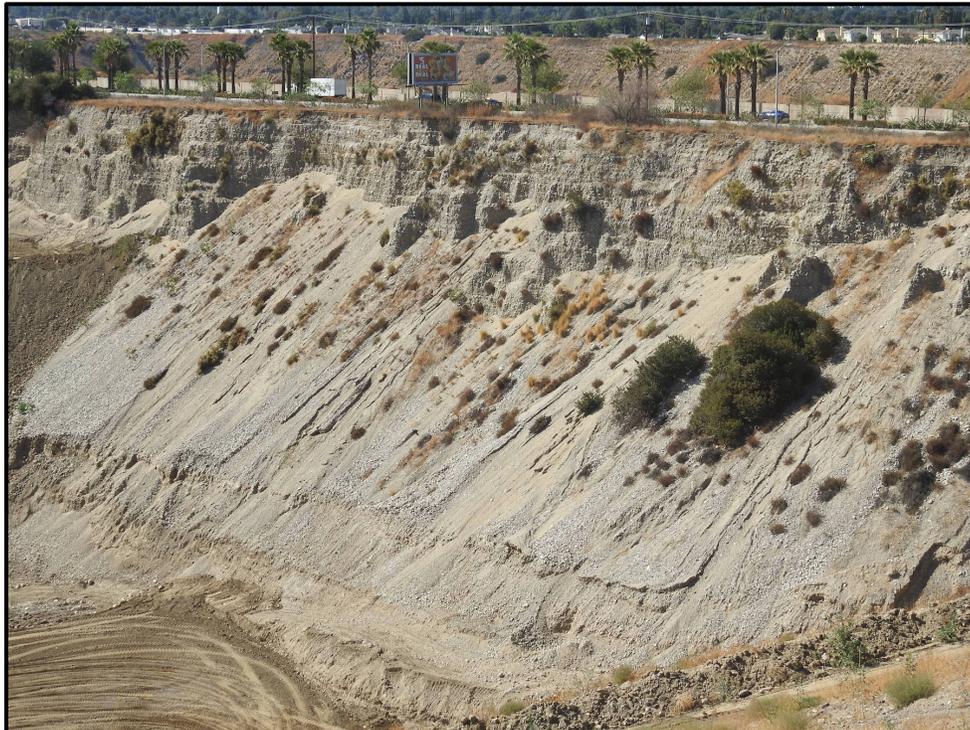
**2017 September** – West Pit (Area 1). Overview of north side wall. Veneer of talus material covering lower (diagonally-inclined) portion of slope. View to northwest.

Loose soils derived from the alluvium in the upper West Pit side slopes mantle the lower slopes in that pit. The talus resulted from weathering and raveling of the upper slopes and thinly covers most of these lower slopes. The slopes include exposures of underlying alluvium in places. The talus is generally composed of gravel, cobbles and boulders, similar to the alluvium from which it is derived. This material is being removed incrementally as the West Pit is filled.

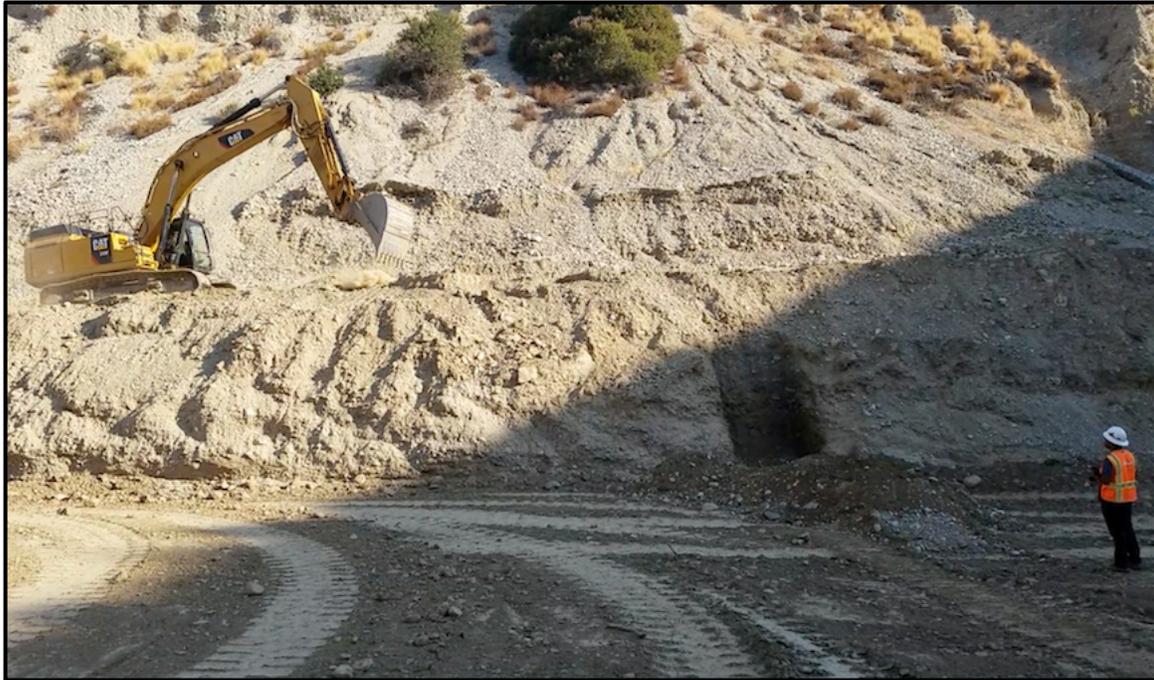
**2017 September** – West Pit (Area 1). Geologic evaluation of side wall materials by means of excavated pits. View to north.

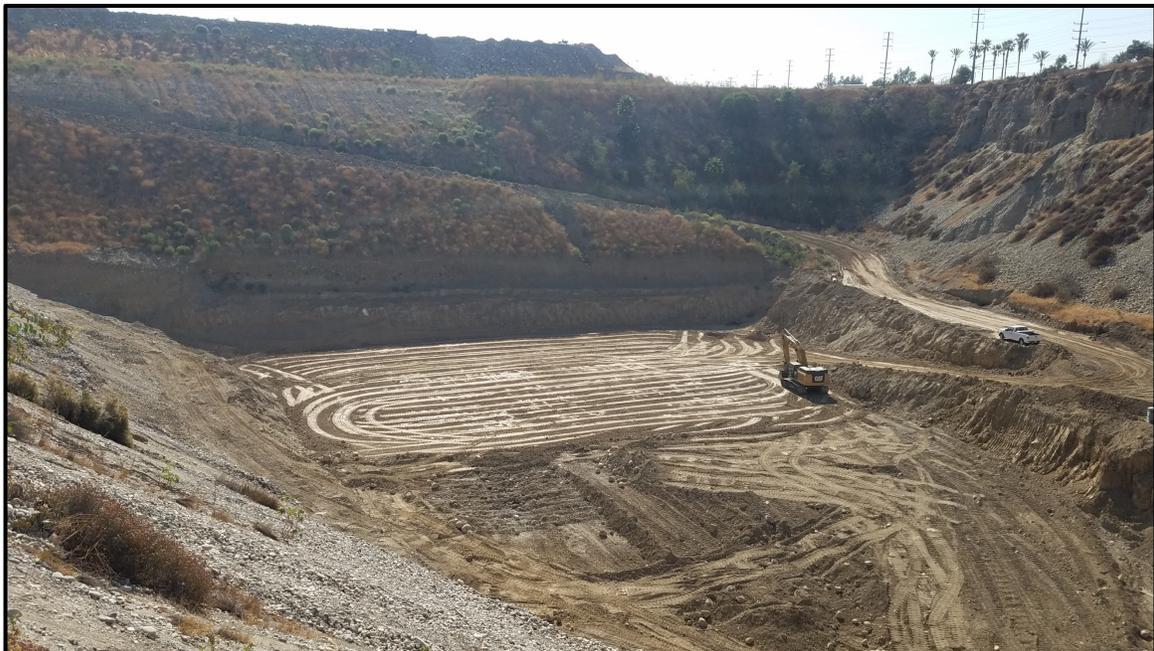
**2017 September** – West Pit (Area 1). Overview of exposed bottom in preparation for placement of engineered fill. View to east.

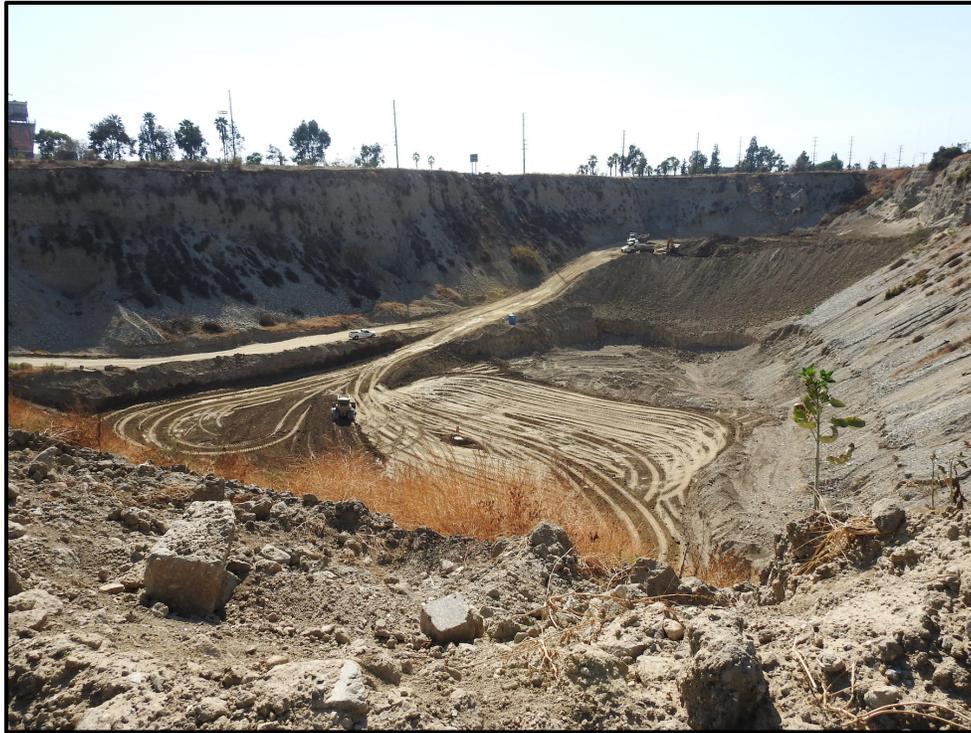
**2017 September** – West Pit (Area 1). Overview of new engineered fill pad. Removed and stockpiled wash products in background. View to southwest.

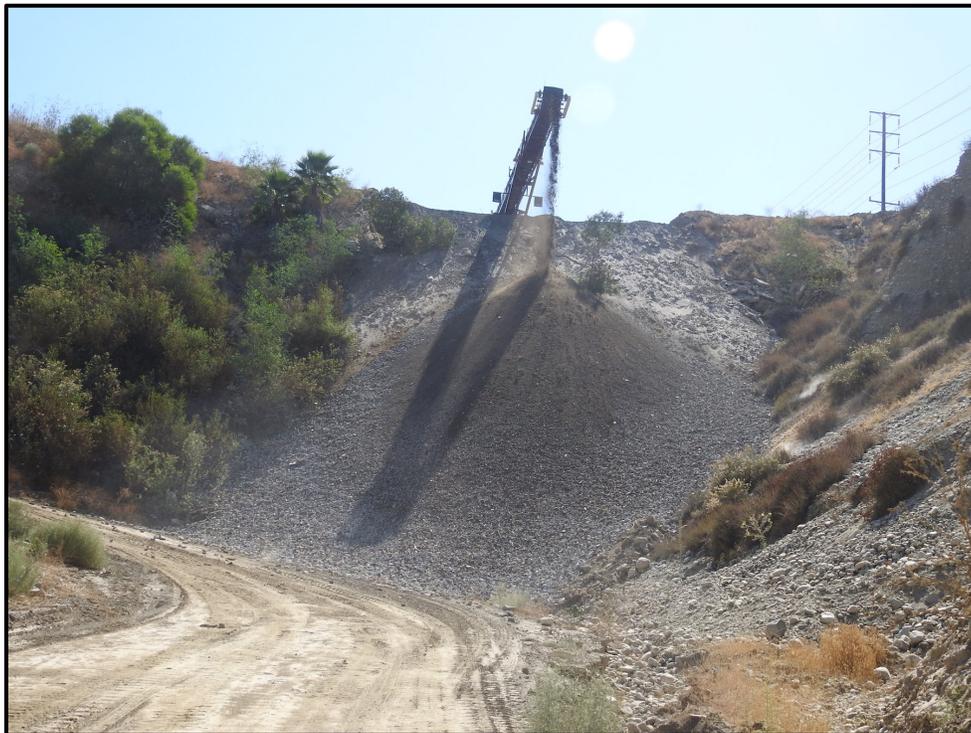
**2017 September** – West Pit (Area 1). Blended rubble fill produced in Area 2S being transported and stockpiled in West Pit. View to southeast.

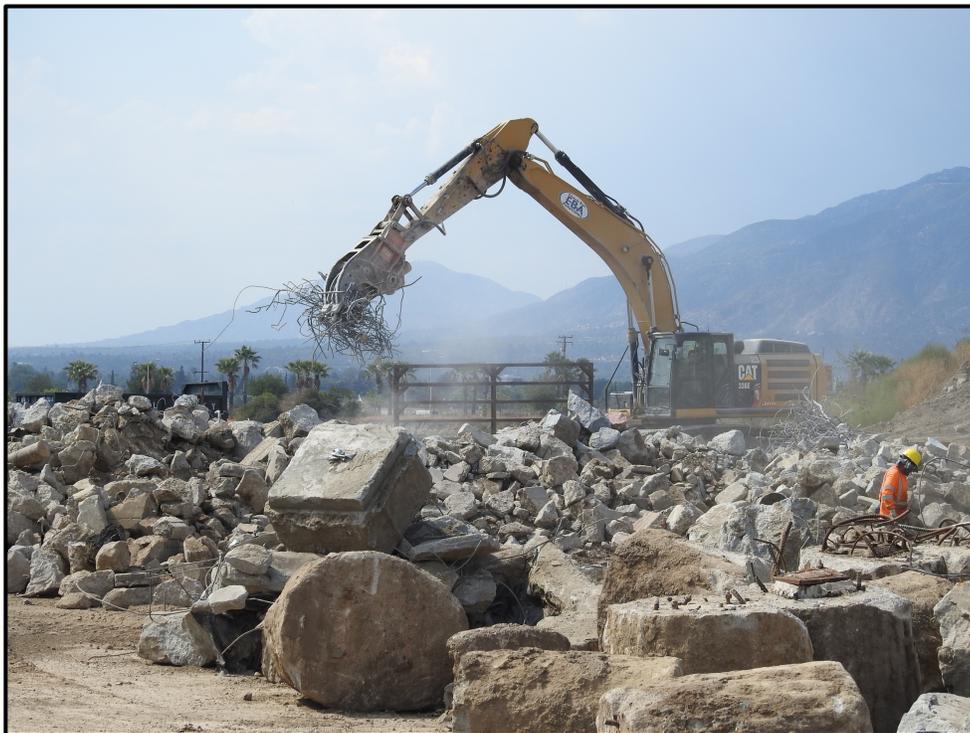
**2018 January** – South-Central Area (Area 2S). Removal of steel from inert debris. Large-scale field sieve in background. View to west.

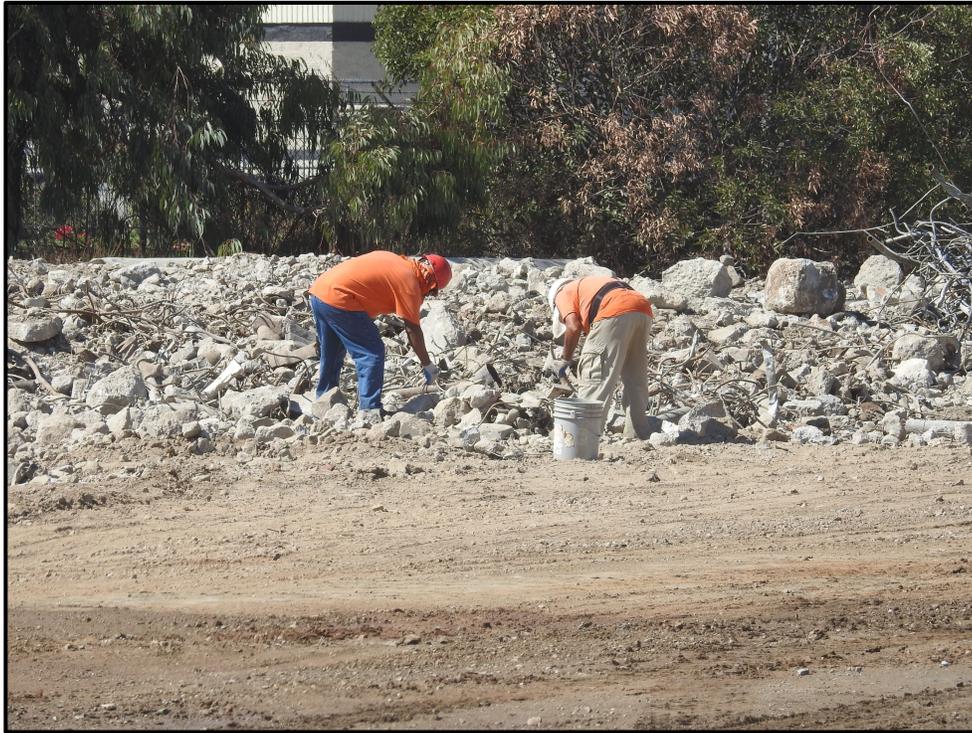
**2017 September** – South-Central Area (Area 2S). Removal via hand labor of undesirable material.

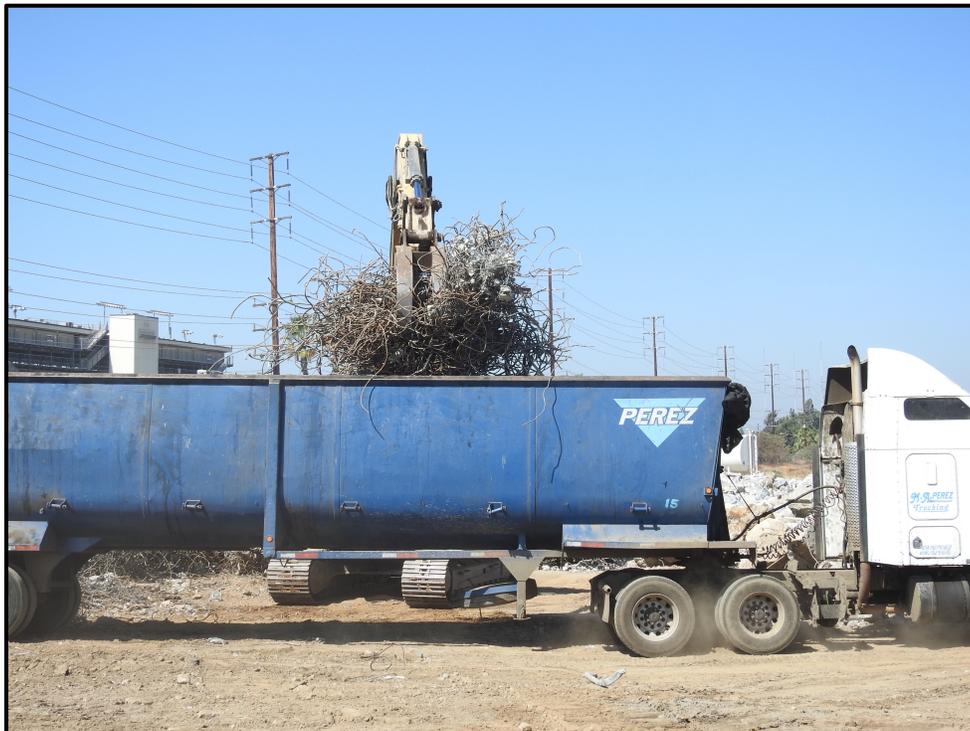
**2018 September** – South-Central Area (Area 2S). Export of stockpiled steel from site. View to southwest.

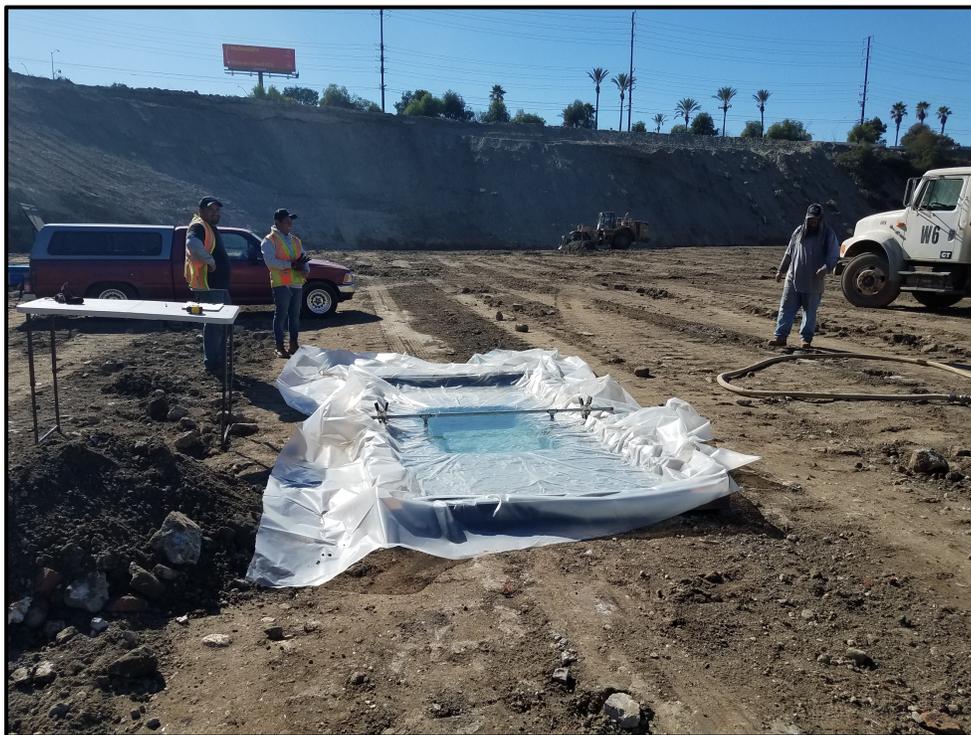
**2017 November** – Southeast Pit (Area 3S). Large-scale bulk density testing of blended rubble fill. Water volume measurement of excavated pit. View to south.

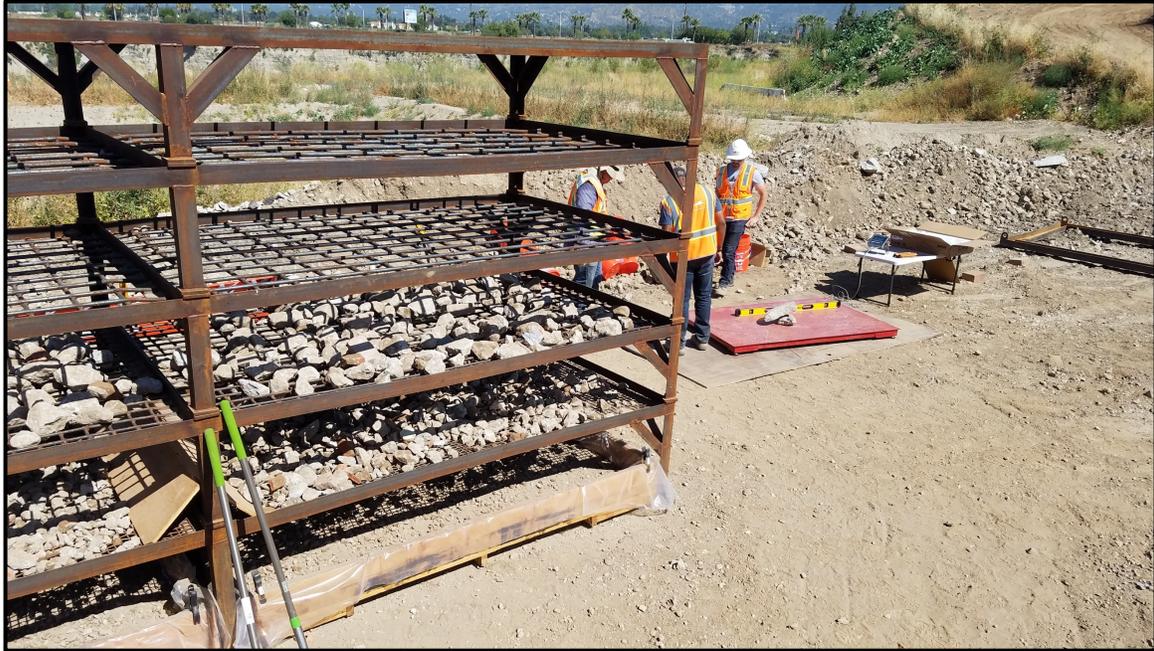
**2017 May** – South-Central Area (Area 2S). Large-scale gradation testing of the blended rubble fill excavated during a bulk density test. View to northwest.

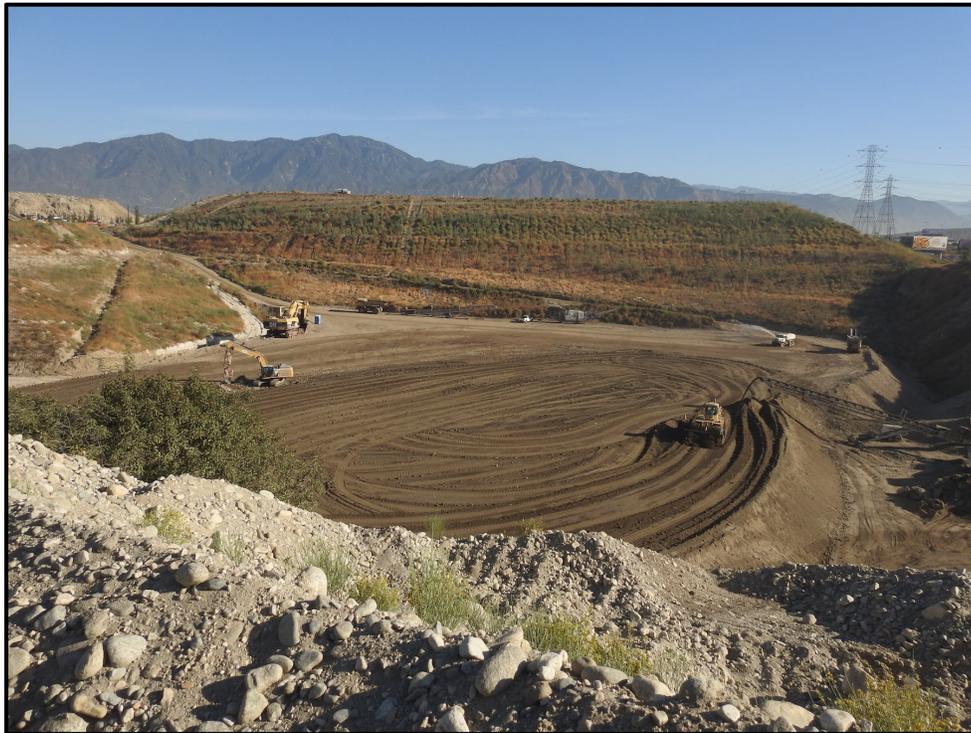
**2017 September** – Southeast Pit (Area 3S). Engineered fill pad, Area 3N surcharge fill in background, and Zone A material at background-left. View to north.

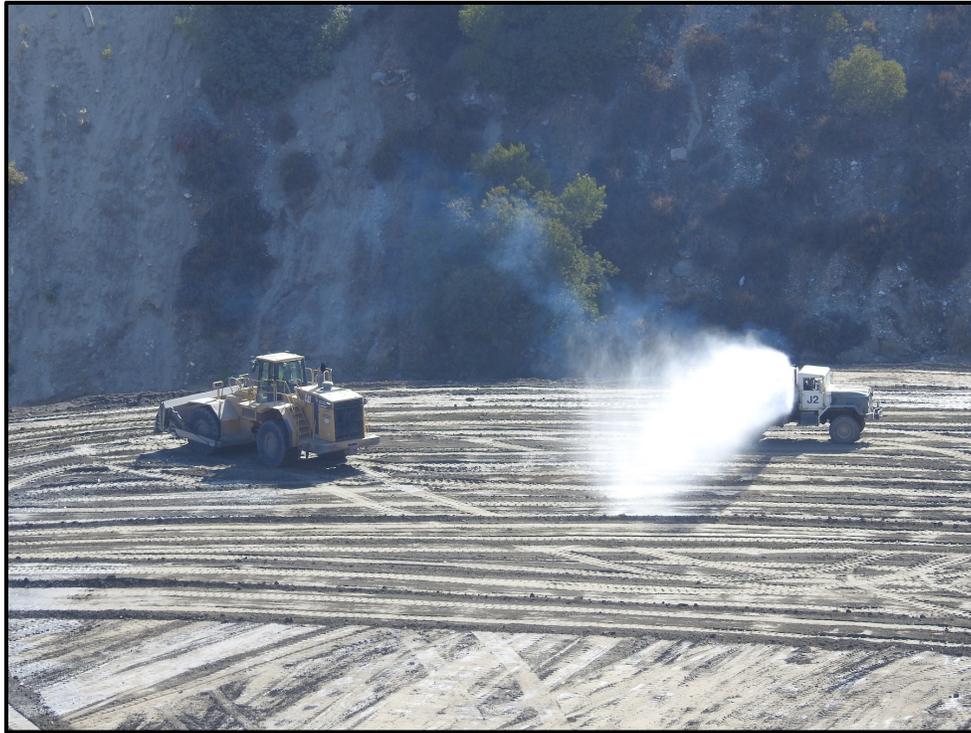
**2017 October** – Southeast Pit (Area 3S). Moisture conditioning and compaction at engineered fill pad. View to southeast.

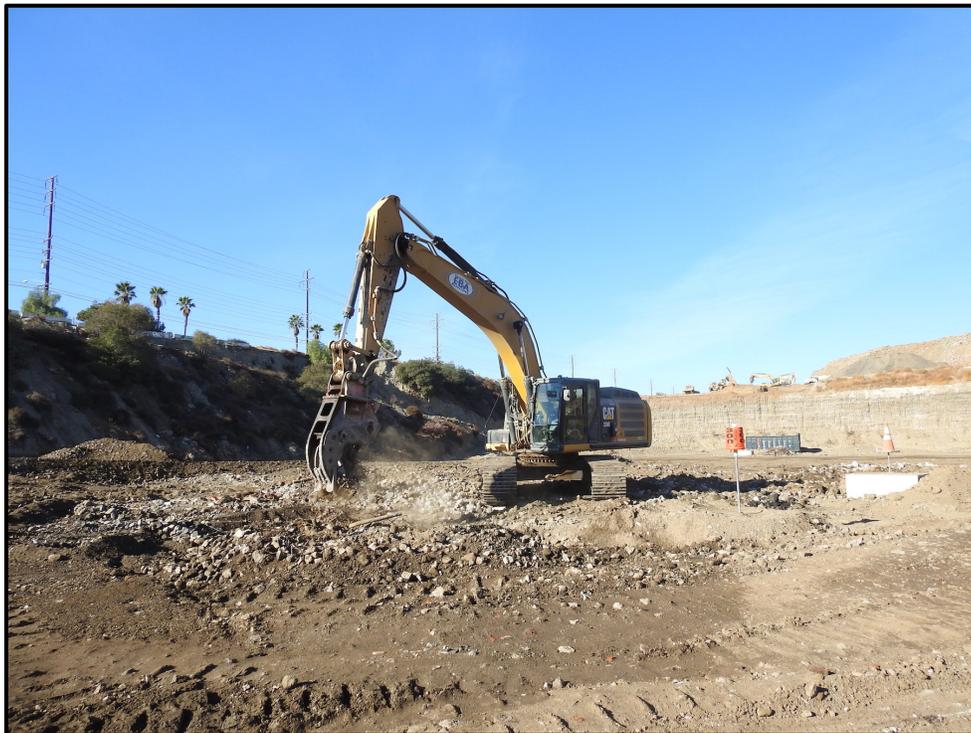
**2017 November** – Southeast Pit (Area 3S). Pulverization of oversized inert debris material. Settlement monument SM300 at right. New settlement monument SM310 with exposed base at far right. View to southwest.

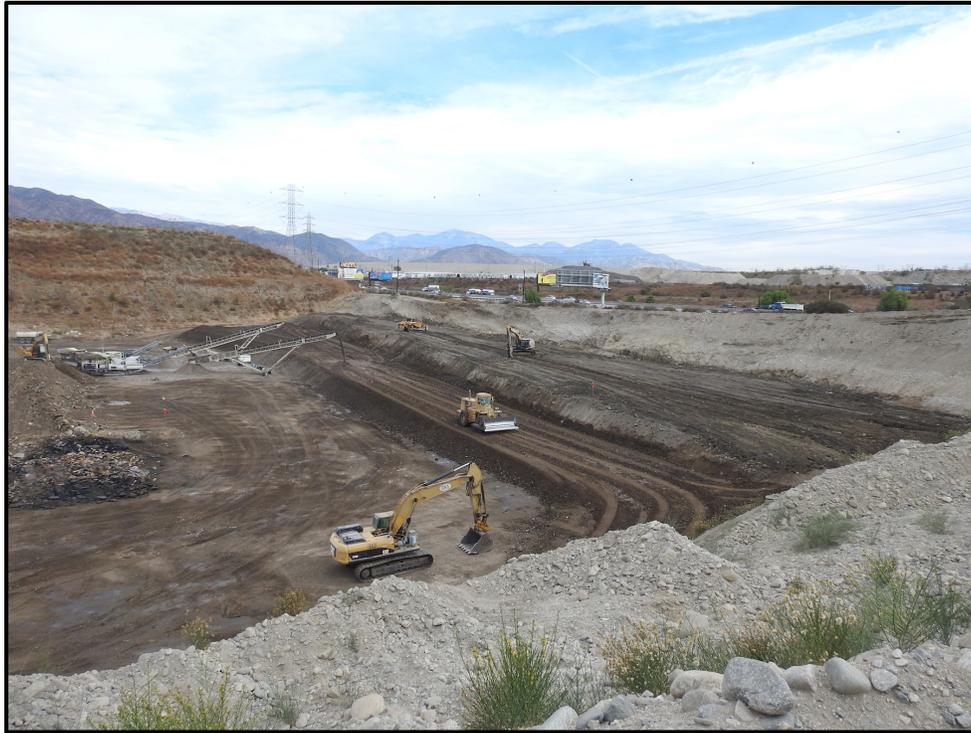
**2018 January** – Southeast Pit (Area 3S). Grading operations. View to northeast.

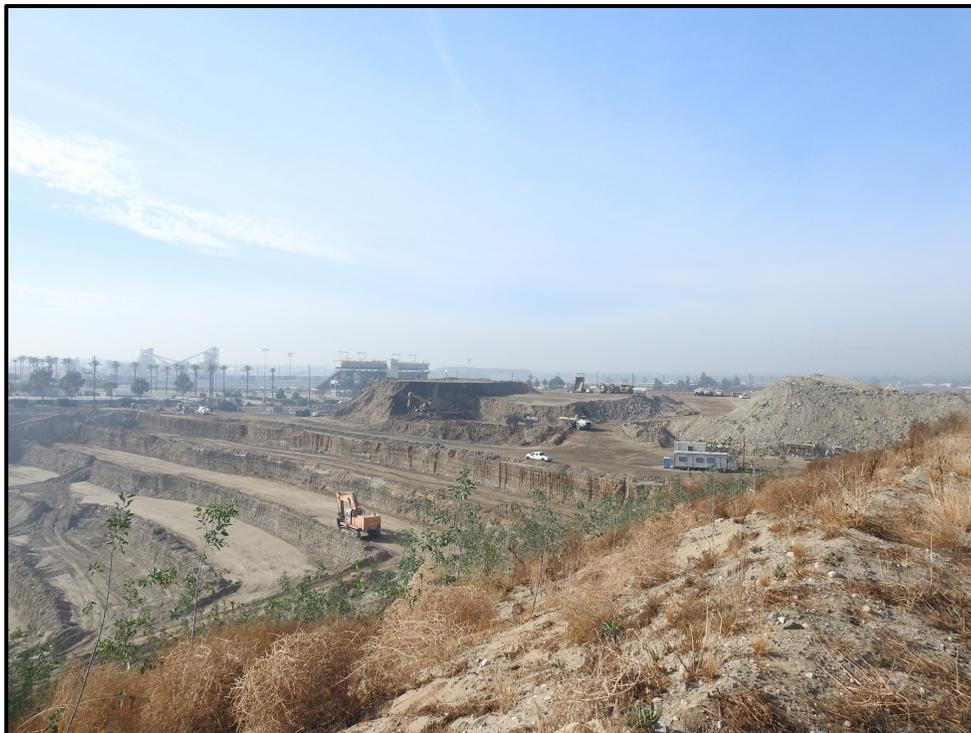
**2018 January** – Southeast Pit (Area 3S) and central site area (Area 2A) in background. Overview of Zone A removals. View to southwest.

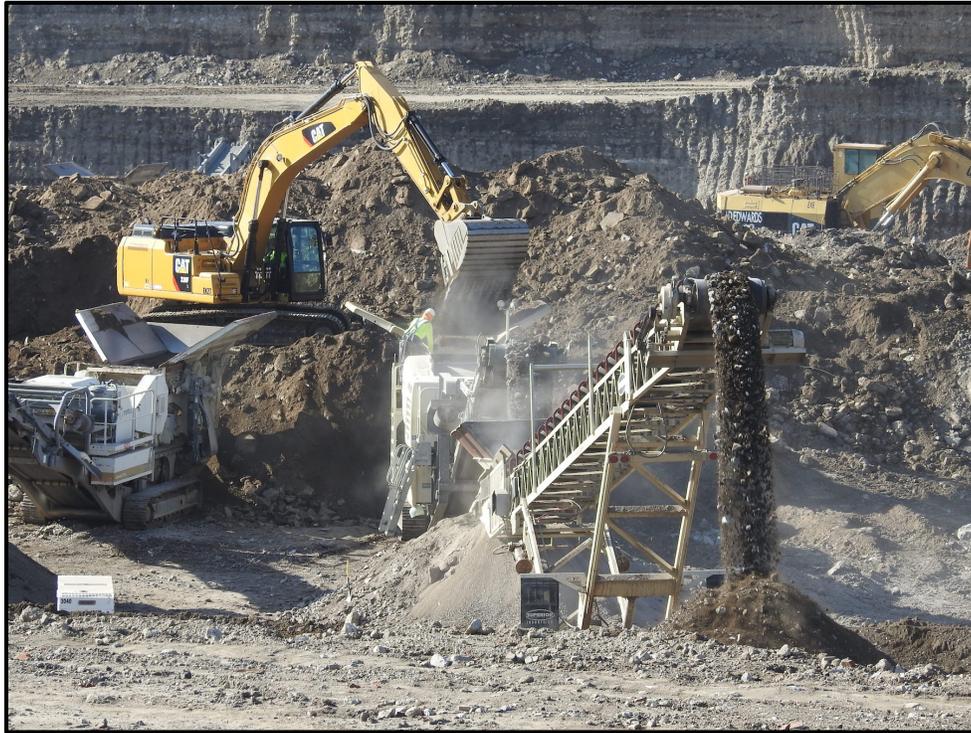
**2018 January** – Southeast Pit (Area 3S). Crushing and production of blended rubble fill. View to west.

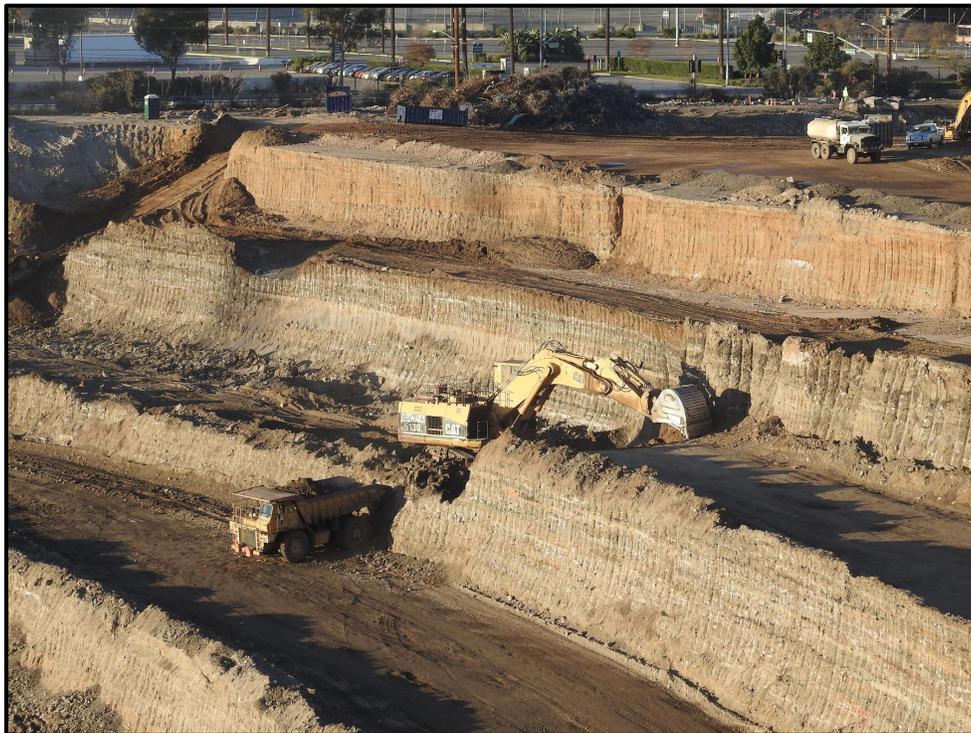
**2018 January** – Southeast Pit (Area 3S). Removals of Zone A material at west side of pit. Material transported to active fill area within pit. View to southwest.

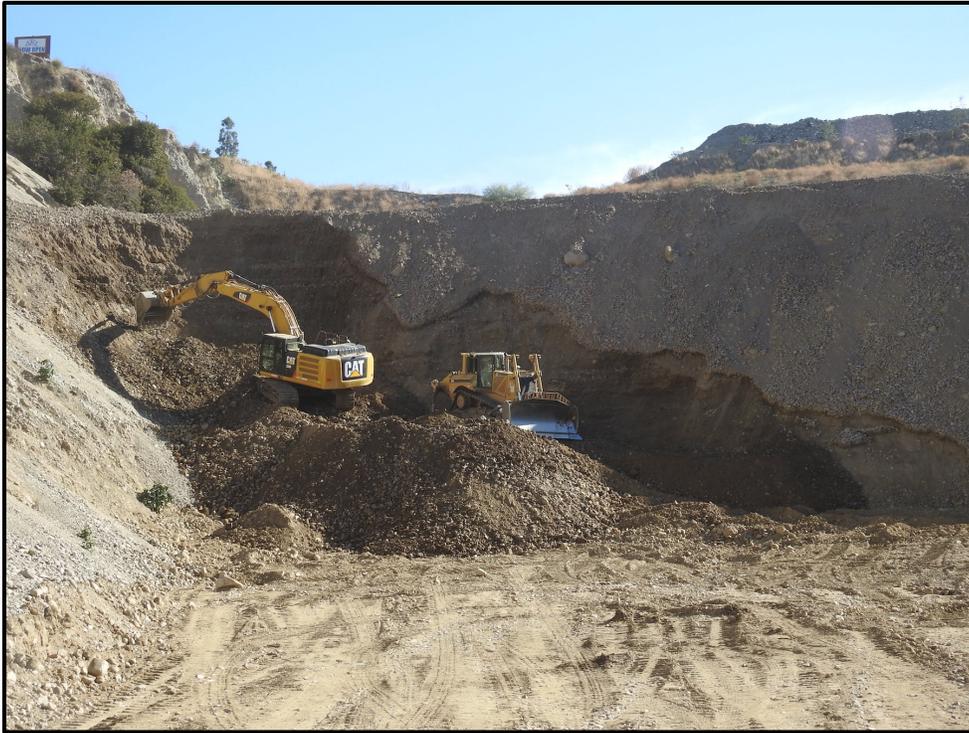
**2018 February** – West Pit (Area 1). Removals of sloughed material at slope face and exposing new engineered fill. View to east.

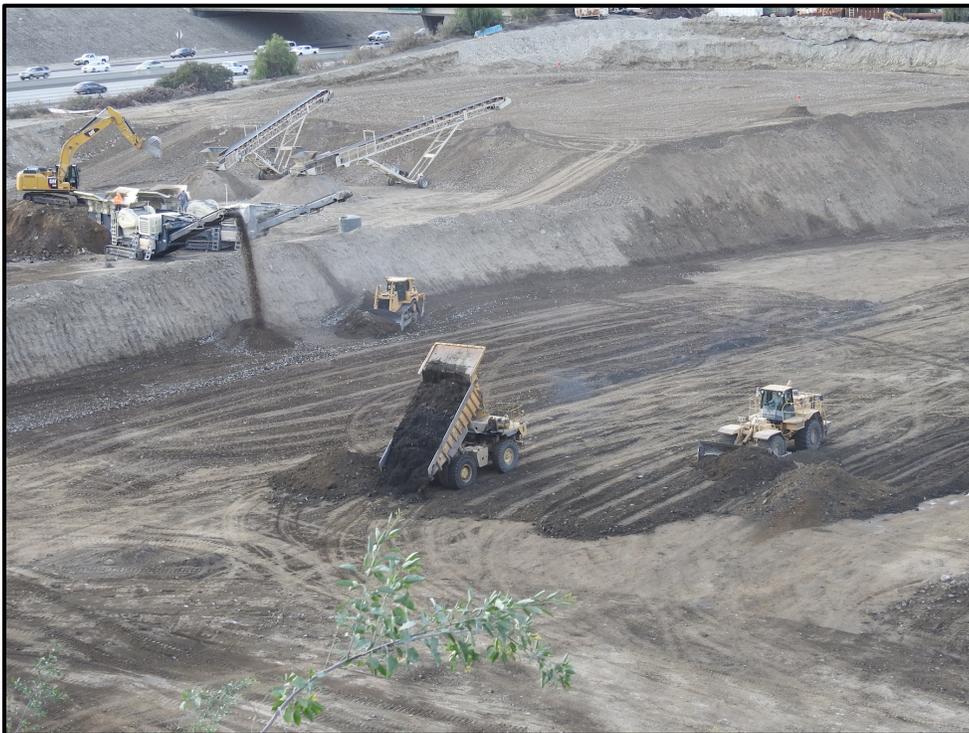
**2018 February** – Southeast Pit (Area 3S). Placement of Zone A material within active fill area. View to southeast.

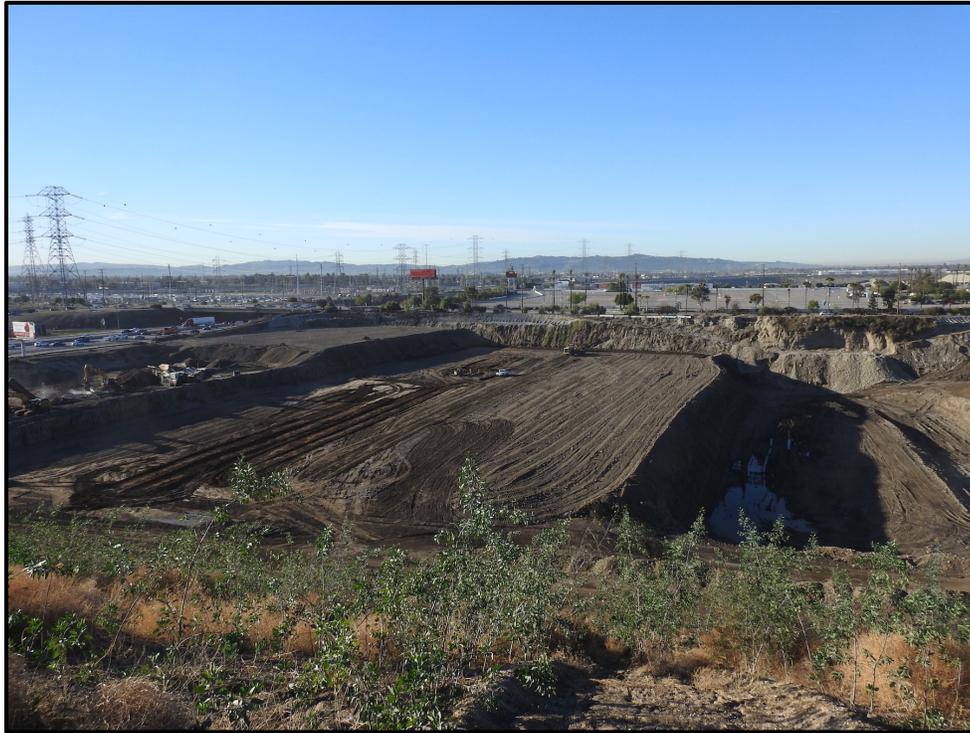
**2018 March** – Southeast Pit (Area 3S). Overview of engineered fill. View to southeast.

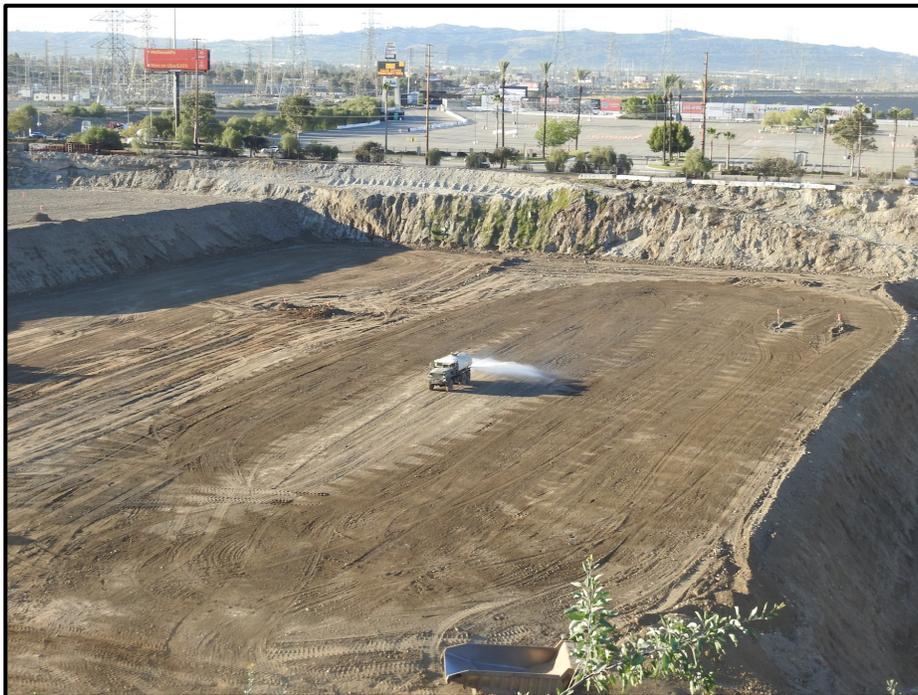
**2018 March** – Southeast Pit (Area 3S). Overview of engineered fill. Settlement monument cluster at background-right of water truck (SM301, SM308), at background-left of water truck (SM300, SM310), and SM307 is at far left on next bench up. View to southeast.
