# Site Circulation Report

LAUSD SCHOOL MODERNIZATION PROJECT -  
MCKINLEY AVENUE ELEMENTARY SCHOOL

*Prepared by:*  
**LIN Consulting, Inc.**

*October 17, 2018*

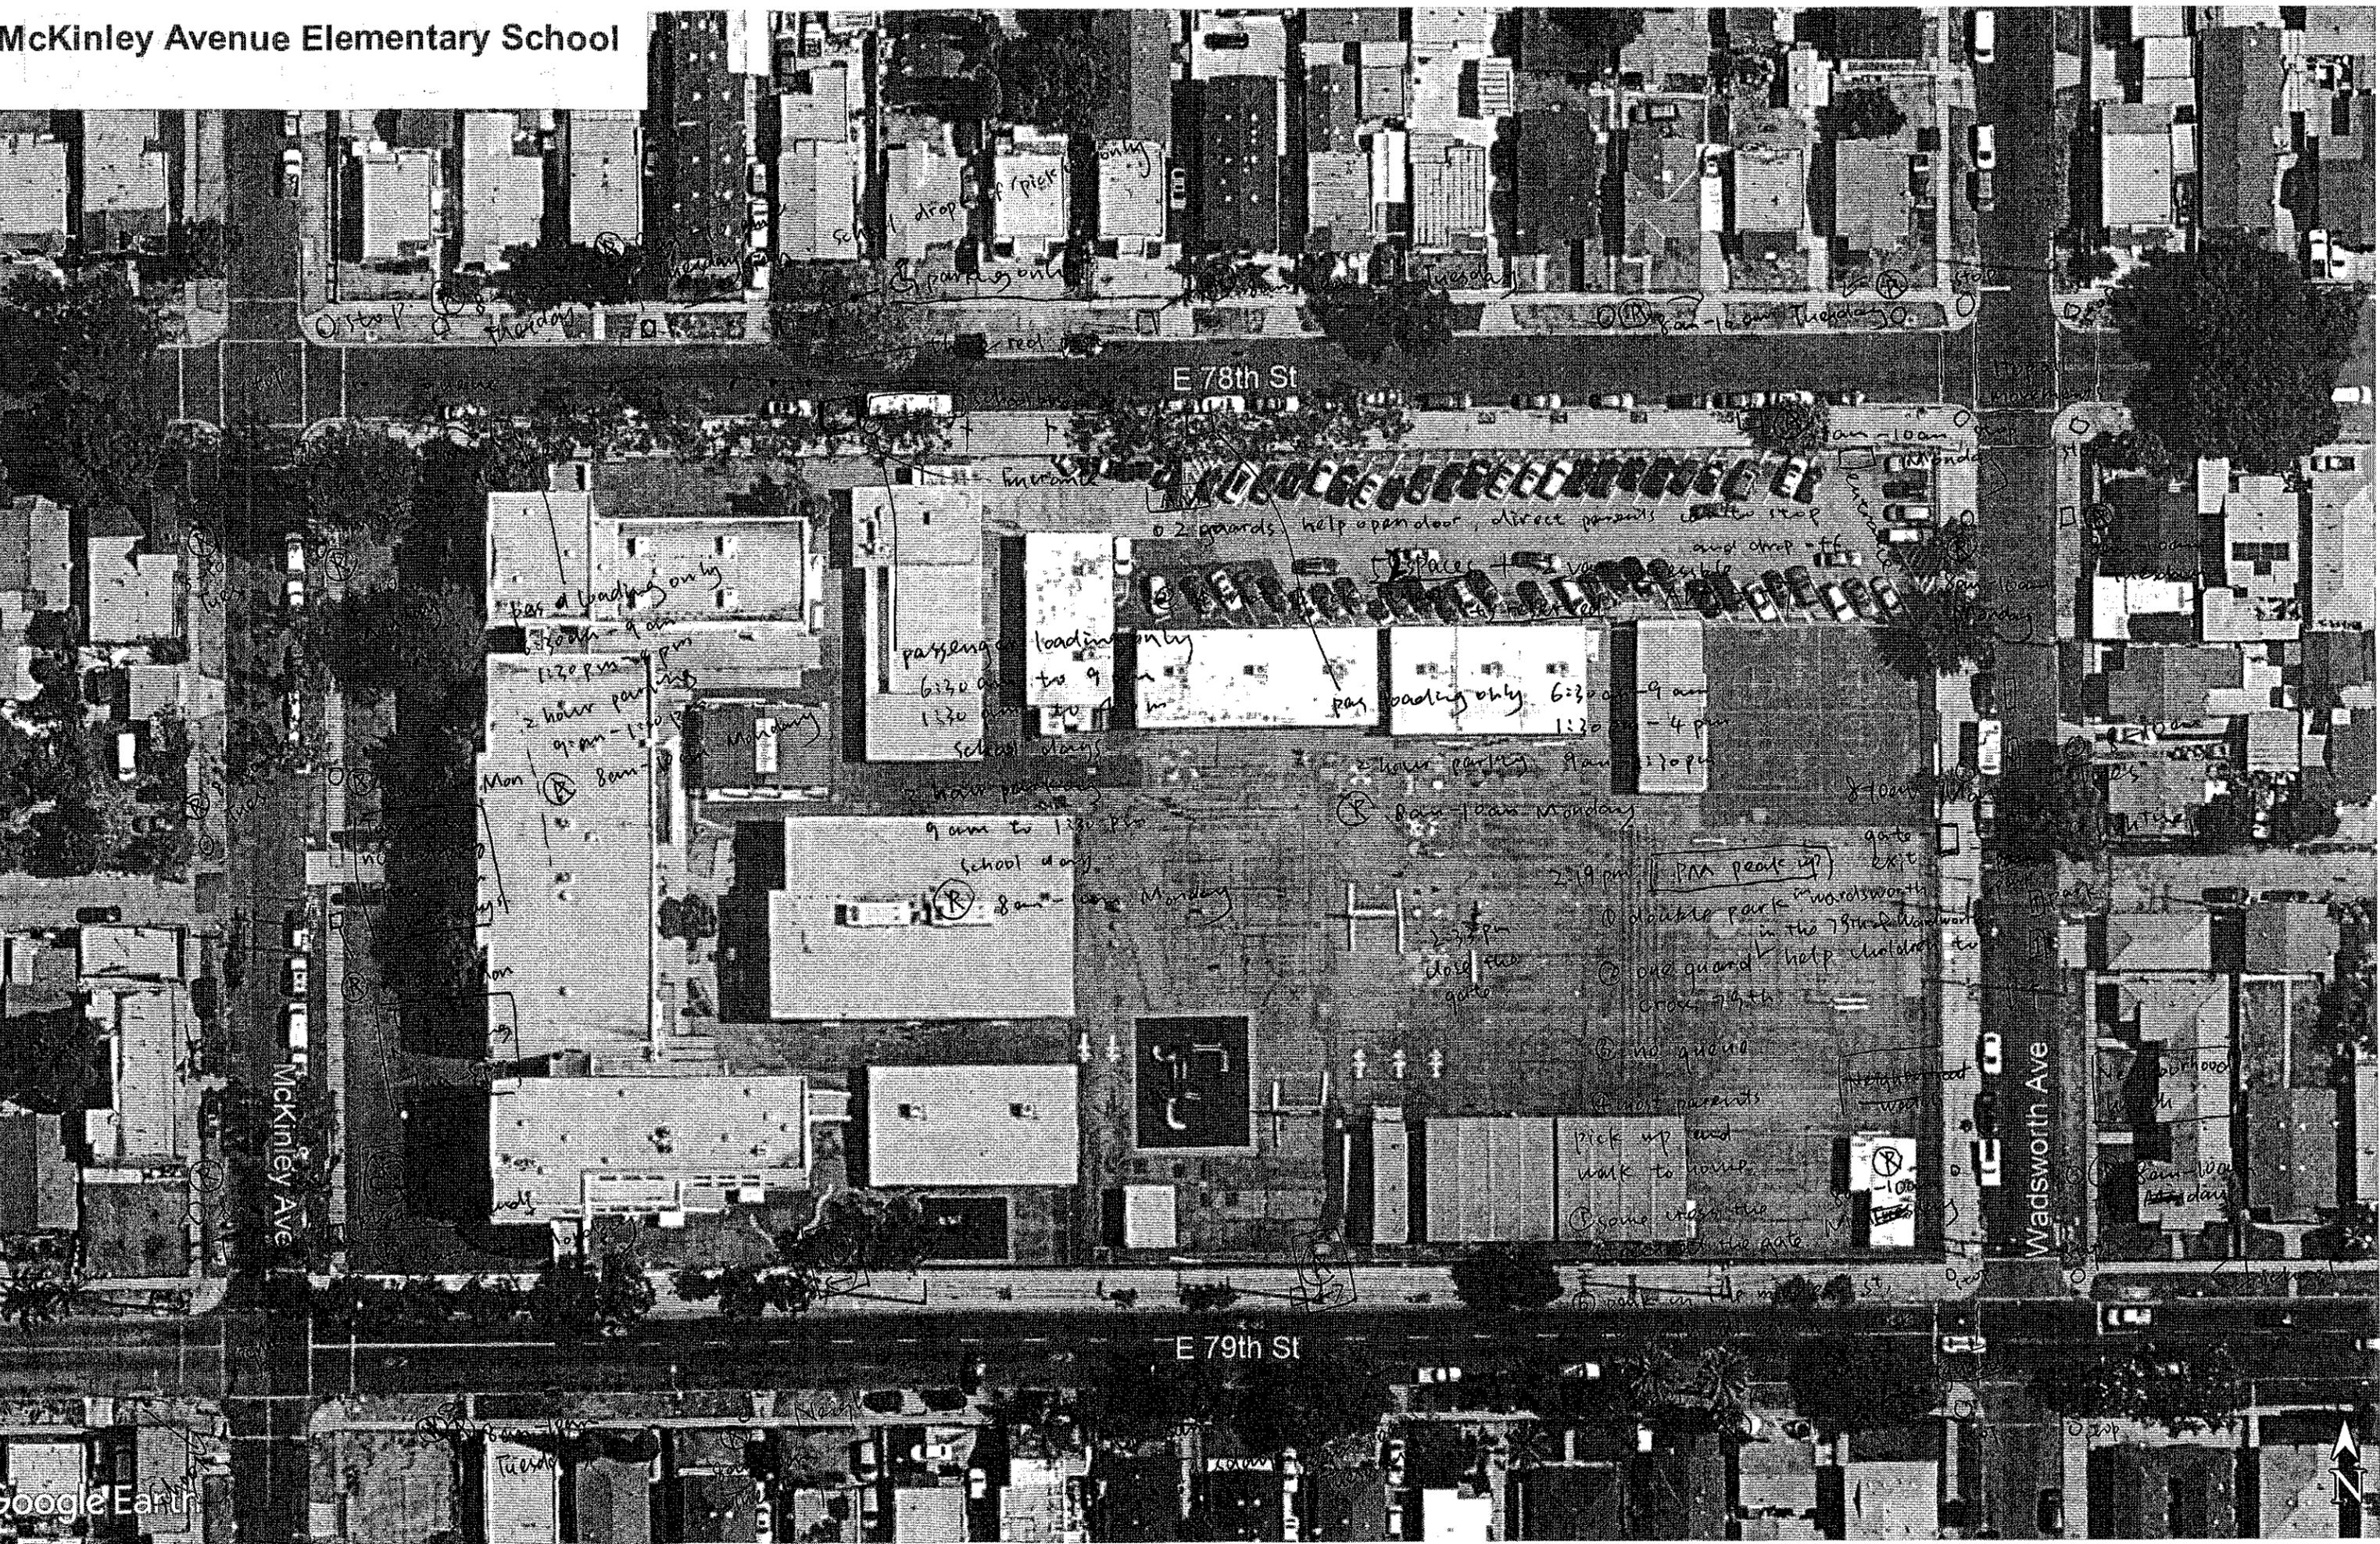
2:19 pm  
 1 PM peak up  
 double park in the 7300 block Wadsworth  
 one guard help children to cross 79th  
 no guards  
 most parents pick up and walk to house  
 some cross the street at the gate  
 walk on the sidewalk

\* AM curb parking utilization very high (~95%)

\* Midday curb parking utilization ~50-75%

\* No q noted in PM @ 78th / McKinley

\* Occasional blocking of crosswalks - PM

\* Occasional stopping / parking in red curb zone

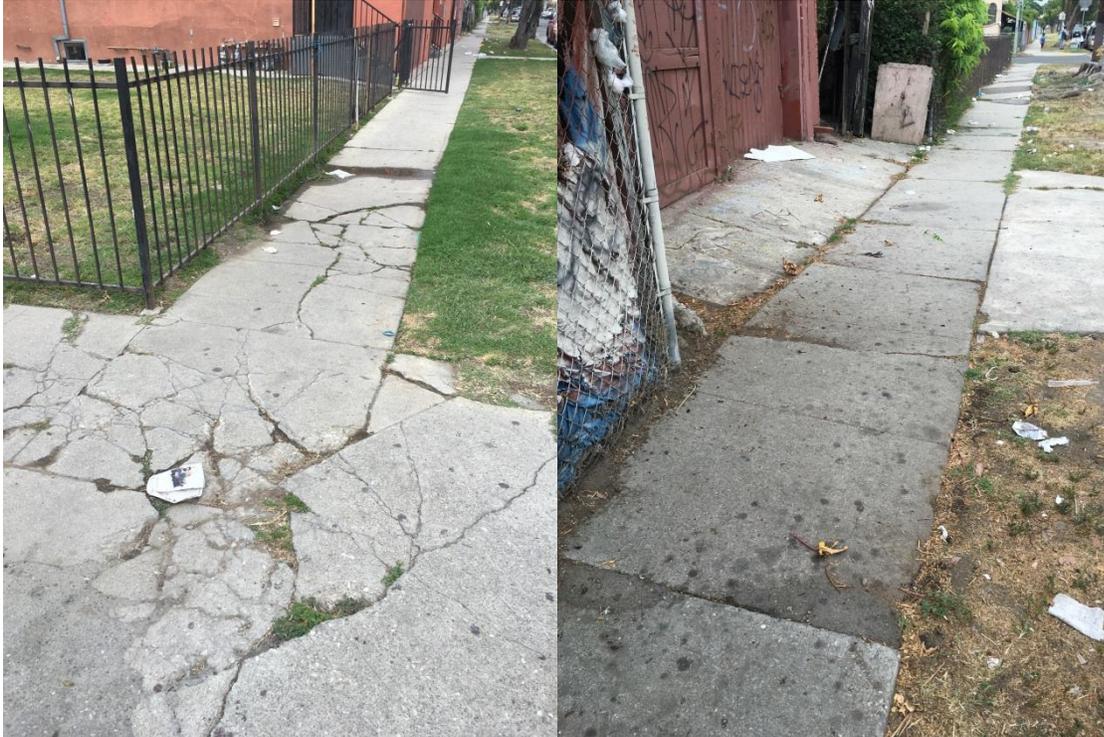
Sidewalk is generally uneven on the west side of McKinley Avenue; gates left open block sidewalk traffic

- Bicyclists observed on sidewalks, conflicting with pedestrians
- McKinley Avenue
  - Sidewalks are generally uneven and cracked on the west side, which may be difficult to traverse in a wheelchair

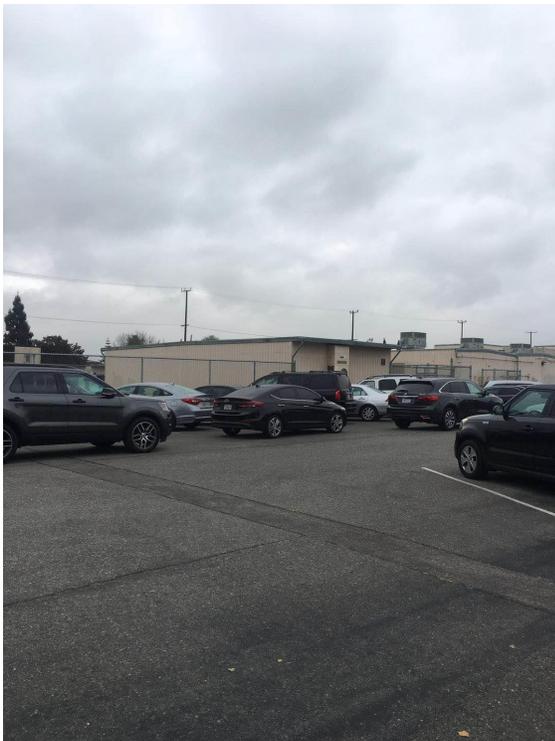
Double parking in the faculty parking lot

At the McKinley Avenue ES campus, there is one parking lot for faculty and staff. According to school administrators, some late-arriving faculty or staff, including substitute teachers, often park on the street since the lot is usually full by the morning bell. Visitors are required to park on the street. This parking lot is located at the northeast corner of the campus and contains 52 marked spaces, 3 reserved spaces, and 2 van-accessible spaces. This lot was observed to be greater than 95% utilized during a typical school day. Approximately 5 cars were observed to be double-parked in the lot during school hours.

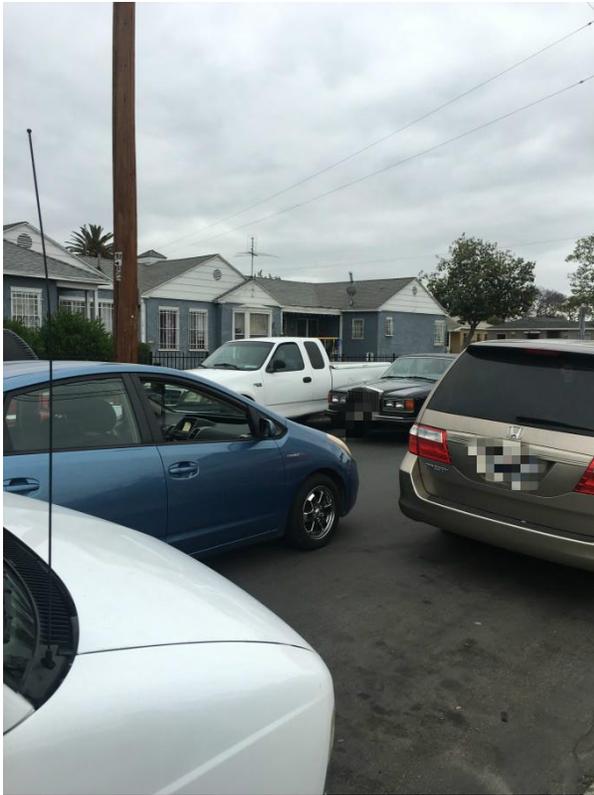
Double parking on both sides of Wadsworth Avenue during the afternoon bell period

During the afternoon bell period, parents were observed to occasionally double-park in the travel lane in both directions of Wadsworth Avenue near the gate to pick up students, blocking through traffic. Some students walk from the gate along Wadsworth Avenue and cross East 79th Street with the help of a school volunteer. Due to the high volume of students and parents, queues of up to 80 feet in length were observed eastbound on East 79th Street. **Appendix D** contains traffic counts that were obtained from the City of Los Angeles Department of Transportation (LADOT) *NavigateLA* database.

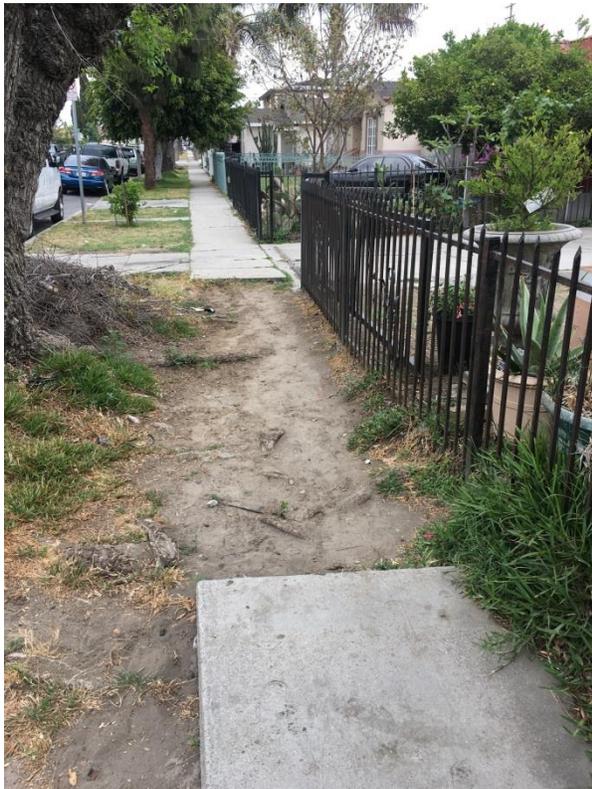
A large gap in the sidewalk on the south side of East 79th Street, which may affect pedestrian safety and accessibility

- East 79th Street
  - Sidewalks are mildly uneven, cracked, may be difficult to traverse in a wheelchair, and a large gap exists on the south side
  - Street lighting partially obstructed by trees, sidewalks on the north side may be in shadows

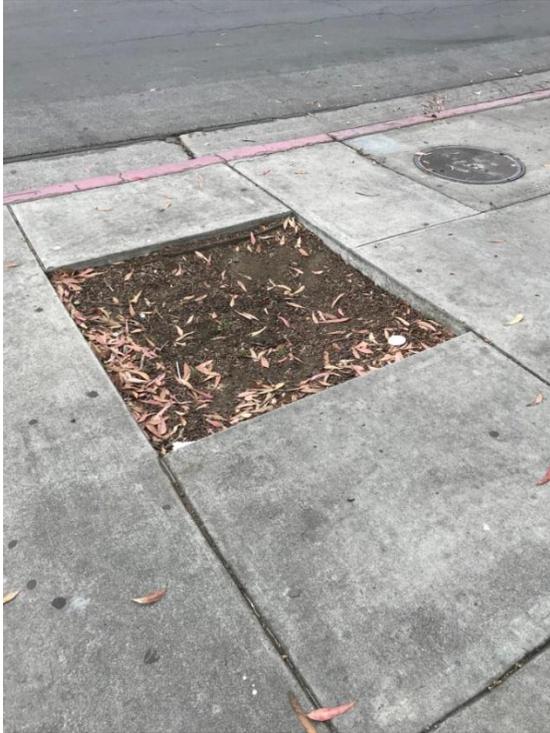
Tree wells do not have trees or covers; may cause difficulty for vision-impaired pedestrians

- Although outside of the jurisdiction of LAUSD, tree trimming may help to improve street lighting coverage on the school side of each street
- Although outside of the jurisdiction of LAUSD, planting small canopy trees in vacant tree wells which can provide shade but not block street lighting
- Although outside of the jurisdiction of LAUSD, completion of sidewalk gaps and repair of sidewalks
- Crossing guard warrant analysis is recommended at the McKinley Avenue and East 78th Street intersection
- Review latest Engineering and Traffic Survey for McKinley Avenue with the City of Los Angeles, and whether the school zone is properly signed

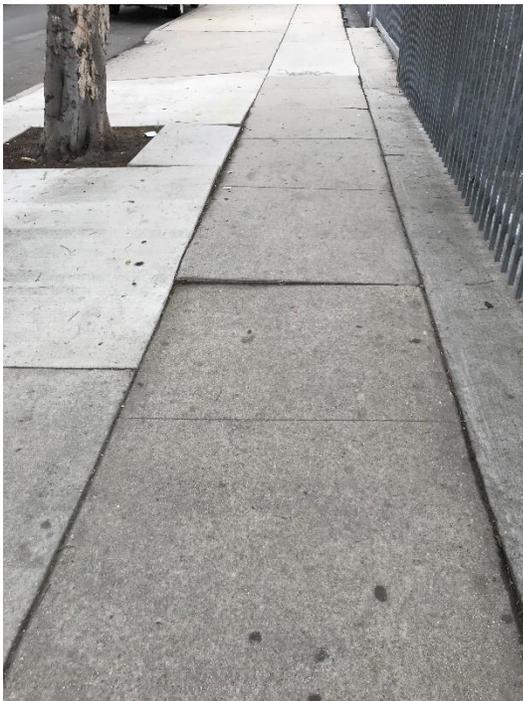
Tree roots lifting sidewalk can cause a difficult walking environment on East 78th Street

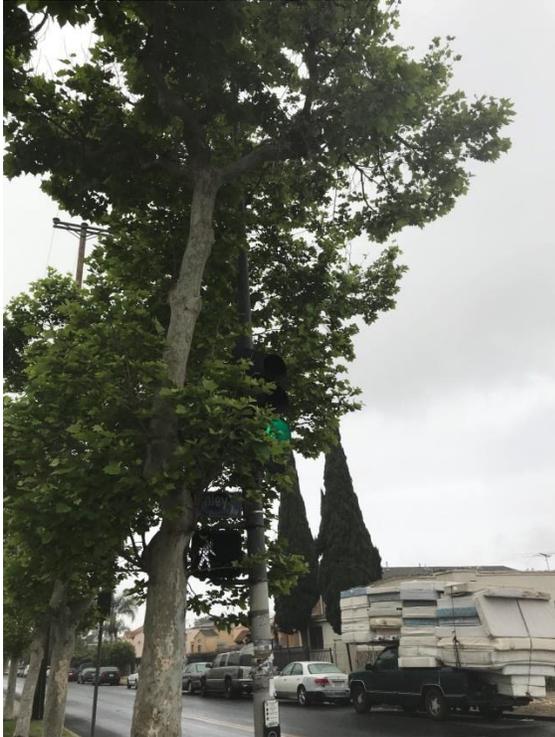
Street lighting obscured at intersection of McKinley Avenue and East 79th Street

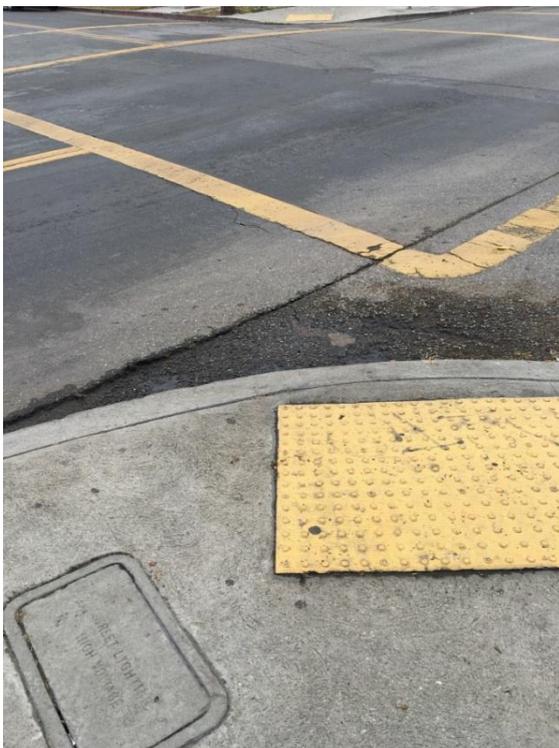
Curb ramp in the northeast corner of the intersection East 79th Street and McKinley Avenue has possible ponding, degraded pavement, and vertical grade differences over one-half inch

- Empty tree wells, may be hard to detect for people with visual impairments
  - The curb ramp in the northeast corner of the intersection East 79th Street and McKinley Avenue has possible ponding and degraded pavement, and vertical transition between curb ramps and street paving exceeds one-half inch, which may be difficult for pedestrians in wheelchairs to traverse

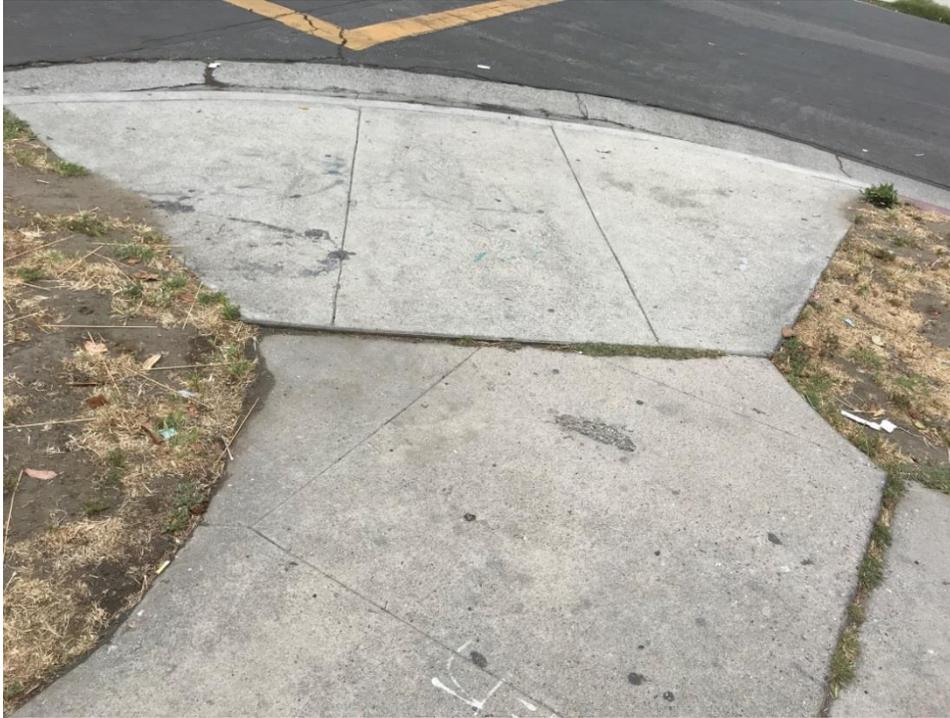
In the intersection of East 78th Street and McKinley Avenue, the vertical grade difference of the ramp at the street in the southeast corner is larger than one-half inch

- Bicyclists observed on sidewalks, conflicting with pedestrians
  - Vertical curb ramp transitions between sidewalk and street surface at the intersection McKinley Avenue and East 78th Street exceeds one-half inch, which may be difficult for pedestrians in wheelchairs to traverse

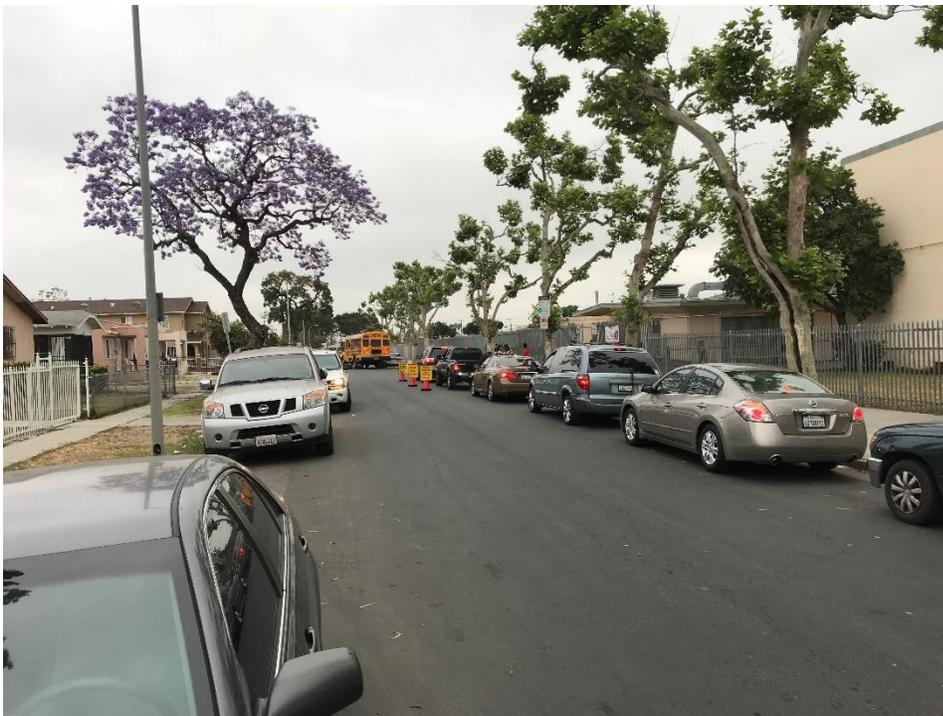
Valet service has high compliance, and adequate signing informs drivers of procedure at East 78th Street
