**PHASE I ENVIRONMENTAL
SUBJECT SITE ASSESSMENT**
ASTM E: 1527-13

**220-240 North Quince Street
in
Escondido, California 92025**

DATE: November 13, 2015

PROJECT NUMBER: 15-1005

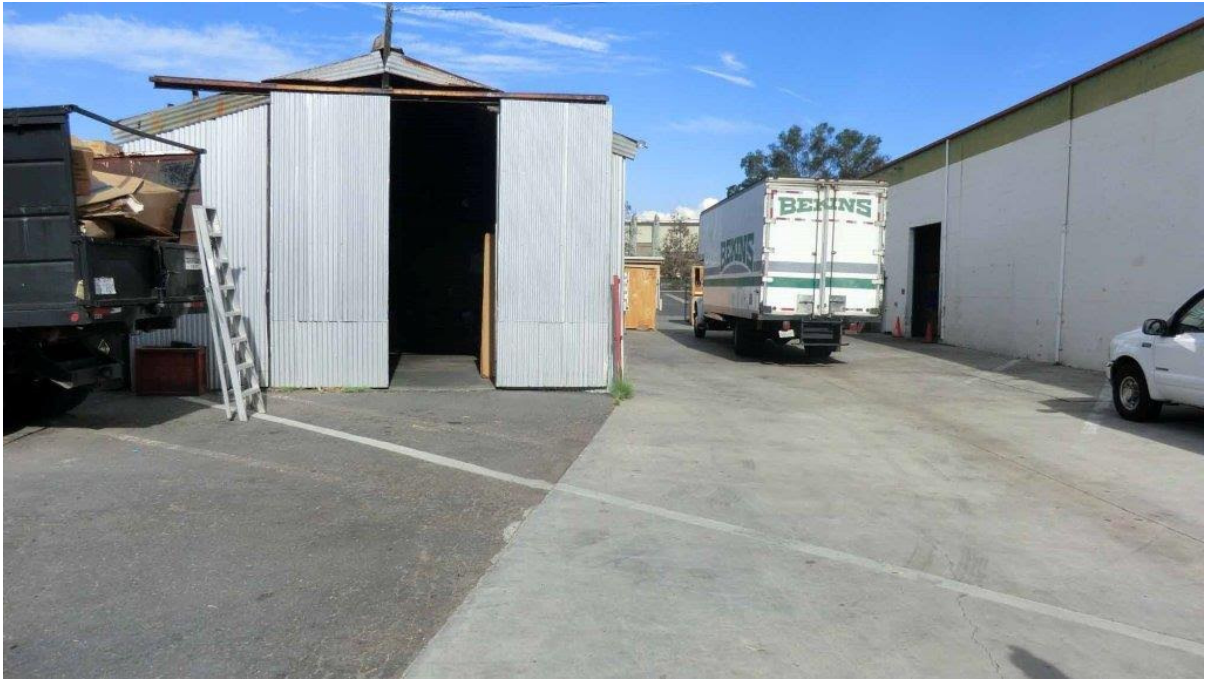
Facing east from near northwest corner of subject site; maintenance building at left and north side of northernmost warehouse at right. Partly seen at right is one of two concrete pavement patches indicating removed underground fuel tanks.

Storage tanks – Except for two pavement patches, no direct evidence of underground or aboveground tanks was noted. Building permits for two 550 gallon underground gasoline and diesel tanks in 1974 were found in City Records. This was corroborated in an interview with the onsite tenant and results of the sub-surface survey described below.

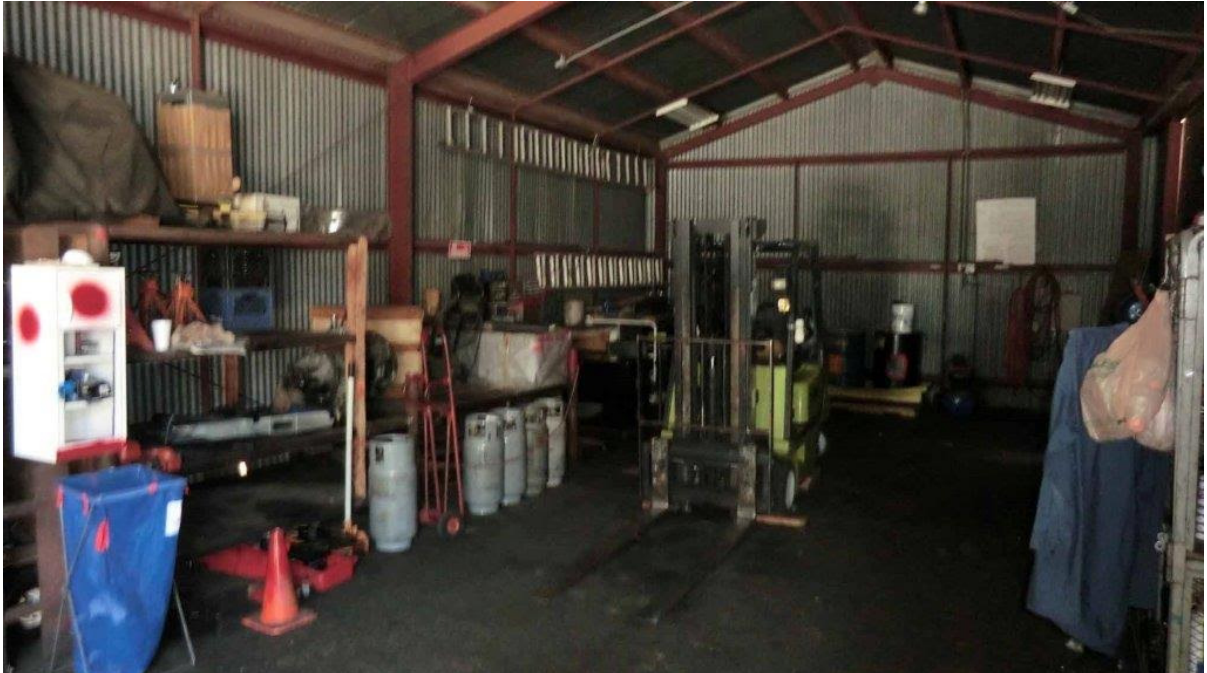
Facing east inside maintenance building. Typical automotive maintenance products were observed. The concrete floor here had petroleum product staining but no significant cracking. At rear are drums holding waste oil.

The smaller steel building was in use for automotive repair/maintenance. Work benches and tools for this were present, and two secondary-containment pallets holding drums of waste oil filters, and waste coolant. Smaller quantities of other automotive chemicals were also present. Most areas of the maintenance building floor appeared to be stained by oil but no wet surface or significant floor cracking suggested penetration to underlying soil. No underground pit or floor lift was present.

Interior or exterior stains/corrosion – In the maintenance building oil-staining of floor surfaces was noted.

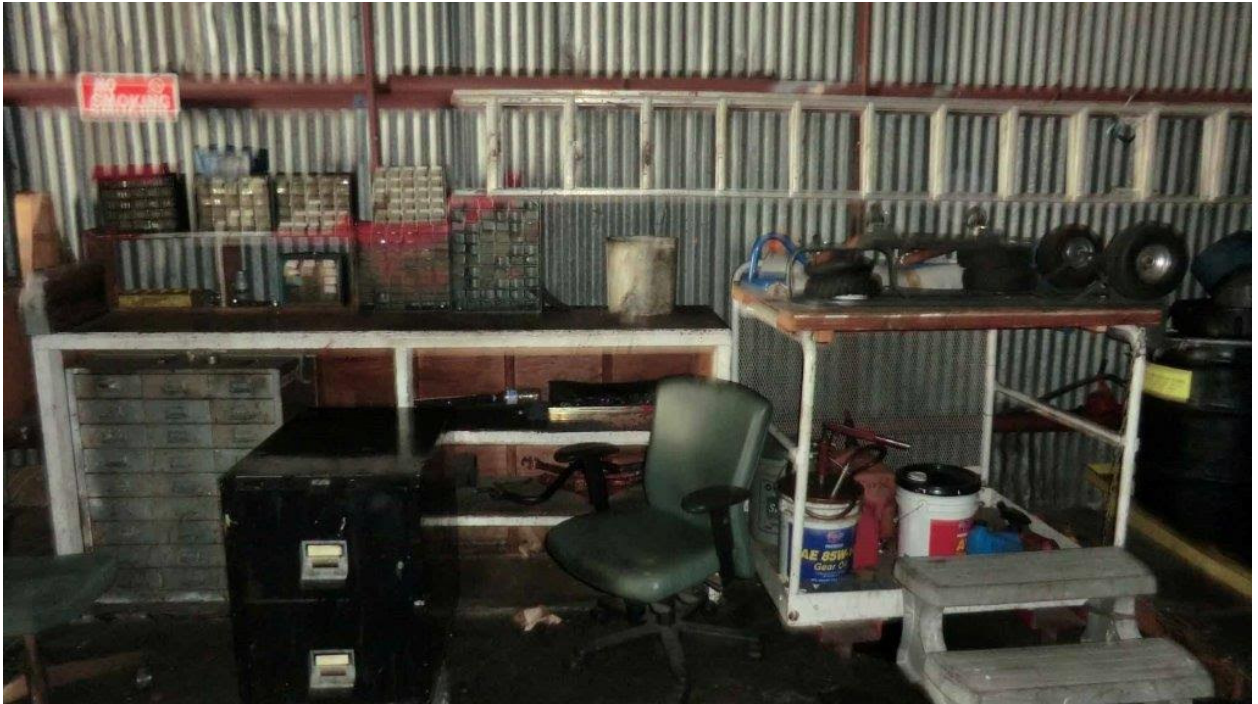
Facing north inside metal maintenance shed, workbench with typical maintenance equipment and materials.

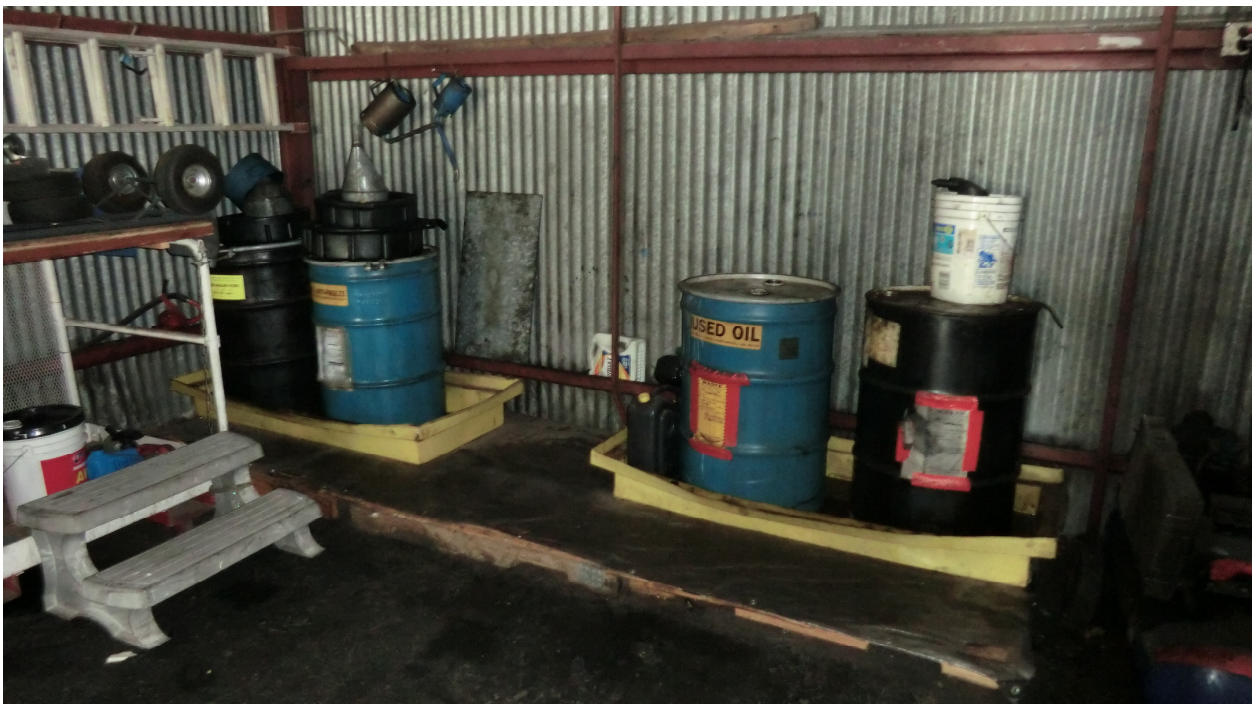
Closer view of onsite waste oil storage in metal maintenance shed with secondary containments.

Hazardous Materials Storage/Use – This section describes the types, quantities, container types, and storage conditions of hazardous materials observed at the subject site. Typical vehicle maintenance materials were found including several pails of lubricating oil and four drums labeled as holding waste oil and coolant; these were noted to overlie secondary containments.

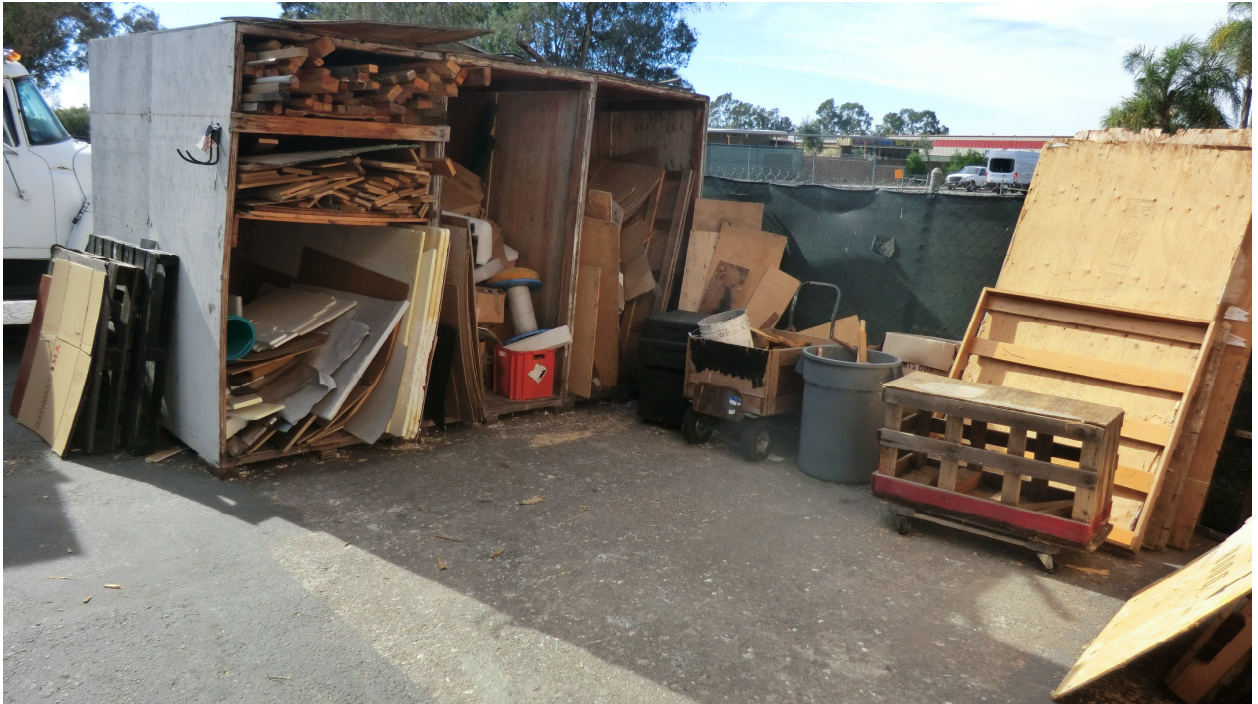
Outdoor workshop for crate/pallet repair along north boundary of subject site (boundary fence shown).

A small parking area was at the northwest corner of the subject site, west of the maintenance building. Adjoining the maintenance building to its west and north was an area in use for repair of crates and pallets, with stacked spare lumber pieces, workbenches, and tools present.

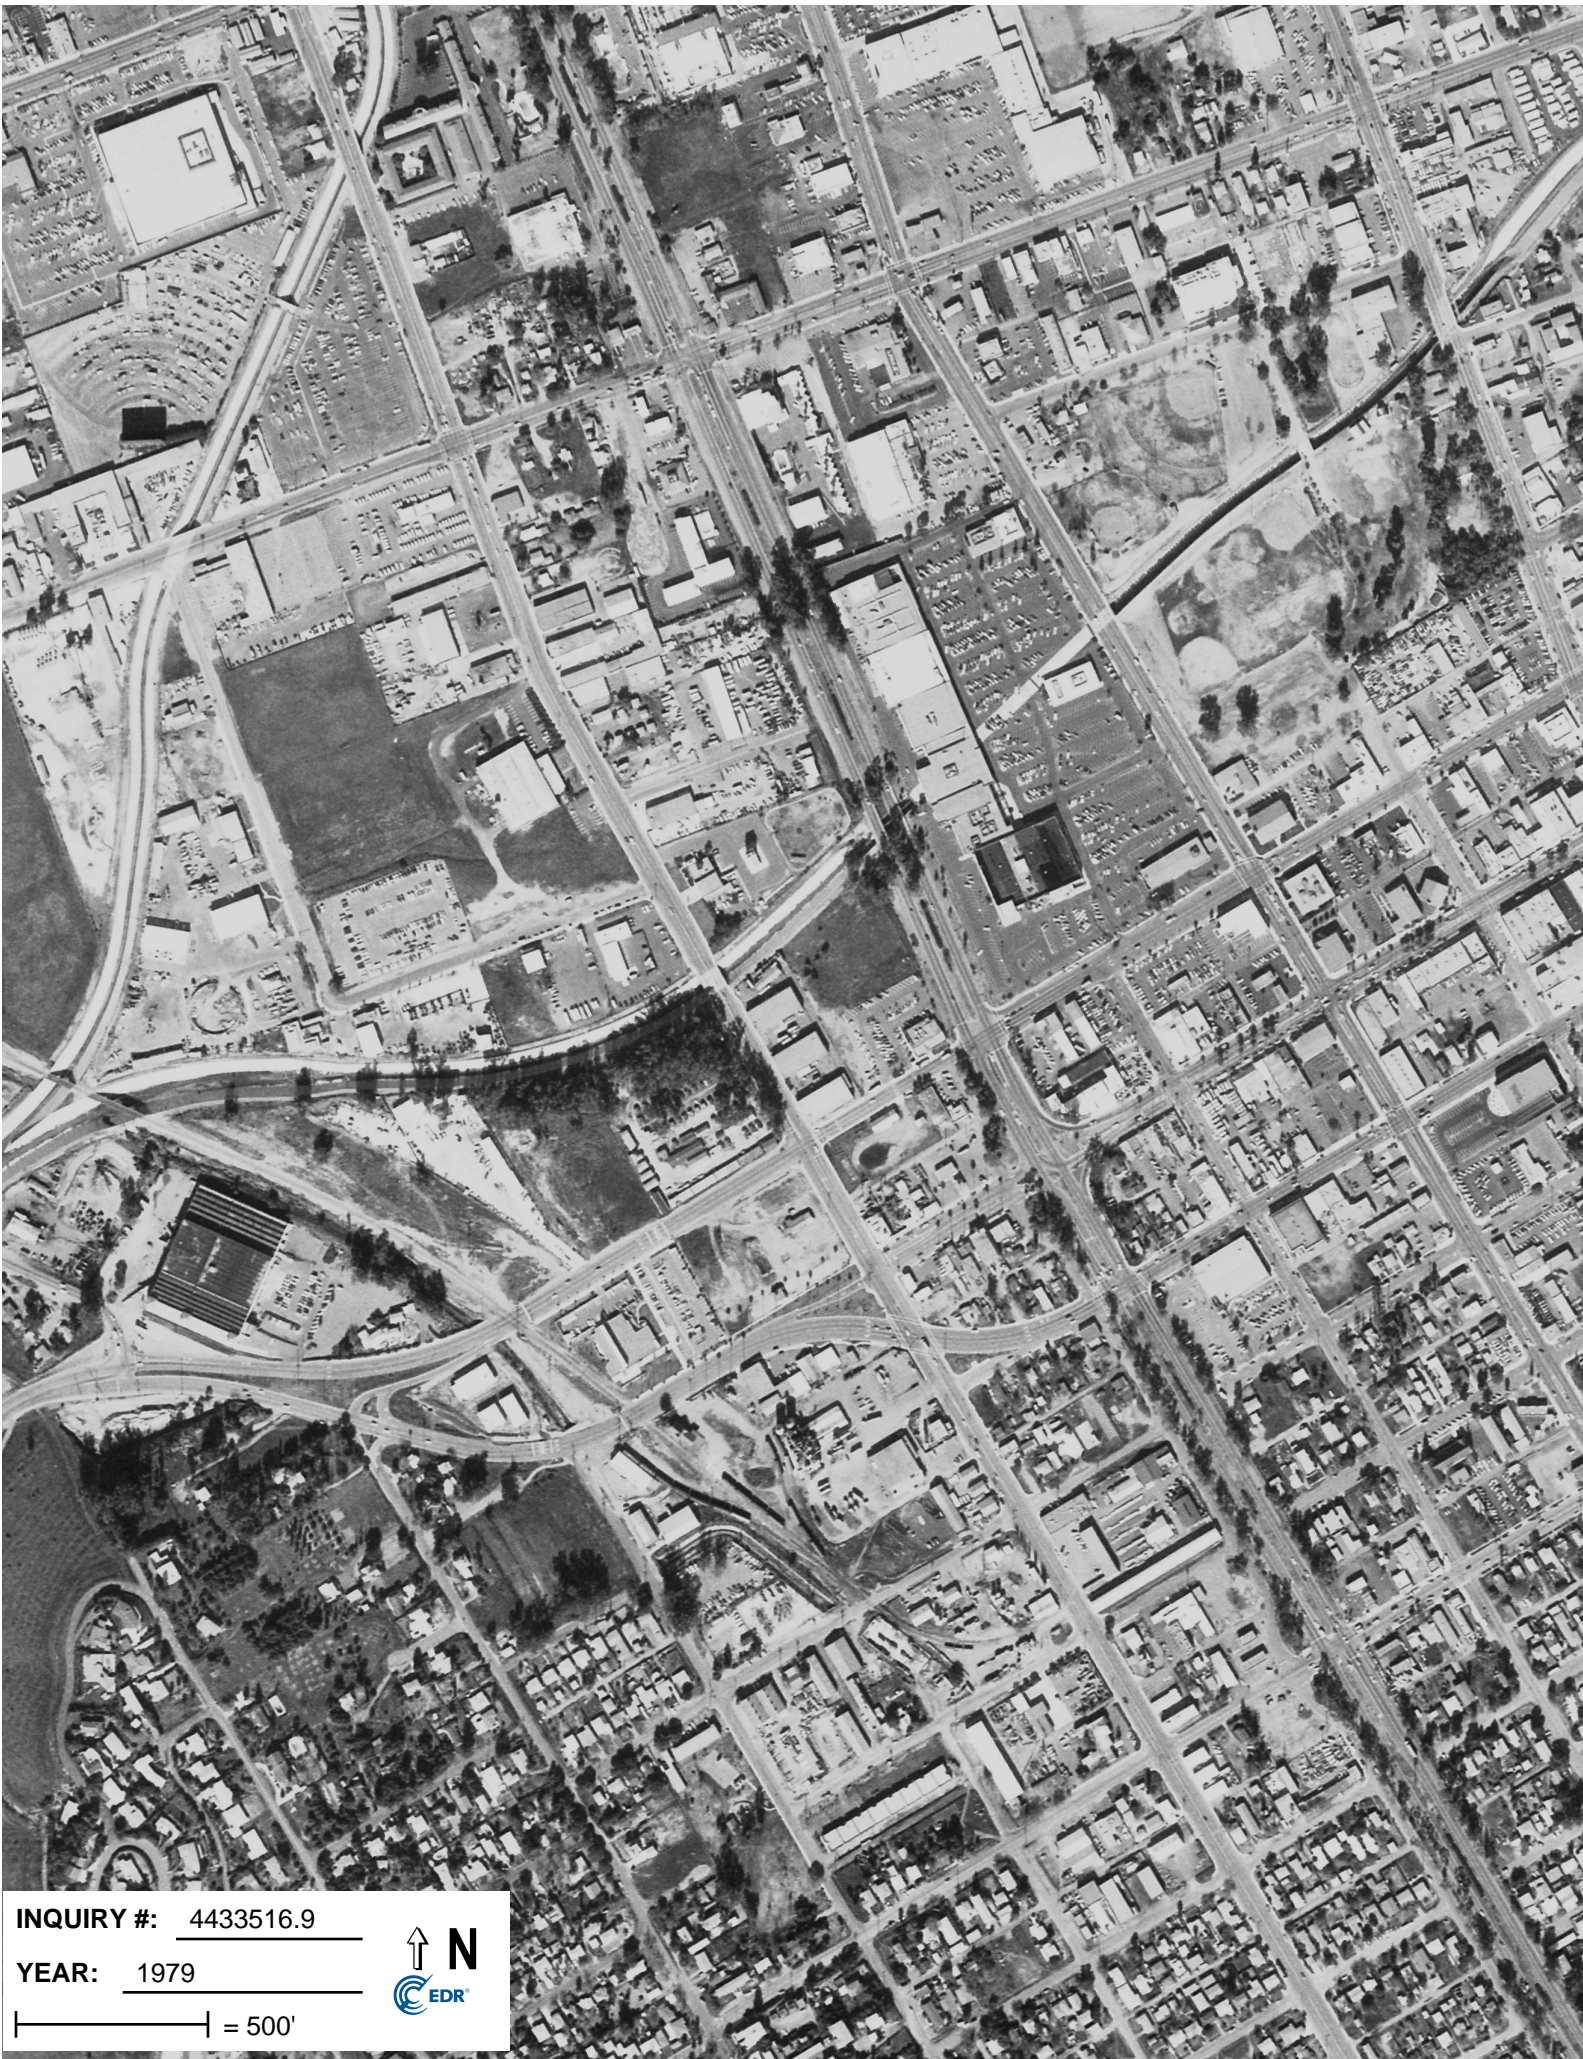
YEAR: 1979

1979	The subject site was interpreted to have equipment in between onsite structures. Southwest of subject site a building appeared removed with land cleared.
1985	Additional activity/development was noted to the east of the subject site; long structures were interpreted to be a storage facility and offices with parking lot. Southwest of subject site a structure and paved parking lot are on the opposite corner of subject site, as well as a paved parking lot south of subject site. Most features consistent with current onsite/vicinity development.
1989	The onsite building appeared largely unchanged, west of the subject site the structures have been removed and land has been cleared. Other surroundings appeared similar to as seen in the preceding photograph.
1995	Additional development to the east of the subject site was interpreted as essentially the same as currently observed development.
2005	The subject site and its surroundings appeared similar to as seen in the preceding photograph.
