Appendix B
Biological Evaluation and Wetland Delineation Technical Memorandum

April 16, 2019

Project No. 5025183001

Subject: Environmental Evaluation Memo for the Orange Memorial Park Water Capture Project, South San Francisco, San Mateo County, California

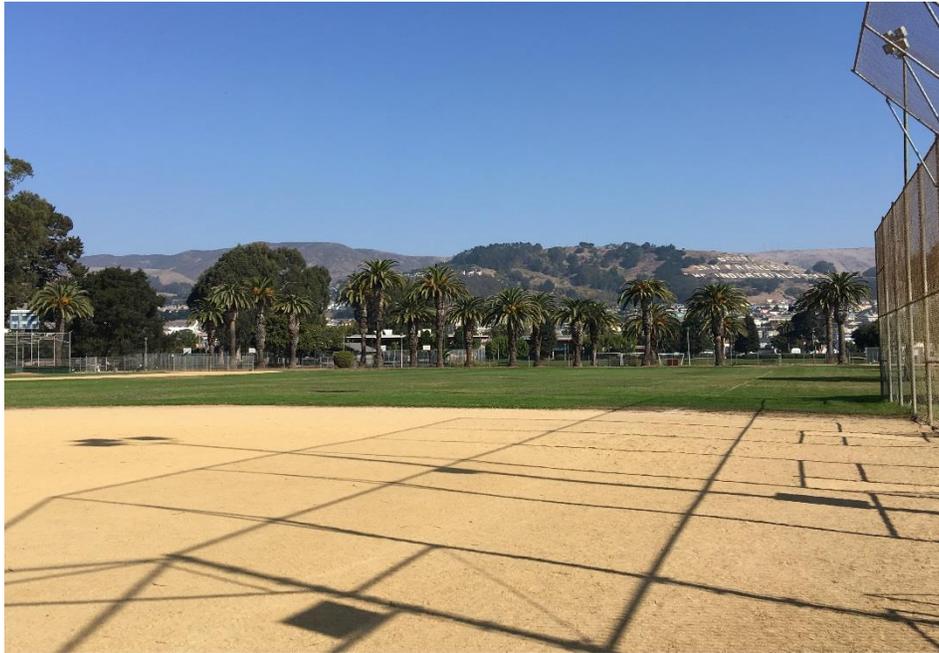
Photograph 1. At the southeast corner of the baseball field looking northeast.

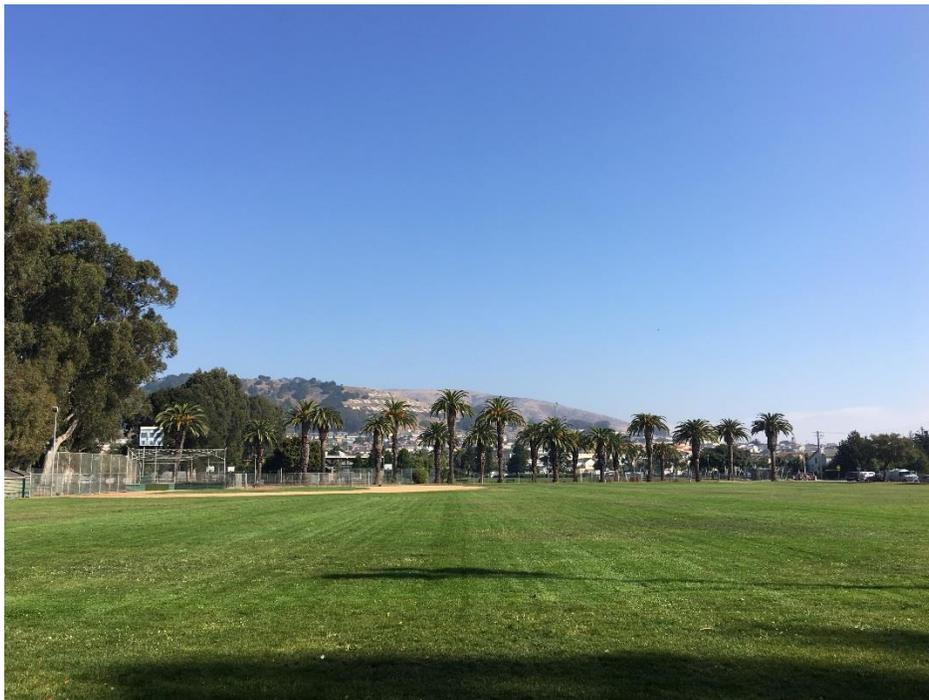
Photograph 2. View of the baseball field looking east toward the row of palm trees lining either side of Colma Creek channel.

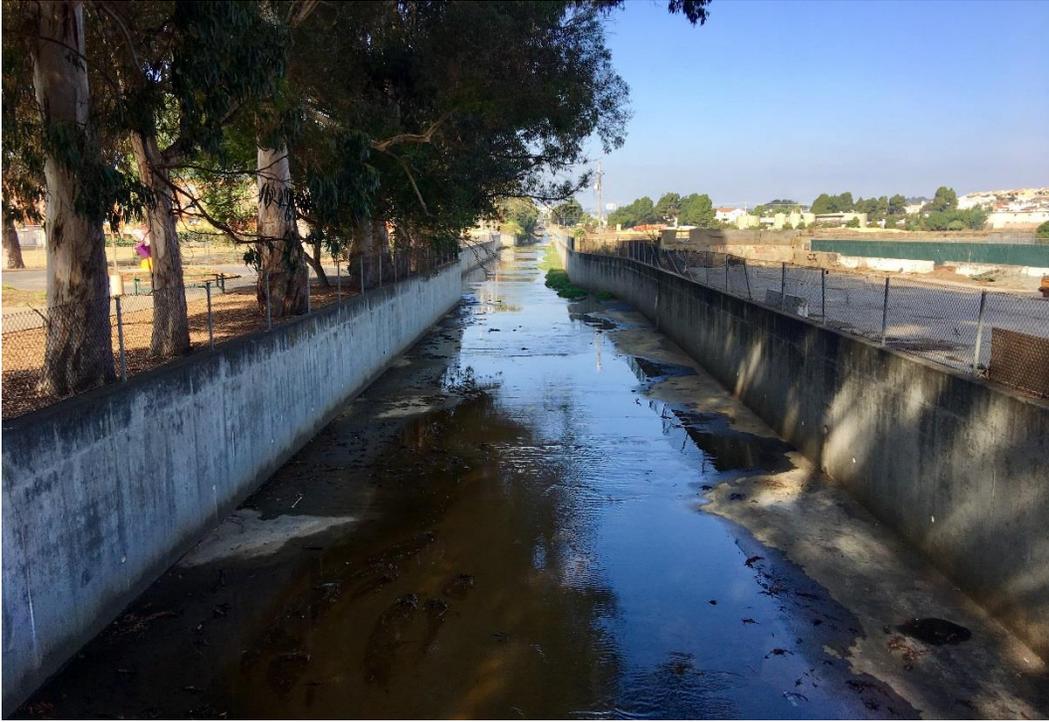
Photograph 9. View from the center of the pedestrian bridge looking north up Colma Creek channel.

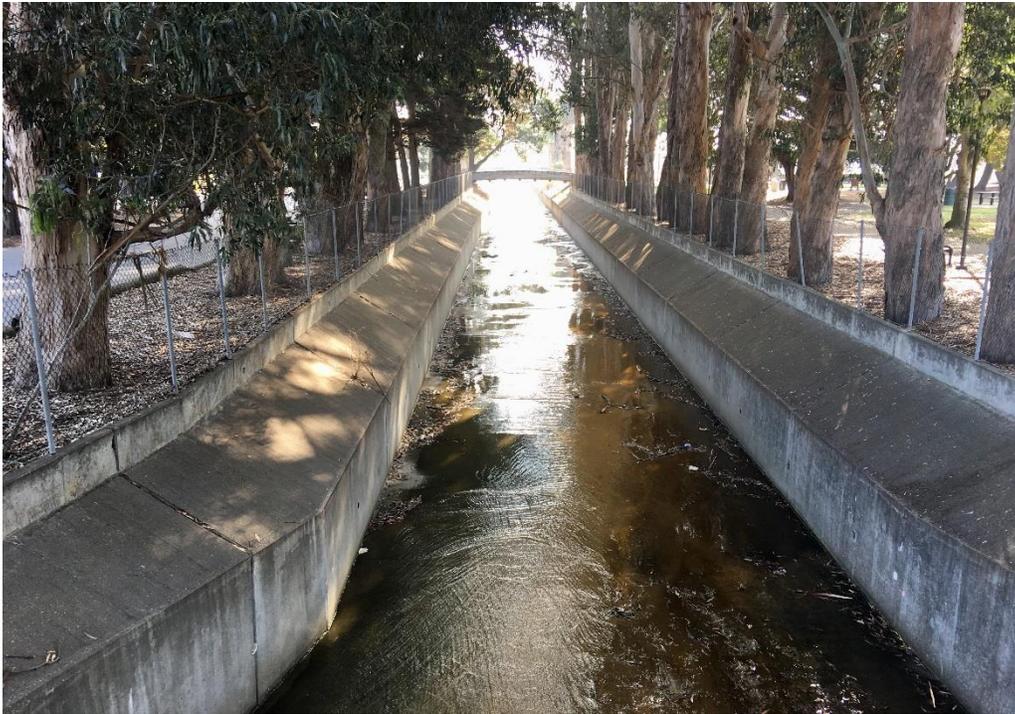
Photograph 10. View from the center of the pedestrian bridge facing south down Colma Creek.

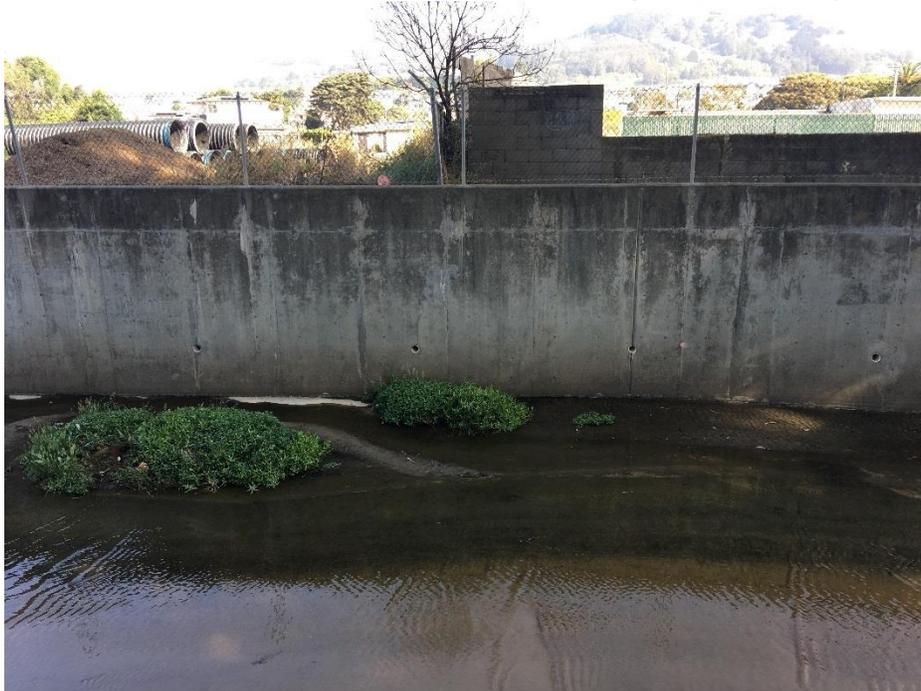
Photograph 12. View from the west side of Colma Creek looking northeast and showing the concrete lining of the channel.

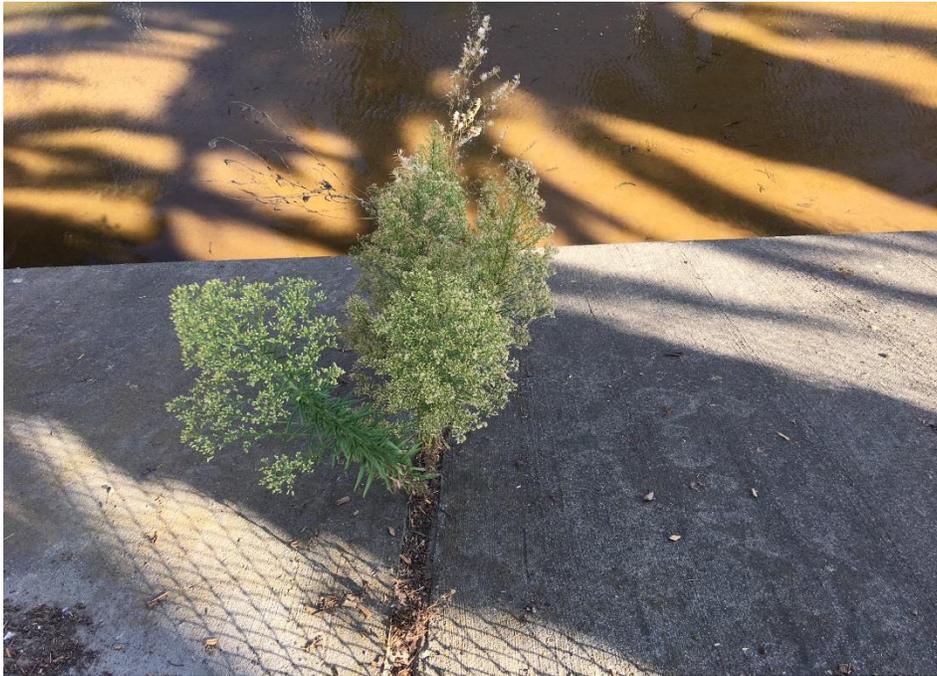
Ruderal upland species, such as Canada horseweed (*Erigeron canadensis*) were observed growing in the joints near the top of the channel close to Orange Avenue.

Photograph 17. Vegetation growing out of the crack between concrete slabs lining Colma Creek channel.

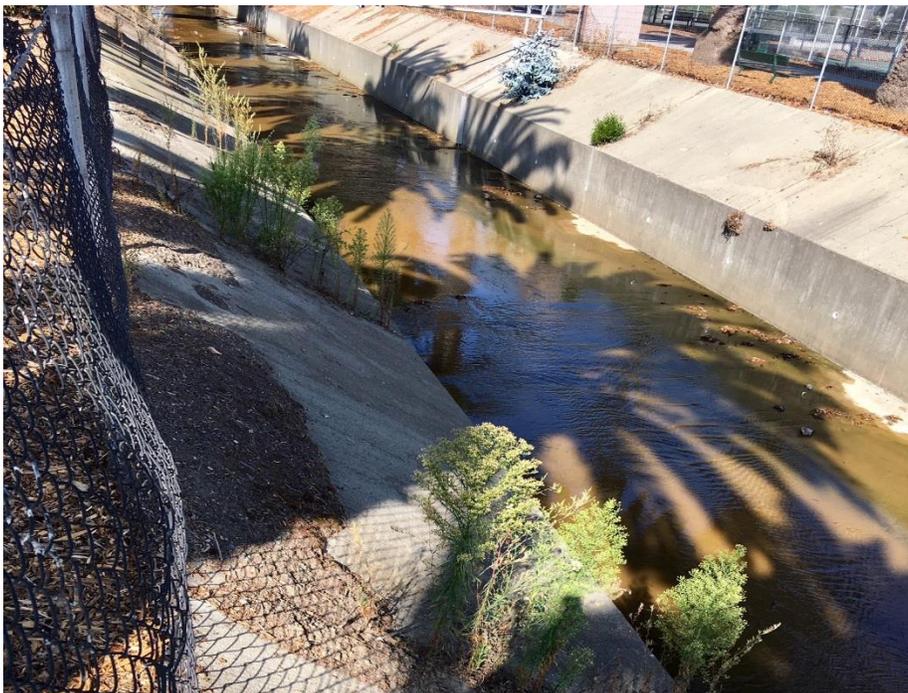
Photograph 18. Vegetation growing out of the crack between concrete slabs lining Colma Creek channel.

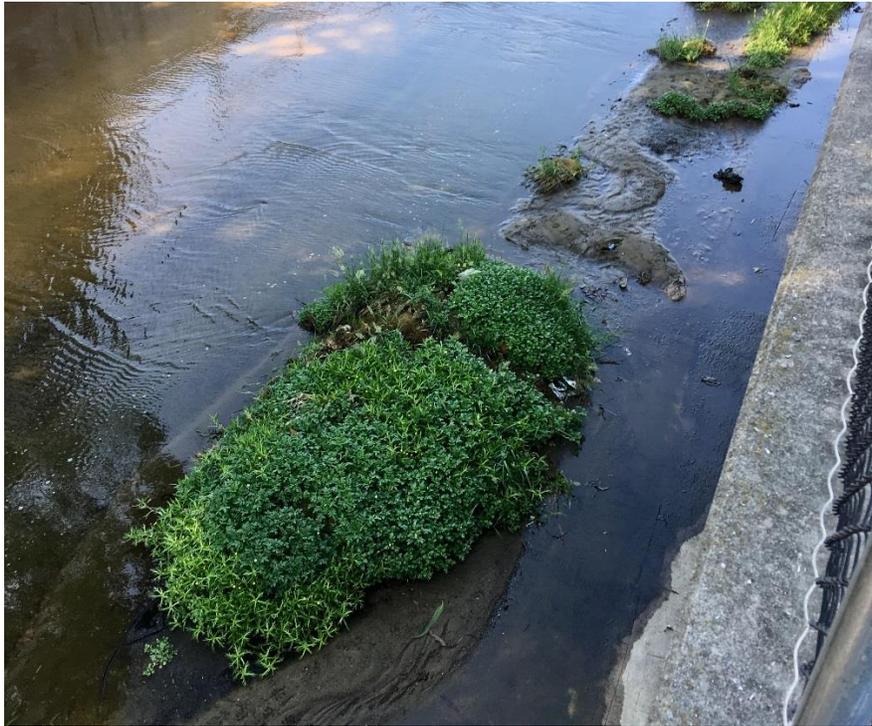
Within the survey area, the channel is unvegetated with the exception of a narrow strip along the northern side of the channel bottom near the northwestern boundary of the survey area and several of the joints at the top of the channel near the southeastern end of the survey area (Photos 5 and 6, Attachment A). The narrow strip of herbaceous vegetation along the channel concrete bottom was observed during the October 2018 site visit, but was under water during the March 2019 site visit. This vegetation was growing in areas where patches of sediment were present along the channel bottom.

Photograph 21. View of water and vegetation growing in Colma Creek channel bottom.

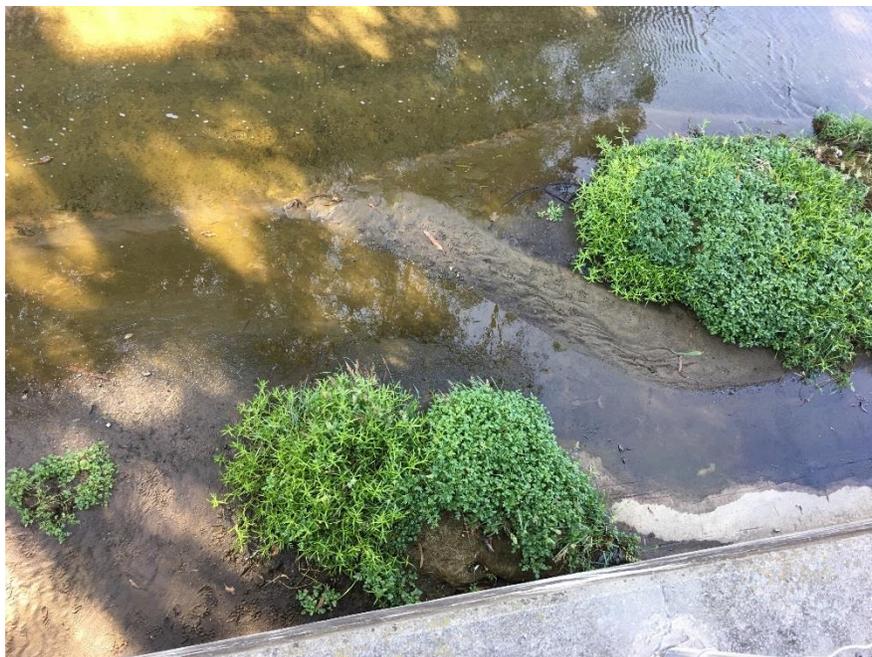
Photograph 22. View of siltation and other debris within Colma Creek.

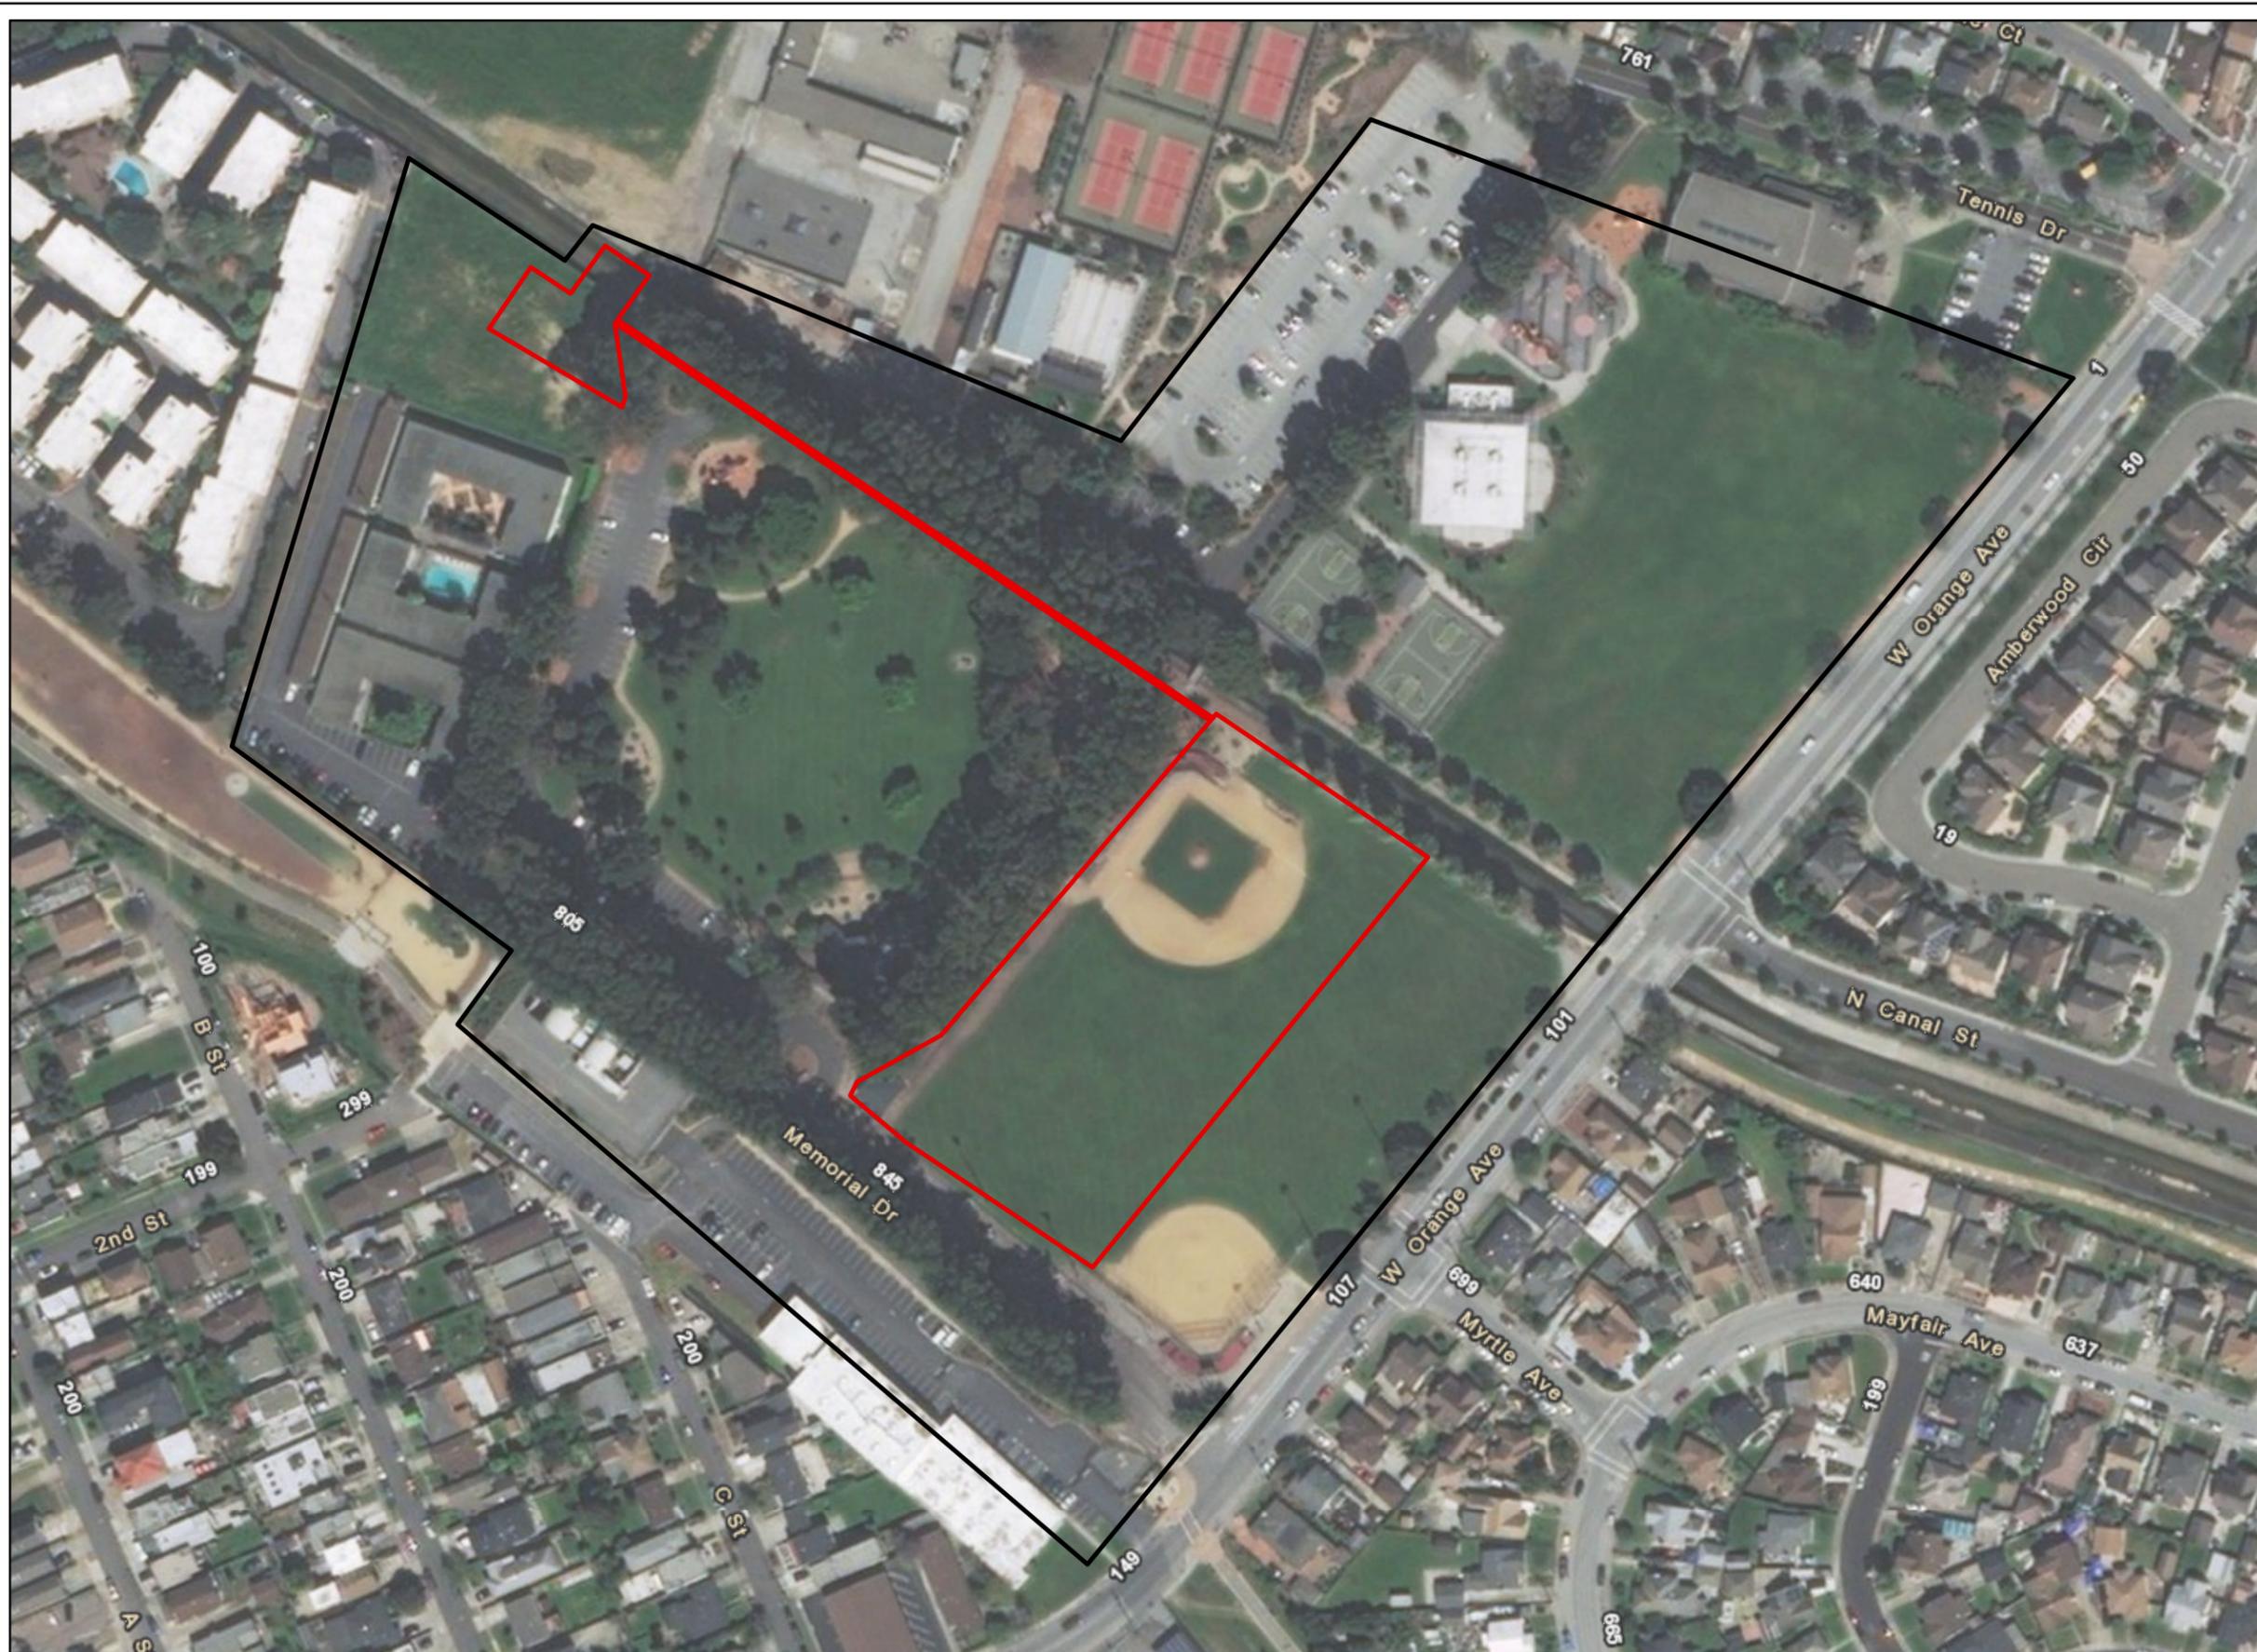
FIGURE 3
 Site Overview
 Biological Technical Report
 Orange Memorial Park
 South San Francisco, CA

- Project Boundary
- Survey Area

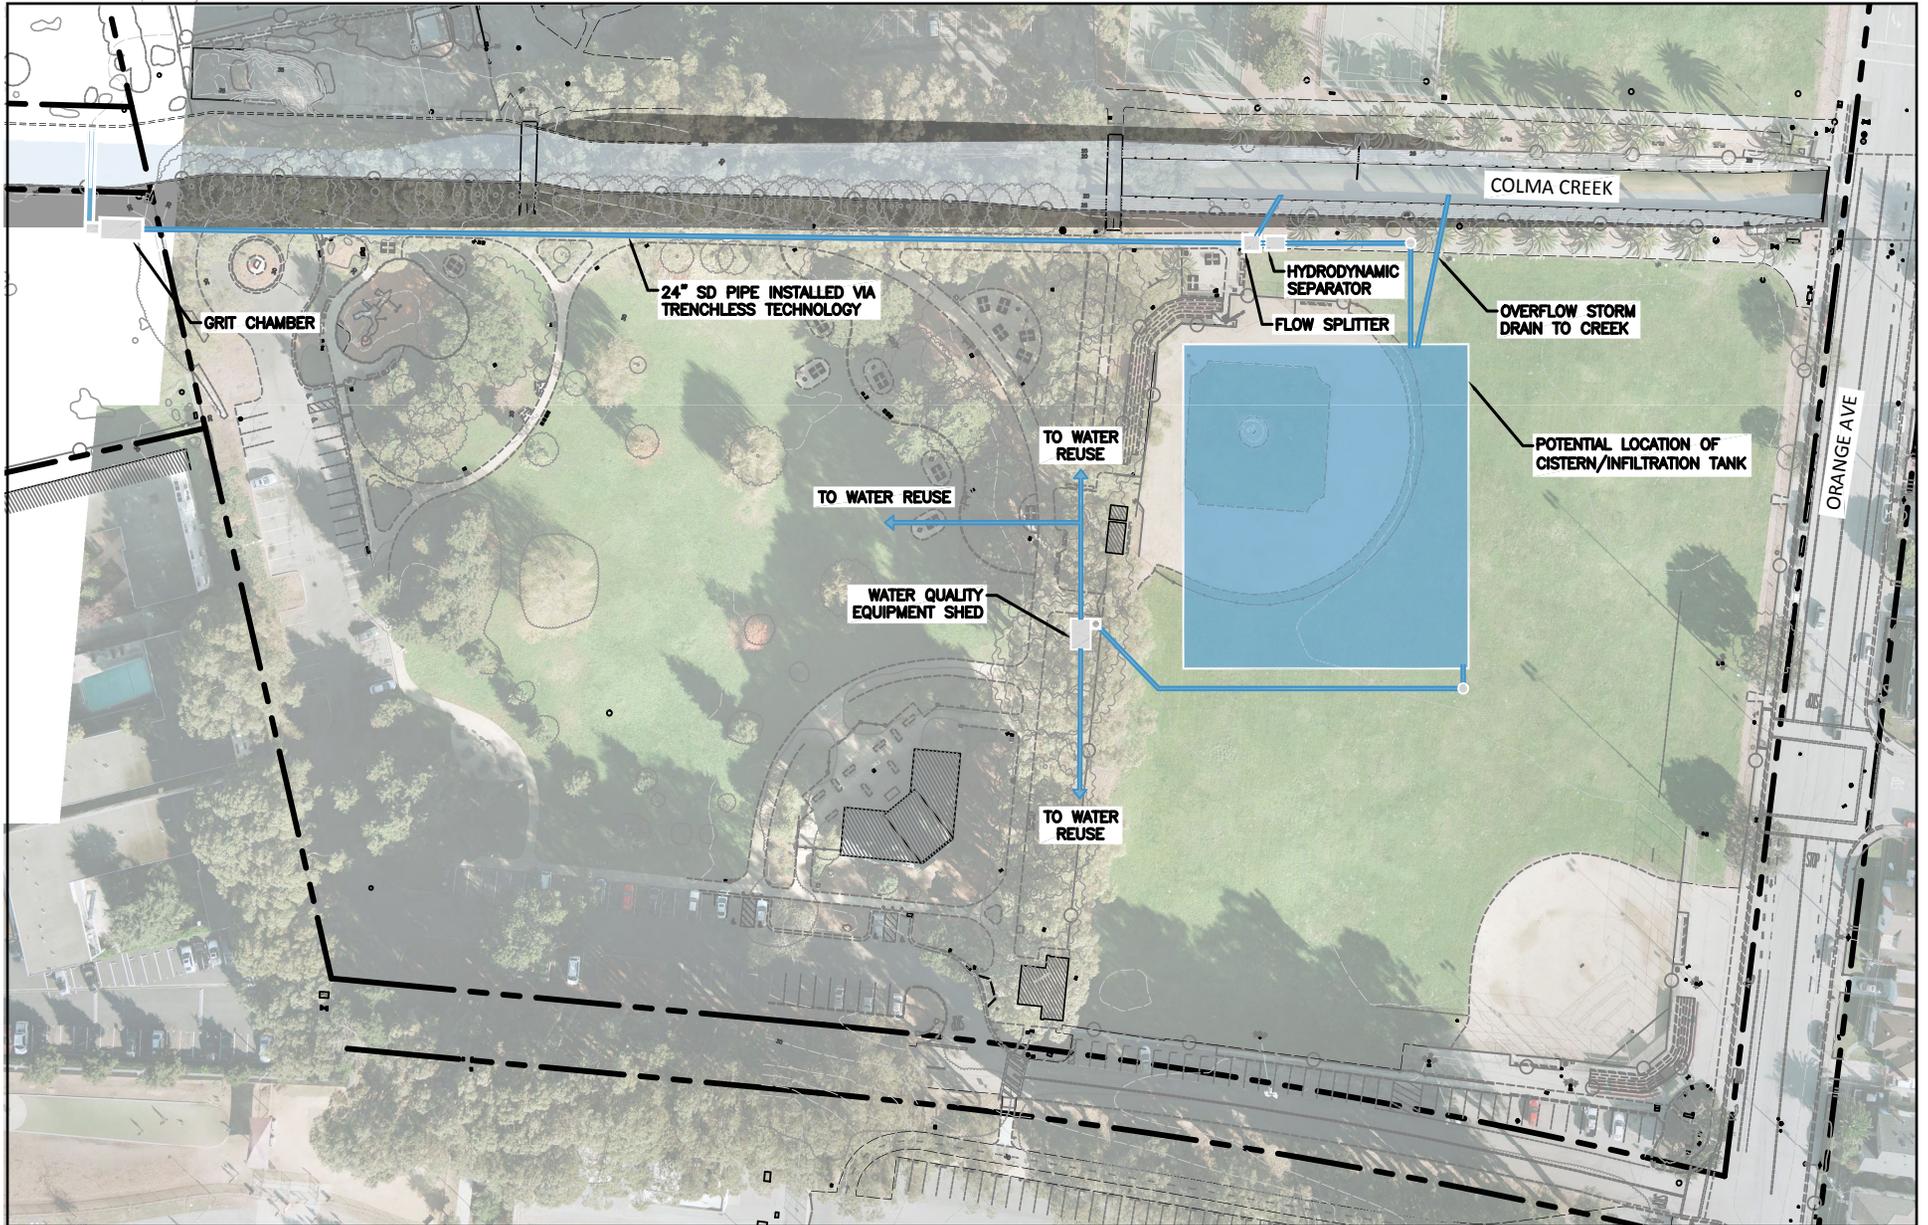
FIGURE 4

Site Plan
Biological Technical Report
Orange Memorial Park
South San Francisco, CA

and treat 8 to 13 percent of the annual drainage from approximately 6,300 acres of land in the City of South San Francisco, Town of Colma, the City of Daly City, and a portion of unincorporated San Mateo County. The project site plan is provided as Figure 4 in Attachment D.

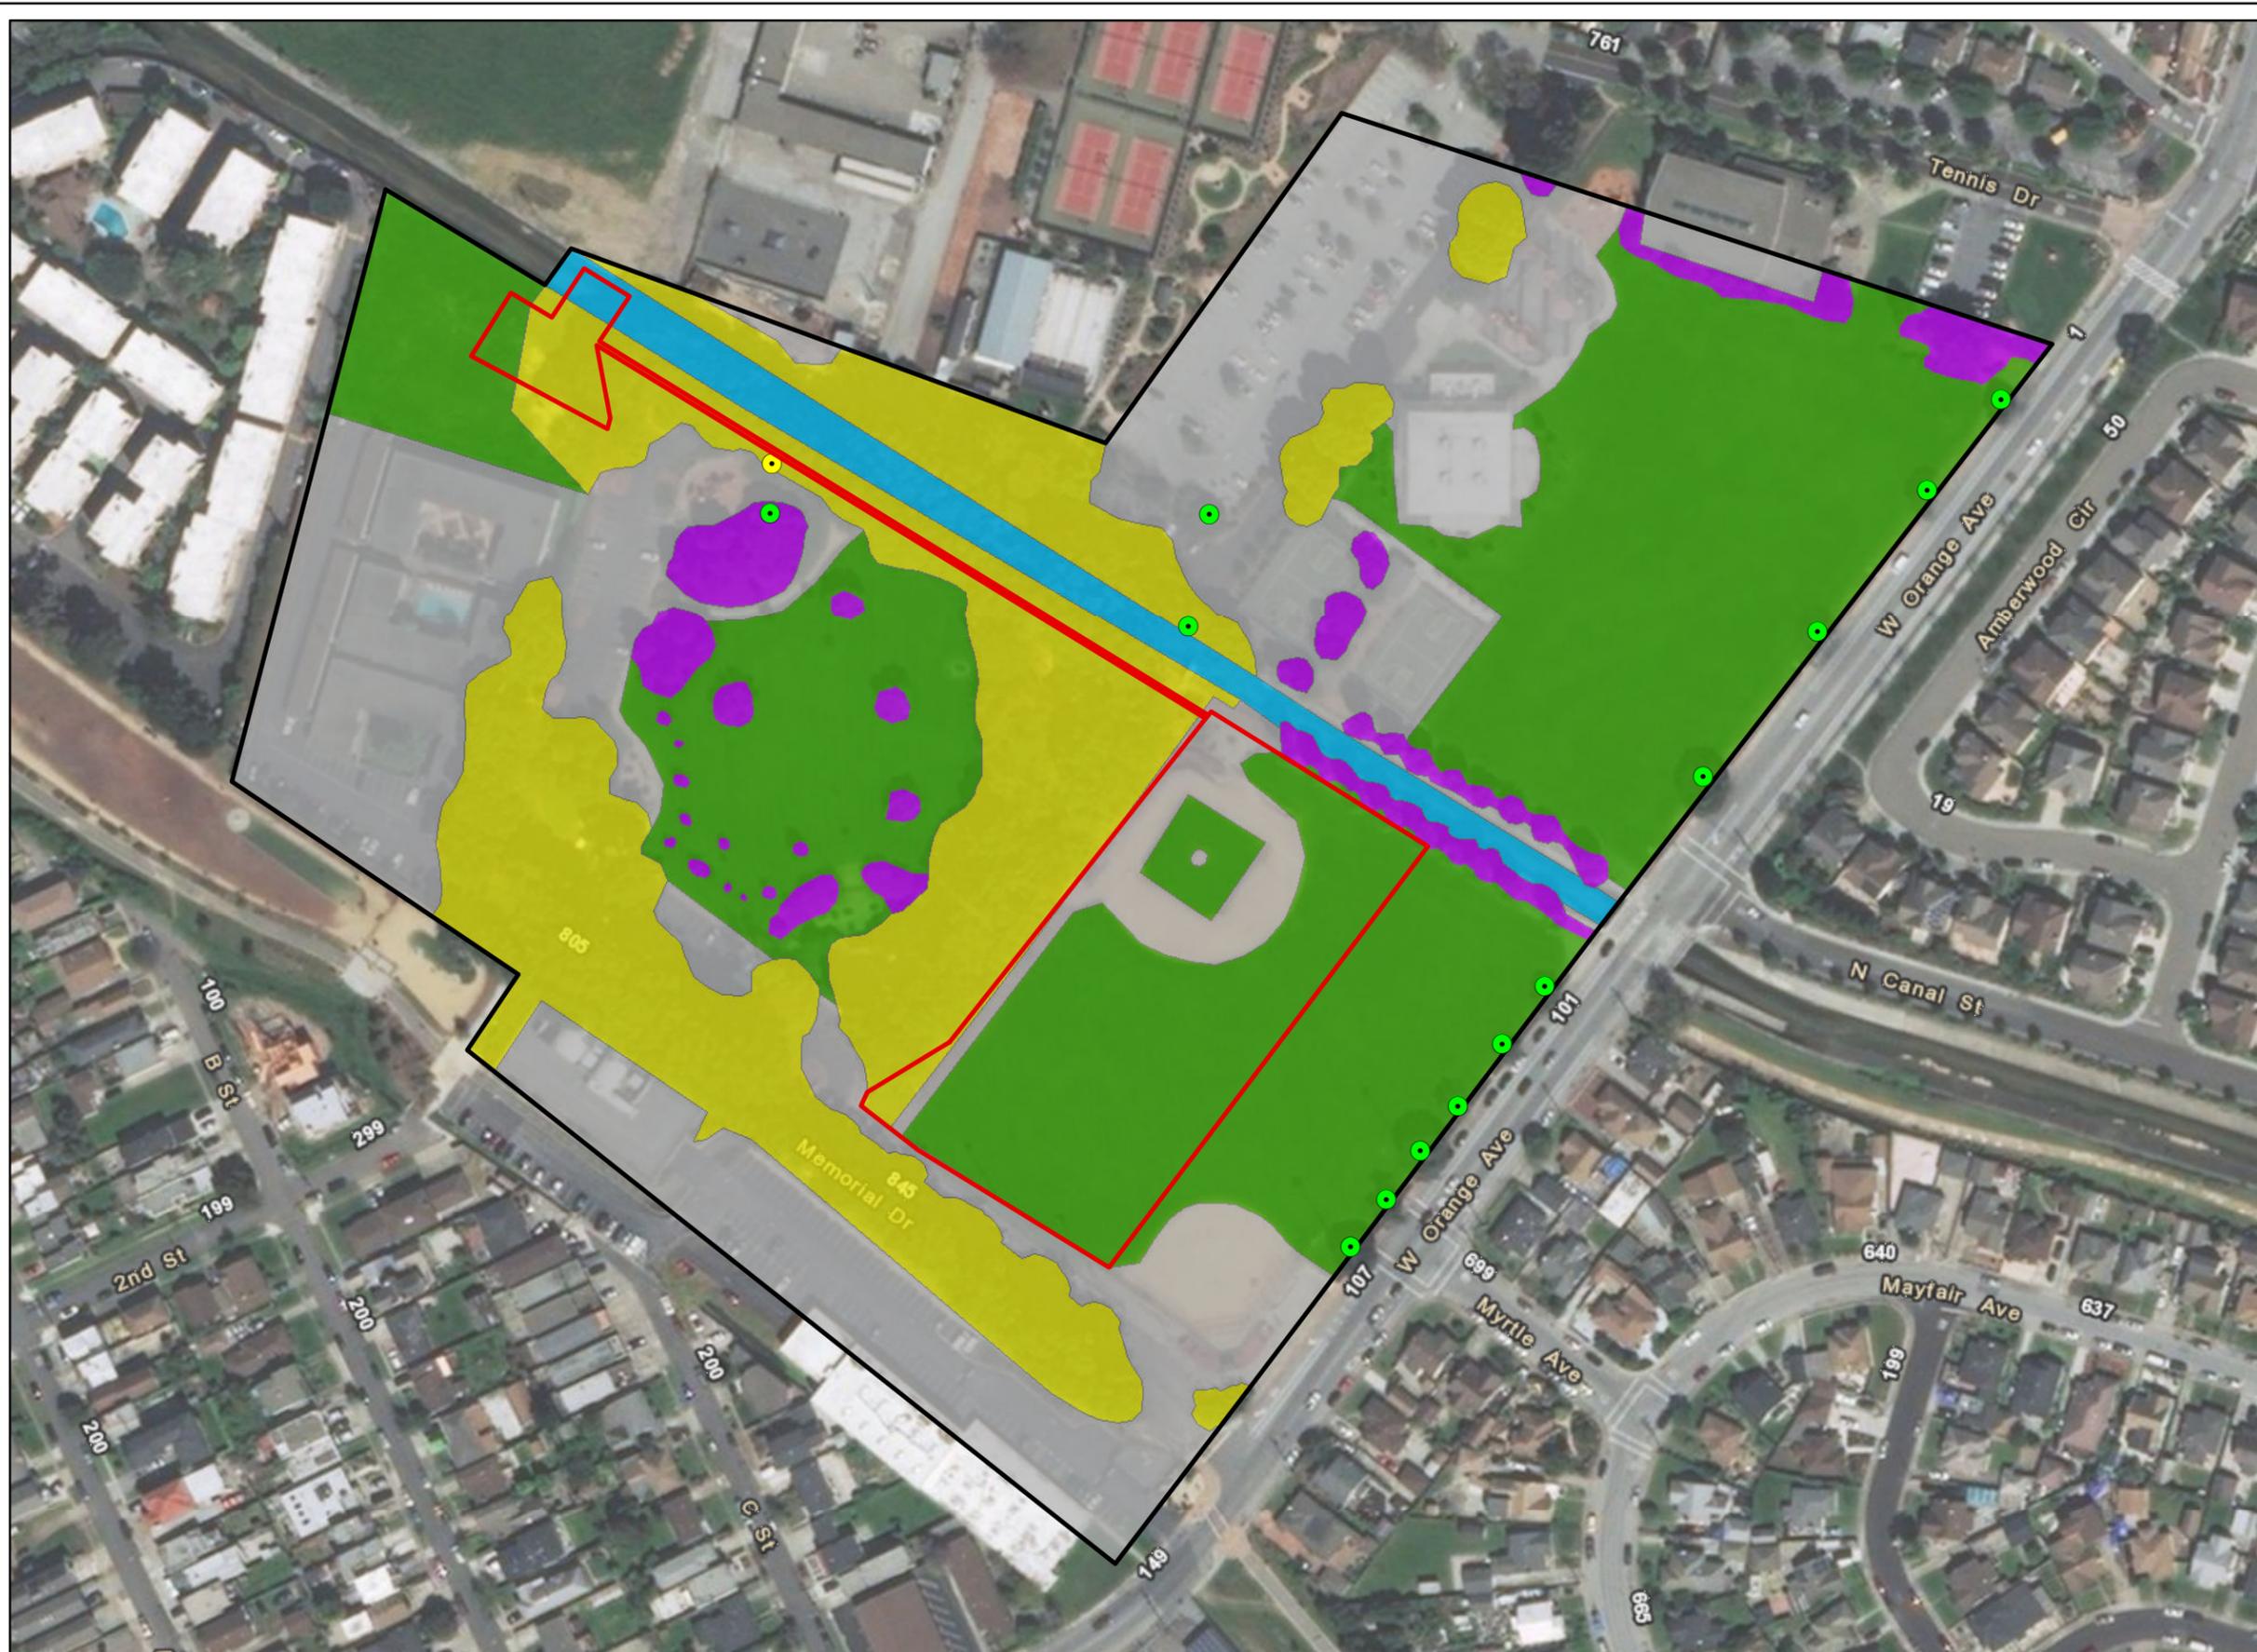
- Project Boundary
 - Survey Area
 - Coast Live Oak
 - Western Sycamore
- Vegetation and Land Cover Types**
- Channel
 - Eucalyptus Woodland
 - Grass/Turf
 - Ornamental
 - Urban/Developed

Vegetation communities within the survey area include grass/turf, urban/developed, eucalyptus woodland, ornamental, and a channel (Attachment D Figure 5). The vegetation overall is typical of an urban park setting, with mostly ornamental plantings and eucalyptus trees planted for shade and boundary. Large swaths of maintained (presumably turf) grass occupies much of the open areas. There is a baseball field and a softball field that accounts for the southeastern and eastern portion of the survey area. Picnic tables, benches, park buildings and a small playground structure are also within the survey area. The Colma Creek Flood Control Channel runs from the north to southeast along the eastern boundary of the park. Within this reach of the Colma Creek Flood Control Channel, the channel bottom and sides are lined with concrete. A summary of vegetation communities and acreage within the survey area is provided below in Table 1. Photographs of the vegetation communities are provided in Attachment A Site Photographs (Photos 1 and 2).

One mature western sycamore tree was mapped within the survey area (Attachment D Figure 5). This tree is located along the edge of the eucalyptus trees that are growing along the Colma Creek Flood Control Channel in the northwestern part of the survey area.

Thirteen mature coast live oak trees were mapped within the survey area (Attachment D Figure 5). One tree is adjacent to the playground located in the northwestern part of the survey area, one is located along the northern bank of the Colma Creek Flood Control Channel just east of the lower footbridge, one is part of the landscaping adjacent to a parking lot, and the other ten trees are located along West Orange Avenue, which serves as the eastern boundary of both Orange Memorial Park and the survey area.

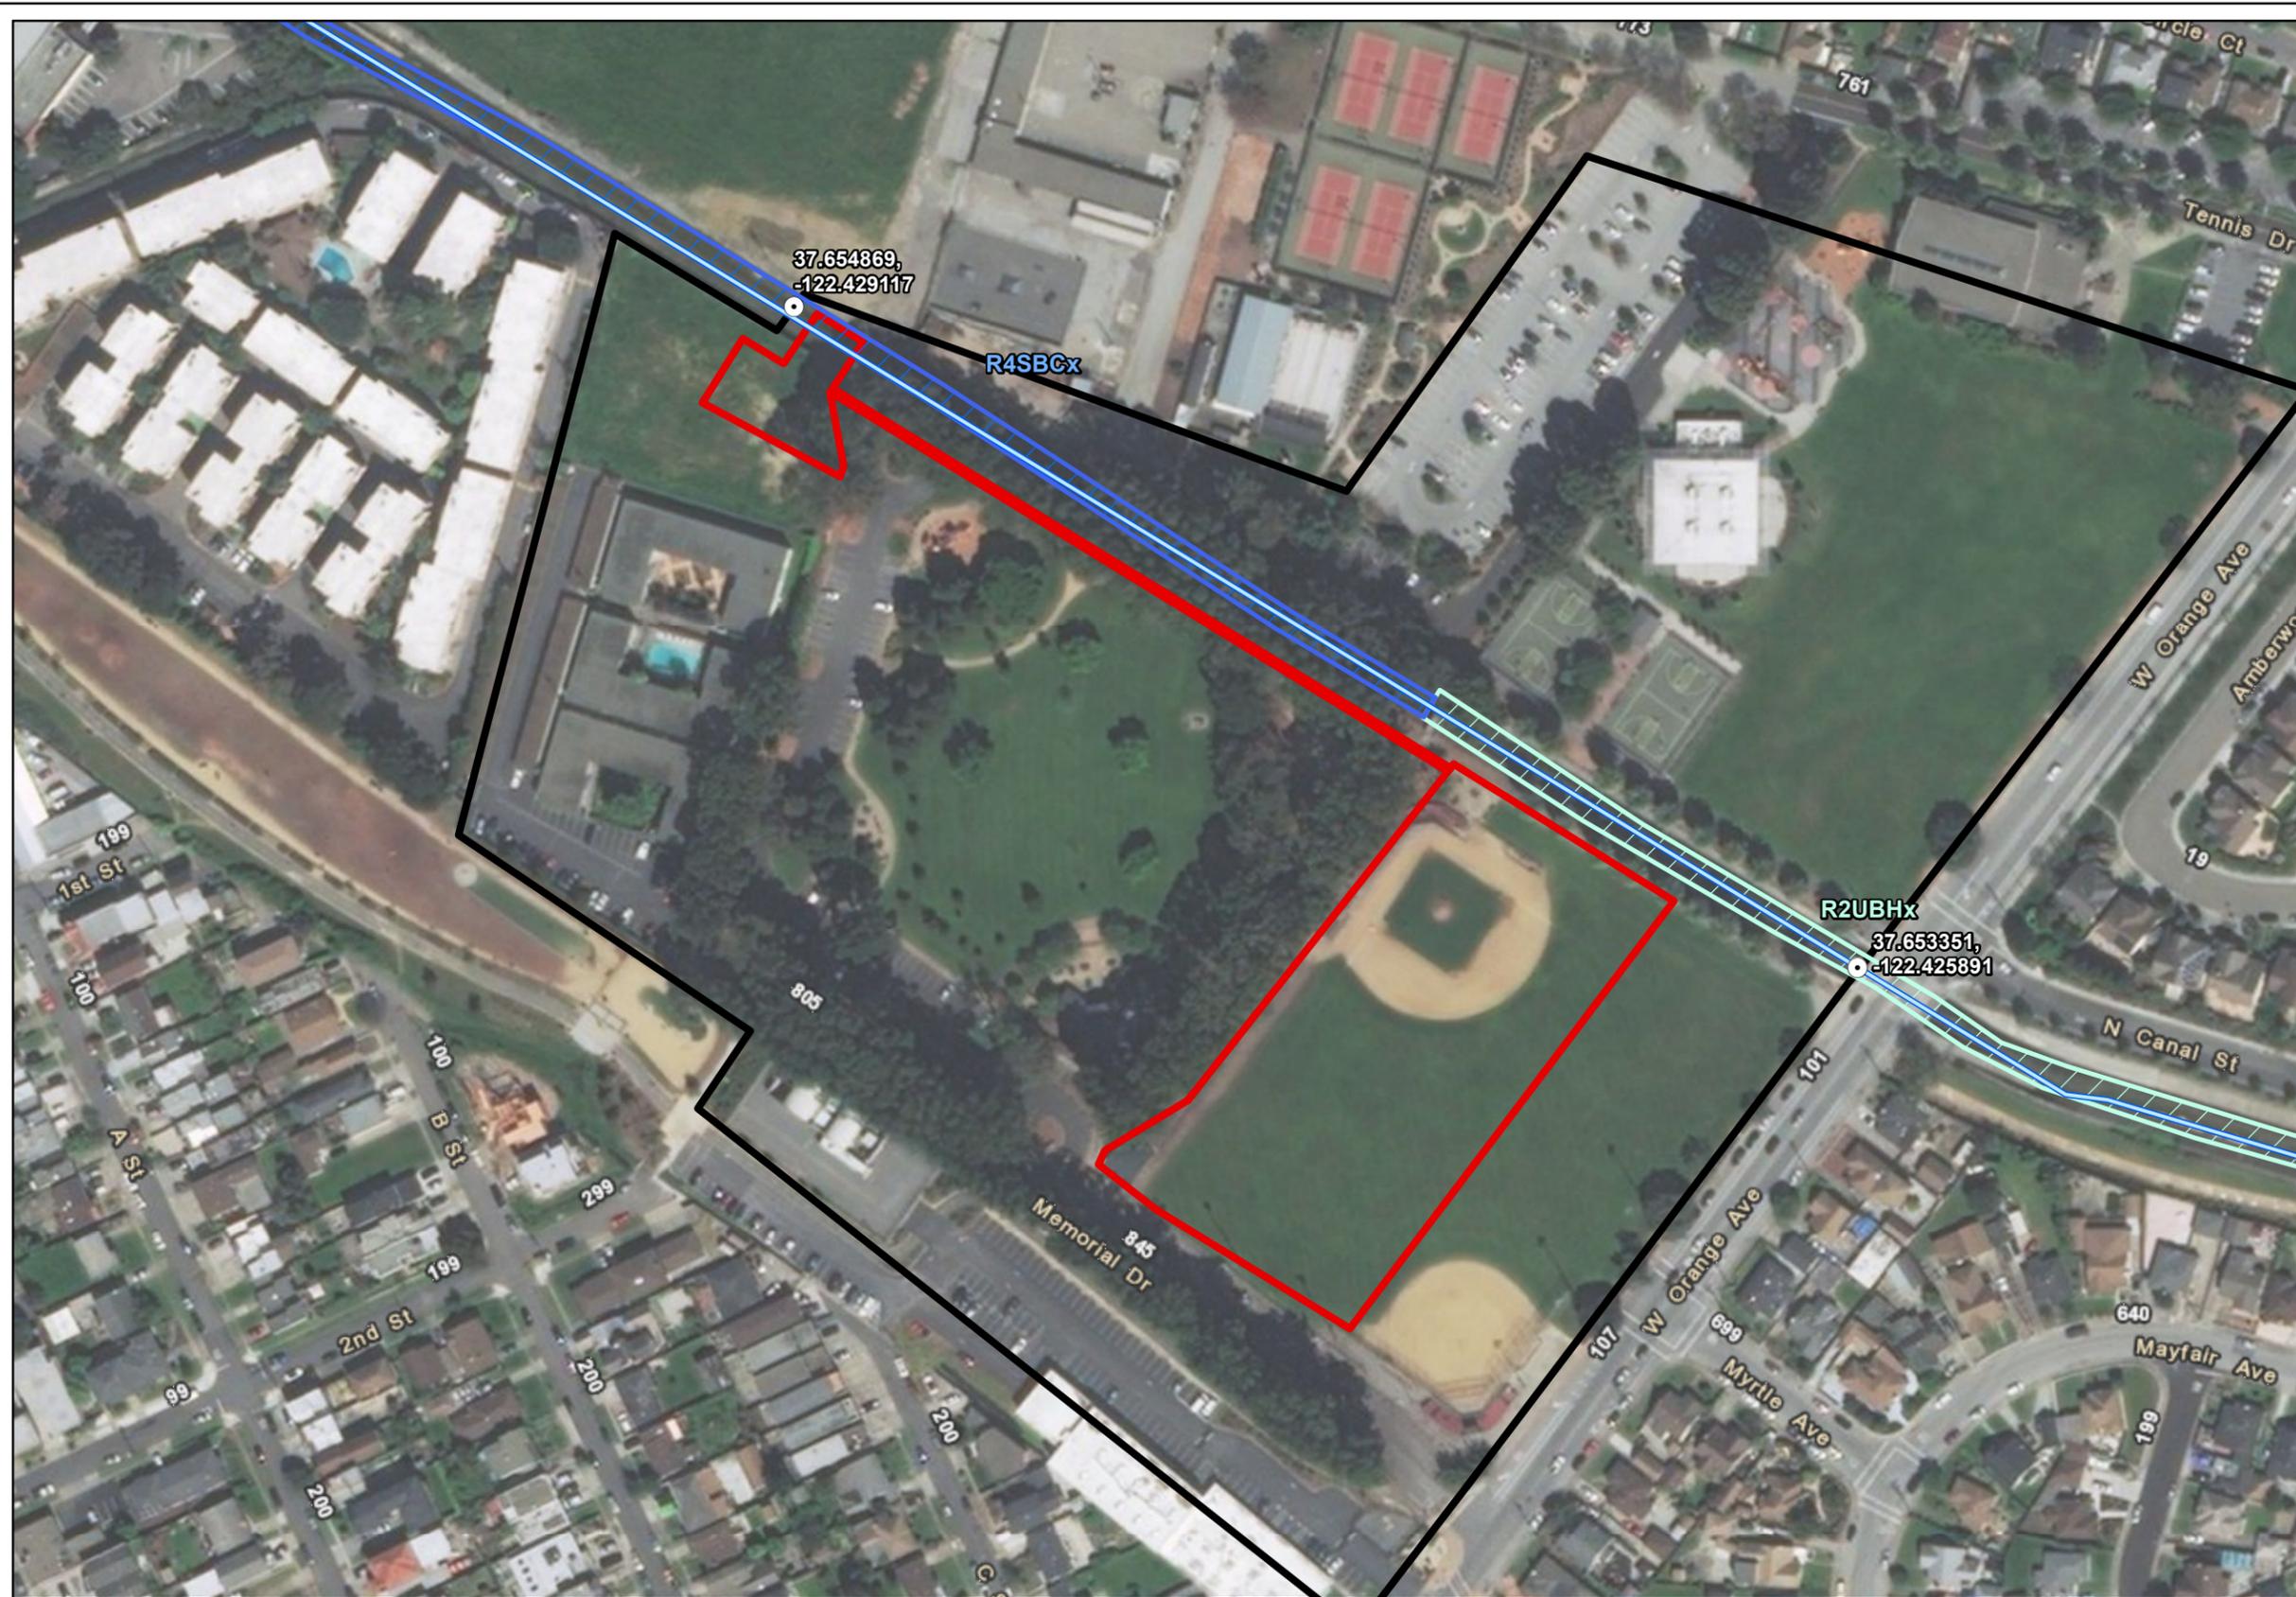
FIGURE
6

- Project Boundary
- Survey Area
- Control Points (Lat/Long, WGS84)
- National Hydrography Dataset Flowlines**
- Perennial
- NWI Wetland Classification**
- Riverine, Lower Perennial, Unconsolidated Bottom, Permanently Flooded, Excavated
- Riverine, Intermittent, Streambed, Seasonally Flooded, Excavated

The results of the delineation are discussed in the following sections. Figure 6 provides a map of the NWI Wetlands Mapper data. Figure 7 provides a map of the potential WUS within the concrete drainage channel, including points delineating the Ordinary High Water Mark (OHWM) during the dry season. No wetlands were identified within the survey area, therefore wetland delineation data forms are not included. Appendix A includes site photographs of Colma Creek. Table 3 summarizes aquatic resources mapped in the survey area.

An approximately 1,092-foot long (0.70 acre) portion of the Colma Creek Flood Control Channel lies within the 25-acre survey area, bisecting Orange Memorial Park in a northwest to southeast direction (Attachment D Figure 6 and Figure 7). The bottom and sides of this part of the channel are entirely lined with concrete. Upstream of the northwestern-most Orange Memorial Park pedestrian bridge, the channel is approximately 12 feet deep with vertical banks. Downstream of this bridge and continuing to Orange Avenue, the channel narrows with banks that are vertical from the channel bottom up to approximately 6 feet where they slant out at a 45-degree angle to the top of the channel (Photos 3 and 4, Attachment A). Downstream of Orange Avenue, the concrete channel widens and becomes trapezoidal.
