Appendix B
Biological Evaluation and Wetland Delineation Technical Memorandum

April 16, 2019

Project No. 5025183001

Subject: Environmental Evaluation Memo for the Orange Memorial Park Water Capture Project, South San Francisco, San Mateo County, California

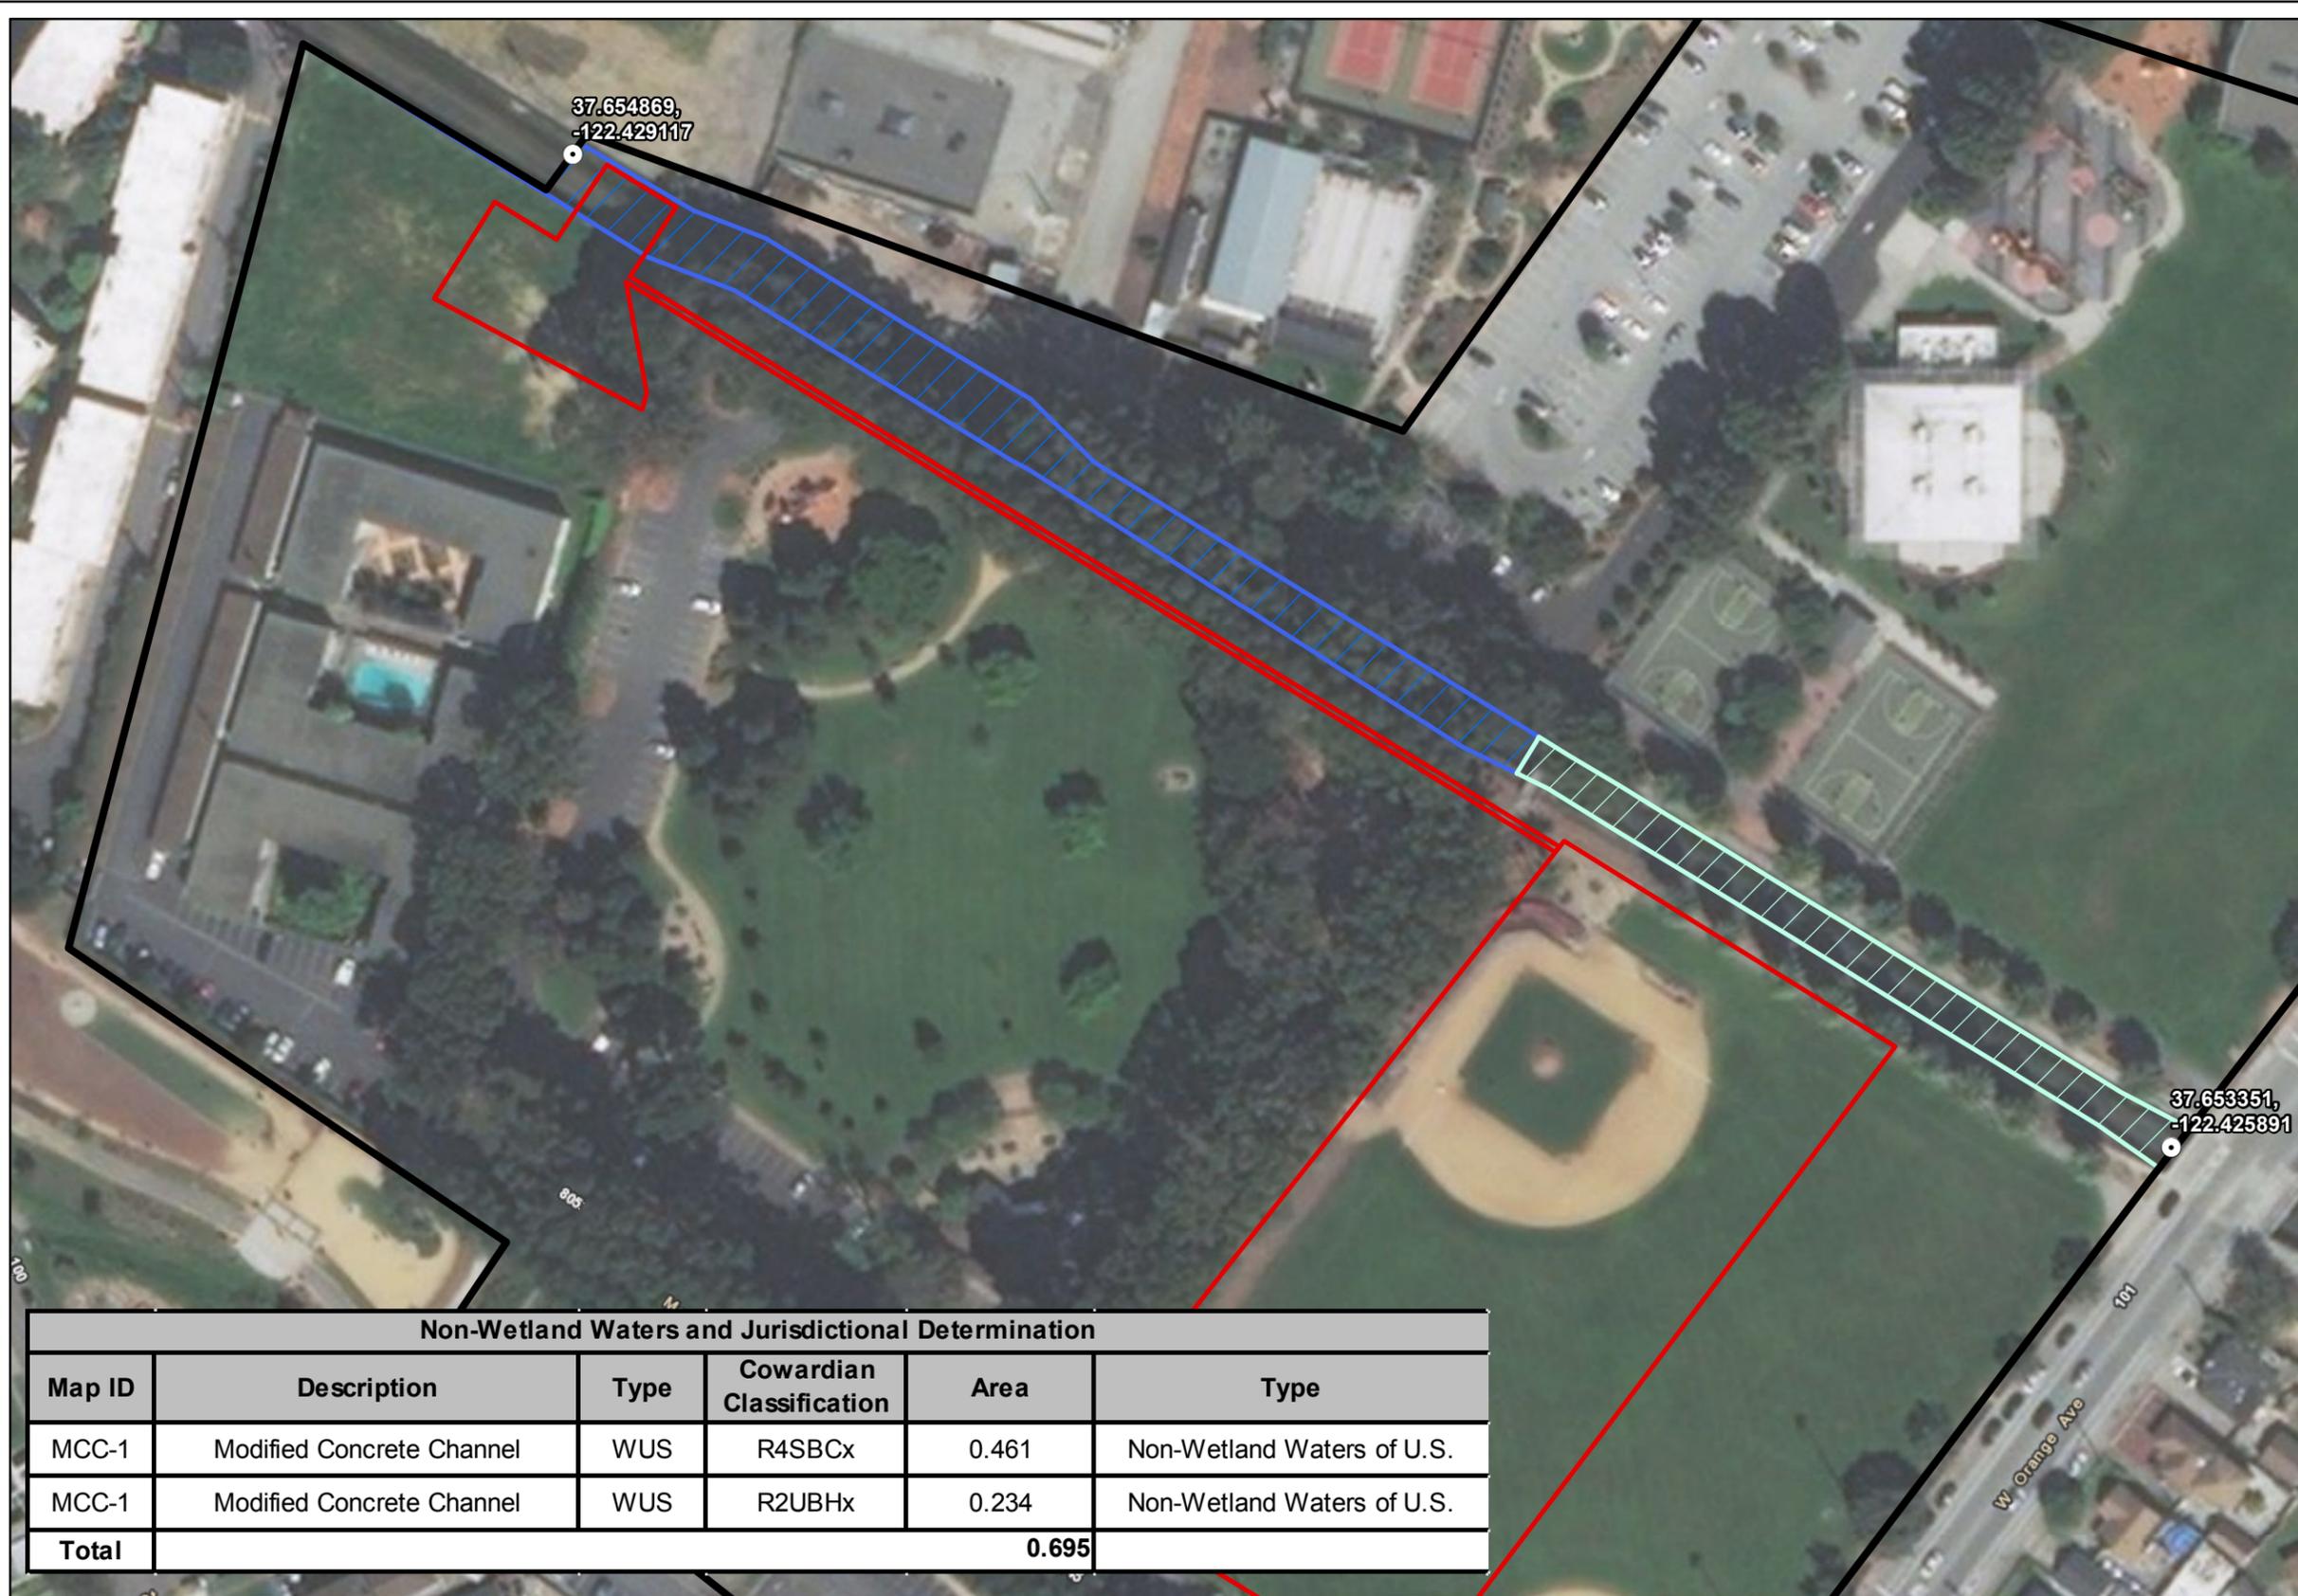
- Project Boundary
- Survey Area
- Control Points (Lat/Long, WGS84)
- Waters of the U.S.**
- Modified Concrete Channel: R2UBHx
- Modified Concrete Channel: R4SBCx

Non-Wetland Waters and Jurisdictional Determination					
Map ID	Description	Type	Cowardian Classification	Area	Type
MCC-1	Modified Concrete Channel	WUS	R4SBCx	0.461	Non-Wetland Waters of U.S.
MCC-1	Modified Concrete Channel	WUS	R2UBHx	0.234	Non-Wetland Waters of U.S.
Total				0.695
