Appendix B – Biological Resources Report

February 8, 2019

RE: *Biological Technical Report for the City of Avalon Five Corners Project*

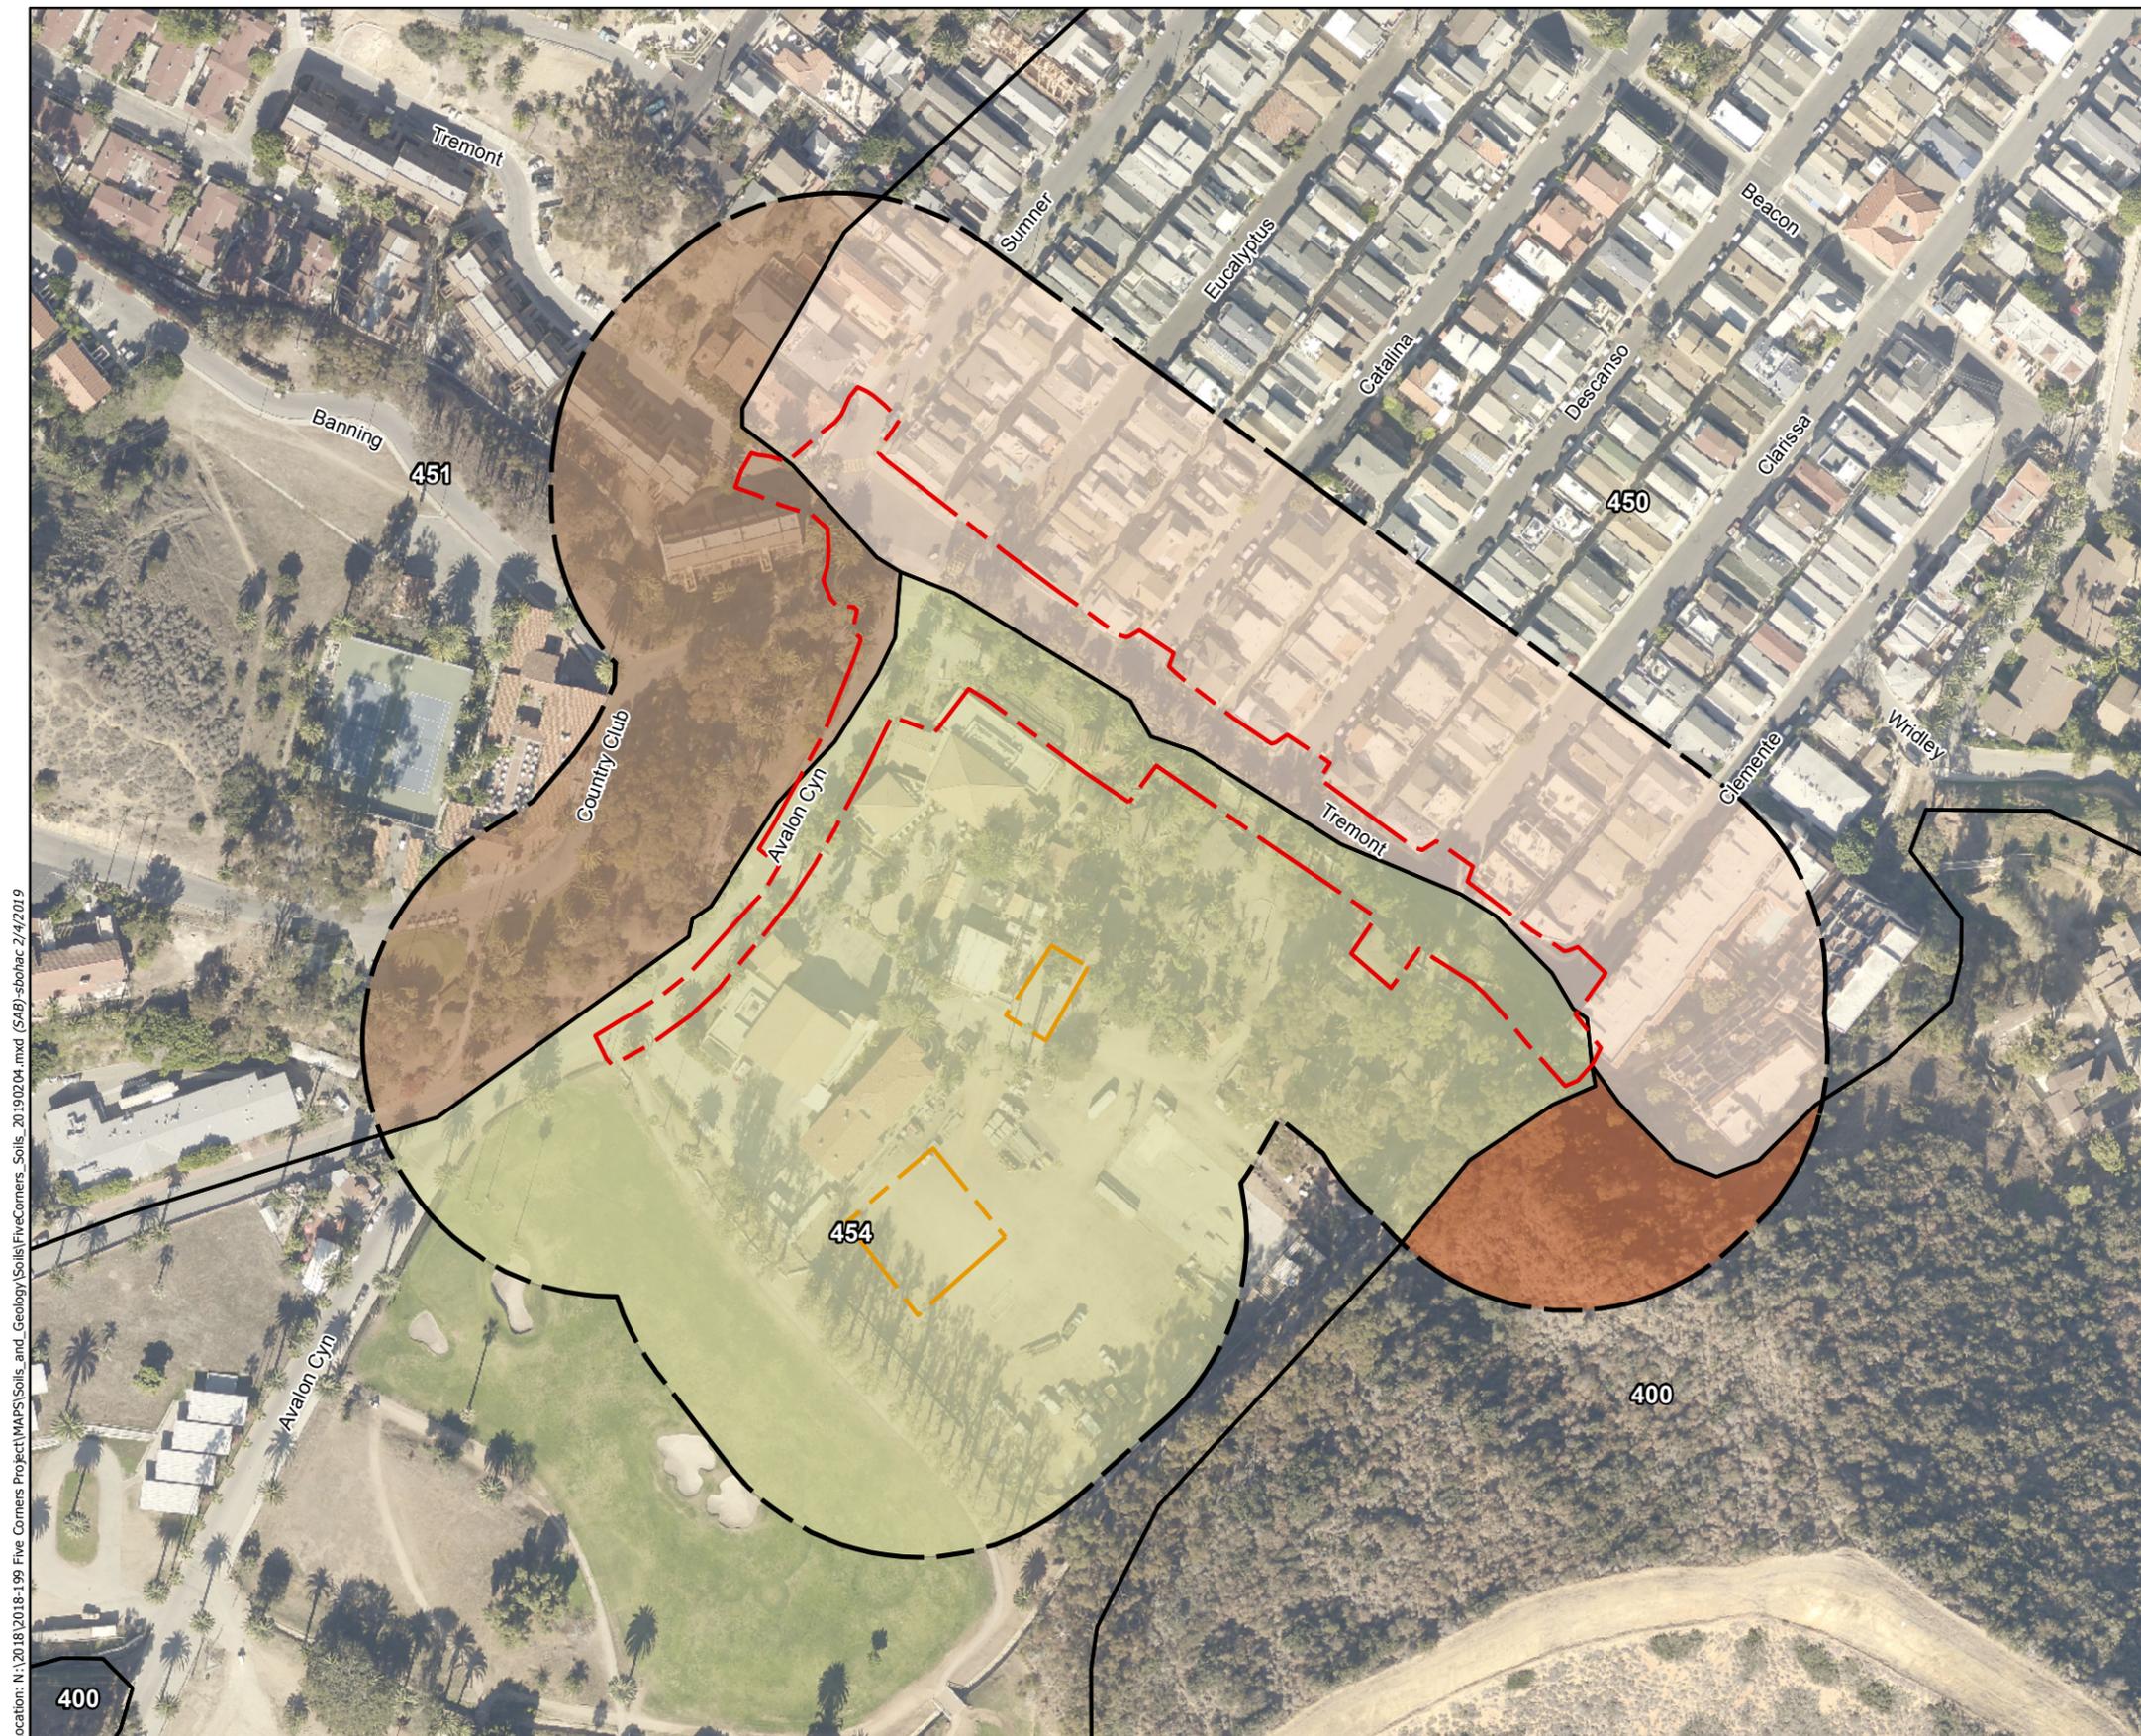
Figure 3
Natural Resources Conservation
Service Soil Types

Natural Resources Conservation Service (NRCS)
 Soil Survey Geographic (SSURGO) Database for
 Los Angeles, CA

As depicted in Figure 3. *Natural Resources Conservation Service Soil Types*, four soil series are mapped within the BSA (National Resource Conservation Service [NRCS] 2018):

- 450 - Urban land-Xerorthents, landscaped, association 0 to 8 percent slopes
- 454 - Typic Argixerolls-Calcic Haploxerolls-Urban land complex, 2 to 8 percent slopes, landscaped
- 451 - Nauti, landscaped-Urban land complex, 8 to 30 percent slopes
- 400 - Oboship-Nauti-Bosun complex, 50 to 75 percent slopes

Urban land-Xerorthents, landscaped, association (0 to 8 percent slopes) and Typic Argixerolls-Calcic Haploxerolls-Urban land complex (2 to 8 percent slopes, landscaped) consist mostly of deep, well-drained soils that have formed from pavement, buildings, and human-transported materials over alluvium. These soils are typically associated with golf courses and urban land and have low runoff potential. Soils in these series are not considered hydric.

Nauti, landscaped-Urban land complex (8 to 30 percent slopes) occurs in a small portion of the BSA. Nauti soil series mostly consists of moderately deep, excessively drained soils formed from Quartz-diorite. It is typically associated with hills and has a very high runoff potential. Soils in this series are not considered hydric.

Oboship-Nauti-Bosun complex, 50 to 75 percent slopes occurs in a small portion of the BSA. This area could consist of either of the three series. Bosun series mostly consists of somewhat excessively drained soils that formed in materials weathered from quartz-diorite porphyry. Bosun soils are on side slopes of interfluves on hills and mountains on islands. The Oboship series consists of deep, well-drained soils that formed in materials weathered from dioritic rock. Oboship soils are also on side slopes of interfluves of dissected hills and mountains on offshore islands. Soils mapped in this complex are not considered hydric. The area mapped with Oboship-Nauti-Bosun complex is the only area in the BSA that supports a native plant community.
