# **DRAFT INITIAL STUDY/MITIGATED NEGATIVE DECLARATION**

## **Recess Storage Project 4224 Sonoma Highway Santa Rosa, California**

Prepared for:  
City of Santa Rosa  
Planning and Economic Development Department  
100 Santa Rosa Avenue, Room 3  
Santa Rosa, CA 95404

June 2019

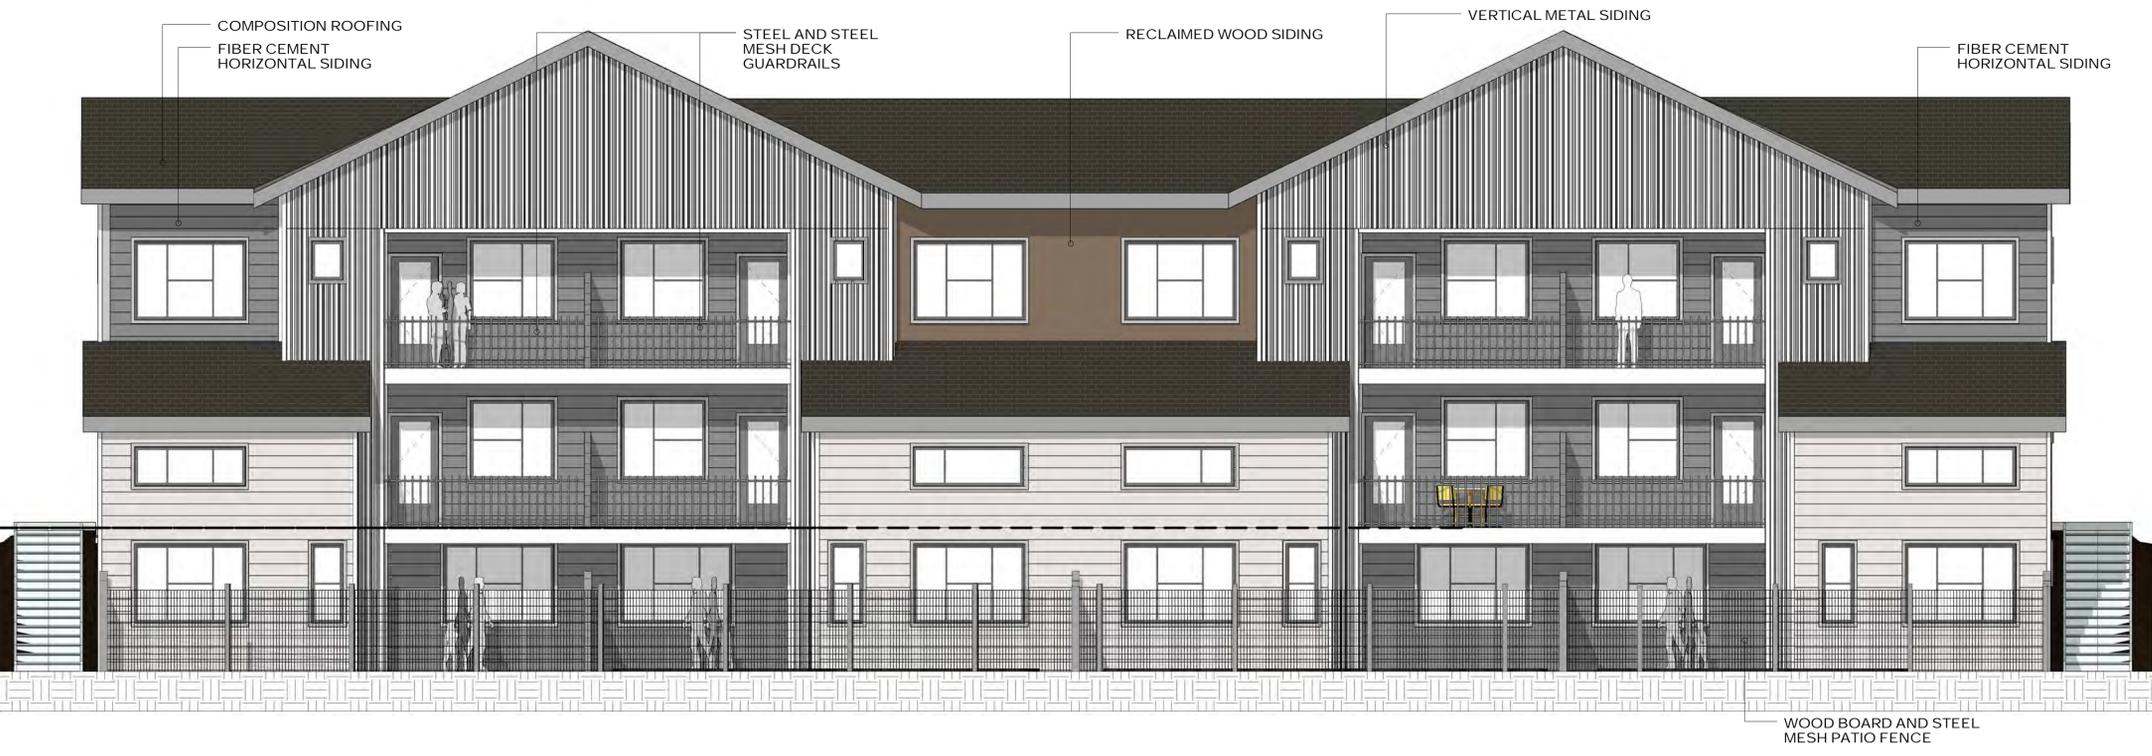
Residential Units 7-14 East Elevation  
Scale 3/16" = 1'-0"

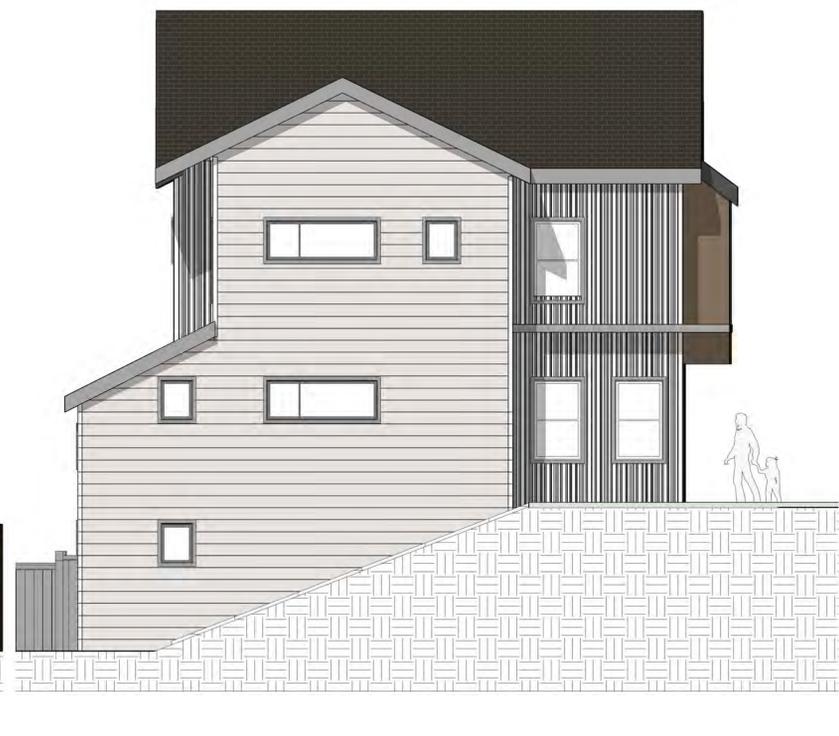
Residential Units 7-14 North Elevation  
Scale 3/16" = 1'-0"

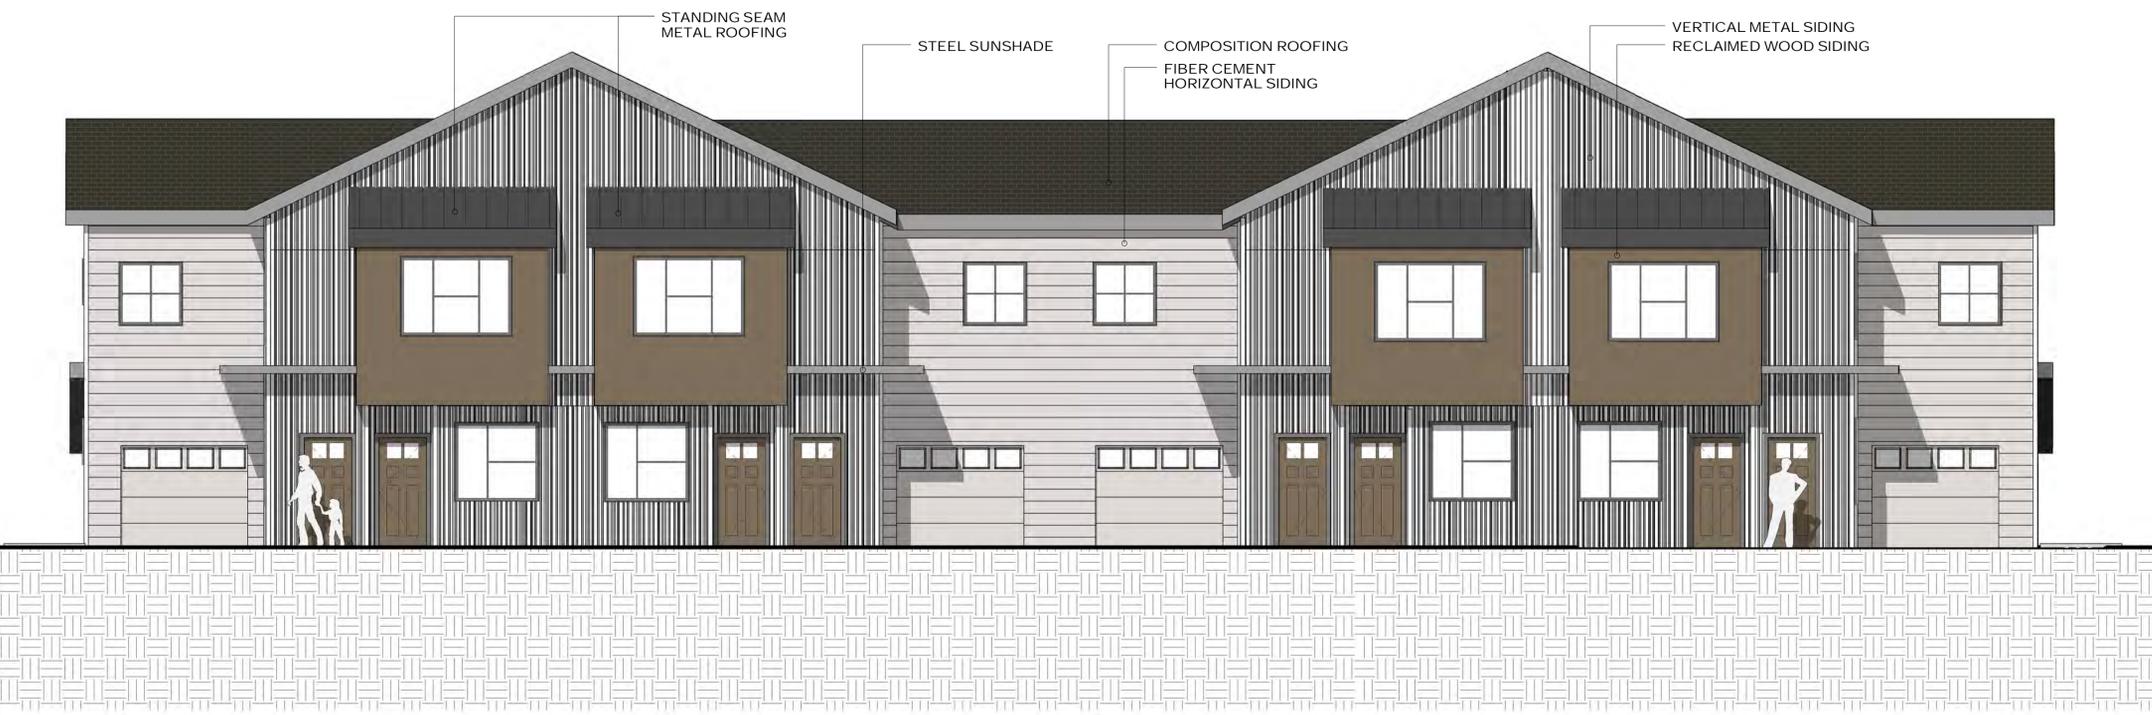
Residential Units 7-14 West Elevation  
Scale 3/16" = 1'-0"

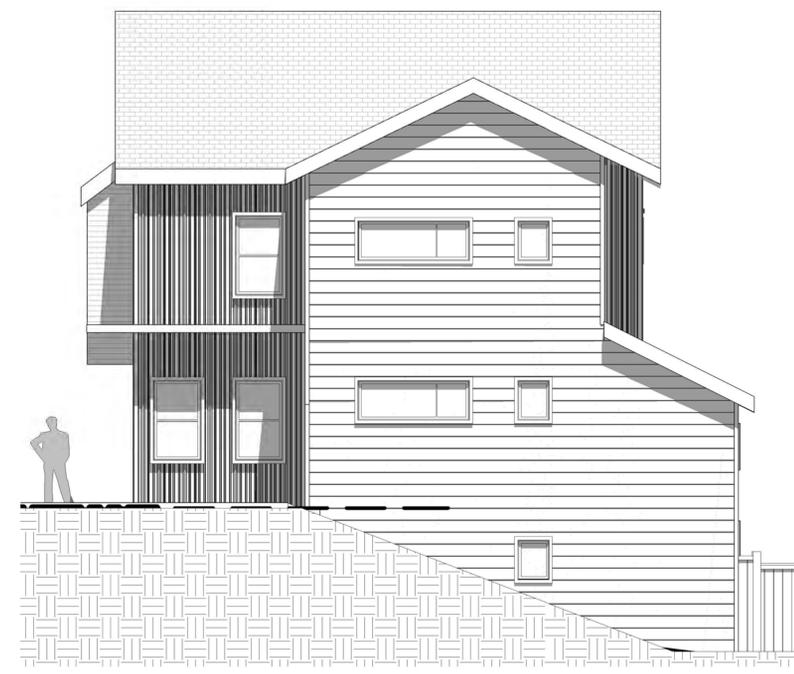
Residential Units 7-14 South Elevation  
Scale 3/16" = 1'-0"
