Biological Assessment / Biological Evaluation Report
for the
East Sand Slough Side Channel Project

Sacramento River Forum
May 16, 2019

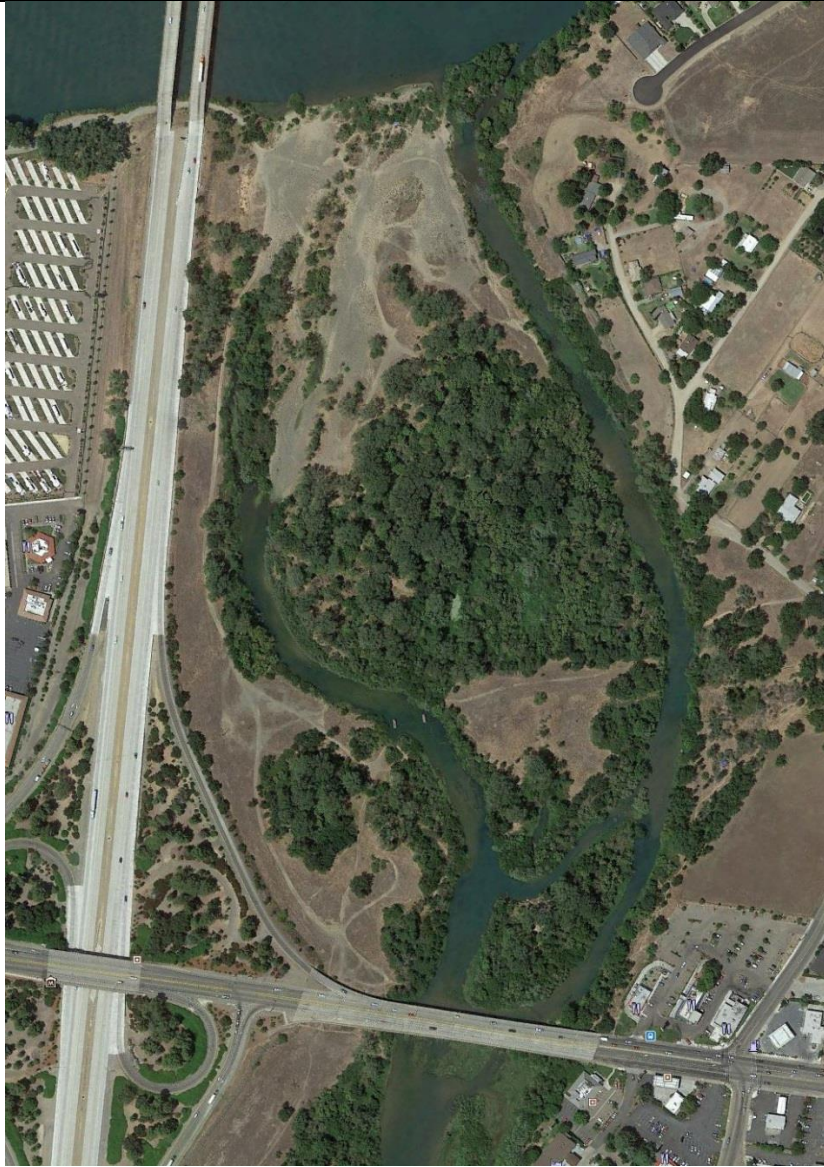
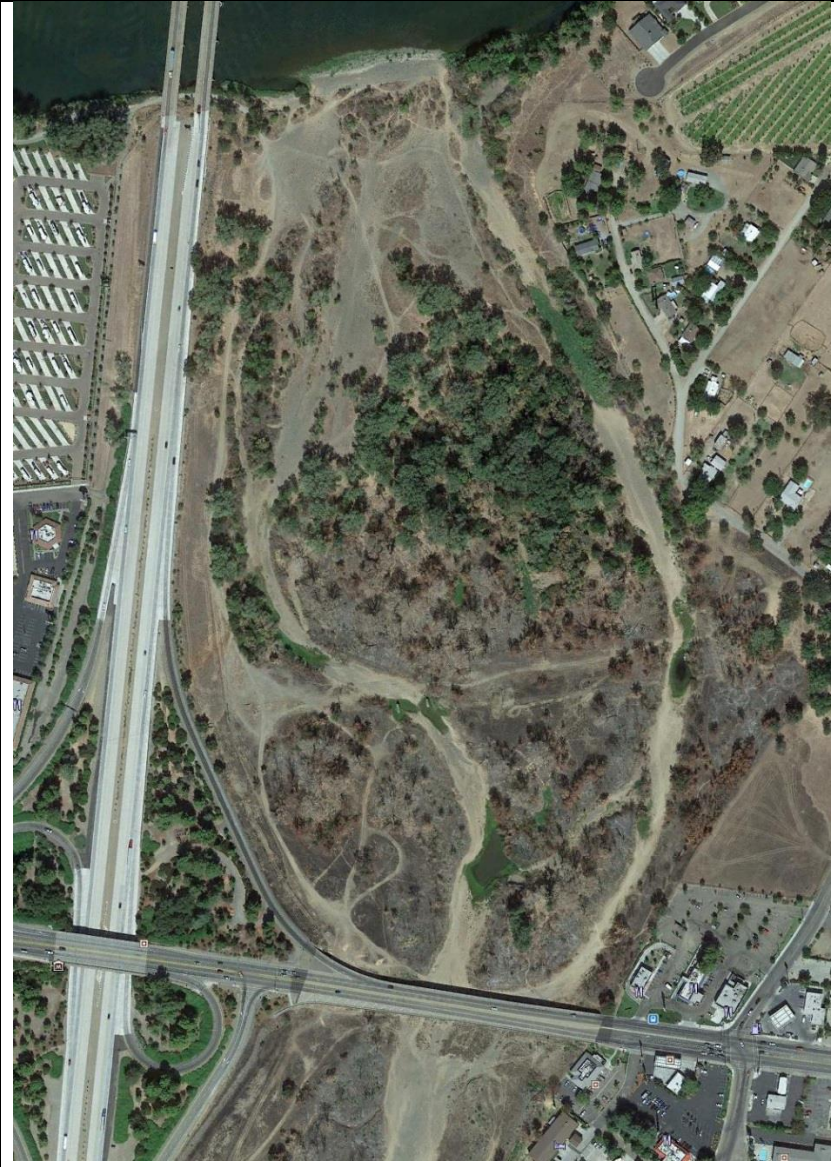
Figure 3. Comparison of Vegetation Changes Following Loss of Lake Red Bluff and 2013 East Sand Slough Fire.

Lake Red Bluff conditions (photo date: 7/27/2011)

Post-2013 Fire (photo date: 8/27/2013)

The Red Bluff Diversion Dam (RBDD) was completed in 1964 to provide irrigation flows for the Tehama-Colusa Canal and Corning Canal. The dam raised the upstream water elevation, creating 'Lake Red Bluff' which led to the increased growth of riparian forest within the slough due to a higher water table. In 2011, the dam was decommissioned and the dam gates were permanently raised, lowering the water surface elevation along East Sand Slough. This change stressed and killed some of the riparian vegetation along the slough. A wildfire in June 2013 within East Sand Slough burned many of the trees and riparian vegetation throughout the northern half of the slough (Resource Conservation District of Tehama County 2017). Figure 3 shows imagery of the northern slough both during Lake Red Bluff Conditions and following the 2013 fire. Following the 2013 fire, burned areas were quickly colonized by annual grasses and early-successional shrubs such as blue elderberry, box elder, and arroyo willow. Remnant patches of riparian forest and woodland remain on the uplands north of Antelope Boulevard.

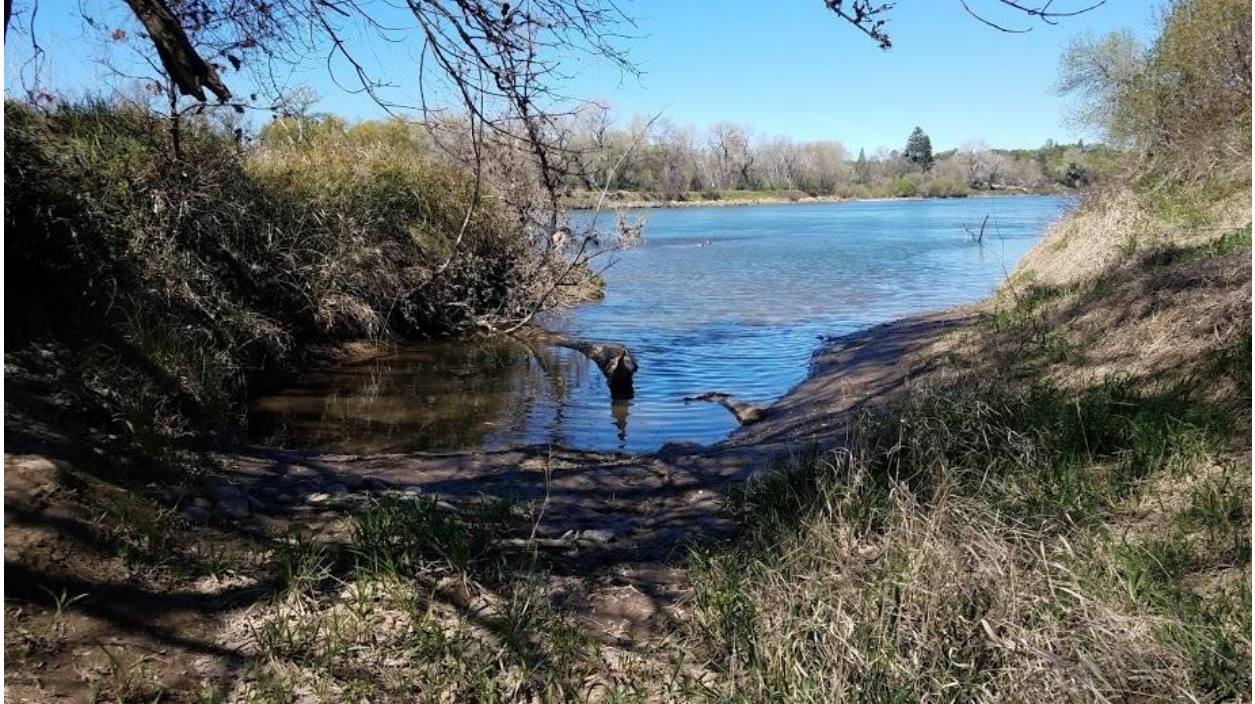
Figure 1. The primary inlet into the slough from the Sacramento River. Photo date: March 28, 2018.

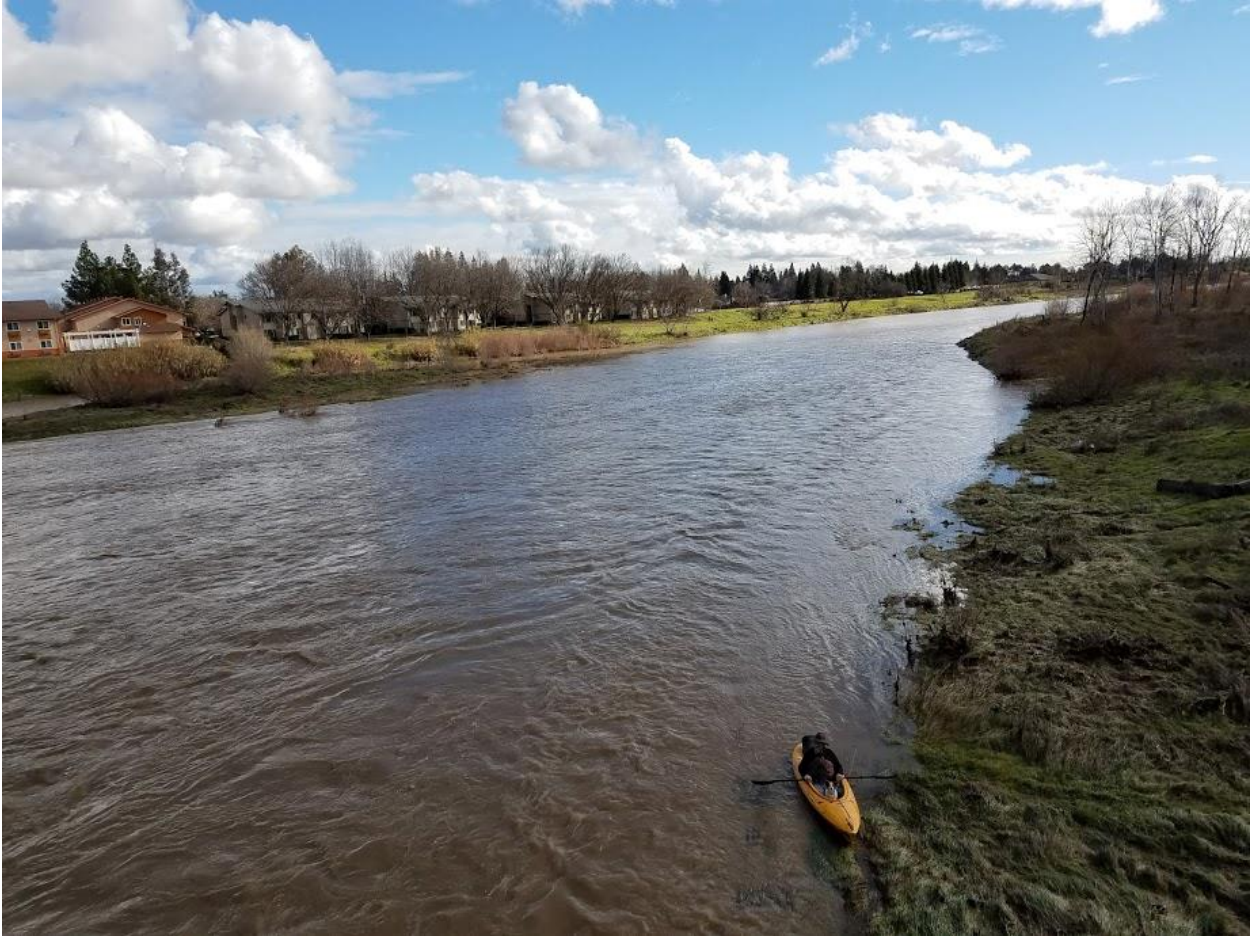
Figure 16. A photo looking south from Antelope Blvd taken on January 11, 2017. Flows on along the Sacramento River were measured near 9,637 CFS at the Bend at the time this photo was taken. The peak flow was 13,172 CFS at 4am that morning.

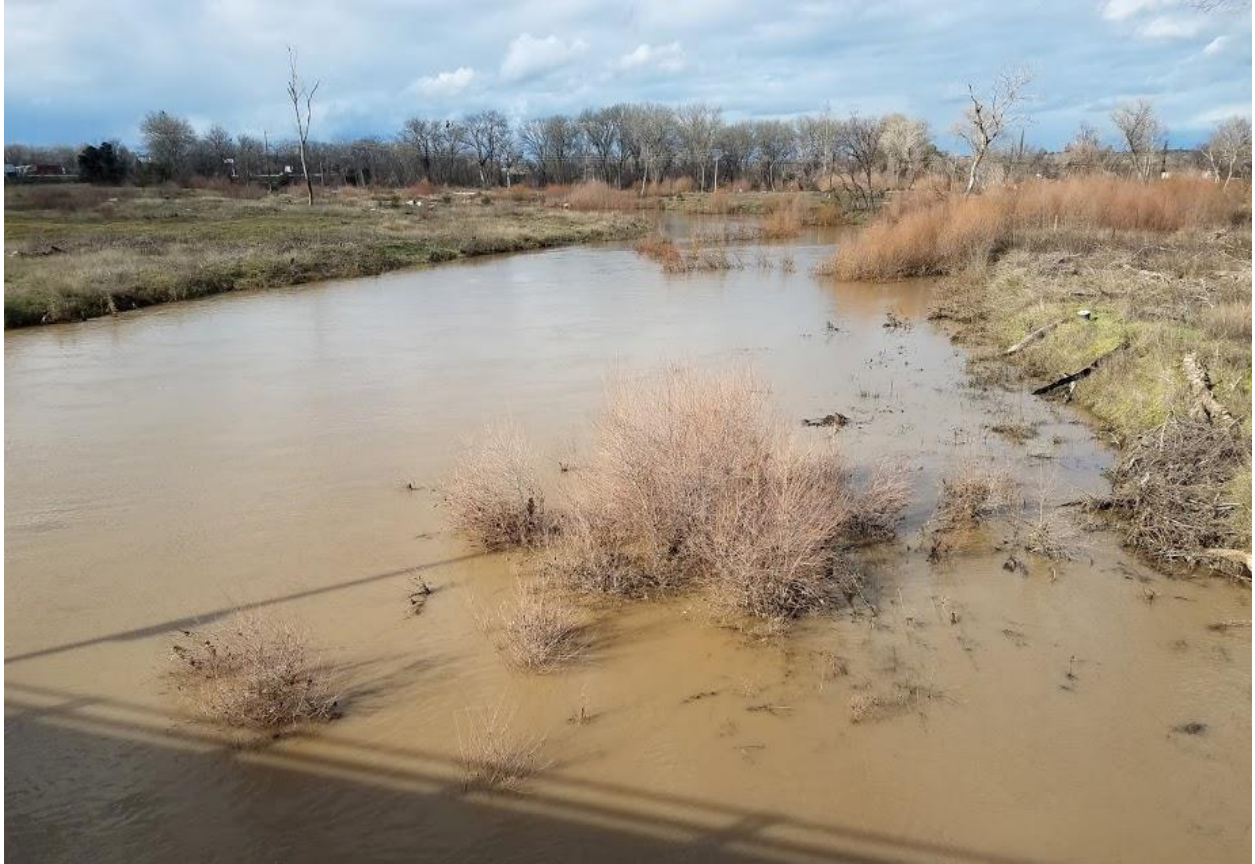
Figure 17. A photo looking north from Antelope Blvd taken on January 11, 2017. Flows on along the Sacramento River were measured near 9,637 CFS at the Bend at the time this photo was taken. The peak flow was 13,172 CFS at 4am that morning.

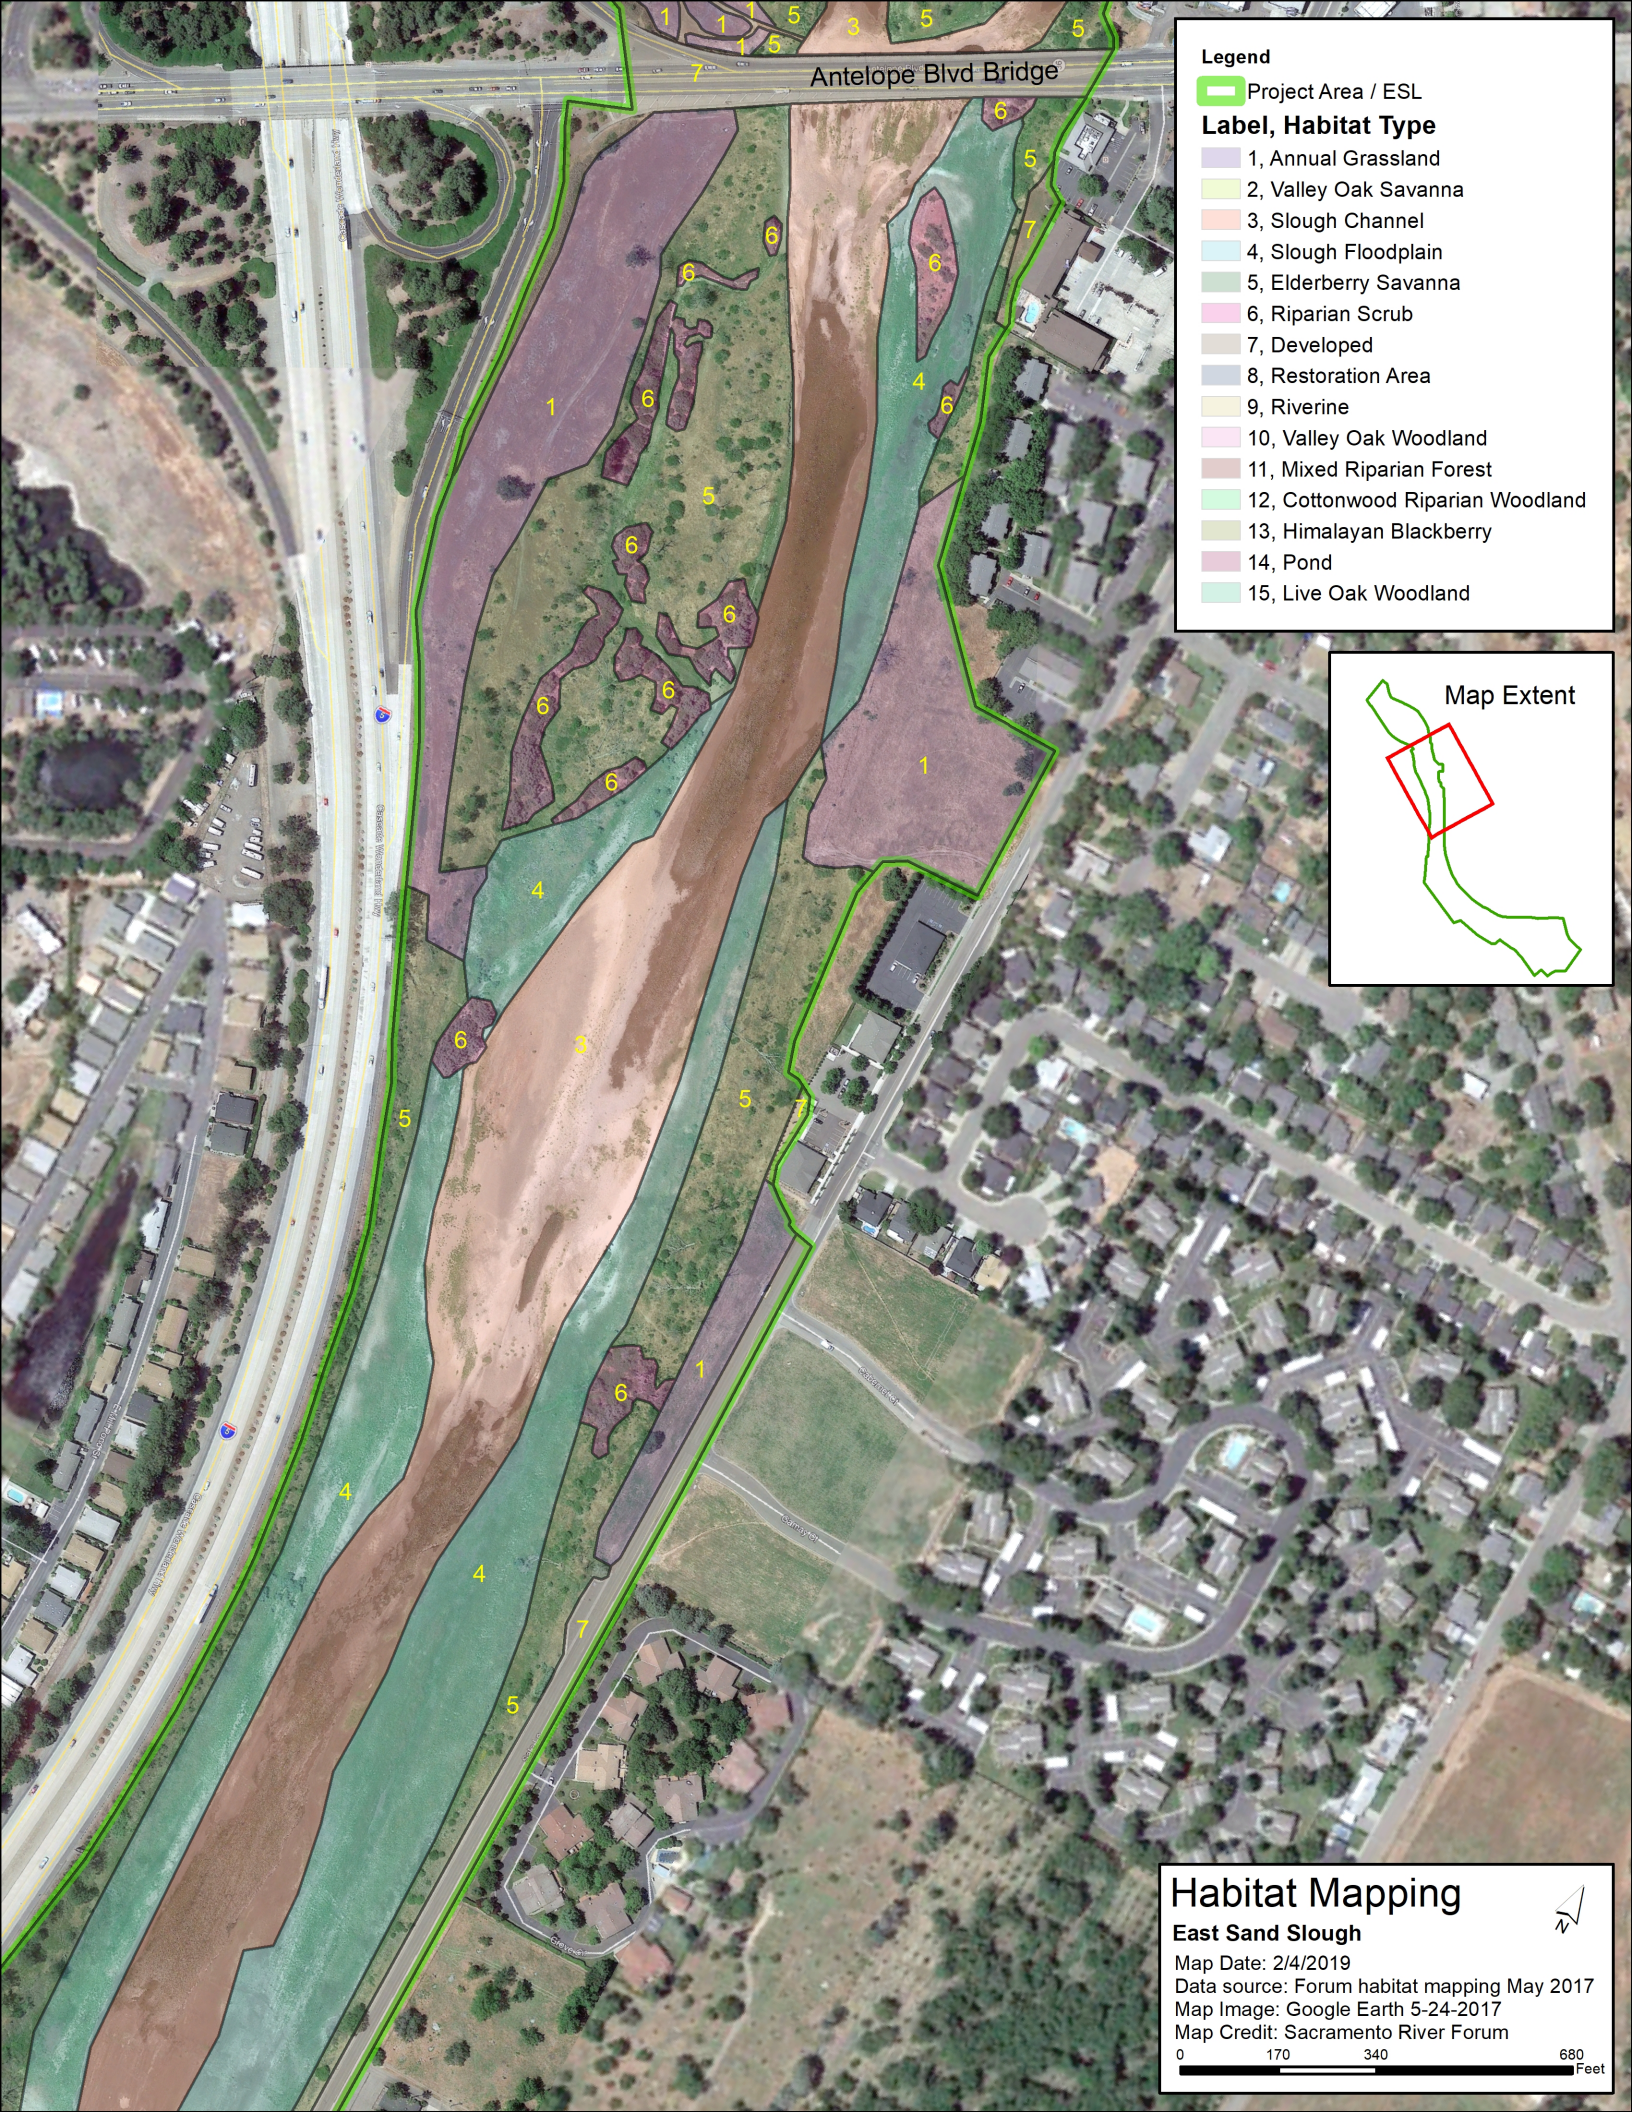
Habitat Mapping

- Project Area / ESL
- Label, Habitat Type**
- 1, Annual Grassland
- 2, Valley Oak Savanna
- 3, Slough Channel
- 4, Slough Floodplain
- 5, Elderberry Savanna
- 6, Riparian Scrub
- 7, Developed
- 8, Restoration Area
- 9, Riverine
- 10, Valley Oak Woodland
- 11, Mixed Riparian Forest
- 12, Cottonwood Riparian Woodland
- 13, Himalayan Blackberry
- 14, Pond
- 15, Live Oak Woodland

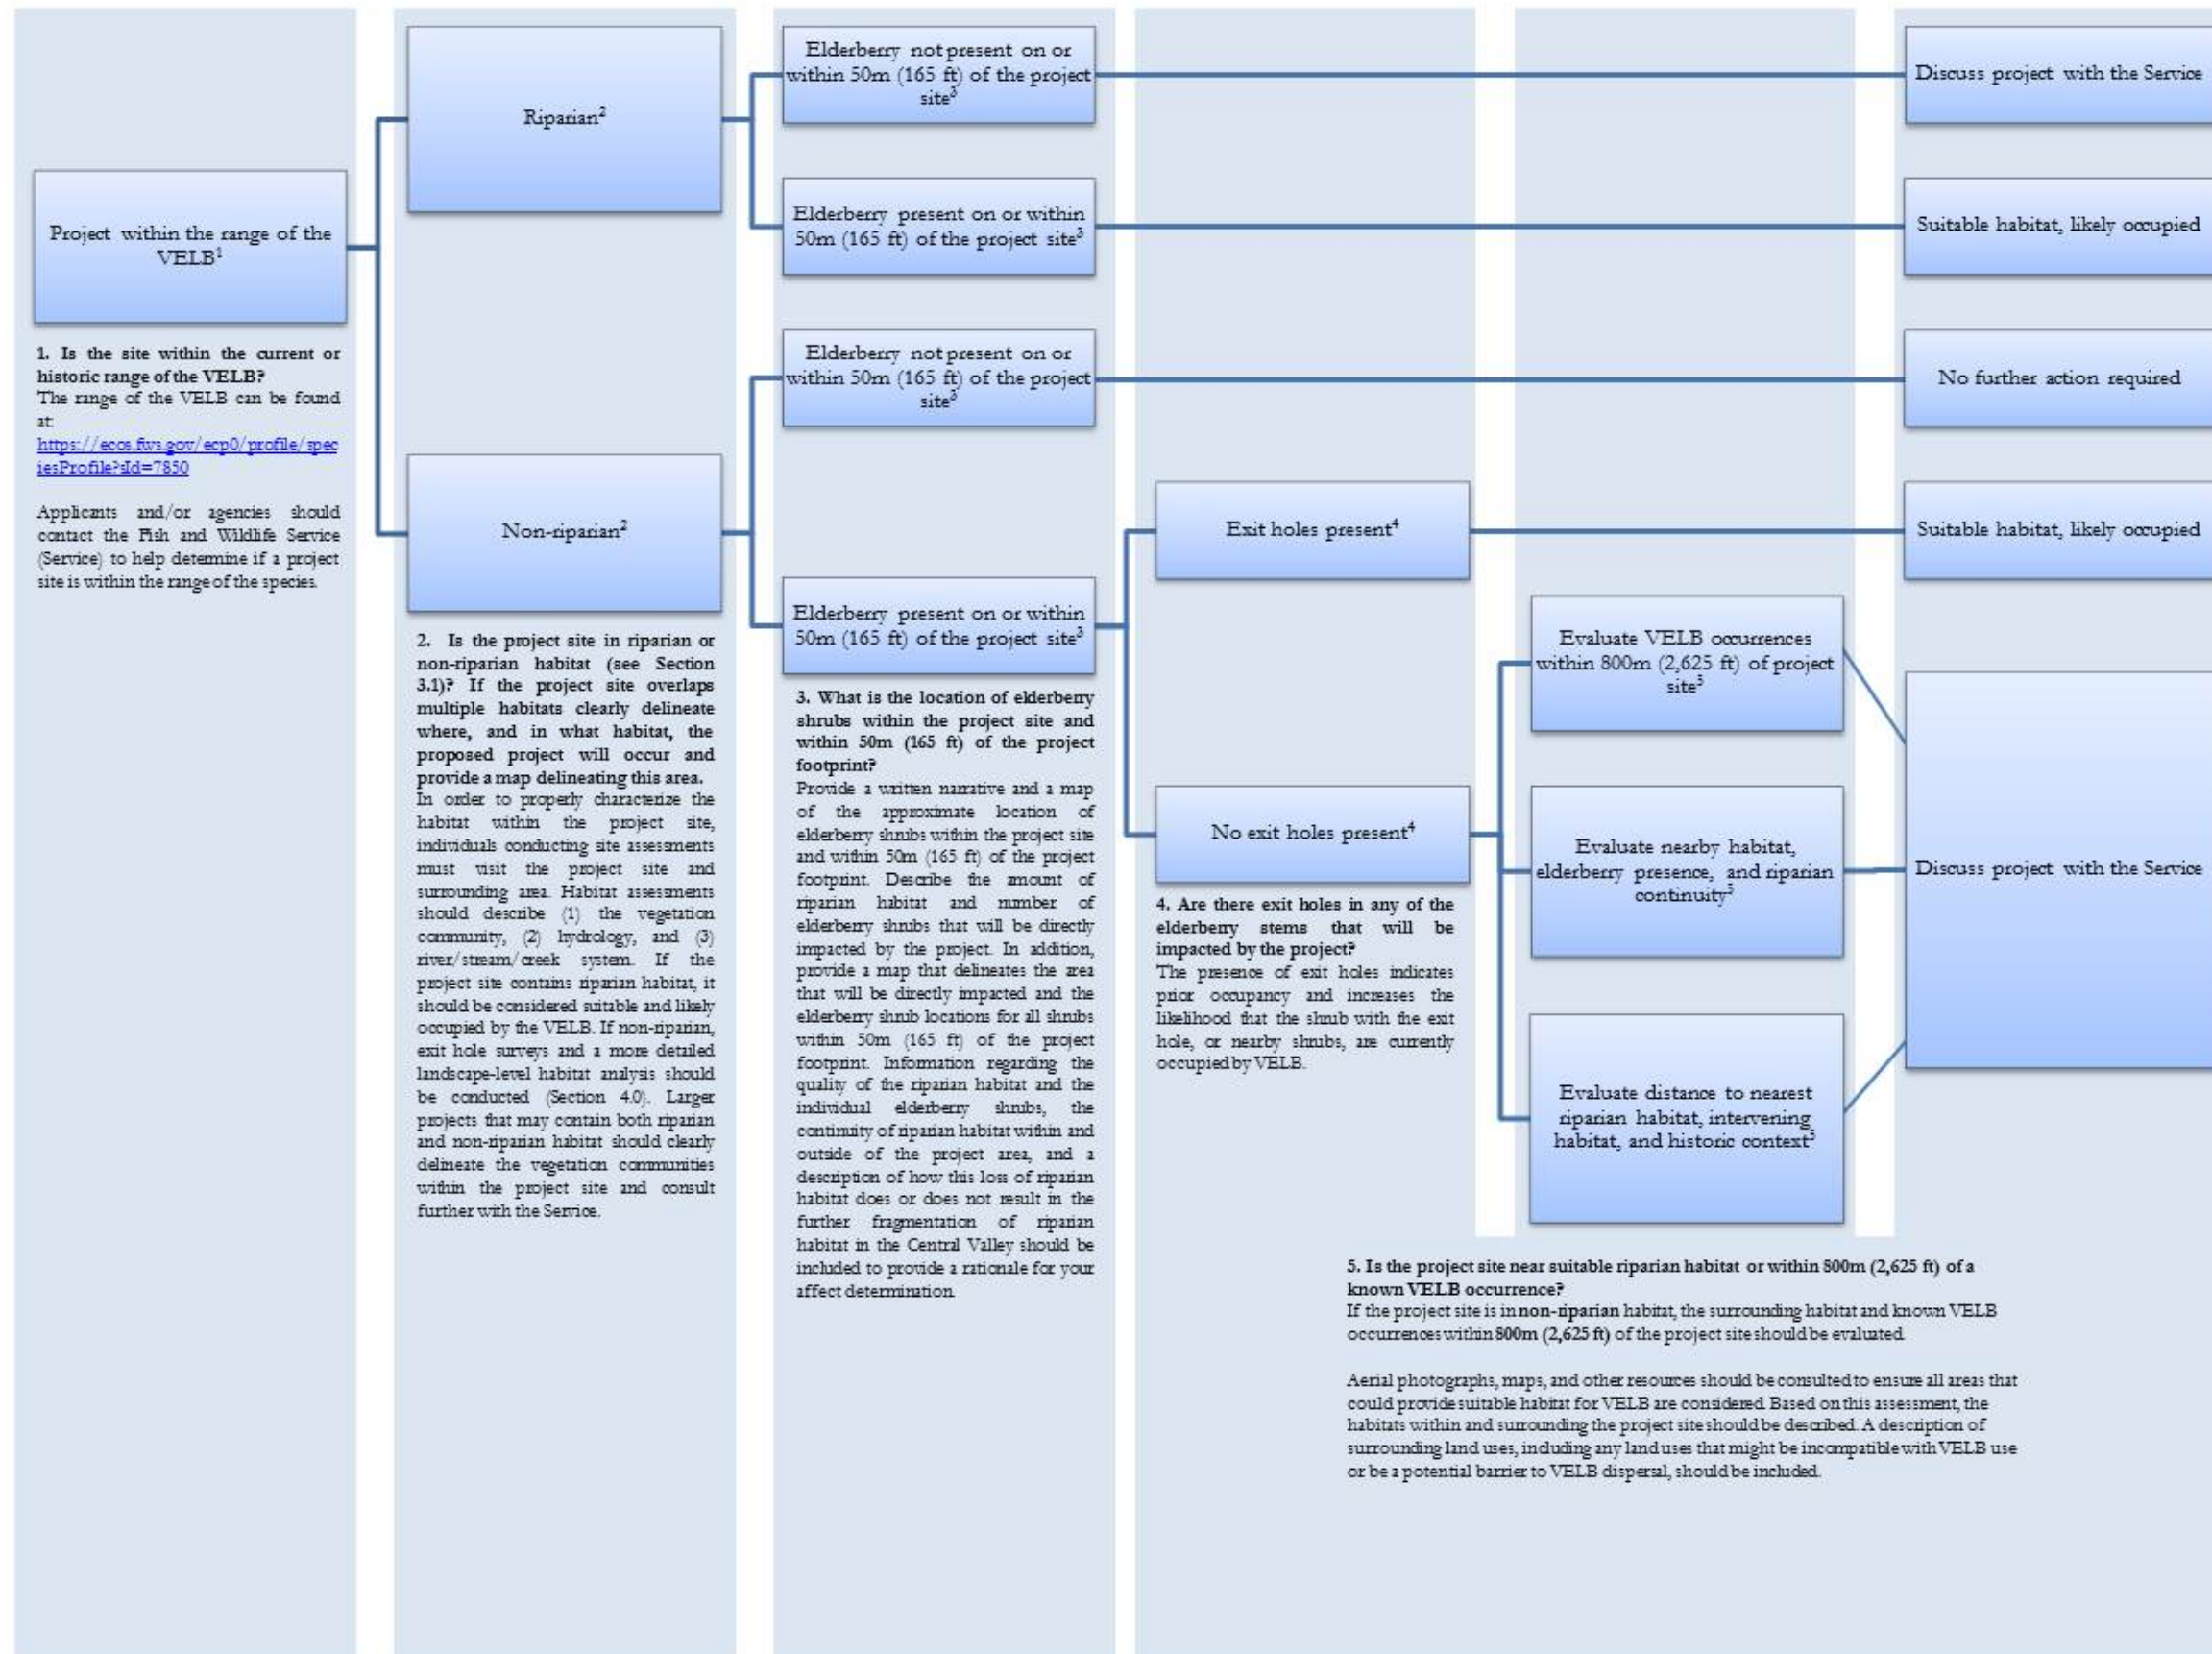
Figure 2. Decision tree to determine the likelihood of a particular elderberry shrub being occupied by valley elderberry longhorn beetle.

1. Is there a riparian area, elderberry shrubs, or known VELB records within 800 meters (2,526 feet) of the proposed project?
Isolated, non-riparian elderberry clumps are less likely to be occupied or become colonized by VELB and those beyond 800 meters (2,526 feet) from the nearest elderberry clump become increasingly less likely to be occupied. Therefore, a qualified biologist can assess the distance of the elderberry shrub from the nearest riparian area, elderberry shrub, and known occupied elderberry location.

2. Was the site continuous with a historical riparian corridor?
Fragmentation of riparian corridors in the Central Valley has resulted in the isolation of elderberry shrubs or clusters that may provide important linkages between or within riparian corridors. A qualified biologist can evaluate the project location in the context of the historical riparian system. Isolated elderberry clumps that were part of a historic riparian vegetative community may still support VELB.
