### 3.1 Database Research and Literature Review

## 4 Site Survey

Proposed Packwood Creek Bridge

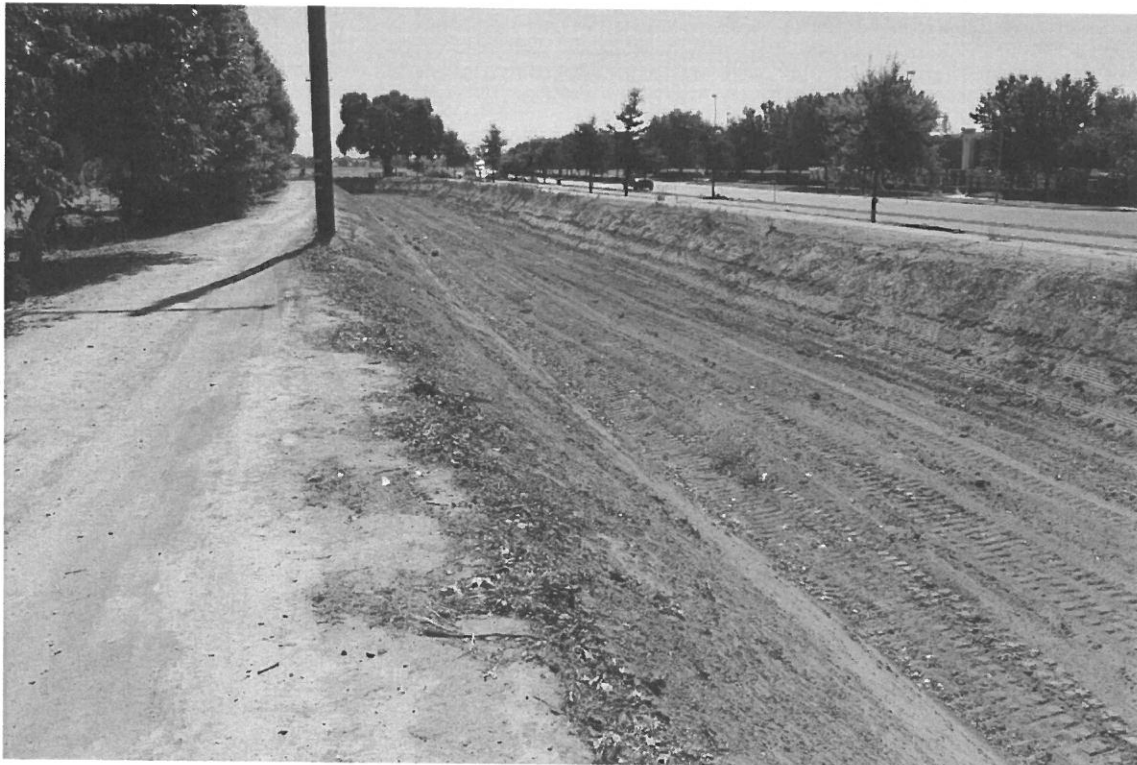
FIGURE 1 : TYPICAL CREEK CONDITIONS AFTER REGULAR MAINTENANCE. VIEW LOOKING EAST, CAMERON AVE. TO THE RIGHT. (PHOTO TAKEN JULY 23, 2016)

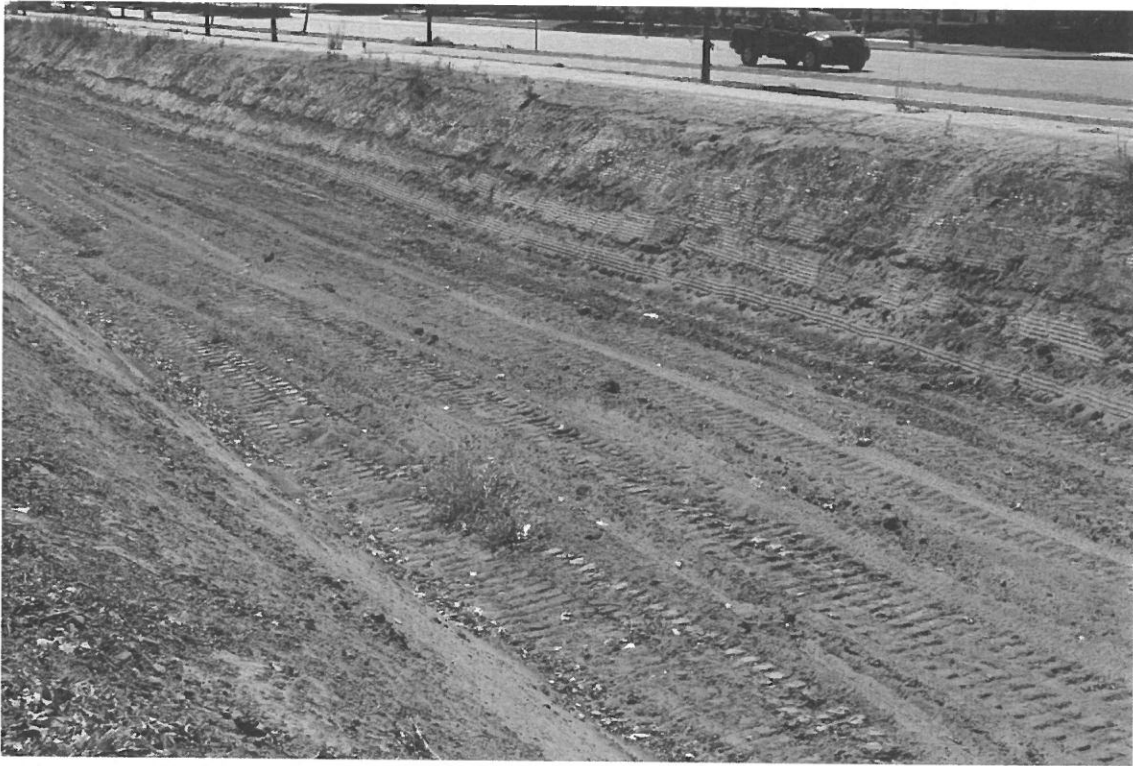
FIGURE 2 : TYPICAL CREEK CONDITIONS AFTER REGULAR MAINTENANCE. VIEW CLOSE TO PROPOSED BRIDGE CROSSING. (PHOTO TAKEN JULY 23, 2016)

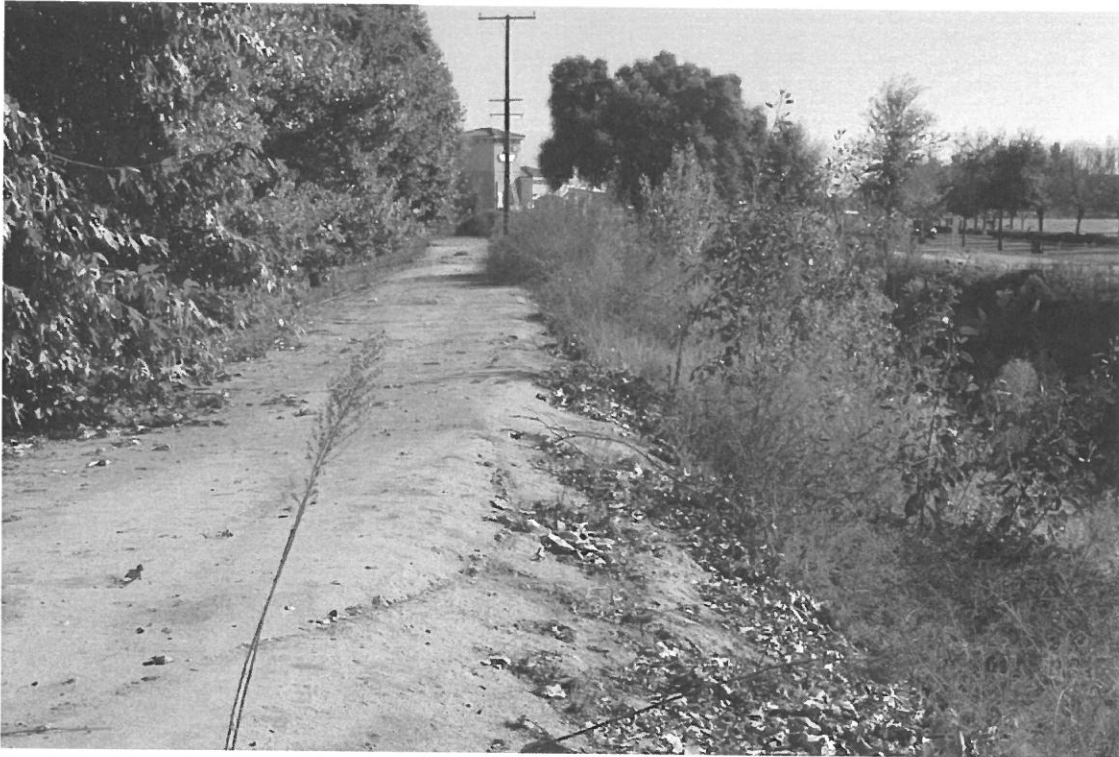
FIGURE 4 : CREEK WITH VEGETATION IN BETWEEN MAINTENANCE PERIOD. VIEW LOOKING EAST. (PHOTO TAKEN OCTOBER 22, 2017)

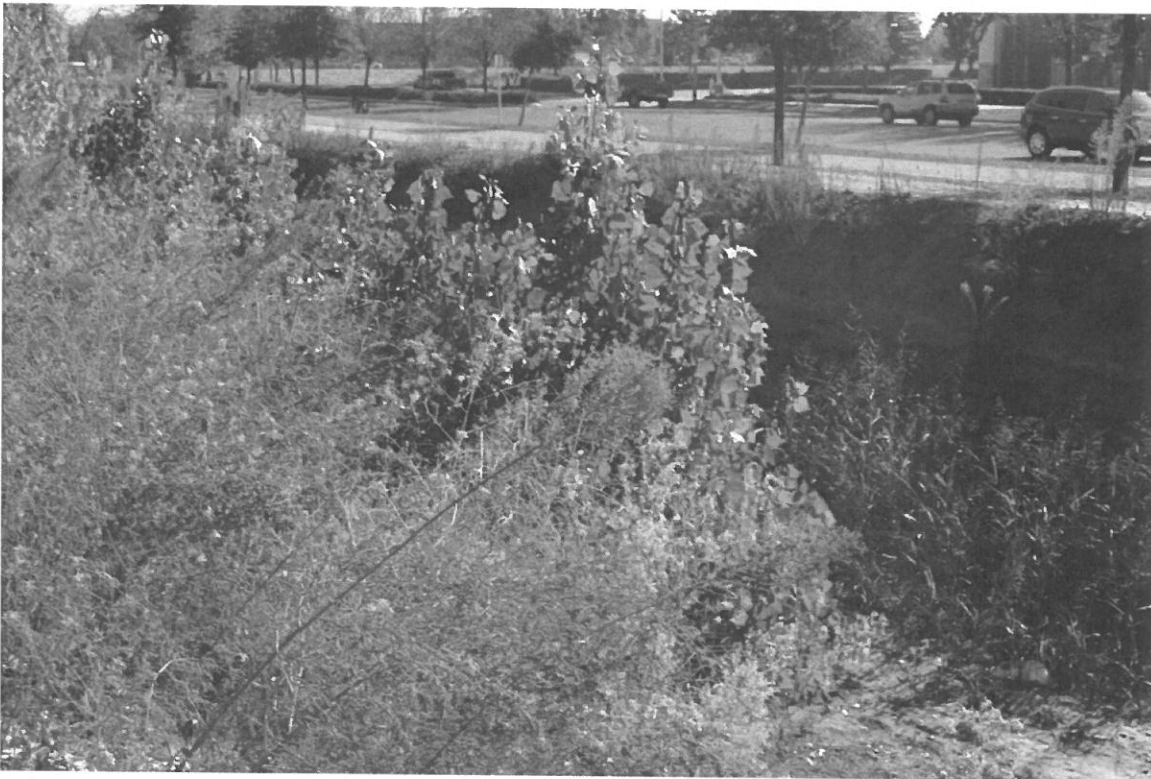
FIGURE 5 : CREEK IN BETWEEN MAINT. PERIOD WITH COTTONWOOD SUCKERS. VIEW JUST EAST OF PROPOSED BRIDGE CROSSING. (PHOTO TAKEN OCTOBER 22, 2017)

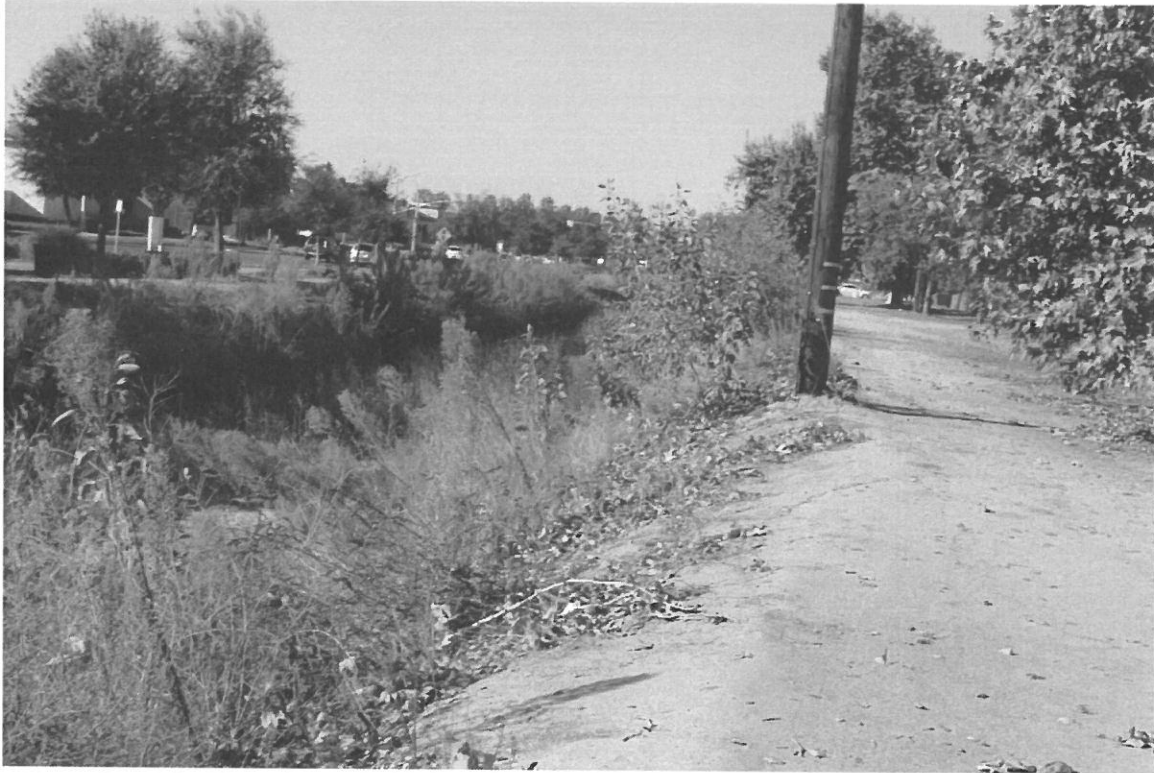
FIGURE 6 : CREEK WITH VEGETATION IN BETWEEN MAINT. PERIOD. VIEW LOOKING WEST TOWARDS MOONEY BLVD. (PHOTO TAKEN OCTOBER 22, 2017)

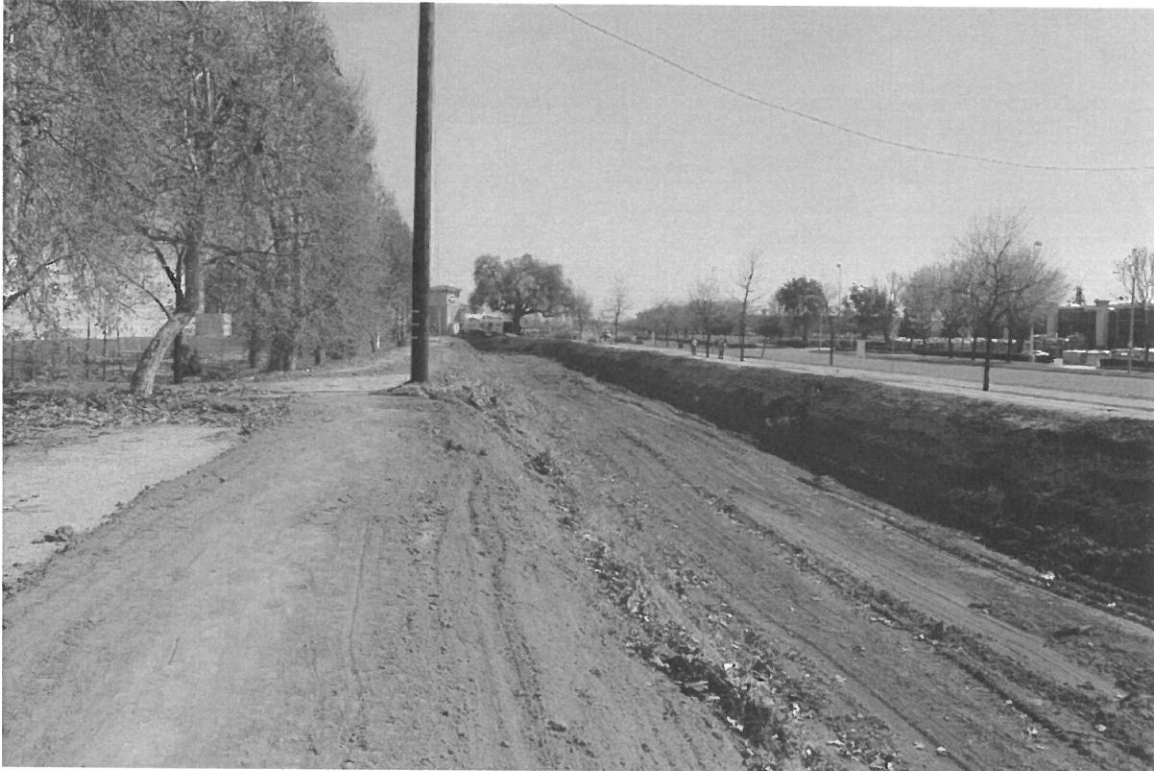
FIGURE 7 : VIEW LOOKING EAST NEAR PROPOSED BRIDGE LOCATION. (PHOTO TAKEN MARCH 9, 2018)

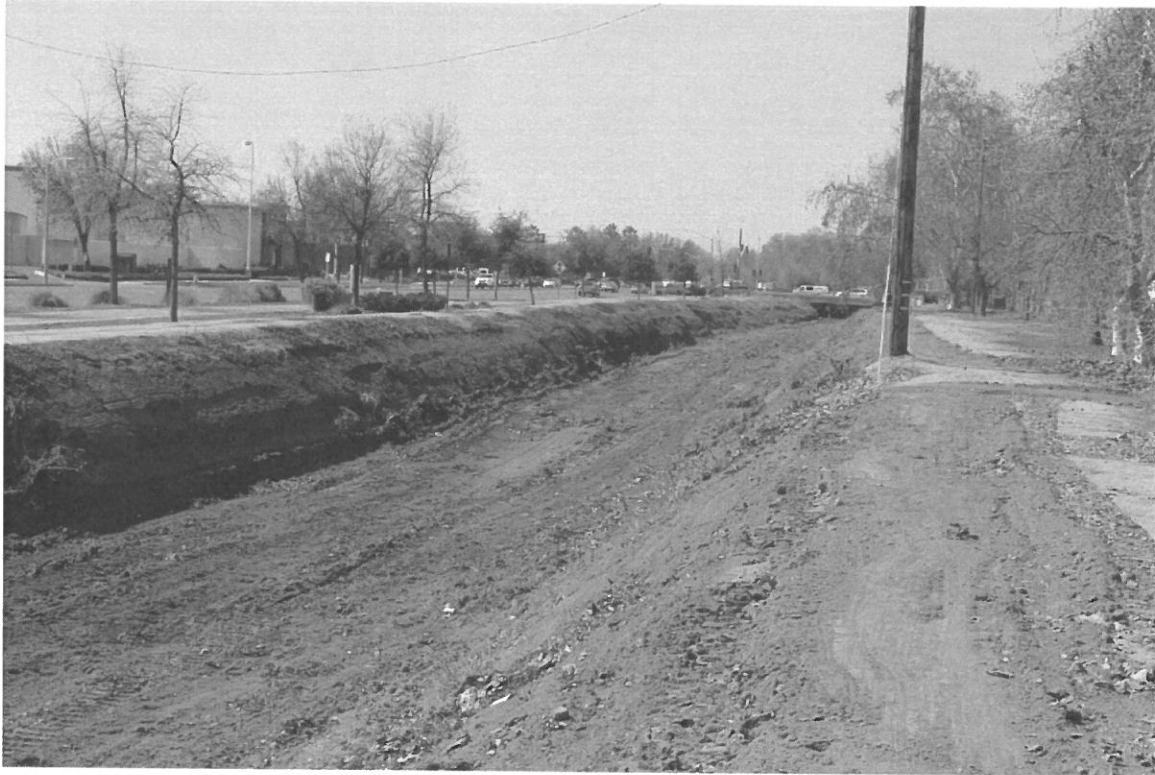
FIGURE 8 : VIEW LOOKING WEST TOWARDS MOONEY BLVD. NEAR PROPOSED BRIDGE LOCATION. (PHOTO TAKEN MARCH 9, 2018)
