Historical Report

Our Lady of Mt. Lebanon Project Historical Resources Technical Report

Architectural
Resources Group

June 15, 2020

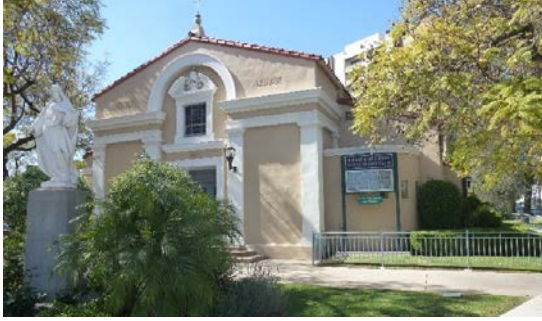
Front façade of the cathedral, 2016. Note the replaced window above the primary door and the added rounded bay to the right of the primary entrance volume, compared to the historic image at right.

These alterations, in particular the addition of the rounded bays at the primary façade and the replacement of original windows with stained, leaded glass windows, have changed the austere appearance of the cathedral as designed by its architect in the late-1930s. Therefore, the cathedral's overall style is still discernable through its intact form, massing, and major elements, but its integrity of design has been diminished by alterations listed above.

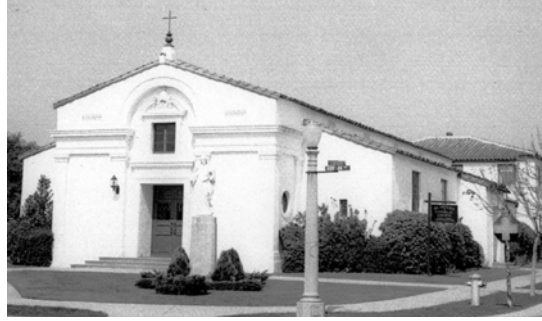
Front façade of the cathedral, circa 1937 (courtesy Archdiocese of Los Angeles Archives, via www.flickr.com)

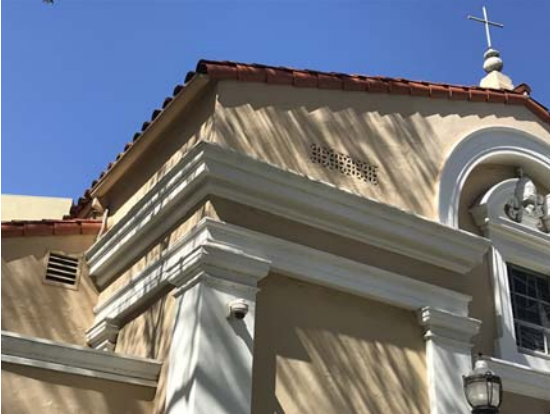
Cathedral, primary (south) façade, exterior details (ARG, 2018)

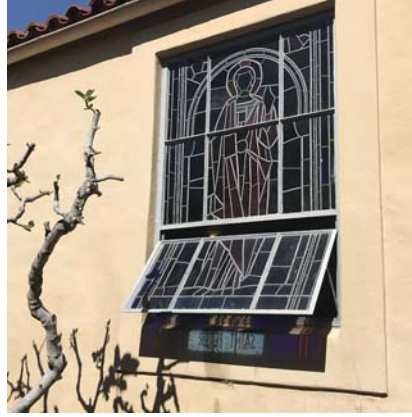
Cathedral, view of typical non-original stained glass/ steel window (ARG, 2018)

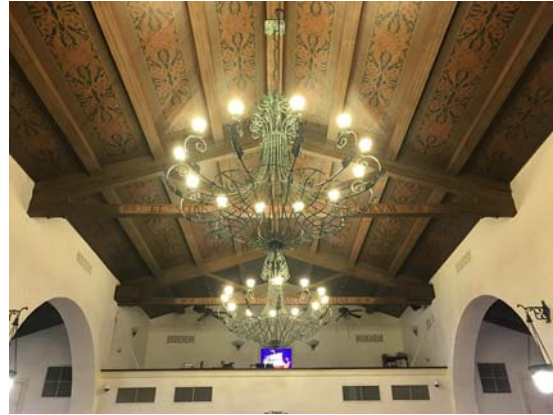
Cathedral interior, view southeast of original stenciled/ painted ceiling and trusses at nave (ARG, 2018)

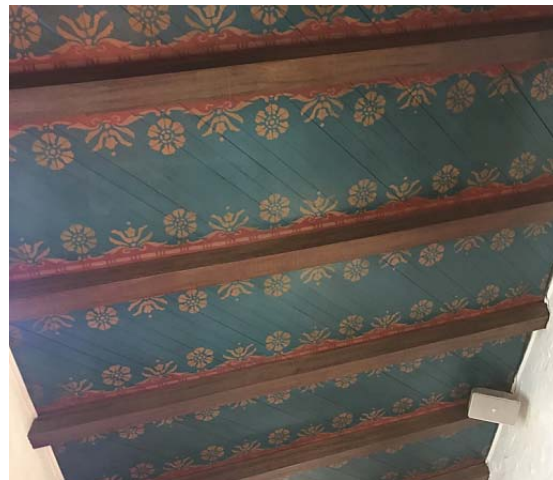
Cathedral interior, view of original stenciled/painted ceiling at side aisle (ARG, 2018)

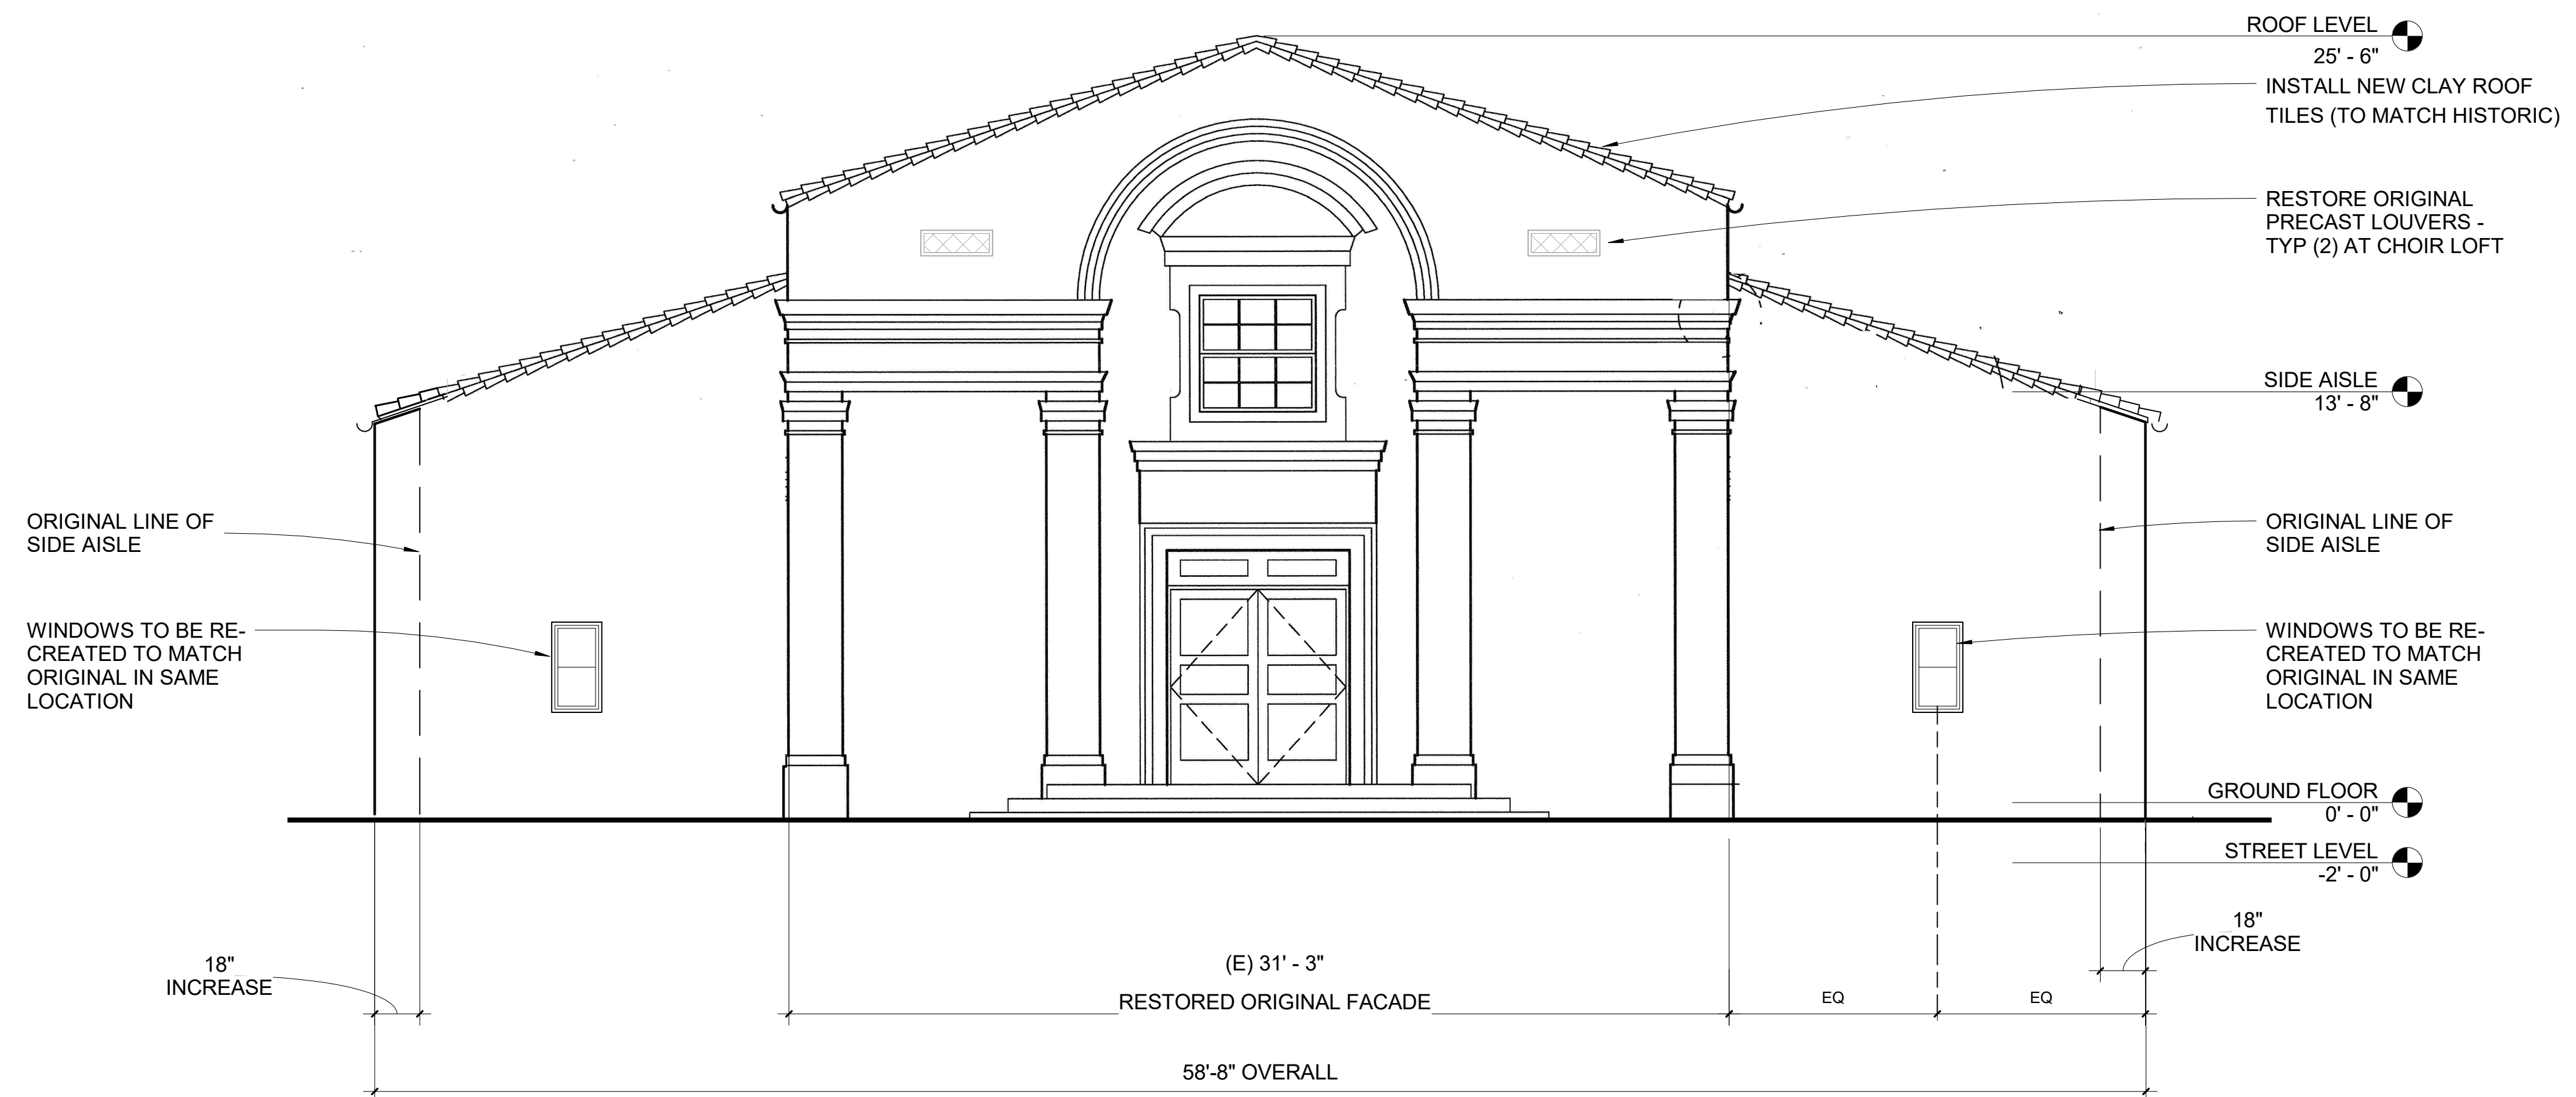
FRONT FACADE

(E) STATUE TO BE REMOVED AND STORED OFF SITE

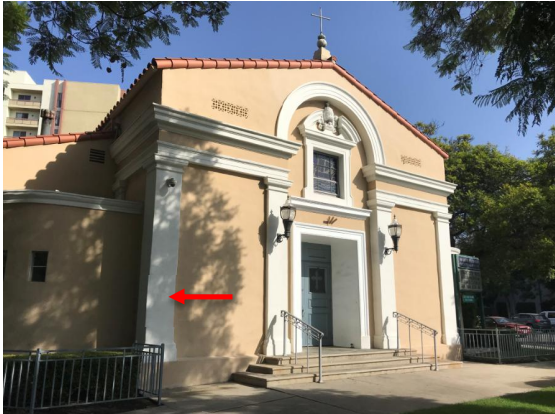
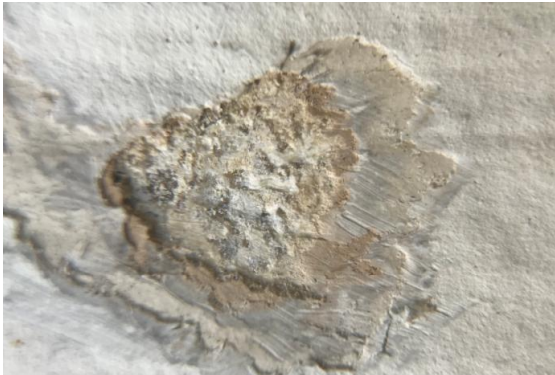
Sample No.	03	Location:	Door trim at main entry, south elevation	
Substrate:	Stucco	Magnification:	30x	<input type="checkbox"/> Mounted <input checked="" type="checkbox"/> Unmounted
