**PHASE I ENVIRONMENTAL SITE ASSESSMENT
CERES GATEWAY COMMERCIAL BUILDING DEVELOPMENT
SW QUADRANT MITCHELL & SERVICE ROADS
CERES, CALIFORNIA**

CTE JOB NO. 25-0846E

JUNE 20, 2019

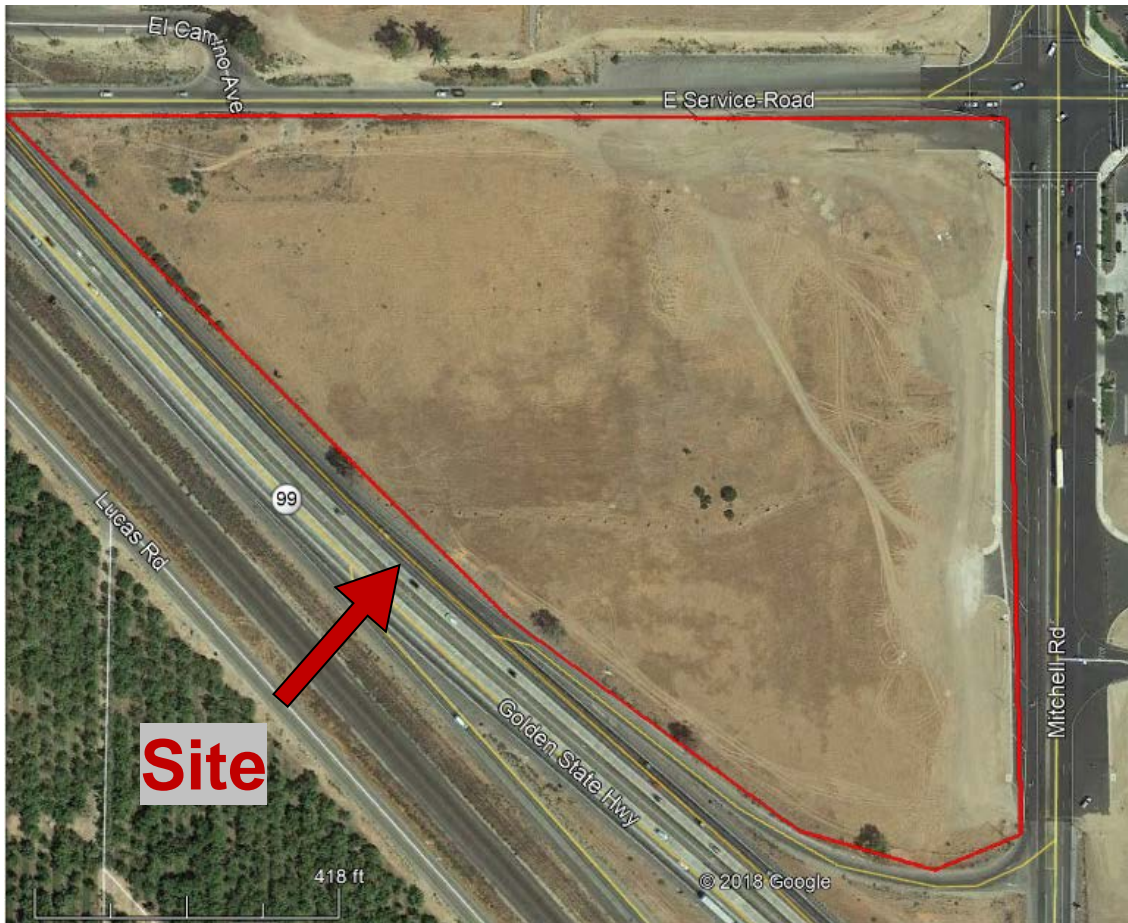
At the time of CTE's field reconnaissance, the Site was undeveloped dry grassy ground cover. The Site generally sloped toward the west-southwest with elevations varying from approximately 93 feet above mean sea level (MSL) in the northeastern portion of the Site to about 92 feet above MSL in the southwestern portion of the parcel. Refer to Google Earth aerial imagery (8/31/2018), below.
