HISTORIC RESOURCES EVALUATION REPORT

**COTTONWOOD SAND MINE PROJECT
SAN DIEGO COUNTY, CALIFORNIA**

PDS2018-MUP-18-023 and PDS2018-RP-18-001

January 2020

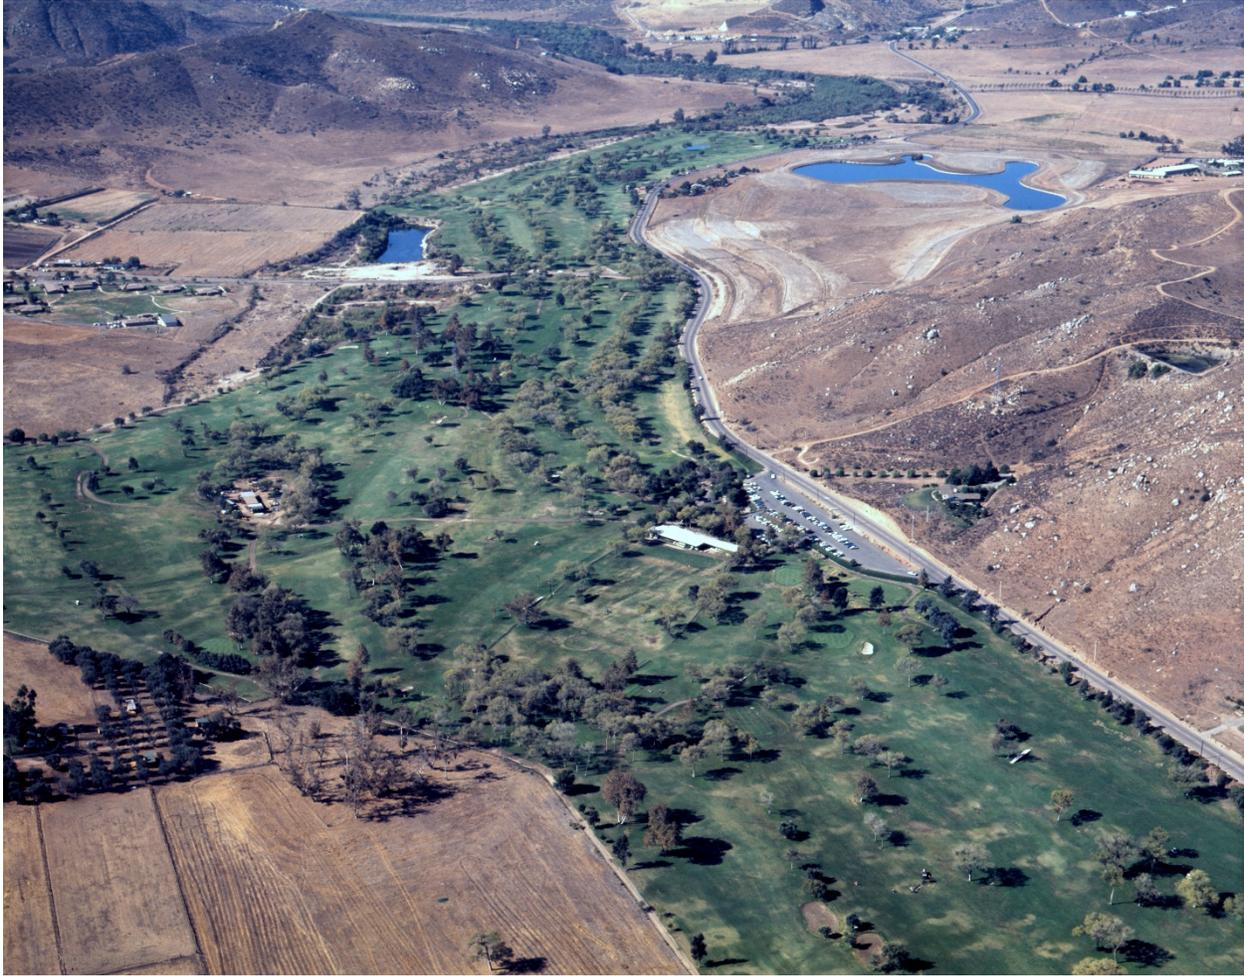
Figure 4. Cottonwood Golf Club Aerial, 1974, facing southwest (UT88:L7265-7, San Diego History Center)

This property is a public golf resort variously referred to as the Cottonwood Golf Club, Cottonwood Golf Course, or Cottonwood Rancho San Diego. It consists of two 18-hole golf courses (The Lakes and Ivanhoe) and associated structures, landscaping, and infrastructure (Figure 4). The clubhouse, parking lot, maintenance facility and Ivanhoe Golf Course were completed by 1964 and were still in use at the time of the current survey. The Lakes Golf Course was complete by 1968, extended to the southwest between 1989 and 1993, and abandoned in 2017; all features remain but most of the landscaping is dead.

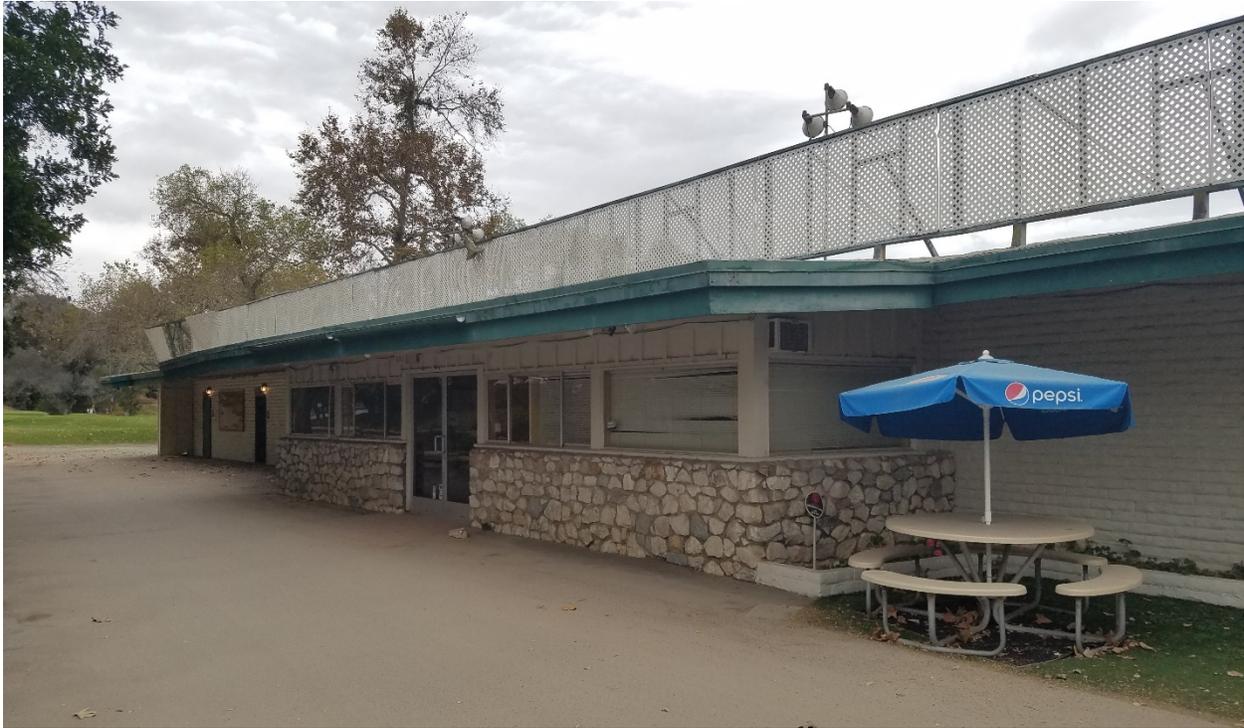
Figure 5. Cottonwood Clubhouse Western Façade, facing northeast (CH-02, 11/19/2019)

A bump-out foyer on the western façade consists of metal-framed fixed and sliding windows above rough stone cladding on either side of aluminum-framed glass double doors (Figure 5). Additional aluminum-framed glass double doors on the south end of the west façade are modern. Additional entrances include single steel doors leading to restrooms, wood paneled doors to the apartment, and aluminum-framed glass doors to the golf shop. Rooftop equipment is screened by white-painted wood lattice.

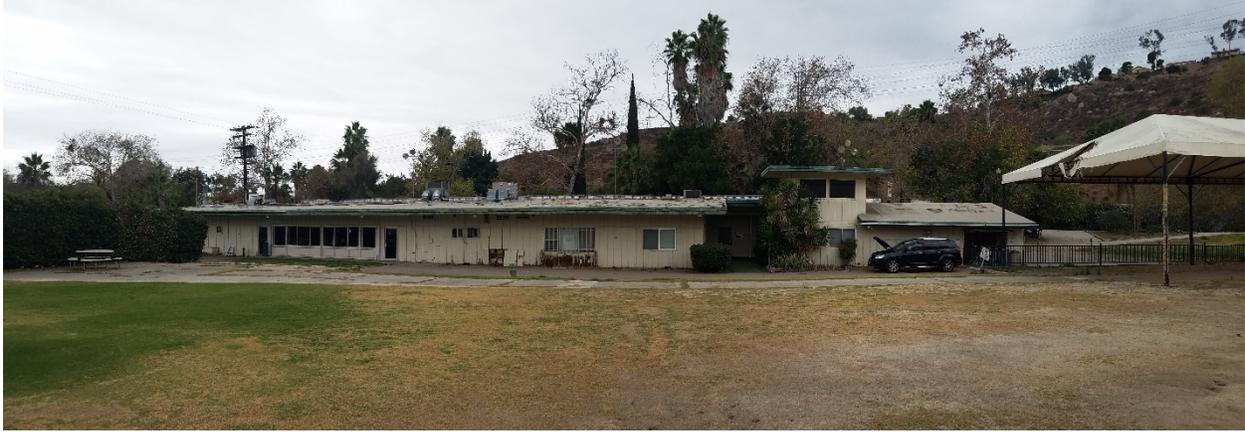
Figure 6. Cottonwood Clubhouse Eastern Façade, with driving range gazebo at right, facing west (CH-15, 11/19/2019)

The eastern extension (1964-1966) has sliding aluminum-framed windows and aluminum-framed glass doors (Figure 6). A large portion of the eastern façade is constructed of picture windows set in a hinged frame, which open the entire wall of the restaurant inside. The northeast extension (1971-1980) has a single-width wooden garage door facing east. A 24' x 24' 'tower' (1971-1980) added a second story to the eastern façade. It has a flat roof with deep overhangs and large fixed picture windows and is accessed by an exterior wooden staircase leading to a wood paneled door. The northern and eastern extensions and tower addition are all clad in vertical wood paneling with narrow batten. The southwestern corner has been extended with simple plywood construction housing a kitchen area.

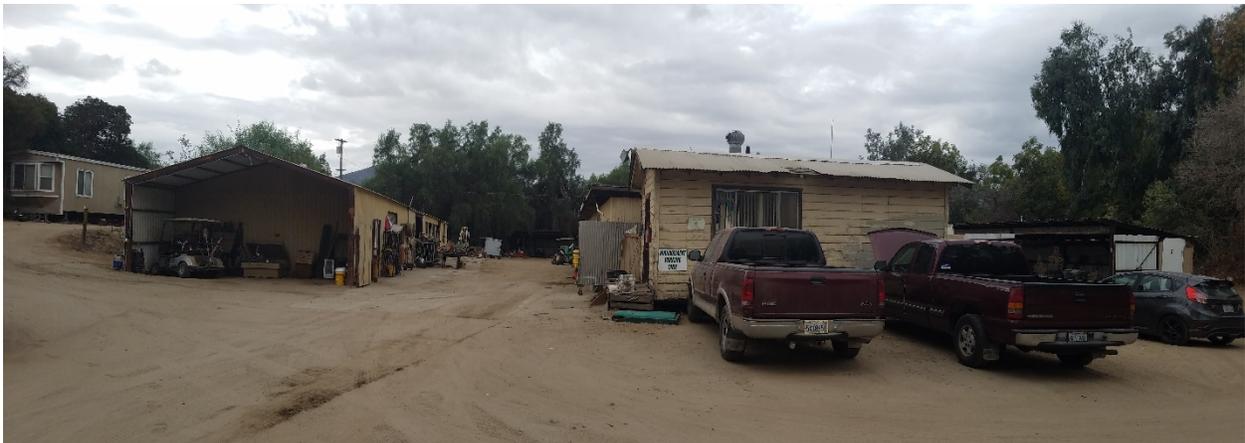
Figure 7. Maintenance Facility, office shack in center, facing southwest (EC-06, 11/19/2019)

South of the clubhouse, near the west end of the Ivanhoe Golf Course, is a facility for golf cart repair and course maintenance (Figure 7). The area is screened by tall trees and consists of three long sheds with open bays, two 60-foot mobile homes, and several small shacks. Scattered around the area are shipping containers, RVs, abandoned vehicles, piles of lumber, and landscape maintenance equipment and supplies.

A shack at the north end of the central sheds serves as an office. It is wood frame construction on concrete pier foundation with wood siding under an end-gabled corrugated metal roof. The structure is in poor condition, with rotted lumber and a sagging porch. The southern row of sheds is modern, in fair condition, with steel roll-up doors and corrugated steel siding and roof over steel frame. The central row of sheds is

corrugated metal roof and siding over wood frame on concrete foundation, in poor condition with rotting lumber and cracked concrete. The northern row is open front, wood frame, with corrugated metal back wall and roof, in poor condition with many roof panels missing.

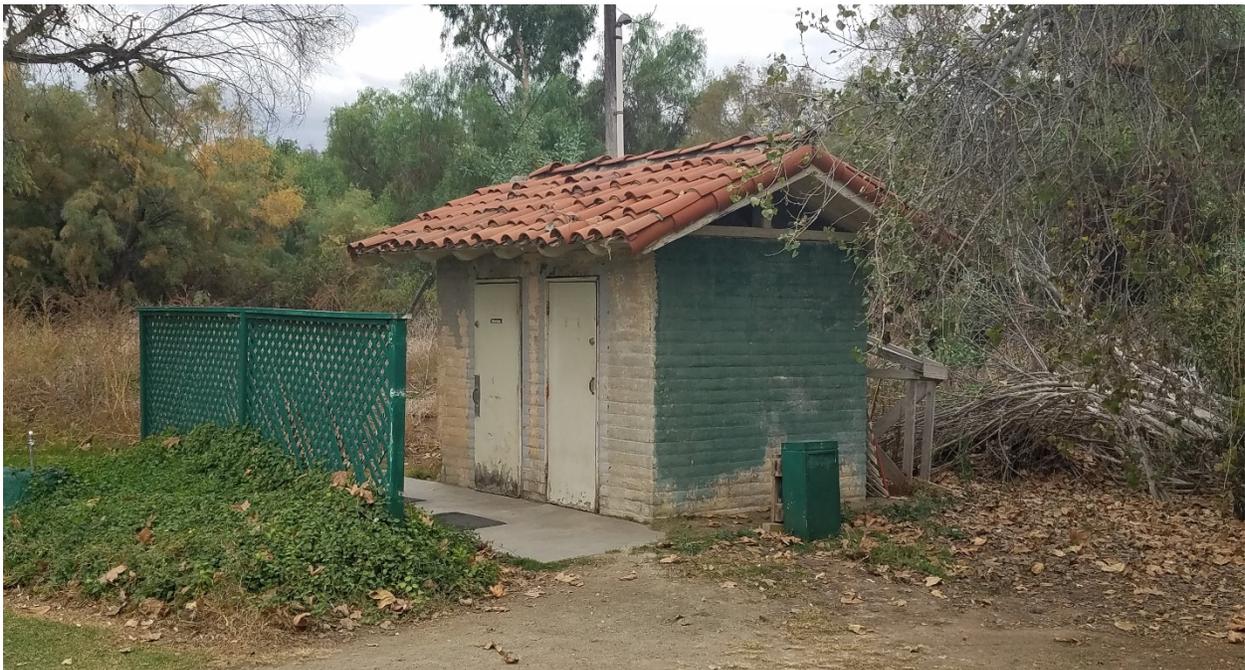
Figure 8. Ivanhoe Golf Course Restroom, facing south (EC-30, 11/19/2019)

The Lakes and Ivanhoe courses each have a small restroom structure (Figure 8). These are both rectangular in plan, with brick construction on slab concrete foundation; red terracotta tile end-gable roof with wide eaves; and two metal doors. The Ivanhoe restroom is in fair condition: the exterior has rotted lumber, missing roof tiles, and rusted door hardware, but the interior has been reconstructed with modern tile and fixtures. The Lakes restroom is in poor condition, with broken and missing roof tiles, foundation water damage, and graffiti.

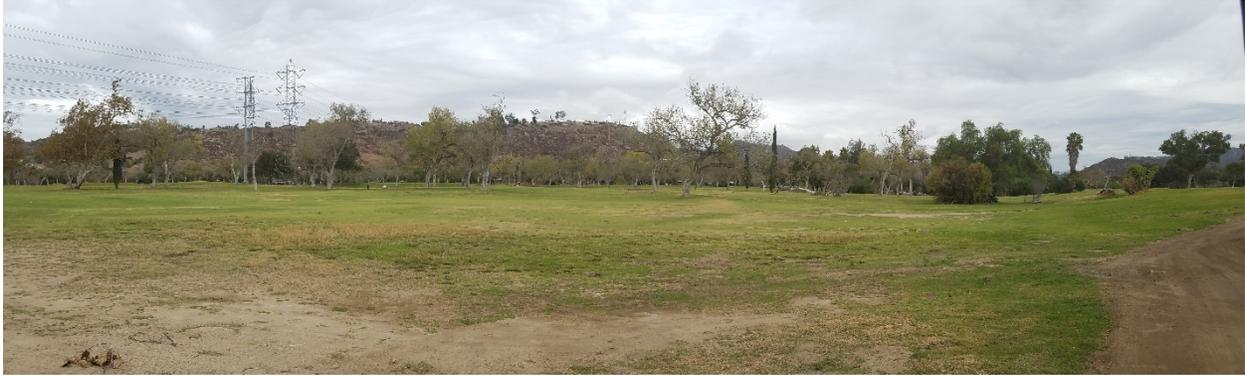
Figure 9. Ivanhoe Golf Course, 3rd Fairway, facing north (IV-05, 11/19/2019)

This is an 18-hole golf course designed by O.W. Moorman and A.C. Sears. It is par 72, covering 6,797 yards on Bermuda grass, making up the east half of the Cottonwood Golf Club (Figure 9). It is currently open and active. Course features include tee boxes, fairways, and putting greens; water hazards, sand bunkers, and non-native landscaping; and golf cart paths and narrow concrete-deck bridges. The bridges all appear to be modern replacements; historic photos show wooden bridges (Figure 10). Larger water features and the path of the Sweetwater River appear to be in the same location as originally constructed; other course features (tee boxes, sand bunkers, etc.) have likely been relocated over the decades.

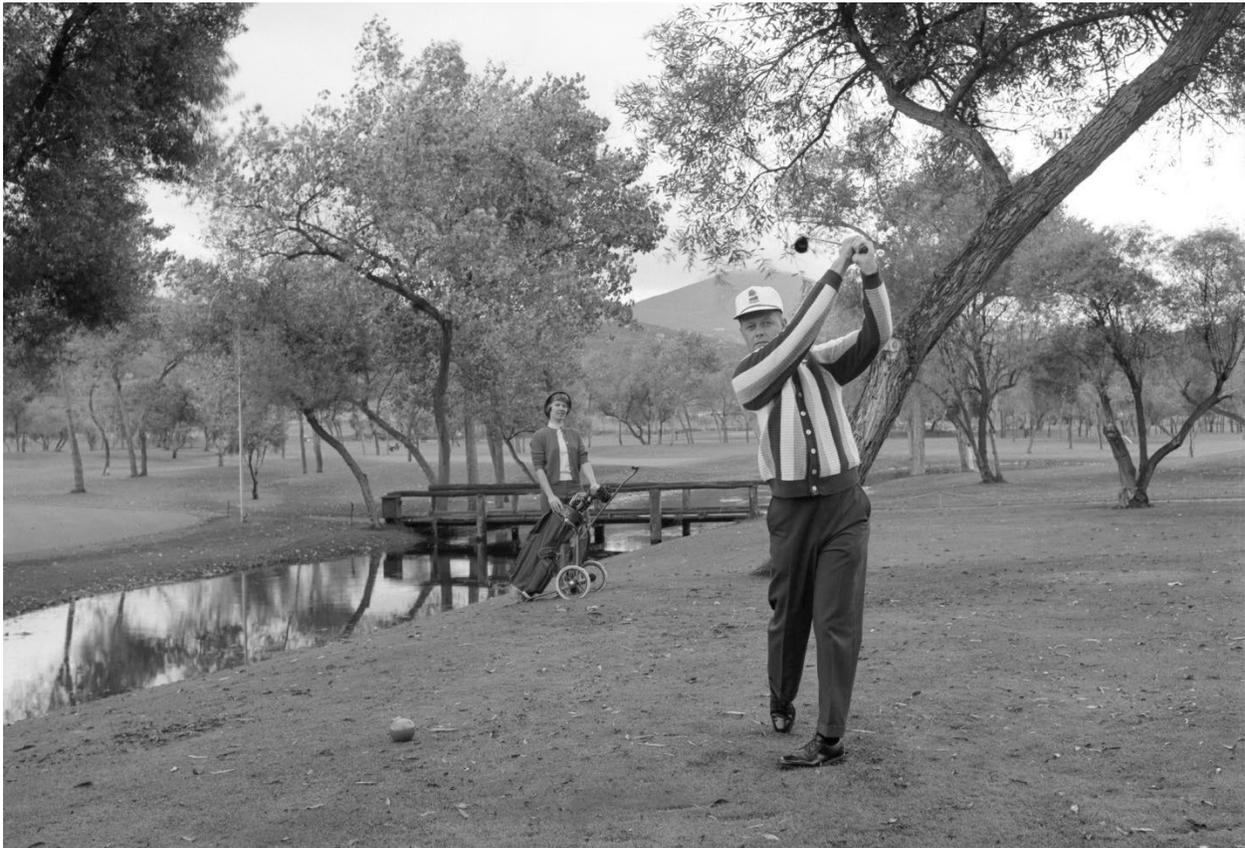
Figure 10. Cottonwood Golf Club, showing original wooden bridge feature, 1966 (86:15877-836, San Diego History Center)

This is an 18-hole golf course designed by O.W. Moorman and A.C. Sears. It is par 71, covering 6,597 yards on Bermuda grass, making up the west half of the Cottonwood Golf Club. It is currently closed and unmaintained; the grass has been allowed to die and the landscaping is overgrown with weeds. Course features include tee boxes, fairways, and putting greens; water hazards, sand bunkers, and non-native landscaping; and golf cart paths and narrow concrete-deck bridges (Figure 11). The bridges all appear to be modern replacements; historic photos show wooden bridges (Figure 10). Larger water features and

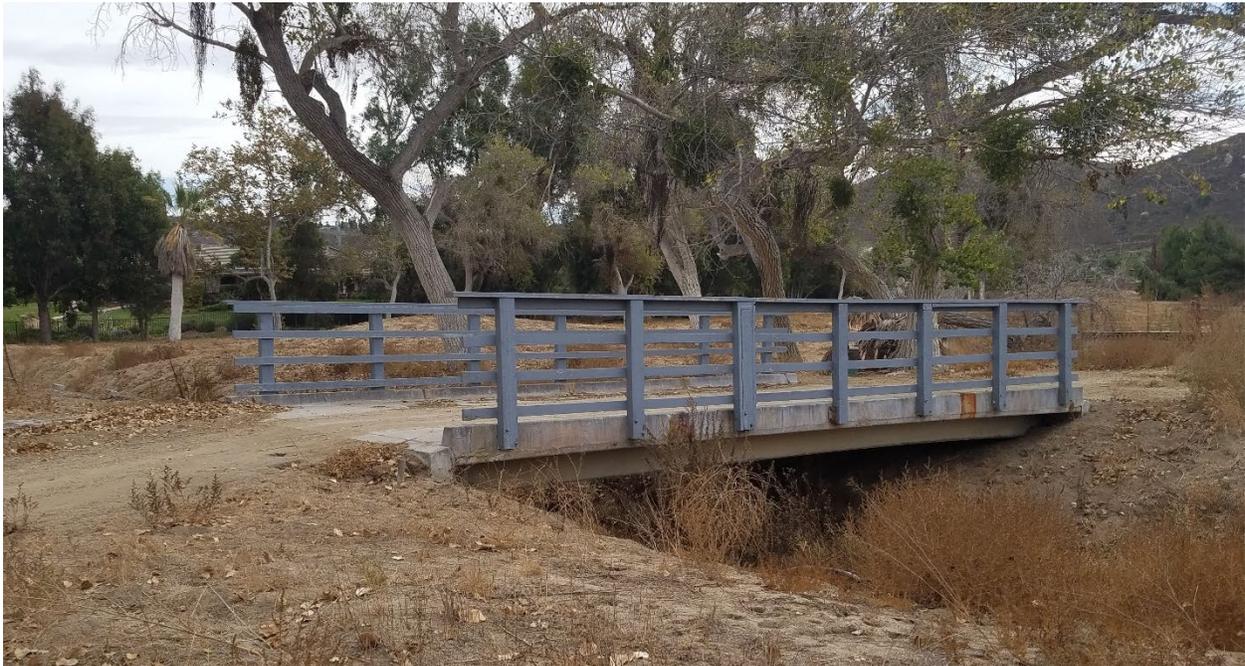
Figure 11. Modern Golf Cart Bridge on The Lakes Golf Course, facing southeast (LA-03, 11/19/2019)

the path of the Sweetwater River appear to be in the same location as originally constructed; other course features (tee boxes, sand bunkers, etc.) have likely been relocated over the decades.

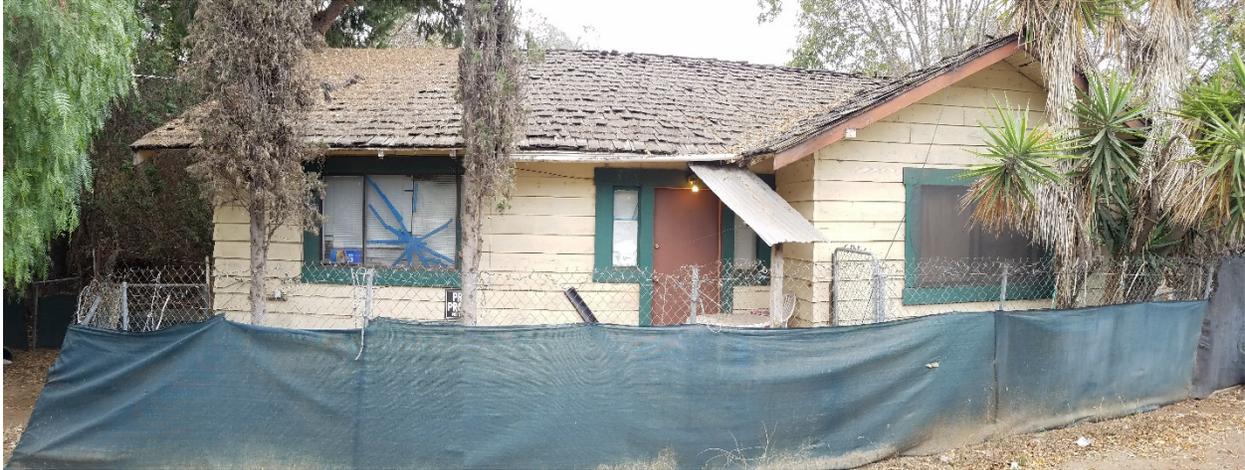
Figure 12. 3629 Willow Glen Drive (P-37-039117) North Façade, facing south (3629-36; 11/19/2019)

This property is a 1900s to 1920s vernacular, single-family residence with an associated garage structure (Figure 12). The original residence is a single story, simple rectangular plan home under a gable-and-wing roof with the front-facing gable covering a 6-foot projection on the north façade. The house was constructed on a slight south-facing slope and has a concrete foundation.

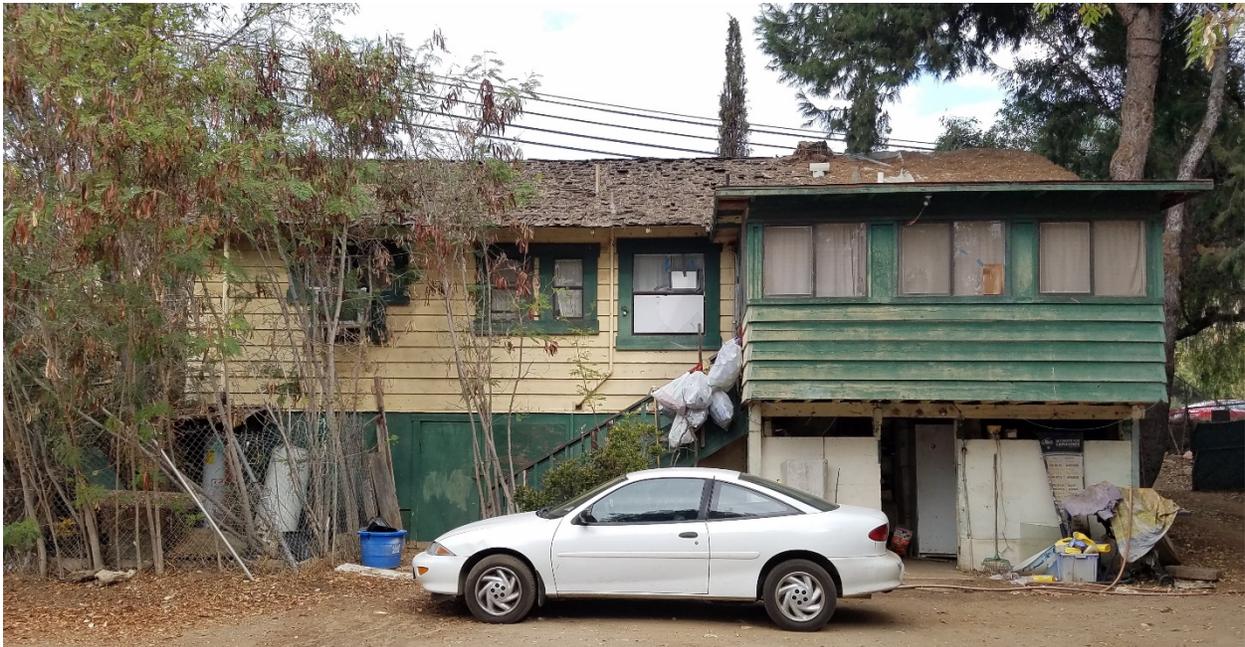
Figure 13. 3629 Willow Glen Drive (P-37-039117) South Façade, showing the 1953-64 addition (right), facing north (3629-25, 11/19/2019)

The area under the house on the slope is enclosed with plywood, except for under a 1953-64 addition to the south façade of the house where the space is open and utilized as a utility room and workshop (Figure 13). Thick horizontal board cladding covers all façades of the house, including the addition, where care was taken to blend the cladding of the addition with the siding on the original house.

The roof of the original house is covered in deteriorated wood shingles; eaves under the gables have fascia, the remainder are exposed rafters. The addition has a flat roof with exposed eaves. Original casing around windows and doors is thick except for thin casing around the windows on the addition. Only the two fixed-sash windows on the street-facing façade are original to the house; the remainder are metal framed sliding or single-hung modern replacements. None of the exterior doors are original.

The cantilevered room addition on the south façade, constructed between 1953-1964 (NETROnline), has a seam that is evident near the roofline and at the junction of the concrete foundation of the original house with the plywood siding under the addition. A wood staircase leads to a door on the west façade of the addition.

It is unclear when the main house was constructed or who the original occupants were. It appears on San Diego County 1928 aerials, but the building records were unavailable at the San Diego County Assessor's Office or with the City of El Cajon, and the address is not listed in early San Diego suburban directories. The house is in poor condition, with broken plate glass mended with tape, unfinished plywood covering missing cladding and windows, extensive wood rot, cracked and spalling concrete, and a collapsing wooden staircase.

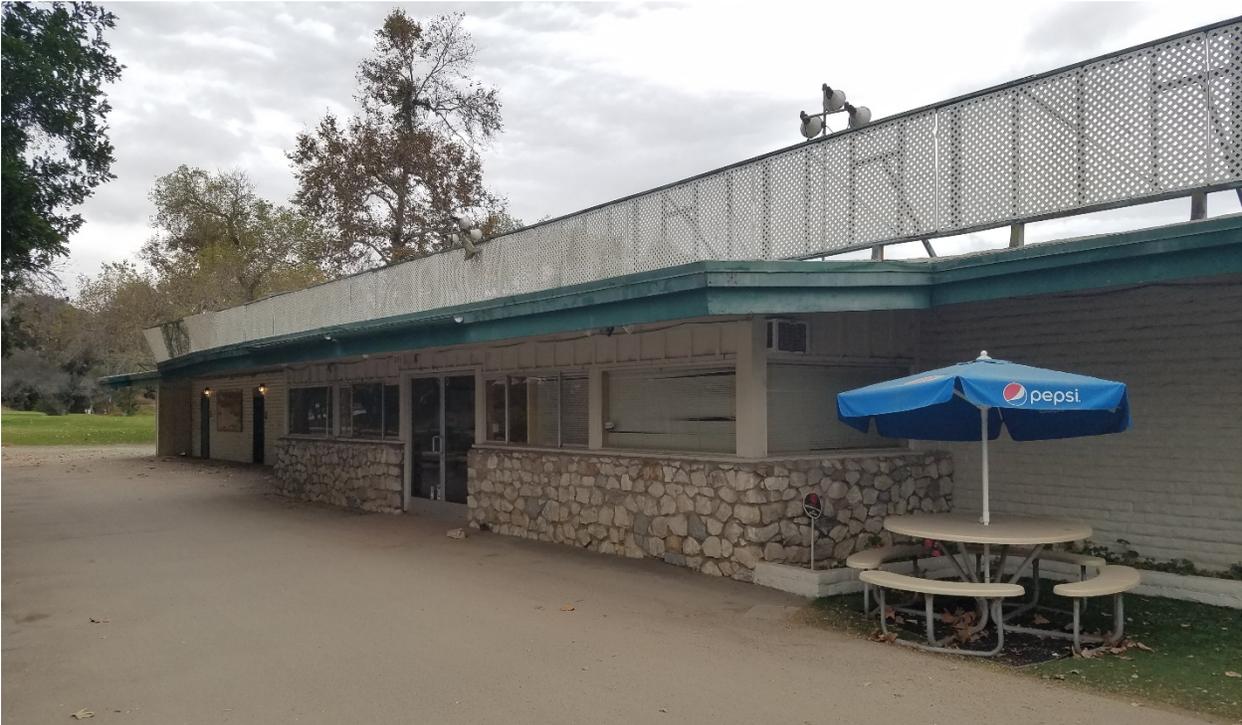
Figure 1. Cottonwood Clubhouse western façade, facing NE (CH-02, 11/19/2019)

A bump-out foyer on the western façade consists of metal-framed fixed and sliding windows above rough stone cladding on either side of aluminum-framed glass double doors (Figure 1). Additional aluminum-framed glass double doors on the south end of the west façade are modern. Additional entrances include single steel doors leading to restrooms, wood paneled doors to the apartment, and aluminum-framed glass doors to the golf shop. Rooftop equipment is screened by white-painted wood lattice.

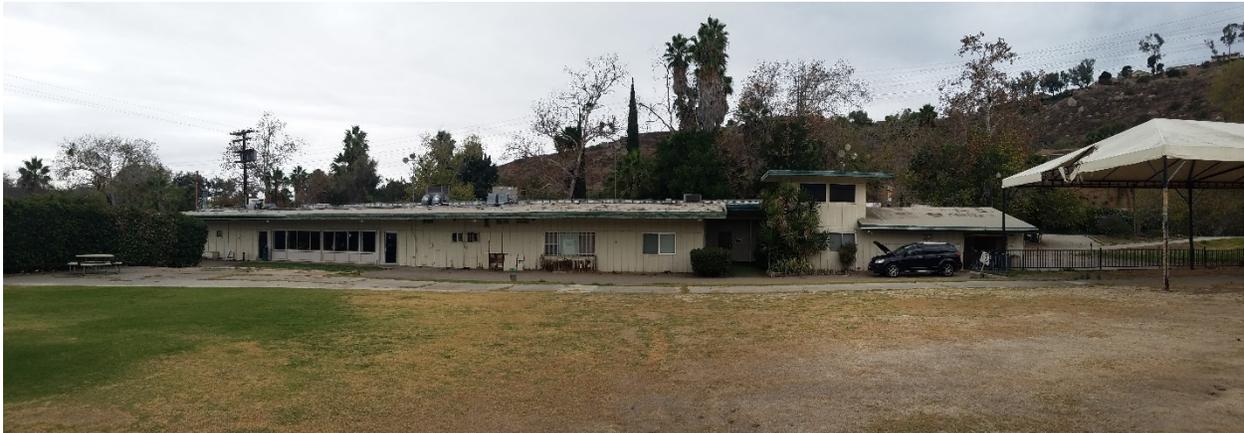
Figure 2. Cottonwood Clubhouse eastern façade, with driving range gazebo at right, facing W (CH-15, 11/19/2019)

The eastern extension (1964-1966) has sliding aluminum-framed windows and aluminum-framed glass doors (Figure 2). A large portion of the eastern façade is constructed of picture windows set in a hinged frame, which open the entire wall of the restaurant inside. The northeast extension (1971-1980) has a single-width wooden garage door facing east. A 24' x 24' 'tower' (1971-1980) added a second story to the eastern façade. It has a flat roof with deep overhangs and large fixed picture windows and is accessed by an exterior wooden staircase leading to a wood paneled door. The northern and eastern extensions and tower addition are all clad in vertical wood paneling with

narrow batten. The southwestern corner has been extended with simple plywood construction housing a kitchen area.

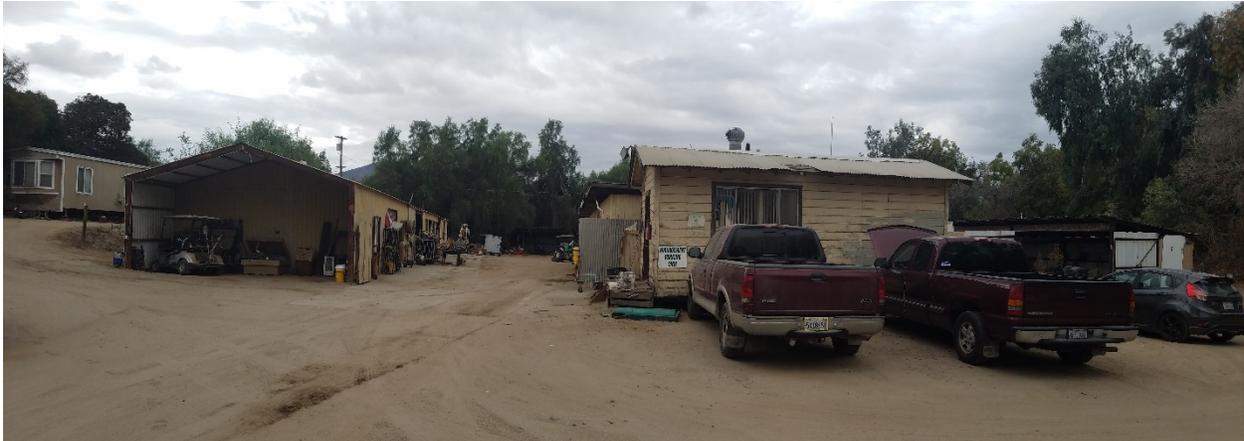
Figure 3. Maintenance facility, office shack in center, facing SW (EC-06, 11/19/2019)

South of the clubhouse, near the west end of the Ivanhoe Golf Course, is a facility for golf cart repair and course maintenance (Figure 3). The area is screened by tall trees and consists of three long sheds with open bays, two 60-foot mobile homes, and several small shacks. Scattered around the area are shipping containers, RVs, abandoned vehicles, piles of lumber, and landscape maintenance equipment and supplies.

A shack at the north end of the central sheds serves as an office. It is wood frame construction on concrete pier foundation with wood siding under an end-gabled corrugated metal roof. The structure is in poor condition, with rotted lumber and a sagging porch. The southern row of sheds is modern, in fair condition, with steel roll-up doors and corrugated steel siding and roof over steel frame. The central row of sheds is corrugated metal roof and siding over wood frame on concrete foundation, in poor condition with rotting lumber and cracked concrete. The northern row is open front, wood frame, with corrugated metal back wall and roof, in poor condition with many roof panels missing.

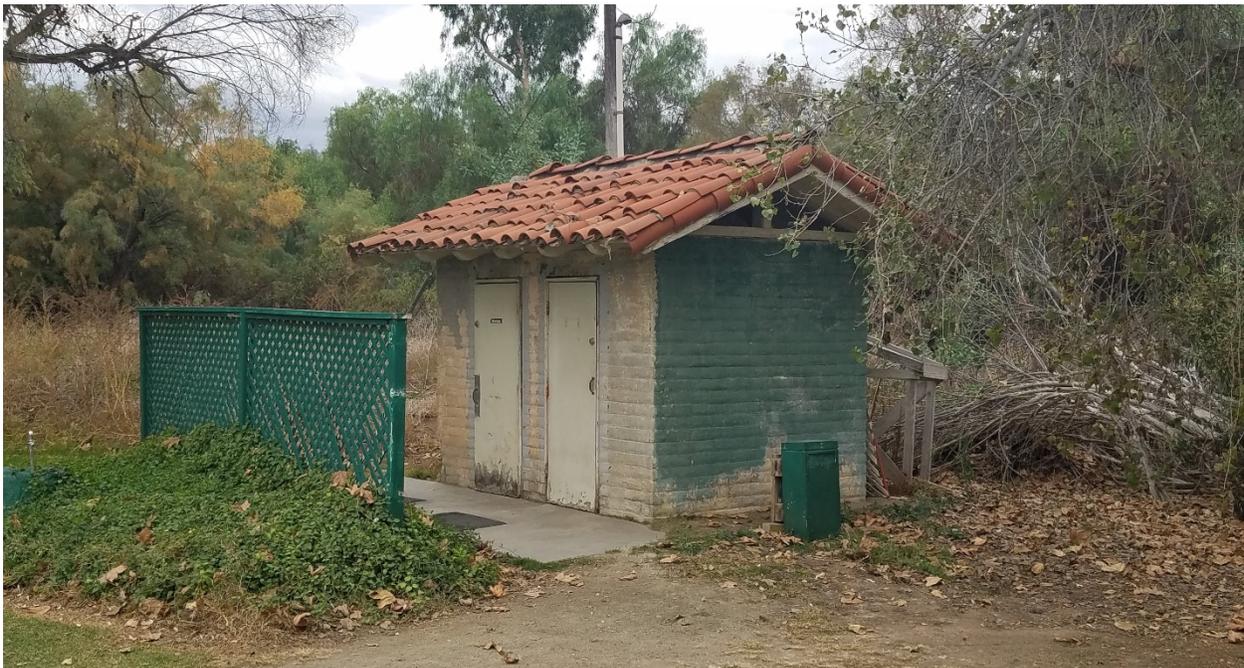
Figure 4. Ivanhoe Golf Course restroom, facing S (EC-30, 11/19/2019)

The Lakes and Ivanhoe courses each have a small restroom structure (Figure 4). These are both rectangular in plan, with brick construction on slab concrete foundation; red terracotta tile end-gable roof with wide eaves; and two metal doors. The Ivanhoe restroom is in fair condition: the exterior has rotted lumber, missing roof tiles, and rusted door hardware, but the interior has been reconstructed with modern tile and fixtures. The Lakes restroom is in poor condition, with broken and missing roof tiles, foundation water damage, and graffiti.

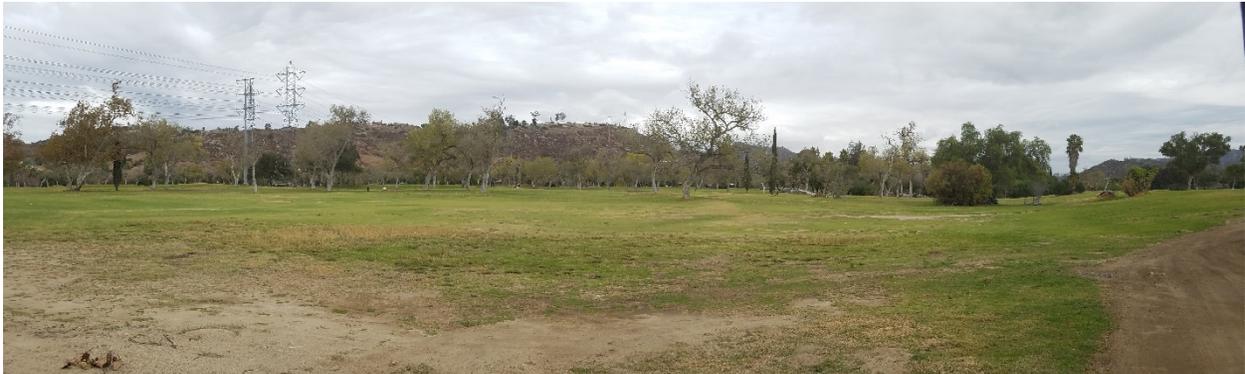
Figure 5. Ivanhoe Golf Course, 3rd fairway, facing N (IV-05, 11/19/2019)

This is an 18-hole golf course designed by O. W. Moorman and A. C. Sears. It is par 72, covering 6,797 yards on Bermuda grass, making up the east half of the Cottonwood Golf Club (Figure 5). It is currently open and active. Course features include tee boxes, fairways, and putting greens; water hazards, sand bunkers, and non-native landscaping; and golf cart paths and narrow concrete-

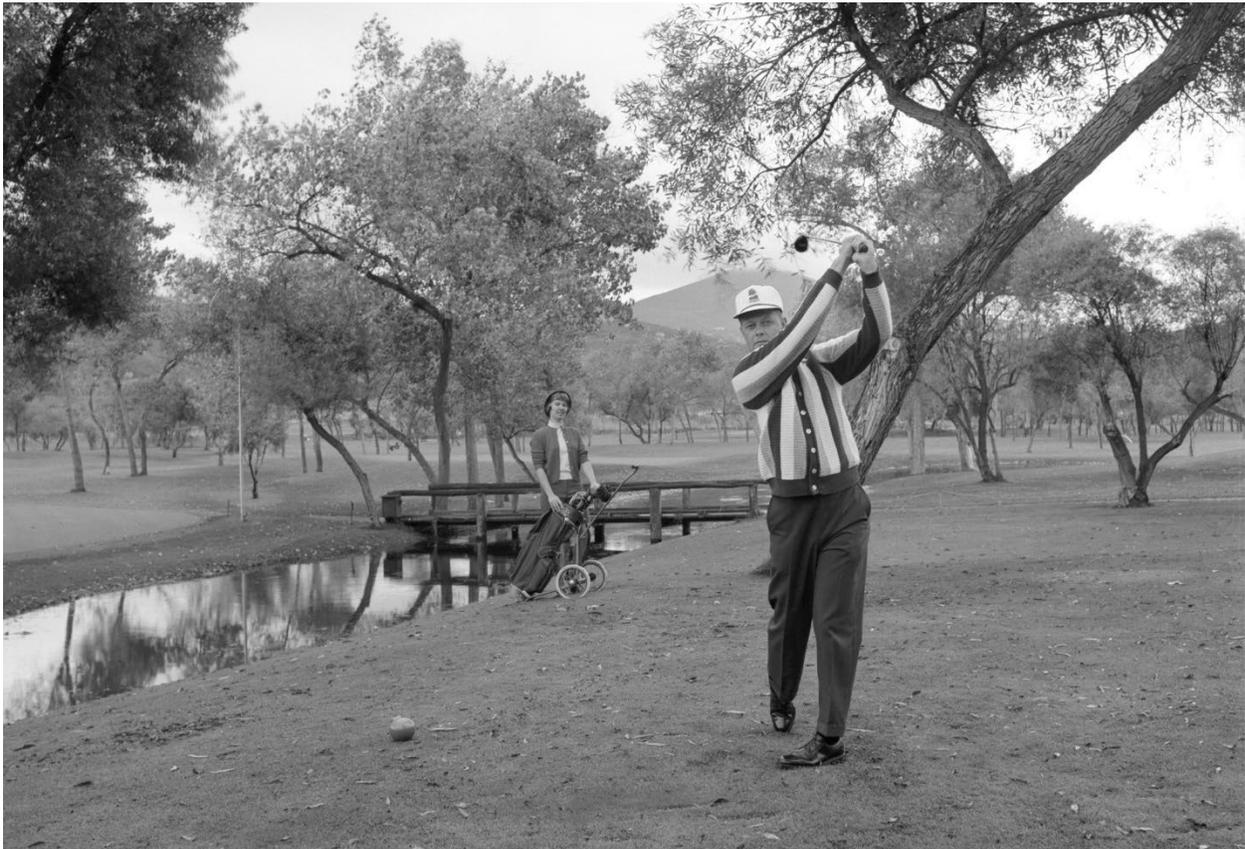
Figure 6. Cottonwood Golf Club, showing original wooden bridge feature, 1966 (86:15877-836, San Diego History Center)

deck bridges. The bridges all appear to be modern replacements; historic photos show wooden bridges (Figure 6). Larger water features and the path of the Sweetwater River appear to be in the same location as originally constructed; other course features (tee boxes, sand bunkers, etc.) have likely been relocated over the decades.

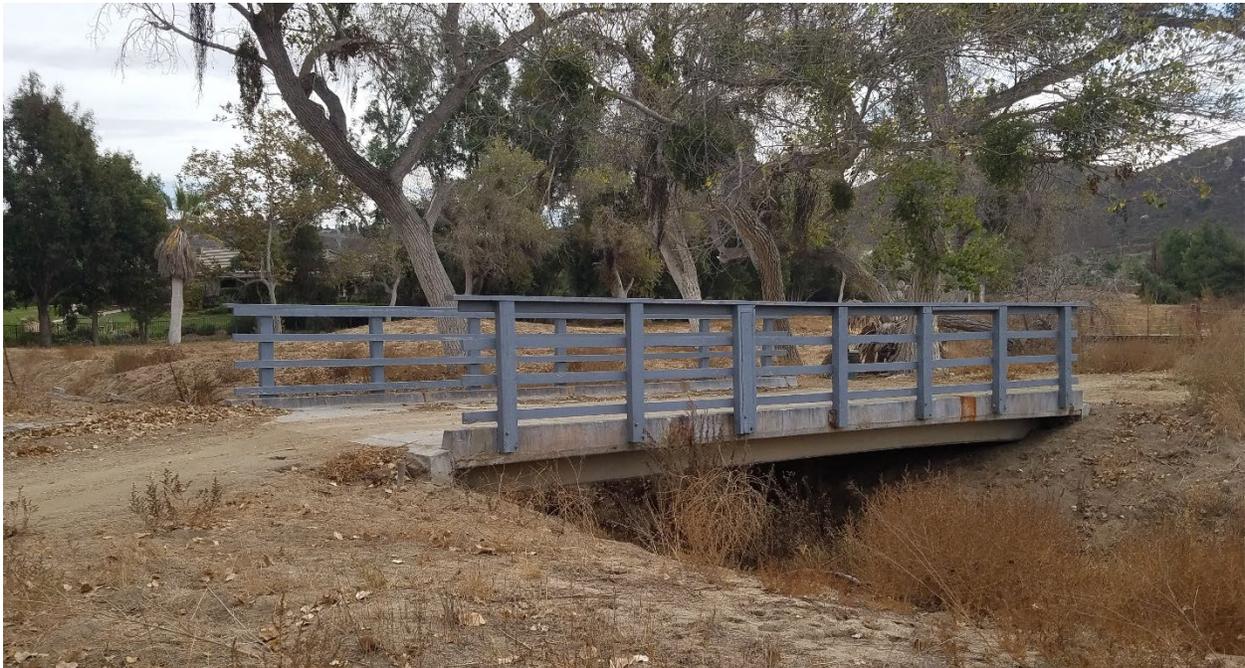
Figure 7. Modern golf cart bridge on The Lakes Golf Course, facing SE (LA-03, 11/19/2019)

This is an 18-hole golf course designed by O. W. Moorman and A. C. Sears. It is par 71, covering 6,597 yards on Bermuda grass, making up the west half of the Cottonwood Golf Club. It is currently closed and unmaintained; the grass has been allowed to die and the landscaping is overgrown with weeds. Course features include tee boxes, fairways, and putting greens; water hazards, sand bunkers, and non-native landscaping; and golf cart paths and narrow concrete-deck bridges (Figure 7). The bridges all appear to be modern replacements; historic photos show wooden bridges (Figure 6). Larger water features and the path of the Sweetwater River appear to be in the same location as originally constructed; other course features (tee boxes, sandbunkers, etc.) have likely been relocated over the decades.

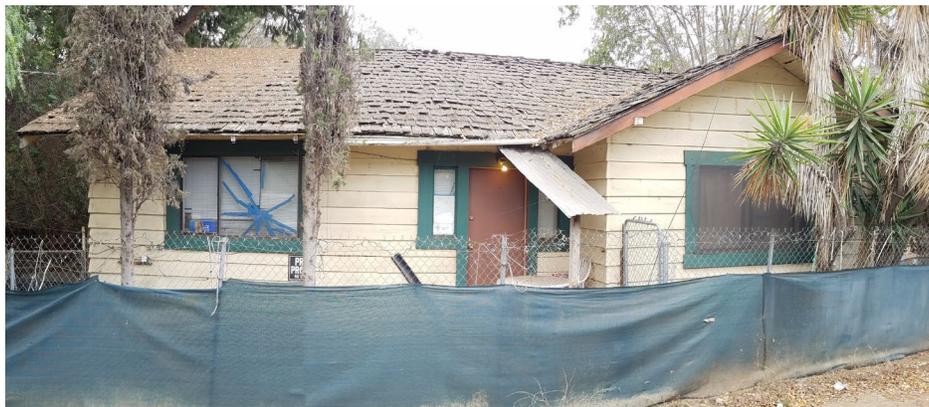
P5b. Description of Photo: IMG 20191119 102748; north façade, facing south; November 19, 2019

***P3a. Description:** 1900-1920s vernacular, single-family residence with an associated garage structure (P5a Photo, Figure 2, pg. 6). The original residence is a single story, simple rectangular plan home under a gable-and-wing roof with the front-facing gable covering a 6-foot projection on the north façade. The house was constructed on a slight south-facing slope and has a concrete foundation. The area under the house on the slope is enclosed with plywood, except for under a 1953-64 addition to the south façade of the house where the space is open and utilized as a utility room and workshop (Figure 1, pg. 5). Thick horizontal board cladding covers all facades of the house, including the addition, where care was taken to blend the cladding of the addition with the siding on the original house.

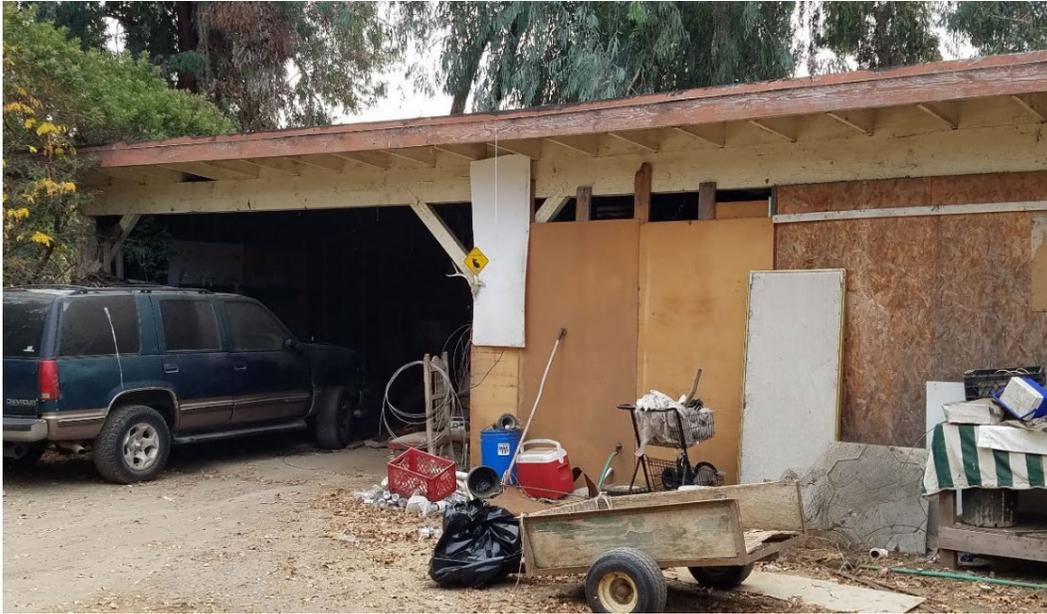
Figure 2. North façade of garage, facing south (3629-17, 11/19/2019).

- B1. Historic Name: Unknown.
B2. Common Name: None.
B3. Original Use: Single-family residence B4. Present Use: Single-family residence
*B5. Architectural Style: Vernacular
*B6. Construction History: Original residence constructed circa 1900-1928; 1953-1964 addition on the south façade of the residence.
*B7. Moved? No Yes Unknown Date: N/A Original Location: N/A
*B8. Related Features: A rectangular 80 x 30 foot, three-bay garage was constructed 60 feet south of the residence before 1953 (NETROnline) but does not look to be of the same age or quality of workmanship or material as the house. The garage is of wood construction, with a flat roof and wide eaves. The western bay is enclosed by a single wood board, tilt-up door (Figure 2, pg. 6).

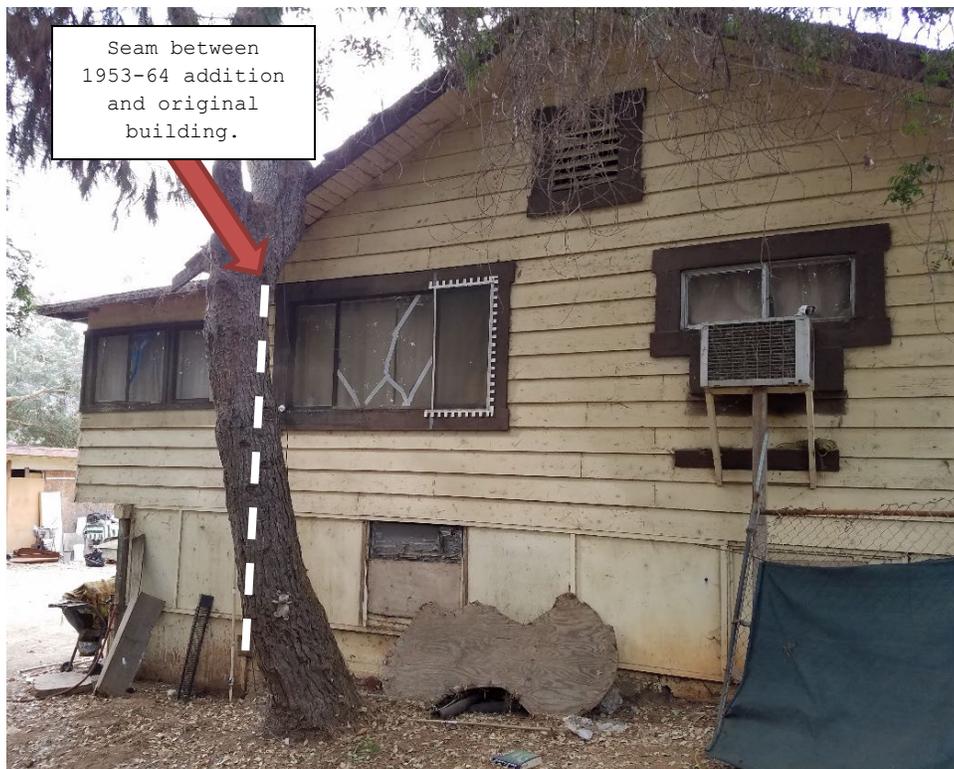
Figure 3. East façade of the building, showing the original residence (right) and the 1953-64 addition (left), facing west (3629-01, 11/19/2019).

Seam between
1953-64 addition
and original
building.
