Appendix E

Jurisdictional Delineation Datasheets

WETLAND DETERMINATION DATA FORM – Arid West Region

Project/Site: Cottonwood Golf Course City/County: El Cajon/San Diego Sampling Date: 9/18/18
 Applicant/Owner: HELIX JO# SIR-02 State: CA Sampling Point: SP1
 Investigator(s): Larry Sward, Erica Harris Section, Township, Range: N/A; T16 S; R1 W
 Landform (hillslope, terrace, etc.): man-made basin Local relief (concave, convex, none): none Slope (%): 2-3%
 Subregion (LRR): C; Mediterranean California Lat: 32.7397775 Long: -116.92880491 Datum: NAD83
 Soil Map Unit Name: Visalia Sandy Loam, 2-5% NWI classification: PUBHx

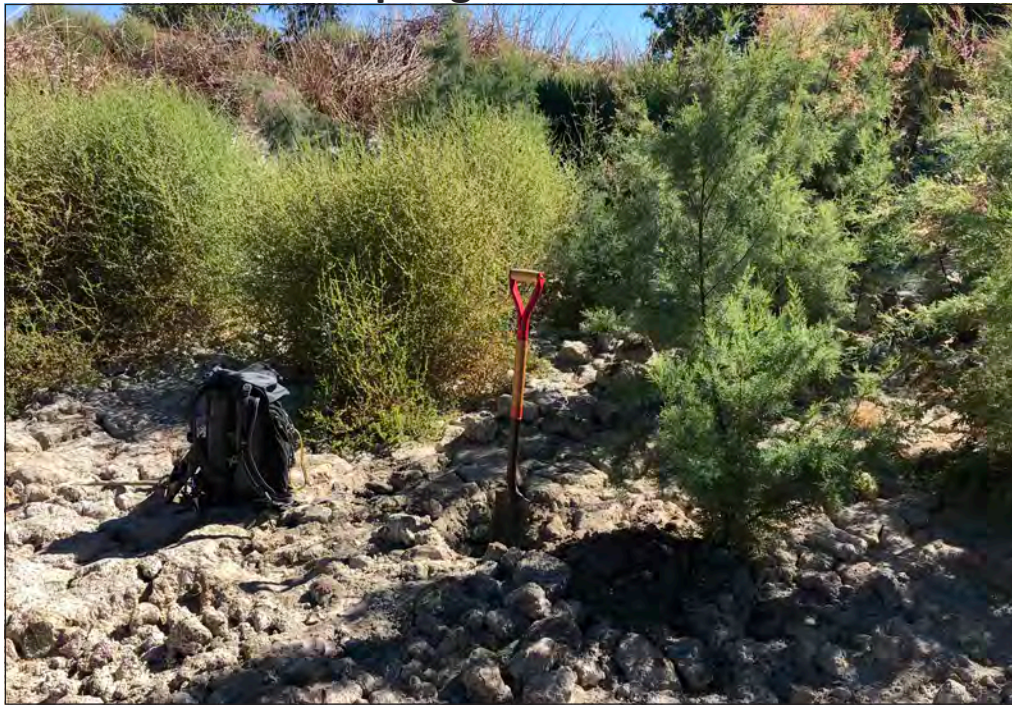
Sampling Point 1. Sample point is located in a man-made basin located in southwestern portion of the site. The hydrology for this feature was formerly maintained anthropogenically (i.e., via a pipe). This is a non-jurisdictional feature.

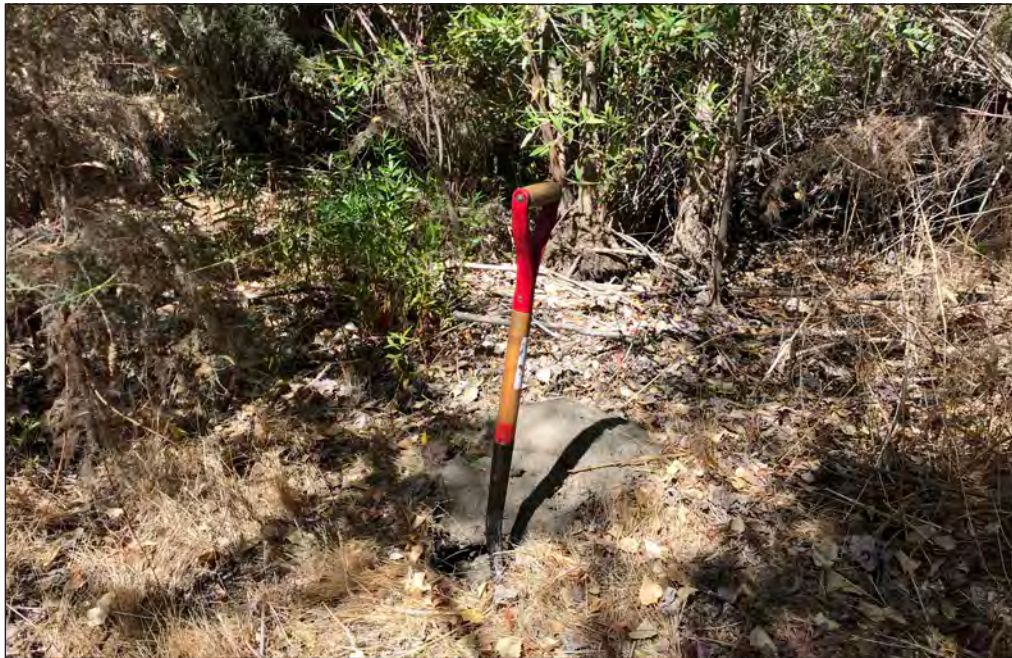
Sampling Point 2. Photo looking west (downstream) in southern cottonwood-willow riparian forest. Location is wetland Waters of the U.S. (WUS)/Waters of the State (WS), and California Department of Fish and Wildlife (CDFW) jurisdictional habitat. Soils at this location were deemed problematic. Sample point is located in the southwestern portion of the site along Sweetwater River, in western portion of site.

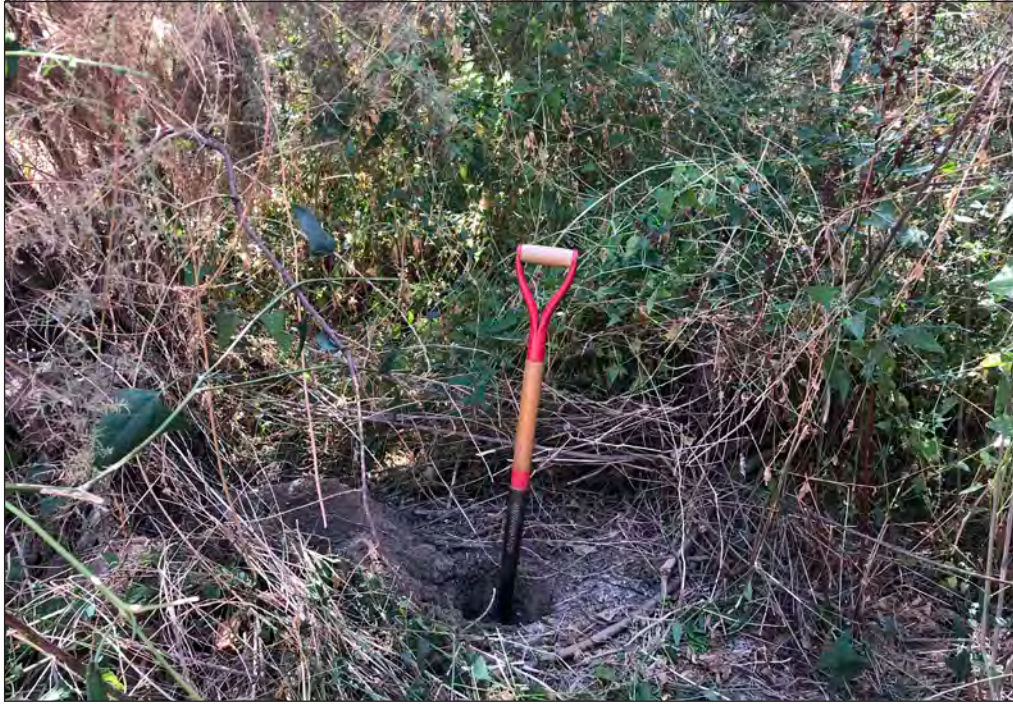
Sampling Point 3. Photo is looking southwest (downstream) in southern cottonwood-willow riparian forest. Location is wetland WUS/WS and CDFW jurisdictional habitat. Sample point is located in the southwestern portion of the site along Sweetwater River.

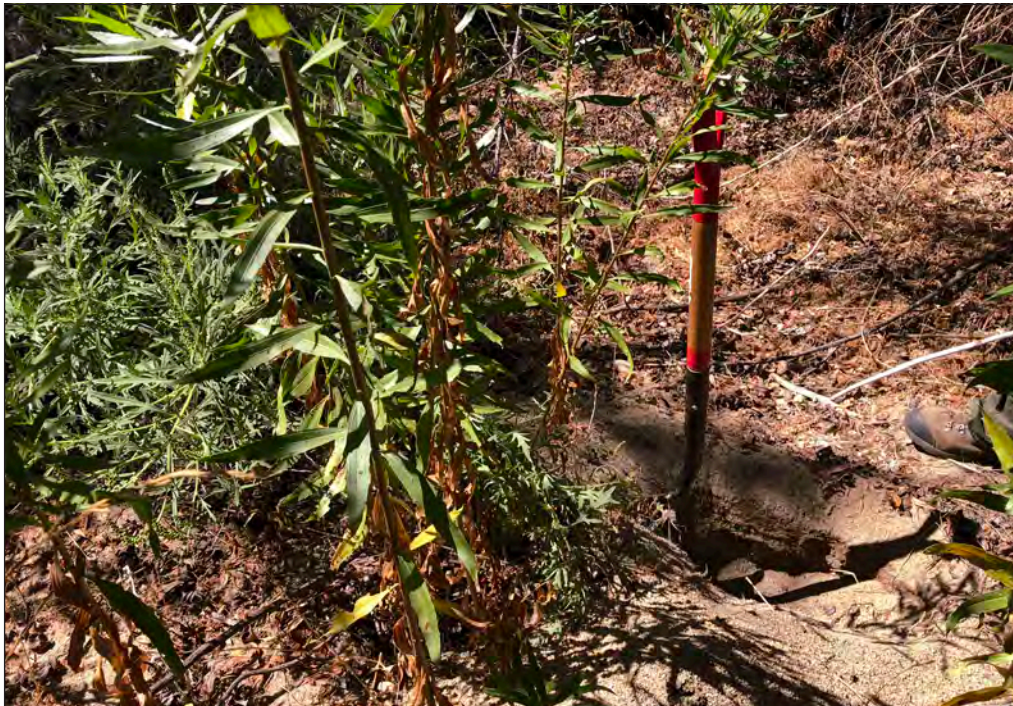
Sampling Point 4. Photo is looking north in southern cottonwood-willow riparian forest. Location is wetland WUS/WS and CDFW jurisdictional habitat. Sample point is located in the southwestern portion of the site along Sweetwater River.

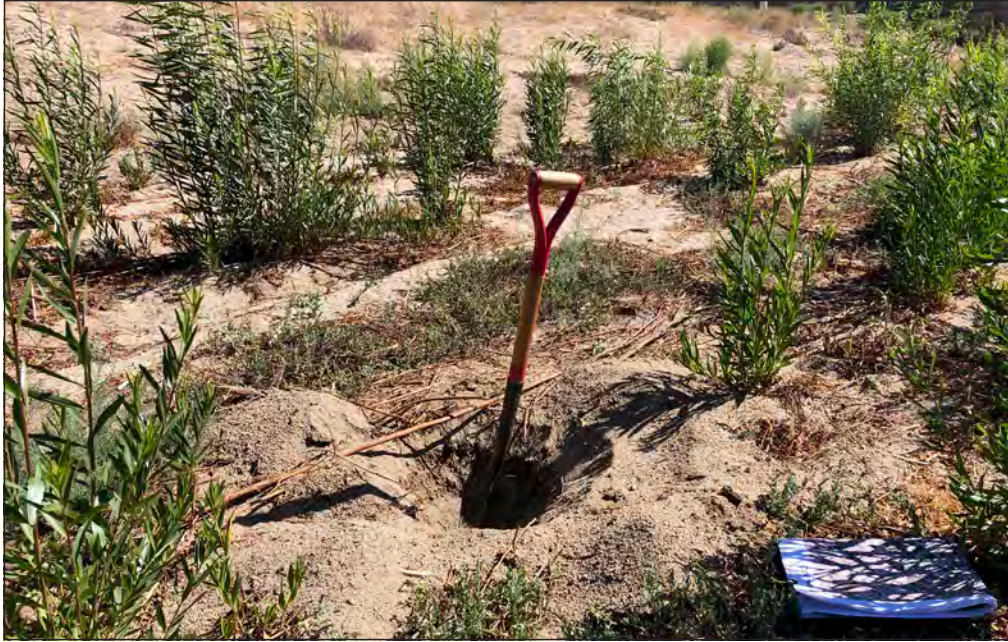
Sampling Point 5. Photo is looking south, with streambed in foreground and channel slopes in background. This location is periodically maintained. Vegetation at this location was deemed problematic (managed plant communities). Location is wetland WUS/WS and CDFW jurisdictional habitat. Sample point is located in the western portion of the site along Sweetwater River.

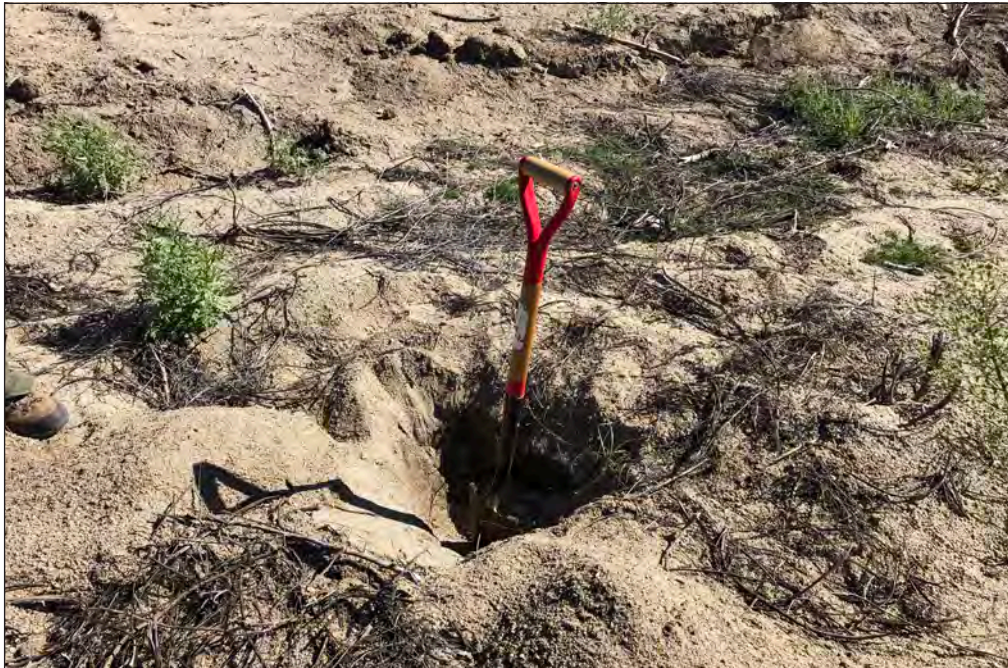
Sampling Point 6. Photo is looking southeast in a maintained section of streambed. This location is periodically maintained. Vegetation at this location was deemed problematic (managed plant communities). This location is wetland WUS/WS and CDFW jurisdictional habitat. Sample point is located in the central portion of the site, east of Steele Canyon Drive, along Sweetwater River.

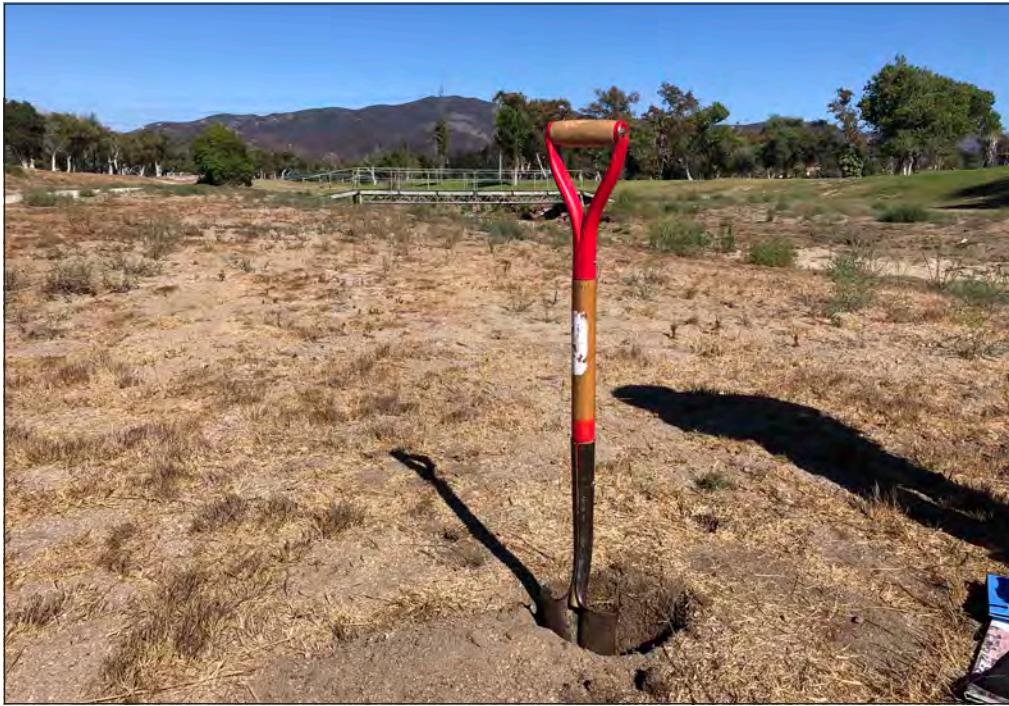
Sampling Point 7. Photo is looking northeast (upstream) in a maintained section of the Sweetwater River's streambed. This location is CDFW jurisdictional habitat. Sample point is located on terrace that is north of the Sweetwater River's active floodplain. This sample point is north of Sample Point 6.

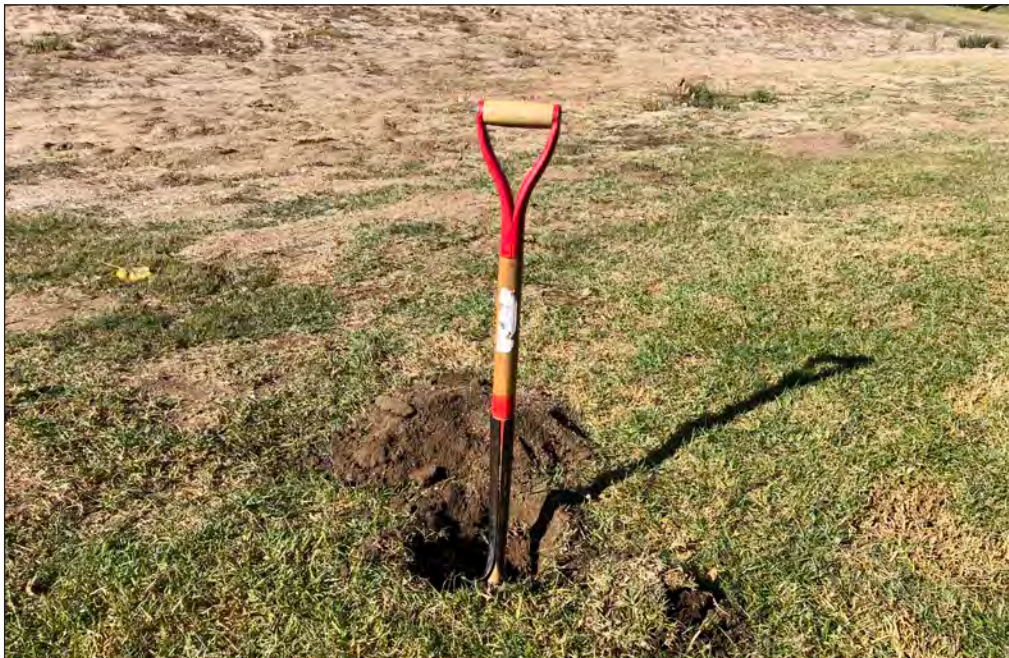
Sampling Point 8. Photo is looking northeast (upstream) in a maintained section of the Sweetwater River's streambed. This location is periodically maintained. Vegetation at this location was deemed problematic (managed plant communities). This location is wetland WUS/WS and CDFW jurisdictional habitat. Sample point is located in central portion of the site.

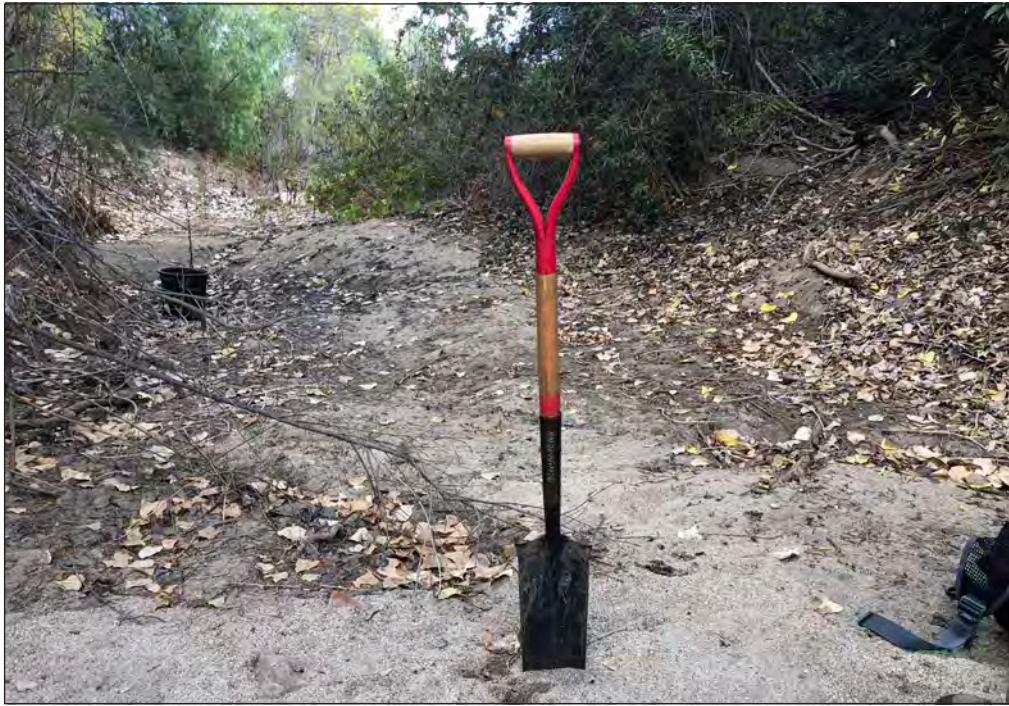
Sampling Point 9. Photo is looking northeast (upstream) in the active floodplain of the Sweetwater River. This location is non-wetland WUS/WS and CDFW jurisdictional habitat. Sample point is near the eastern boundary of the site.

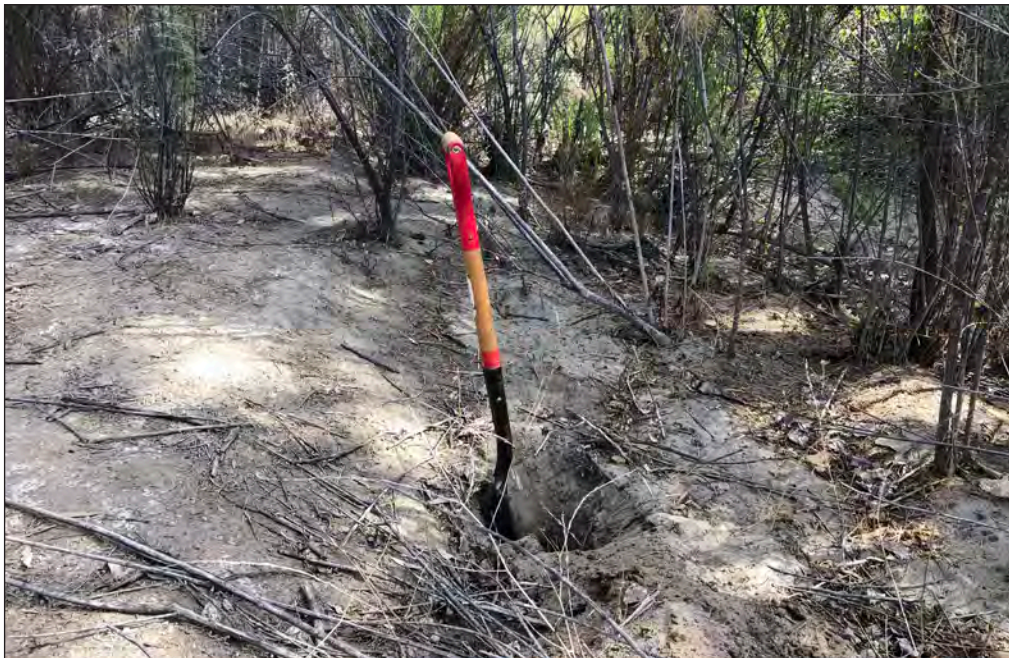
Sampling Point 10. Photo is looking northeast (upstream) on a terrace within the active floodplain of the Sweetwater River. This location is a non-wetland WUS/WS and CDFW jurisdictional habitat. Sample point is near the eastern boundary of the site.

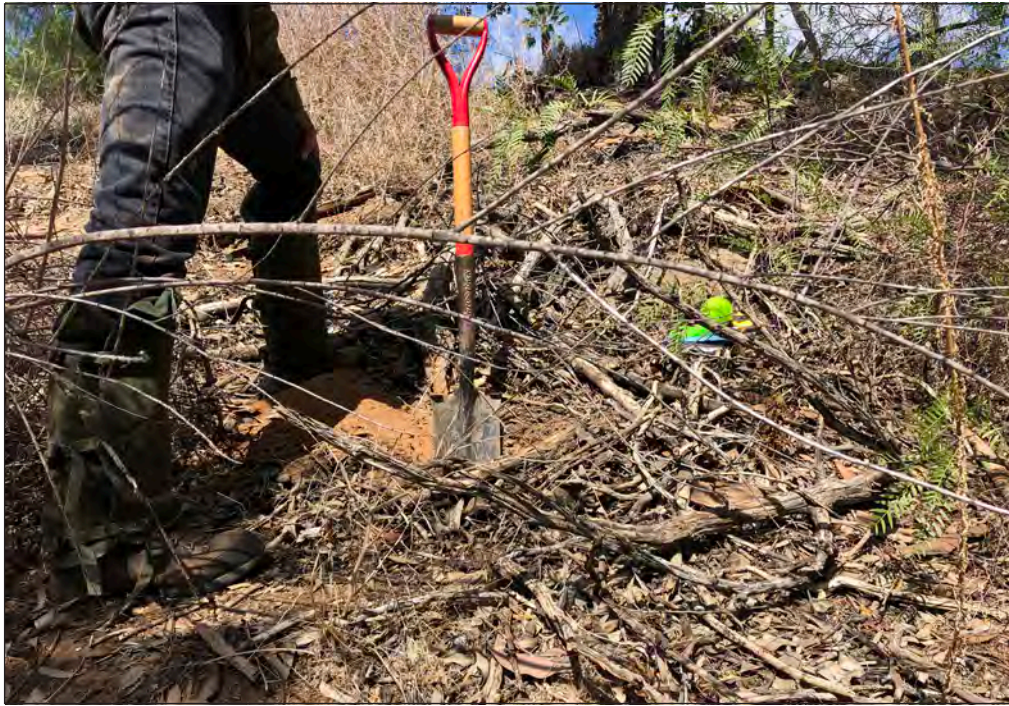
Sampling Point 11. Photo is looking northwest (upslope) at an upland location. This location is an upland and not subject to wetland regulations. Sample point is above Sample Points 9 and 10.

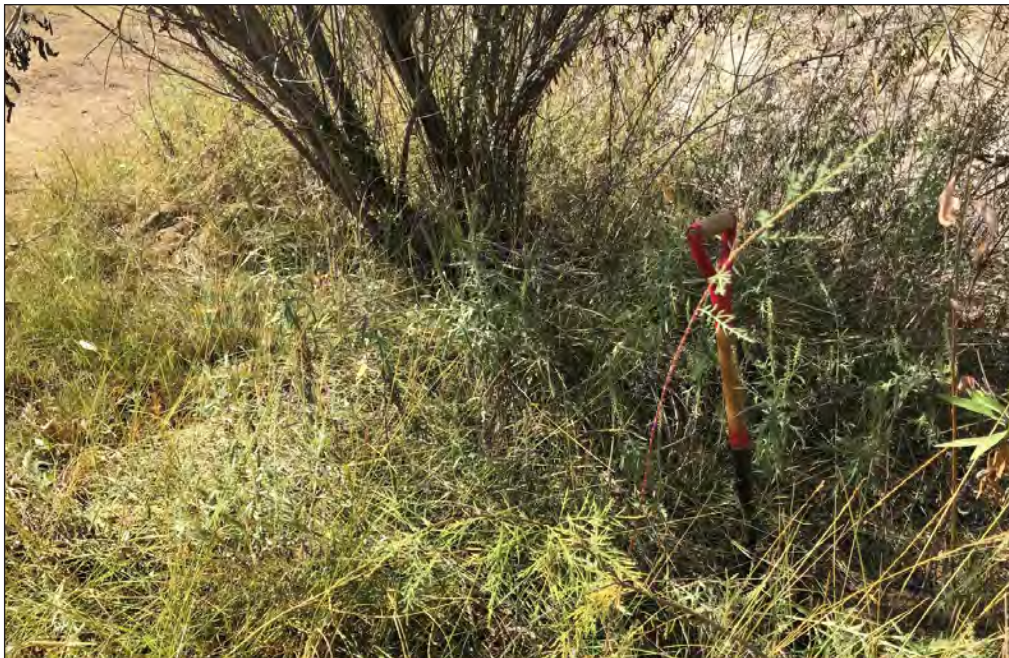
Sampling Point 12. Photo is looking southwest (downstream) in a small stand of mule fat (*Baccharis salicifolia*). The low flow channel of the Sweetwater River is located to the right in this photo. To the left is a maintained slope within the golf course. This location is wetland WUS/WS and CDFW jurisdictional habitat. Sample point is located in the northeastern portion of the site.

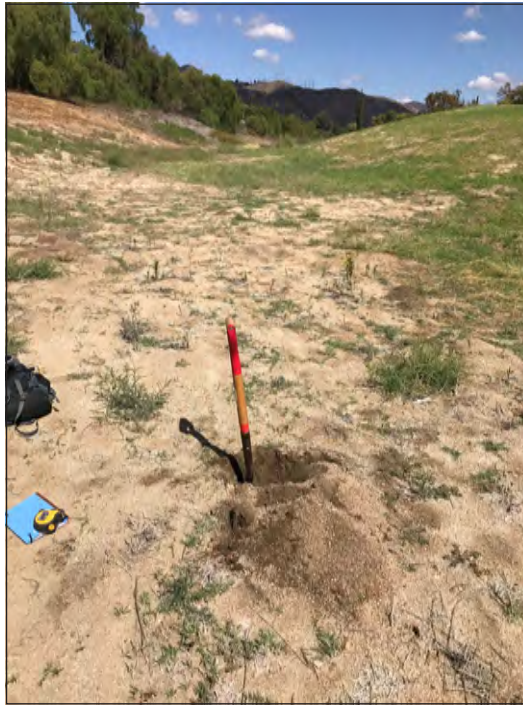
Sampling Point 13. Photo is looking northeast (upstream) in the active floodplain of the Sweetwater River. This location is periodically maintained. Vegetation at this location was deemed problematic (managed plant communities). Soils at this location are also deemed problematic (vegetated sand and gravel bars within flood plains). This location is wetland WUS/WS and CDFW jurisdictional habitat. Sample point is in northeastern portion of the site.

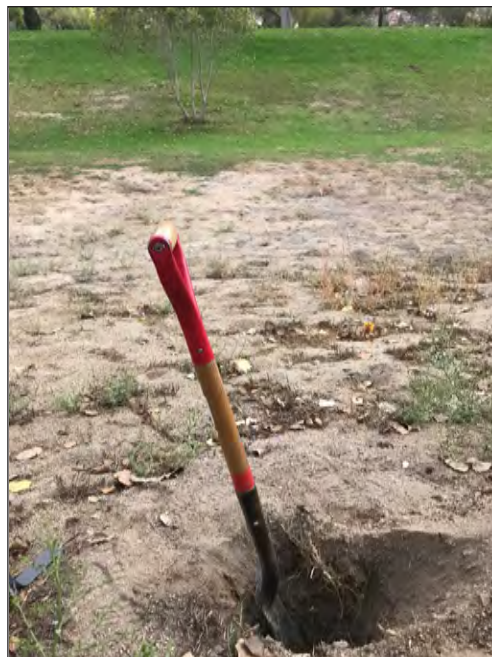
Sampling Point 14. Photo is looking south within trapezoidal channel containing the Sweetwater River. This location is above the OHWM and therefore not a WUS but is within CDFW jurisdiction as a streambed. Sample point is located in central portion of the site.

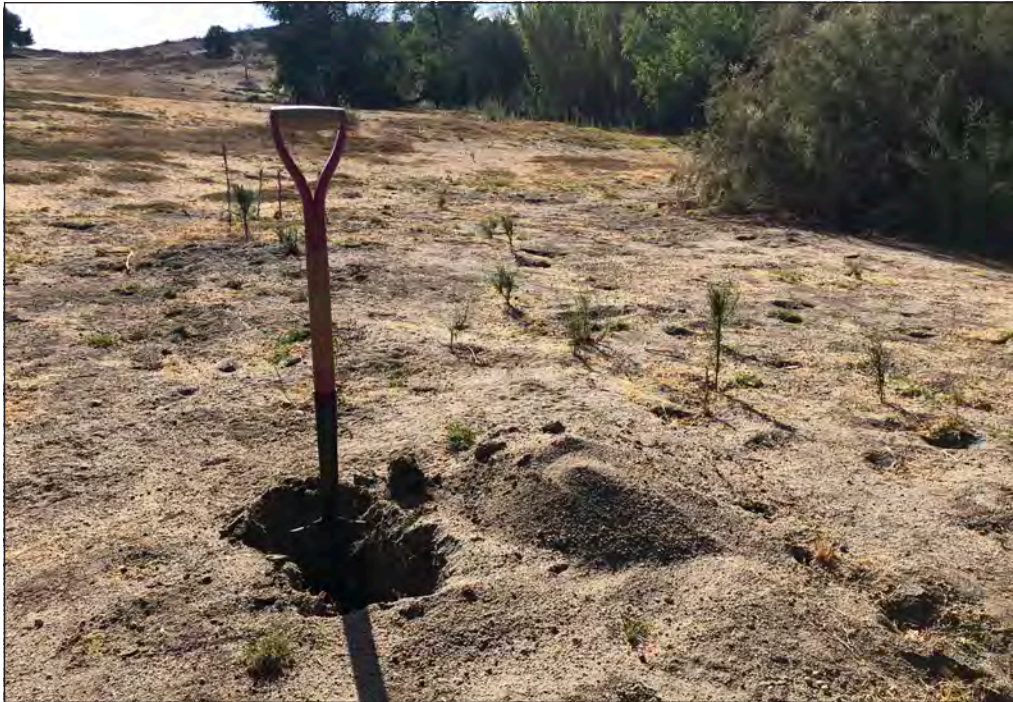
Sampling Point 15. Photo is looking west, along the interface between the riparian forest and abandoned golf course. This location is an upland and not subject to wetland regulations. Sample point is located near the western boundary of the study area.

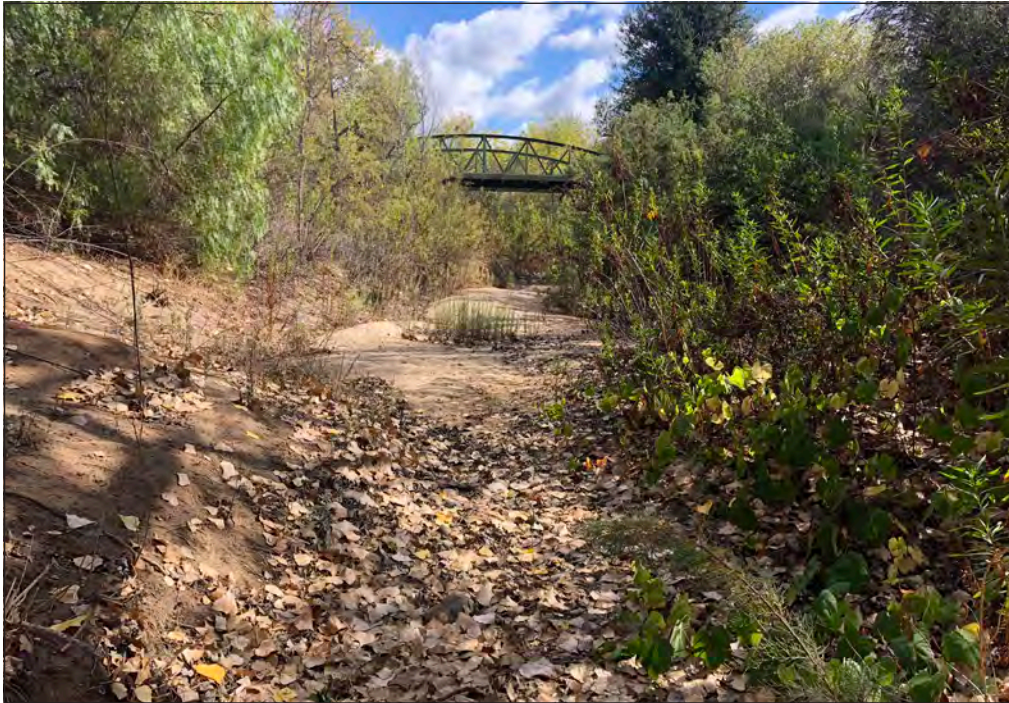
Photo 1. Northeastern portion of site where Sweetwater River enters the project boundary. Photo is facing northeast (upstream).

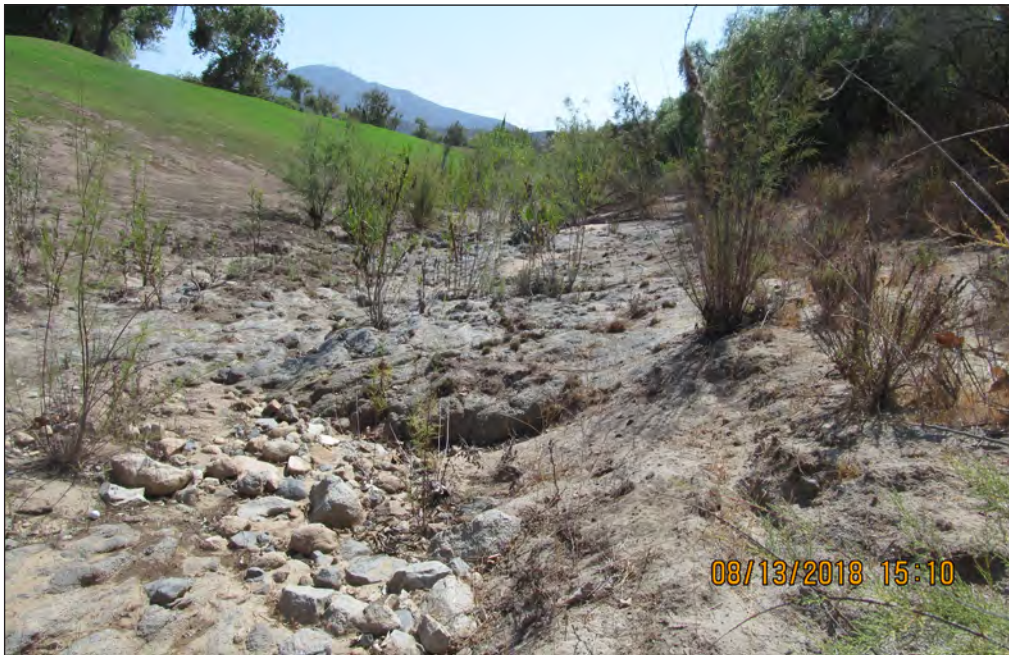
Photo 2. Upstream portion of Sweetwater River where low-flow channel has grouted rock. In northeastern portion of site. Photo is facing southwest (downstream).

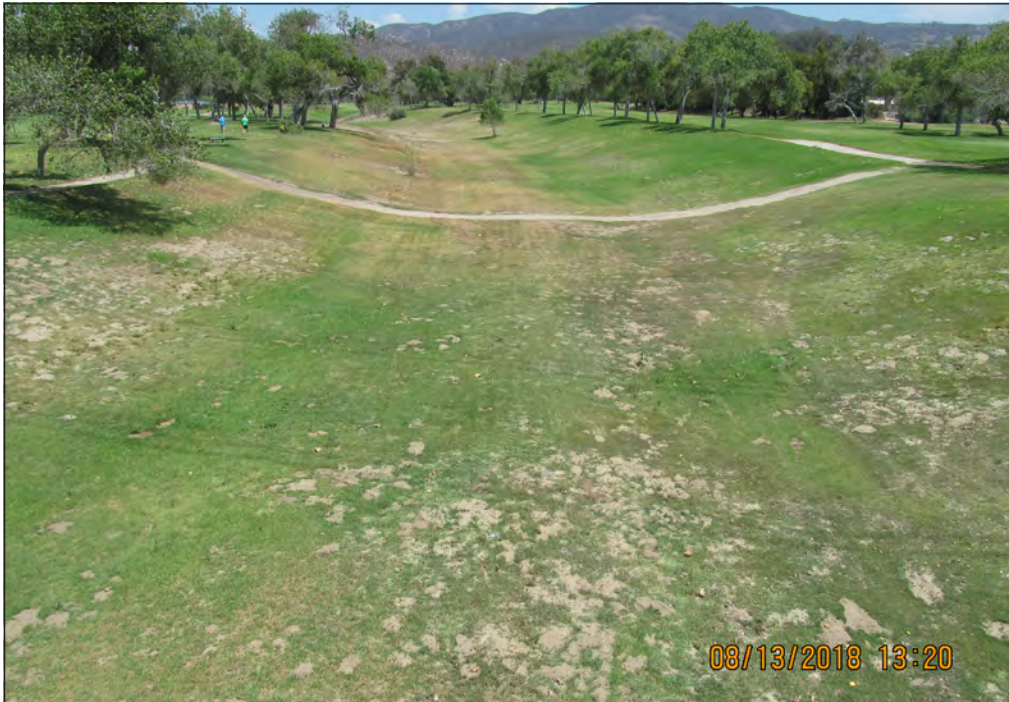
Photo 3. Overview of Sweetwater River within developed portion of golf course that is actively maintained. Photo is facing northeast (upstream).

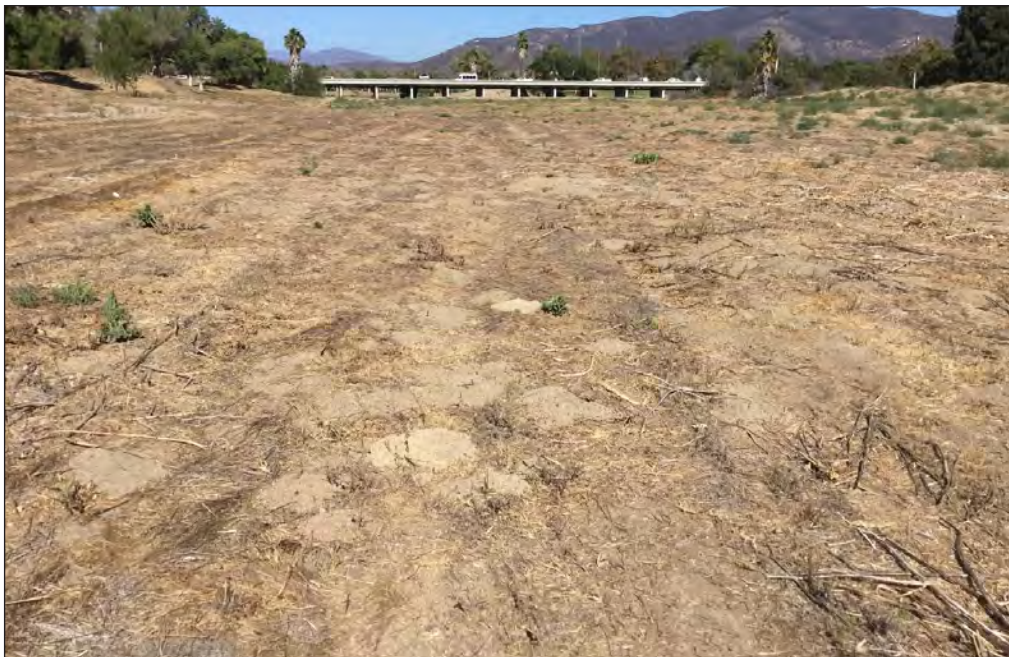
Photo 4. Overview of Sweetwater River within closed portion of the site to the east of Steele Canyon Road. Photo is facing northeast (upstream). This section of the river is periodically mowed.

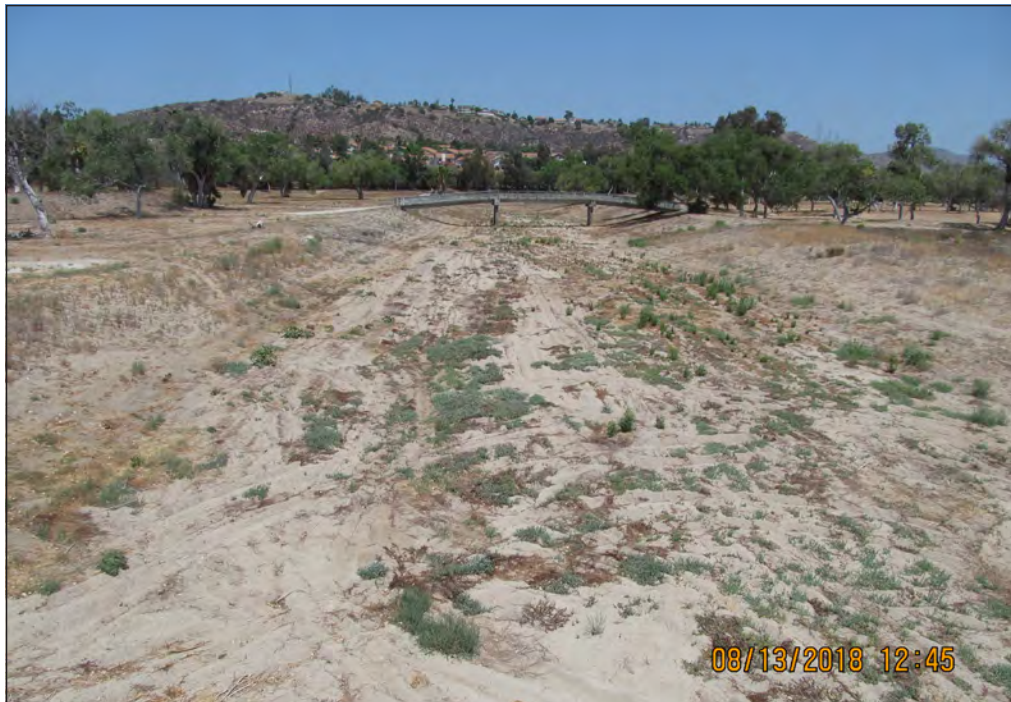
Photo 5. Overview of Sweetwater River within closed portion of the site in the southwestern portion of the site. Photo is facing northeast (upstream). This section of the river is periodically mowed.

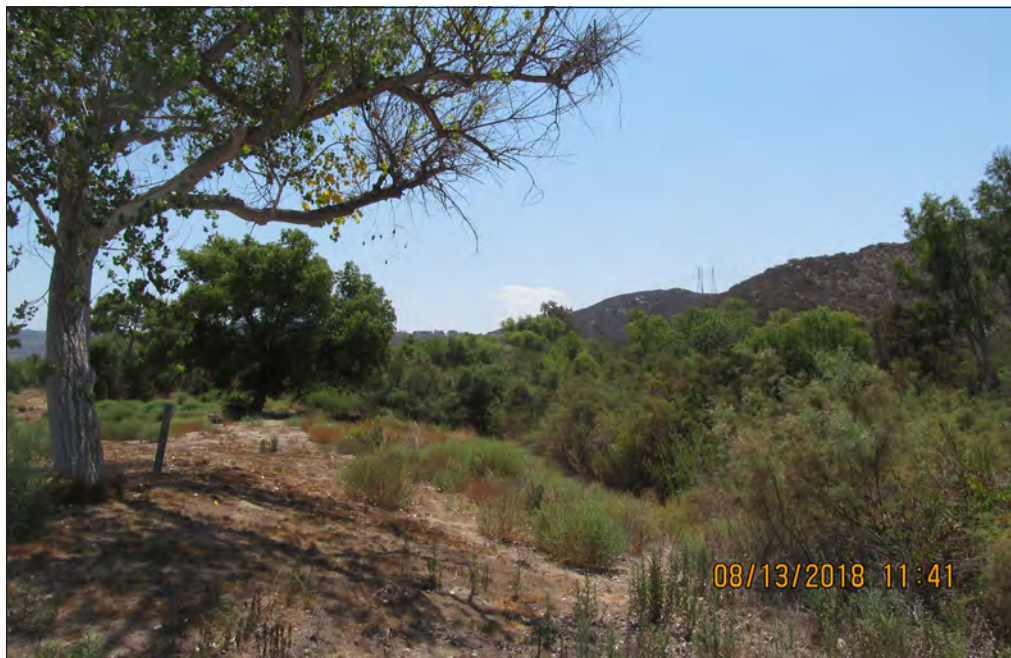
Photo 6. Overview of riparian forest habitat along Sweetwater River in the southwestern portion of the site. Photo is facing east (upstream).

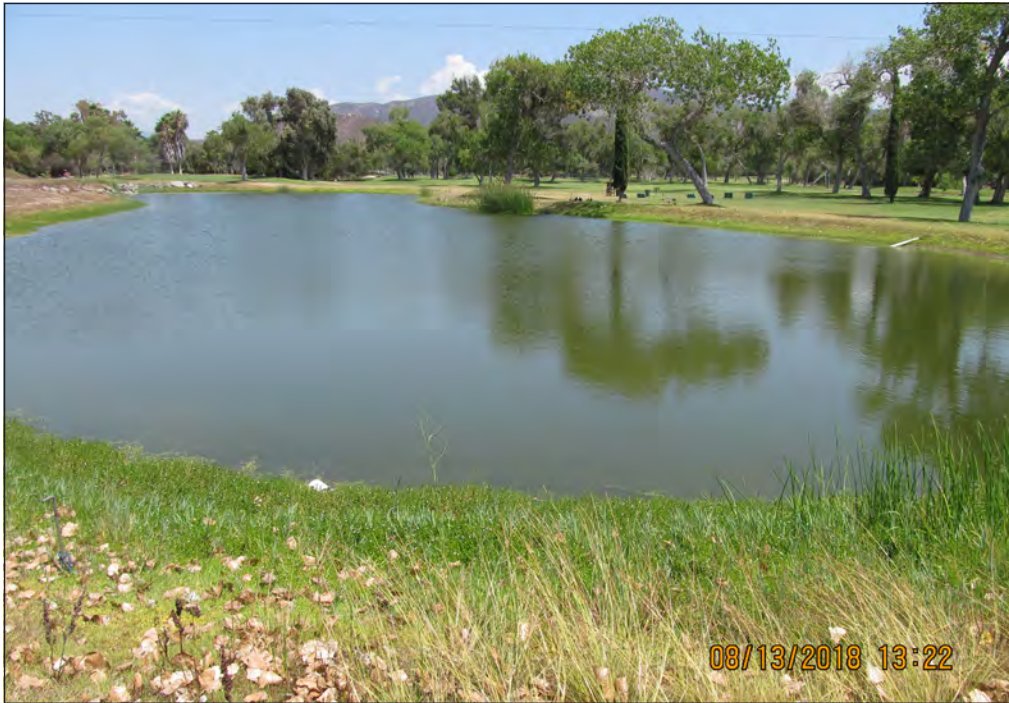
Photo 7. Man-made pond in the eastern portion of the site. Photo is facing east. Water is from an anthropogenic source.

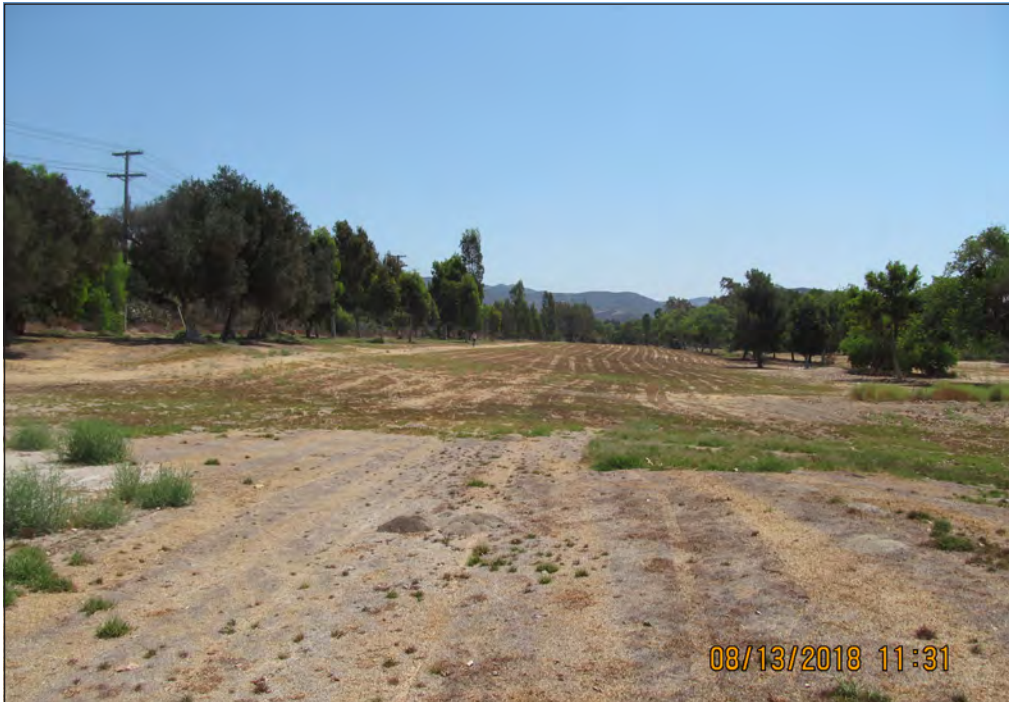
Photo 9. Disturbed habitat in the western portion of the site where golf course maintenance was discontinued. Photo is facing east.

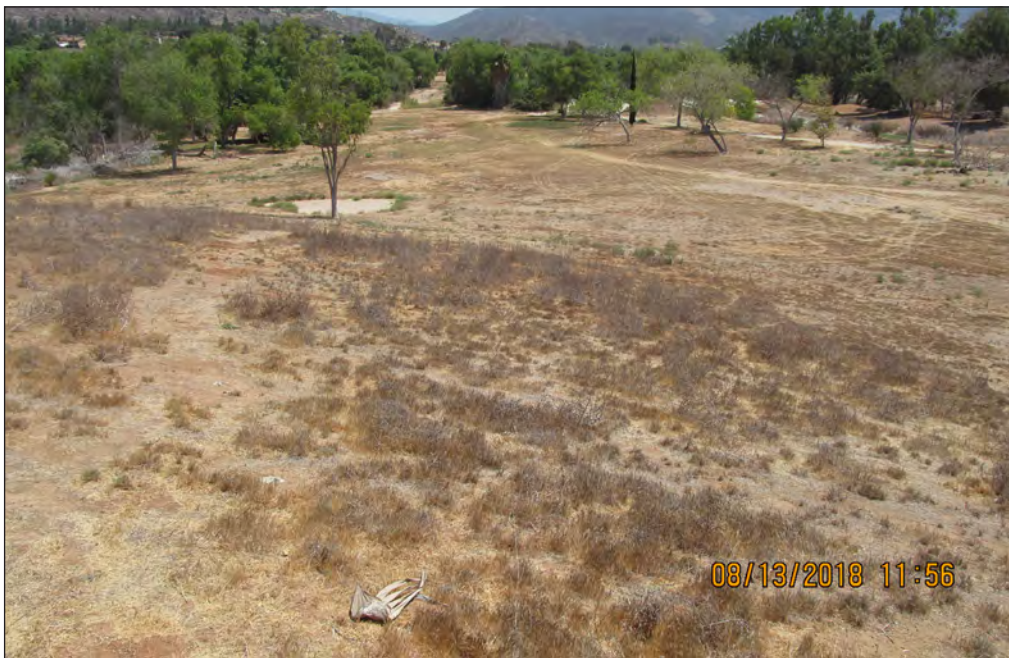
Photo 10. Overview of disturbed habitat in the western portion of the site where golf course maintenance was discontinued. Riparian habitat along the downstream portion of Sweetwater River is on the left side of the photo, which is facing east.
