Phase I Environmental Site Assessment

PHASE I ENVIRONMENTAL SITE ASSESSMENT REPORT

Alder Logistics Center

10380 Alder Avenue
Bloomington, California 92316

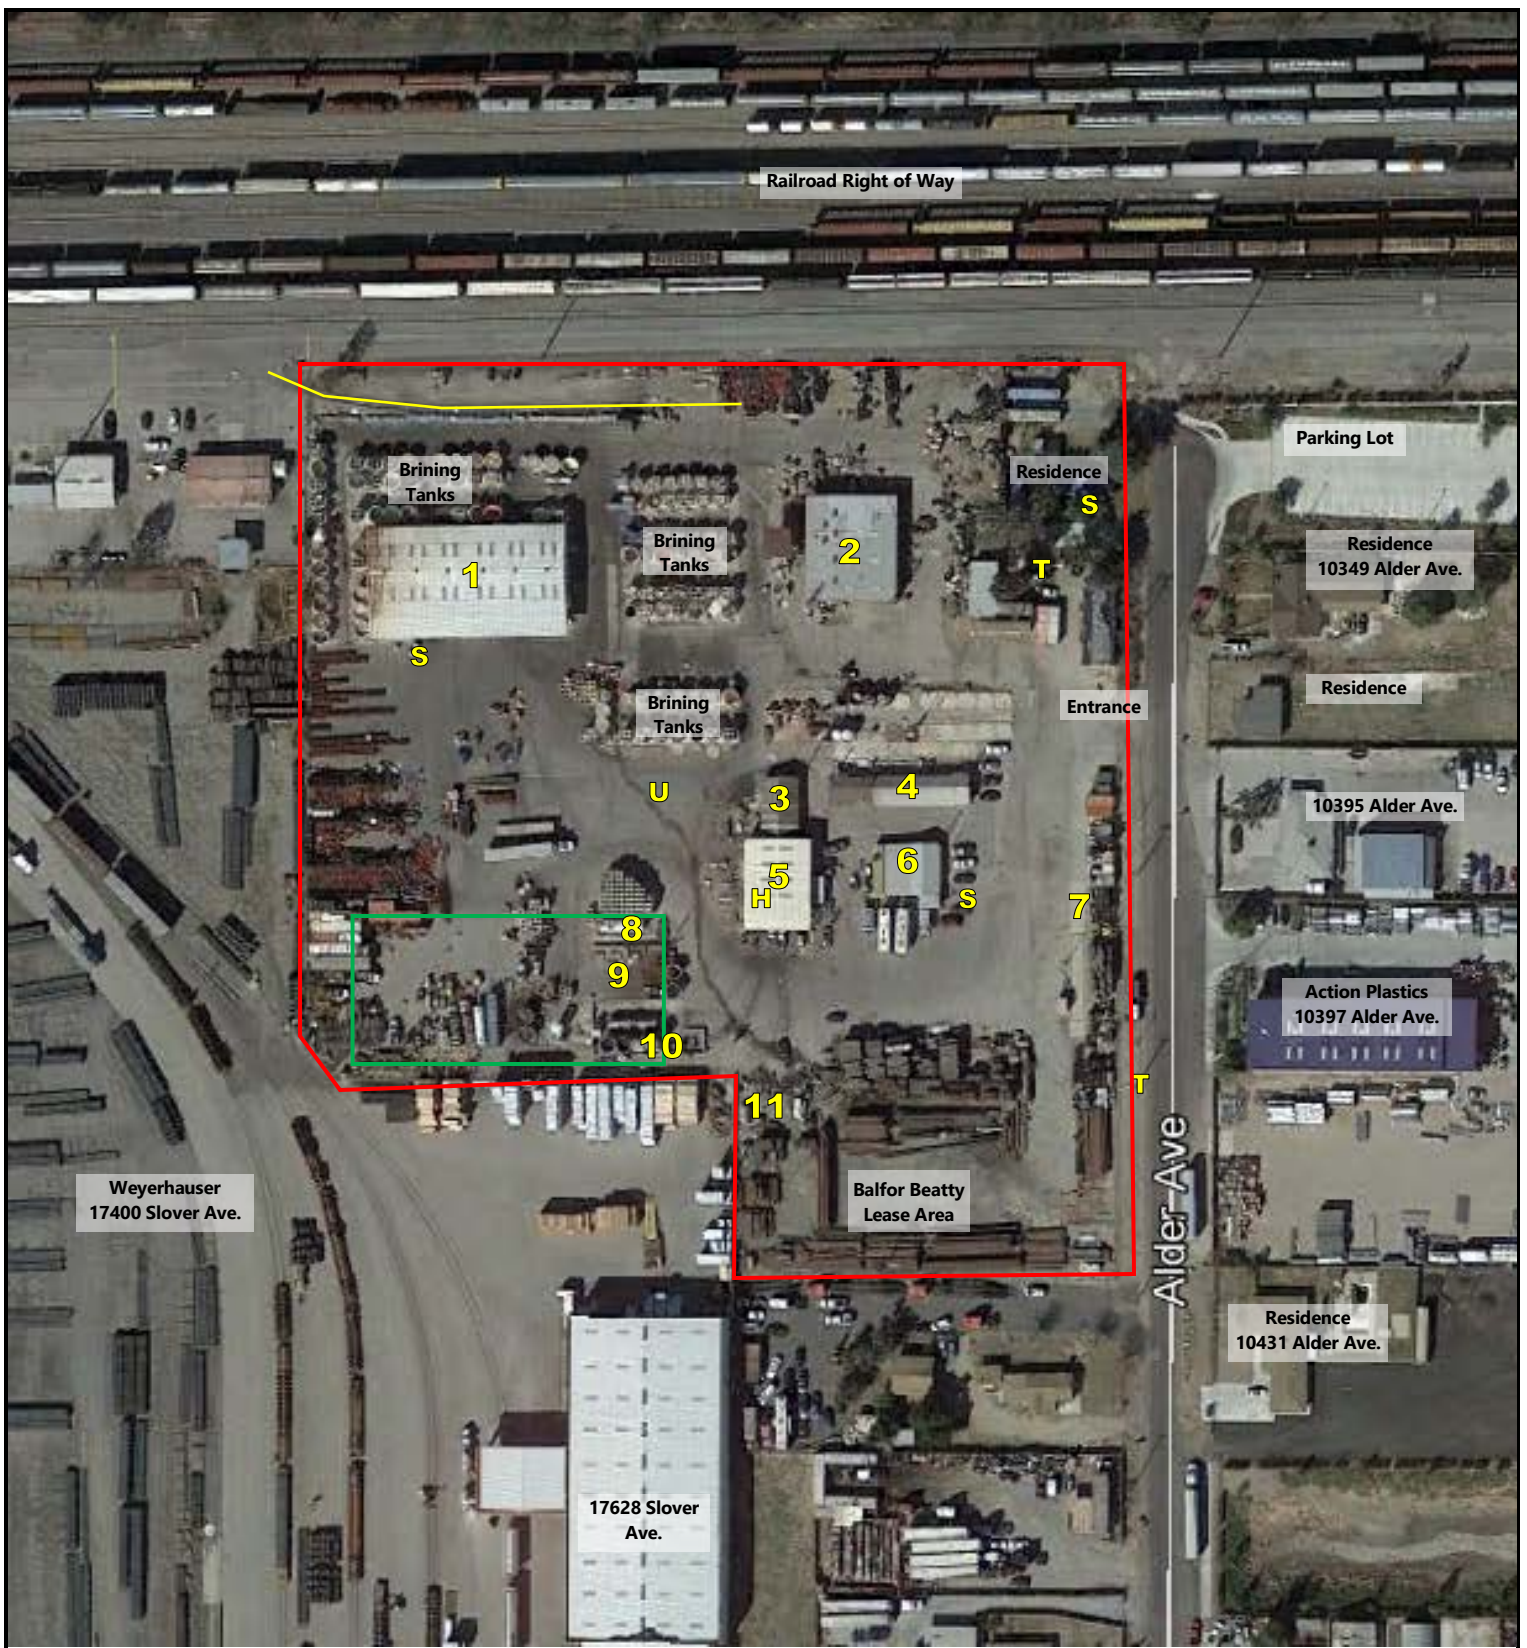
FIGURE 2: SITE PLAN
Project No. 18-230432.1

- KEY:**
- Subject Property
 - Railroad Spur
 - Brine Pond Soil Cap Area
- H** – Hazardous Waste Storage Area
 - T** – Transformer
 - S** – Septic Tanks
 - U** - Former USTs
