# PHASE I ENVIRONMENTAL ASSESSMENT

Warner Center I  
20935, 20955, 21011, and 21031 Warner Center Lane  
Woodland Hills, Los Angeles County, California 91367

Property Solutions Project No. 20131178

Dated: May 10, 2013

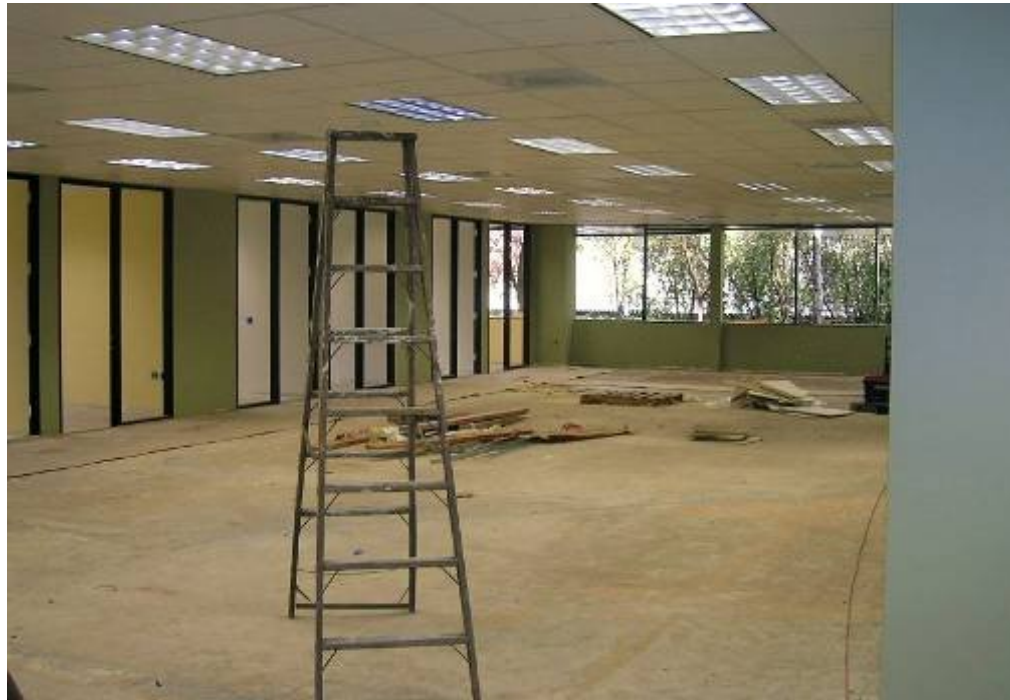
17 View of a major renovation undergoing in one of the buildings in the Subject.

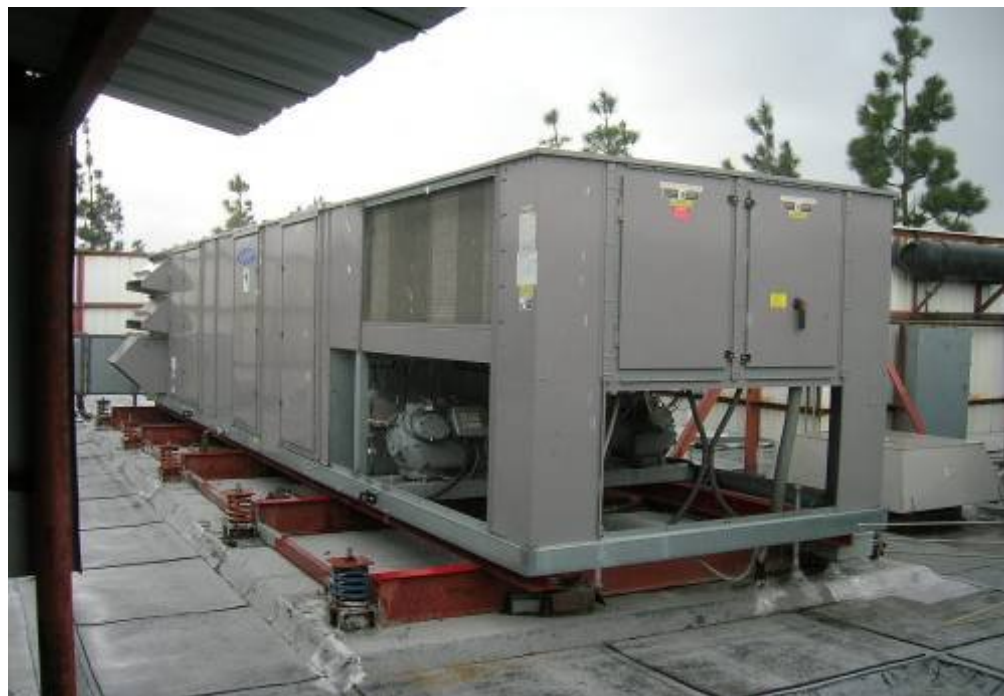
24

View of one of two large air conditioning systems installed on the roof of Bldg F6 at the Subject. Bldg F5 HVAC systems are identical to this.
