Central Coast Blue

Responses to Comments on Final Addendum to the Central Coast Blue EIR

City of Pismo Beach

September 2023

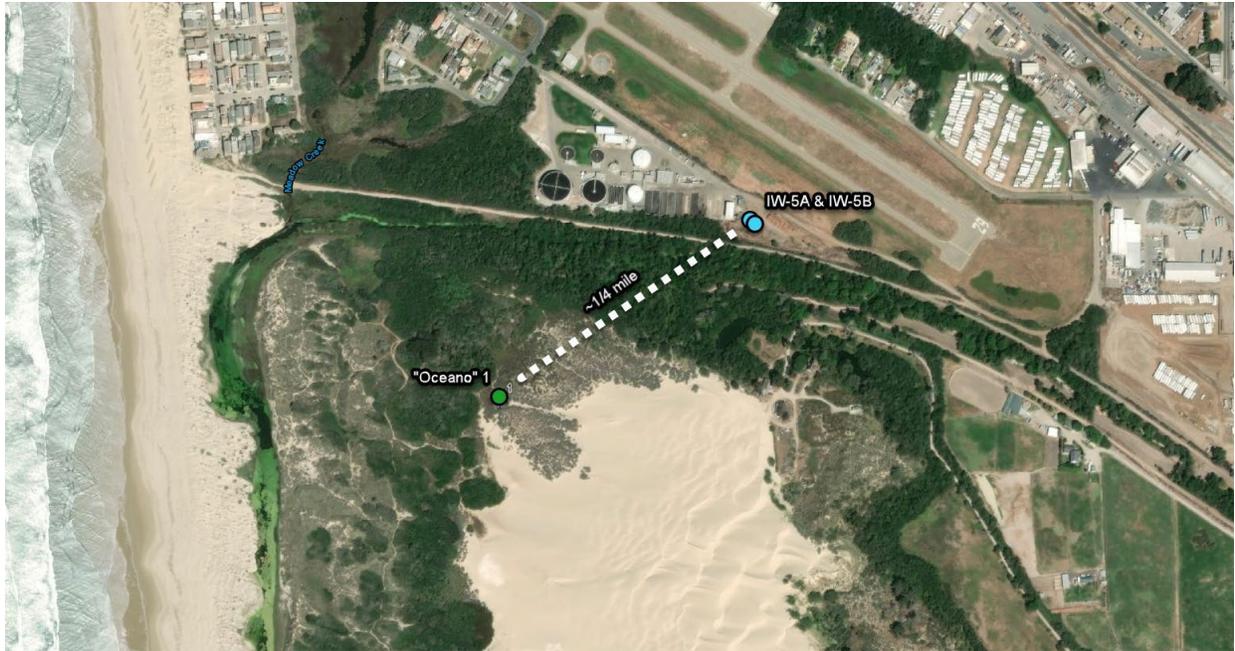
Our records indicate there is one known plugged and abandoned oil or gas well located approximately ¼ mile from proposed injection wells IW-5A and IW-5B, as shown below (Figure 1). The injection wells are proposed for injection at a depth of approximately 200 to 600 feet below ground surface. The details of the oil or gas well located near the injection wells is discussed below.

Figure 1. Proposed injection wells (IW-5A & IW-5B) and plugged and abandoned oil well ("Oceano" 1). To view information and locations for oil and gas wells visit <https://www.conservation.ca.gov/calgem/Pages/WellFinder.aspx>

Well	Status
<p>"Oceano" 1 Madonna Construction Co. API: 079-00329</p>	<p>The record review process shows that this well is not abandoned consistent with current PRC and California Code of Regulations, title 14, (CCR) as of August 24, 2020.</p> <p>Based on the well records:</p> <ol style="list-style-type: none"> 1. Casing shoe plug is not to current standards (CCR section 1723.3). 2. Surface plug is not to current standards (CCR section 1723.5). <p>The base of freshwater is at approximately 1,000 feet measured depth according to the electric log run on 3/14/1957. A cement plug was placed from 1,100 feet to 777 feet according to records. The cement plug meets current standards for freshwater protection.</p>

CalGEM recommends that the plugged and abandoned oil well be considered in any modeling of injection pressure and fluid flow. CalGEM recommends that injection wells be completed in a stratigraphically equivalent or higher zone positioned above the base of freshwater plug, if there is potential for the injection wells to influence the well. Careful consideration of the proposed injection interval placement may reduce the potential risk for downward or upward flow between the injection interval and the portion of the plugged and abandoned well below the base of freshwater plug.

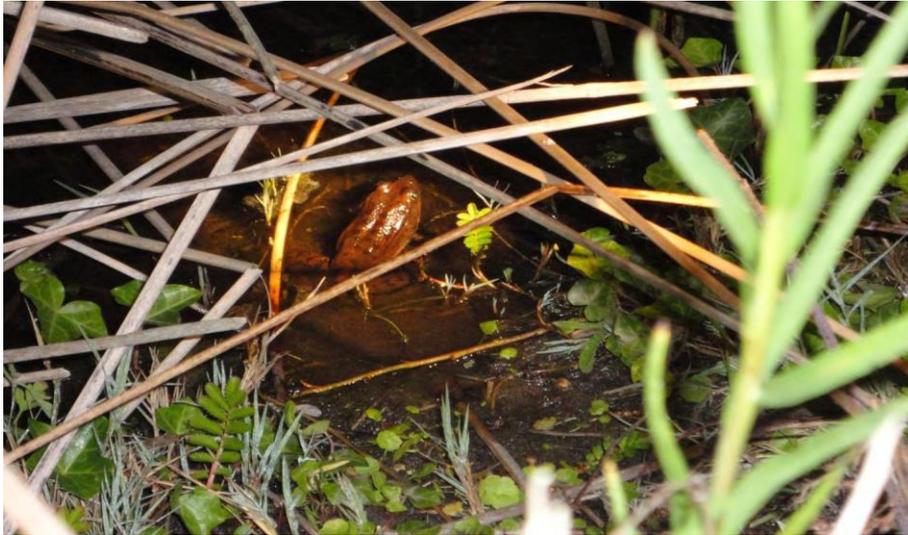
The CRLF, pictured below, was observed at the footbridge that was installed by SSLOCSD many years ago. The footbridge was recently removed due to homeless encampment activities, on the westerly boundary of the SSLOCSD property.

Photo 18. Individual California red-legged frog observed near footbridge during night eyeshine survey (May 30, 2012).

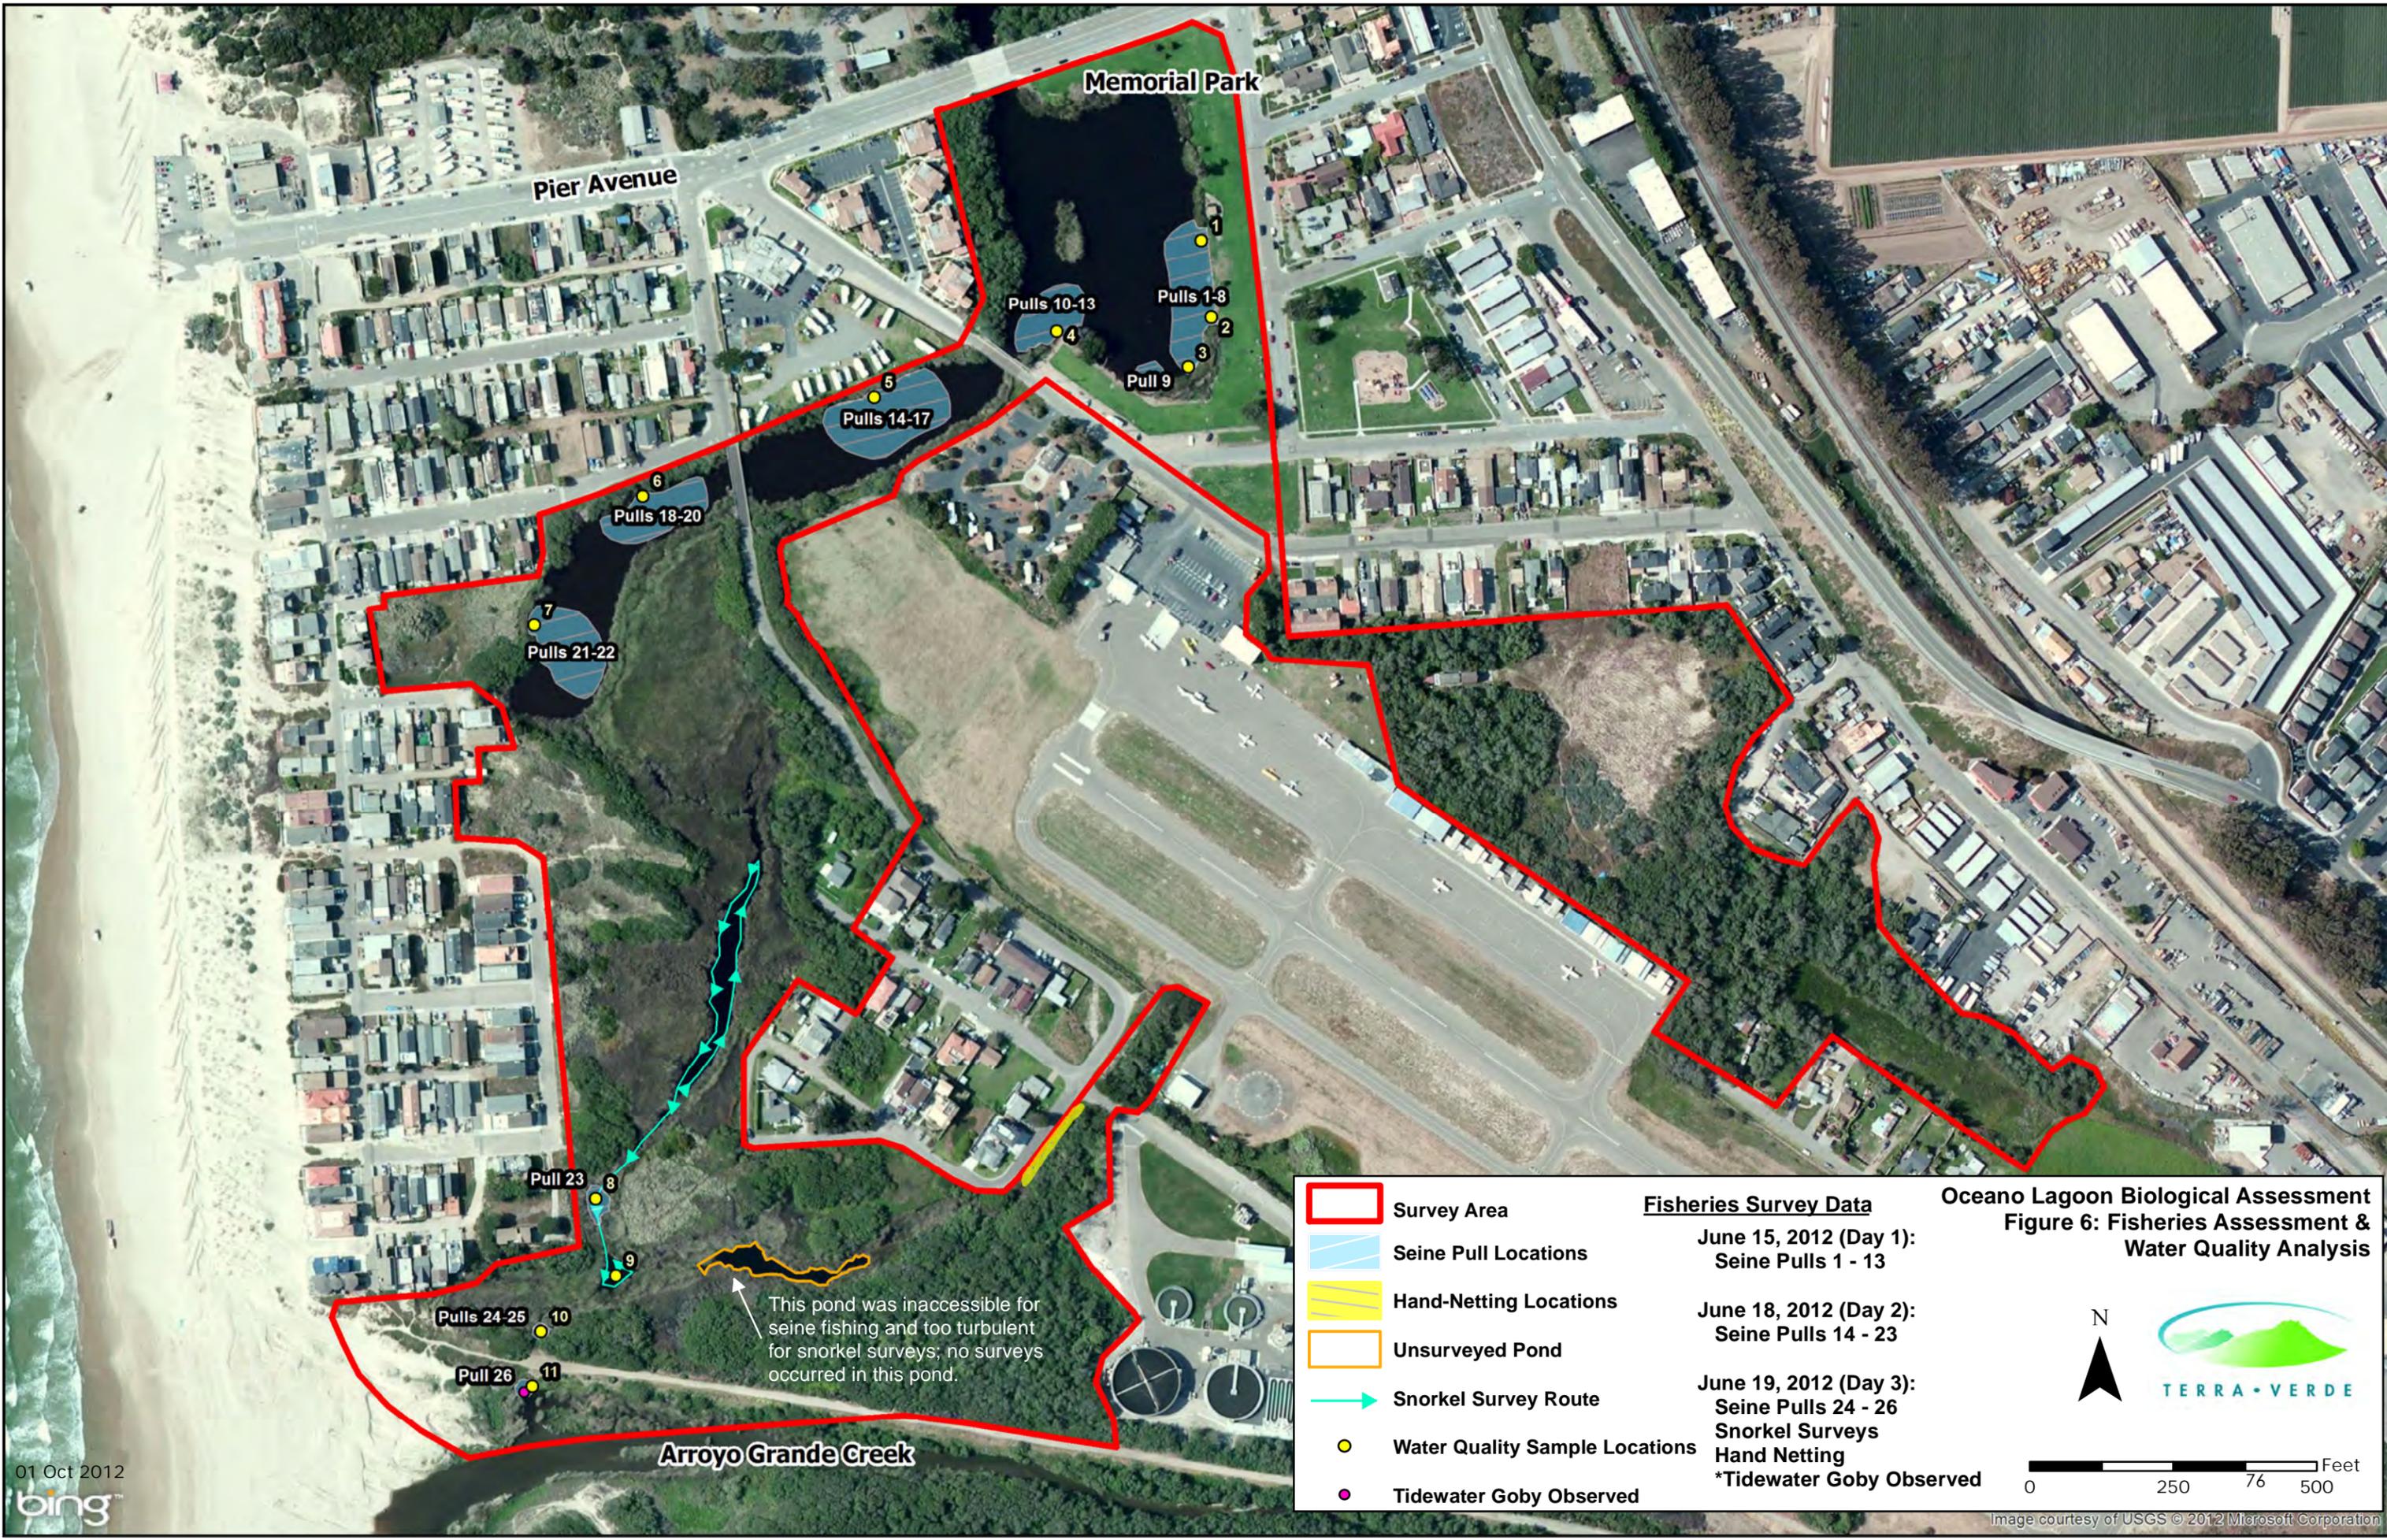
<ul style="list-style-type: none"> Survey Area Seine Pull Locations Hand-Netting Locations Unsurveyed Pond ➔ Snorkel Survey Route ● Water Quality Sample Locations ● Tidewater Goby Observed 	<p>Fisheries Survey Data</p> <p>June 15, 2012 (Day 1): Seine Pulls 1 - 13</p> <p>June 18, 2012 (Day 2): Seine Pulls 14 - 23</p> <p>June 19, 2012 (Day 3): Seine Pulls 24 - 26 Snorkel Surveys Hand Netting *Tidewater Goby Observed</p>	<p>Oceano Lagoon Biological Assessment Figure 6: Fisheries Assessment & Water Quality Analysis</p> <div style="text-align: center;">

The results of the water quality analysis closely correlate with the fisheries assessment data, which shows a greater population density and species diversity in areas of the upper lagoon with a higher percent of dissolved oxygen. Factors that determine the percent dissolved oxygen in an aquatic system include diffusion from the air, wind, and other factors that create turbulence at the surface, and photosynthesis (Horne 1994). The greatest percent of dissolved oxygen was observed in the open water habitat of the upper portion of the lagoon. This is likely due to the wind turbulence observed at this location during surveys and the amount of available sunlight to execute photosynthesis. As the lagoon transitions from deep, open water to a shallow, densely vegetated freshwater marsh, the percent of dissolved oxygen declines, along with the overall density of fish populations. Table 2 below summarizes the data collected during the water quality analysis. See Figure 6 for a review of water quality sampling locations.

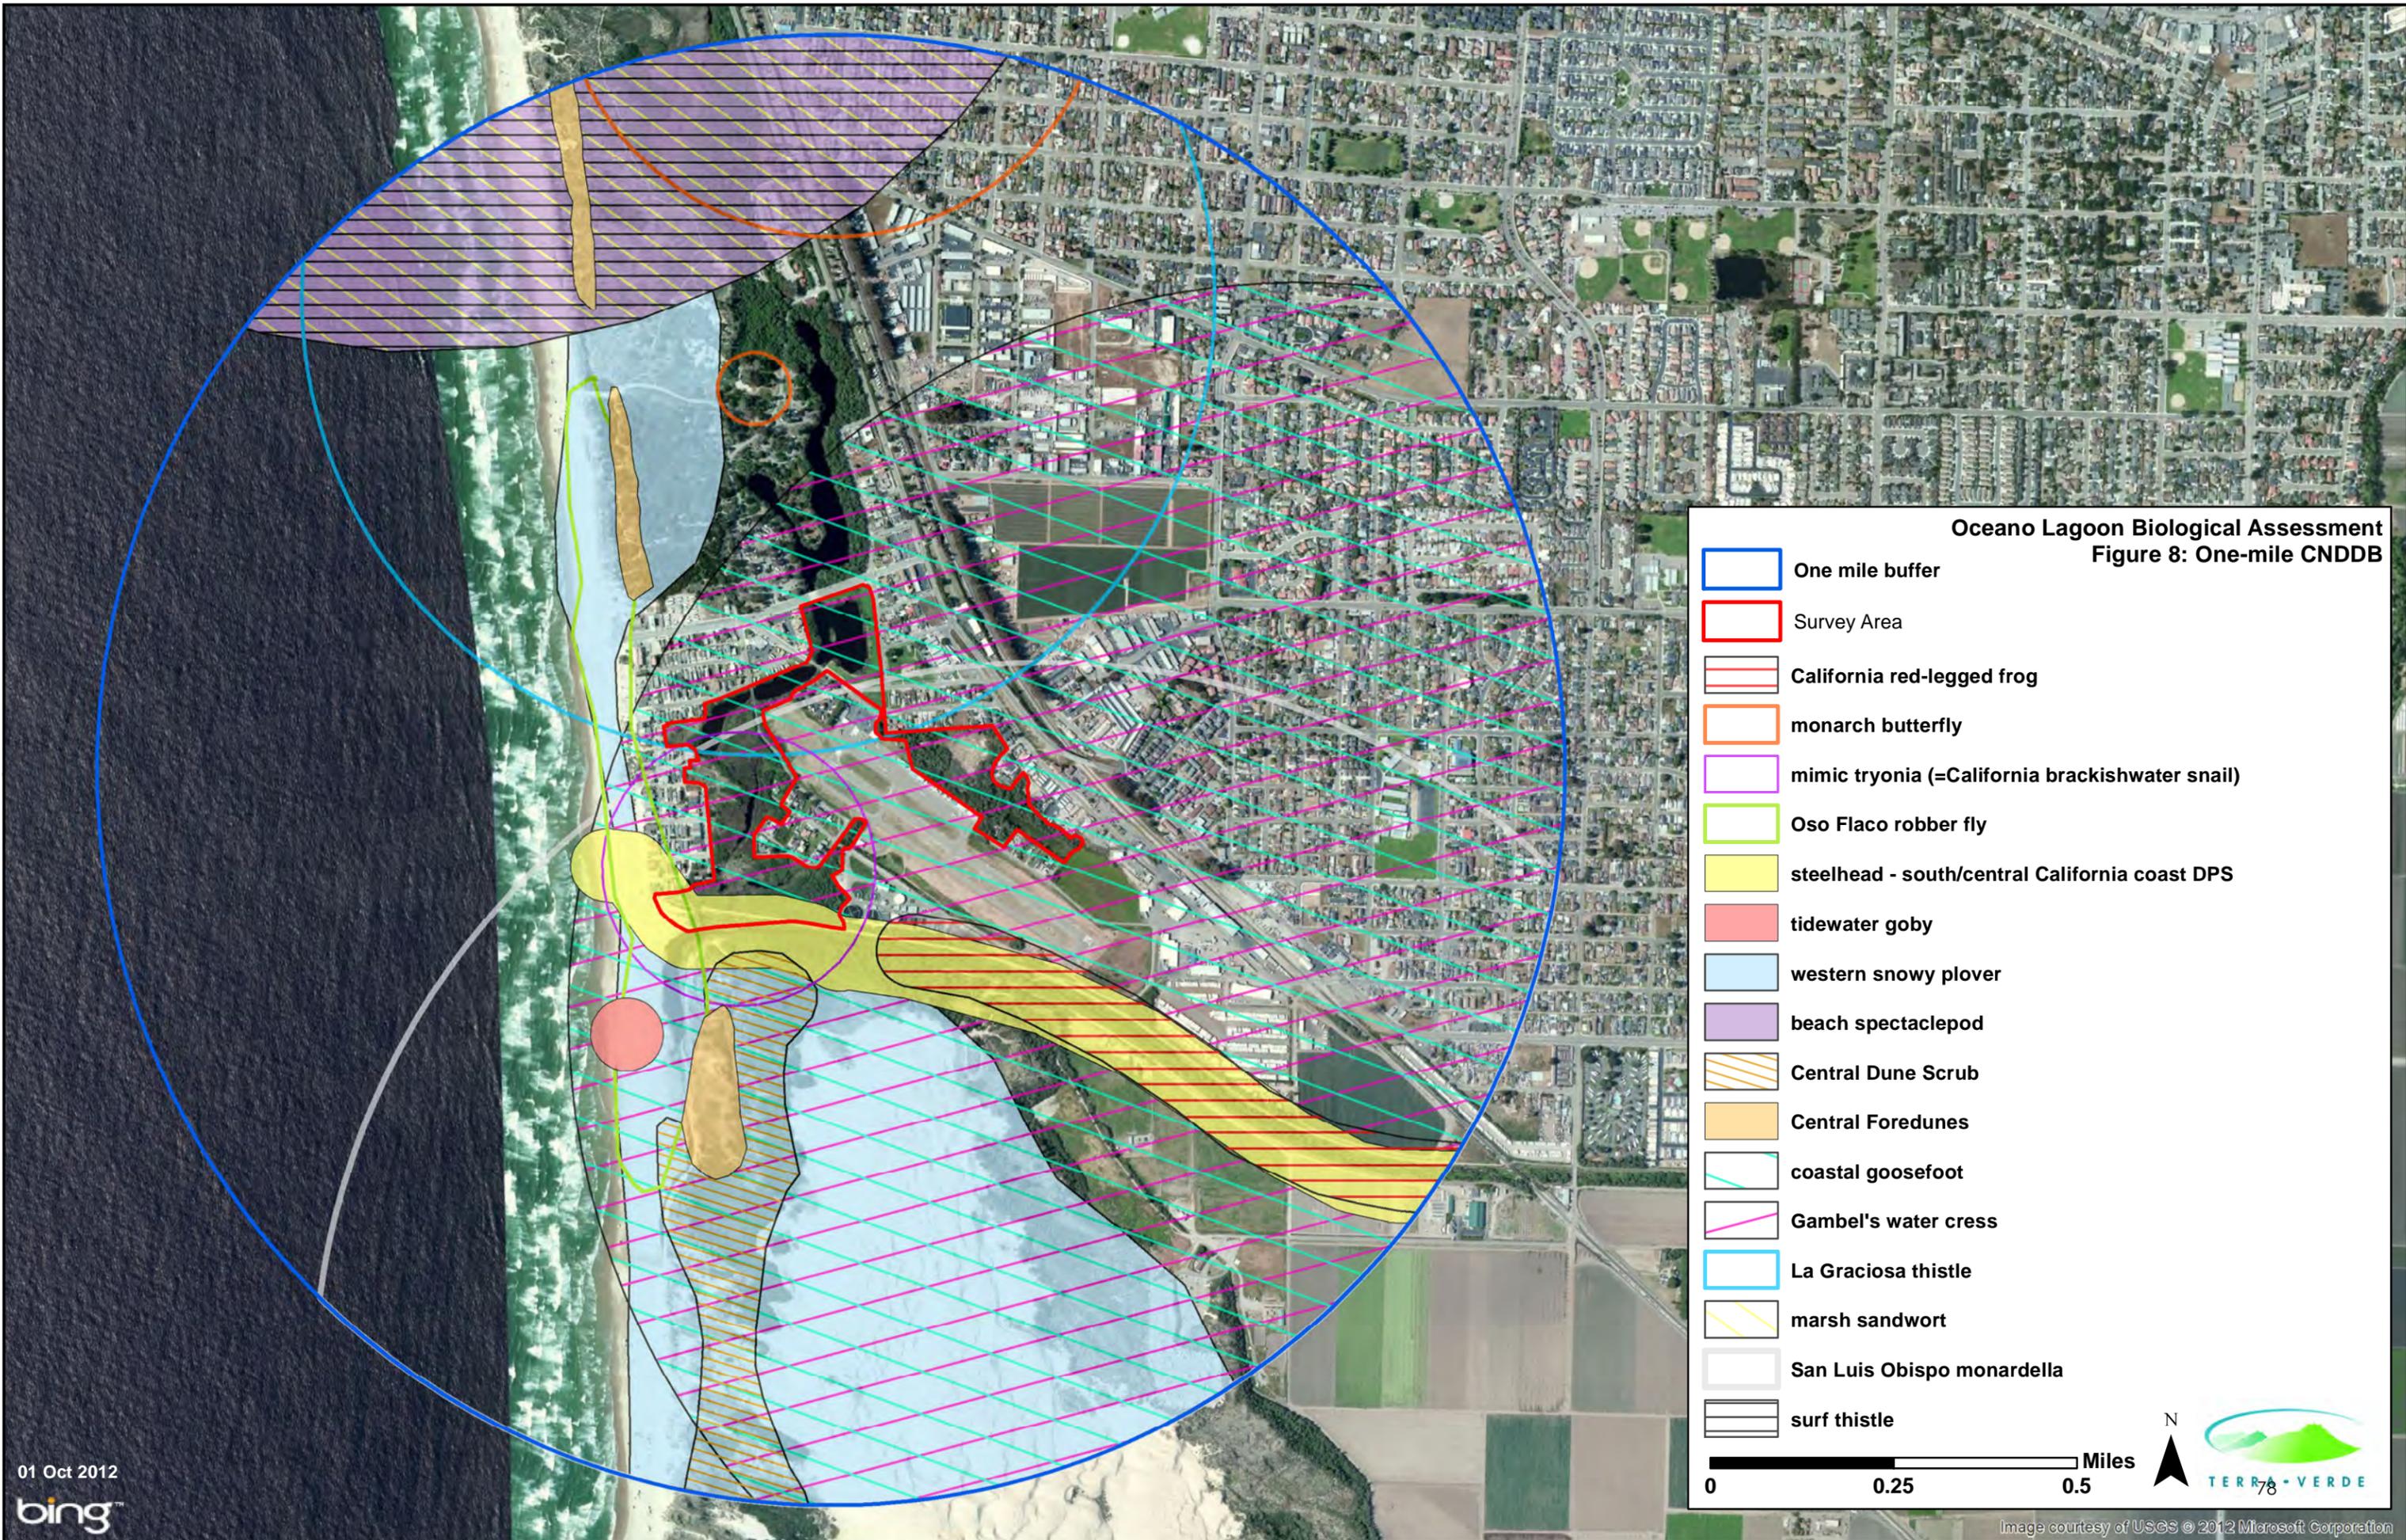
Oceano Lagoon Biological Assessment
Figure 8: One-mile CNDDB

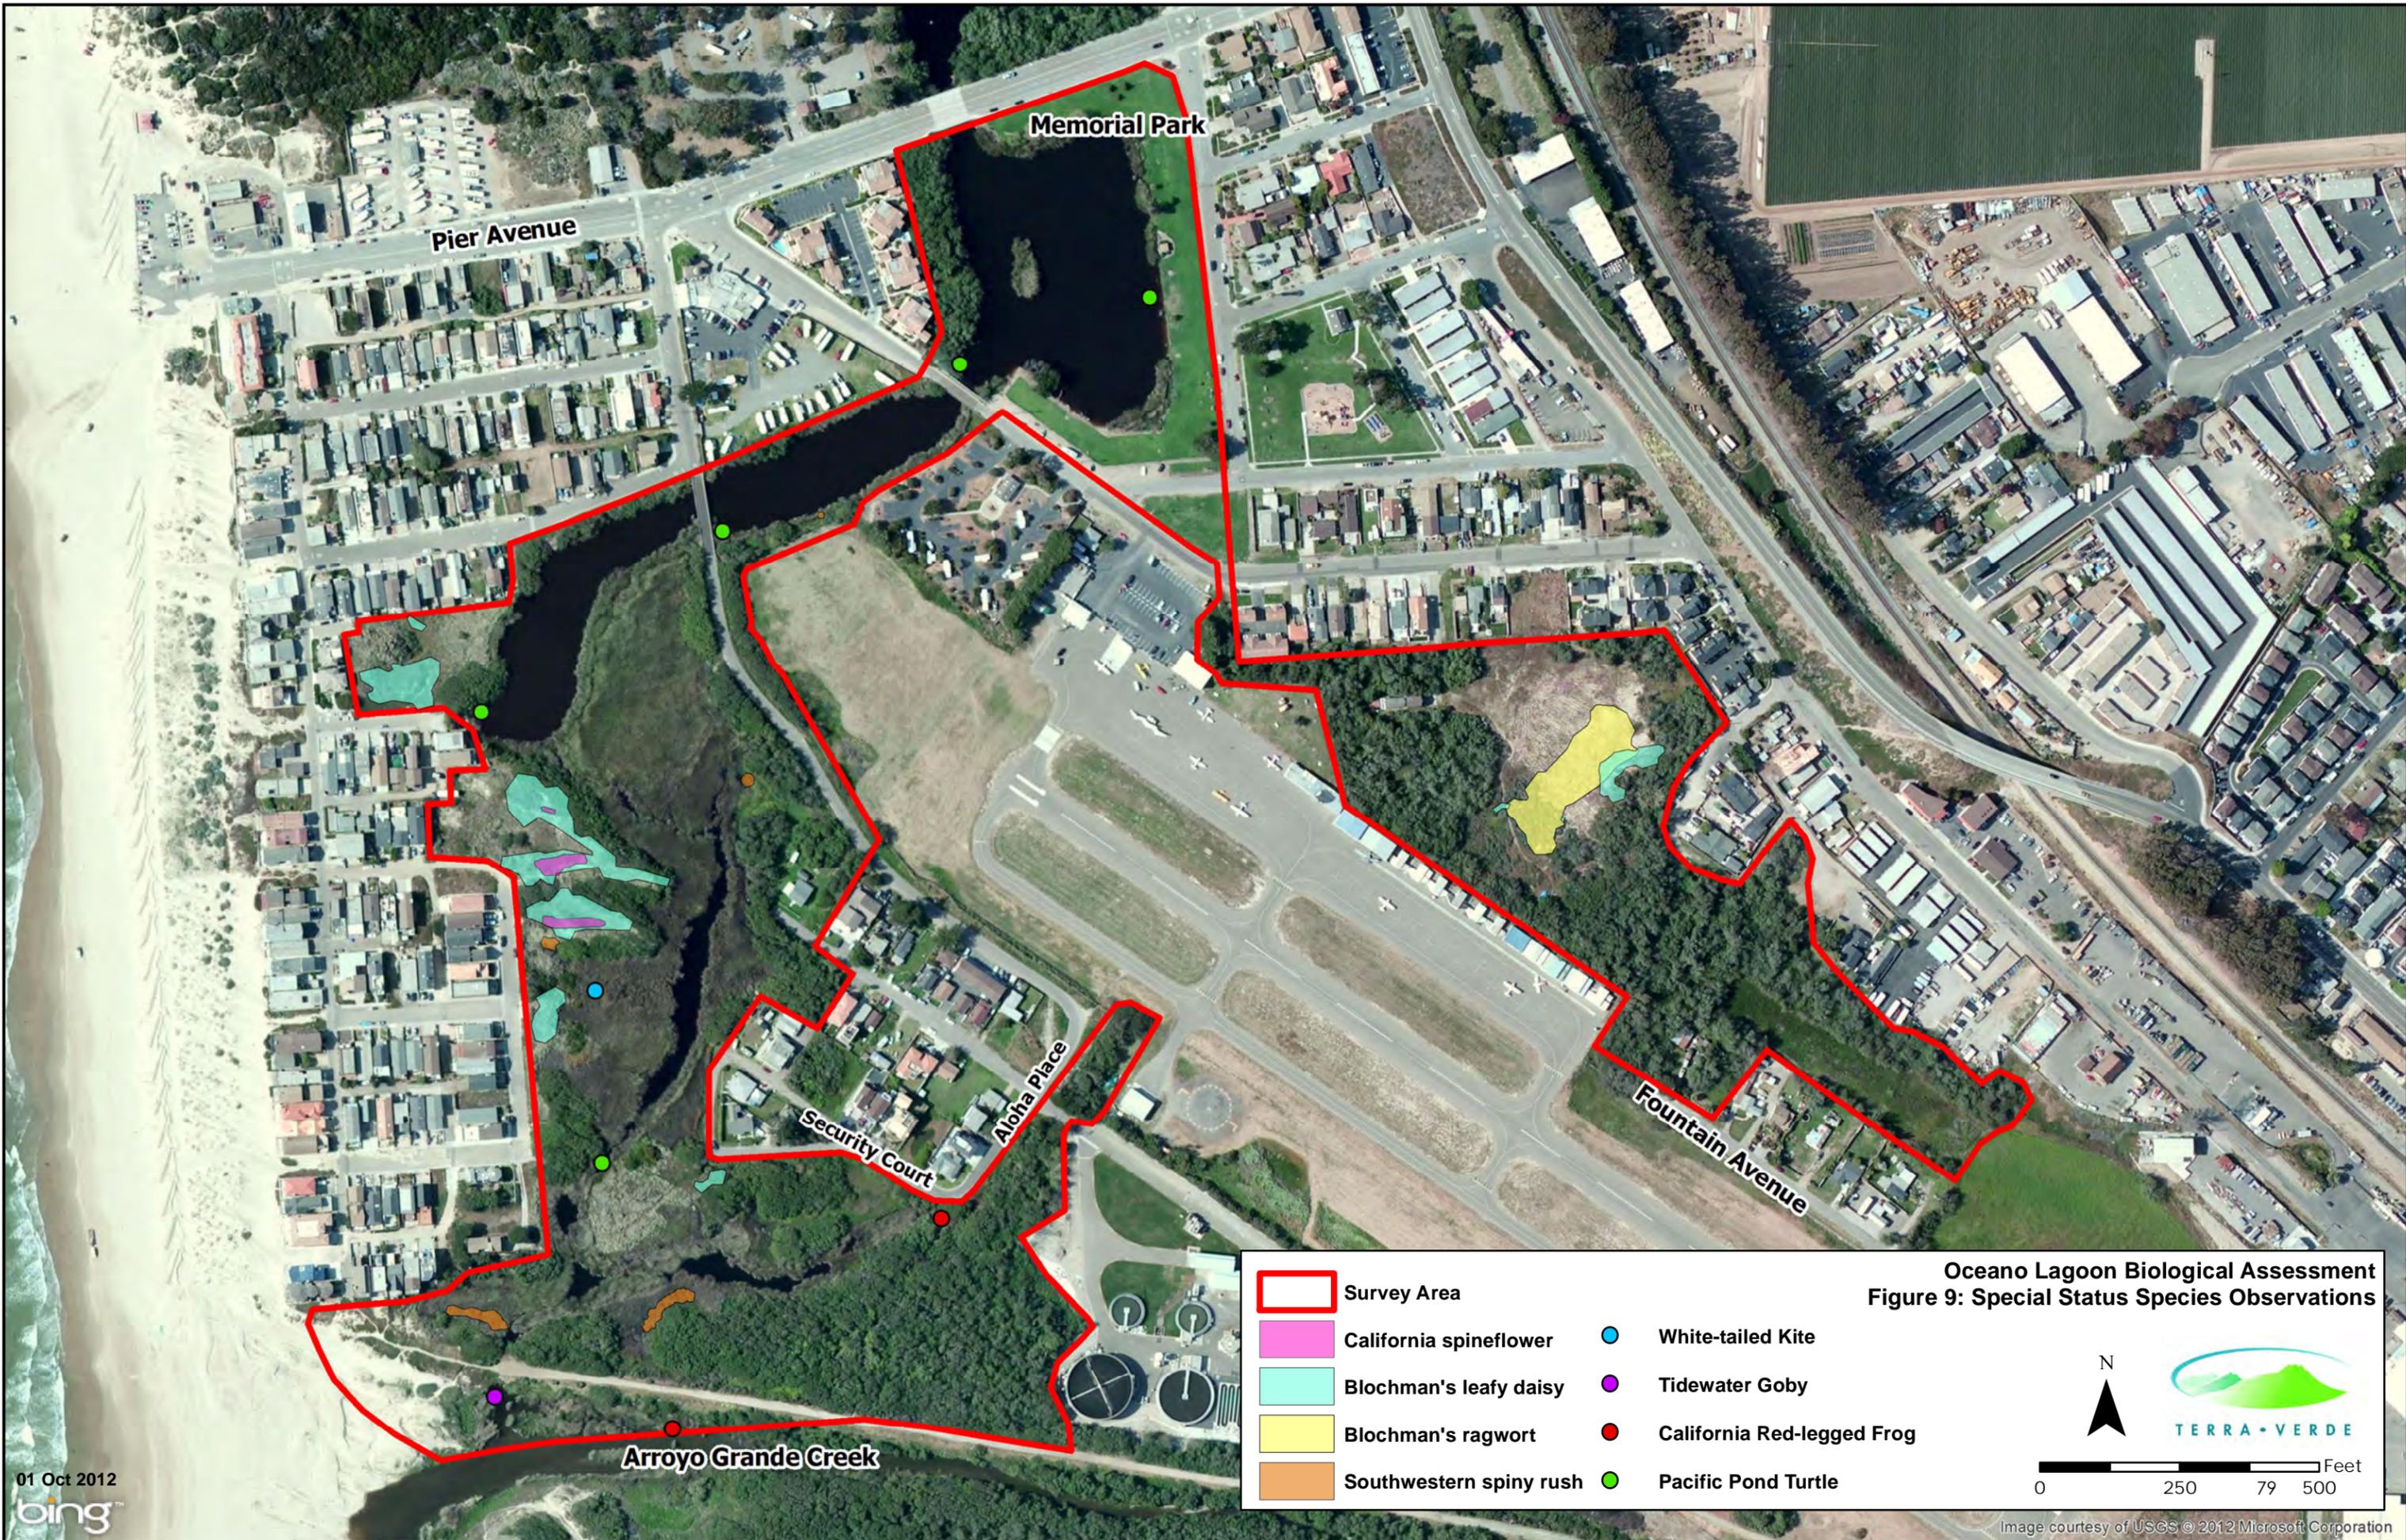
Oceano Lagoon Biological Assessment
 Figure 9: Special Status Species Observations

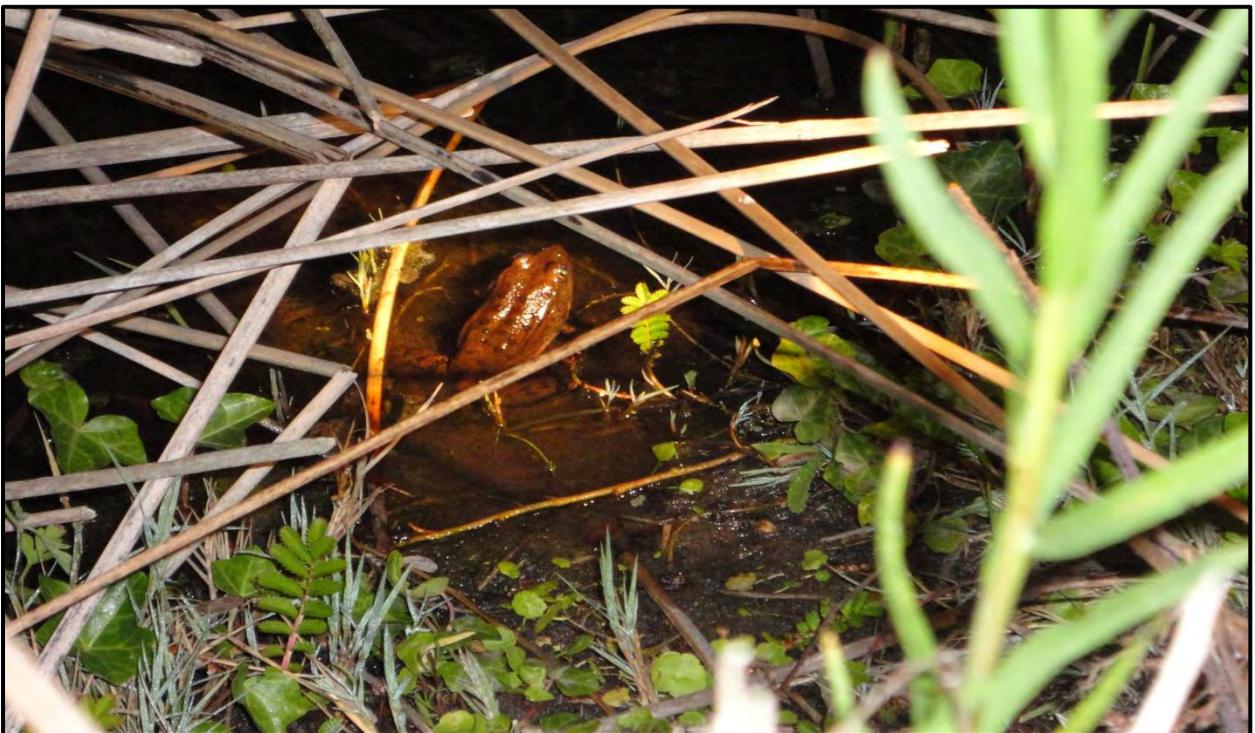
Photo 18. Individual California red-legged frog observed near footbridge during night eyeshine survey (May 30, 2012).

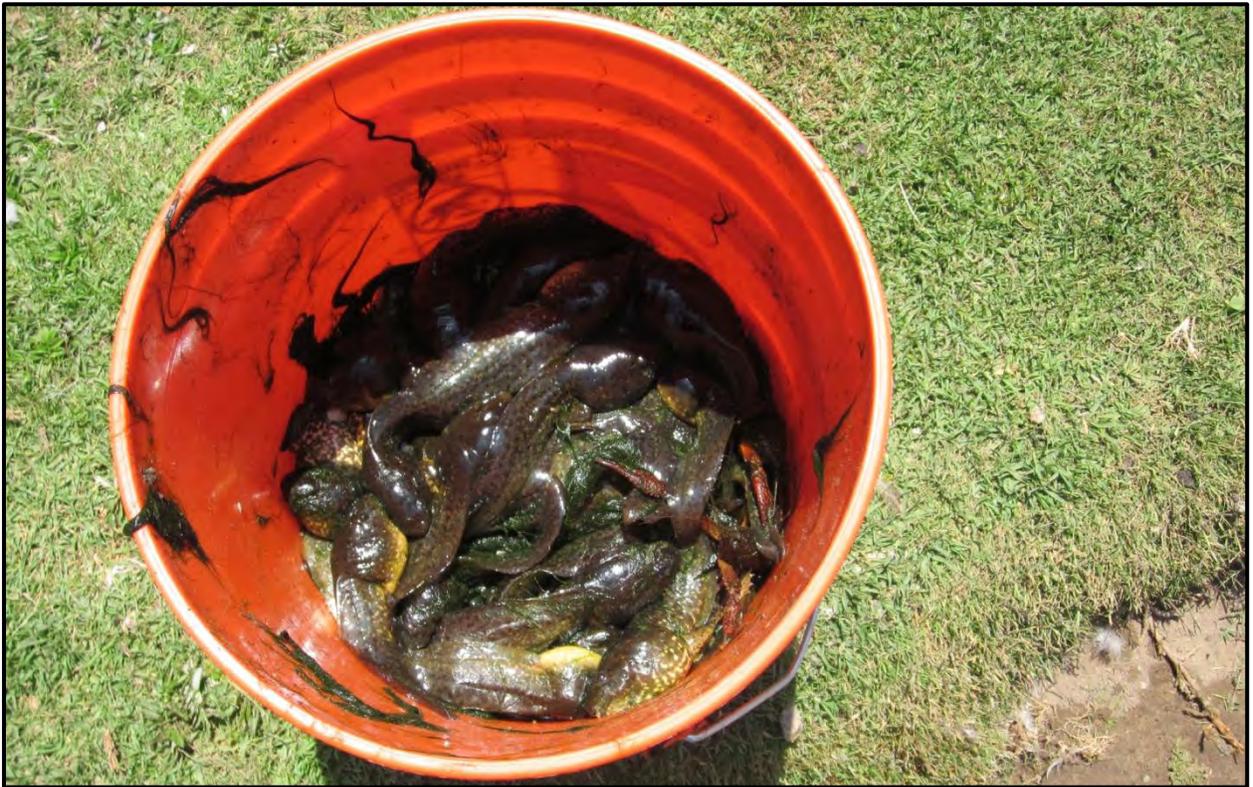
Photo 20. American bullfrog tadpoles caught in seine net (June 15, 2012).

this location was the highest abundance of bull frog captured during the course of the surveys, (see Photo 20 in Appendix D).

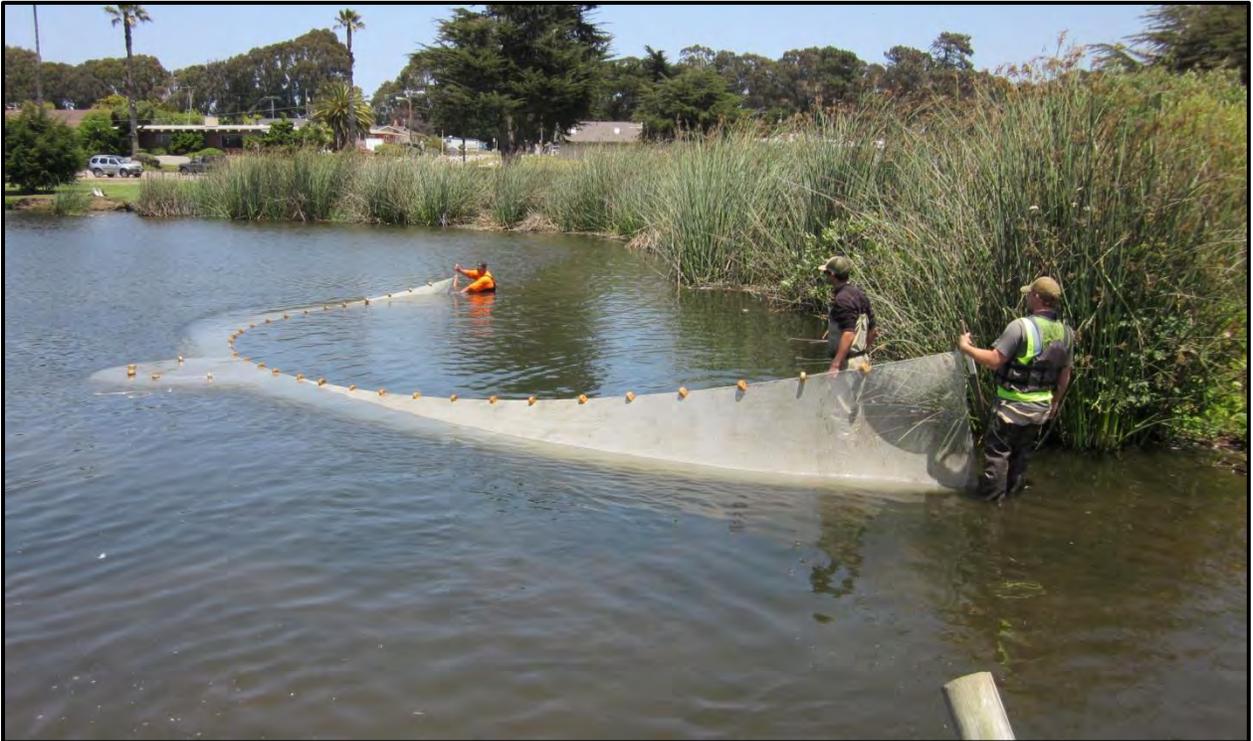
Photo 21. Seining along the eastern perimeter of Memorial Park (June 15, 2012).

A fisheries assessment was conducted within the Meadow Creek Lagoon, which included all accessible, open water areas within the survey area. The lagoon was sampled by a team of four biologists over the course of three days on June 15, 18, and 19, 2012. These efforts consisted of two and a half days of seine fishing and a half-day of snorkel surveys. One narrow channel of water in the southern extent of the survey area with restricted access was sampled by hand-netting; another larger channel of water in the southern extent of the survey area was not surveyed due to inaccessibility for seine fishing, and lack of visibility for snorkel surveys (see Figure 6: Fisheries Assessment and Water Quality Analysis). A beach seine 22 meters (m) long by 1.8 m deep and with a mesh size of approximately 3 millimeters was the primary sampling tool used to capture fish. A 1-foot by 1-foot hand net with similar mesh size was used when the seine was not applicable. In most cases, the seine was deployed by two to four biologists that utilized traditional seining tactics. The large seine allowed for the potential capture of benthic, semi-pelagic, and pelagic species. A two-man canoe was also utilized to deploy the seine in areas of deep water (greater than five feet deep).

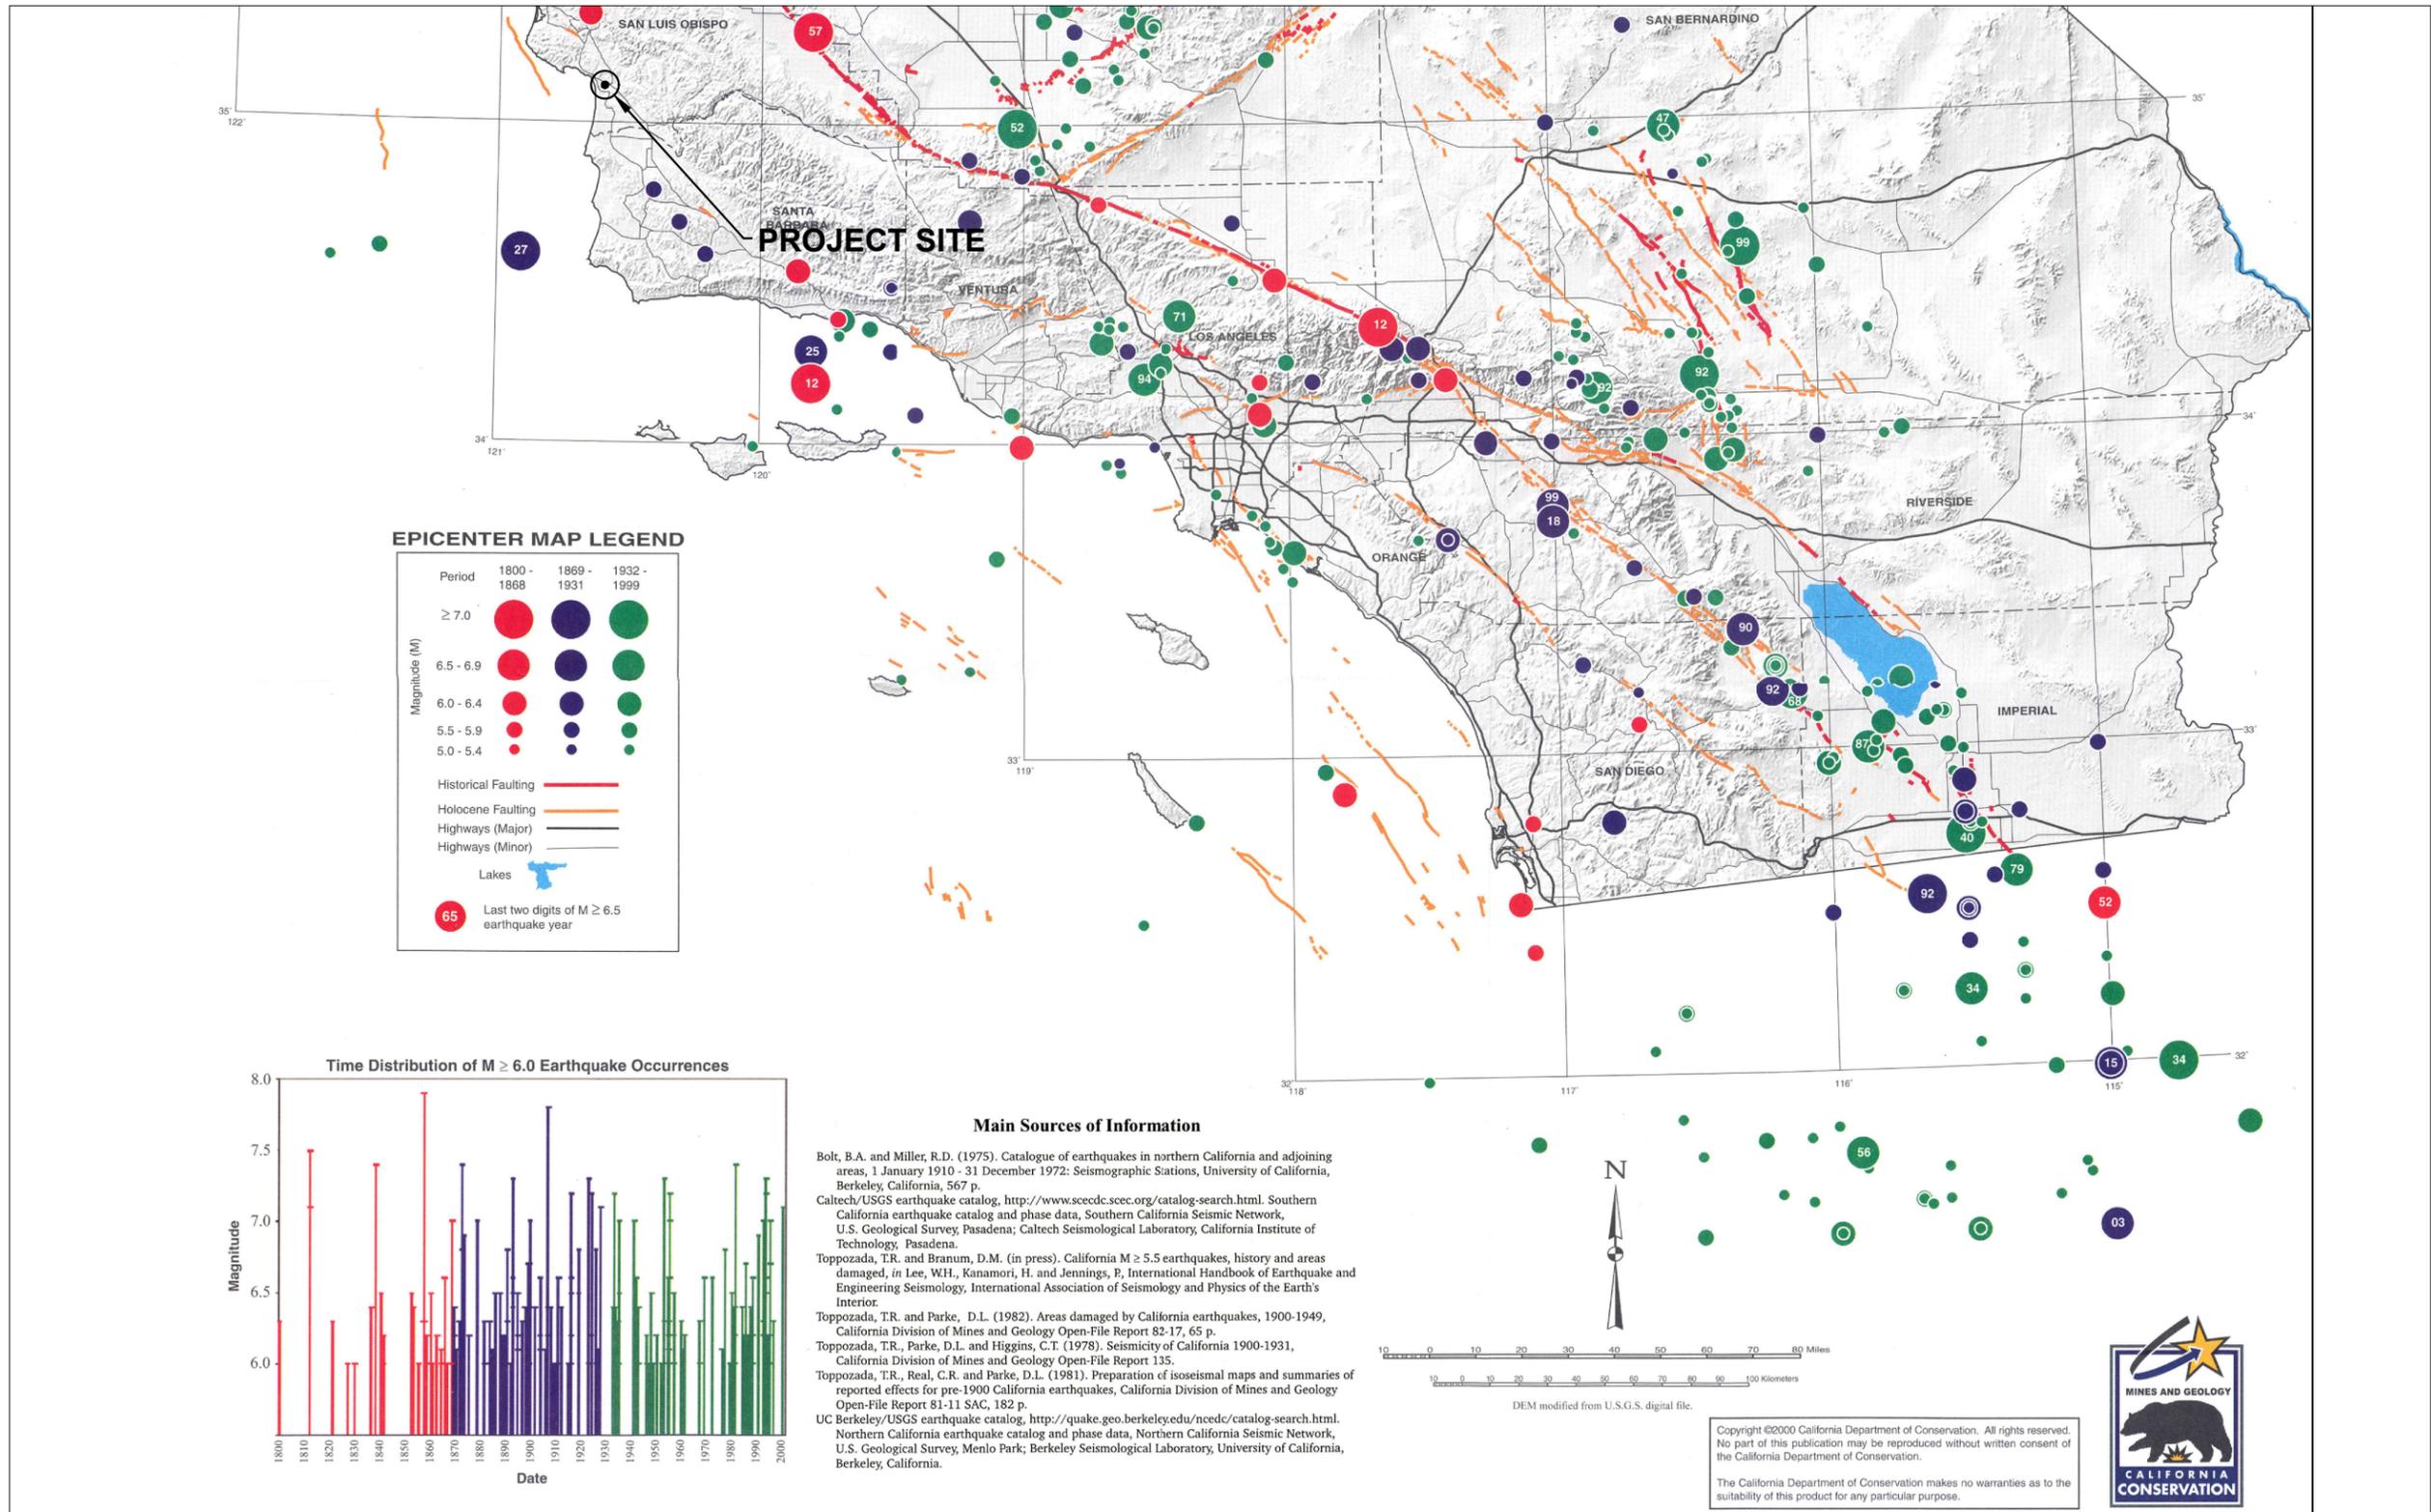
EPICENTER MAP OF SOUTHERN CALIFORNIA EARTHQUAKES (1800-1999)

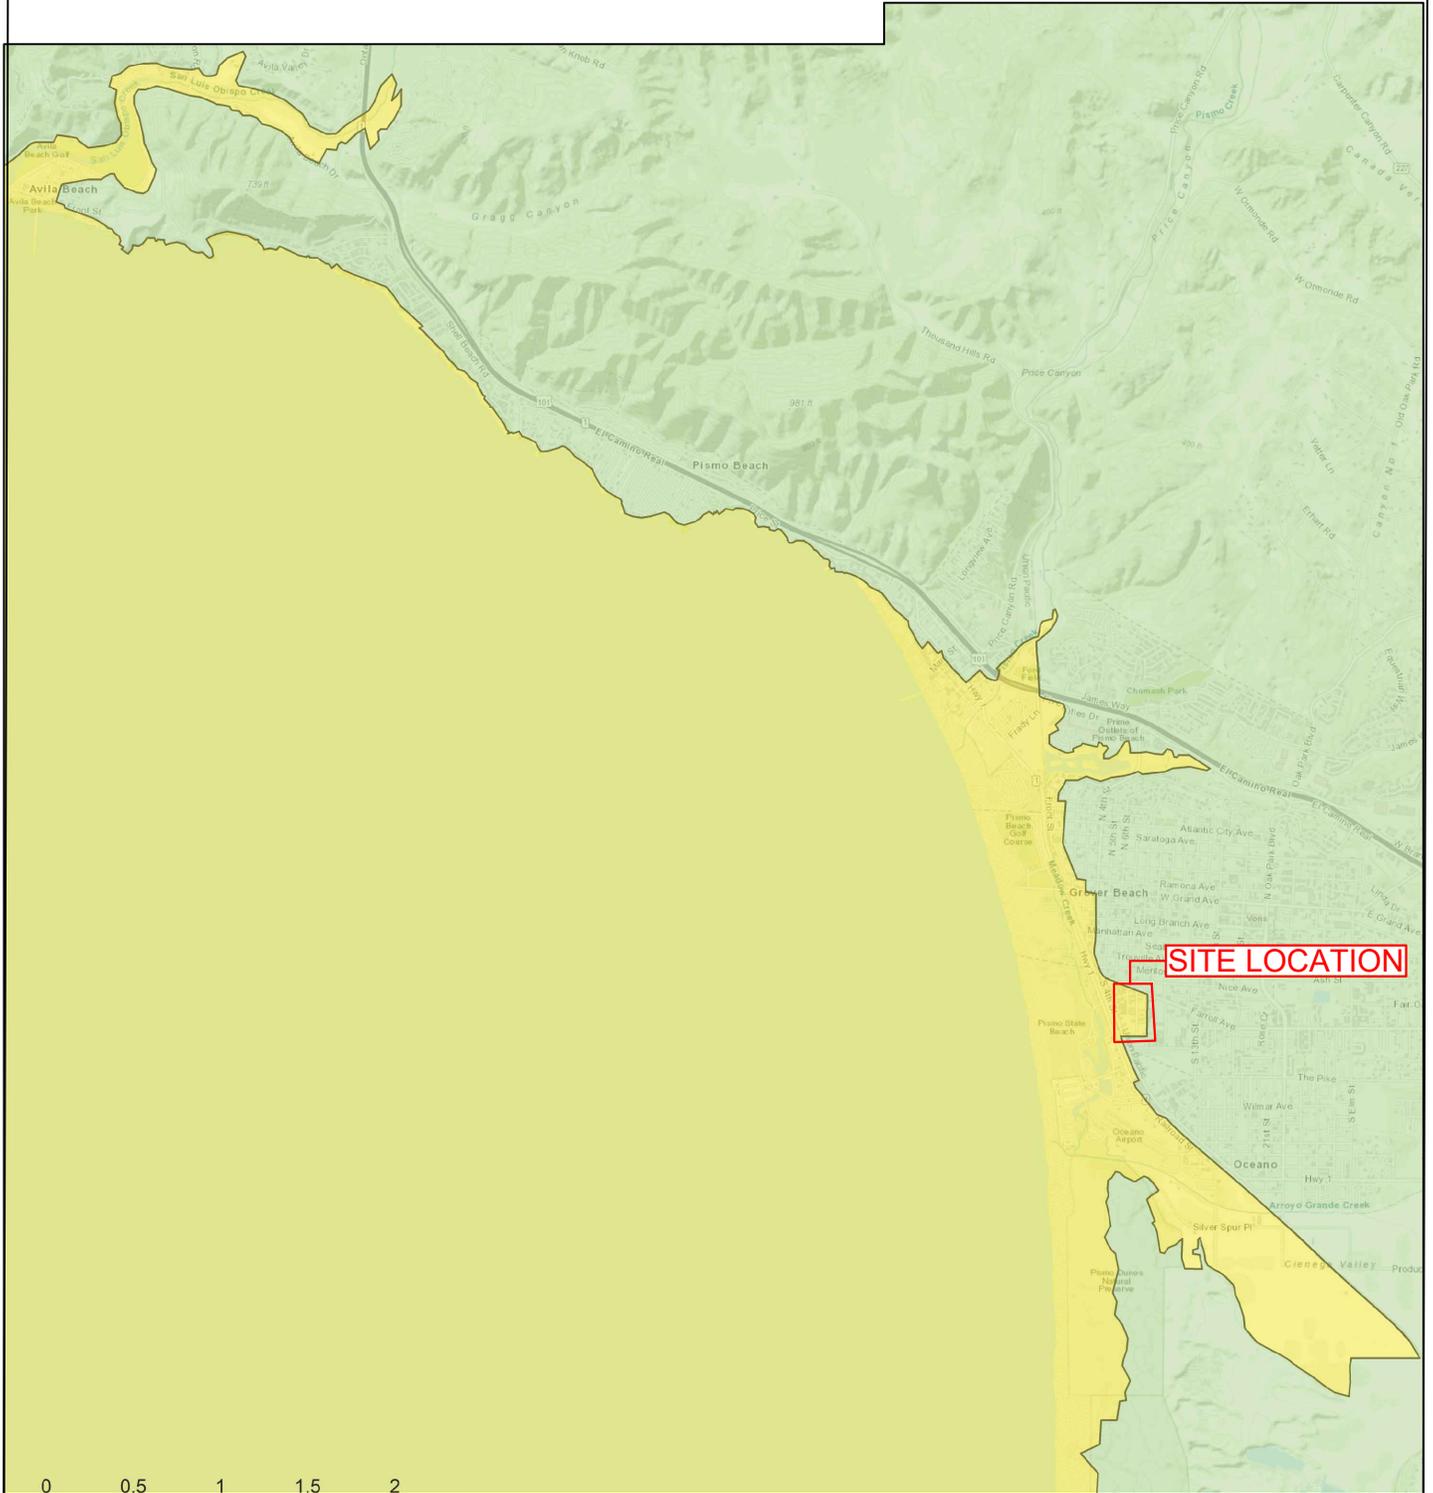
Tsunami Hazard Map
