Central Coast Blue

Responses to Comments on Final Addendum to the Central Coast Blue EIR

City of Pismo Beach

September 2023

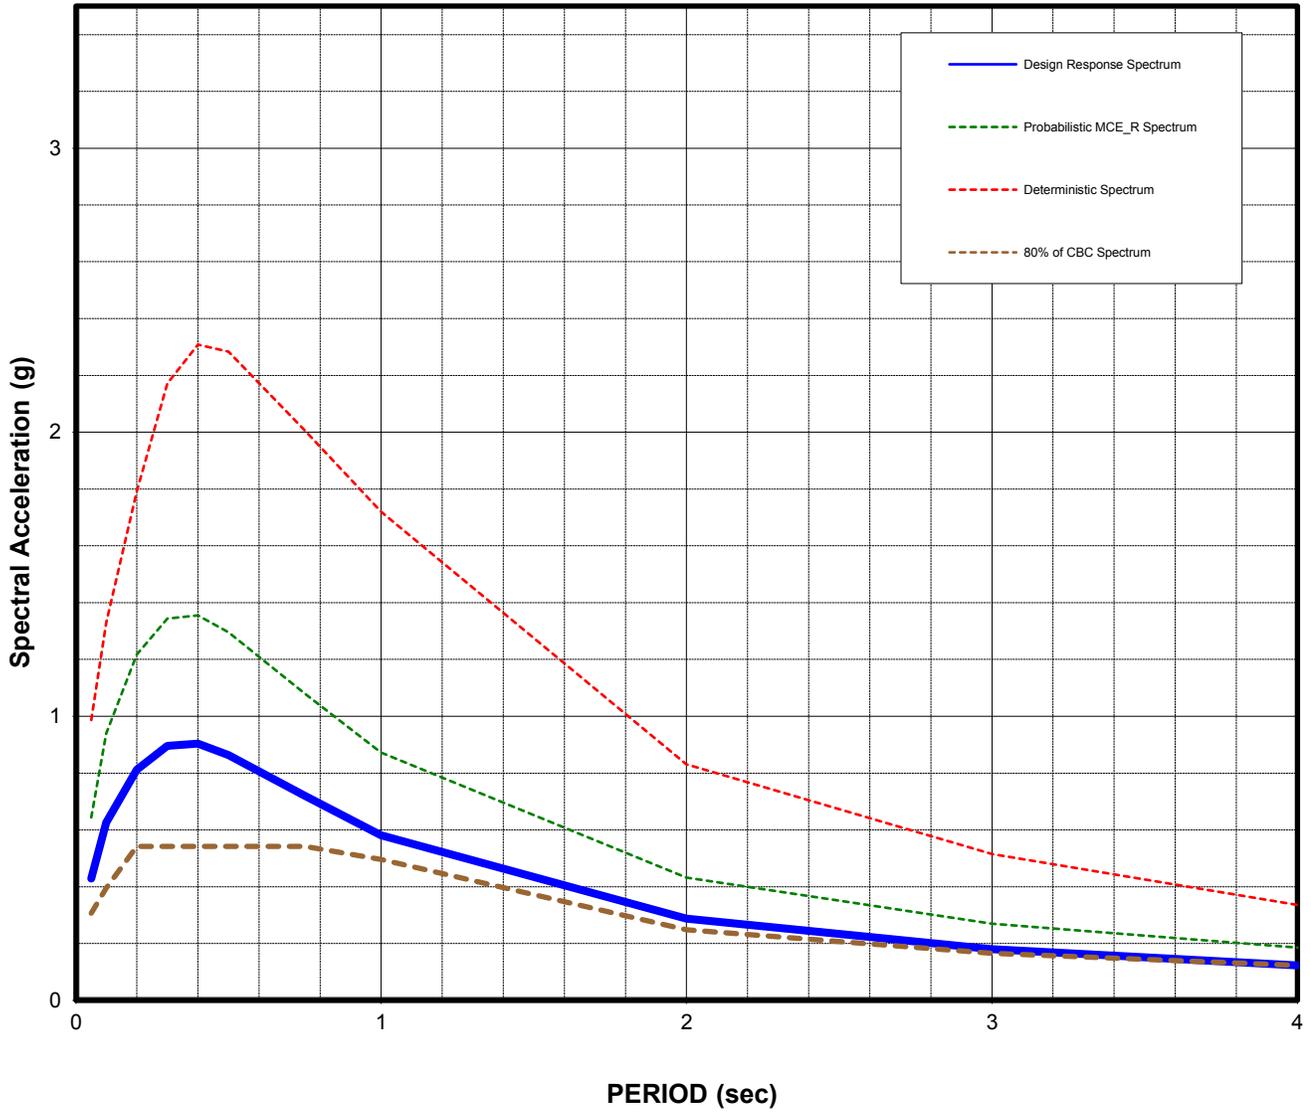
Note: Calculated using EZFRISK program Risk Engineering, version 8.07

SITE SPECIFIC DESIGN RESPONSE SPECTRUM per ASCE 7-16 and 2019 CBC

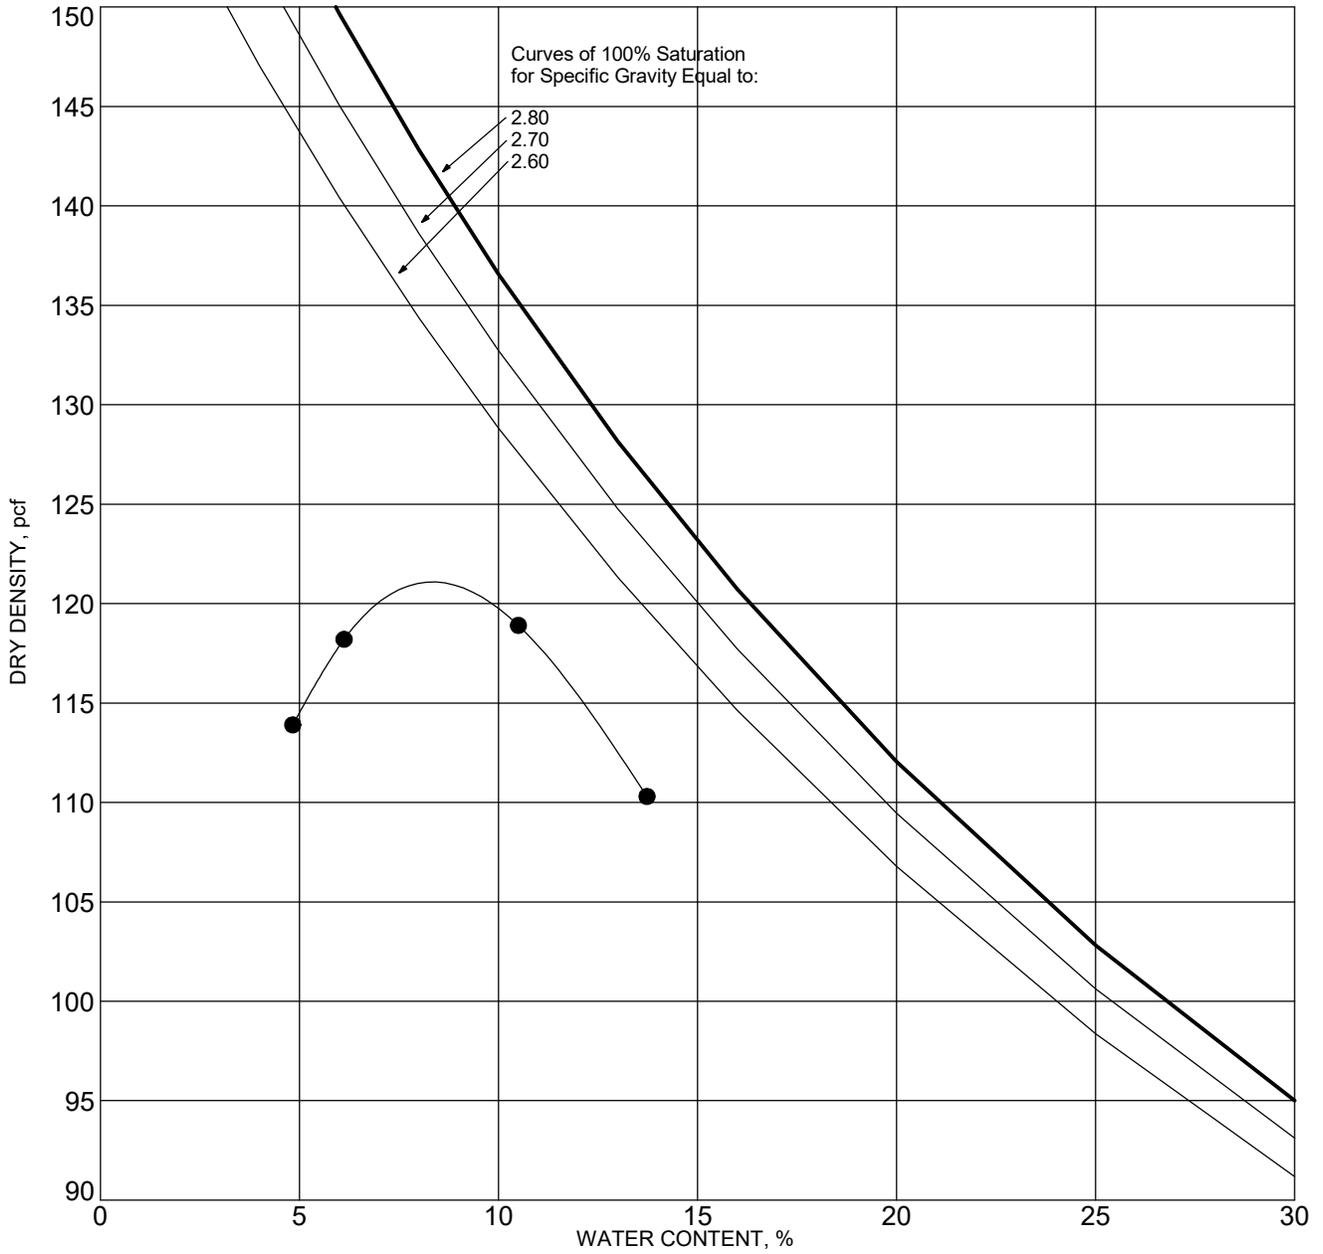
Drawing No.
 B-1

SYMBOL	BORING NO.	DEPTH (ft)	DESCRIPTION	ASTM TEST METHOD	OPTIMUM WATER, %	MAXIMUM DRY DENSITY, pcf
●	BH -05	11.5	SILTY SAND (SM)	D1557 Method D	8	122.5

MOISTURE-DENSITY RELATIONSHIP RESULTS

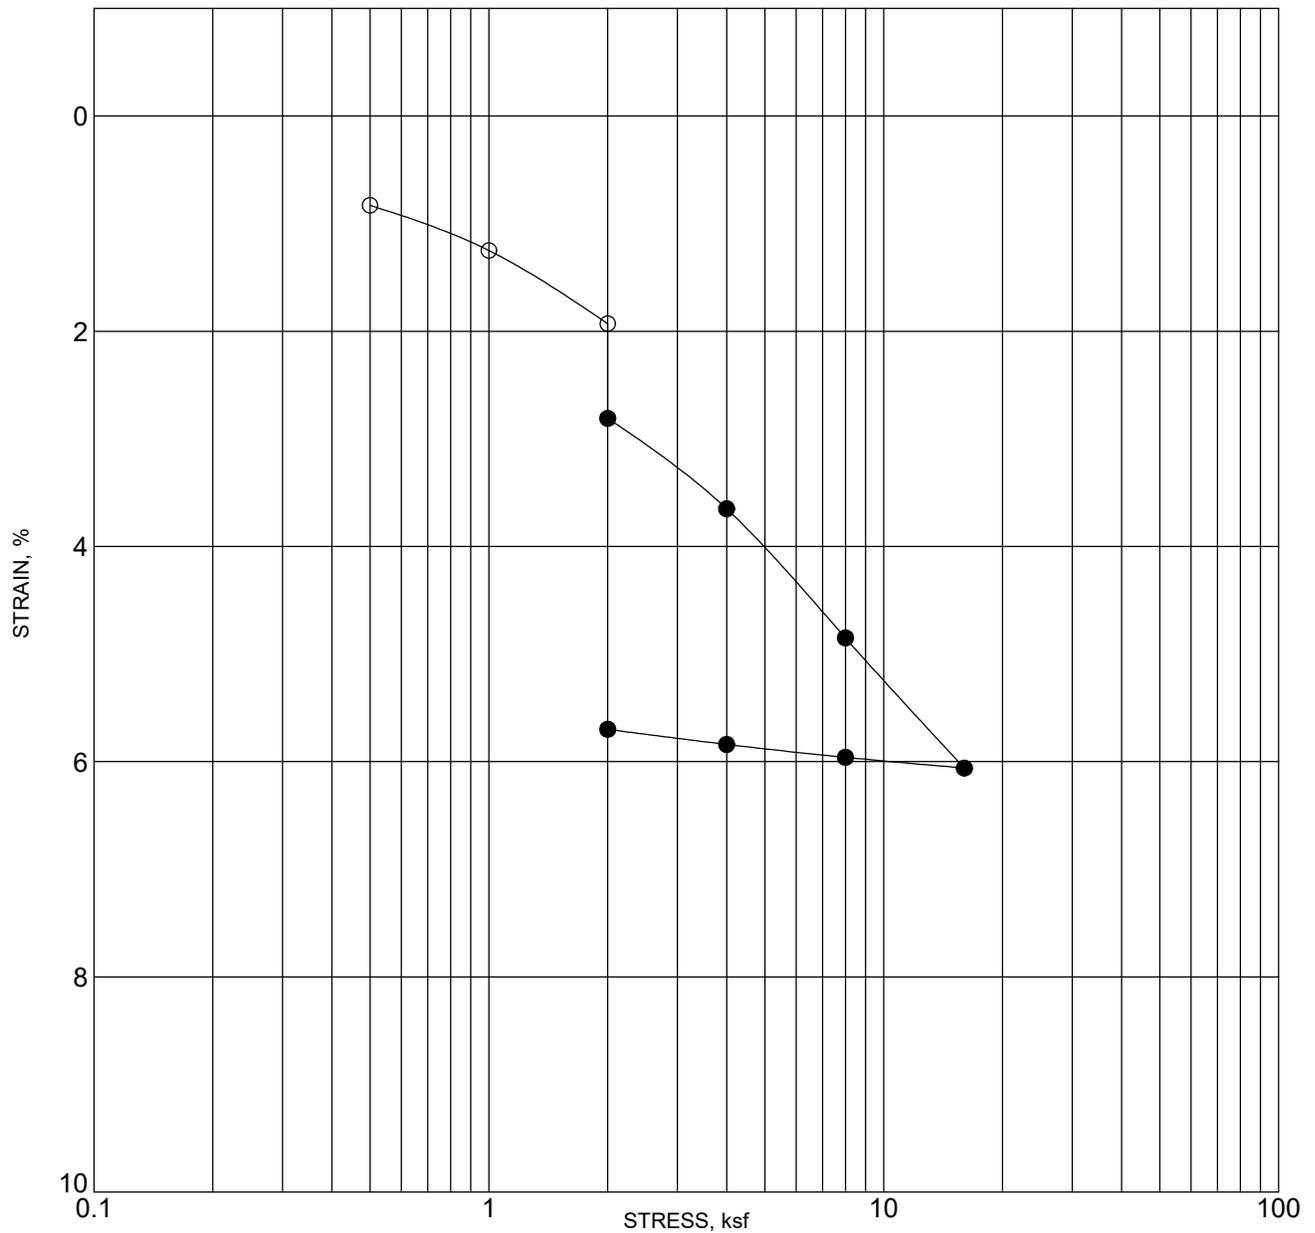
Drawing No.
 B-2

BORING NO. :		BH-3		DEPTH (ft) :		5	
DESCRIPTION :		Silty Sand (SM)					
MOISTURE CONTENT (%)		DRY DENSITY (pcf)		PERCENT SATURATION		VOID RATIO	
INITIAL	5	100	20			0.636	
FINAL	17	112	100			0.460

NOTE: SOLID CIRCLES INDICATE READINGS AFTER ADDITION OF WATER

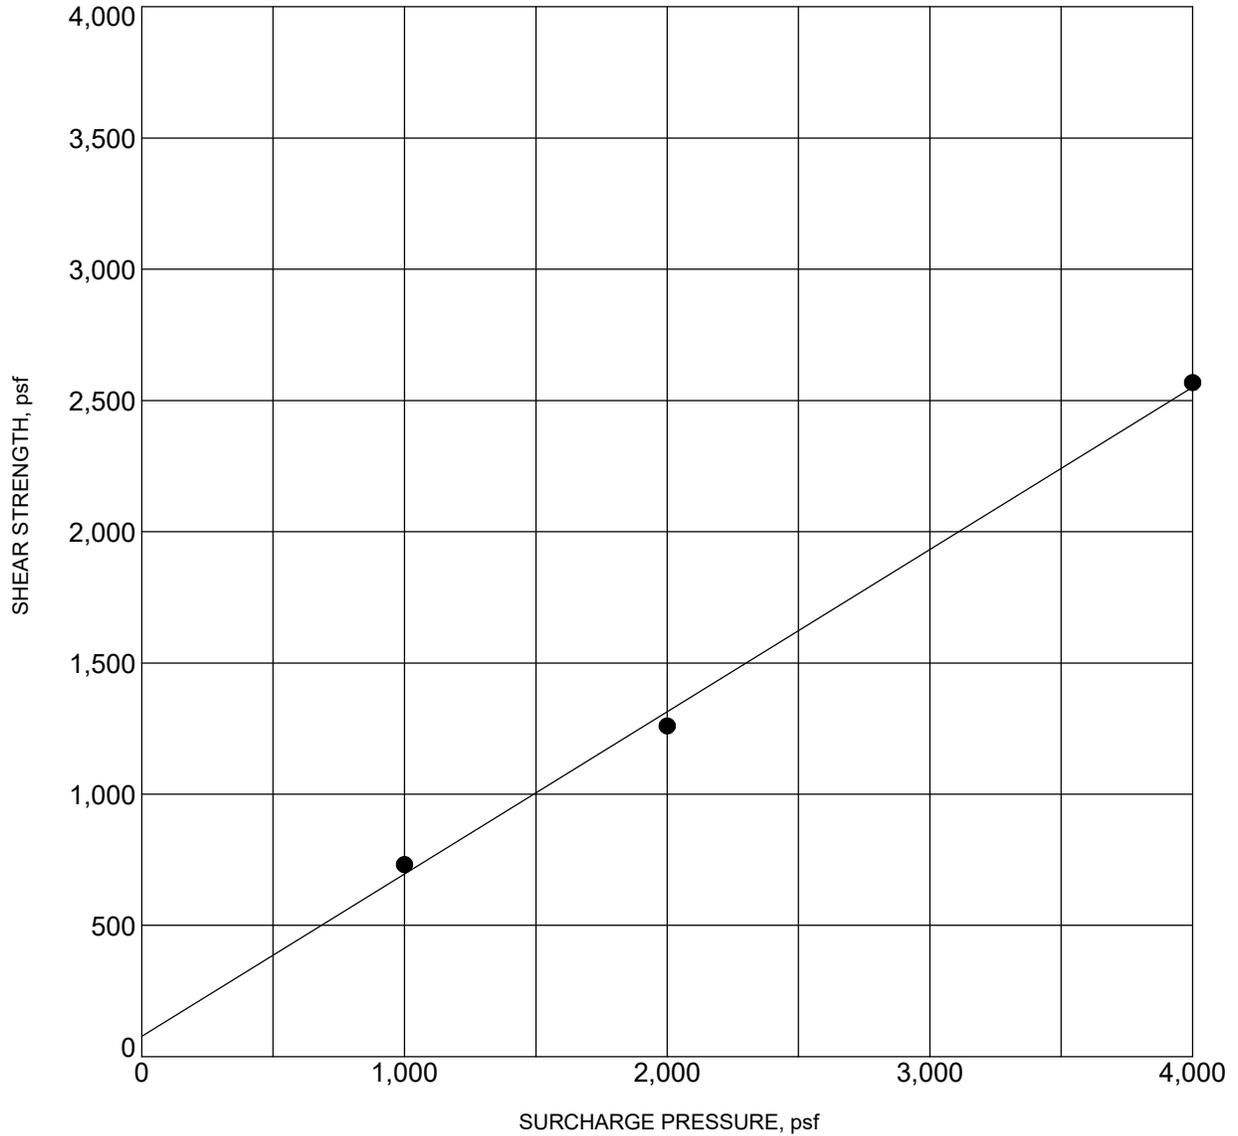
Project No. Drawing No.
21-31-323-01 B-3

BORING NO. :	BH-1	DEPTH (ft) :	5-6.5
DESCRIPTION :	Clayey Sand (SC)		
COHESION (psf) :	100	FRICTION ANGLE (degrees):	32
MOISTURE CONTENT (%) :	7.0	DRY DENSITY (pcf) :	96.0

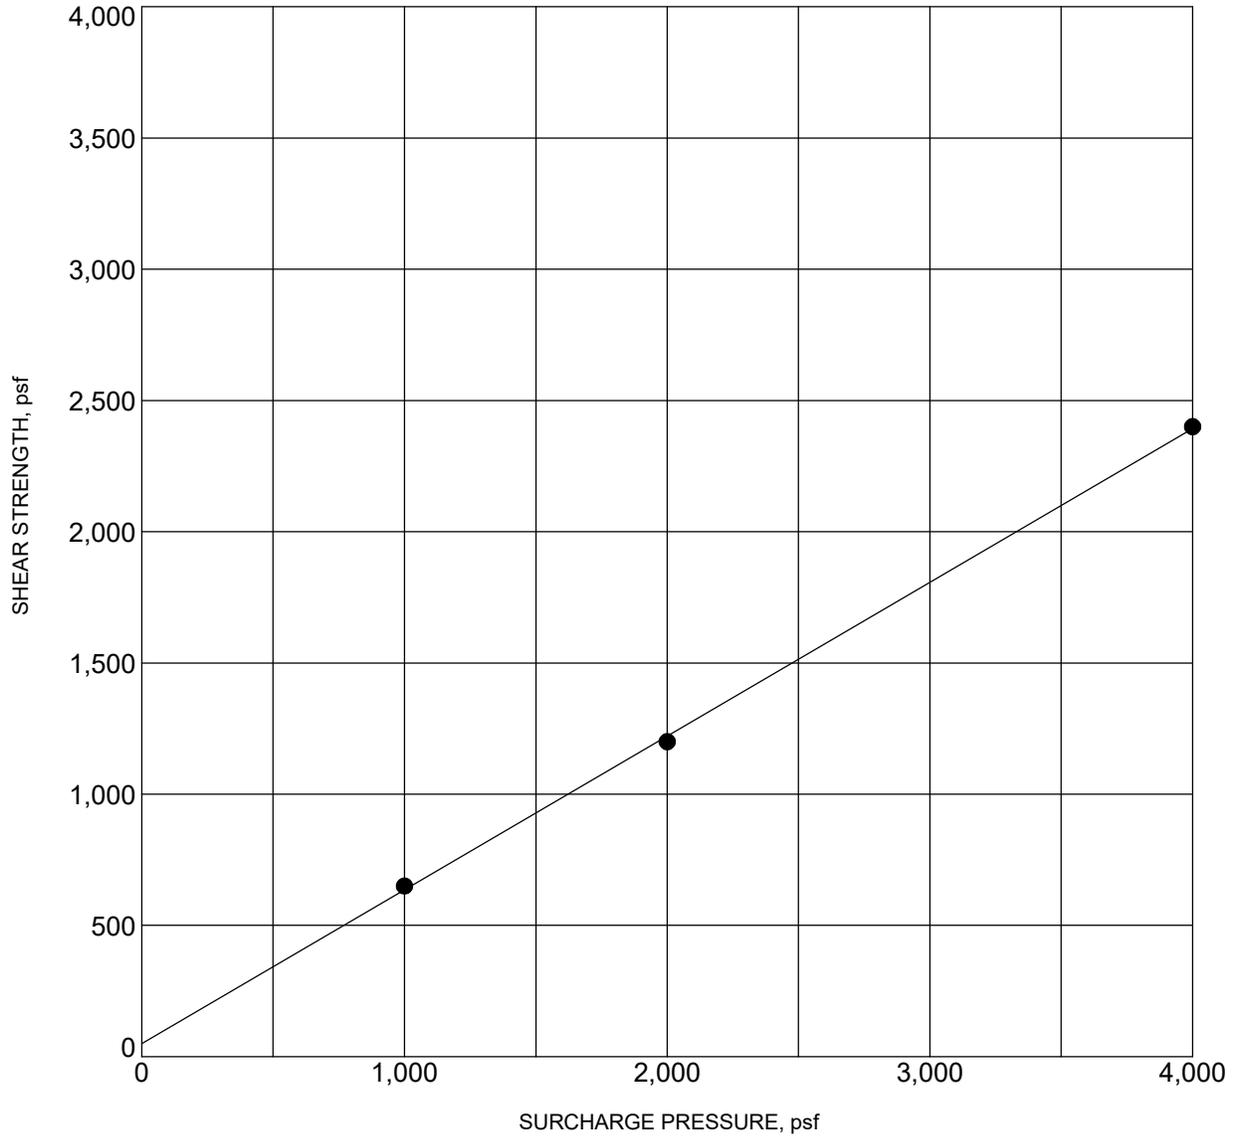
Project No. Drawing No.
 21-31-323-01 B-4a

BORING NO. :	BH-2	DEPTH (ft) :	25-26.5
DESCRIPTION :	Silty Sand (SM)		
COHESION (psf) :	50	FRICTION ANGLE (degrees):	30
MOISTURE CONTENT (%) :	22.0	DRY DENSITY (pcf) :	106.0

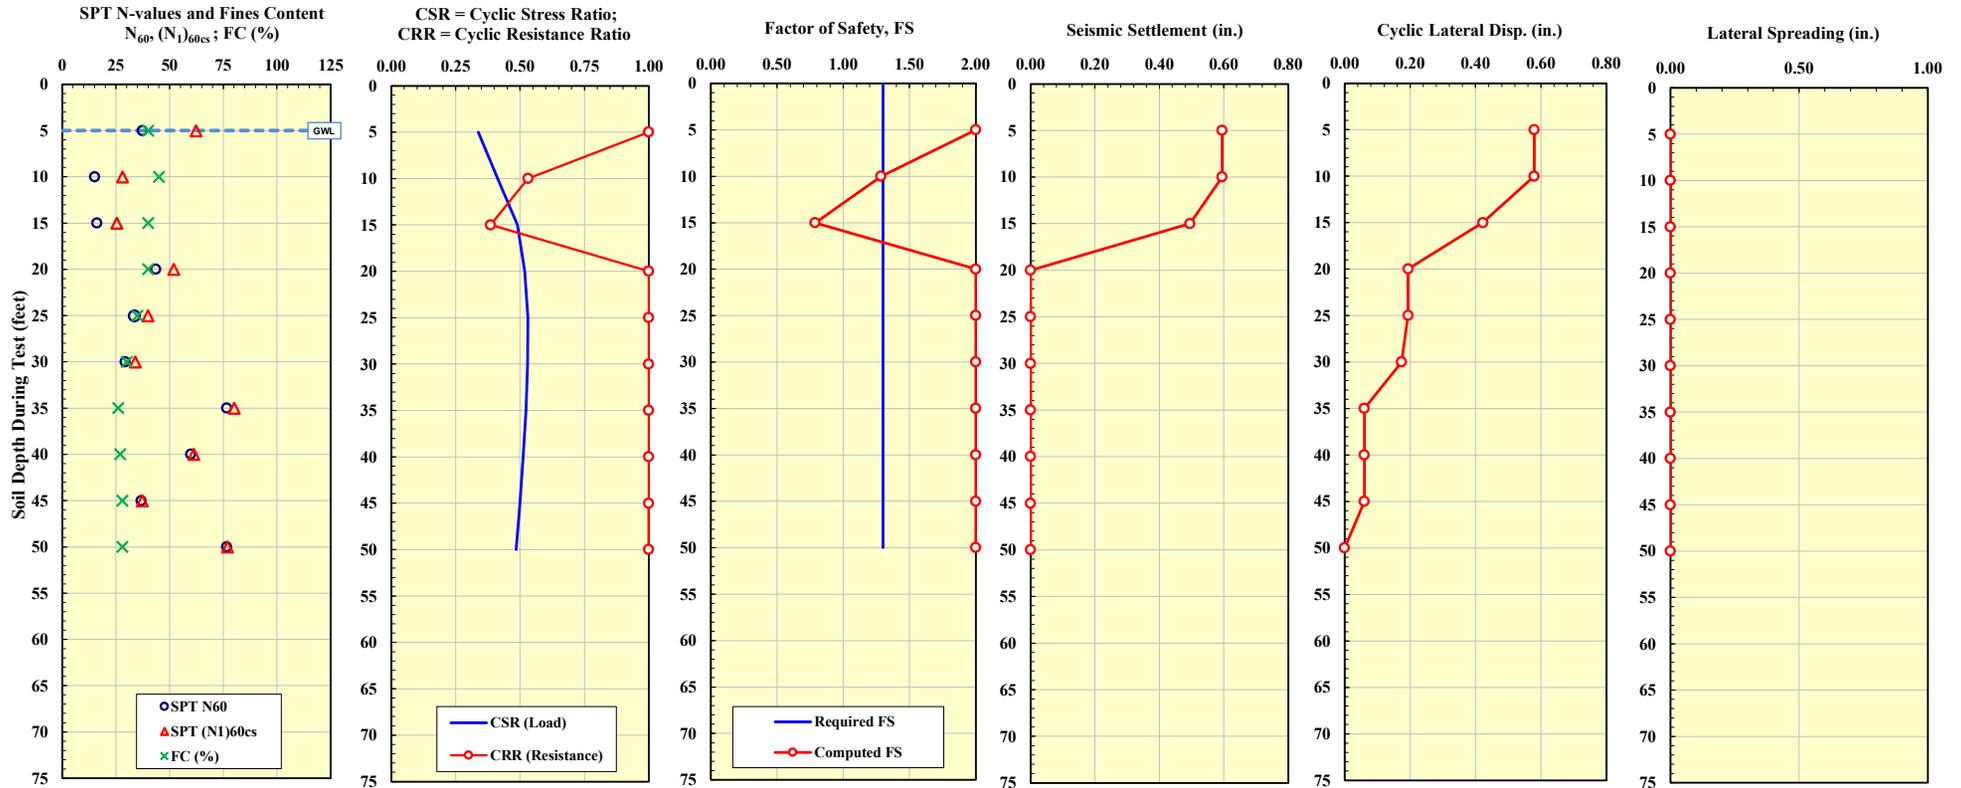
SEISMIC DESIGN PARAMETERS	
Earthquake Moment Magnitude, M_w	6.70
Peak Ground Acceleration, A_{max}	0.52 g
Factor of Safety Against Liquefaction, FS	1.30

Liquefaction Triggering:
Boulanger-Idriss (2014)

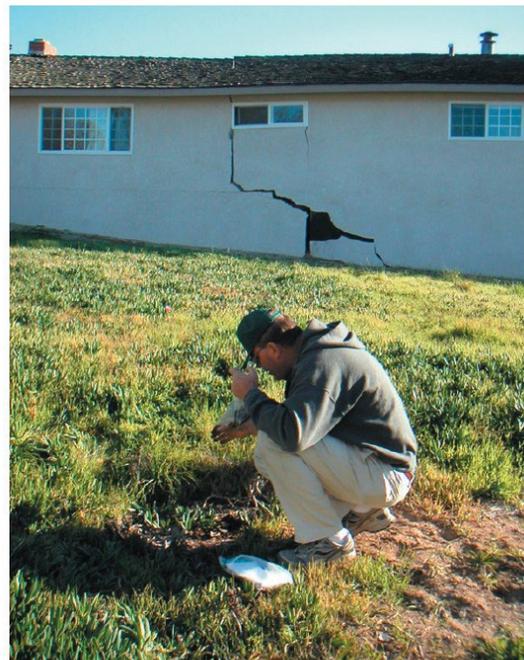
Figure 2: Damage to House in Oceano, California from Lateral Spreading During 2003 San Simeon Earthquake (USGS 2004a)

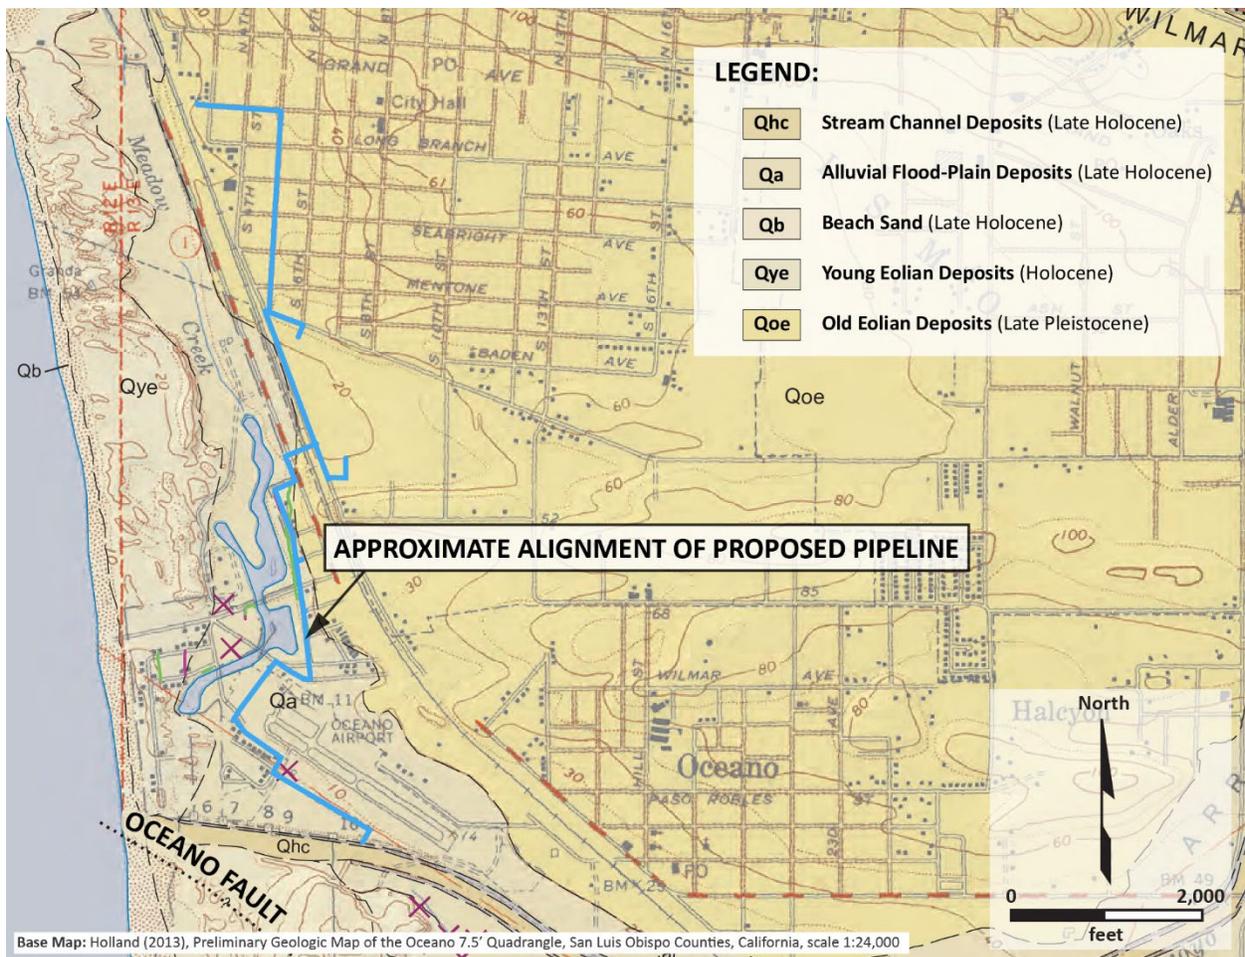
The surficial geology in the project area as mapped by Holland (2013) is shown on Figure 3. Geology along the proposed pipeline alignment is mapped by Holland (2013) as Holocene age Alluvium Flood-Plain deposits (Qa) and Pleistocene Old Eolian Deposits (Qoe). Geologic

Figure 3: Geologic Map (Holland 2013)

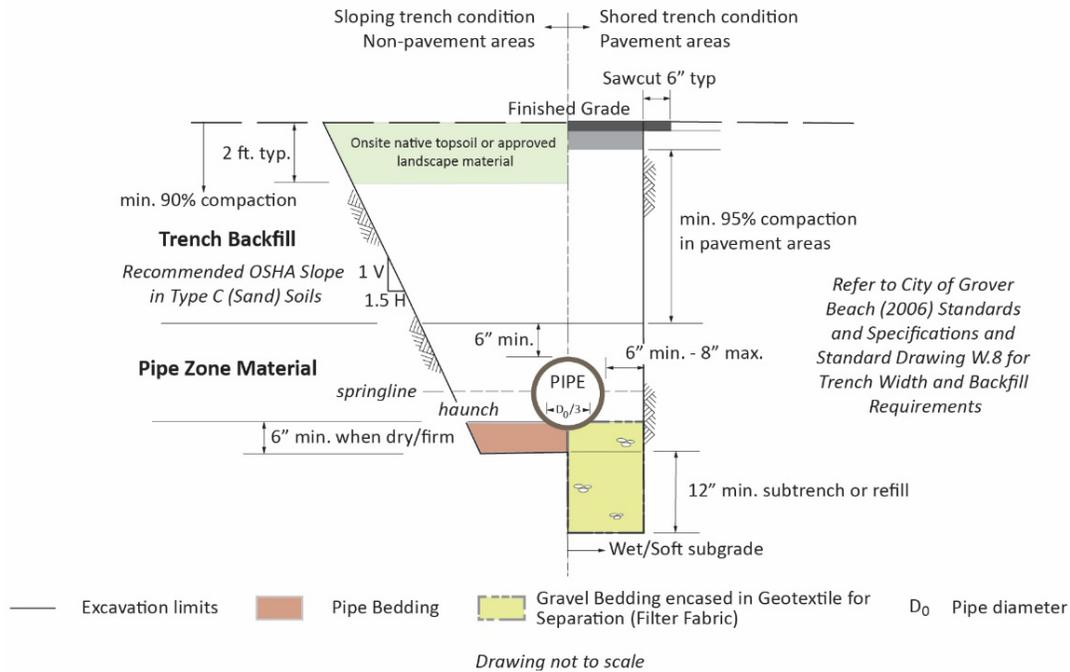
bedding, initial backfill, and subsequent backfill material for trench backfill. Material recommendations for bedding, pipe zone, and trench backfill material are described in Section 5.1.1 of this report. The pavement area shown in Figure 4 is applicable to the majority of the project where the pipeline will be installed using open cut trench methods below the existing road.

Figure 4: Trench Detail

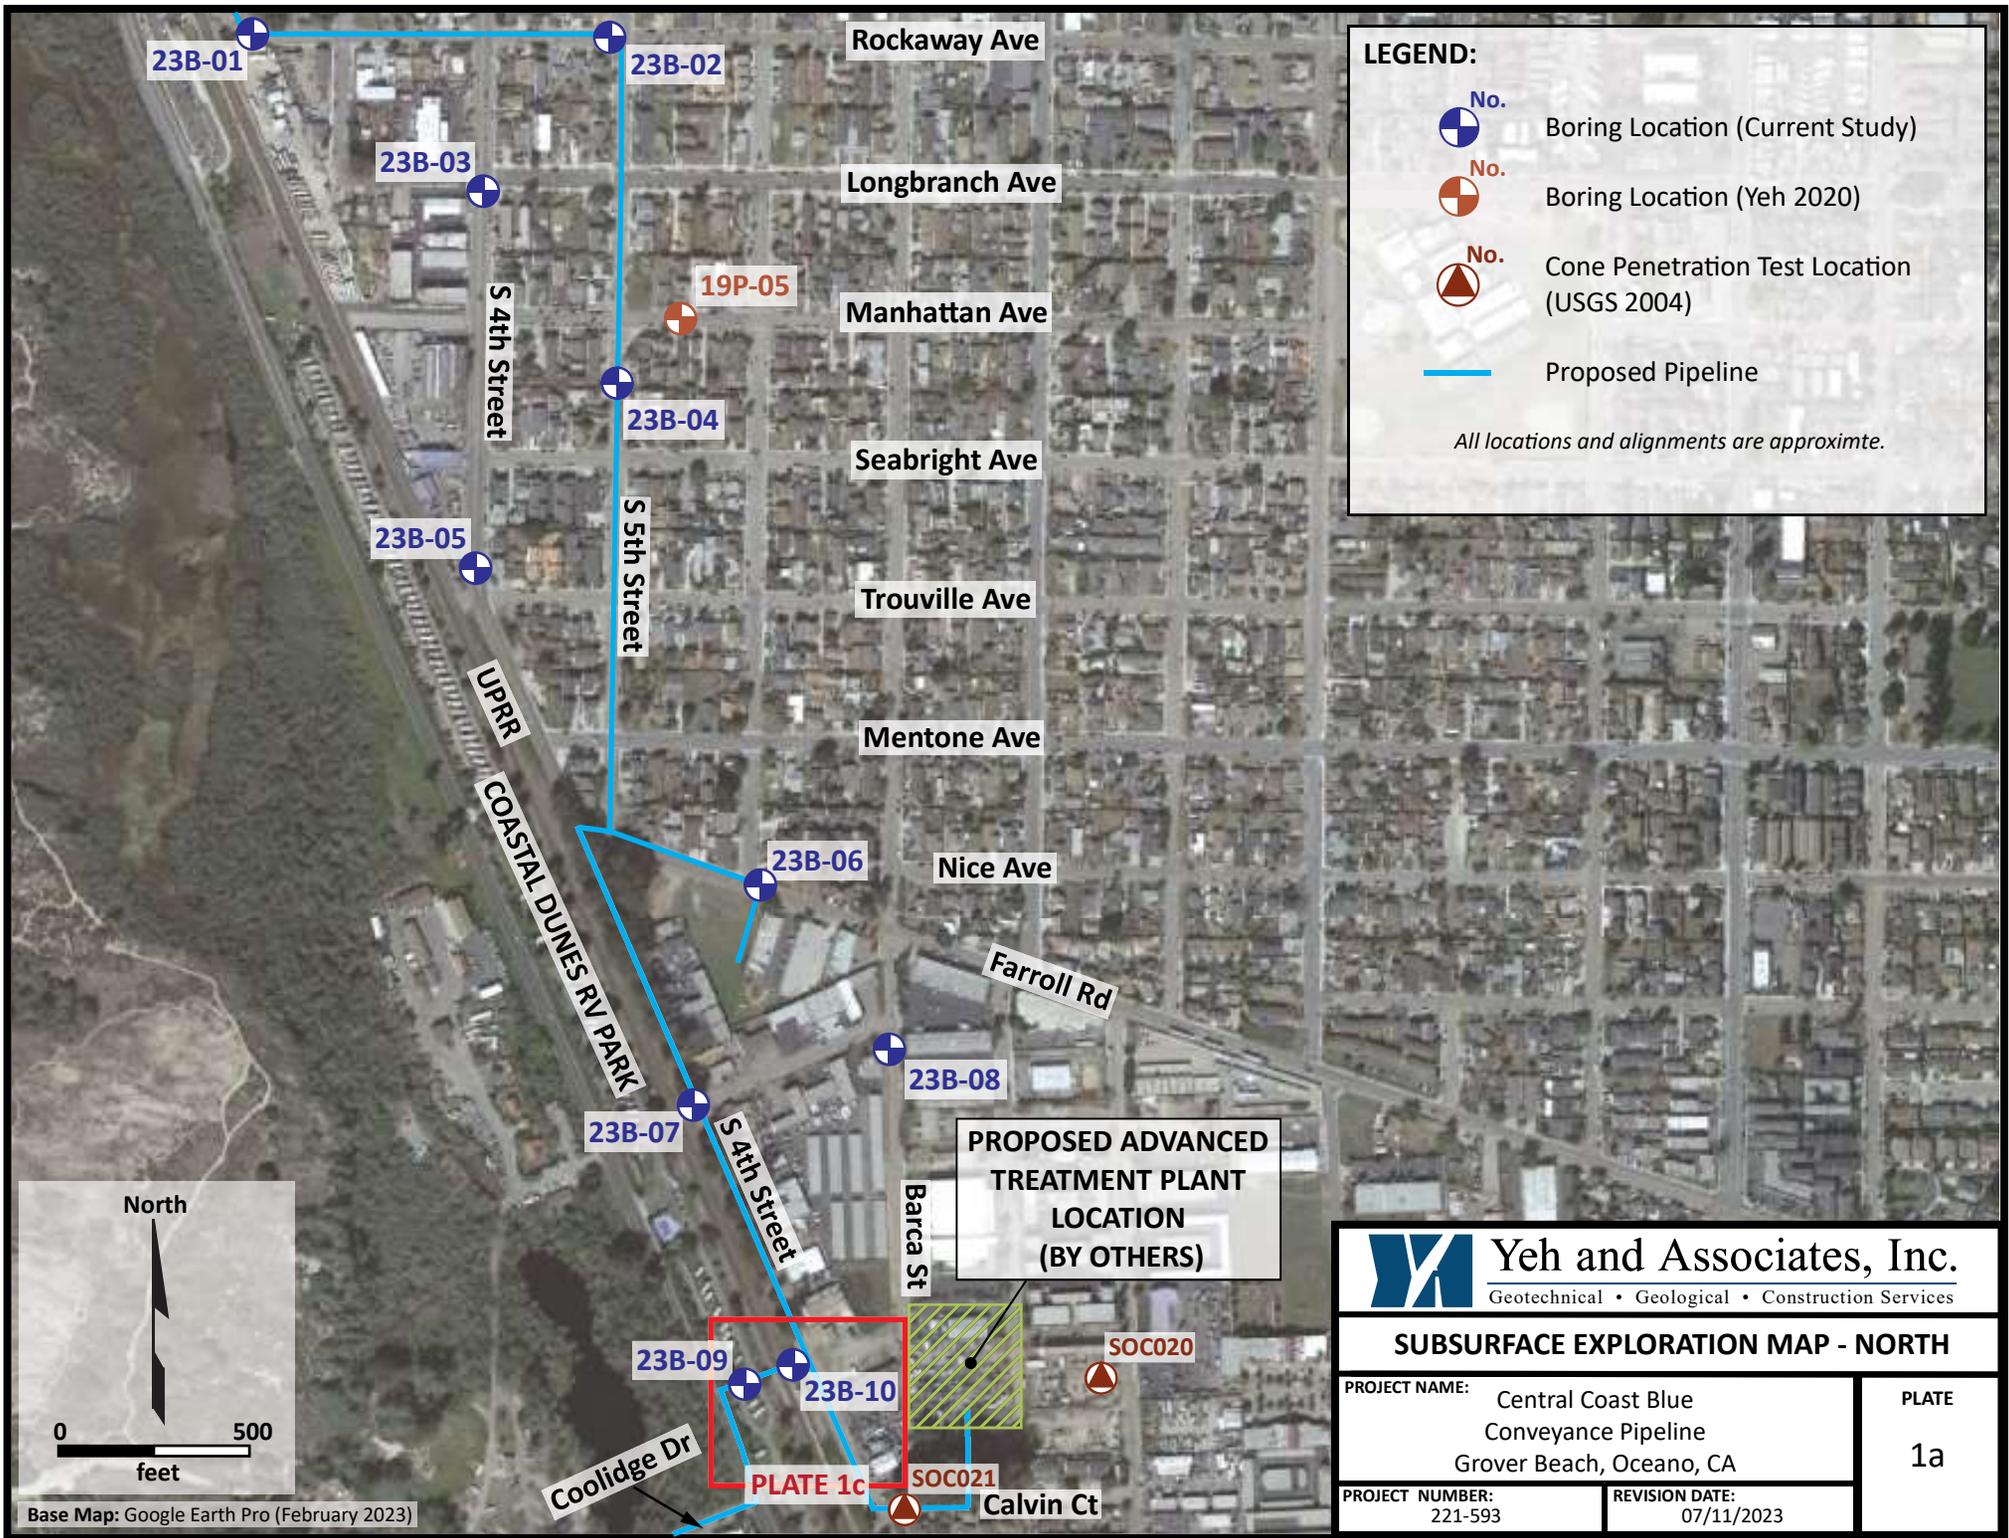
Yeh and Associates, Inc. Geotechnical • Geological • Construction Services		SUBSURFACE EXPLORATION MAP - NORTH	
		PROJECT NAME: Central Coast Blue Conveyance Pipeline Grover Beach, Oceano, CA	PLATE 1a
PROJECT NUMBER: 221-593		REVISION DATE: 07/11/2023

Plates 1a and 1b – the Field Exploration Maps present a plan of the project area and proposed improvements. The project includes the design of approximately 2 miles of pipeline to intercept

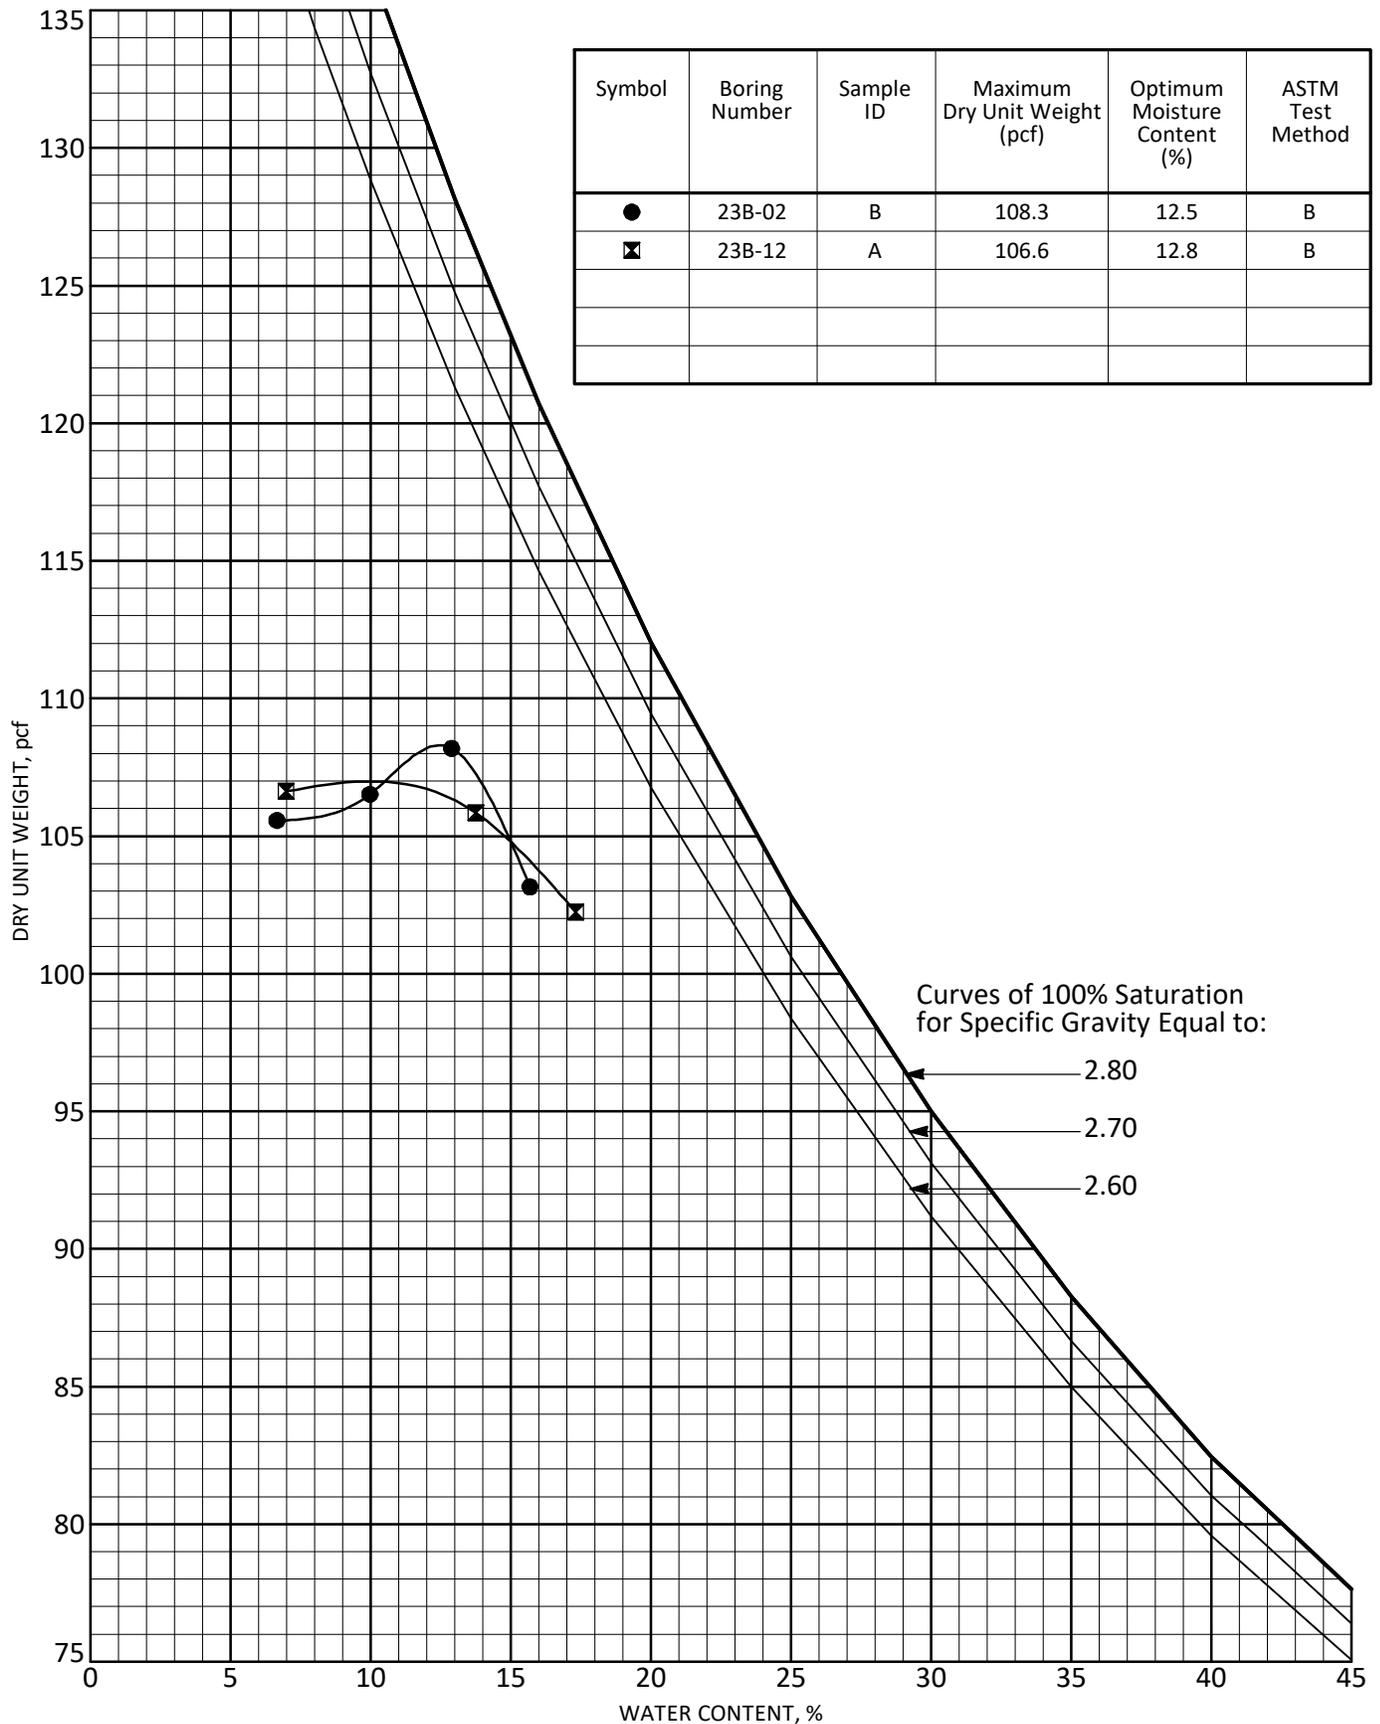
MOISTURE-DENSITY RELATIONSHIP

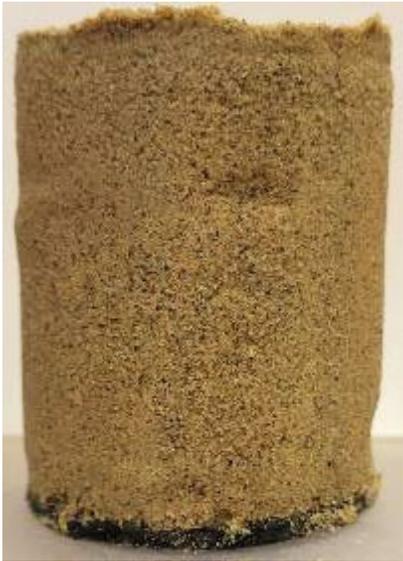
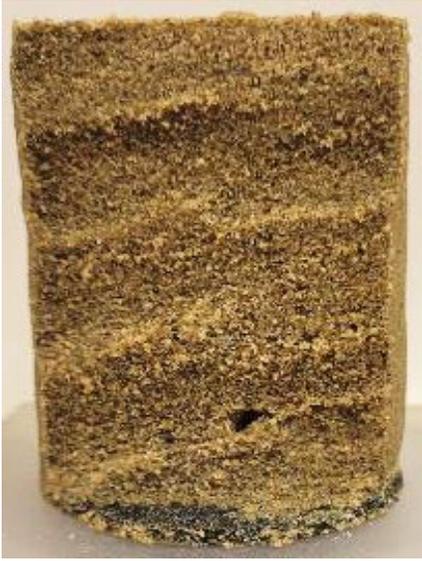
HYDRAULIC CONDUCTIVITY
 Central Coast Blue

SAMPLE ID	Boring Number 23B-10		CLASSIFICATION	Sieve Size	% Passing	Other Parameters			
	Sample Number 49	Sample Depth, ft 27.50		Classification Poorly-graded SAND (SP): brown, moist to wet	3/8-in. (9.5mm)	---	Liquid Limit	---	
SAMPLE PROPERTIES		Initial	Final	#4 (4.75mm)	---	Plastic Limit	---		
	Mass, g	452.18	447.03	#16 (1.18mm)	---	Plasticity Index	---		
	Water Content, %	23.6%	22.2%	#30 (0.6mm)	---	Estimated Gs	2.7		
	Dry Density, pcf	101.0	101.0	#100 (0.150mm)	---				
	Saturation, %	95%	90%	#200 (0.075mm)	---				
	Void Ratio	0.67	0.67						
	Diameter, in	2.42	2.42						
	Height, in	3.00	3.00						
	Area, in ²	4.60	4.60						
	Volume, in ³	13.80	13.80						
TEST SUMMARY				Sample Type	MC				
				Permeant	Deaired Tap-Water				
				Pipette Area, cm ²	0.263				
REMARKS				k _{avg} 20°C, cm/s	6.3E-03				
				Tested By	GLF				
PERMEATION DATA				Test Method: ASTM D5084 (Method C)					
				Tested by: N. Derbidge

Reviewed by: R. Hooke					
	Trial	Date	Time, sec	Temp _{AVG} , °C	σ', ksf	μ, ksf	i _o	i _f	k _t , cm/s
	1	5/5/23	12	20.9	2.9	10.1	2.5	0.8	6.4E-03
	2	5/5/23	12	20.9	2.9	10.1	2.5	0.8	6.4E-03
	3	5/5/23	12	20.9	2.9	10.1	2.5	0.8	6.4E-03
	4	5/5/23	12	20.9	2.9	10.1	3.0	0.9	6.5E-03
5	5/5/23	12	20.9	2.9	10.1	3.0	0.9	6.5E-03	
6	5/5/23	12	20.9	2.9	10.1	3.0	0.9	6.5E-03	
SAMPLE IMAGES

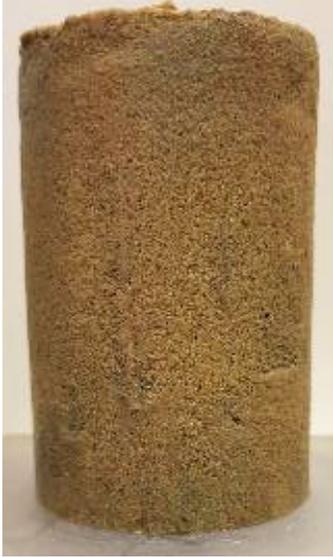
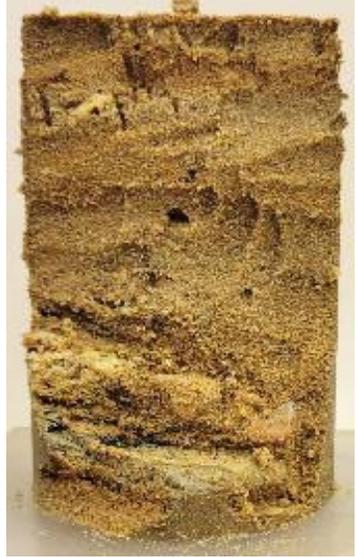
HYDRAULIC CONDUCTIVITY
 Central Coast Blue

SAMPLE ID	Boring Number 23B-09			CLASSIFICATION	Sieve Size	% Passing	Other Parameters		
	Sample Number	5			3/8-in. (9.5mm)	---	Liquid Limit	---	
Sample Depth, ft	20.00				#4 (4.75mm)	---	Plastic Limit	---	
Classification	Poorly-graded SAND (SP): light brown, moist, with silty sand partings and gravel on one end of the sample				#16 (1.18mm)	---	Plasticity Index	---

#30 (0.6mm)	---	Estimated Gs	2.7	
					#100 (0.150mm)	---			
				#200 (0.075mm)	---				
SAMPLE PROPERTIES		Initial	Final	TEST SUMMARY	Sample Type		MC		
	Mass, g	613.45	611.30		Permeant	Deaired Tap-Water			
	Water Content, %	22.0%	21.6%		Pipette Area, cm ²	0.263			
	Dry Density, pcf	104.1	104.1		k _{avg} 20°C, cm/s	4.0E-04			
	Saturation, %	96%	94%		Tested By	GLF			
	Void Ratio	0.62	0.62	REMARKS	Test Method: ASTM D5084 (Method C)				
	Diameter, in	2.42	2.42		Tested by: N. Derbidge				
	Height, in	4.00	4.00		Reviewed by: R. Hooke				
	Area, in ²	4.60	4.60						
	Volume, in ³	18.40	18.40						
PERMEATION DATA	Trial	Date	Time, sec	Temp _{AVG} , °C	σ', ksf	μ, ksf	i _o	i _f	k _t , cm/s
	1	5/7/23	300	19.9	2.2	10.1	1.9	0.5	4.0E-04
	2	5/7/23	300	19.9	2.2	10.1	1.9	0.5	4.0E-04
	3	5/7/23	300	19.9	2.2	10.1	1.9	0.5	4.0E-04
	4	5/7/23	300	19.9	2.2	10.1	1.9	0.5	4.0E-04
	5	5/7/23	300	19.9	2.2	10.1	1.9	0.5	4.0E-04
	6	5/7/23	300	19.9	2.2	10.1	1.9	0.5	4.1E-04

SAMPLE IMAGES

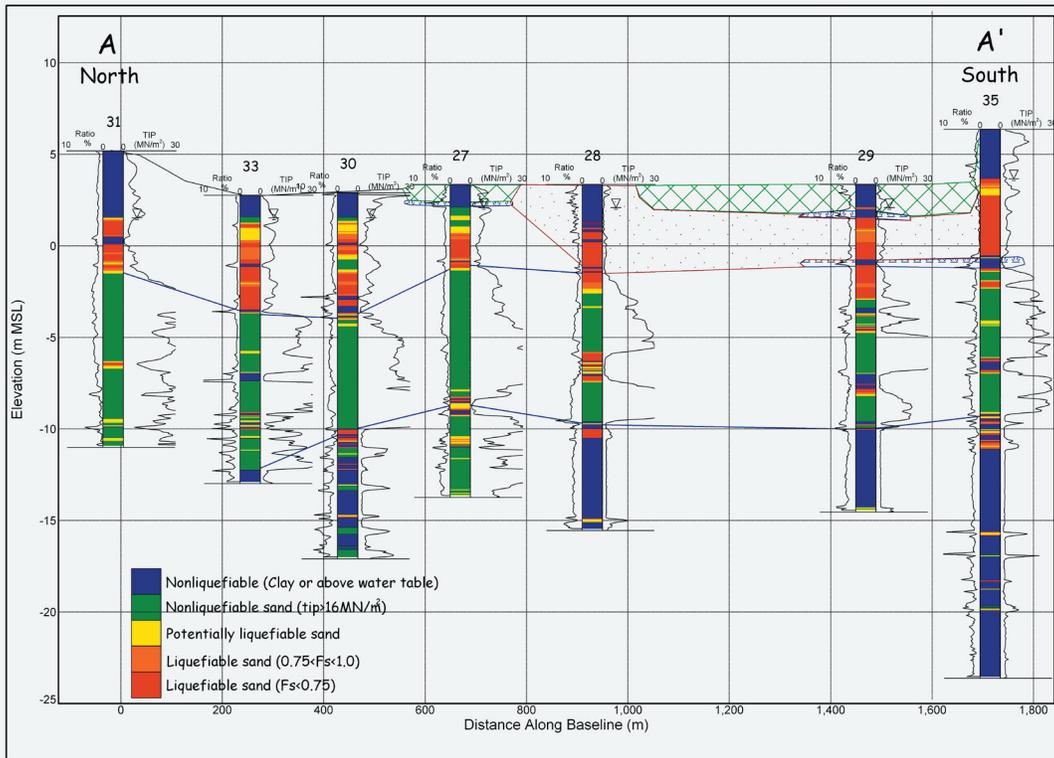
Figure 6c.

Figure 6. North-south cross section (A-A') at Oceano of generalized shallow subsurface conditions based on SCPT soundings. See Figure 5 for location of cross section. Cross section includes profiles of CPT tip and friction ratio, geologic units, and water table with (a) shear-wave velocity (V_s), (b) liquefaction factors of safety for a M6.5 and PGA=0.25 g, and (c) liquefaction factors of safety for a M6.8 and PGA=0.4 g.

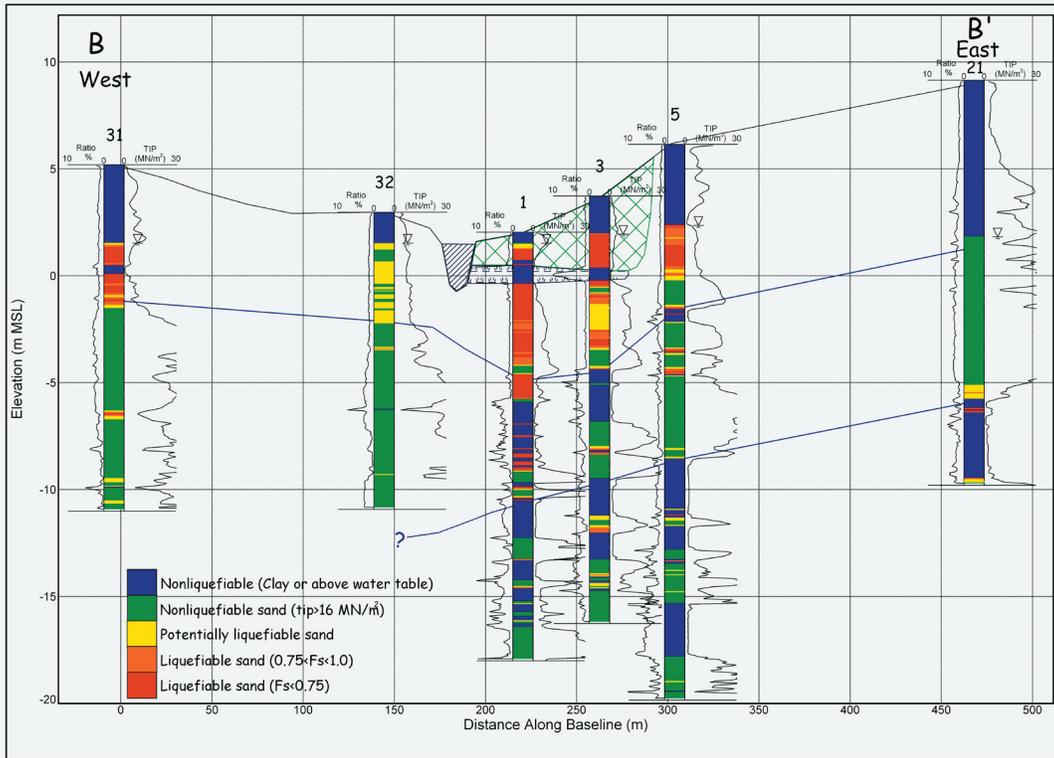
Figure 7c.

Figure 7. East-west cross section (B-B') at Oceano of generalized shallow subsurface conditions based on SCPT soundings. See Figure 5 for location of cross section. Cross section includes profiles of CPT tip and friction ratio, geologic units, and water table with (a) shear-wave velocity (V_s), (b) liquefaction factors of safety for a M6.5 and PGA=0.25 g, and (c) liquefaction factors of safety for a M6.8 and PGA=0.4 g.

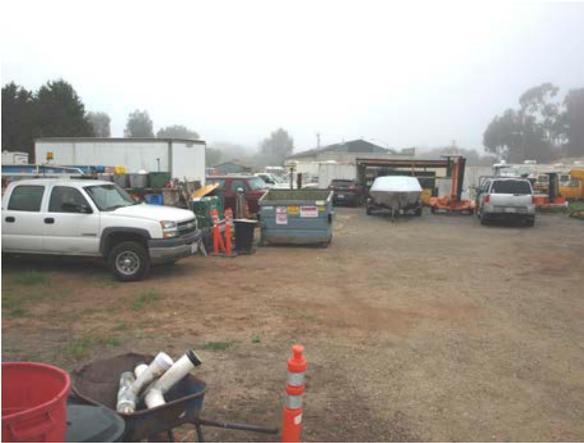
Photograph 1. View of the eastern portion of the subject property, facing west.

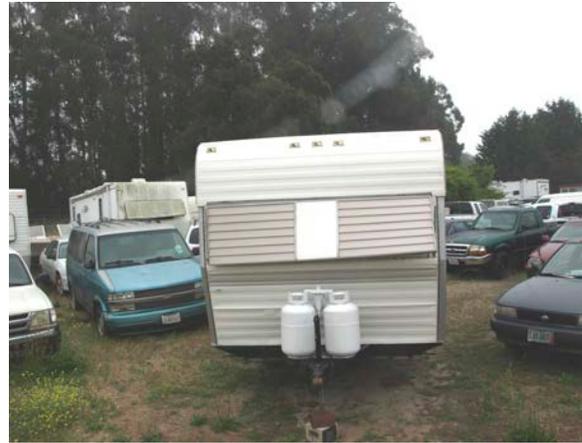
Photograph 2. View of vehicles and campers parked on the southeastern portion of the subject property, facing southwest.

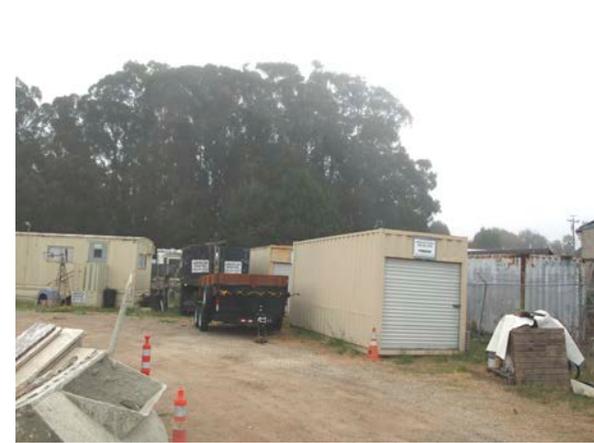
Photograph 3. View of storage containers and equipment located on the eastern portion of the subject property, facing south.

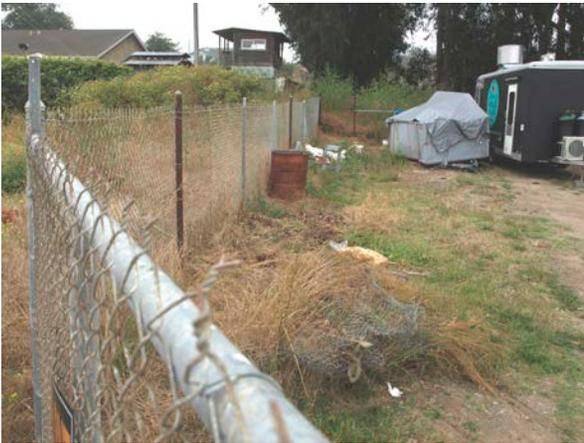
Photograph 4. View of two 55-gallon drums located on the southeastern portion of the subject property, facing south.

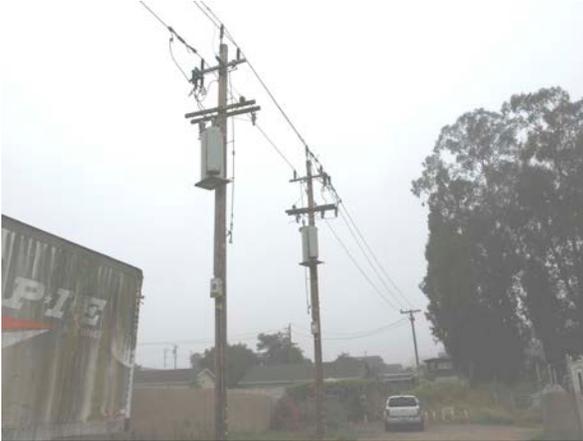
Photograph 7. View of the eastern adjacent pole-mounted transformers along Huber Street, facing south-southeast.

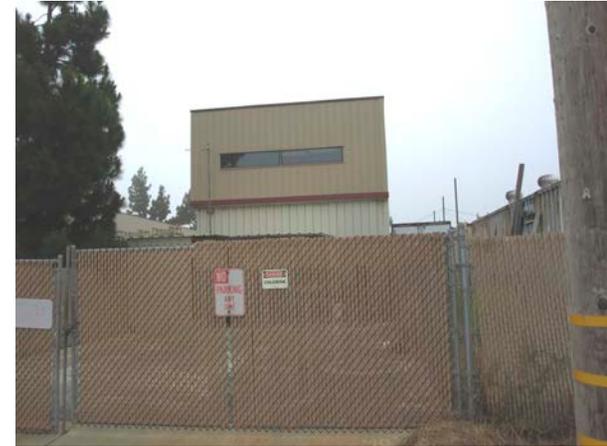
Photograph 9. View of one of the eastern adjacent properties (City of Pismo Beach Well #23).
