**PROJECT SPECIFIC PRELIMINARY
WATER QUALITY MANAGEMENT PLAN
(P-WQMP)**

PEN19-0193/LWQ19-0035

OPTION 1 - HIGH CUBE LOGISTICS SITE PLAN

EUCALYPTUS AVE. AND REDLANDS AVE.

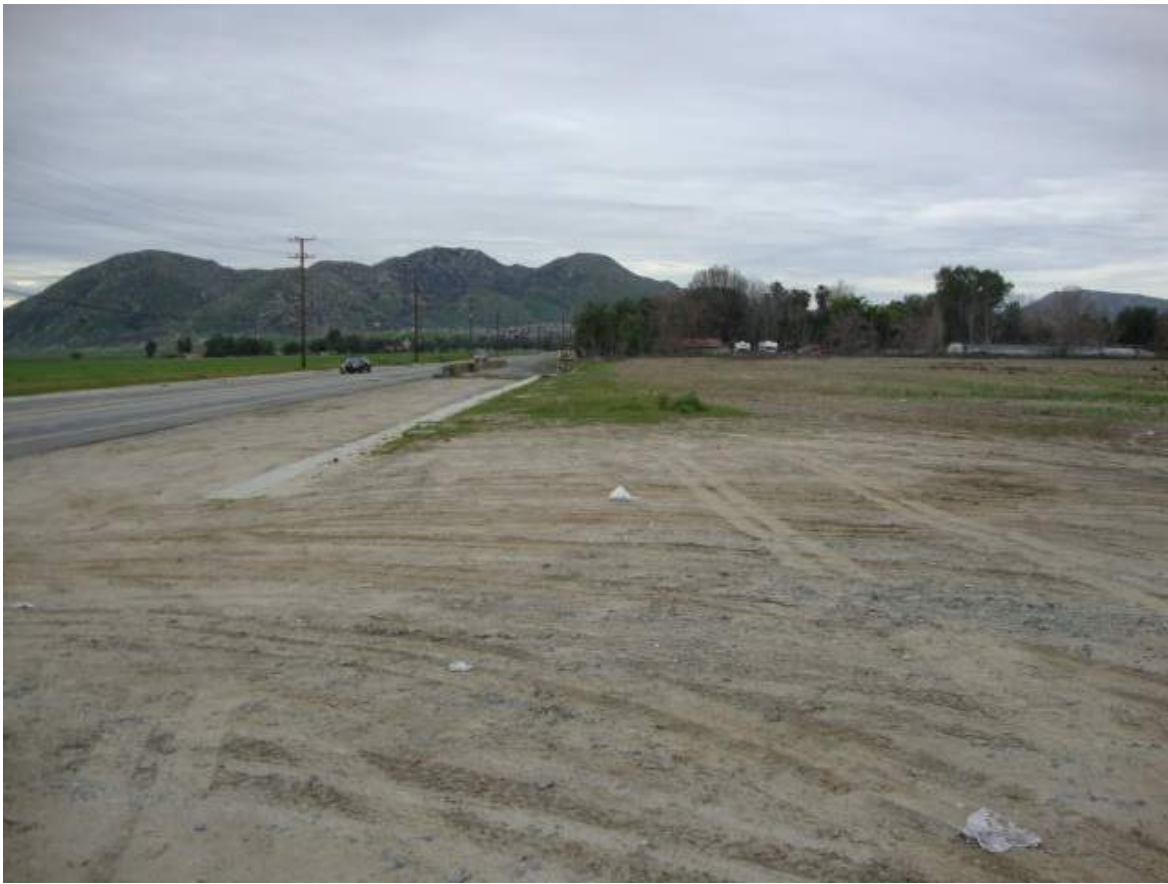
PHOTO 1 VIEW FACING SOUTH FROM NEAR THE NEC OF PARCEL 004 SHOWING THE SITE TO THE RIGHT (WEST) AND REDLANDS BLVD. TO THE LEFT. A CONCRETE RIBBON GUTTER IS PART OF THE DRAINAGE ALONG REDLANDS BLVD. IN THE BACKGROUND IS HALLS NURSERY.

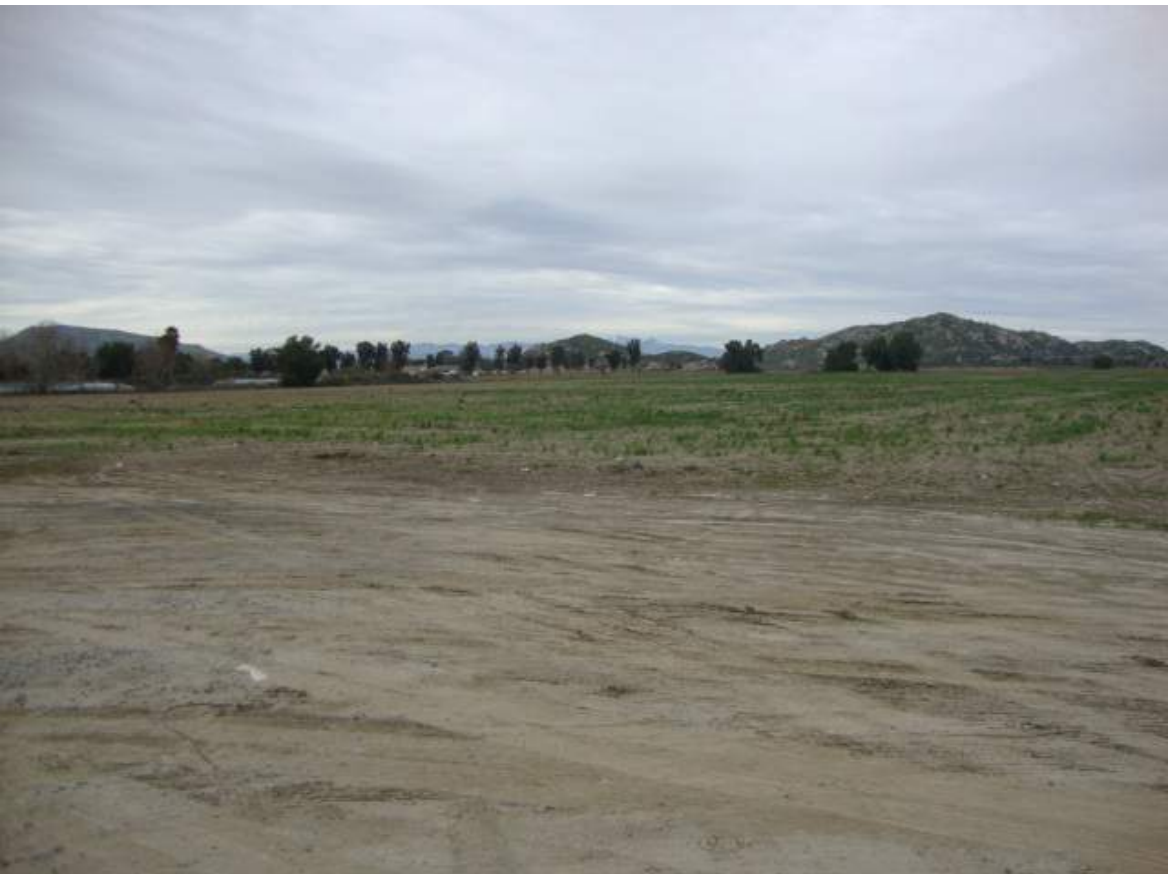
PHOTO 2 VIEW FACING SOUTHEASTERLY LOOKING ACROSS THE SITE FROM THE NEC SHOWING THE VACANT PARCELS, SPARSE VEGETATION AND RECENTLY DISCED CONDITION. CONCRETE PIECES ARE FROM FORMER STRUCTURE DEMOLITION IN THIS AREA.

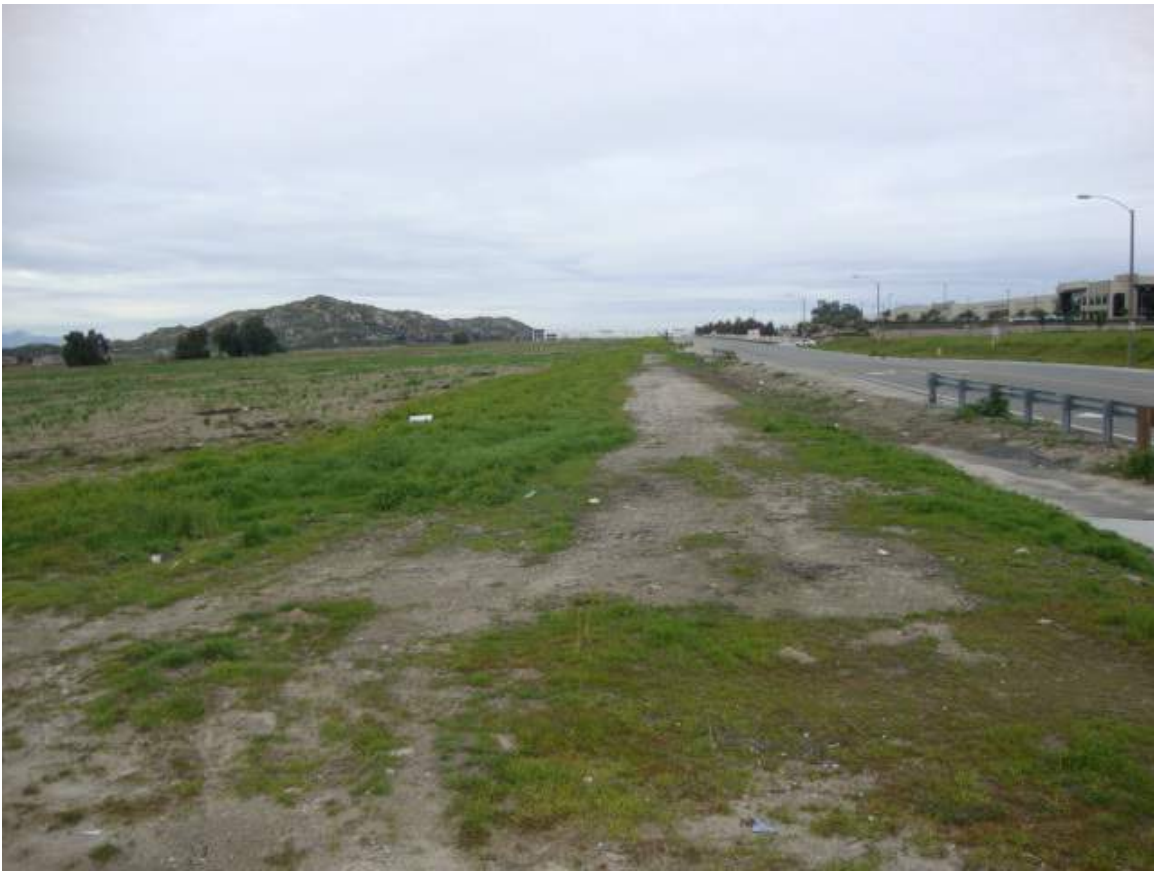
PHOTO 3 VIEW FACING WEST FROM THE NEC OF PARCEL 004 SHOWING EUCALYPTUS AVE. AND SHALLOW DRAINAGE TO THE RIGHT (NORTH) AND THE SITE TO THE LEFT. ALDI WAREHOUSE IS VISIBLE FURTHER NORTH.

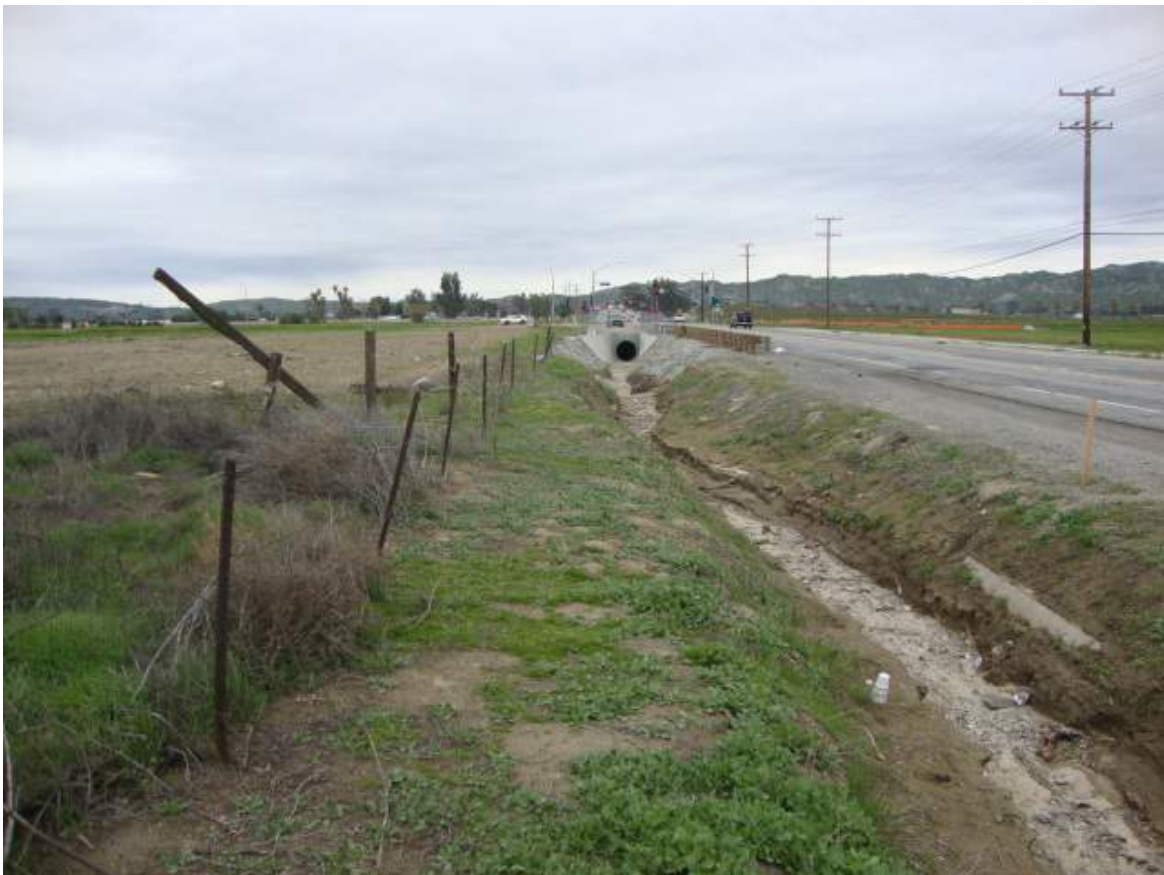
PHOTO 4 VIEW FACING NORTH FROM THE SEC OF PARCEL 004 SHOWING THE SITE TO THE LEFT (WEST) WITH REMNANT FENCING. REDLANDS BLVD. IS PRESENT TO THE RIGHT WITH THE CONCRETE AND EARTHEN DRAINAGE VISIBLE.

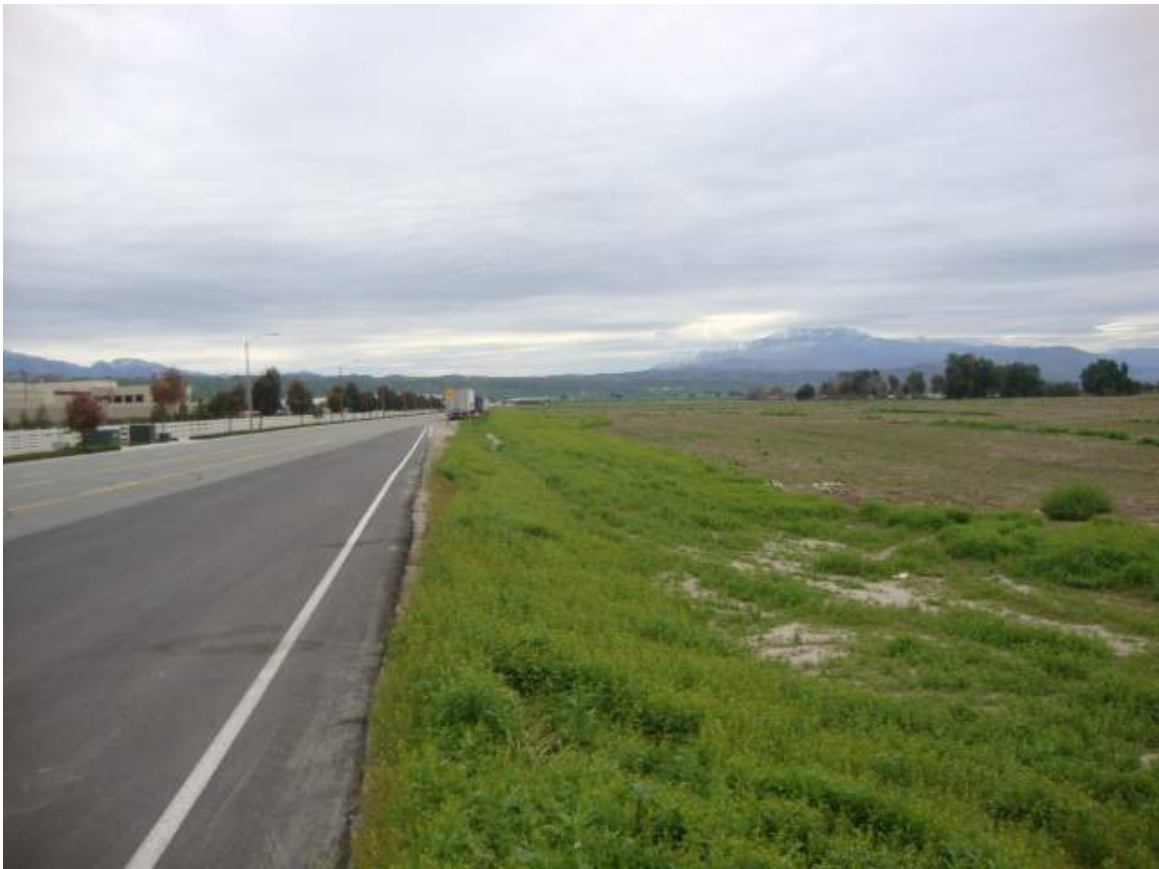
PHOTO 7 VIEW FACING EAST FROM THE NWC OF PARCEL 012 SHOWING THE SITE TO THE RIGHT (SOUTH) AND EUCALPTUS AVE. TO THE LEFT WITH ALDI WAREHOUSE FURTHER LEFT.

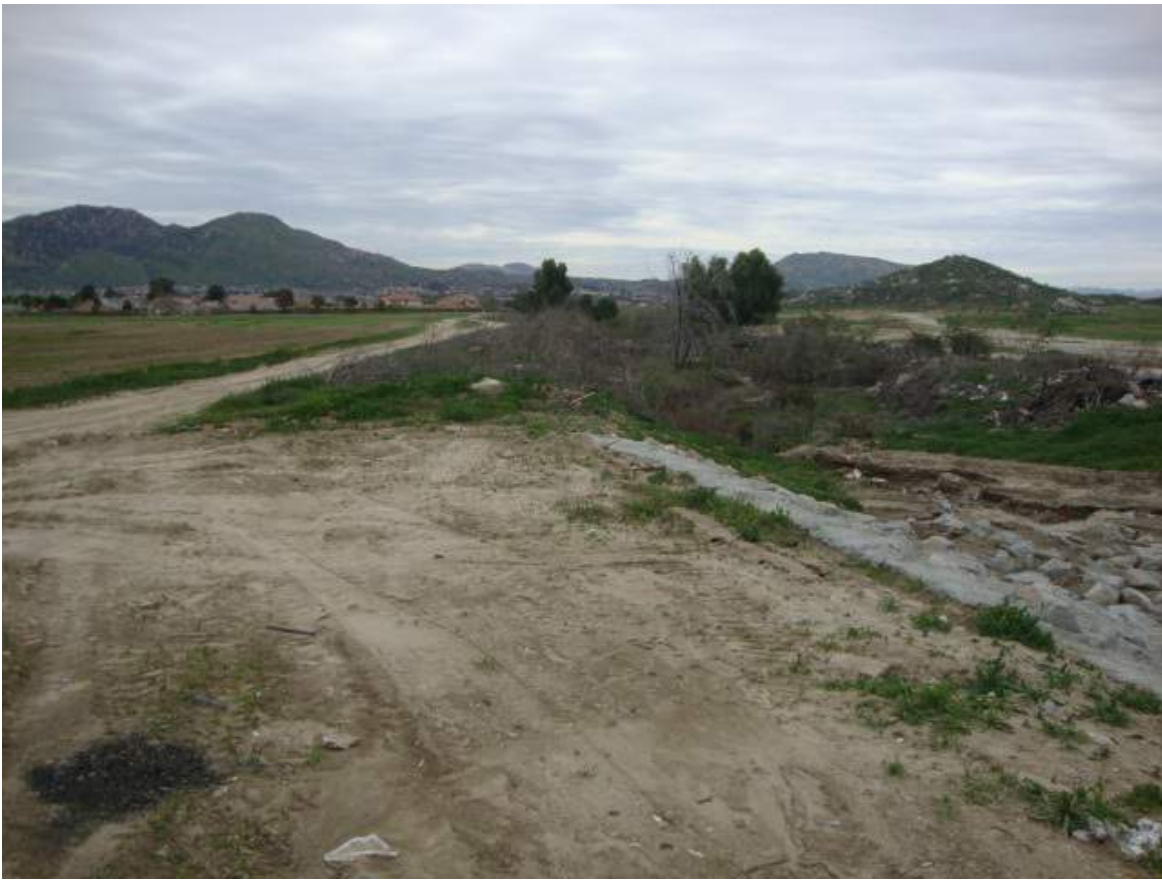
PHOTO 9 VIEW FACING SOUTH FROM THE NEC OF PARCEL 012 SHOWING THE SITE TO THE LEFT (EAST) AND THE QUINCEY CHANNEL TO THE RIGHT. CONSTRUCTION AND SOME MINOR HOUSEHOLD DEBRIS AND TRASH IS PRESENT ALONG THIS SITE BOUNDARY.

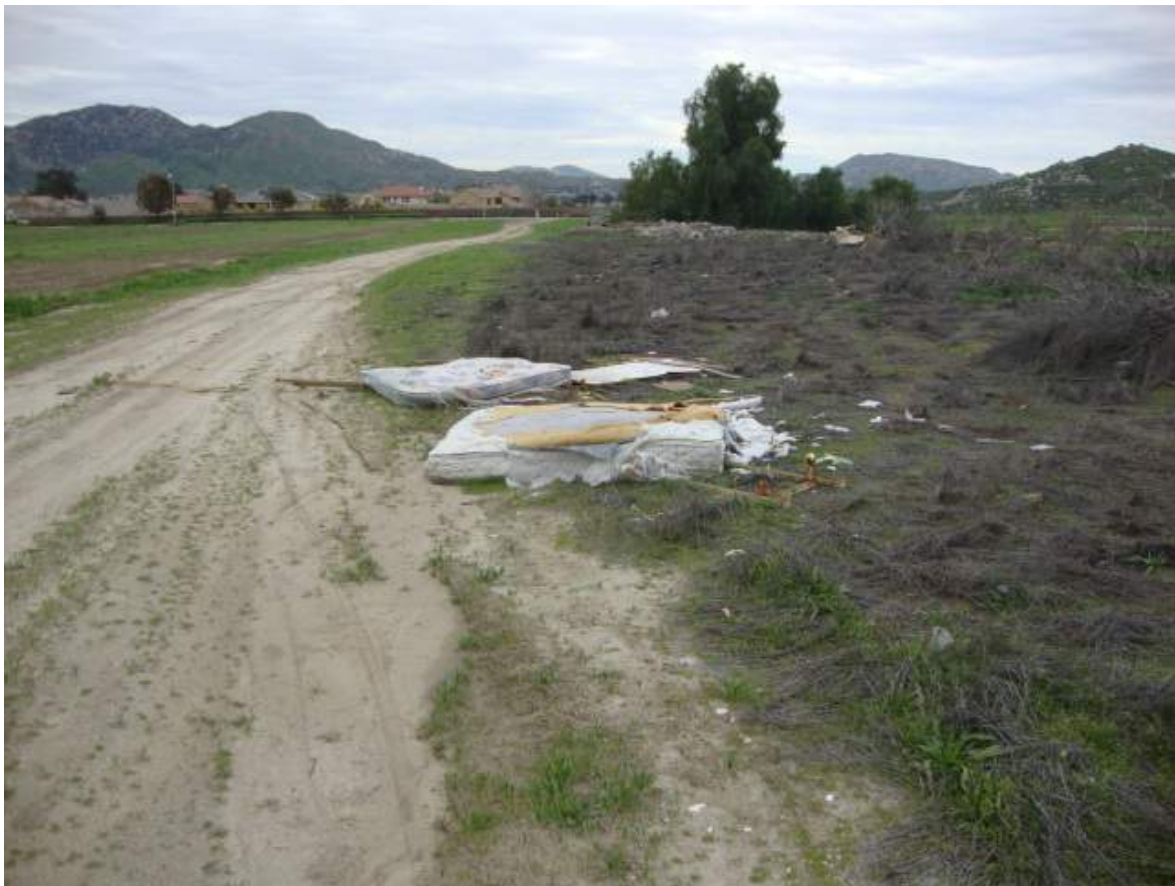
PHOTO 10 VIEW OF MATTRESS AND BOX SPRINGS DUMPED ALONG THE WEST SIDE OF PARCEL 012. IN THE BACKGROUND IS CONSTRUCTION WASTE (CONCRETE).

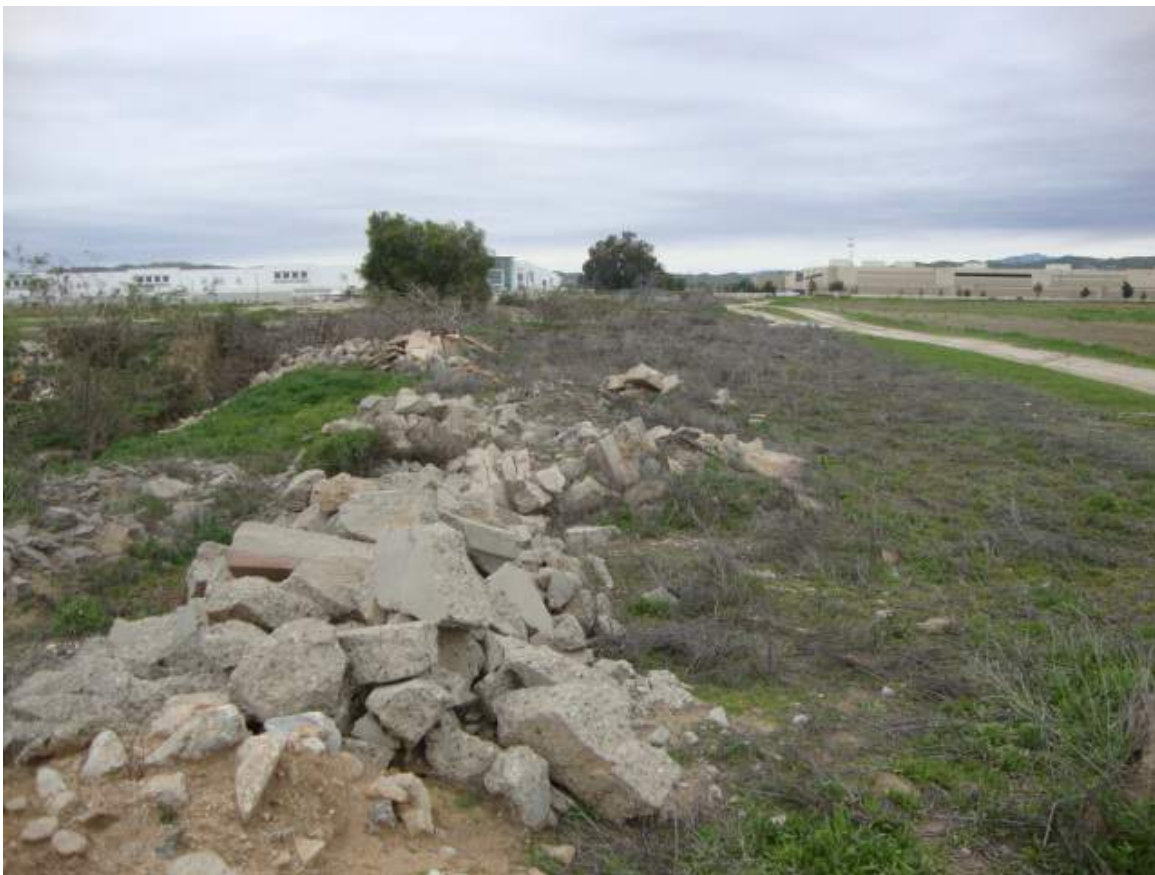
PHOTO 11 VIEW FACING NORTH SHOWING ADDITIONAL CONCRETE DUMPED ALONG THE WEST SIDE OF PARCEL 011 AND THE QUINCEY CHANNEL.

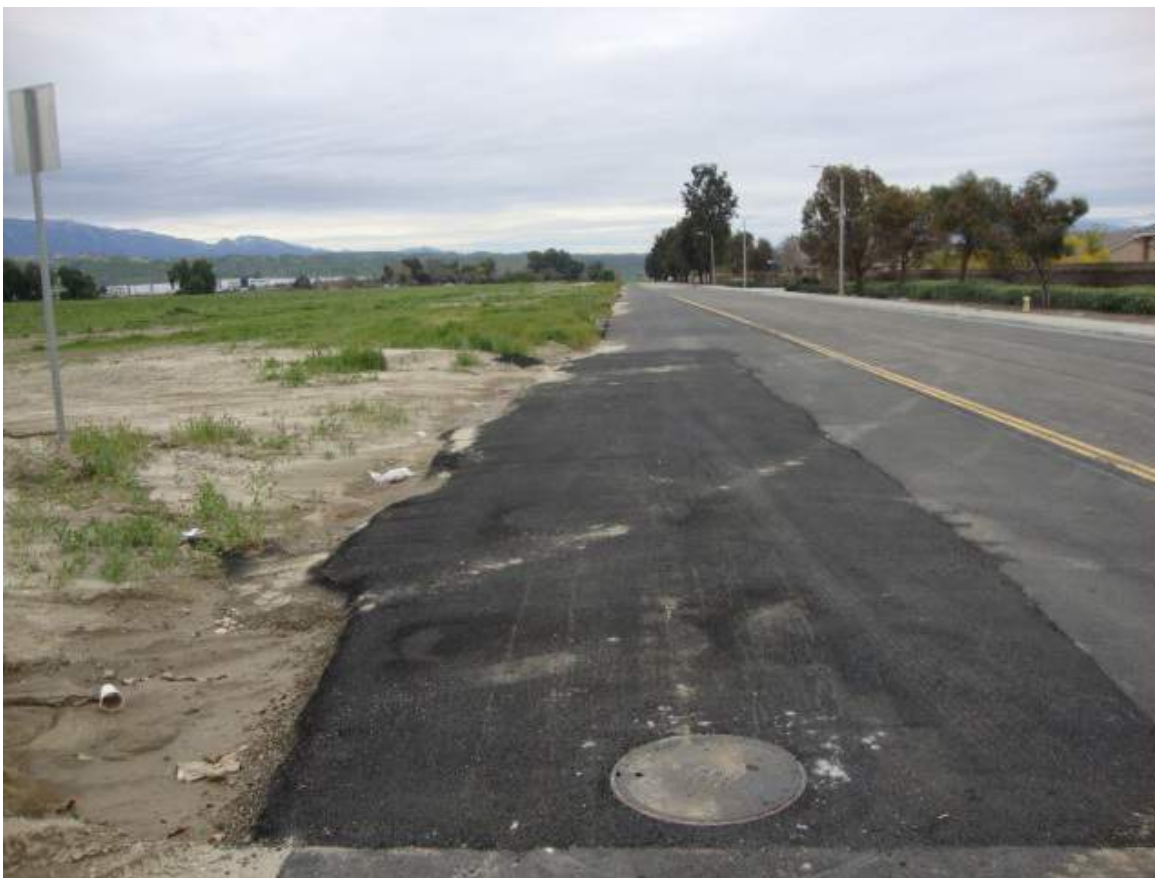
PHOTO 12 VIEW FACING EAST FROM THE SWC OF PARCEL 011 SHOWING THE SITE TO THE LEFT (NORTH) AND ENCELIA AVE. AND SINGLE FAMILY RESIDENTIAL TO THE RIGHT. A SEWER MANHOLE IS VISIBLE IN THE FOREGROUND.

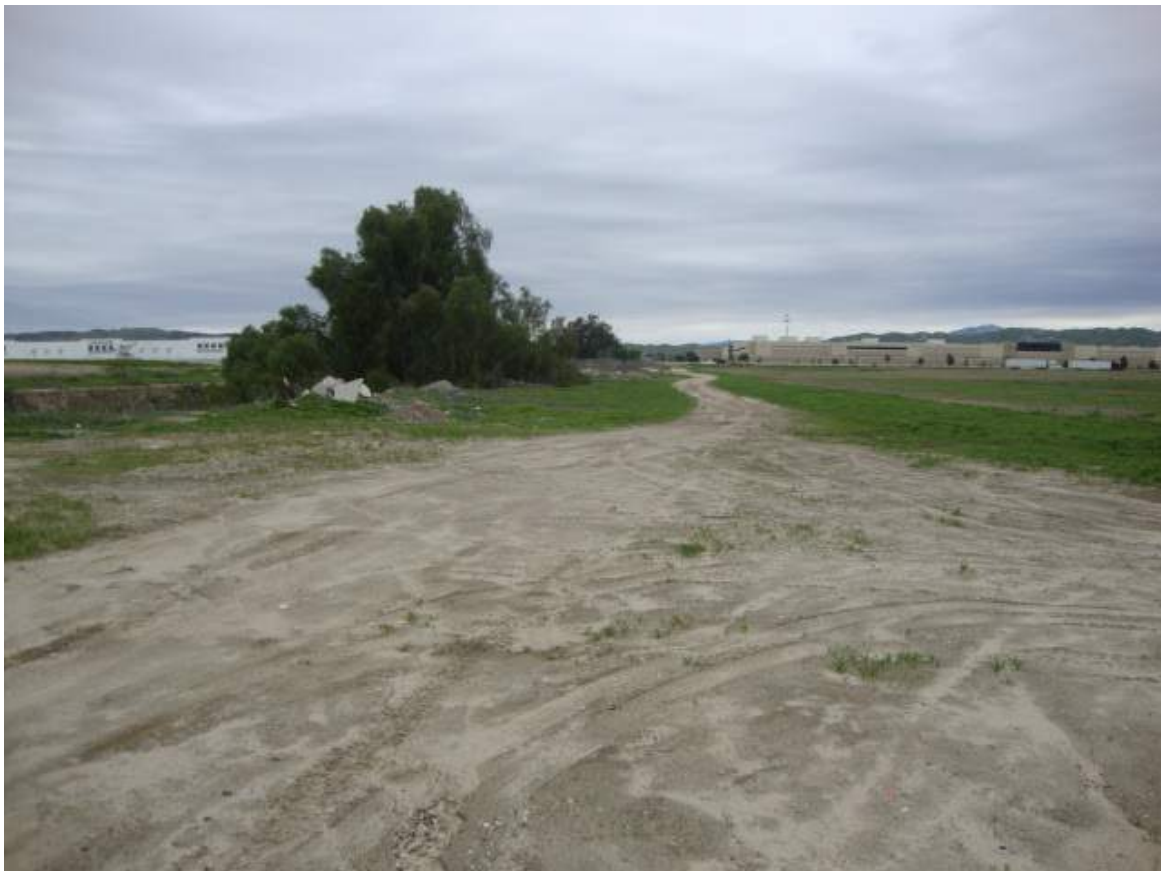
PHOTO 14 VIEW FACING NORTH FROM THE SEC OF PARCEL 011 SHOWING THE SITE TO THE RIGHT (EAST) AND QUINCEY CHANNEL TO THE LEFT. IN THE FOREGROUND IS CONSTRUCTION DEBRIS (CONCRETE). IN THE BACKGROUND IS ALDI WAREHOUSE TO THE RIGHT AND ANOTHER WAREHOUSE TO THE LEFT.

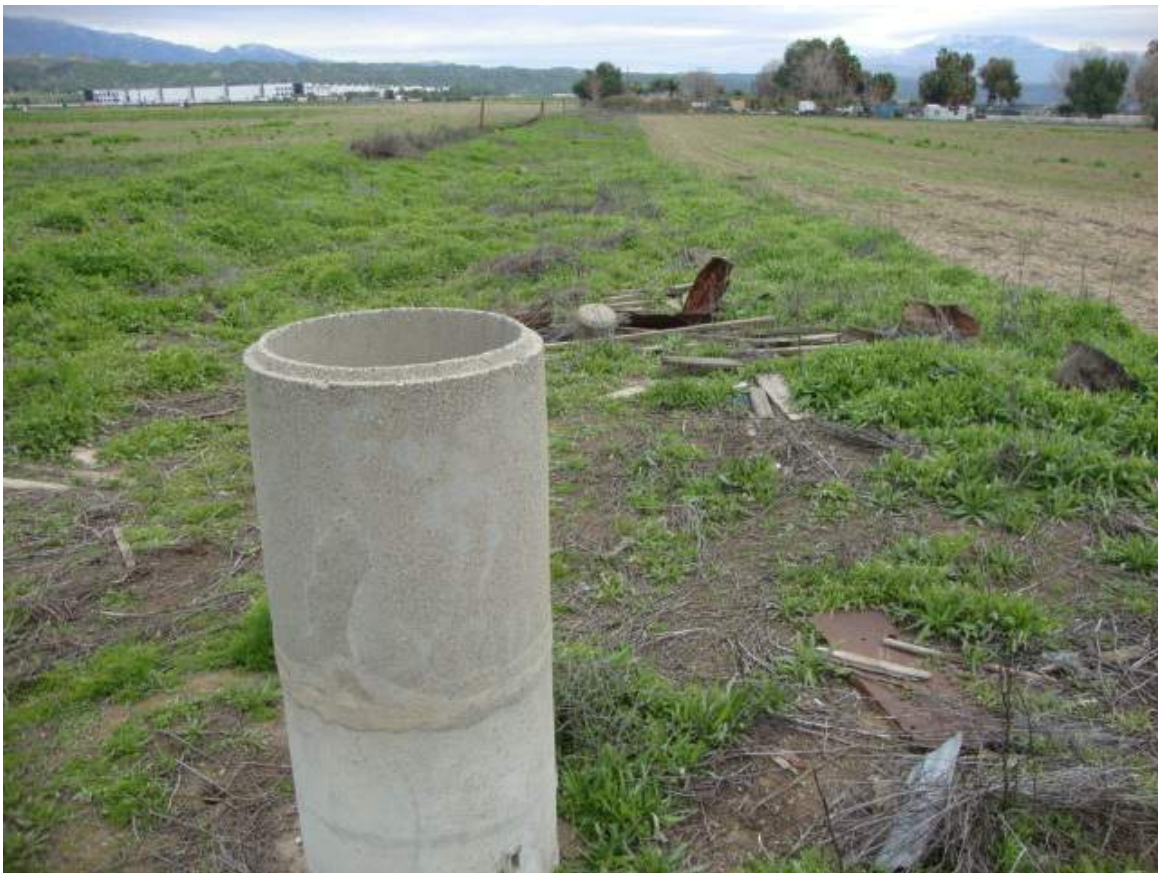
PHOTO 17 VIEW FACING EAST FROM THE INTERSECTION OF PARCELS 002, 003, 009 AND 010 SHOWING THE IRRIGATION STANDPIPE IN THIS AREA AND REMNANT FENCING. SHEET METAL AND WOOD FROM PRIOR STRUCTURES IS ALSO VISIBLE. HALLS NURSERY IS IN THE BACKGROUND.

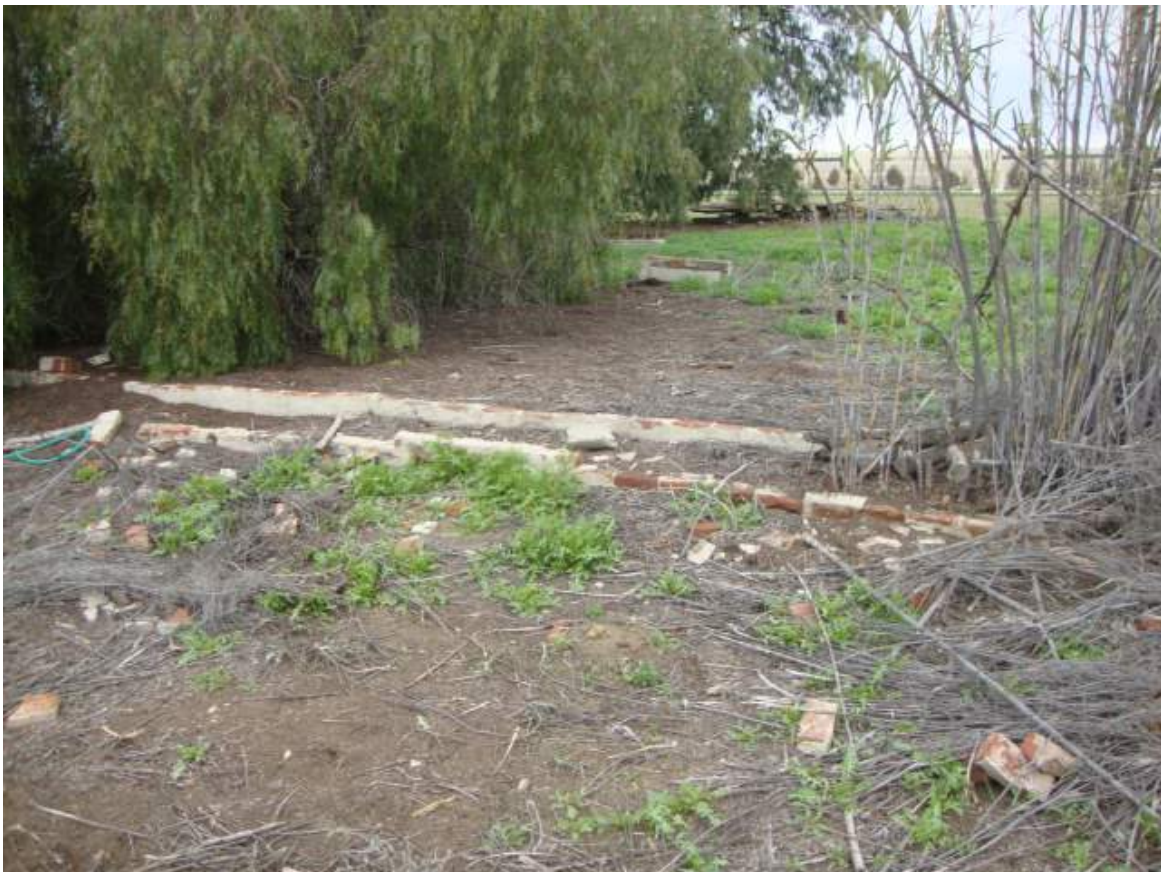
PHOTO 18 VIEW OF ONE OF THE REMNANT FOUNDATIONS PRESENT IN THE AREA OF THE INTERSECTION OF PARCELS 002, 003, 009 AND 010. THROUGH THE PEPPER TREE IS A WOODEN FOUNDATION.

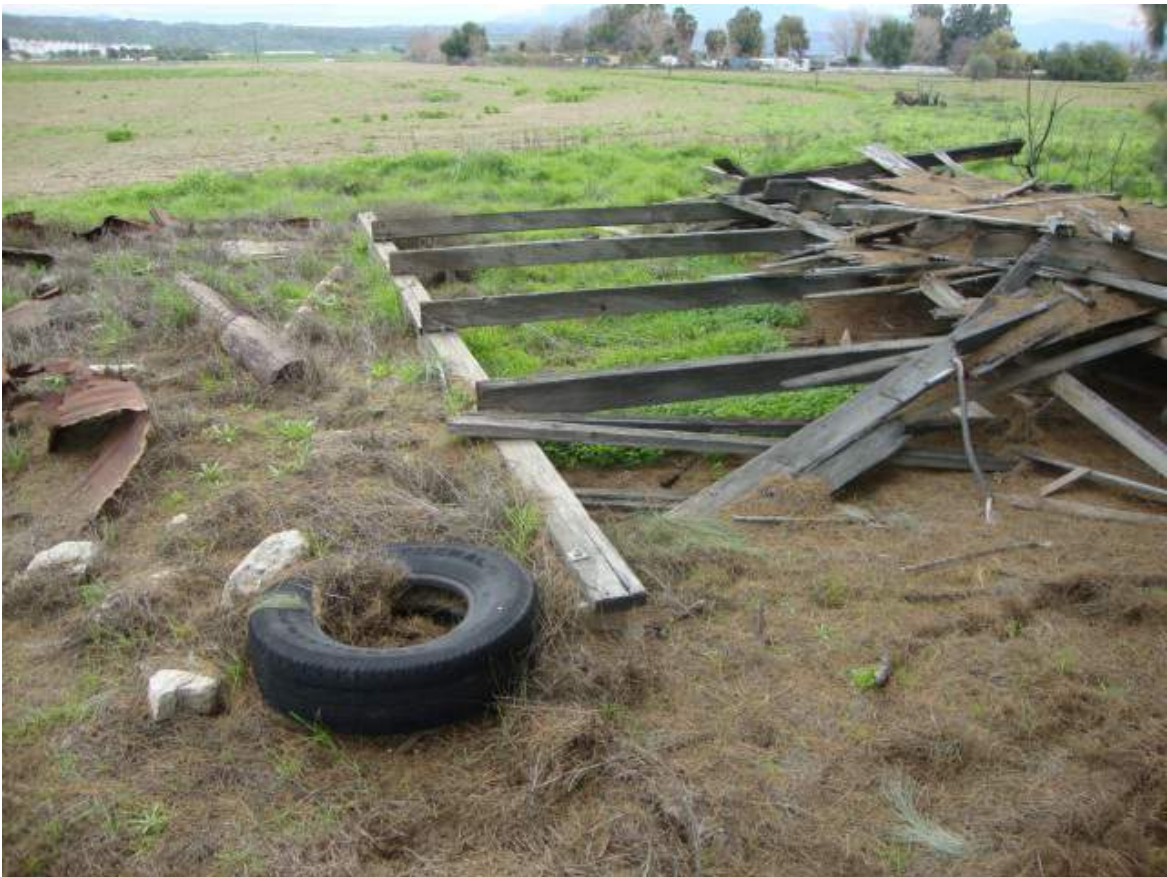
PHOTO 19 VIEW FACING EAST SHOWING THE WOODEN FOUNDATION NOTED IN THE PREVIOUS PHOTOGRAPH.

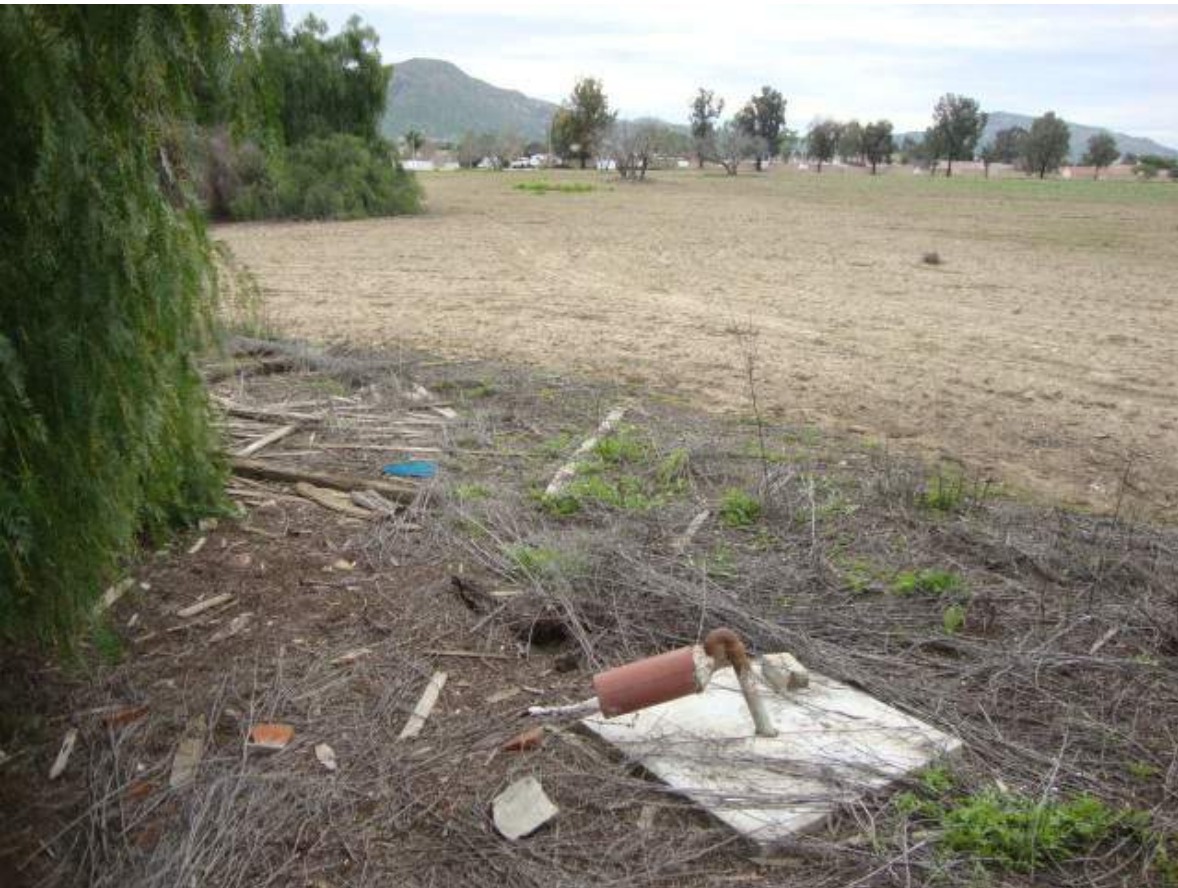
PHOTO 20 VIEW OF A WELL REPORTED IN PREVIOUS ENVIRONMENTAL STUDIES FOR THE SITE LOCATED ON THE WEST SIDE OF THE PEPPER TREES AT THE INTERSECTION OF PARCELS 002, 003, 009 AND 010. THE PIPE IS APPROXIMATELY 2 INCHES IN DIAMETER AND THE CONCRETE IS APPROXIMATELY 2 FEET SQUARE. THE PIPE IS LOOSE AND CAPPED WITH CLAY PIPE AND CONCRETE.

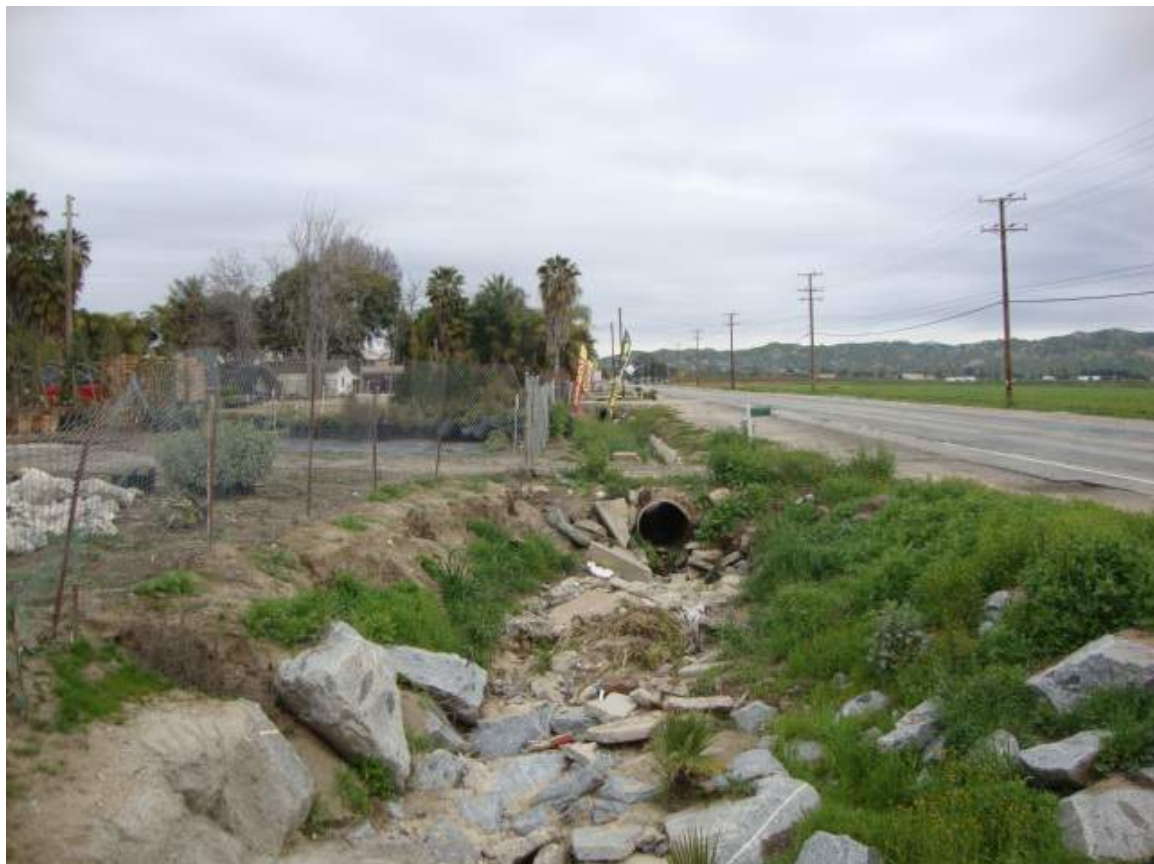
PHOTO 22 VIEW FACING NORTH FROM THE INTERSECTION OF ENCELIA AVE. AND REDLANDS BLVD. SHOWING HALLS NURSERY TO THE LEFT (WEST) AND REDLANDS BLVD. TO THE RIGHT WITH THE EARTHEN CHANNEL ALONG THE ROADWAY.

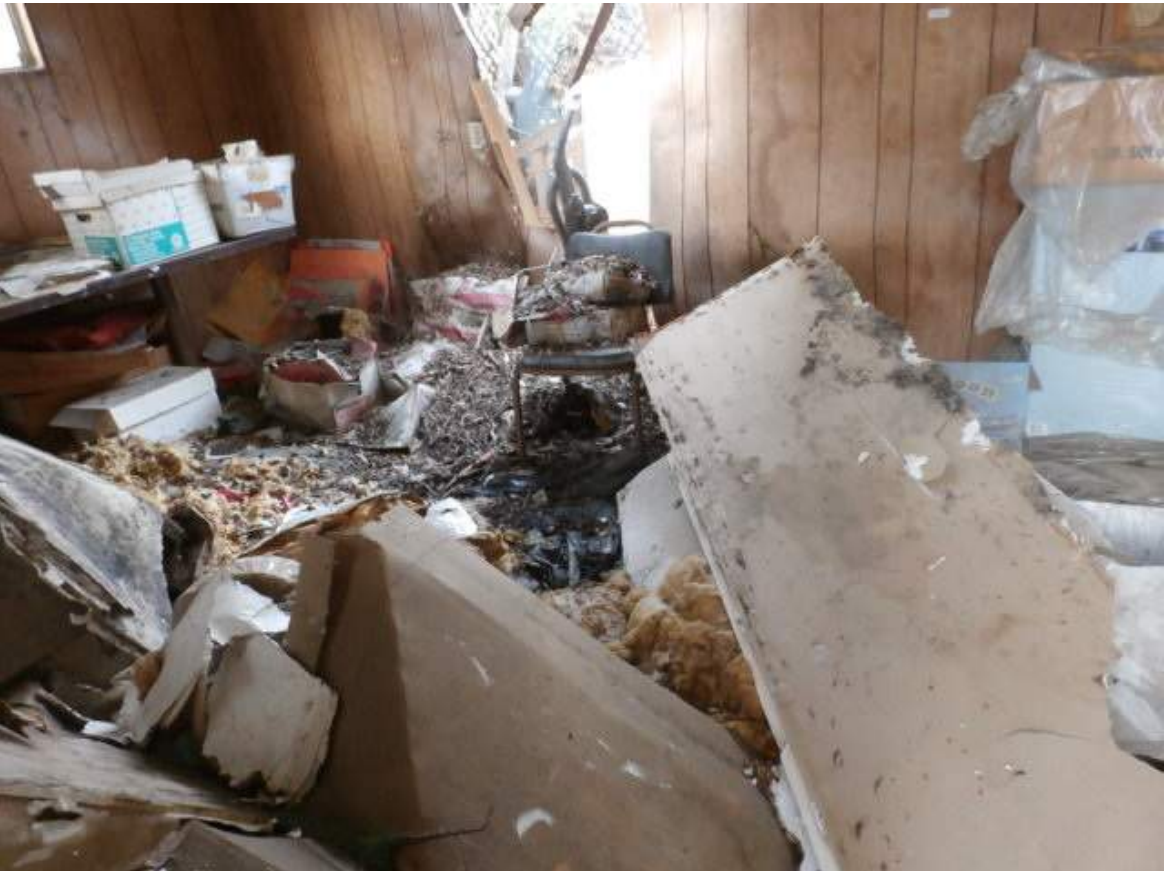
PHOTO 24 SHOWING THE INSIDE OF THE GARAGE ASSOCIATED WITH THE RESIDENCE ADDRESSED 12981 REDLANDS. PART OF THE GARAGE IS DAMAGED.

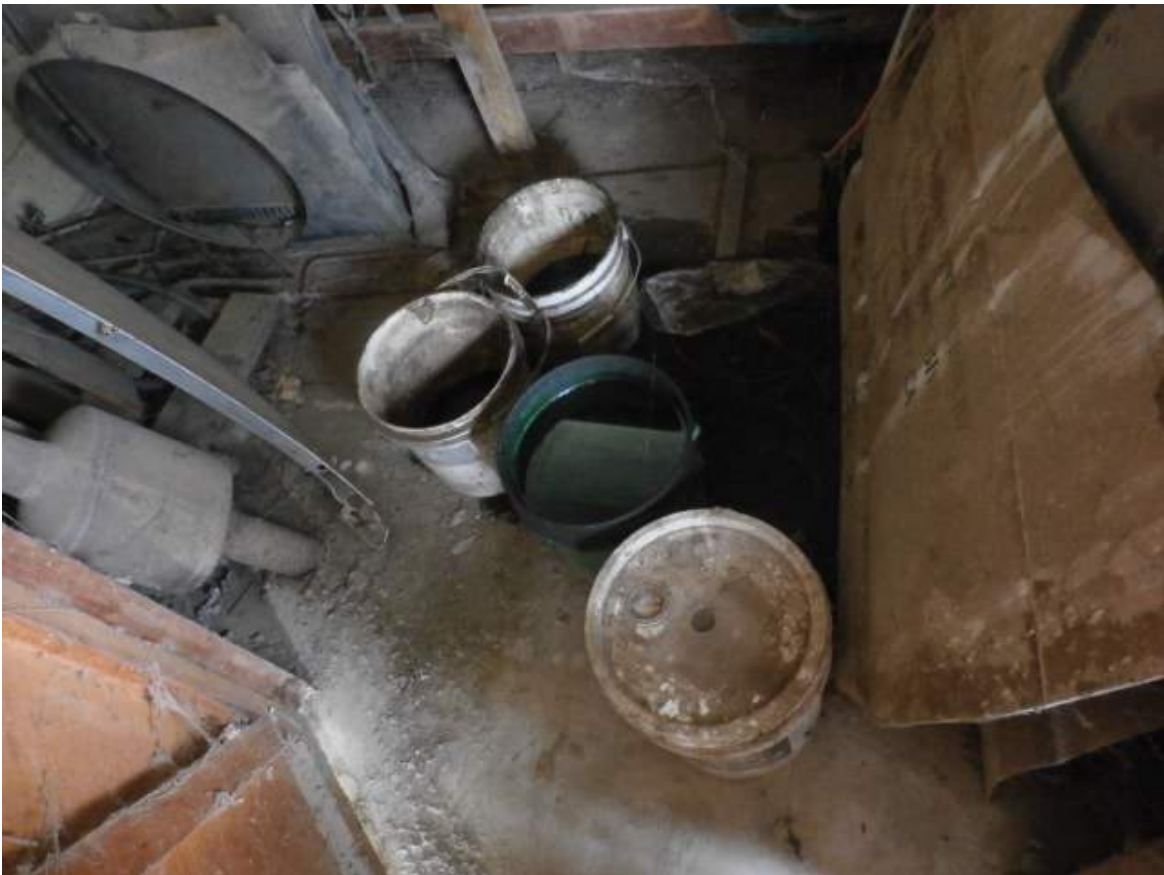
PHOTO 25 NORTH OF THE GARAGE PICTURED IN THE PREVIOUS PHOTOGRAPH IS A SMALL WOODEN SHED WITH THREE 5-GALLON BUCKETS PARTIALLY TO FULL OF WASTE OIL AND ONE EMPTY BUCKET WITH OTHER STORED ITEMS.

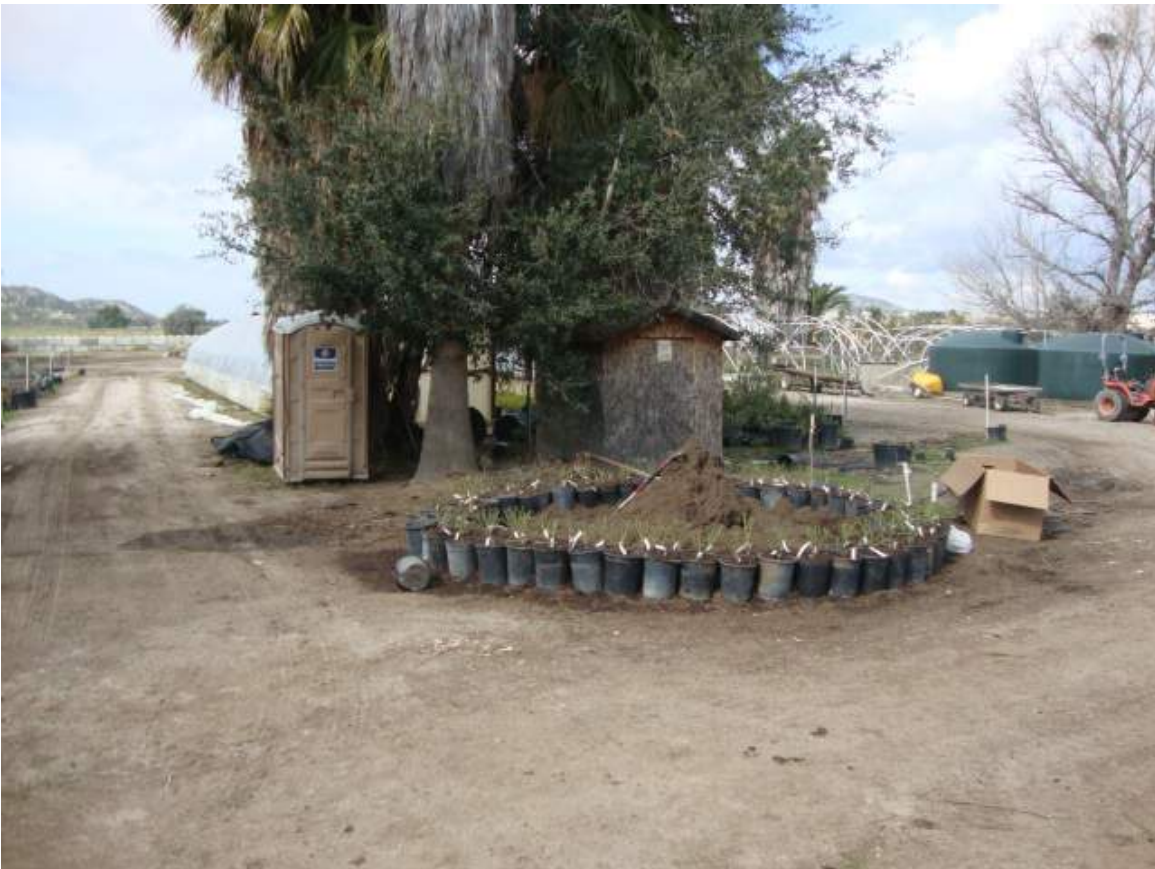
PHOTO 34 VIEW FACING WEST SHOWING THE PESTICIDE STORAGE SHED. TO THE RIGHT (NORTH) ARE THE WATER TANKS ASSOCIATED WITH THE WELL.

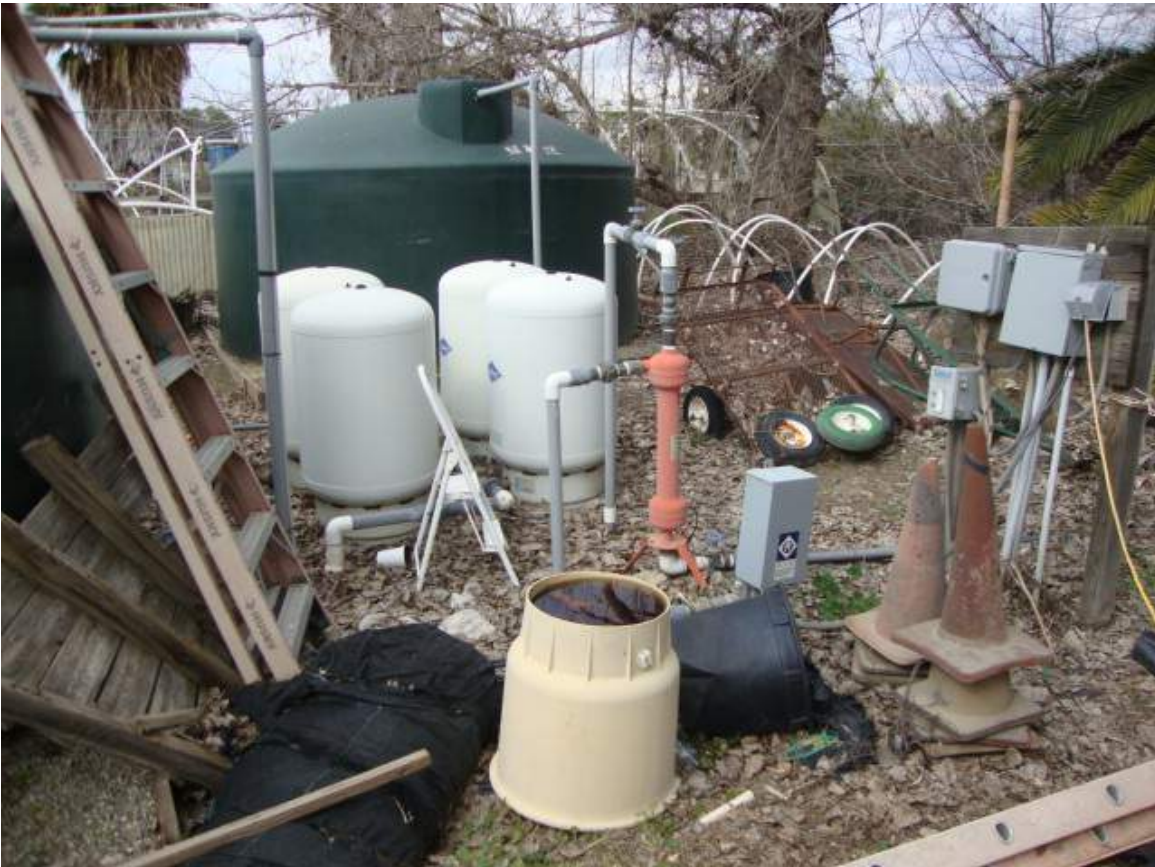
PHOTO 36 VIEW OF THE WATER WELL, BLADDER TANKS, HOLDING TANKS AND FILTERS. PUMP IS ELECTRIC.

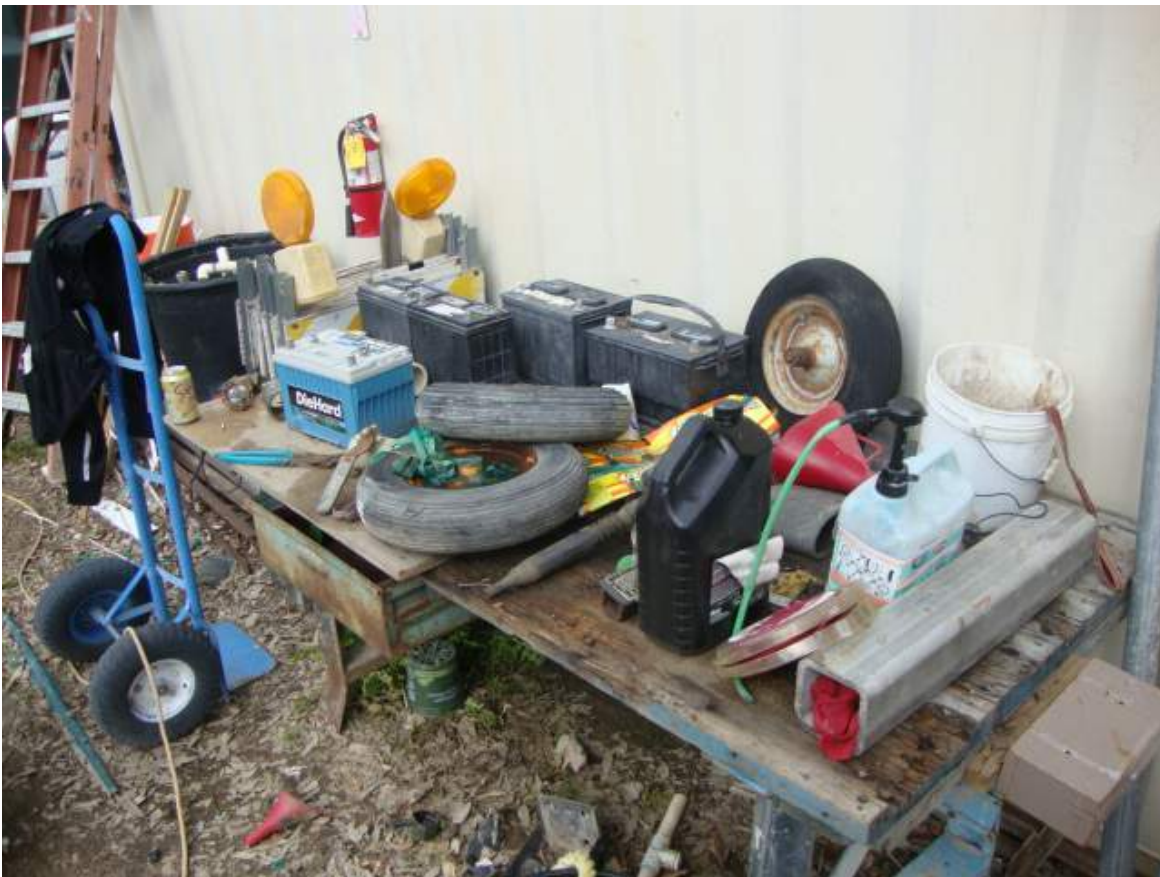
PHOTO 37 VIEW OF THE WORKBENCH SOUTH OF THE 20 FOOT STEEL CONTAINER EAST OF THE WATER WELL. BATTERIES MOTOR OIL ARE STORED HERE.

Only household quantities of hazardous materials and a minor amount of automotive related hazardous waste (waste oil) was observed on the nursery property. These should be disposed of/recycled at a licensed hazardous waste disposal/recycling facility.

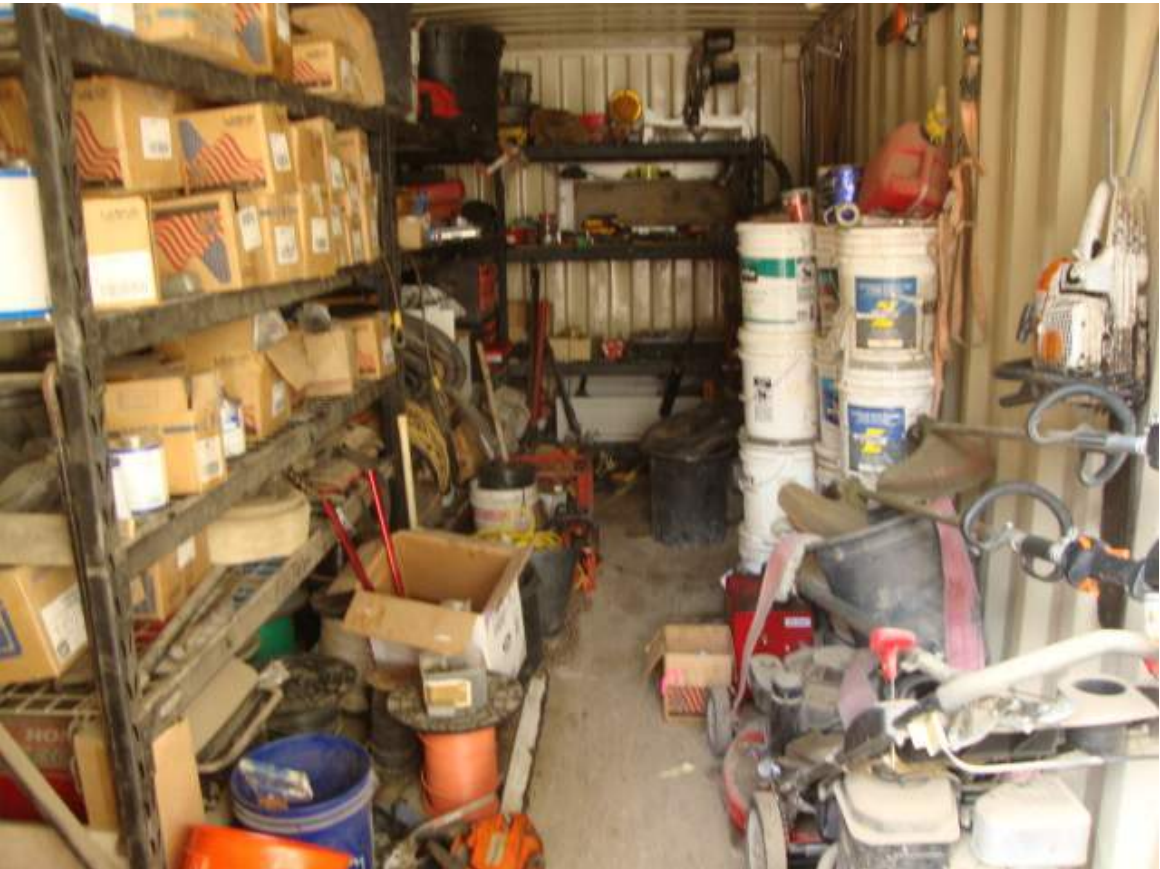
PHOTO 38 VIEW OF THE STORED PARTS AND EQUIPMENT IN THE 20 FOOT STEEL CONTAINER EAST OF THE WATER WELL. THE 5-GALLON BUCKETS ARE PAINT.
