**PROJECT SPECIFIC PRELIMINARY
WATER QUALITY MANAGEMENT PLAN
(P-WQMP)**

PEN19-0193/LWQ19-0035

OPTION 1 - HIGH CUBE LOGISTICS SITE PLAN

EUCALYPTUS AVE. AND REDLANDS AVE.

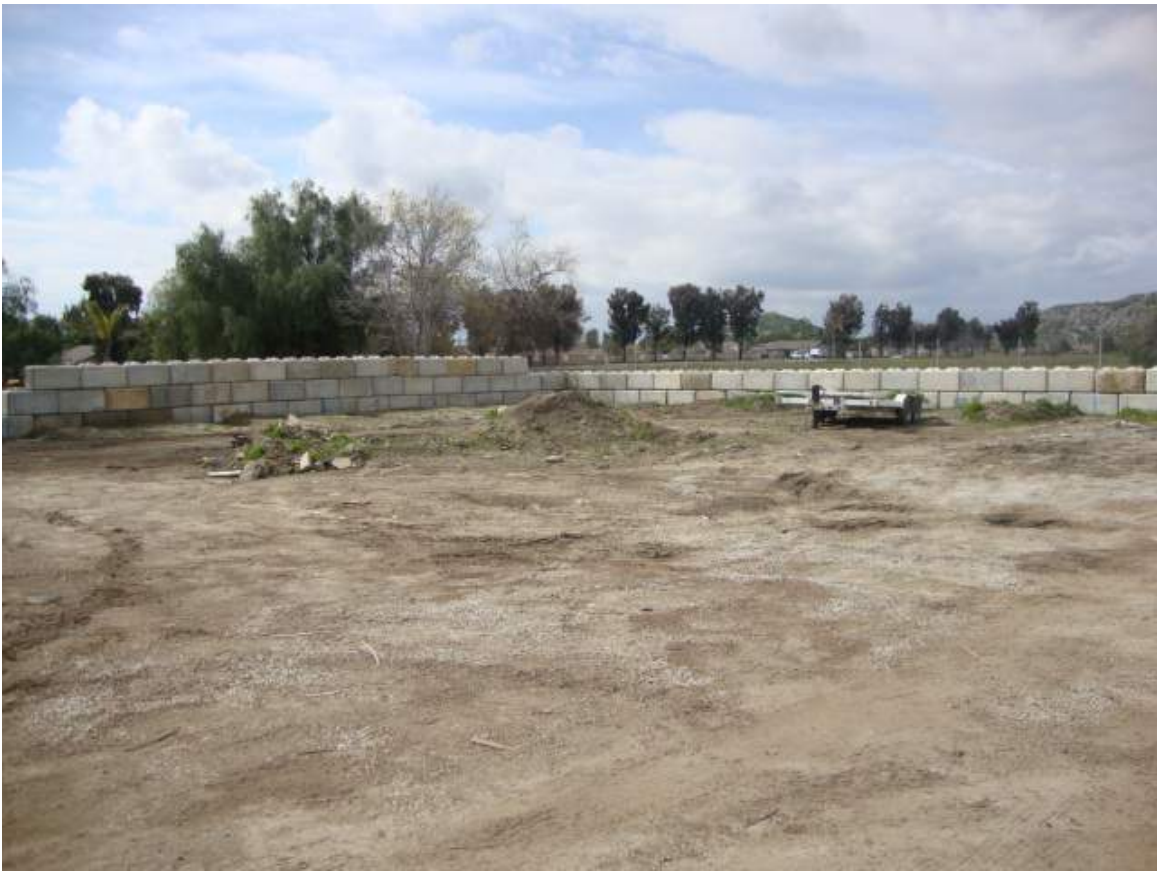
PHOTO 39 VIEW OF THE LARGE CONCRETE BLOCK AT THE WEST-CENTER PORTION OF THE PROPERTY. THE CONCRETE BLOCK ARE THE START OF BUNKERS FOR SAND GRAVEL AND ROCK.

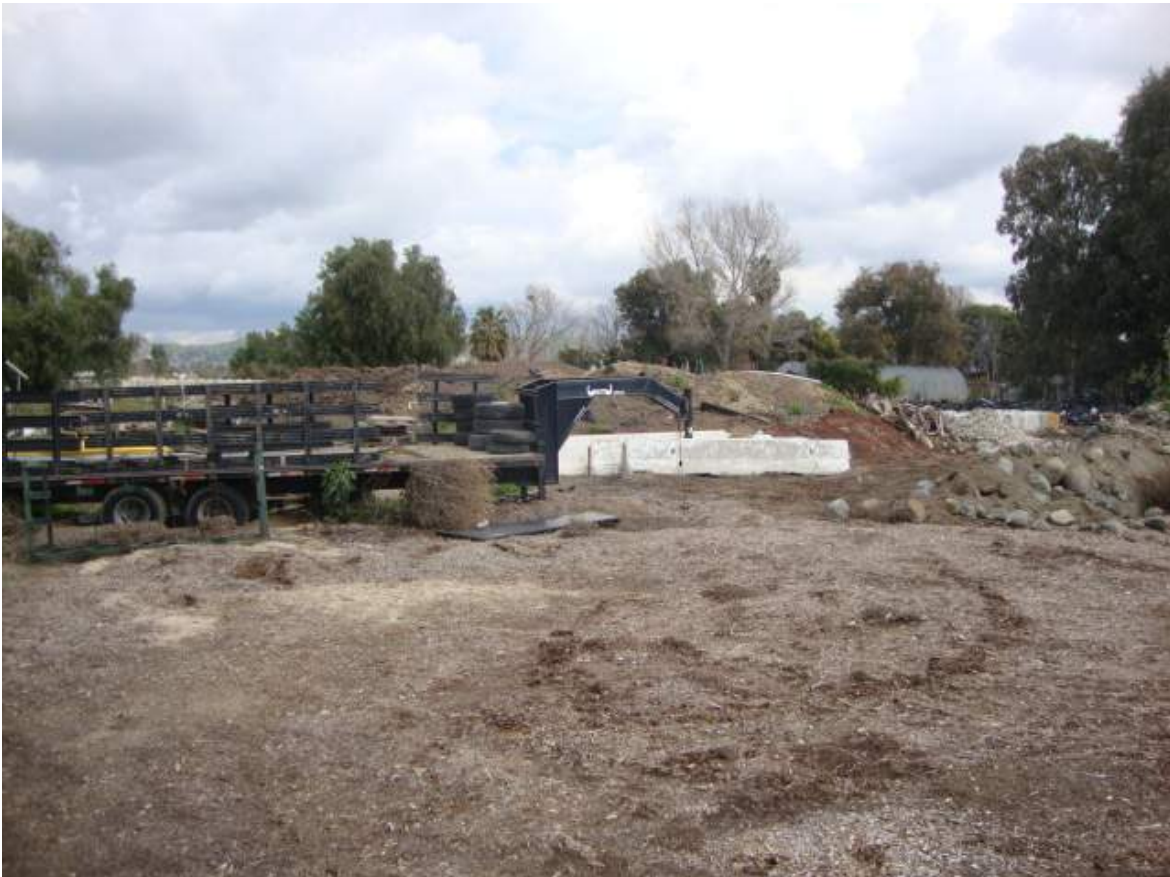
PHOTO 40 VIEW FACING NORTHEASTERLY FROM THE SWC OF THE NURSERY SHOWING THE CONCRETE BLOCK, LARGE PILE OF DIRT, MULCH AND LANDSCAPE POTS STORED IN THIS AREA.

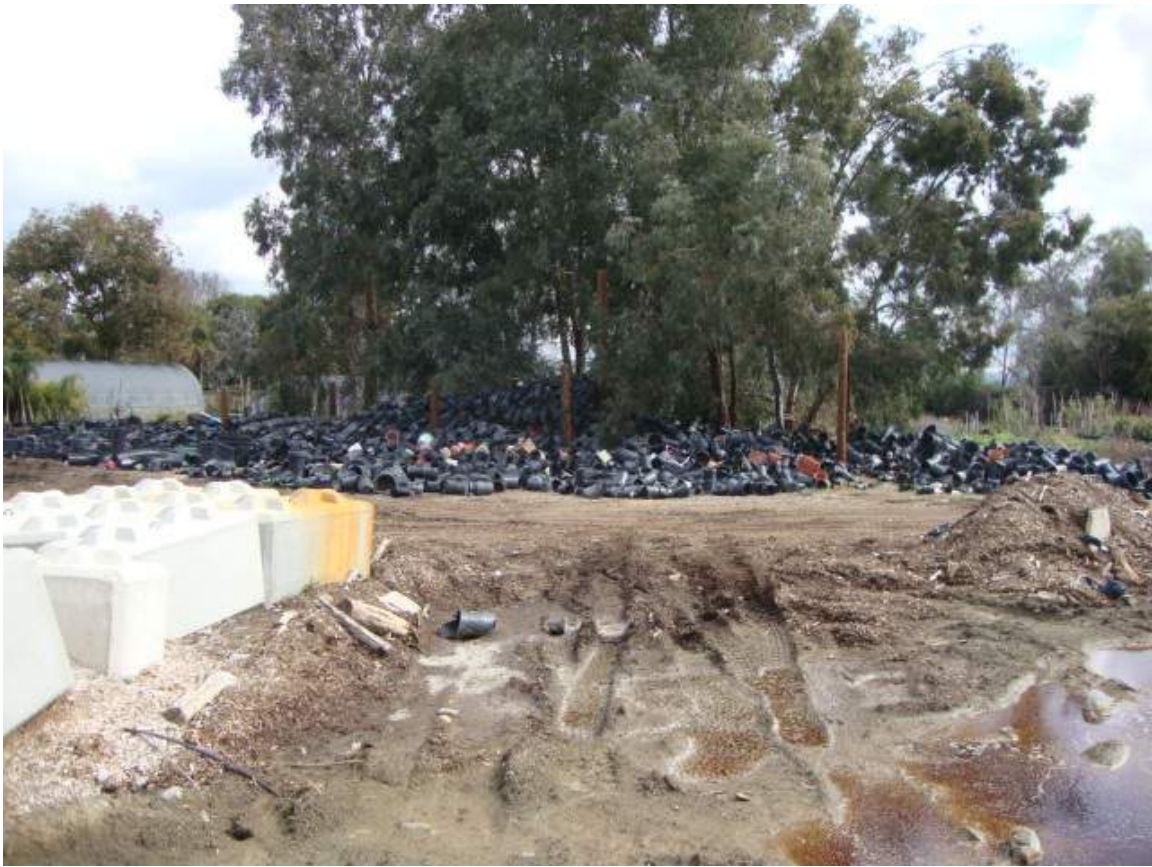
PHOTO 41 VIEW OF THE NUMEROUS LANDSCAPE POTS IN THE SOUTHWEST PORTION OF THE NURSERY.

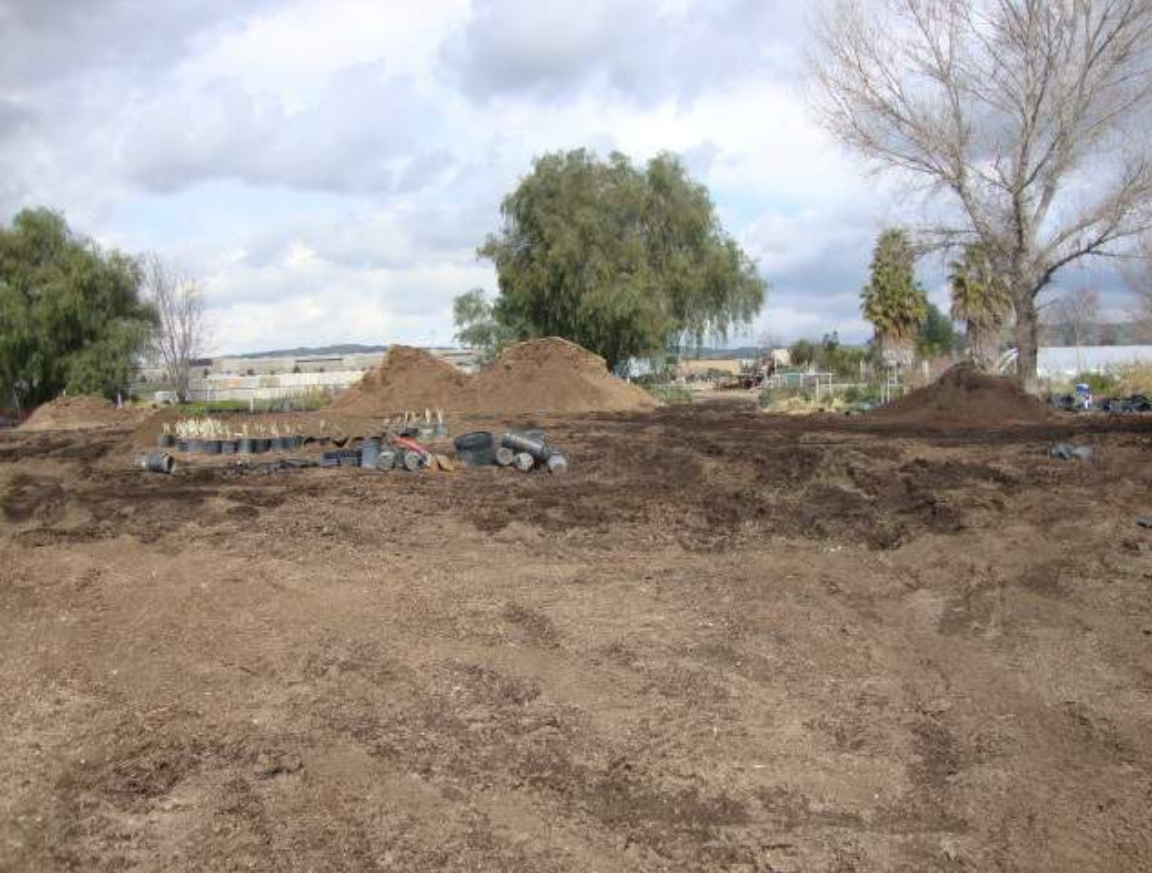
PHOTO 42 VIEW OF THE MULCH STORED IN THE SOUTHWEST PORTION OF THE NURSERY.

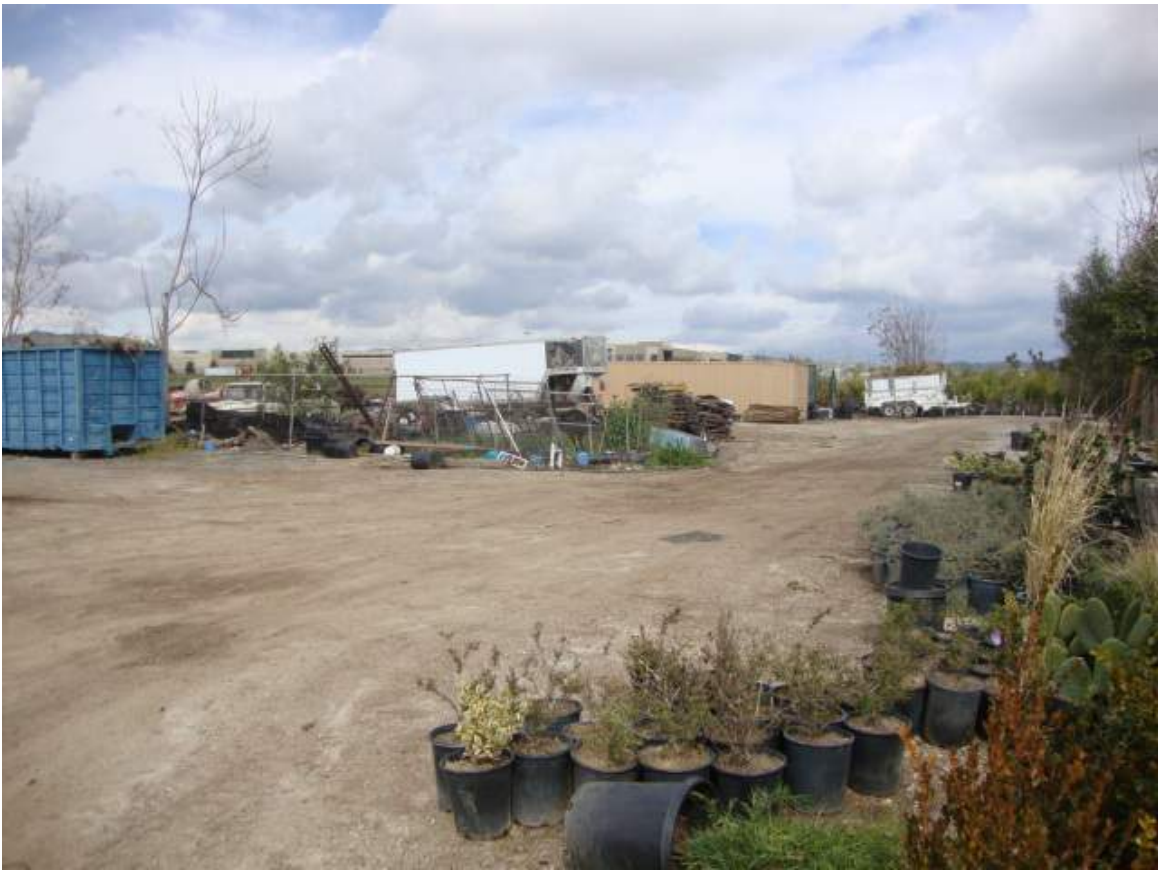
PHOTO 43 VIEW SHOWING A ROLL OFF WITH GREEN WASTE, TRAILERS AND STORAGE CONTAINERS IN THE NORTH WESTERLY PORTION OF THE NURSERY.

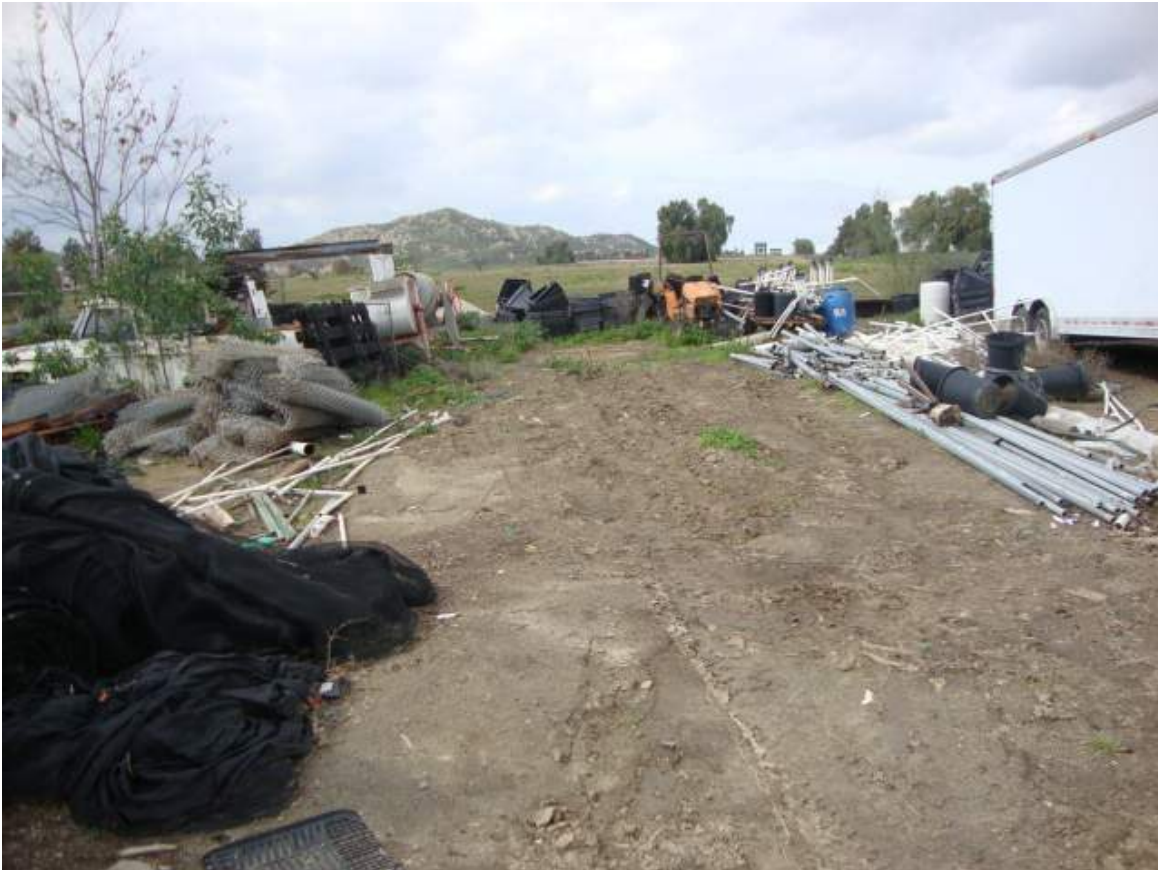
PHOTO 44 VIEW OF THE STORED SHADE CLOTH, PVC AND METAL PIPE, FENCING OLD TRACTOR, EMPTY 55- GALLON PLASTIC DRUMS, AND OTHER MATERIAL IN THE NORTHWESTERLY PORTION OF THE SITE.

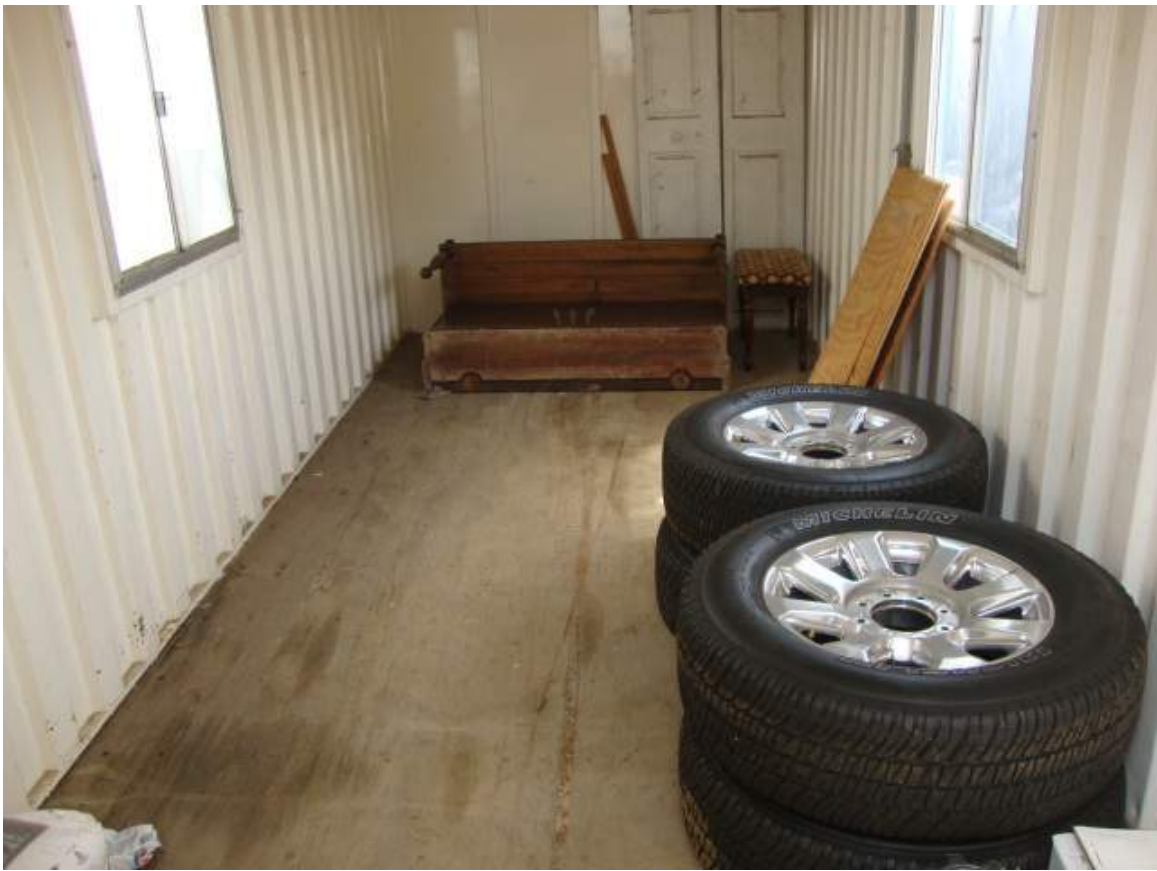
PHOTO 45 VIEW OF THE STORED PERSONAL ITEMS IN ONE OF THE 20 FOOT STEEL CONTAINERS LOCATED IN THE NORTHWESTERLY PORTION OF THE SITE.

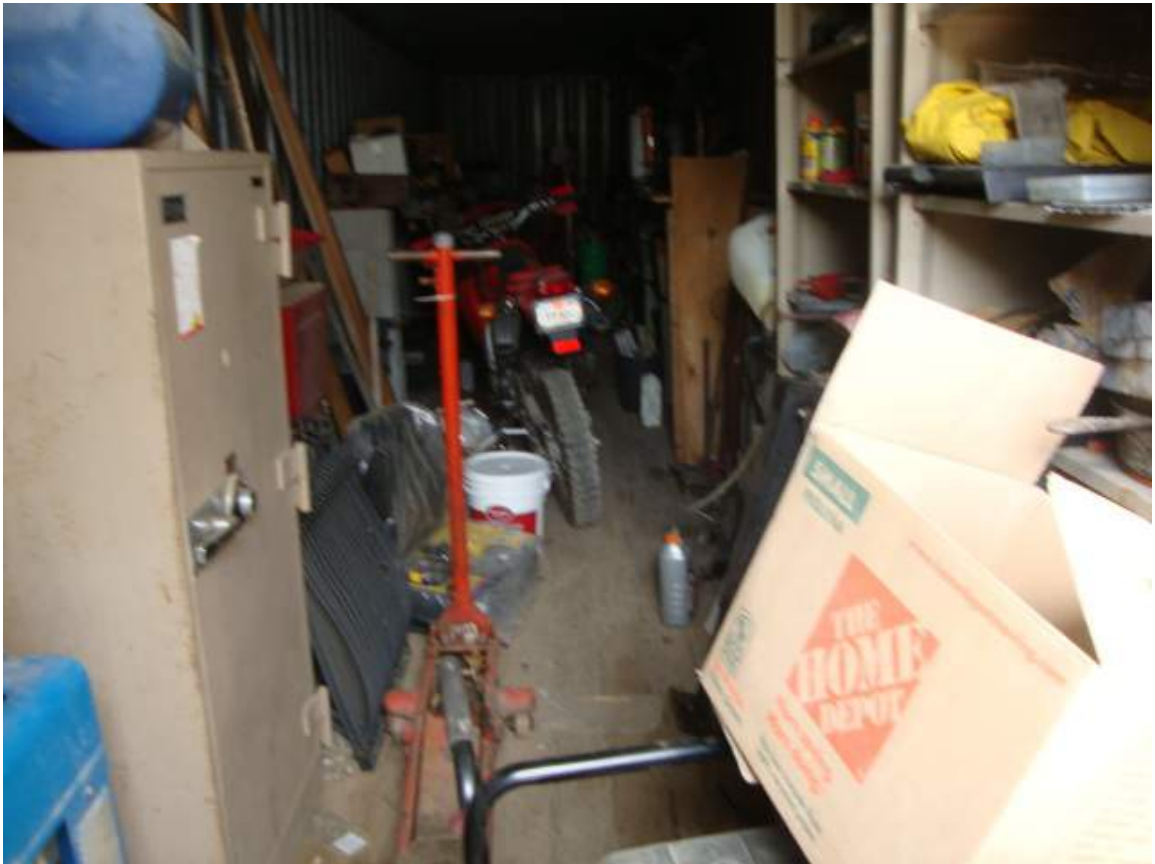
PHOTO 46 VIEW OF THE PERSONAL ITEMS STORED IN THE OTHER 20 FOOT STEEL CONTAINER IN THE NORTHWESTERLY PORTION OF THE SITE.

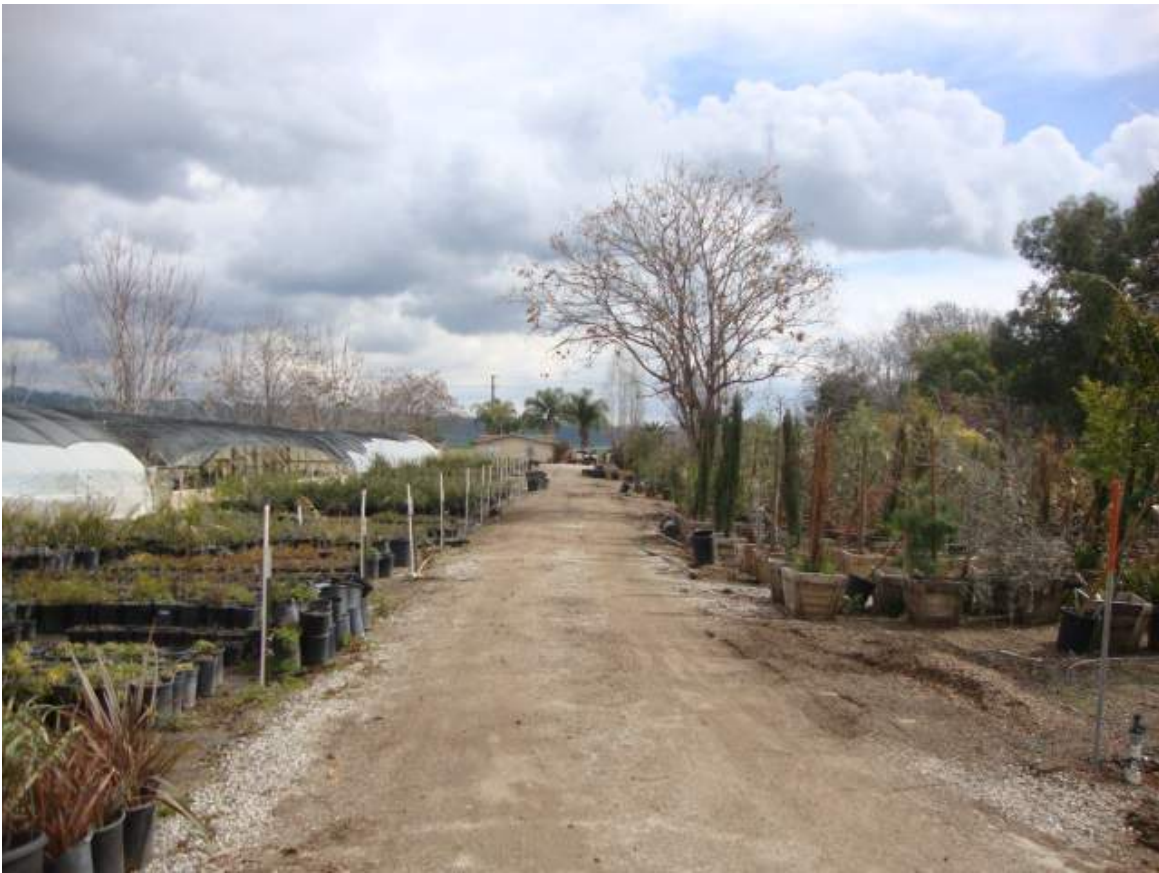
PHOTO 47 VIEW FACING EAST SHOWING THE NORTHER PORTION OF THE NURSERY WITH THE PLANTS AND GREEN HOUSES. IN THE BACKGROUND IS THE RESIDENCE WITH THE ADDRESS OF 12981 REDLANDS.

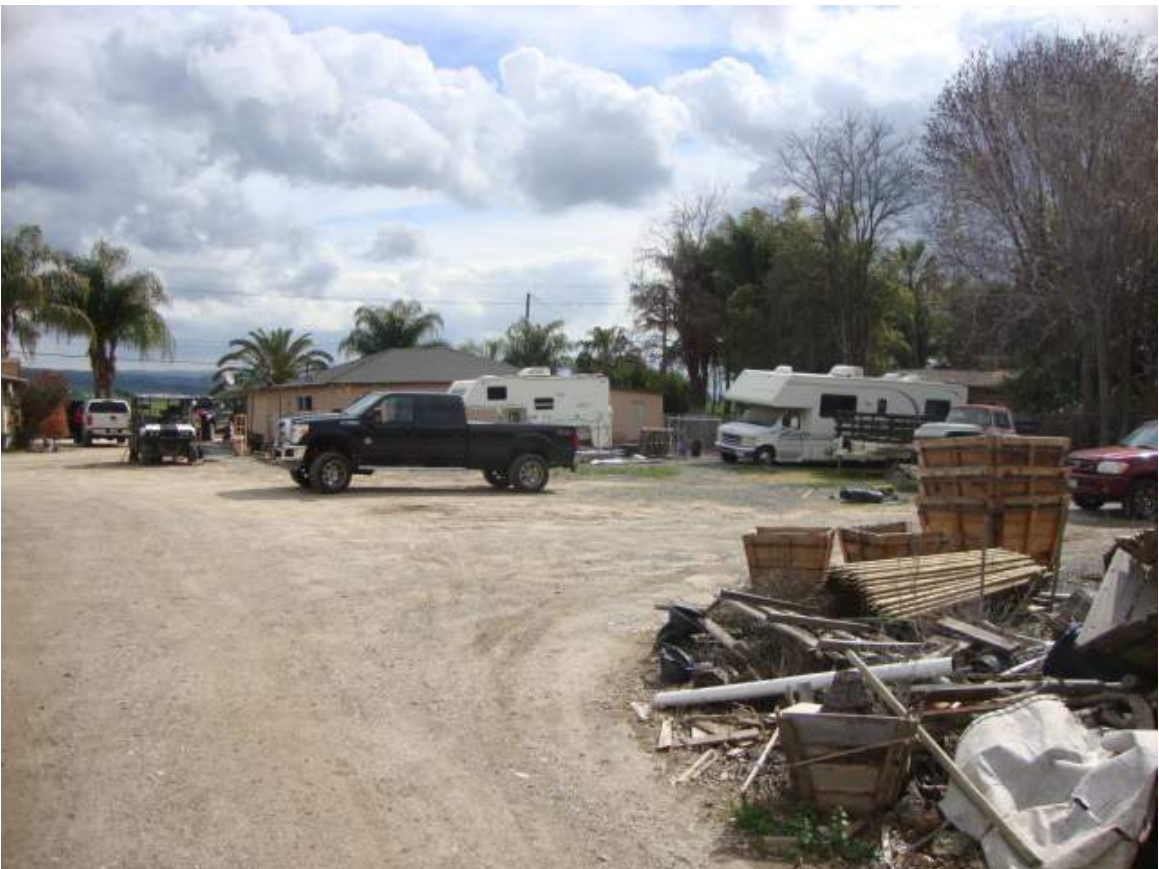
PHOTO 48 VIEW OF THE GARAGE AND STORED TRAILER, MOTOR HOME AND VEHICLES AT 12981 REDLANDS. IN THE FOREGROUND ARE STORED NURSERY MATERIALS.
