# Goleta Train Depot

## Initial Study

**May 2020**

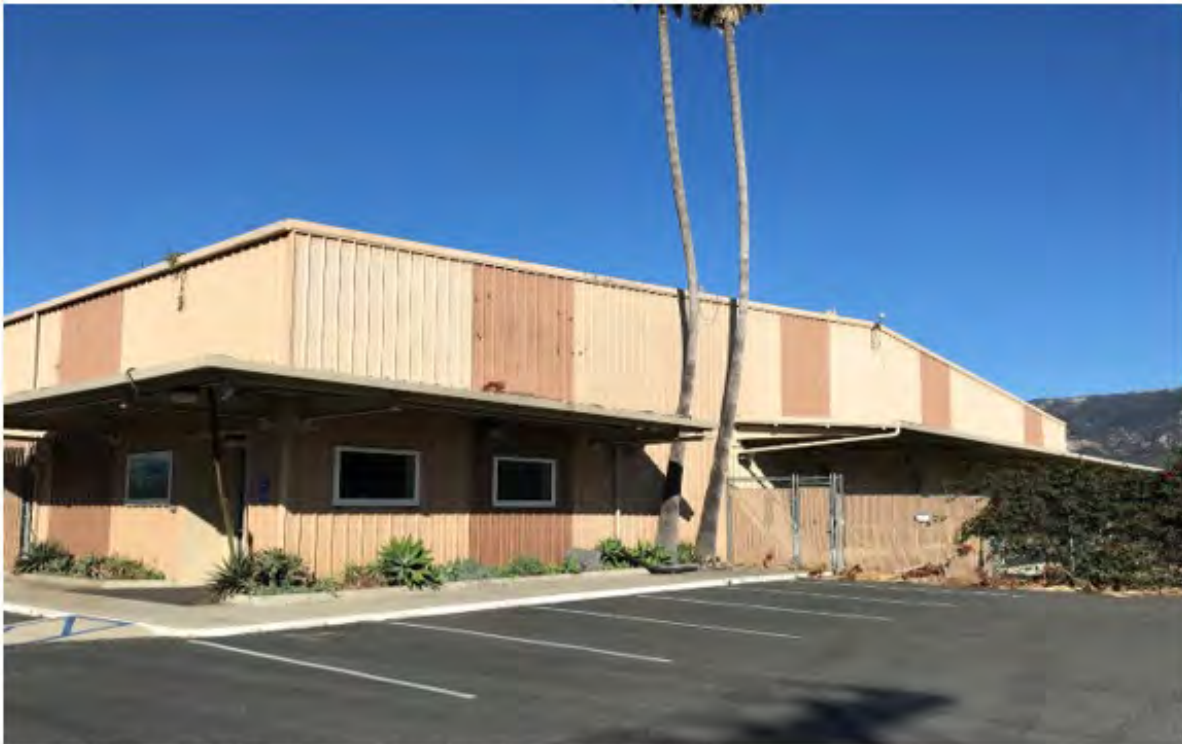
Figure 4a Existing Site Conditions

View of the east side of the existing building looking northwest

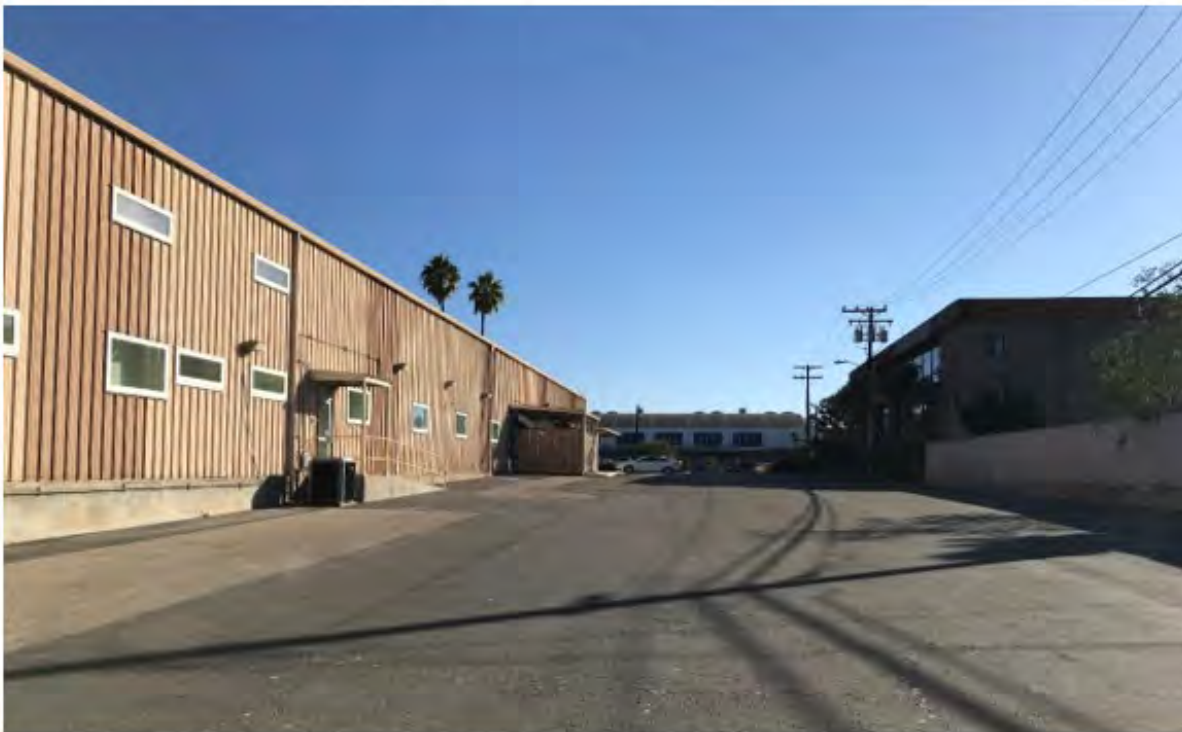
View of the south side of the existing building looking east towards S. Patera Lane

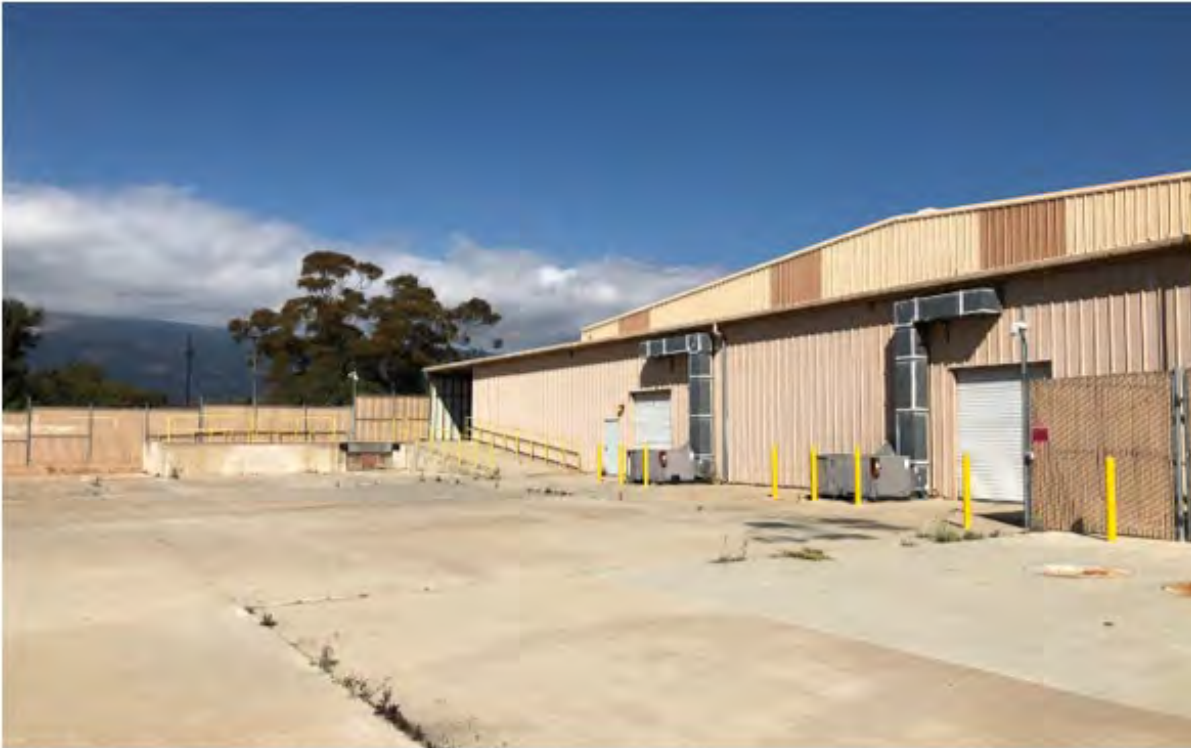
Figure 4b Existing Site Conditions

View of the west side of the existing building looking north

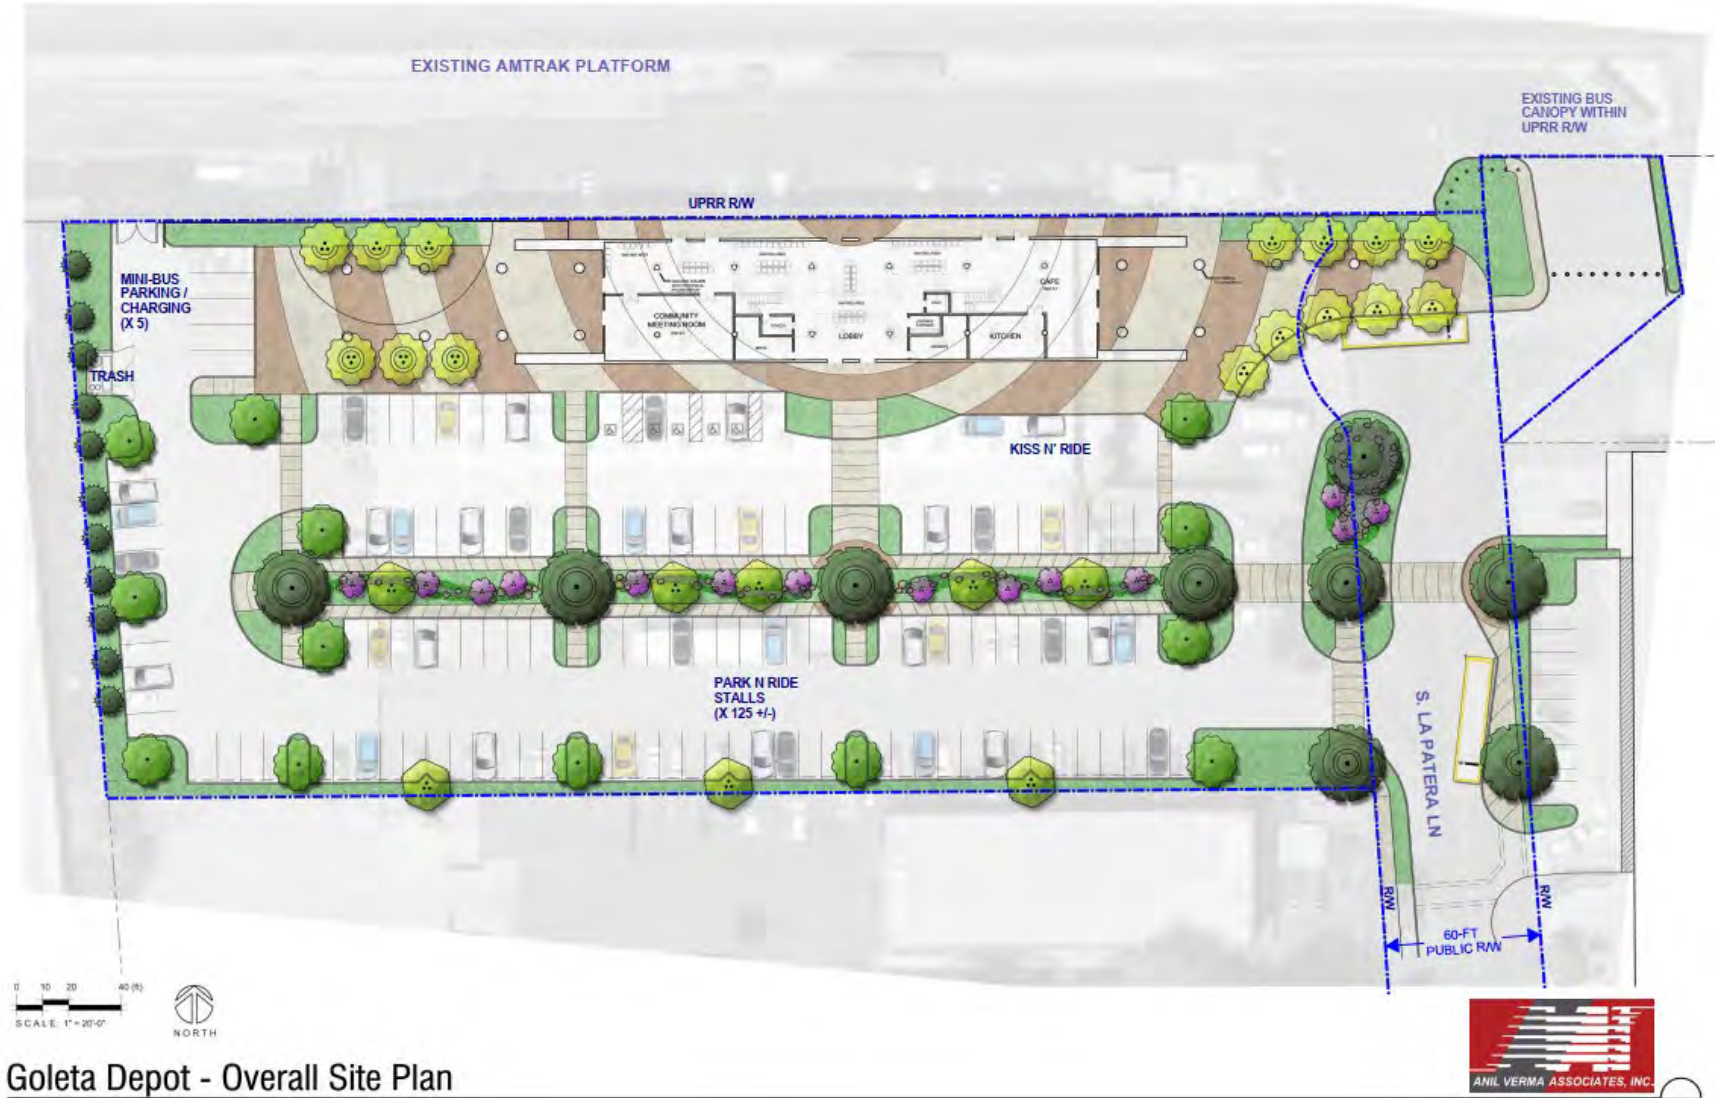
Figure 5 Proposed Development Site Plan

Goleta Depot - Overall Site Plan

In addition to amenities located inside the proposed new Depot building, the project would also provide ample vehicle parking on an adjacent surface parking lot. Outdoor seating and a play area for children may also be provided adjacent to the proposed building. A proposed “Kiss N’ Ride” space in front of the building would allow for designated pick-up and drop-off locations for passengers, including a separate space to accommodate Transportation Network Companies (TNCs) such as Uber and Lyft. Finally, historical displays both inside and outside of the proposed Depot building would provide riders and visitors with a chance to learn more about the railroad history of Goleta and the South Coast area.

On-site, low-intensity lighting would be proposed to be installed throughout the project site within the parking lot, along pedestrian walkways, and outside the Train Depot building to improve on-site wayfinding and safety. Lighting would be designed in compliance with the City’s General Plan policies and development standards within Title 17, Zoning Ordinance relating to outdoor lighting. In addition to on-site lighting, the project would also provide designated crosswalk areas between the Depot’s parking lot and the proposed Train Depot building, as shown in Figure 5.

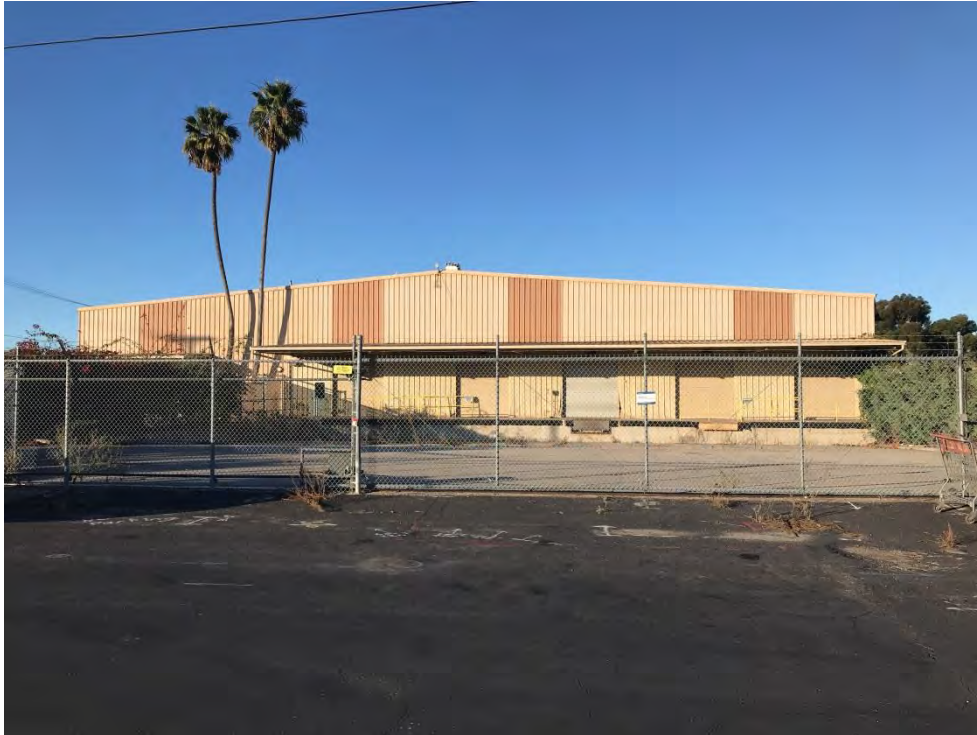
**Photograph 1.** View of the existing warehouse building in the project site. Photograph taken from the east side of the project site, facing west.

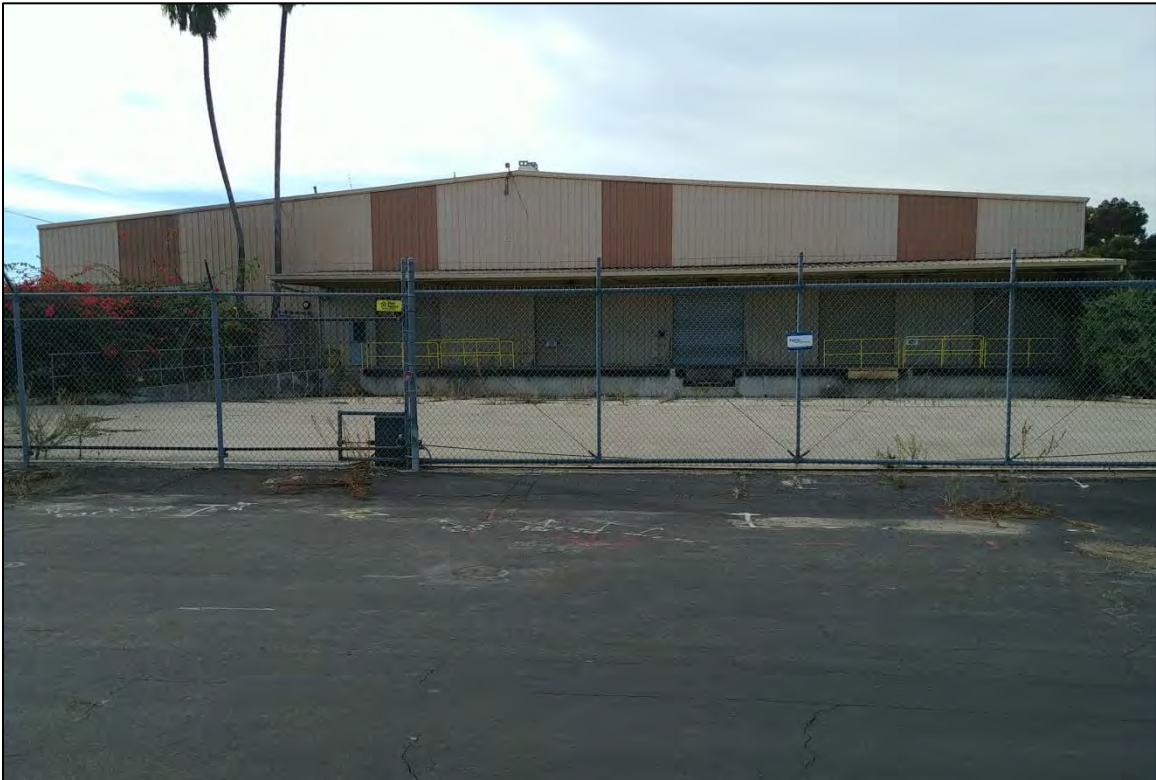
**May 2020**

The 2.48-acre property contains an approximately 36,000 square foot warehouse on the northern half of the parcel. Resting on a concrete foundation, the building has a rectangular footprint and a low-pitched gable roof clad with metal panels. The building appears to be steel-framed and is sheathed with vertical standing seam metal panels which are regularly spaced in an alternating tan and brown pattern around the building. Facing La Patera Lane, the east elevation features a concrete loading dock with concrete steps at one end and metal pole railings at top (Figure 4). The loading dock leads to five large metal roll-up doors and a single entry door which appears to be metal with a single glass pane. A flat metal roof projects from the wall plane to shelter the aforementioned doors. At the southeast corner of the building another flat roof projects from the wall plane and rounds the corner, sheltering windows and the primary entrance to the building. Slightly recessed, the entrance consists of a single aluminum and glass commercial door with a transom and sidelight (Figure 5).

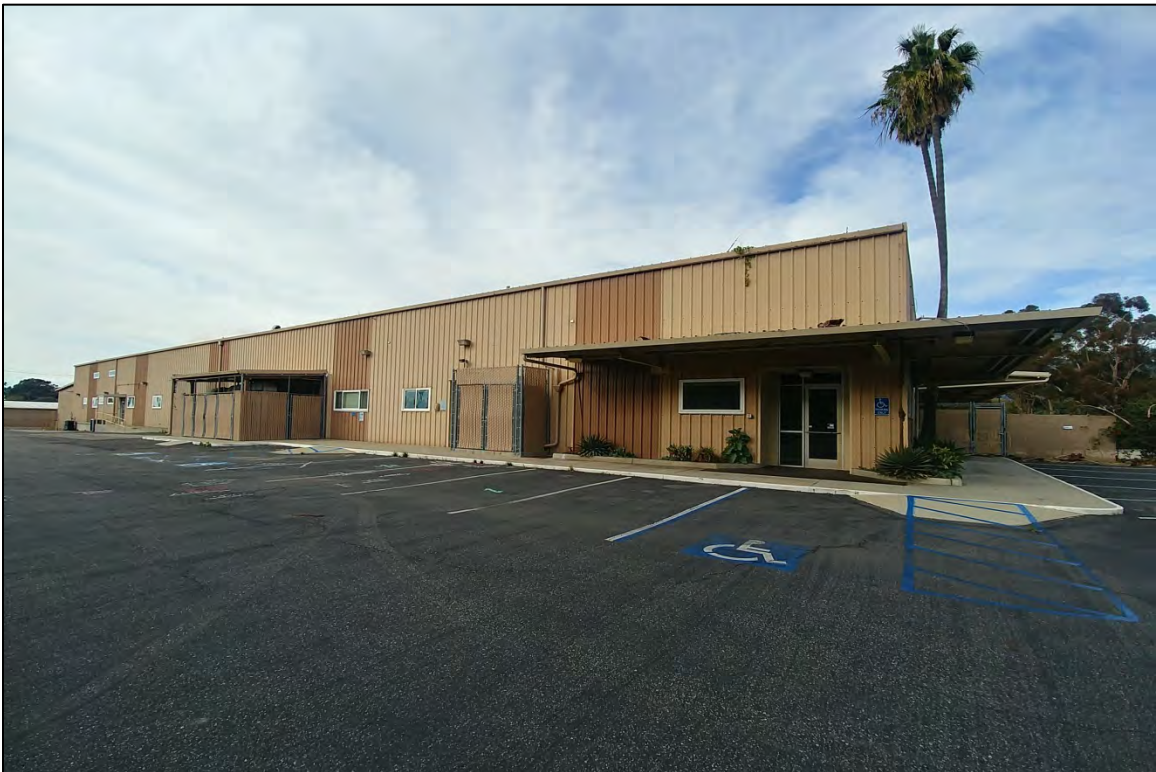
**RINCON CONSULTANTS, INC.**

Fenestration on the east and south elevations includes non-original vinyl-sash fixed and sliding windows. Additional secondary entries are located on the south elevation. One of the entries is recessed and contains a metal door with glazing. Further to the west is another entry consisting of a wheelchair-accessible concrete ramp with a metal pole railing, and an aluminum and glass commercial entry door which is sheltered by a small flat roof with pole supports. Two areas of chain link fencing with screening material conceal mechanical equipment against the south elevation (Figure 5). The north elevation facing the railroad does not contain any windows but displays several metal roll-up doors (Figure 6).

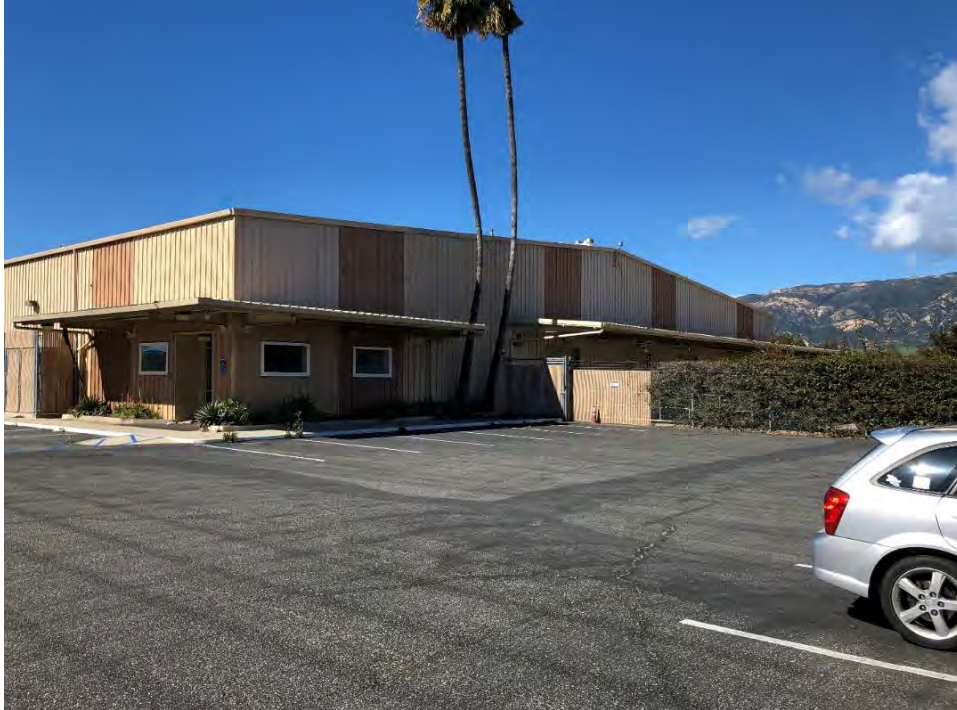
**PHOTO 2.4-1: East Side of Train Station Depot Site**

elevation differential between the train depot location and the intersection of South La Patera Lane and Hollister Avenue. As noted previously, underground fuel tanks are located adjacent to the southwest corner of the warehouse. Area drains are also located throughout the hardscape area.

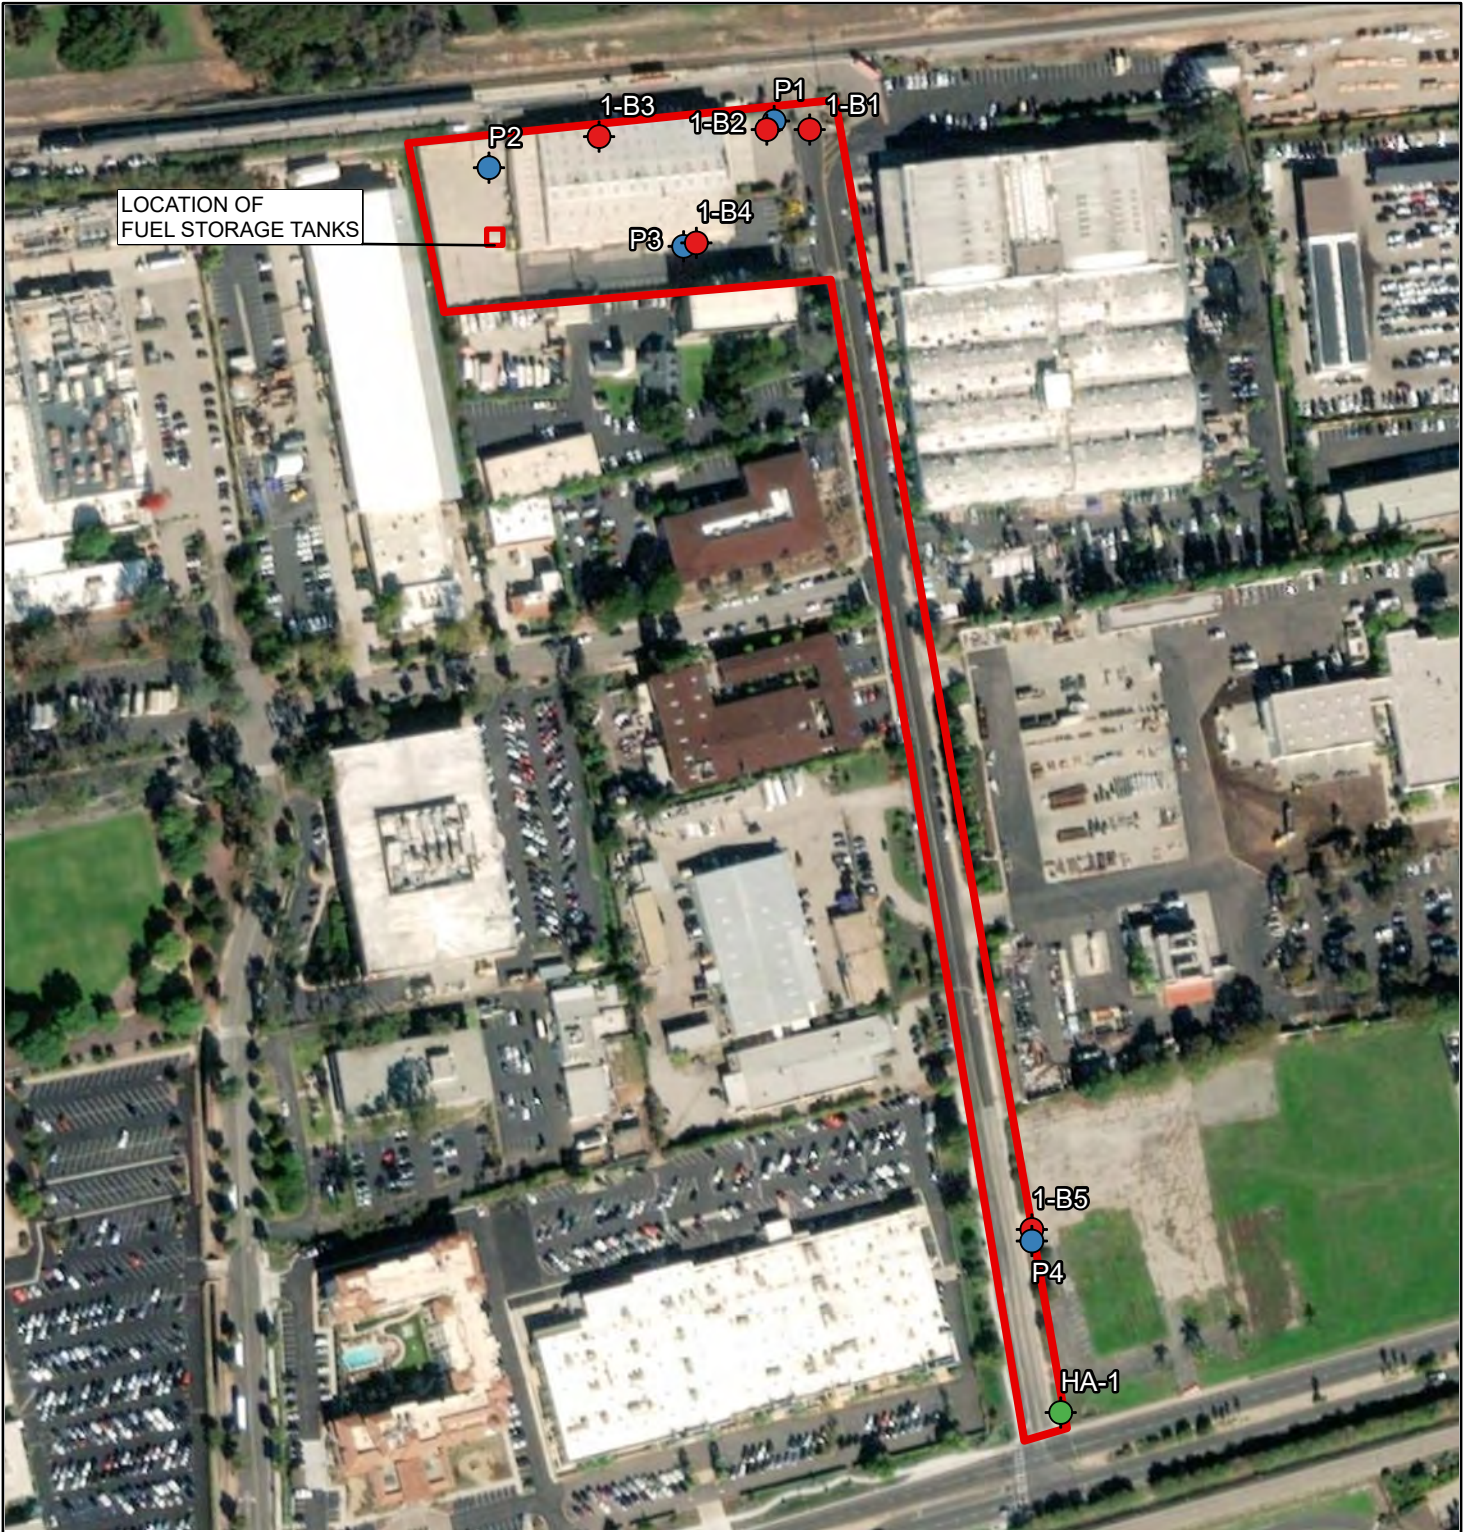
LOCATION OF FUEL STORAGE TANKS

Currently, a warehouse, loading platforms, and parking lots occupy the property. The warehouse occupies roughly half the train depot project area and is located in the northern middle of the project area. There is an approximately 4-foot grade change from exterior grades to the top of the loading platforms. Existing fuel tanks associated with an onsite power generator are located adjacent to the southwest corner of the existing warehouse and the approximate location is noted on Figure 2.

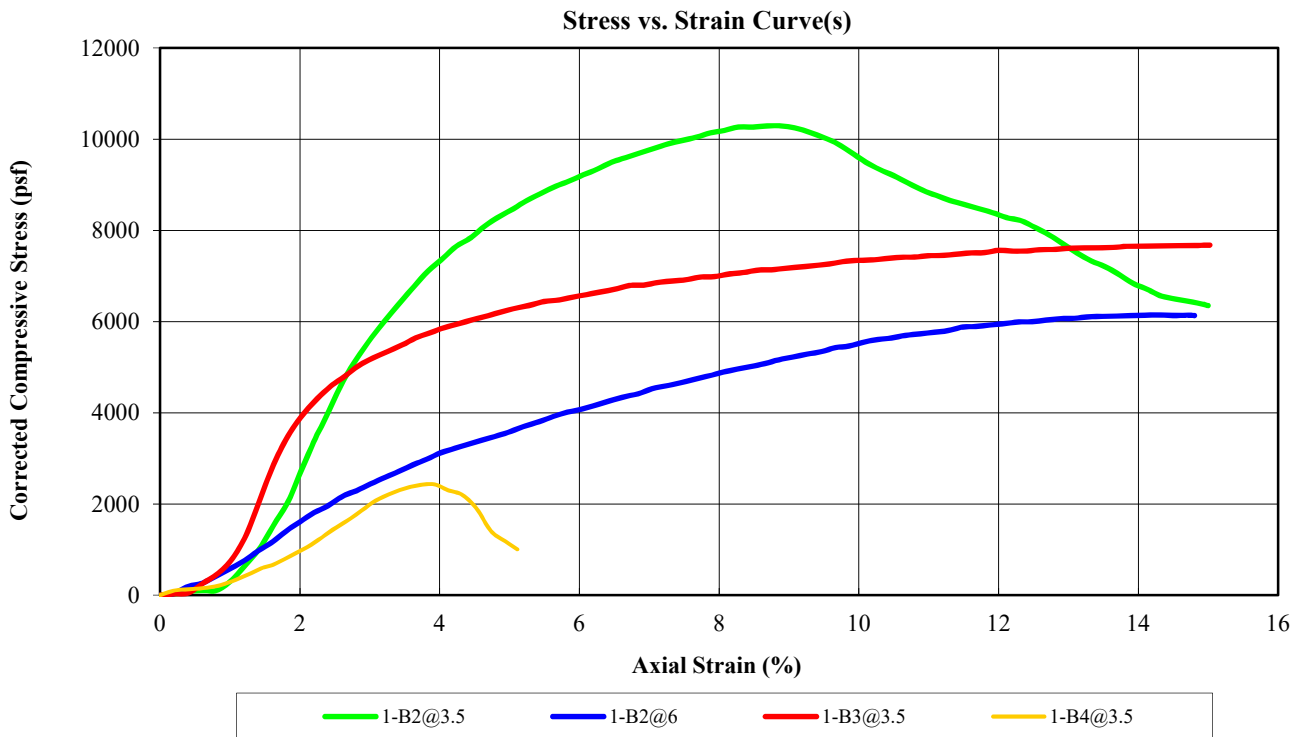
# UNCONFINED COMPRESSION TEST REPORT (ASTM D2166)

SPECIMEN				
BEFORE TEST	1-B2@3.5	1-B2@6	1-B3@3.5	1-B4@3.5
Moisture Content (%)	13.9	16.4	19.8	14.2
Dry Density (pcf)	120.0	115.7	107.8	119.6
Saturation (%)	97.2	100.0	98.3	98.0
Void Ratio	0.38	0.43	0.54	0.38
Diameter (in)	2.410	2.390	2.420	2.420
Height (in)	5.09	5.10	5.05	4.99
Height-To-Diameter Ratio	2.11	2.13	2.09	2.06
TEST DATA				
Unconfined Compressive Strength (psf)	10291	6146	7676	2430
Undrained Shear Strength (psf)	5146	3073	3838	1215
Strain Rate (in./min.)	0.05	0.05	0.05	0.05
Specific Gravity (Assumed)	2.650	2.650	2.650	2.650
Strain at Failure (%)	8.88	14.29	15.02	3.92
Liquid Limit				
Plastic Limit				
Test Remarks				
SPECIMEN	DESCRIPTION			
1-B2@3.5	See exploration logs			
1-B2@6	See exploration logs			
1-B3@3.5	See exploration logs			
1-B4@3.5	See exploration logs

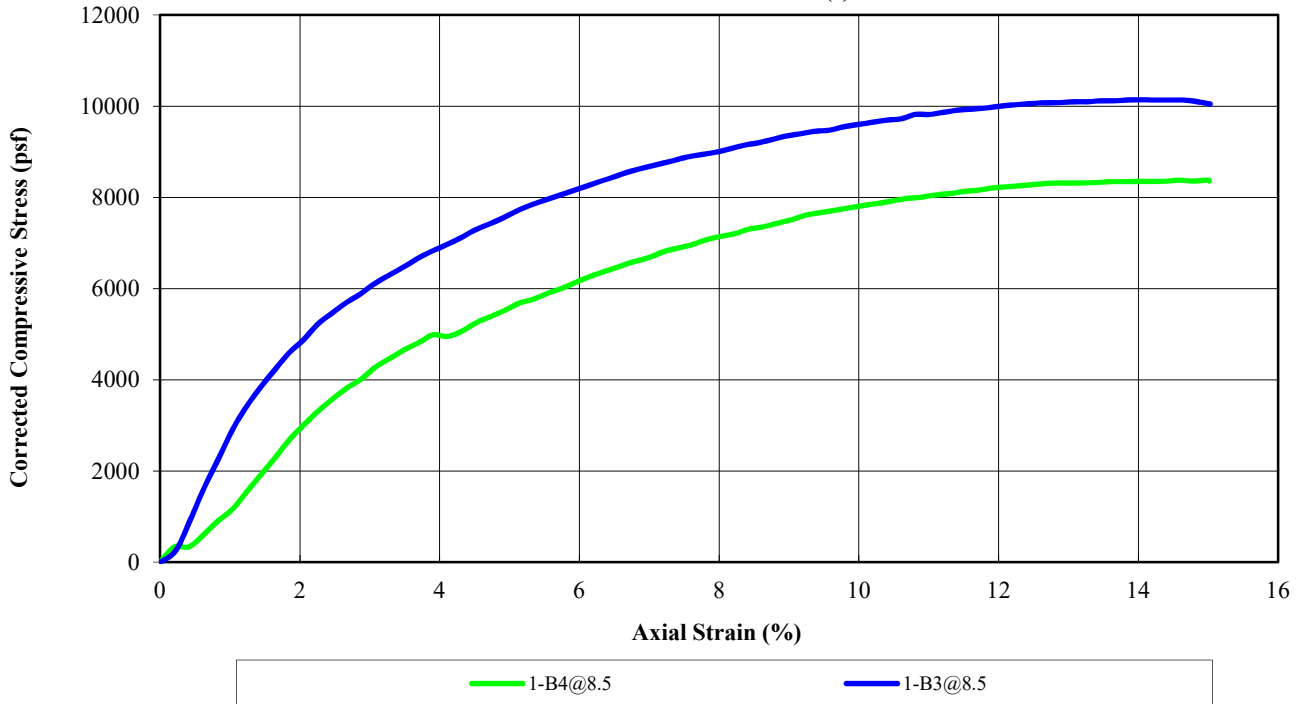
**Stress vs. Strain Curve(s)**

SPECIMEN		
BEFORE TEST	1-B4@8.5	1-B3@8.5
Moisture Content (%)	15.1	16.9
Dry Density (pcf)	116.6	116.4
Saturation (%)	95.6	97.6
Void Ratio	0.42	0.46
Diameter (in)	2.420	2.396
Height (in)	5.00	5.04
Height-To-Diameter Ratio	2.07	2.10
TEST DATA		
Unconfined Compressive Strength (psf)	8380	10138
Undrained Shear Strength (psf)	4190	5069
Strain Rate (in./min.)	0.05	0.05
Specific Gravity (Assumed)	2.650	2.650
Strain at Failure (%)	15.00	13.86
Liquid Limit		
Plastic Limit		
Test Remarks		
SPECIMEN	DESCRIPTION	
1-B4@8.5	See exploration logs	
1-B3@8.5	See exploration logs

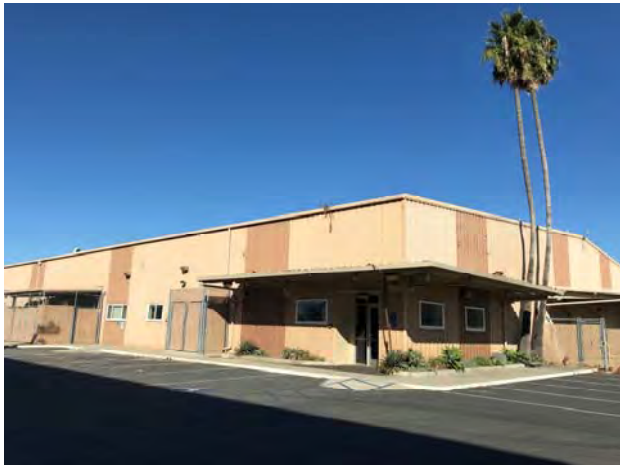
**Photograph 1.** View of the building on the subject property, facing northwest.

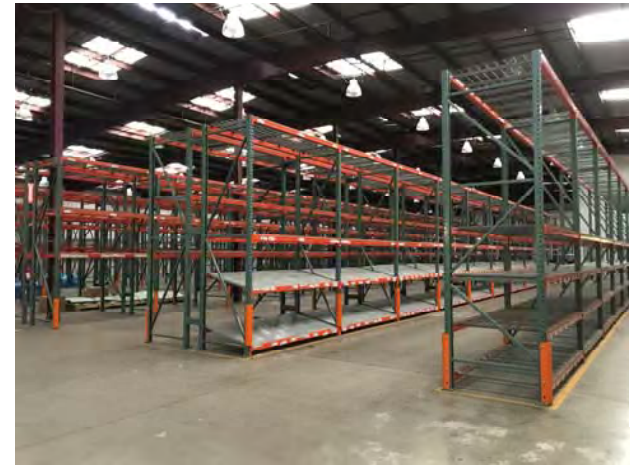
**Photograph 3.** View of the interior vacant warehouse space on the subject property.

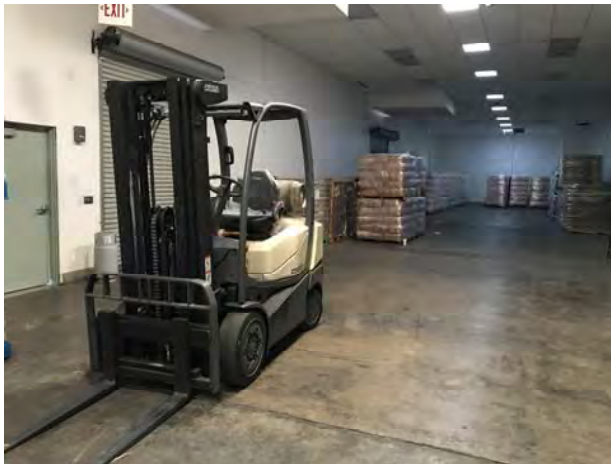
**Photograph 4.** View of the interior Food Bank storage room and hydraulic forklift.

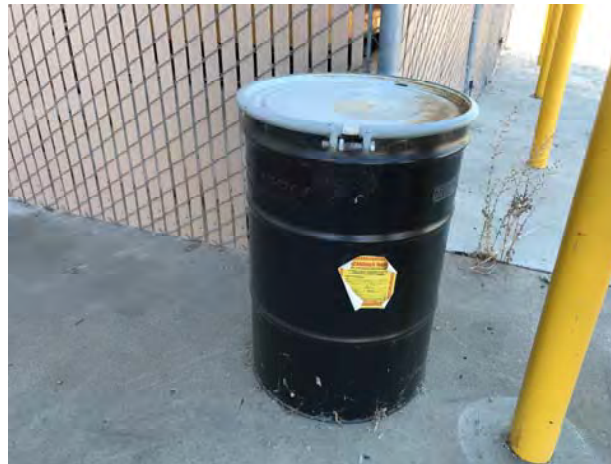
**Photograph 5.** View of a 55-gallon drum (hazardous waste sticker labeled as containing rainwater) located on the western portion of the subject property.

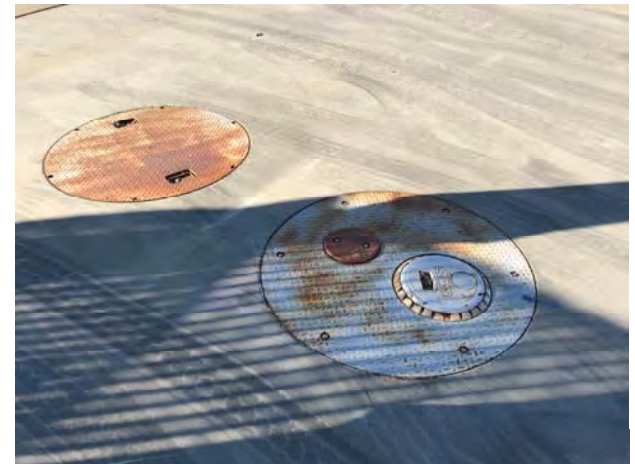
**Photograph 6.** View of the location of an 1,800-gallon UST in the western portion of the subject property.

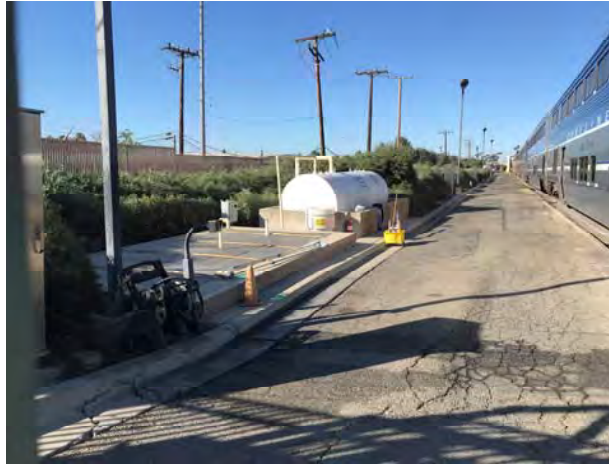
**Photograph 8.** View of the northwestern adjacent 3,000-gallon waste oil AST, facing west.

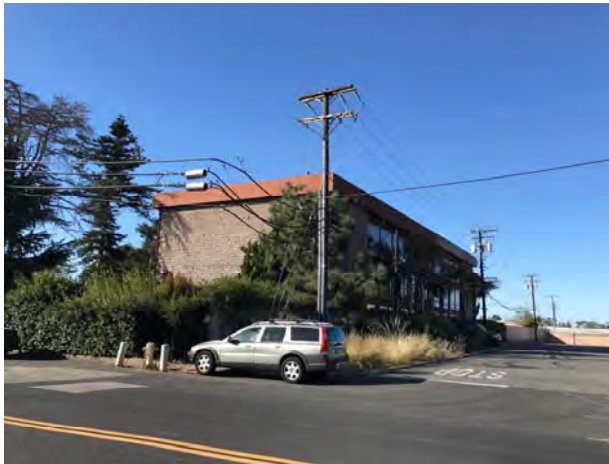
**Photograph 11.** View of the southern adjacent commercial office building and pole-mounted transformers (33 S. La Patera Lane), facing southwest.

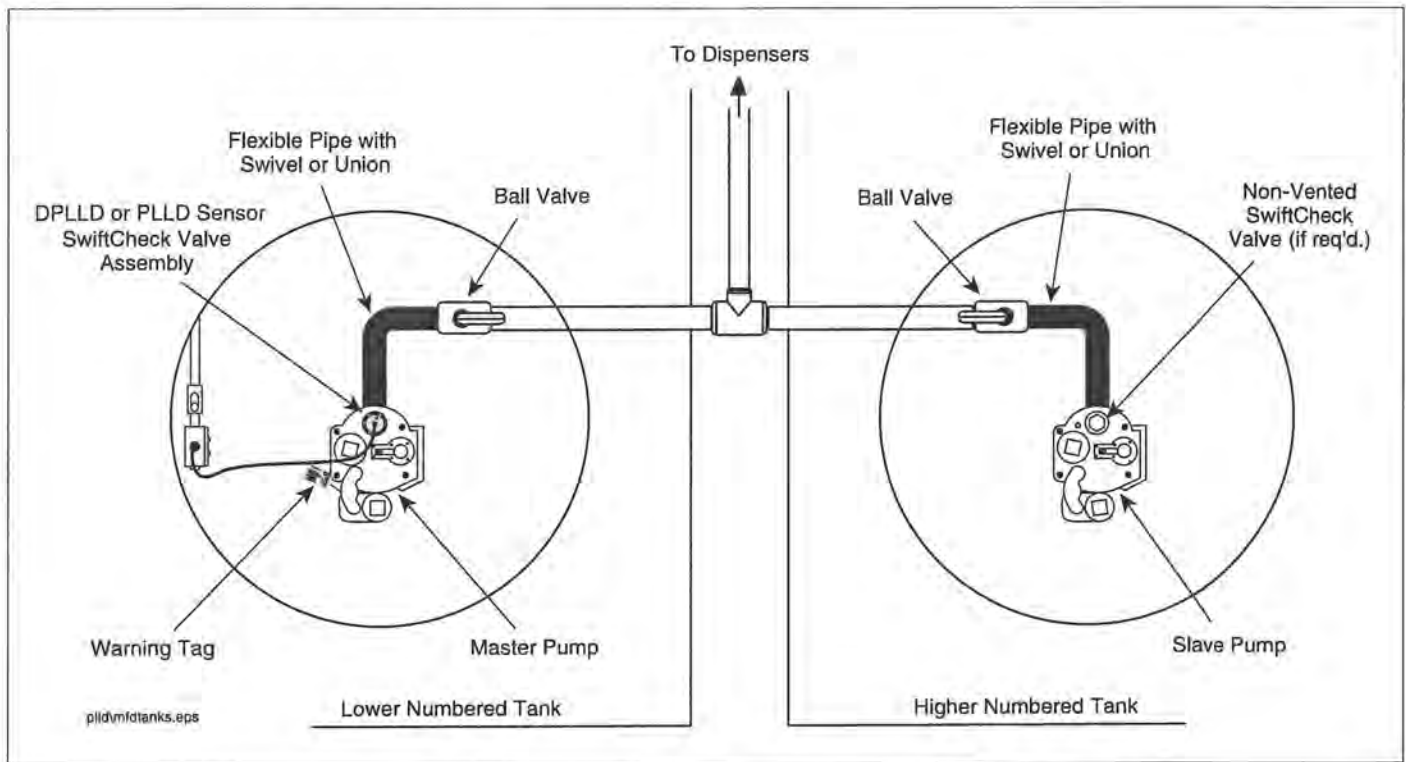
A typical manifolded line installation for DPLLD and PLLD is shown below:

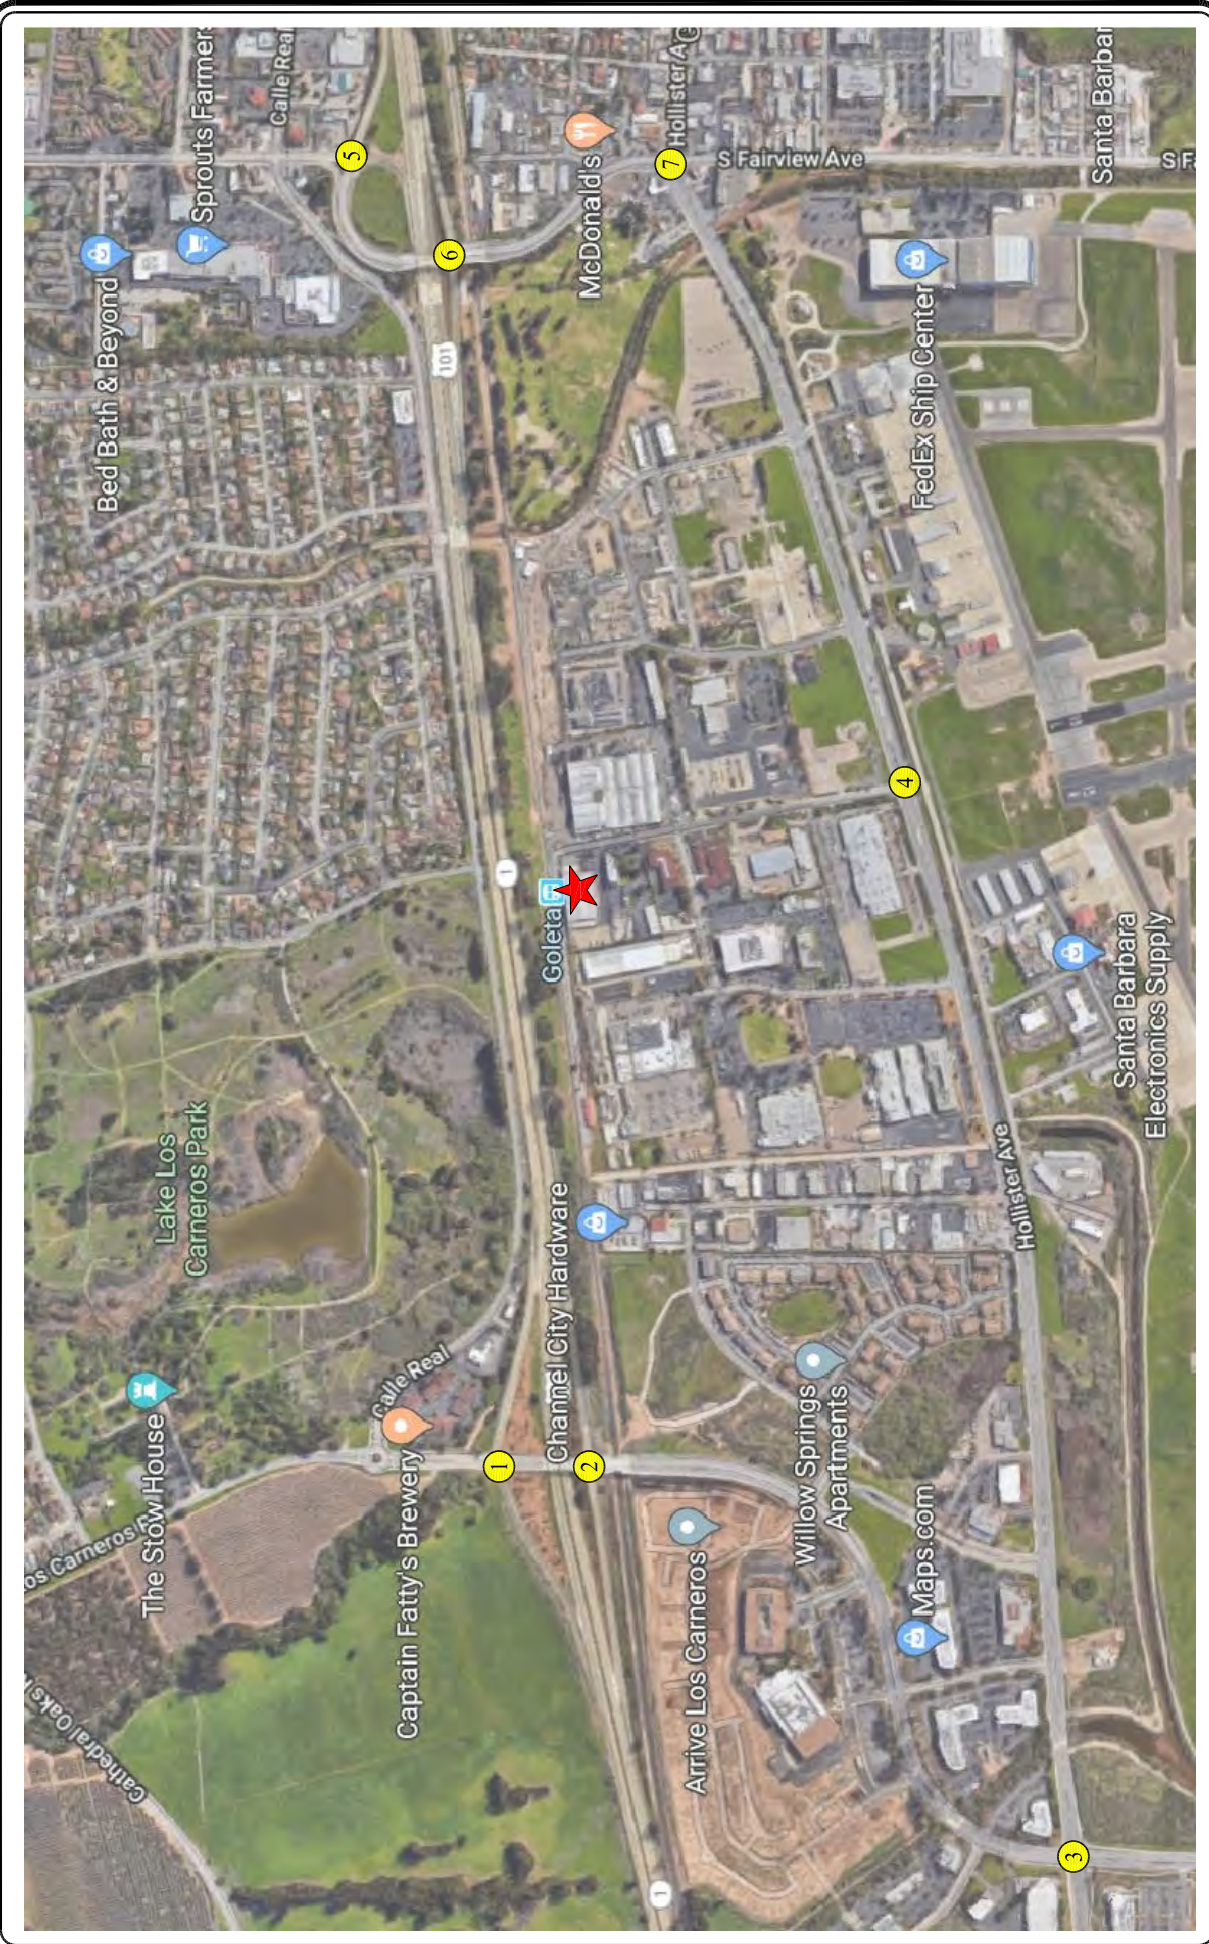
**FIGURE 1-1**  
**VICINITY MAP**

MAP SOURCE: GOOGLE MAPS  
 PROJECT SITE  
 STUDY INTERSECTION

This traffic analysis has been conducted to identify and evaluate the potential traffic impacts of the proposed train depot project (the “Project”) located at 27 S. La Patera Lane in the City of Goleta, California (the “Project Site”). The Project proposes the development of an approximately 9,000 square foot train depot just south of the existing Goleta Amtrak train platform site at the northern terminus of La Patera Lane. The Project Site is generally bounded by La Patera Lane to the north, office buildings to the south, La Patera Lane to the east, and office buildings to the west. The Project Site location and general vicinity are shown in *Figure 1-1*.

The general location of the Project in relation to the study locations and surrounding street system is presented in *Figure 1-1*. The traffic analysis study area is generally comprised of those locations which have the greatest potential to experience traffic due to the proposed Project as defined by the Lead Agency. In the traffic engineering practice, the study area generally includes those intersections that are:

The proposed Project Site is located at 27 S. La Patera Lane in the City of Goleta. The Project Site is bounded by La Patera Lane to the north, office buildings to the south, La Patera Lane to the east, and office buildings to the west. The Project Site location and general vicinity are shown in *Figure 1-1*.

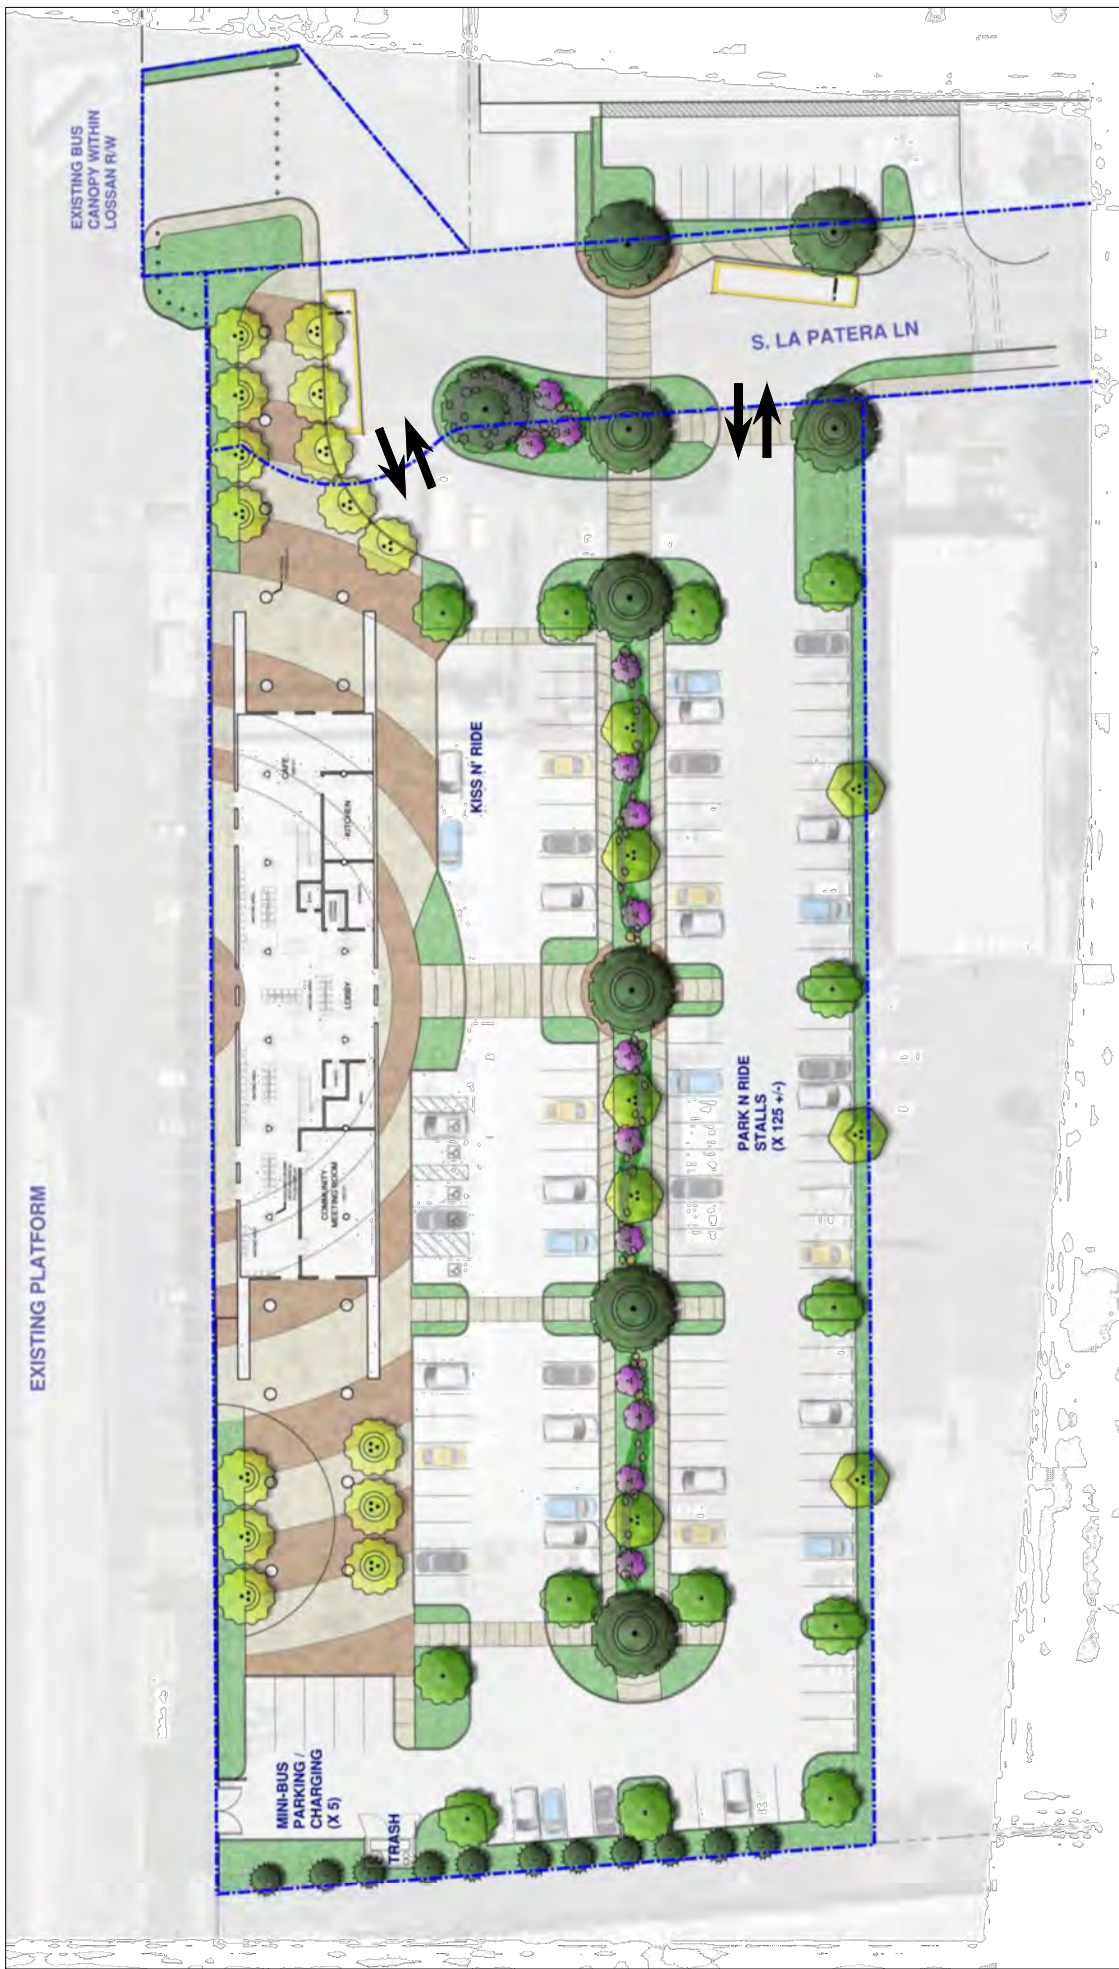
MAP SOURCE: ANIL VERMA ASSOCIATES, INC.

The Project seeks to remove the existing buildings and develop a train depot with approximately 9,000 square feet of building floor area. The Project proposes to provide 125 parking spaces within an on-site surface parking lot. Construction and occupancy of the proposed Project is planned to be completed by the year 2024. The site plan for the proposed Project is illustrated in *Figure 2-1*.

Vehicular access to the Project site will be provided via two driveways along the west side of La Patera Lane (i.e., along the Project Site's easterly frontage). Further discussion on the Project Site access and circulation schemes is provided in Section 3.0.
