# Goleta Train Depot

## Initial Study

**May 2020**

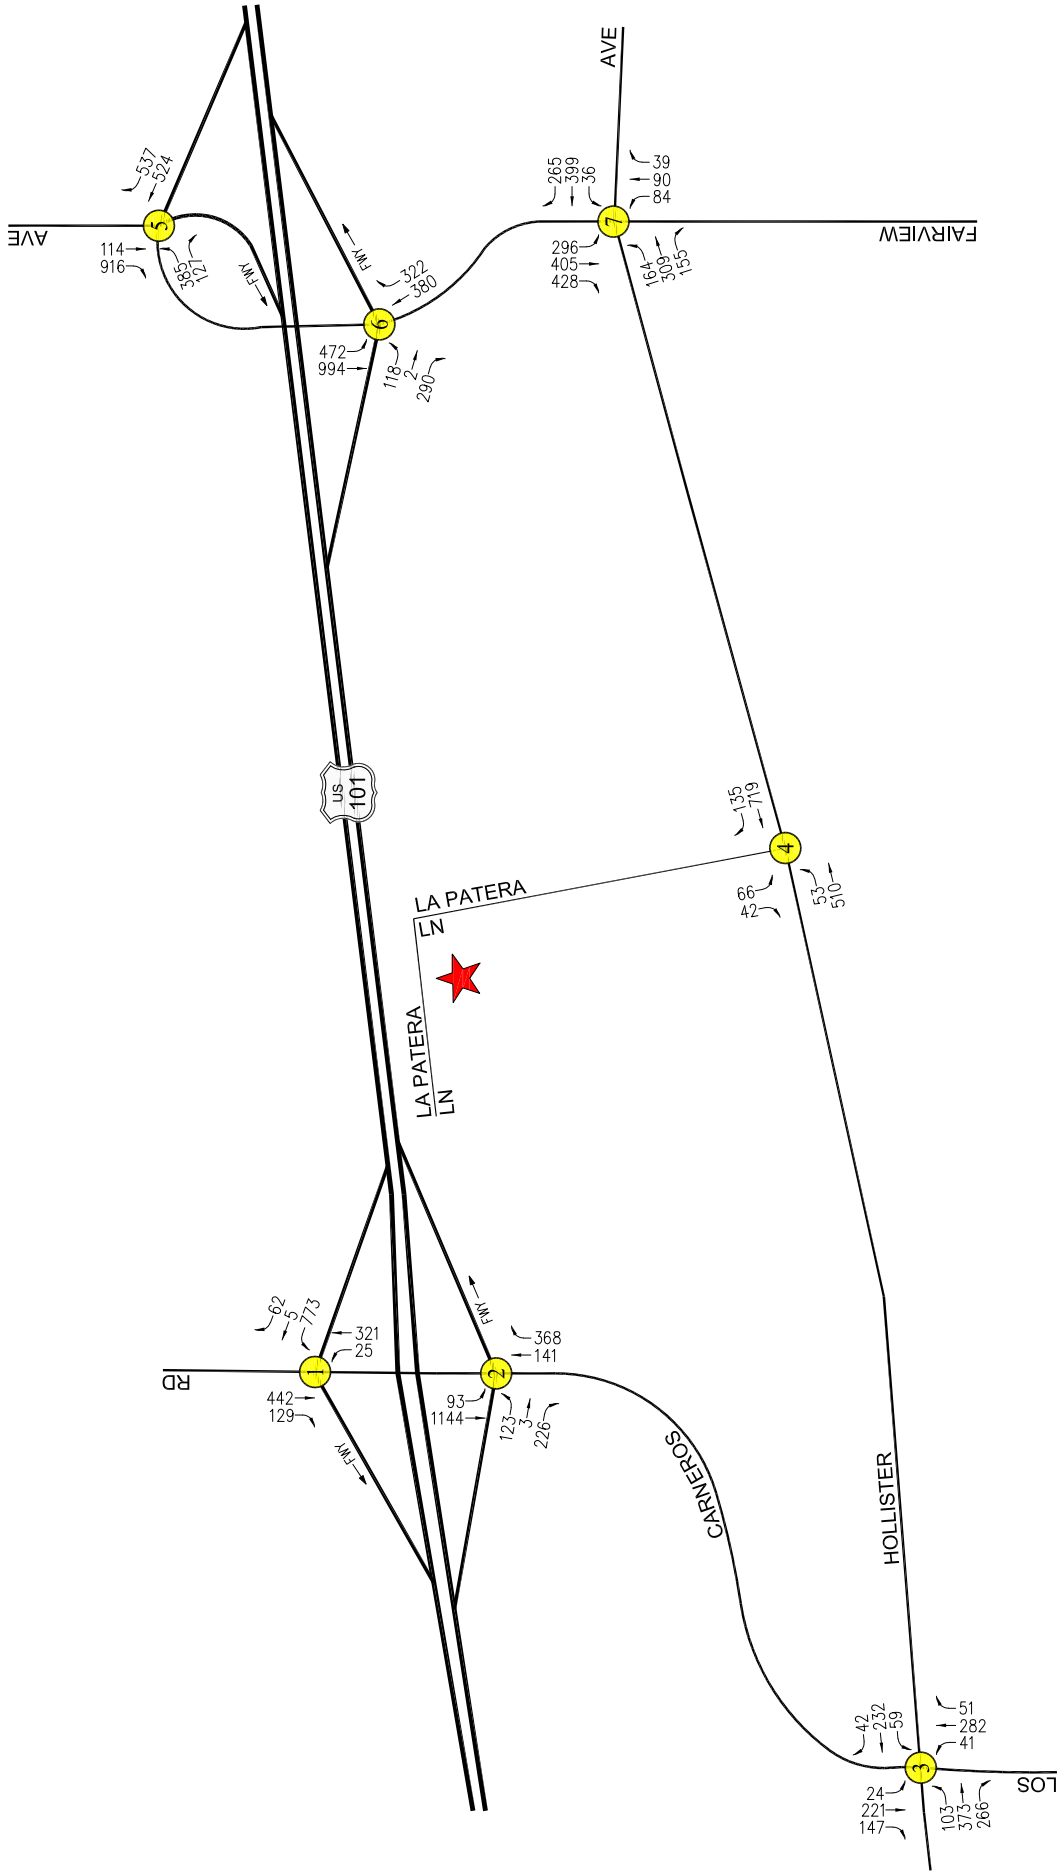
**FIGURE 6-1**  
**EXISTING TRAFFIC VOLUMES**  
 WEEKDAY AM PEAK HOUR  
 GOLETA TRAIN DEPOT

The existing traffic volumes at the study intersections during the weekday AM and PM peak hours are shown in **Figures 6-1** and **6-2**, respectively. Summary data worksheets of the historical traffic counts at the study intersections are contained in **Appendix A**.
