Report:	Biological Resources Letter Report
Date:	June 12, 2020
Project Name:	Mapleview Street Green Streets Project
Project Number(s):	County No. PWG-00455
Project Proponent:	County of San Diego Department of Public Works
Prepared for:	Keshia Montifolca, County of San Diego Department of Public Works, 5510 Overland Ave, San Diego, CA; keshia.montifolca@sdcountyca.gov; (858) 694-3910
Prepared by:	Jaclyn Catino-Davenport, Environmental Science Associates; jcatino-davenport@esassoc.com; (619) 719-4211
Reviewed by:	Barbra Calantas, Environmental Science Associates; bcalantas@esassoc.com; (619) 719-4210

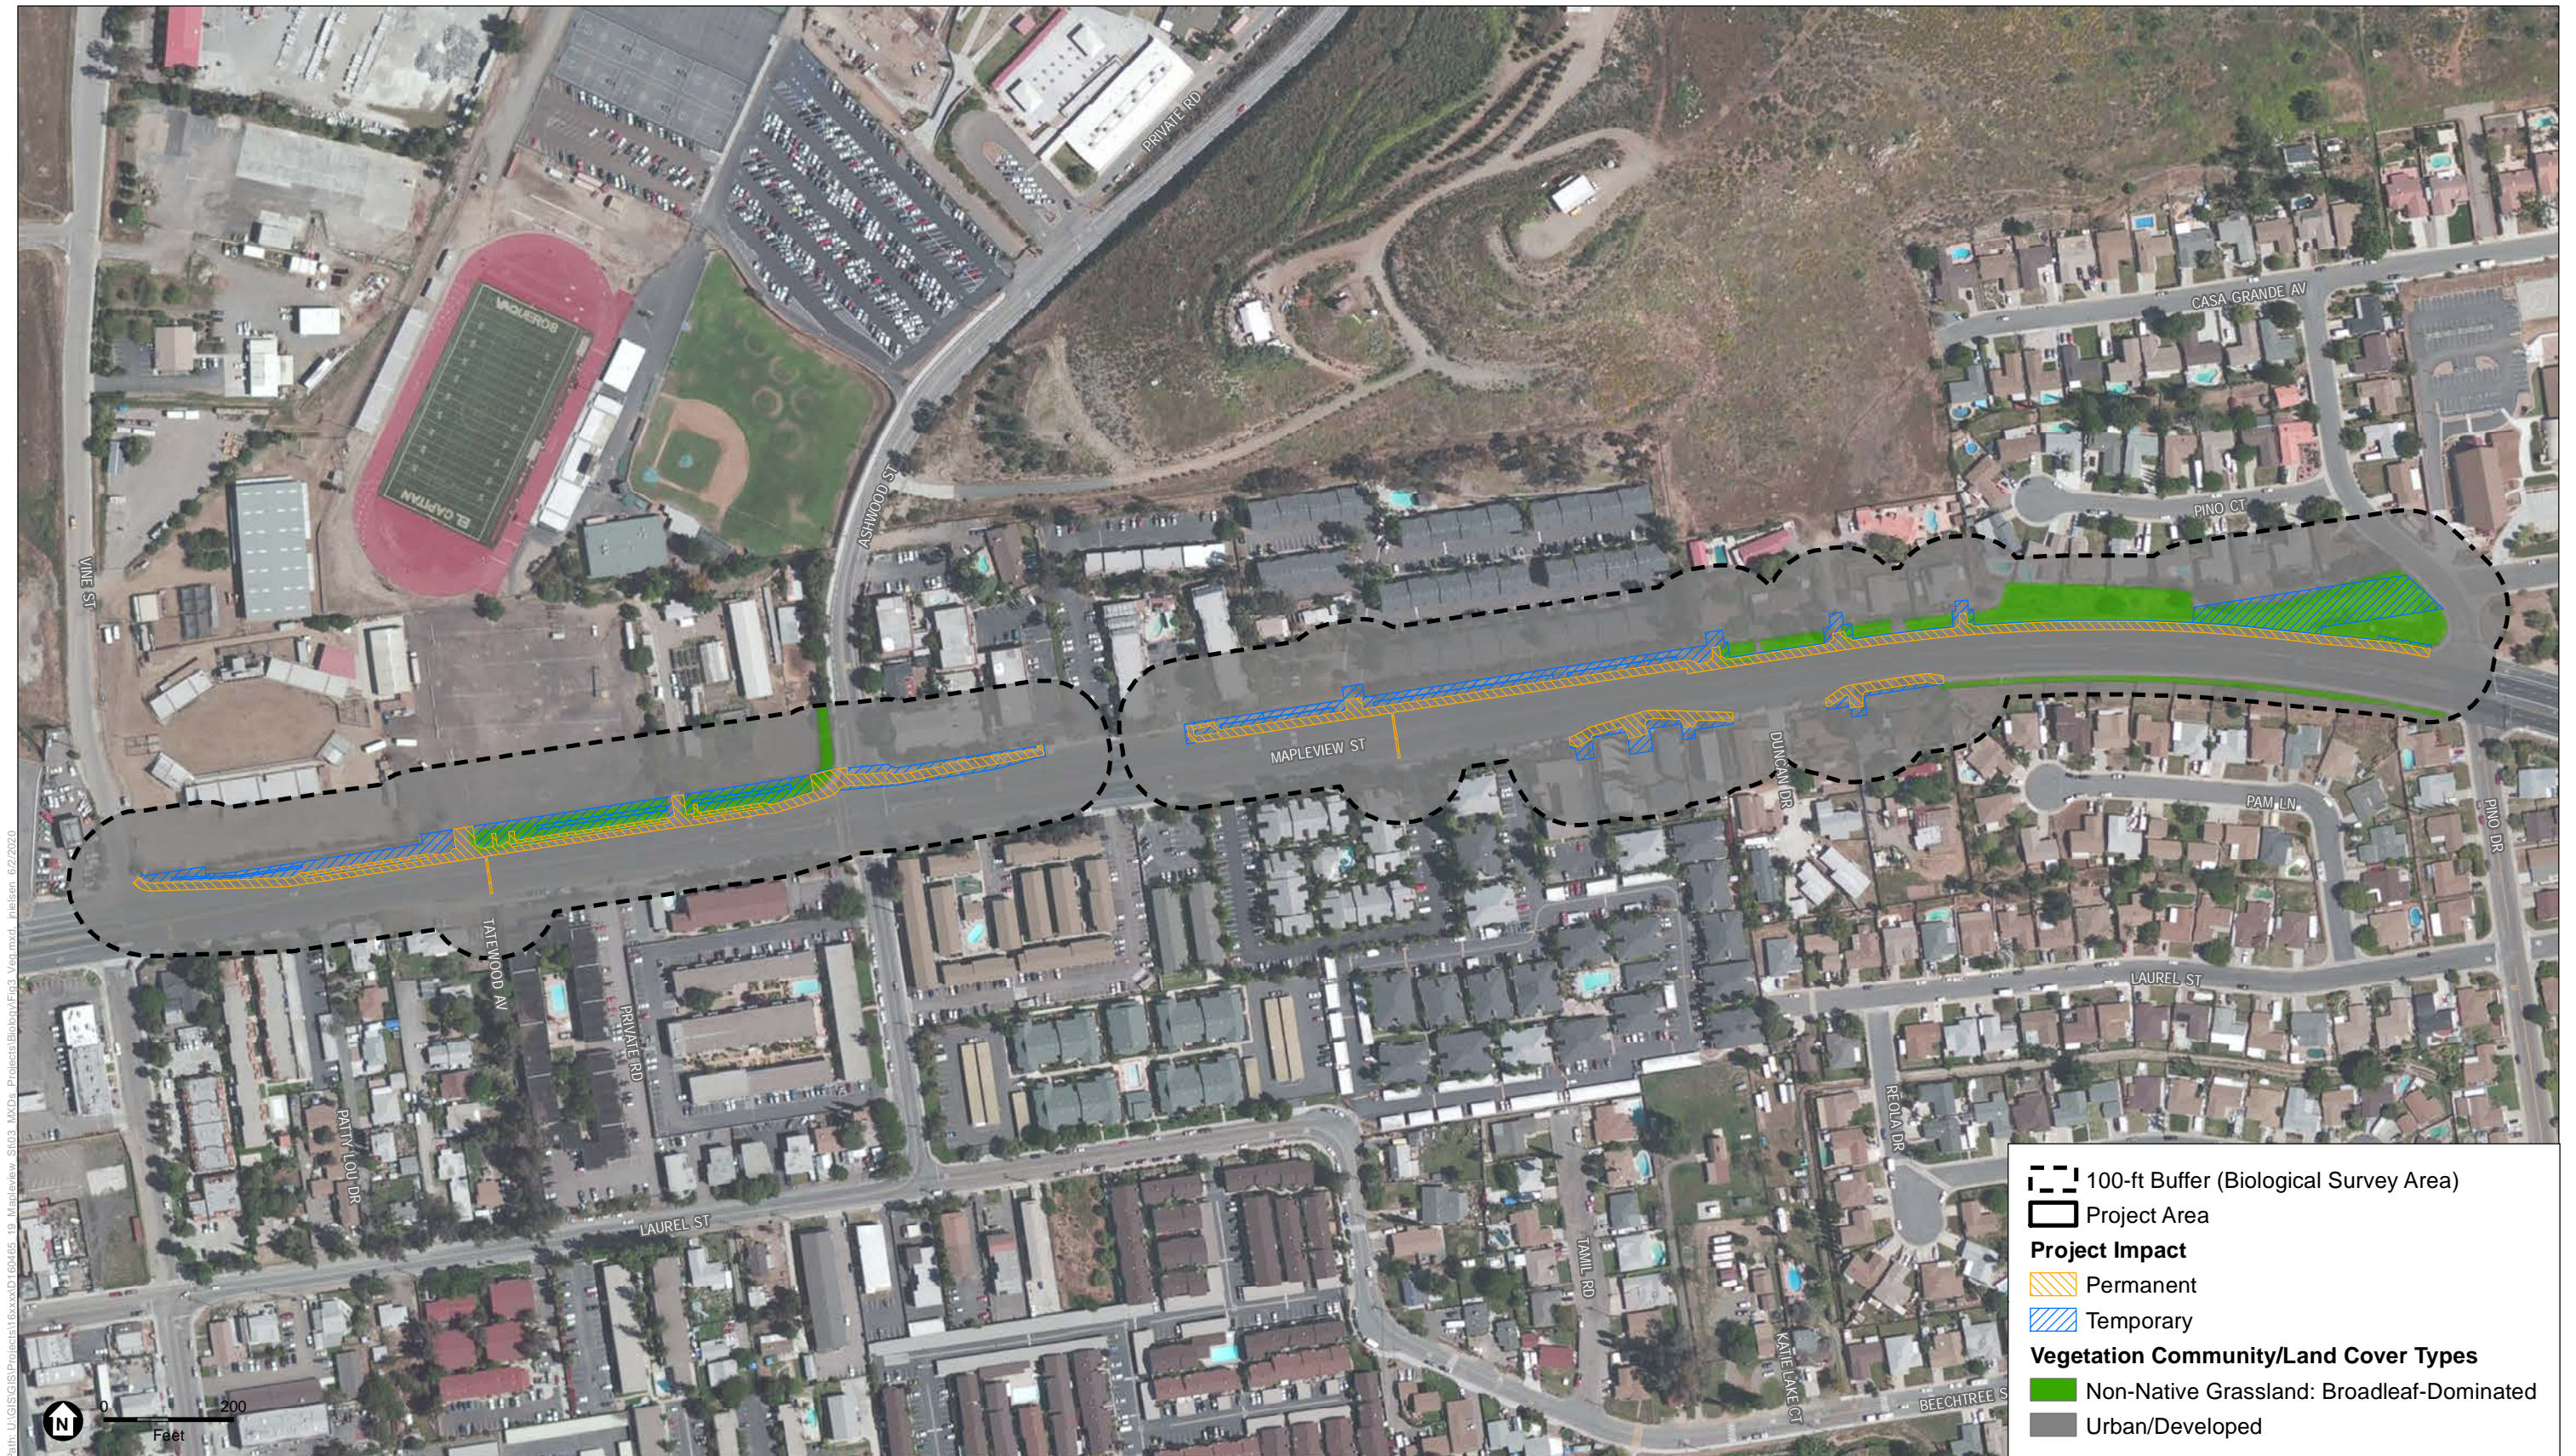
Figure 3
Vegetation Communities/Land Cover

[Dashed Line] 100-ft Buffer (Biological Survey Area)
 [Black Outline] Project Area
Project Impact
 [Yellow Hatching] Permanent
 [Blue Hatching] Temporary
Vegetation Community/Land Cover Types
 [Green] Non-Native Grassland: Broadleaf-Dominated
 [Grey] Urban/Developed

The BSA contains a total of two vegetation communities and land cover types: non-native grassland: broadleaf-dominated and urban/developed (**Table 1** and **Figure 3**). The County of San Diego BMO classify sensitive upland habitats into four tiers of sensitivity: Tier I (rare uplands), Tier II (uncommon uplands), Tier III (common uplands) and Tier IV (other uplands). Wetlands do not have an MSCP tier but are considered a sensitive wetland by local, state, and federal agencies.

Vegetation communities and cover types within the BSA were classified according to *Preliminary Descriptions of the Terrestrial Communities of California* by Holland (1986) as modified by Oberbauer (2008). These communities are depicted in Figure 3 and described below.
