MAPLEVIEW STREET GREEN STREETS PROJECT

Aquatic Resources Delineation Report

Prepared for
County of San Diego Department of
Public Works

June 11, 2020

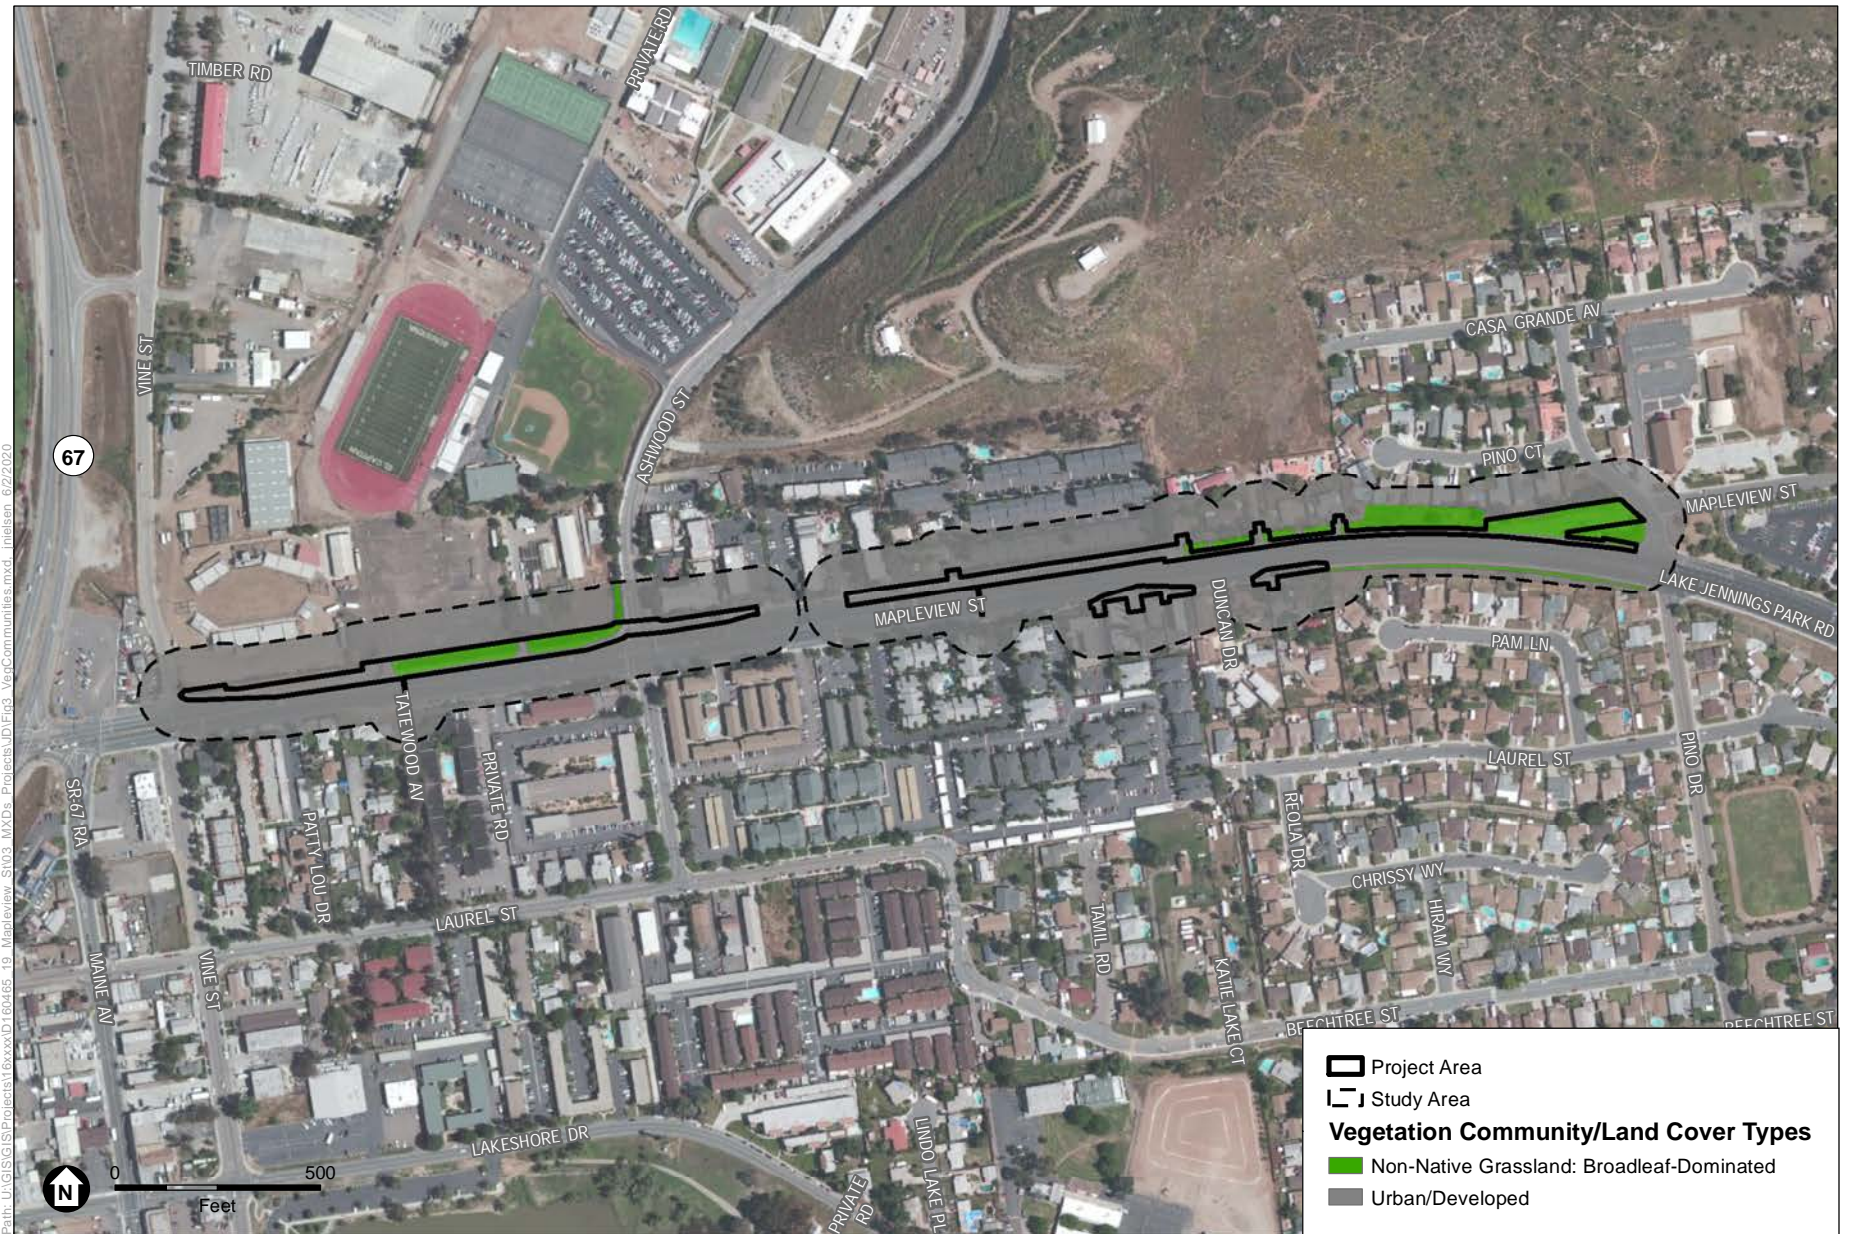
Figure 3
Vegetation Community/Land Cover Types

The study area was limited to one vegetation community and one land cover type: non-native grassland: broadleaf-dominated; and urban/developed. In general, native plants were few and far between, with the exception of a few individual native shrub or tree species, such as laurel sumac (*Malosma laurina*, NL¹) and coast live oak (*Quercus agrifolia*, NL) that managed to grow within undeveloped portions of the study area. Plant species with an obligate wetland indicator status were not observed during the survey. Two plant species containing a facultative wetland indicator status were observed within study area: common knotweed (*Persicaria lapathifolia*) and Mexican fan palm. Common knotweed was observed within the roadside ditch but was not dominant and was limited to a single individual. Mexican fan palm individuals were planted and associated with residential areas. Four plants species containing a facultative wetland indicator status were observed within the study area in low numbers, were not dominant, and included Brazilian pepper tree (*Schinus terebinthifolius*), Jersey cudweed (*Pseudognaphalium luteoalbum*), tree tobacco (*Nicotiana glauca*), and dallis grass (*Paspalum dilatatum*). Plant species observed in the study area are listed in **Appendix B**.

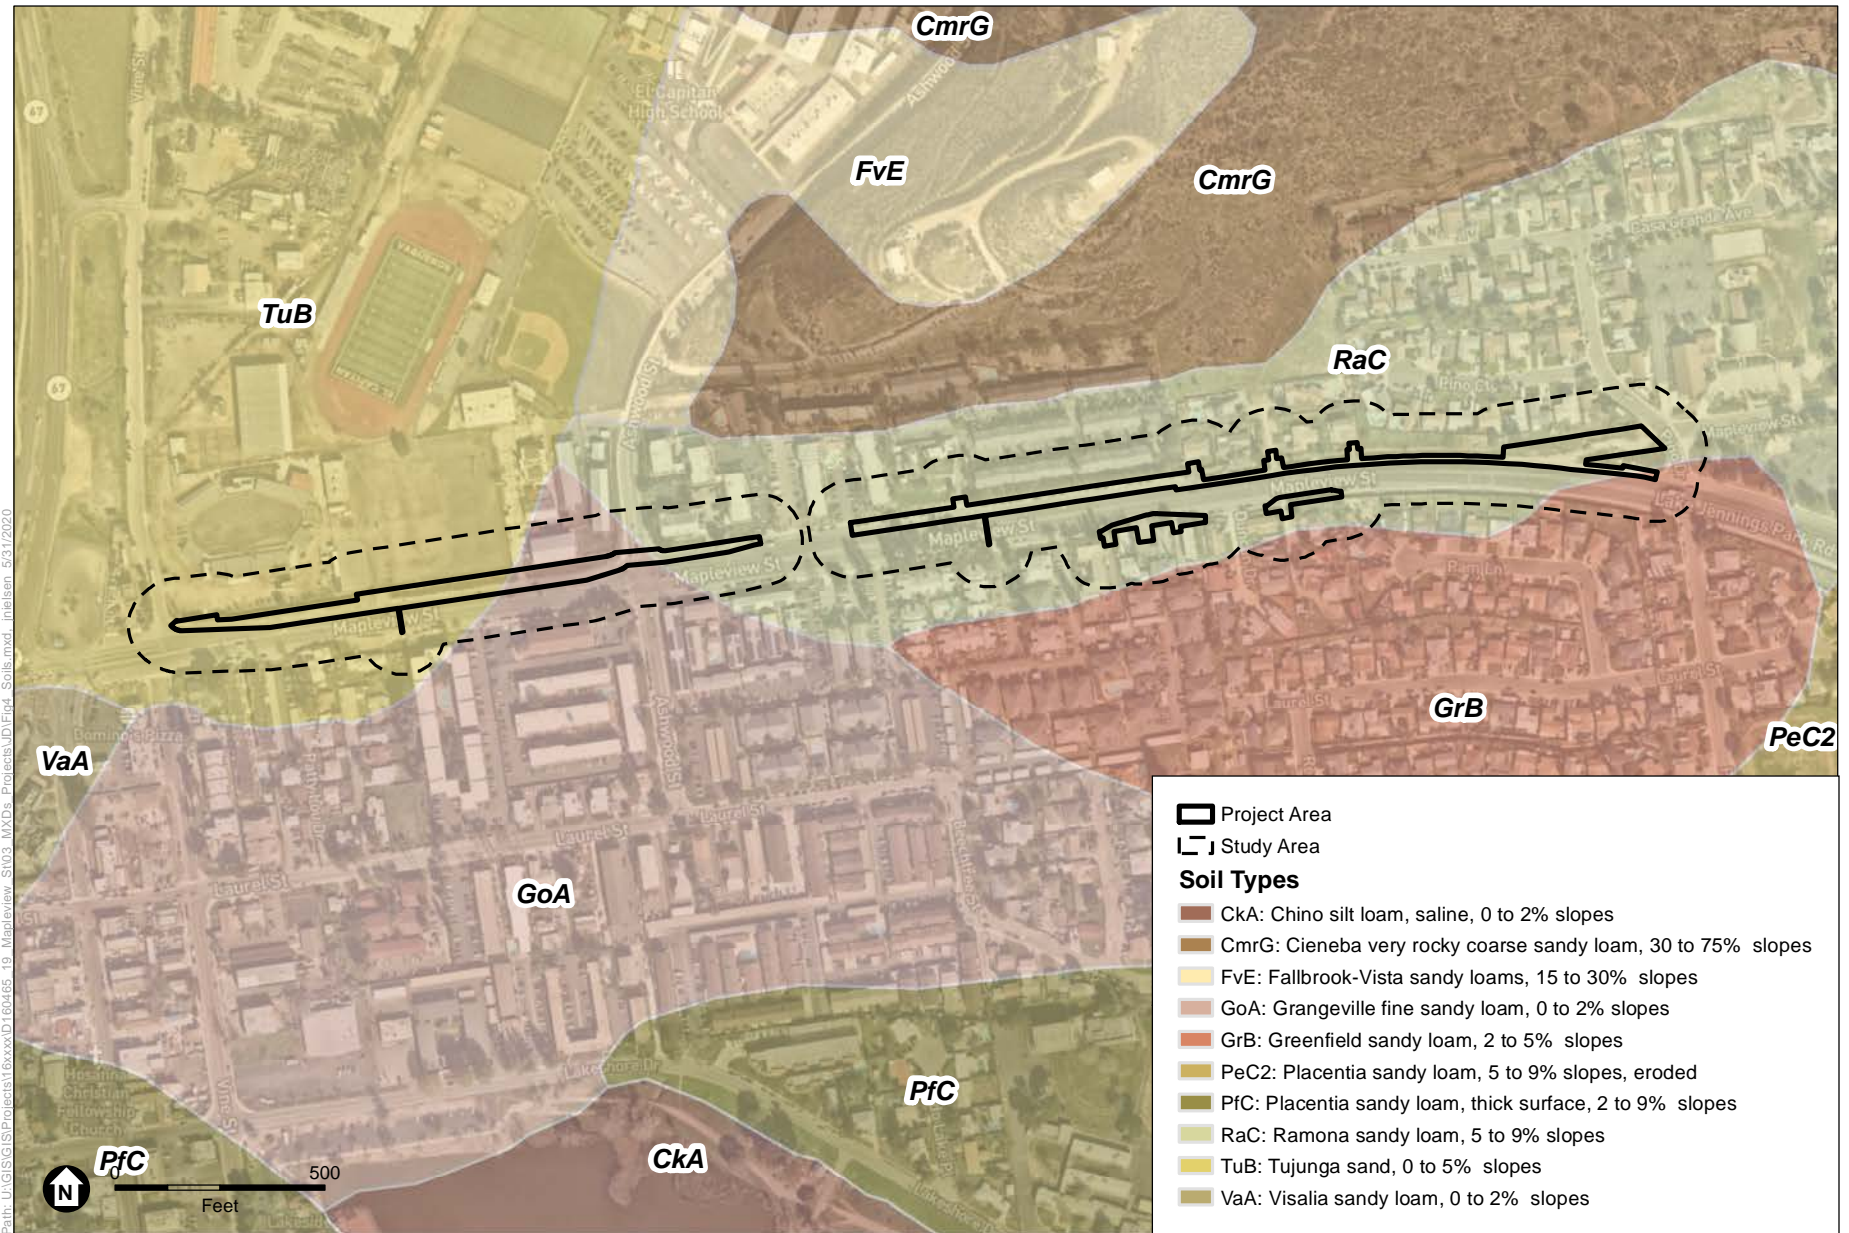
Figure 4
Soils Survey

Soils map units within the study area, as shown in **Figure 4**, include the following: Grangeville fine sandy loam, 0 to 2 percent slopes; Greenfield sandy loam, 2 to 5 percent slopes; Ramona sandy loam, 5 to 9 percent slopes; and Tujunga sand, 0 to 5 percent slopes. Soils in the study area are disturbed due to the historical alteration of the area to accommodate residential and commercial development, including the roadside ditch, which is a man-made feature. Soil pits excavated at two sample points within the roadside ditch (Sample Points 1a and 2a) and two sample points outside the roadside ditch in upland areas (Sample Points 1b and 2b) lacked hydric soil indicators and as such did not meet the parameters of a wetland soil.

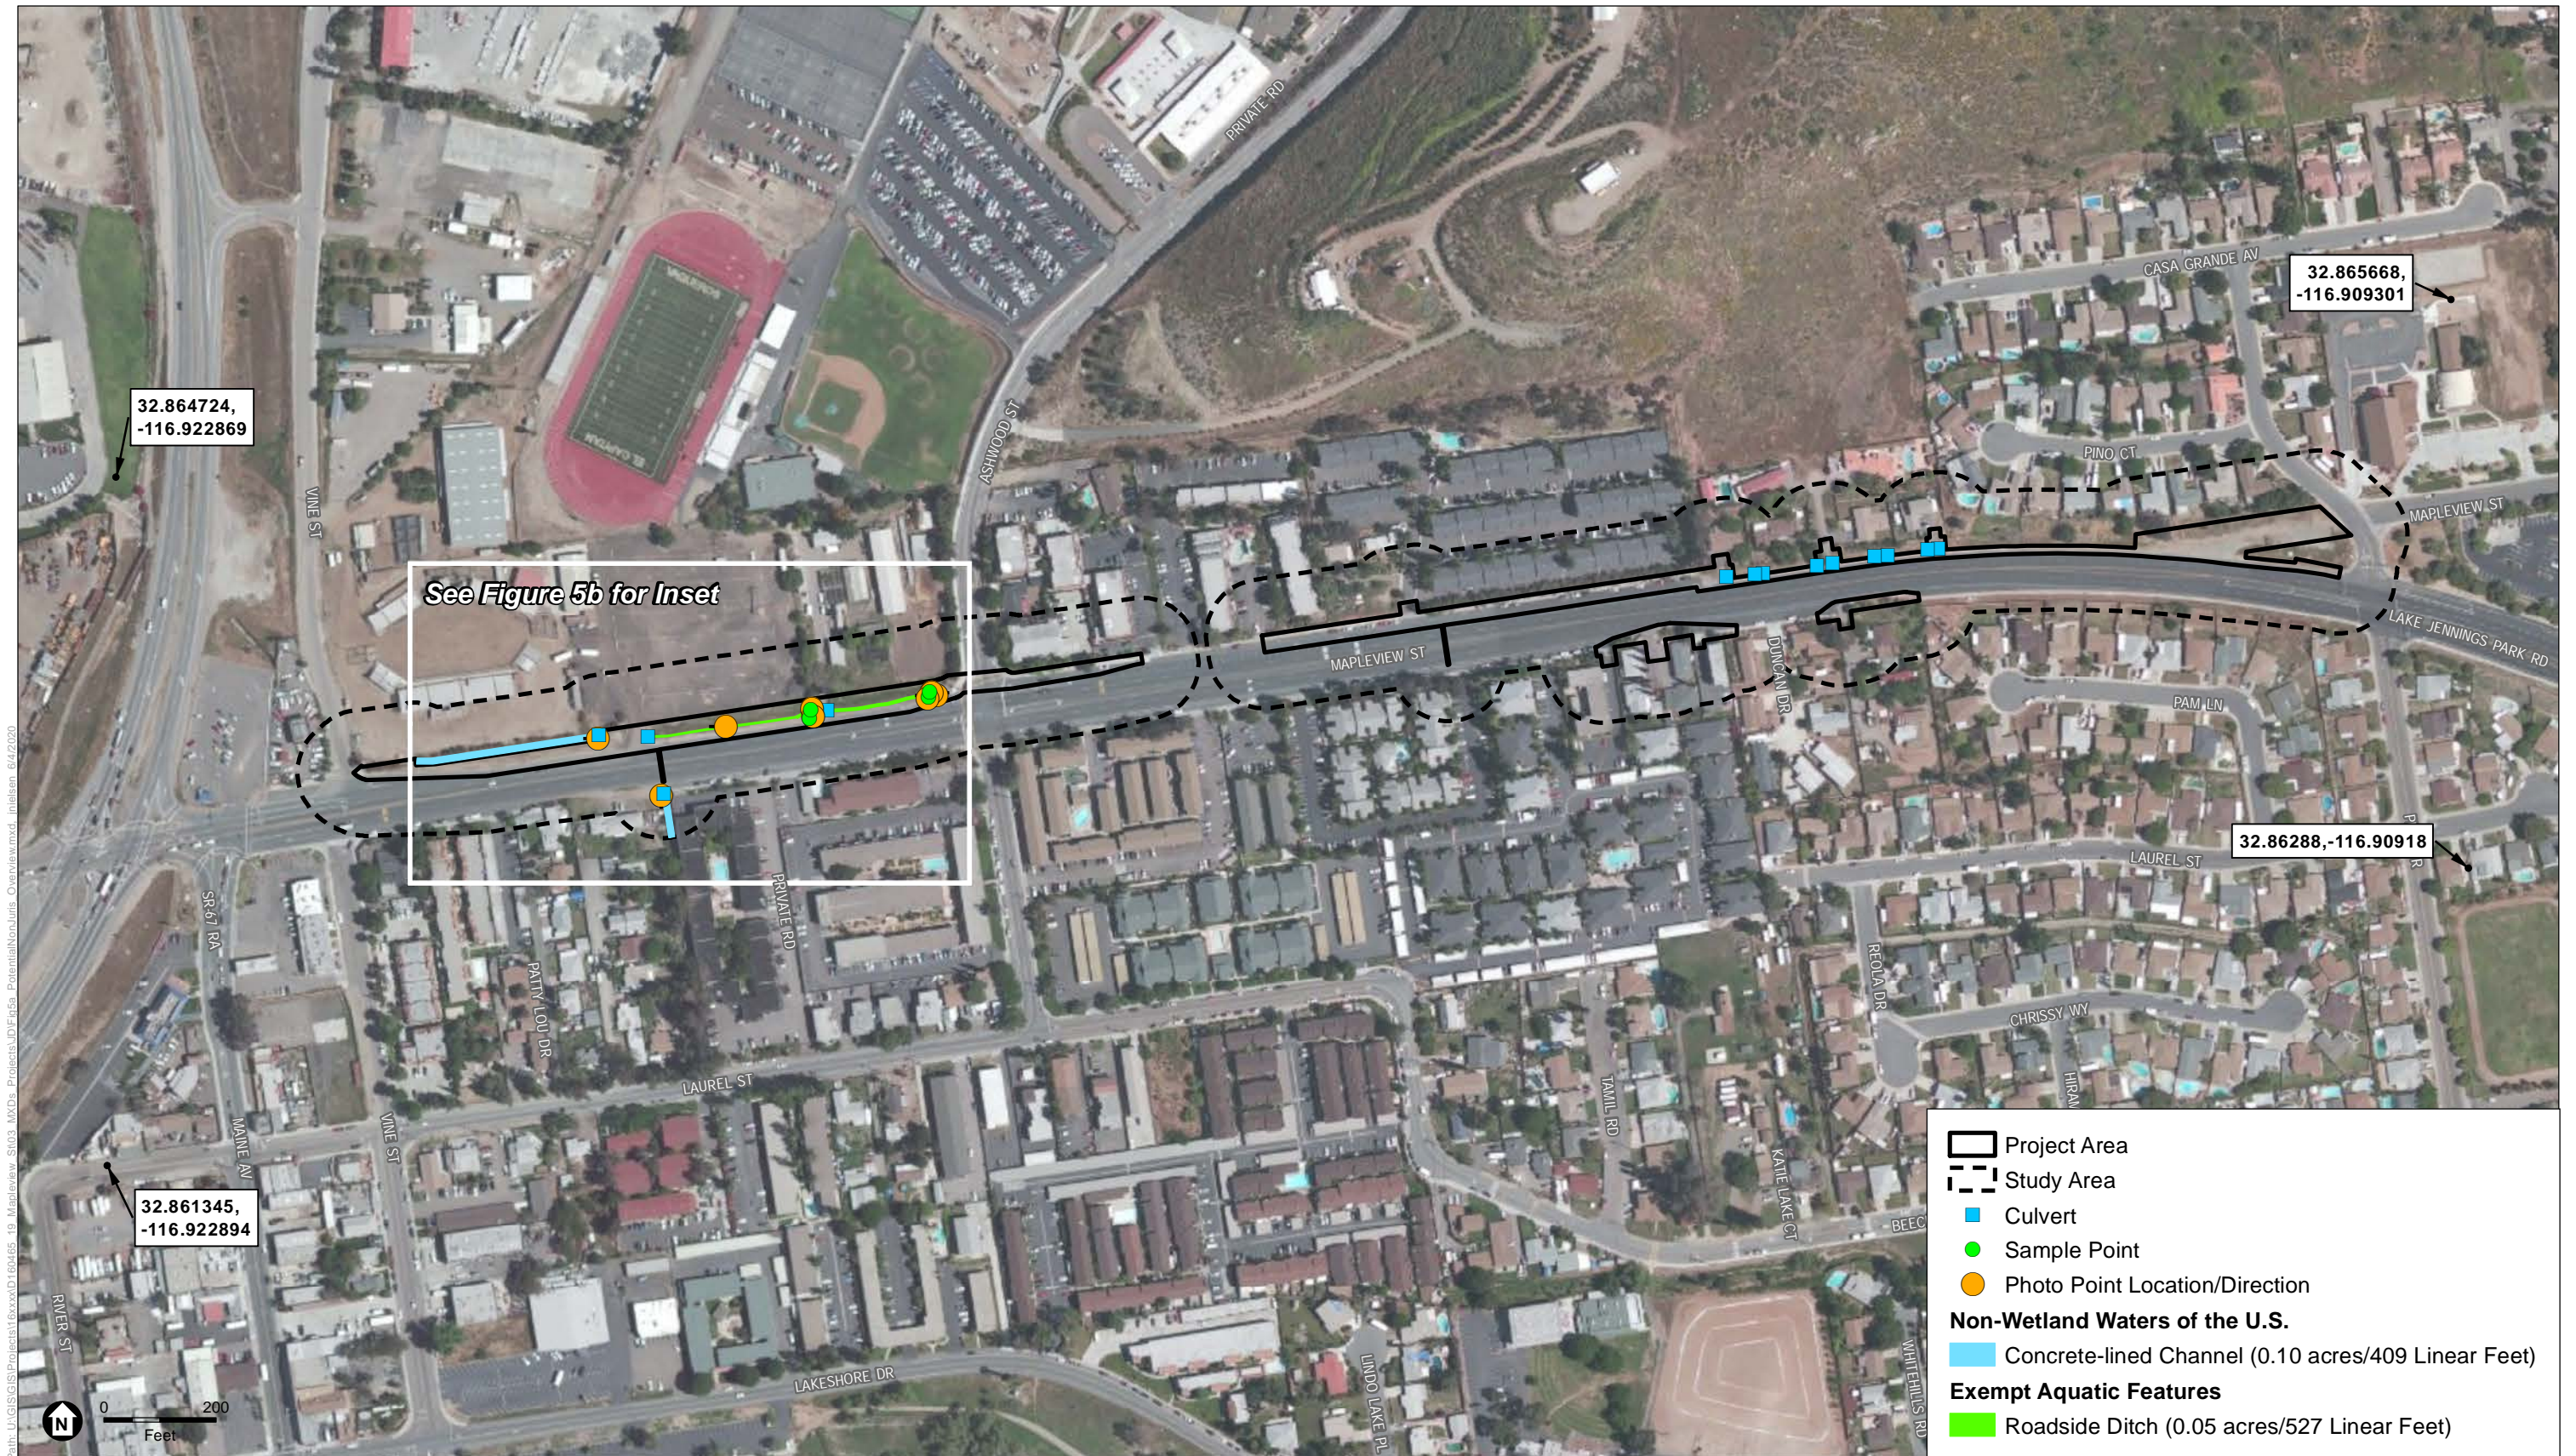
Figure 5a
Waters of the U.S.
Overview

Potential non-wetland waters of the U.S. within the study area are limited to the concrete-lined flood control channel. OHWM indicators observed during the field delineation included staining and saturated soils/concrete and averaged 10 feet wide. The concrete-lined flood control channel is considered non-wetland waters of the U.S. per the Rapanos Guidance as it contains relatively permanent flow and is a tributary to the San Diego River. Therefore, the concrete-lined flood control channel is a potential non-wetland waters of the U.S. and is mapped in **Figures 5a** and **5b**. OHWM data sheets are included in **Appendix C** and photographs are provided in **Appendix D**.

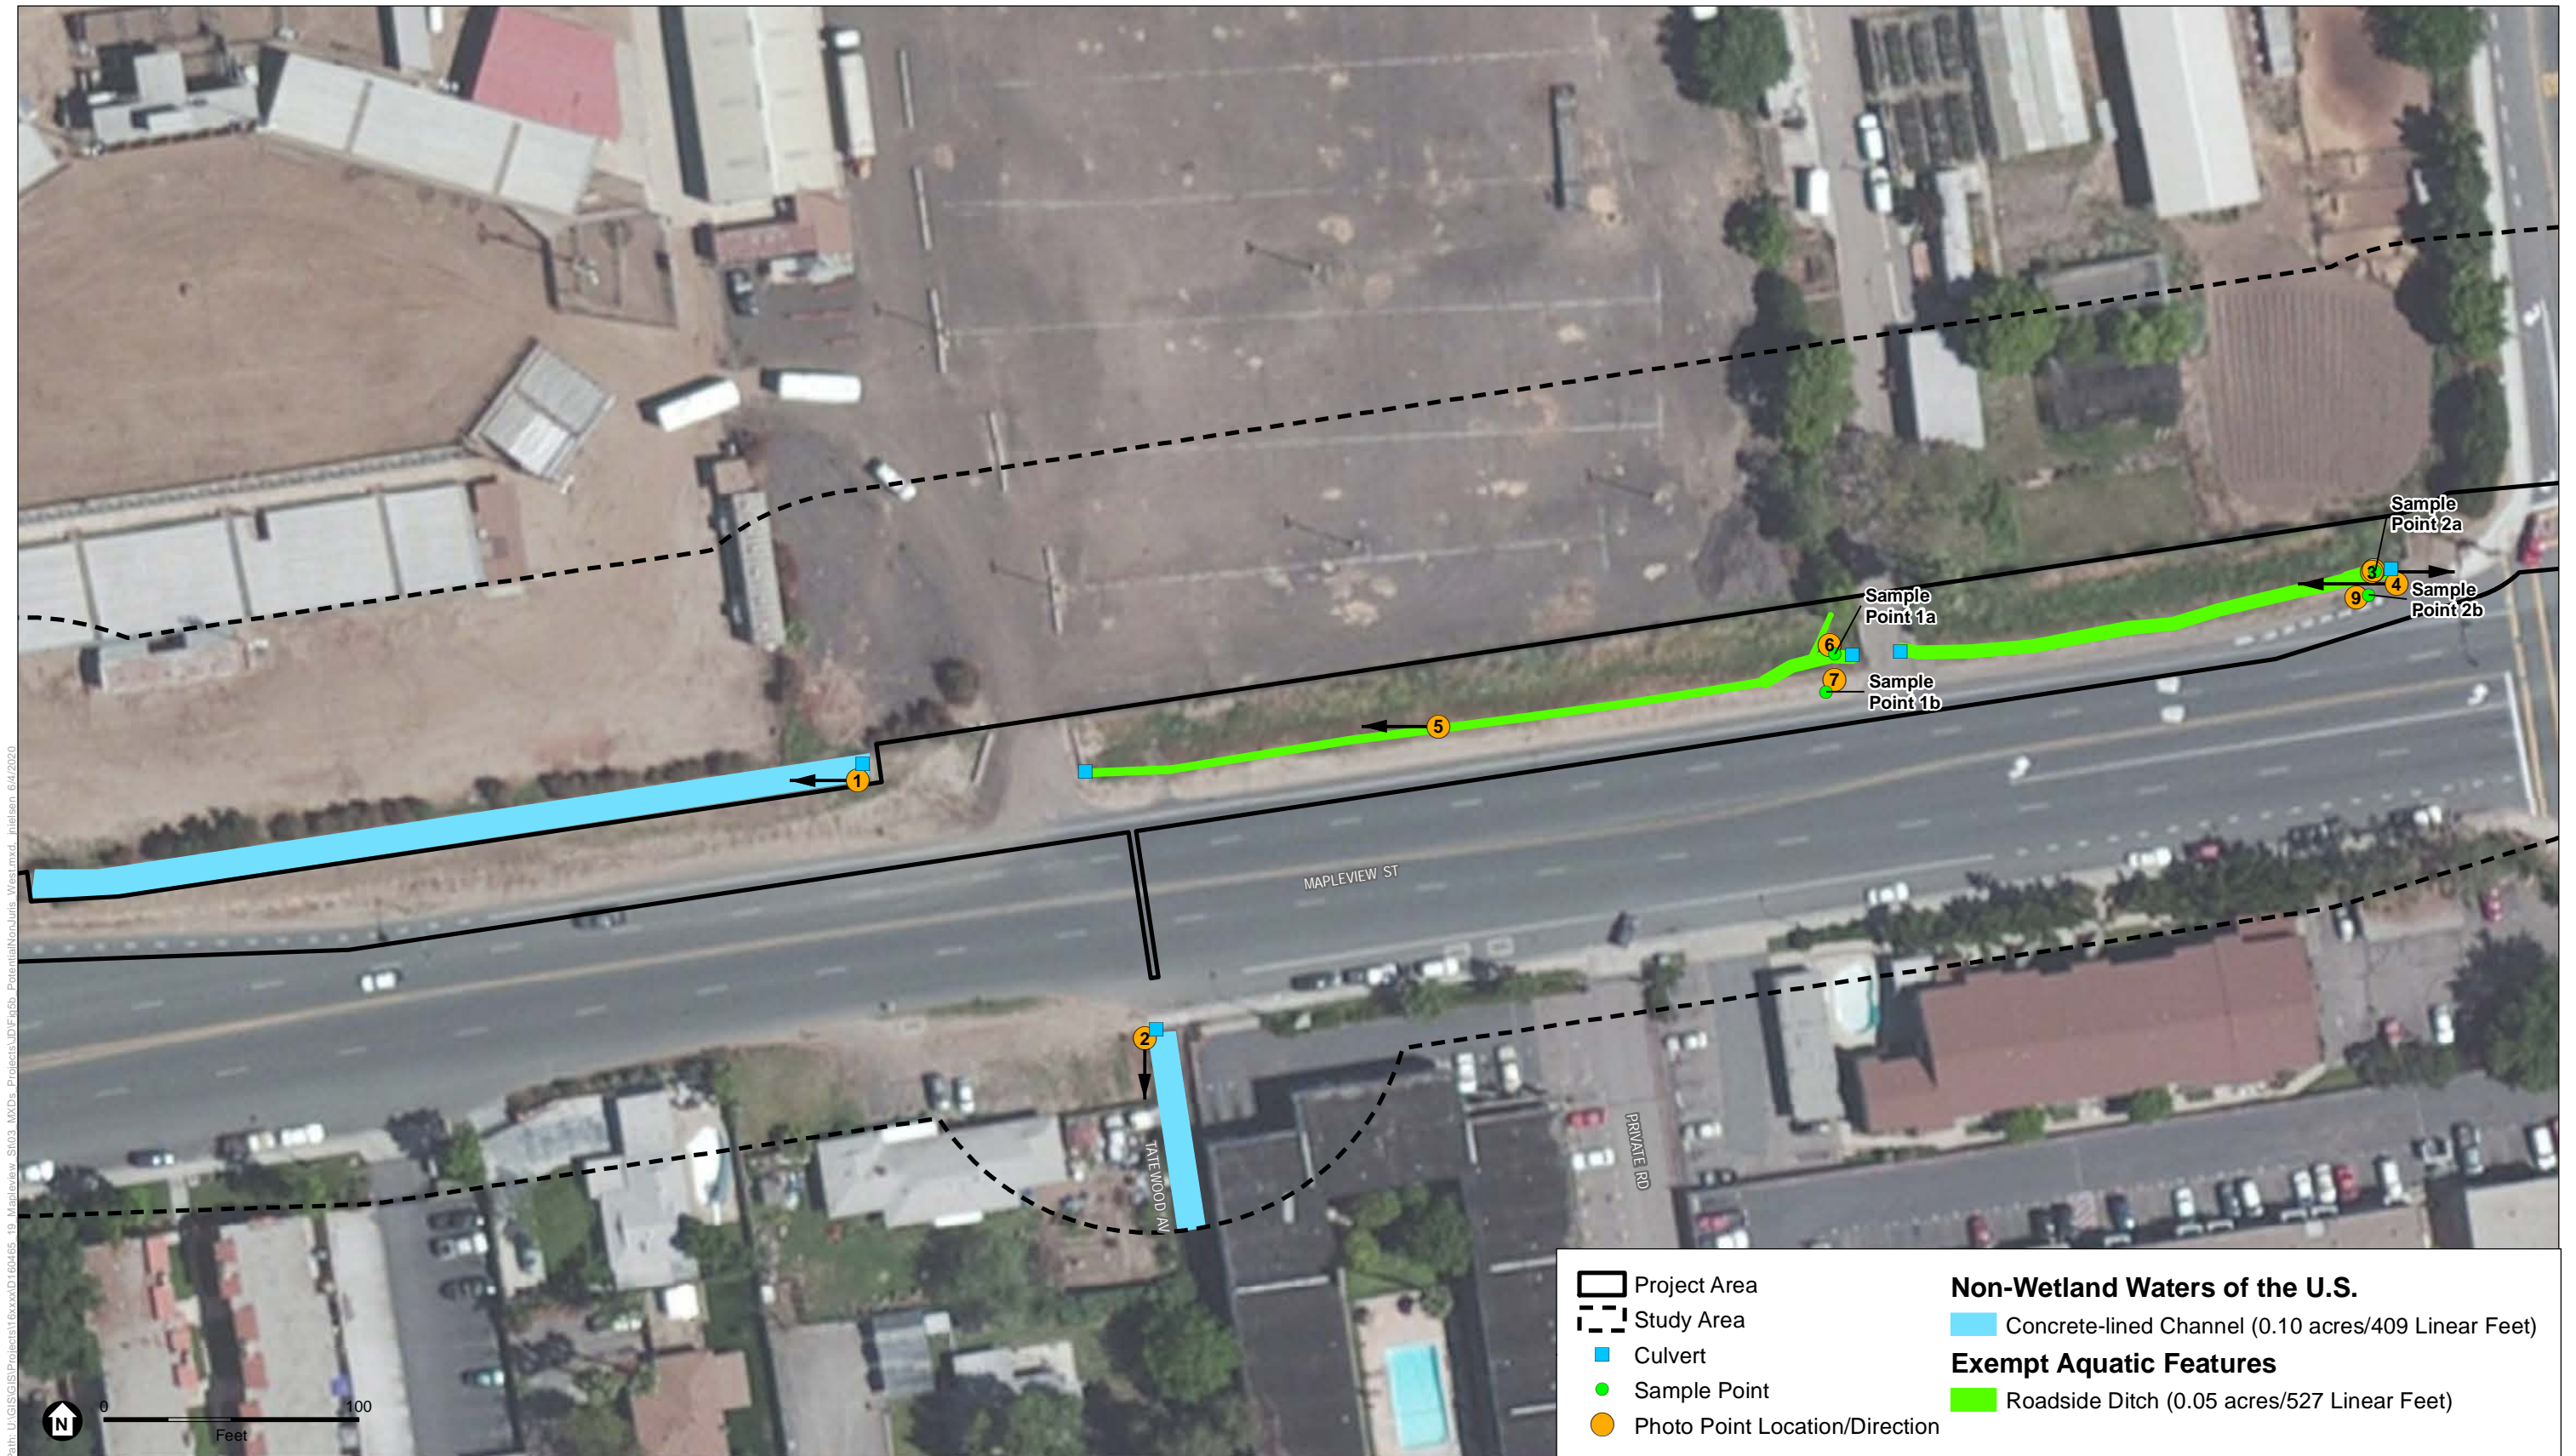
Project Area	Non-Wetland Waters of the U.S.
Study Area	Concrete-lined Channel (0.10 acres/409 Linear Feet)
Culvert	Exempt Aquatic Features
Sample Point	Roadside Ditch (0.05 acres/527 Linear Feet)
Photo Point Location/Direction

Each soil map unit is described below. The datasheets containing the results of the sample points are included in **Appendix C** and the sample point locations are displayed in **Figures 5b, 6b, and 7b**.

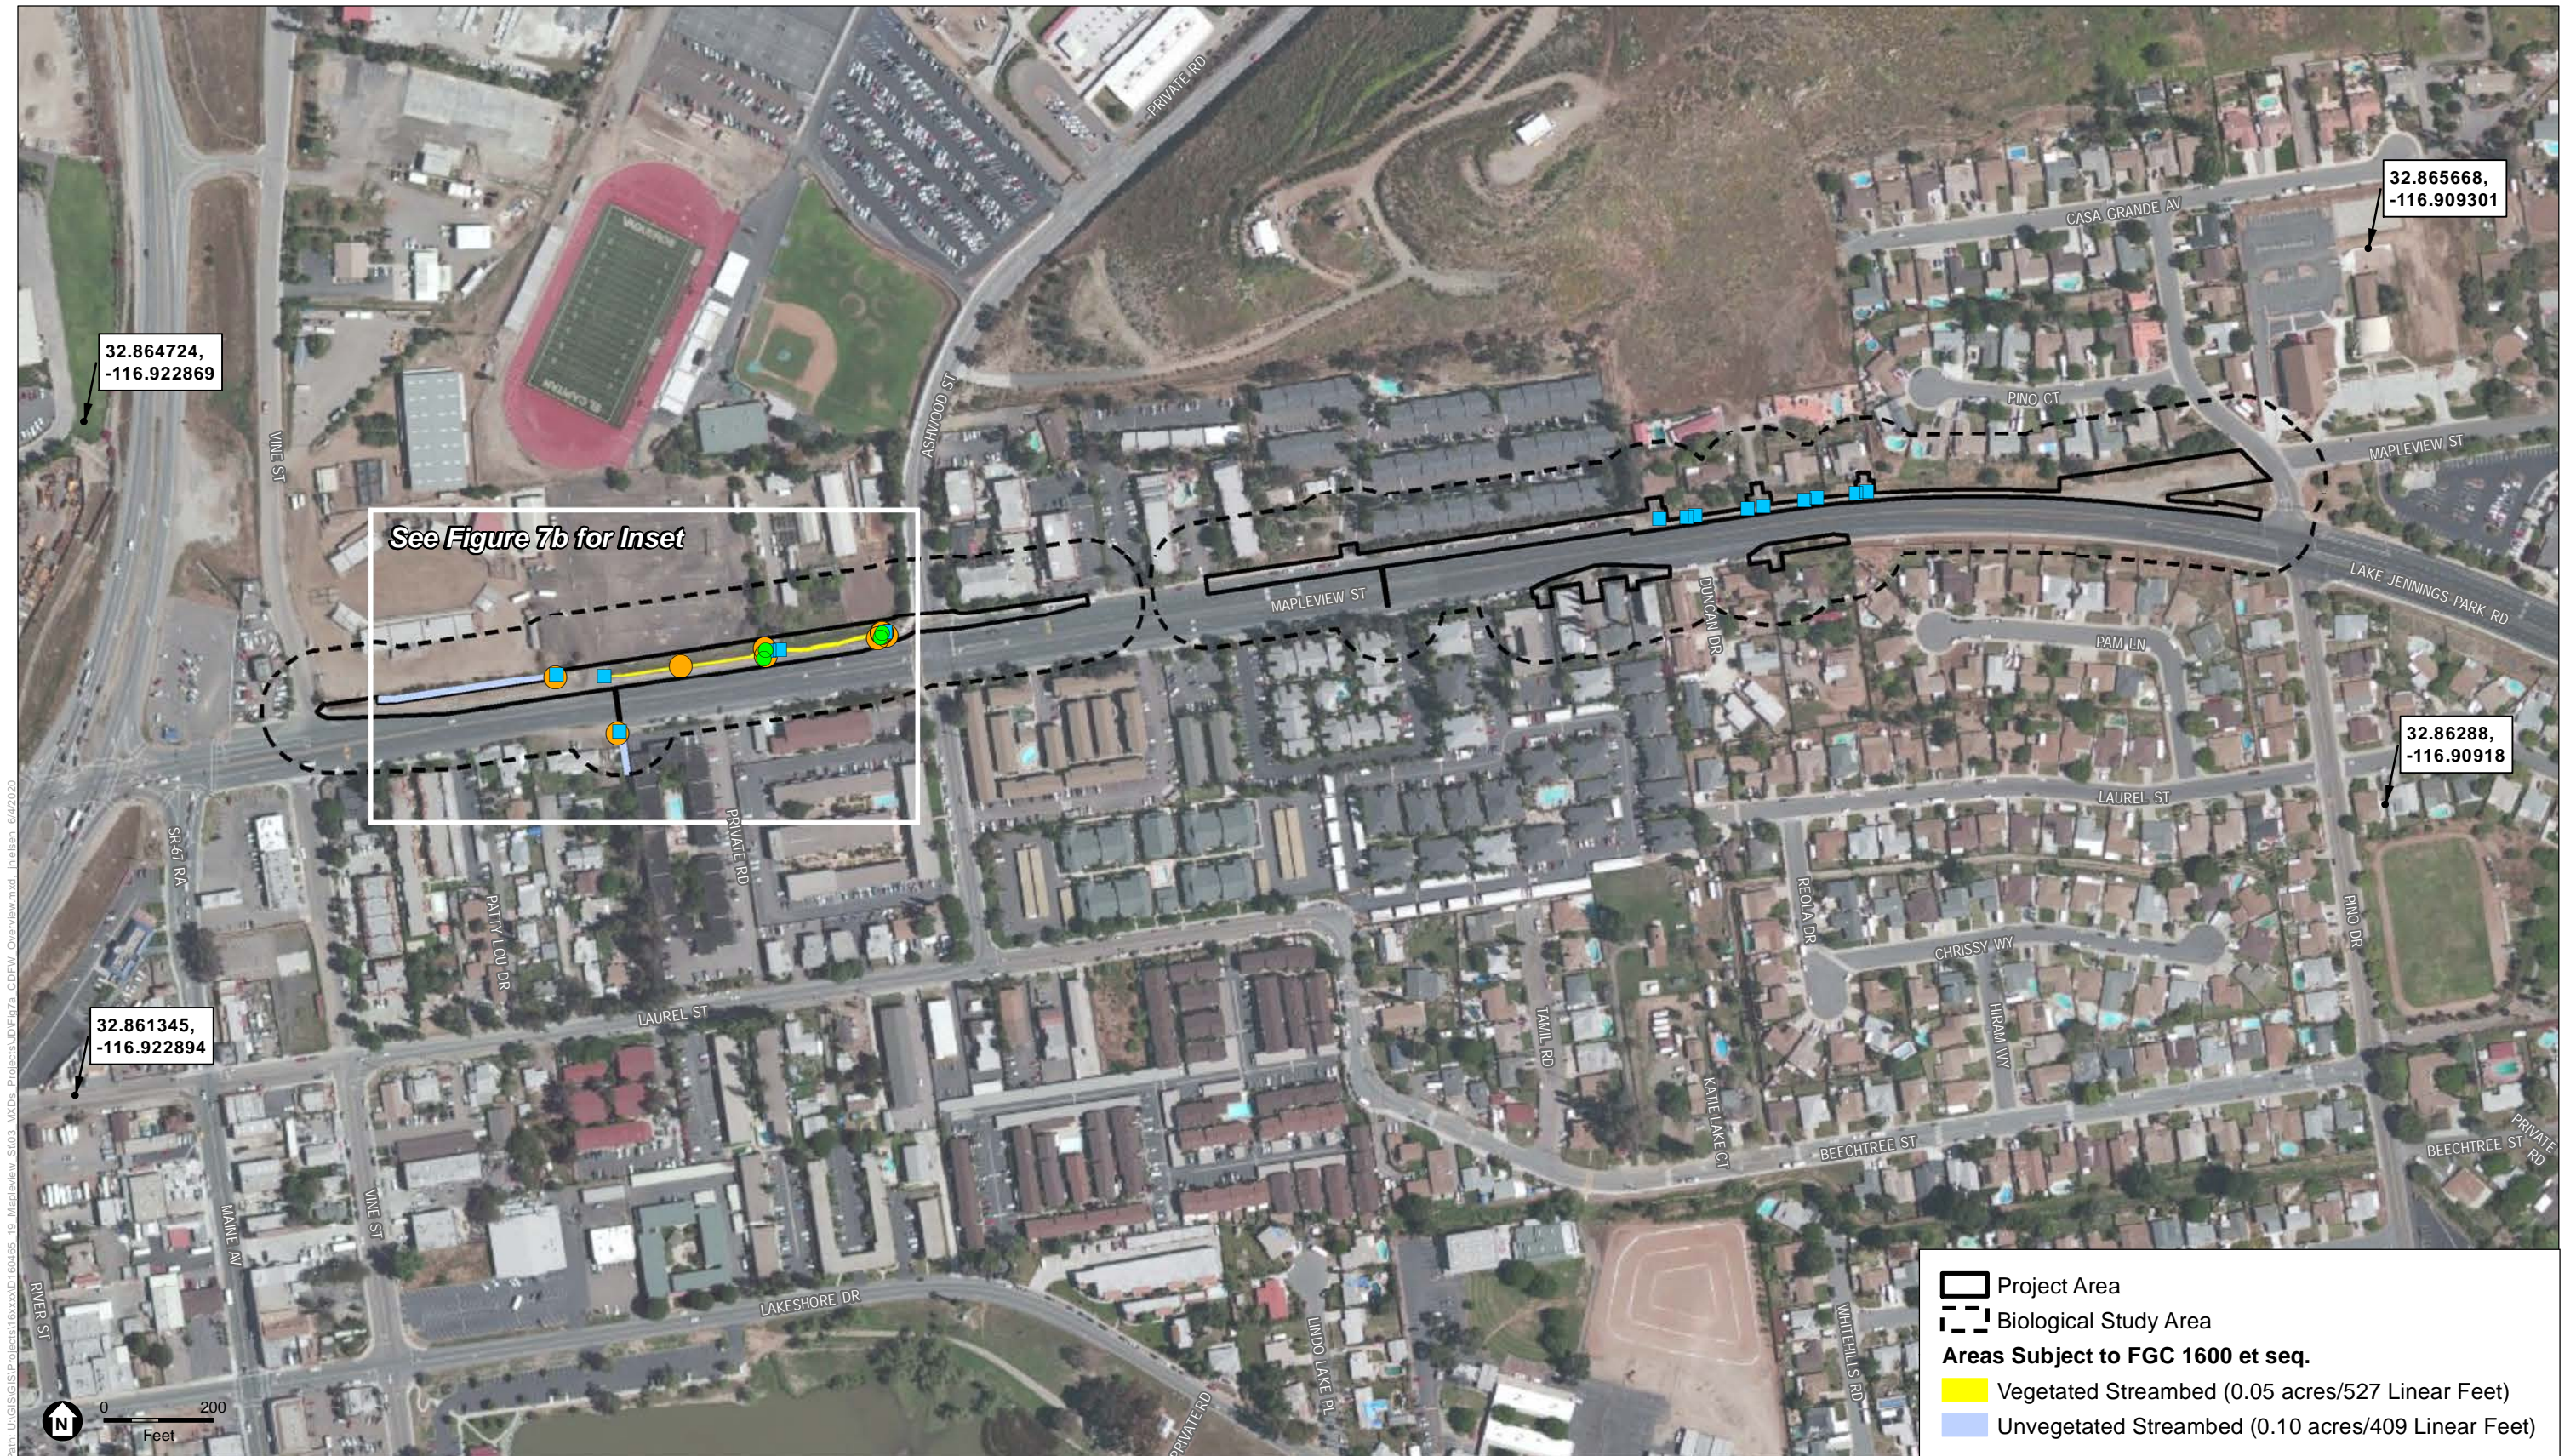
Figure 7a
Areas Subject to FGC 1600 et seq.
Overview

It is anticipated that an LSAA may be required for impacts to the roadside ditch. As part of the project design, improvements to the existing roadside ditch will occur and will include the widening and revegetation of the impacted area. It is anticipated that the expansion of the roadside ditch will result in a net gain of streambed such that no net loss of streambed will occur and no mitigation is expected. Further, the proposed bioswale improvements are designed to improve water quality within and downstream of the study area.

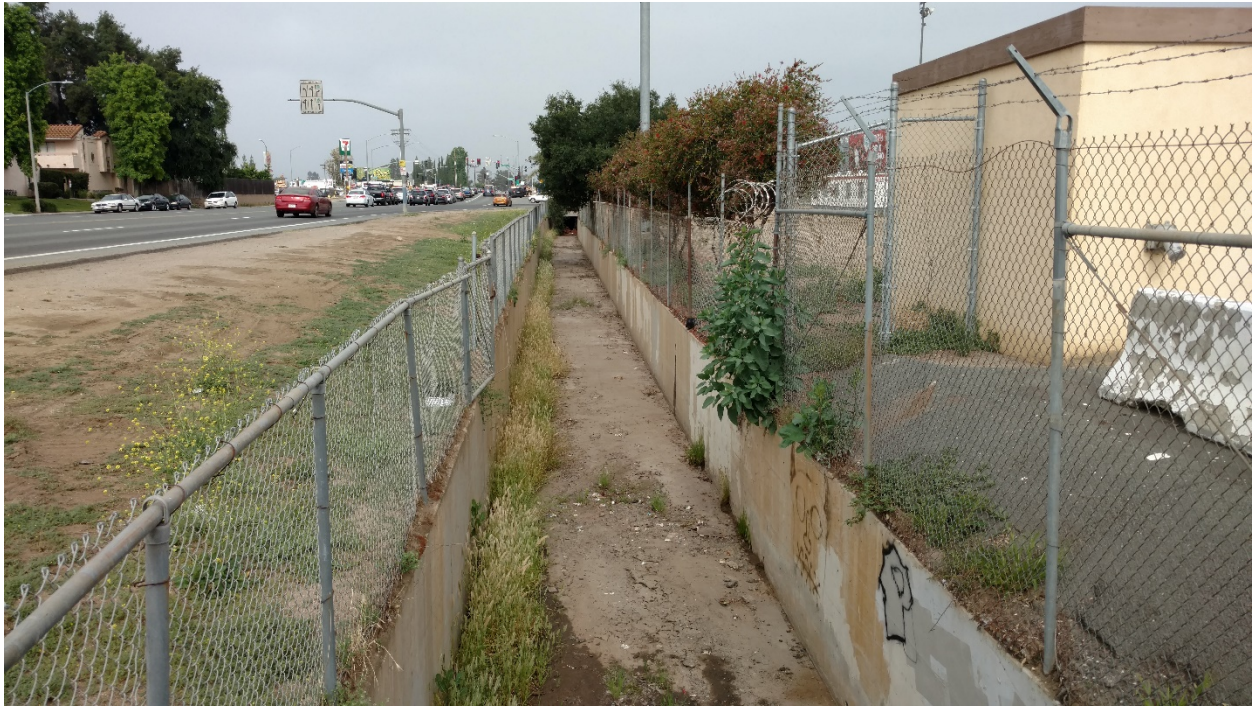
Photograph 1 – Concrete-lined ditch north of Mapleview Street, facing west.

At the time of the field survey, the concrete-lined flood control channel contained wet, non-flowing areas and the roadside ditch was dry (**Appendix D, Photographs 1-5**). The water regime is believed to be intermittent or ephemeral within the concrete-lined flood control channel and ephemeral within the roadside ditch with brief seasonal flows primarily during storm events. The project site receives approximately 9 inches of rain annually with a majority of rains occurring in the period from October to February.

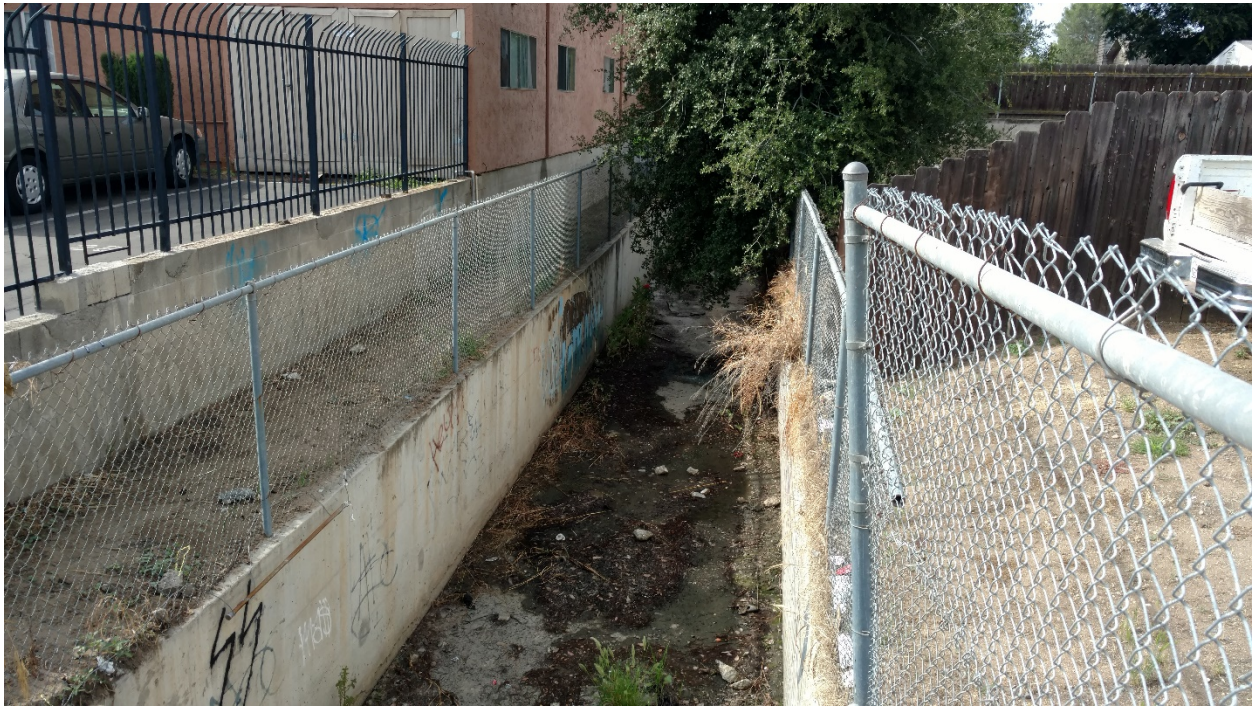
Photograph 2 – Concrete-lined ditch south of Mapleview Street, facing south.

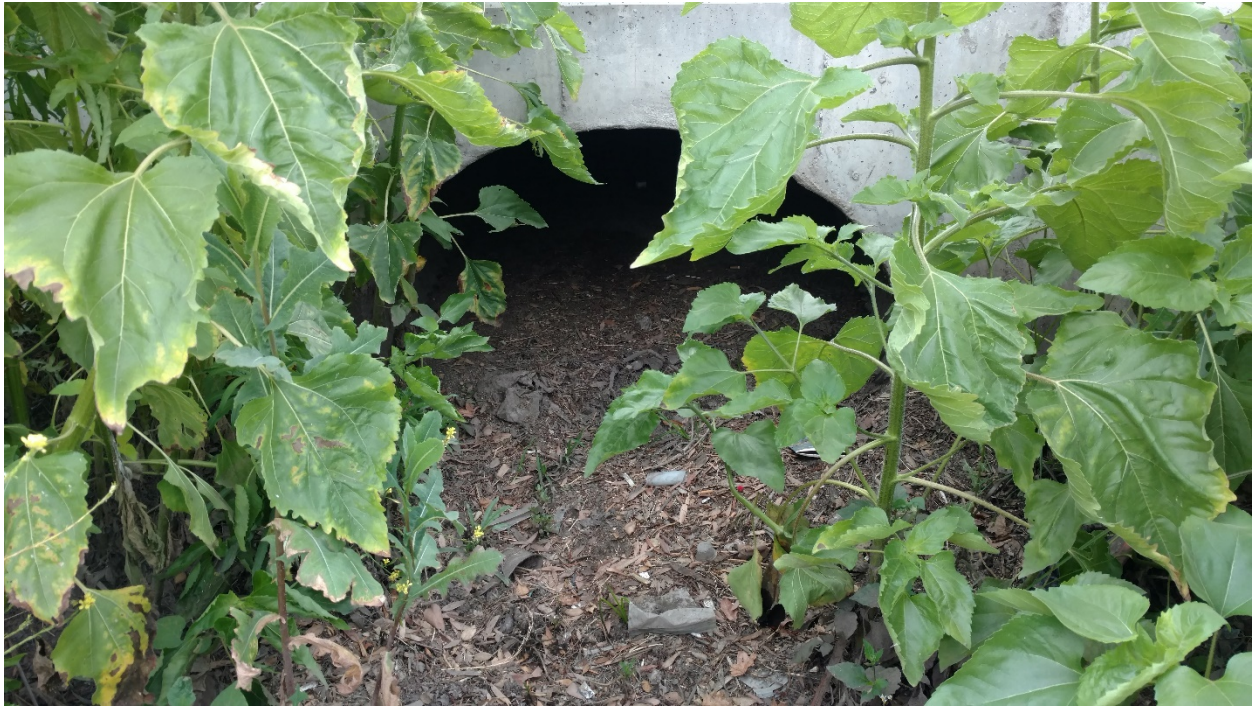
Photograph 3 – Ditch 1 starting point. Culvert west of Ashwood Street and north of Mapleview Street, facing east.

The roadside ditch contributes flow to the concrete-lined flood control channel and flows in an east to west direction. The roadside ditch originates at a culvert north of Maplevue Street and just west of Ashwood Street and carries flows from surrounding developed areas. The roadside ditch travels through two steel-corrugated culverts that are approximately 6 feet wide before entering into the concrete-lined flood control channel to the west. The roadside ditch is approximately 3 to 6 feet wide, 2 feet deep, and 527 feet long.

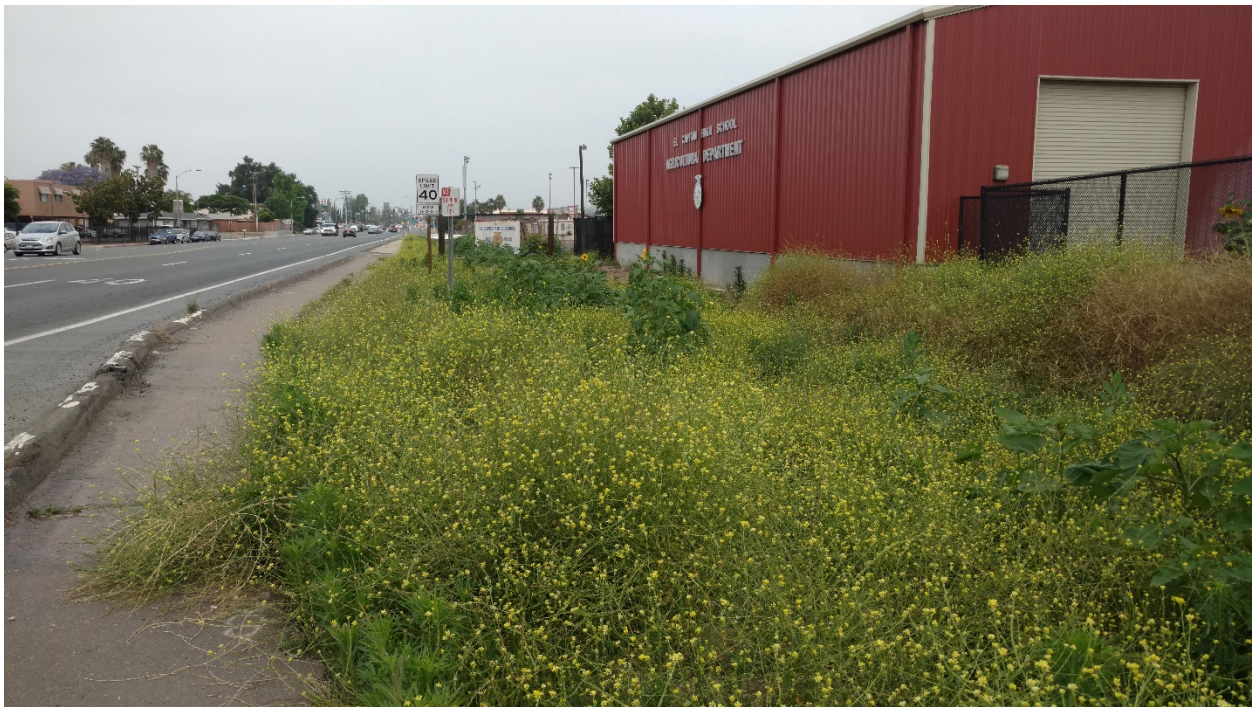
Photograph 4 – Ditch 1 facing west

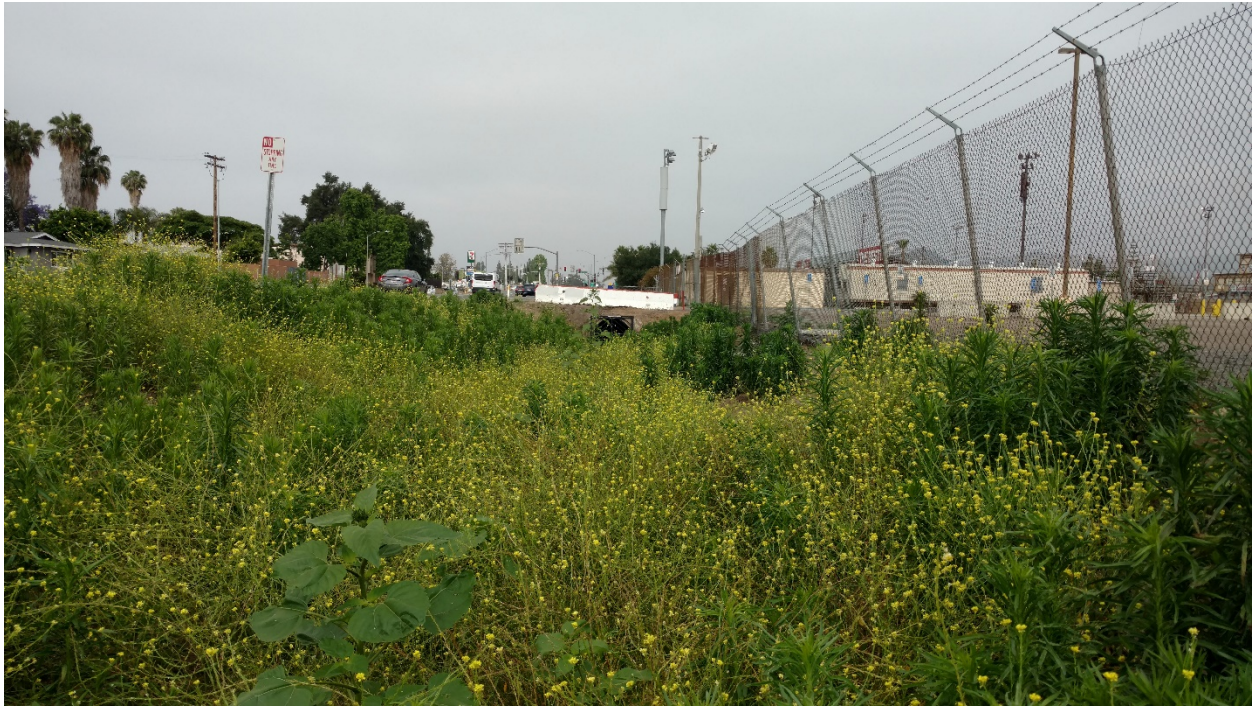
Photograph 5 – Ditch 1 facing west
