**Draft Preliminary Environmental
Assessment Report
Juan Cabrillo Elementary School and
Malibu High School
30237 and 30215 Morning View Drive
Malibu, California**

Prepared for:
**Santa Monica-Malibu United School District
Santa Monica, California**

Prepared by:
**Ramboll Environ US Corporation
Irvine, California**

Date:
May 29, 2015

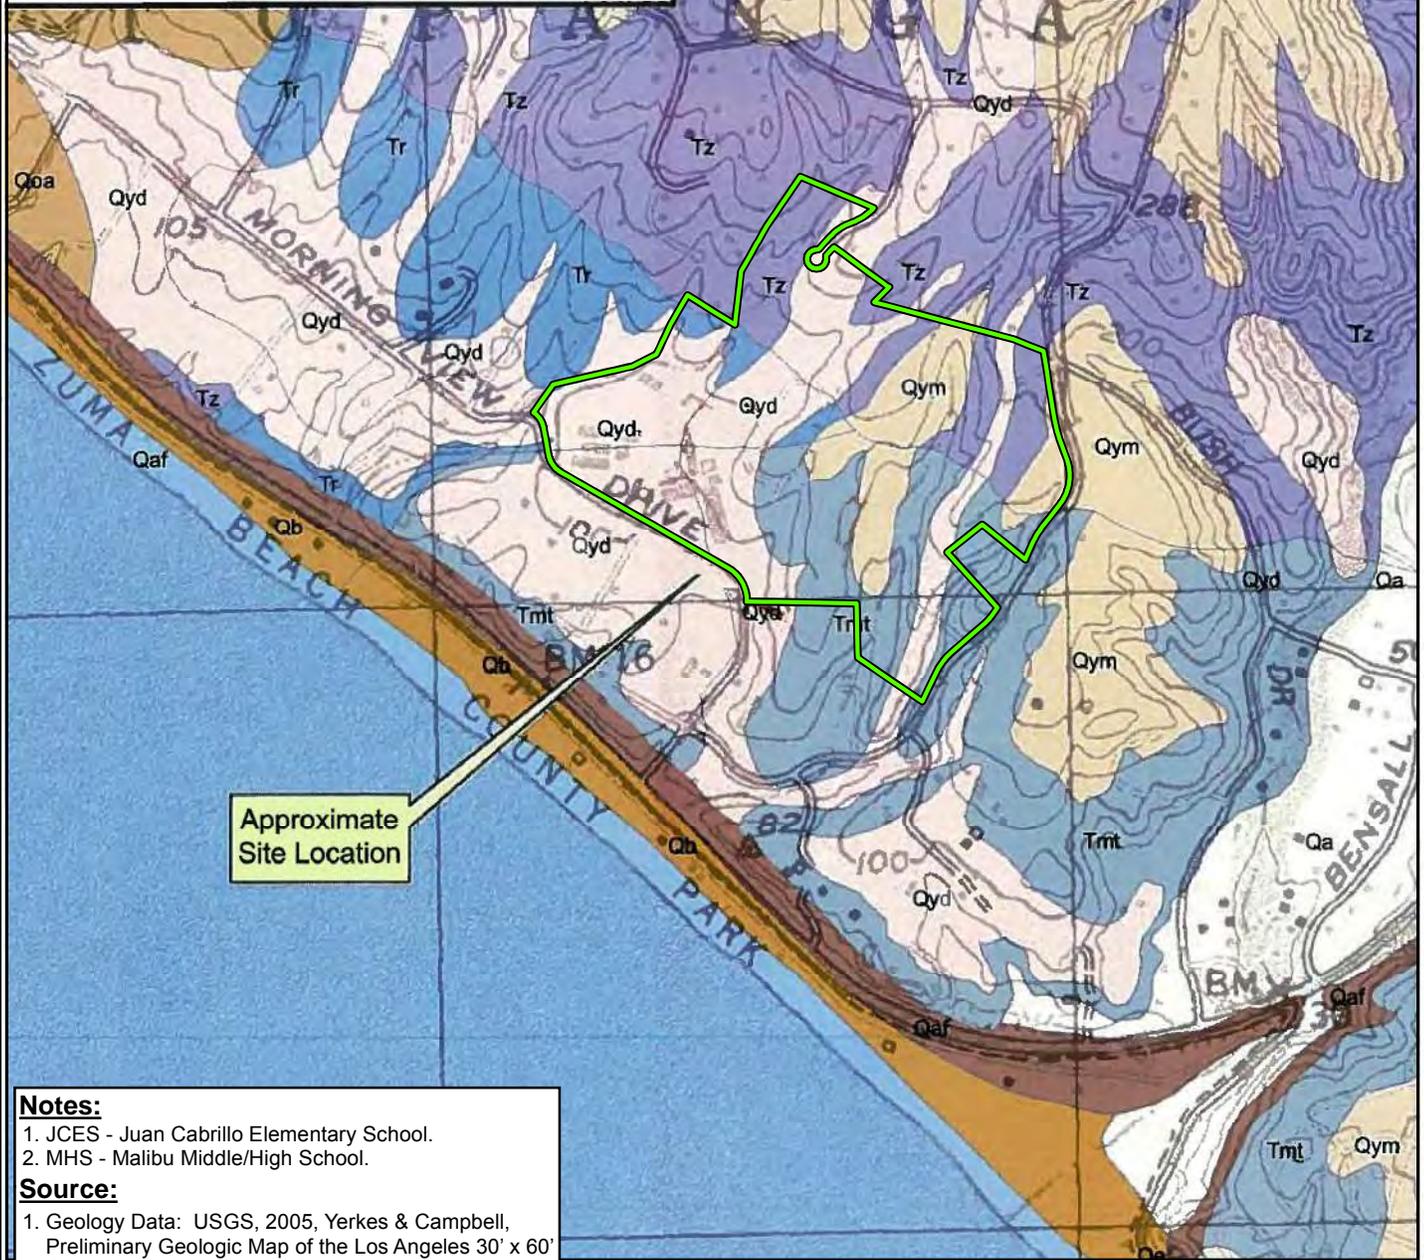
Path: Z:\01_Projects\Malibu High School\03_GIS\PEA Investigation\Figure 4 - Regional Geology - 2015-05-05.mxd

Source:
 1. Geology Data: USGS, 2005, Yerkes & Campbell, Preliminary Geologic Map of the Los Angeles 30' x 60' Quadrangle, Southern California, Version 1.0.

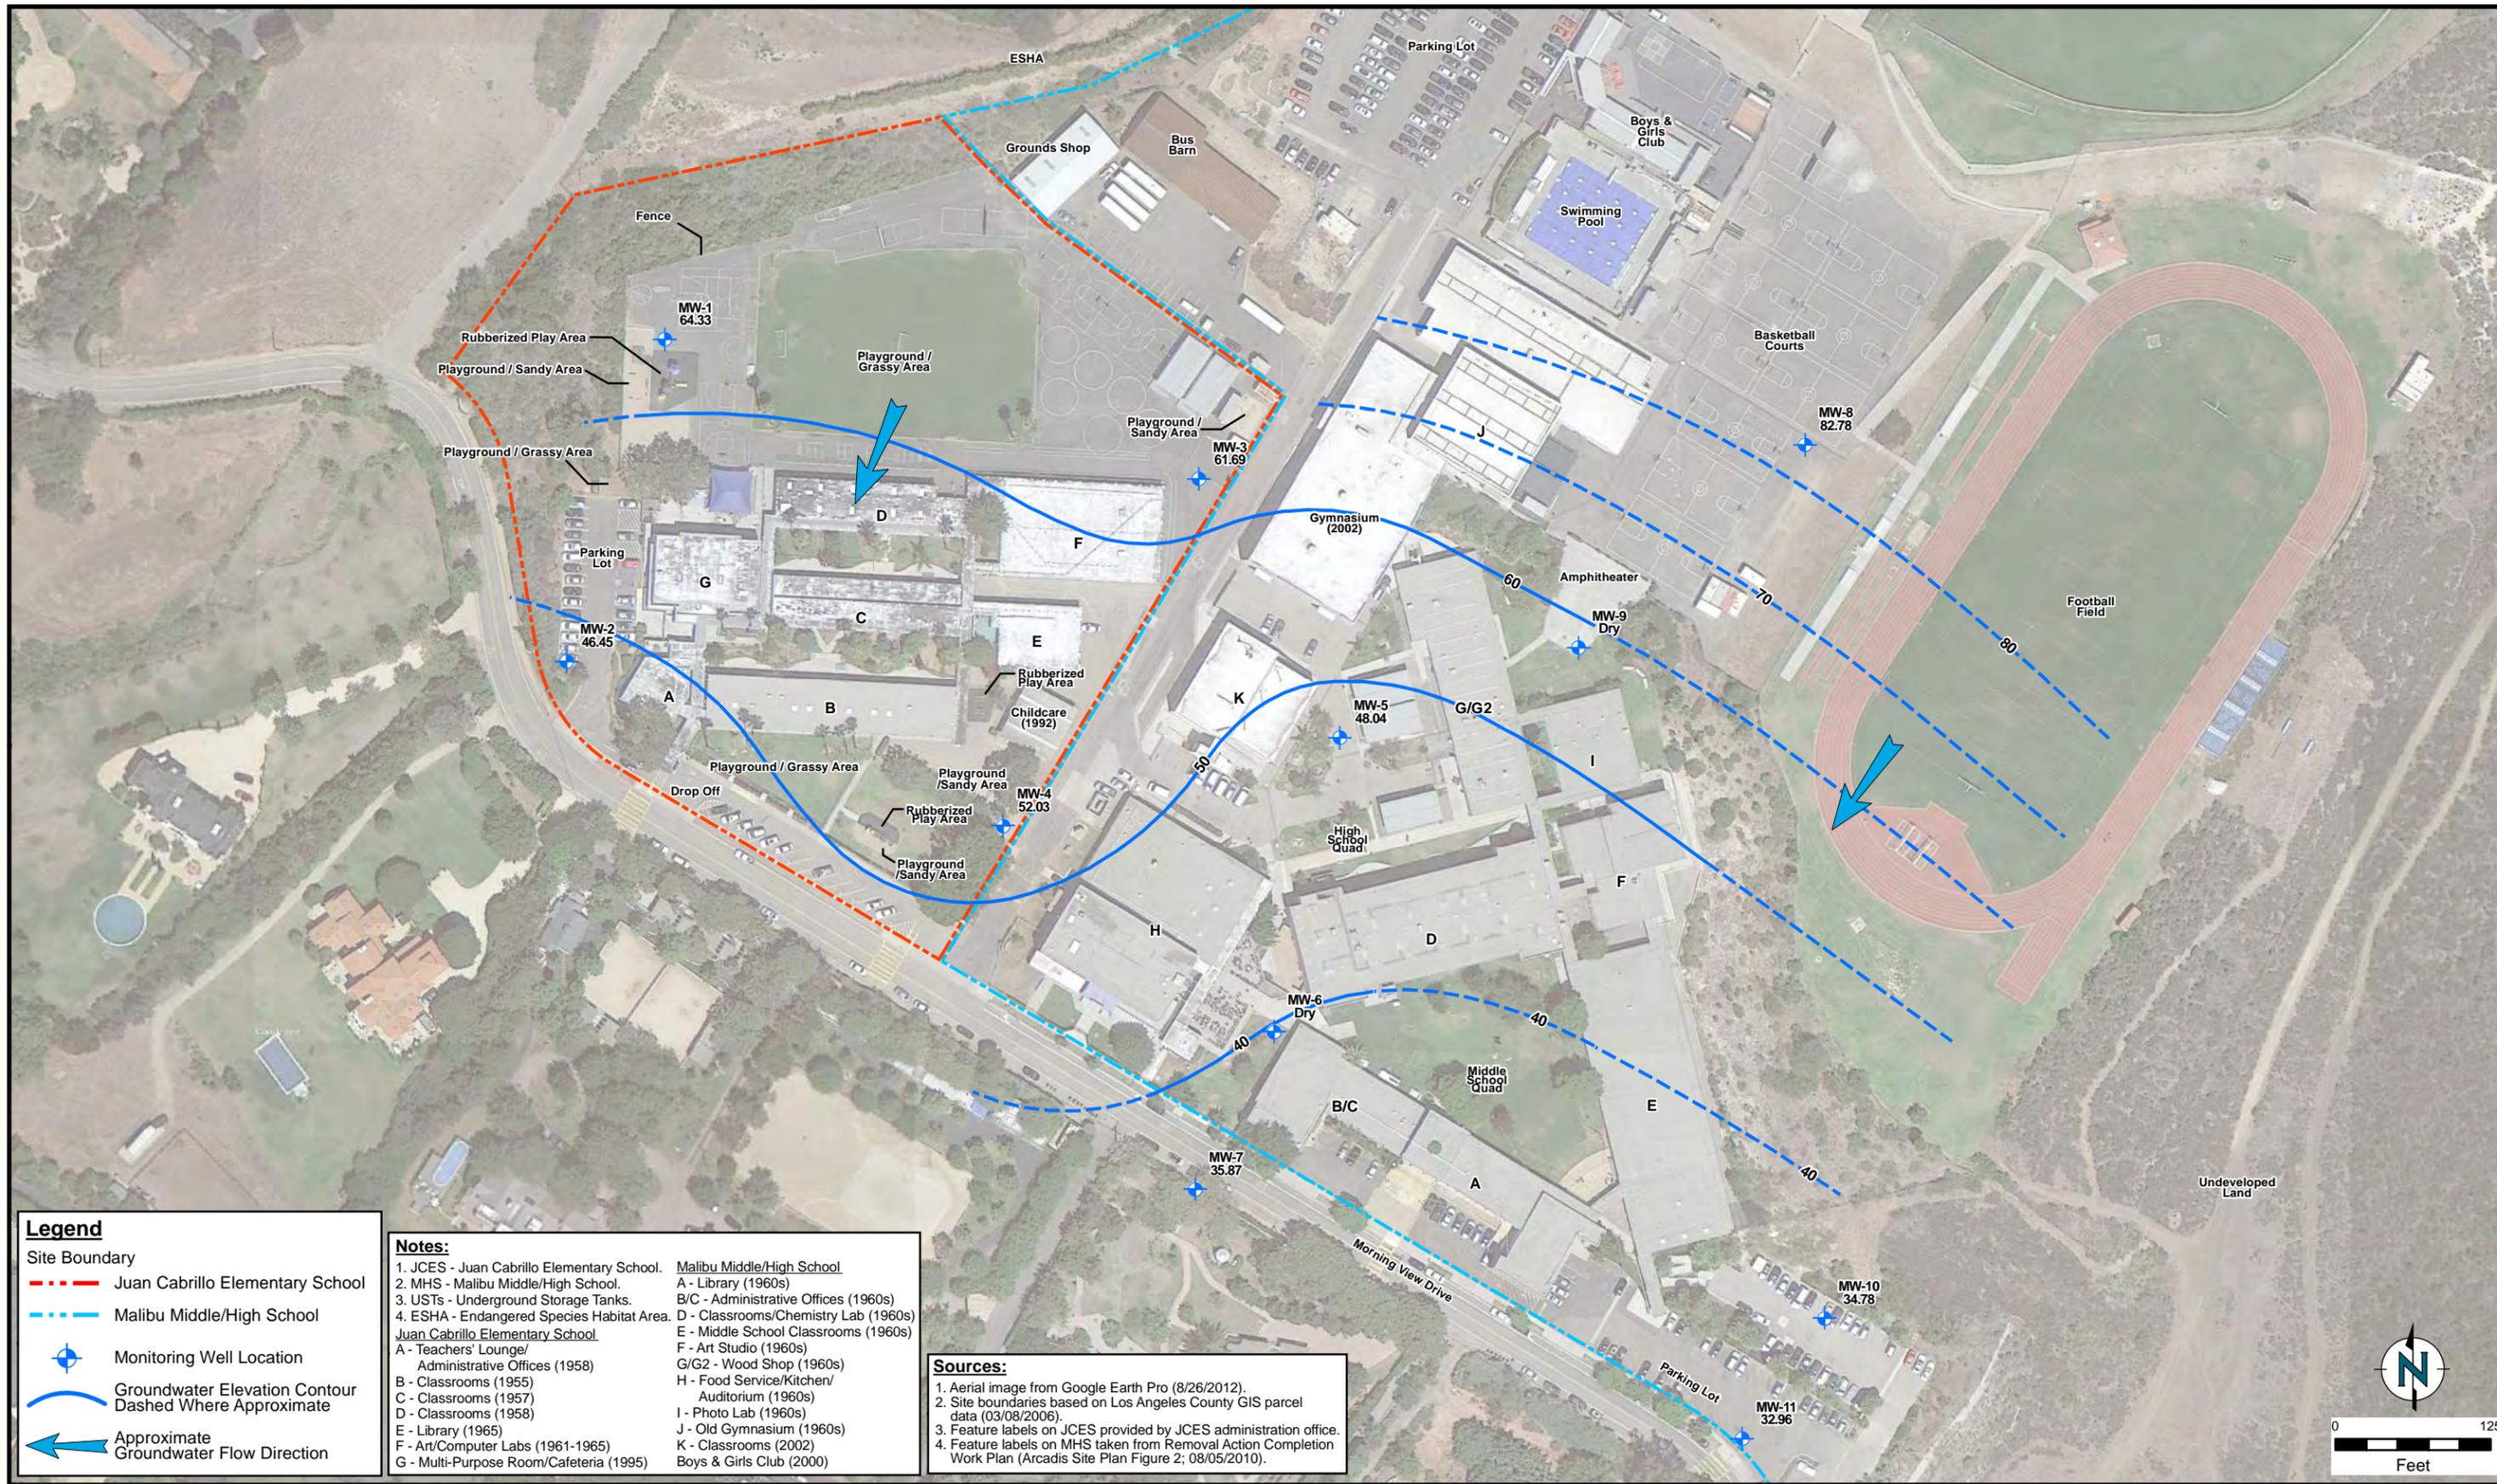
Path: Z:\01_Projects\Malibu_High_School\03_GIS\PEA_Investigation\Figure 6 - Potentiometric Surface Map - July 2014 - 2015-05-05.mxd

- Site Boundary
- Juan Cabrillo Elementary School
- Malibu Middle/High School
- Monitoring Well Location
- Groundwater Elevation Contour
- Dashed Where Approximate
- Approximate Groundwater Flow Direction

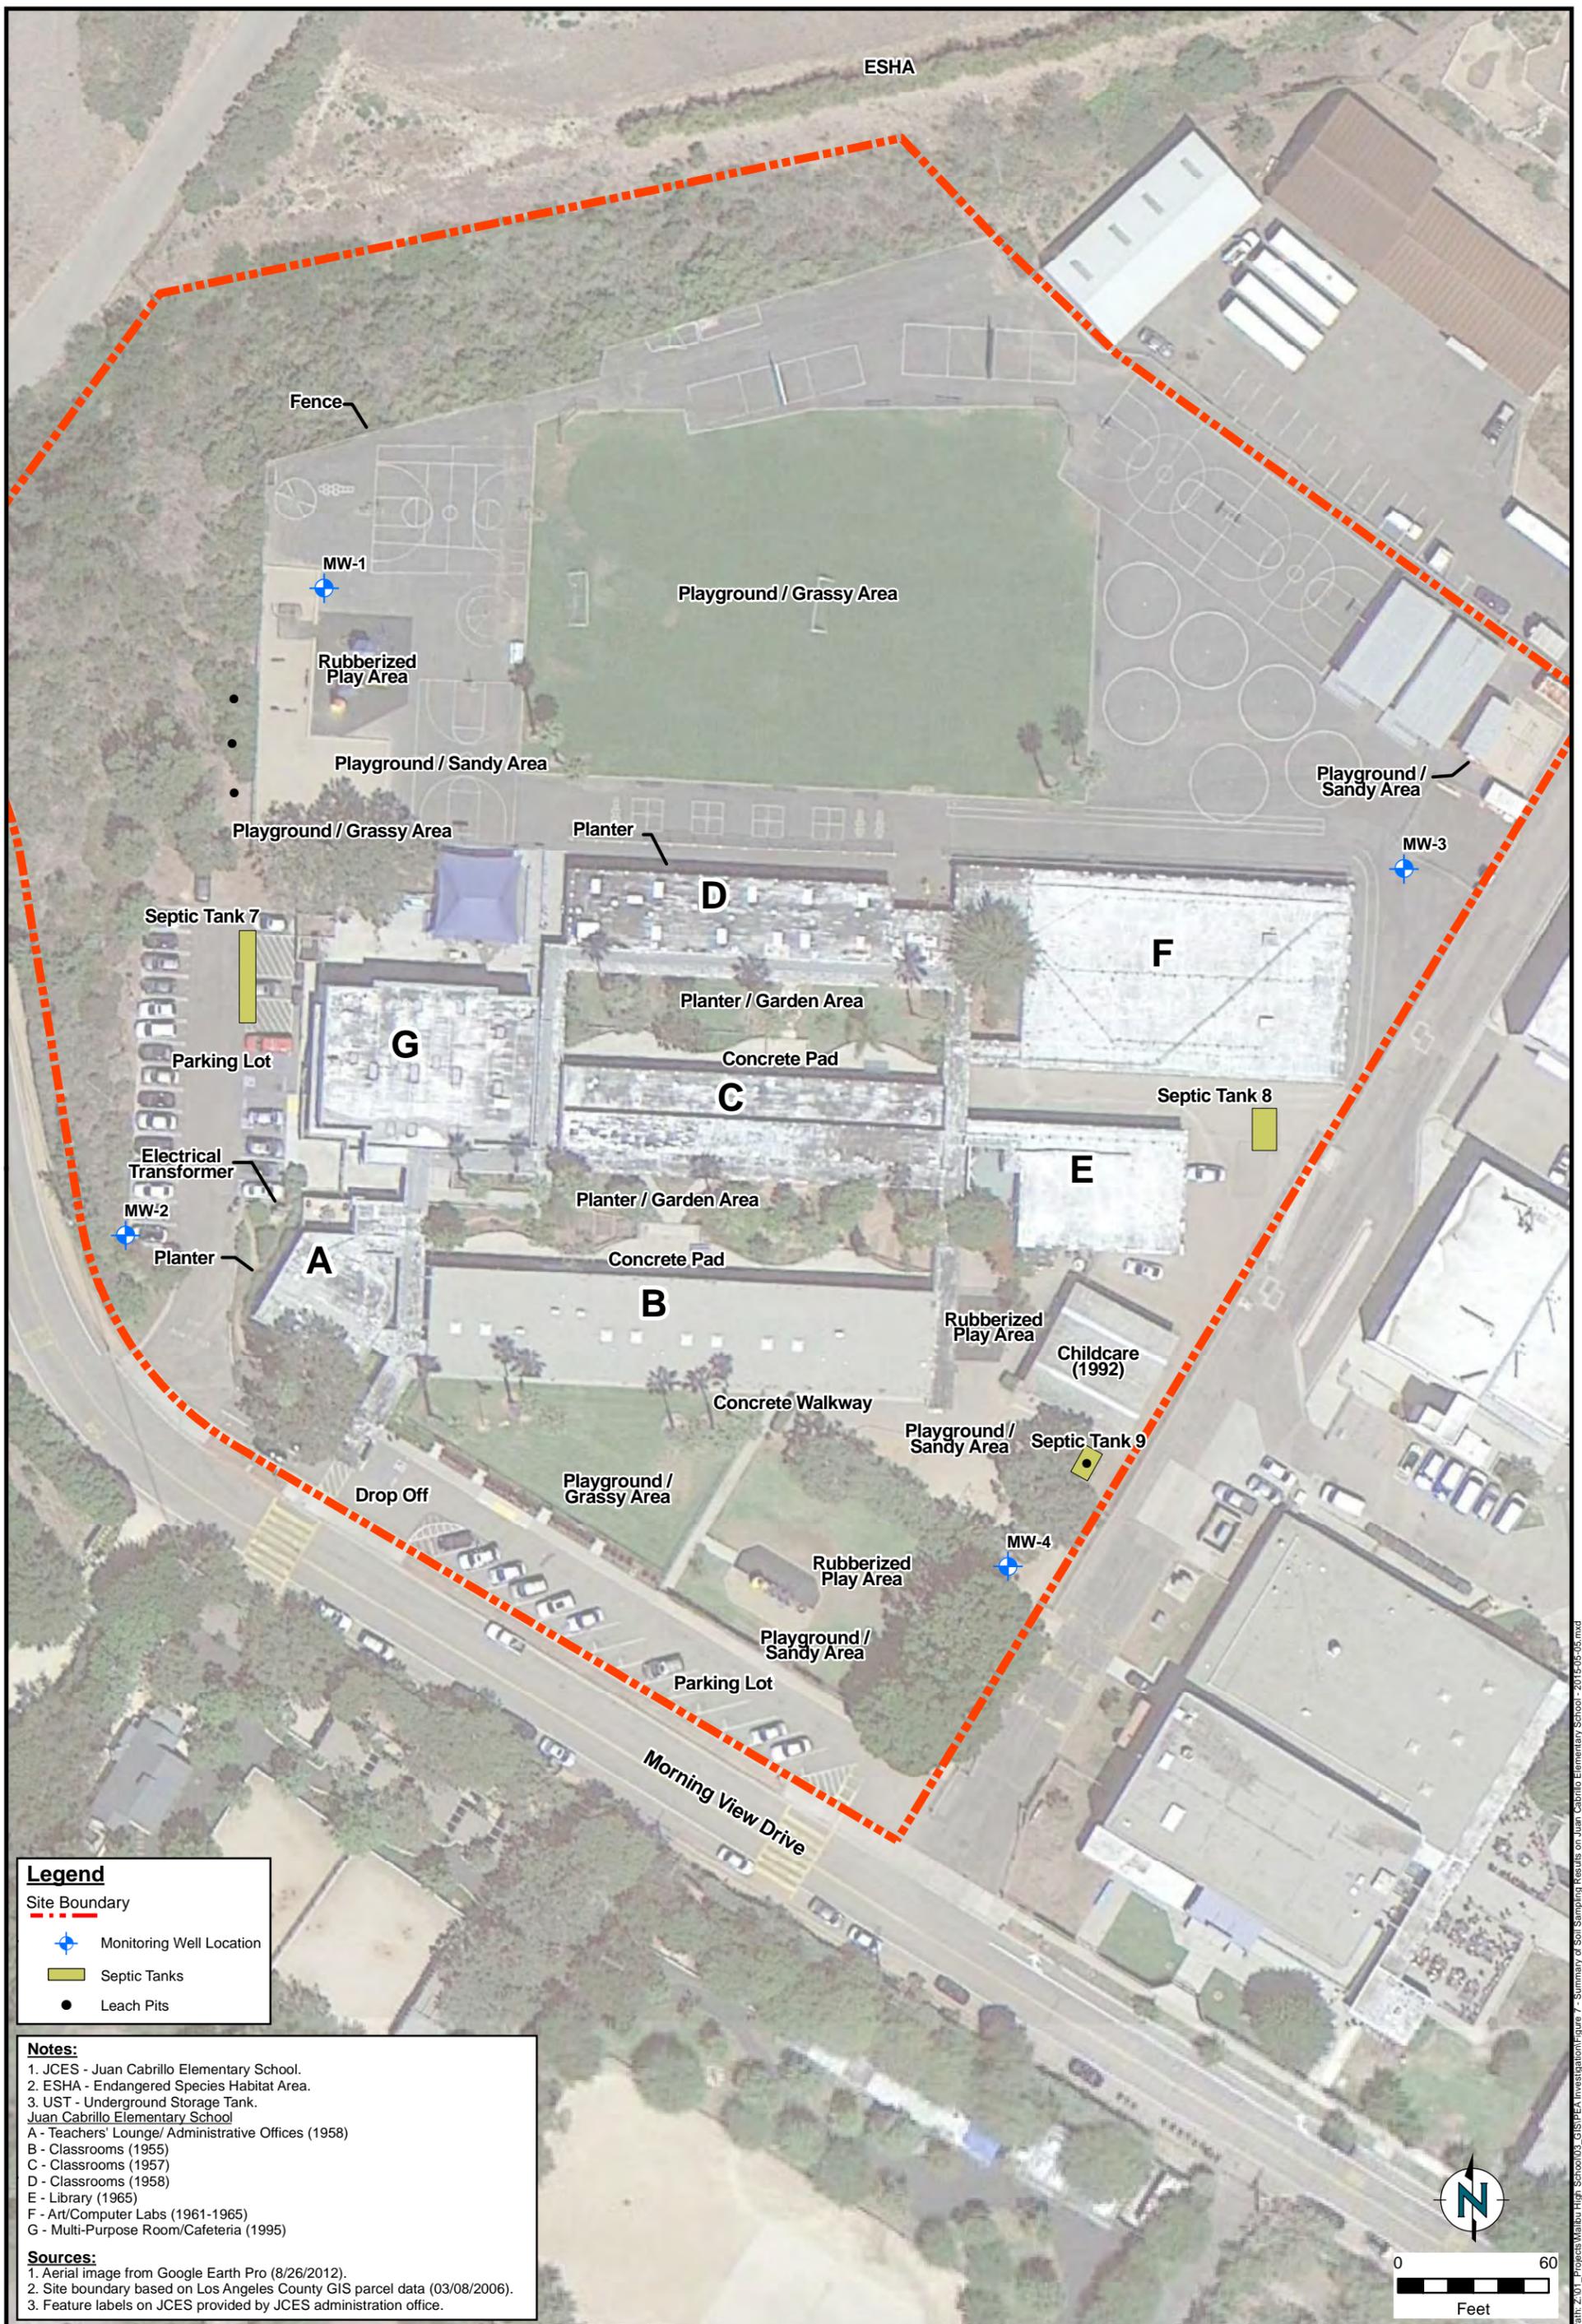
Path: Z:\01_Proj\04_Malibu High_School\02_CISPEA_Investigation\Figure 7 - Summary of Soil Sampling Results on Juan Cabrillo Elementary School - 2015-05-03.mxd

ENVIRON walked the entire school and observed both the exteriors and interiors of the buildings. Areas around the buildings typically are bordered with an approximate 8- to 10-foot wide concrete walkway and a concrete and/or vinyl siding overhang. Buildings A, D, and F are bordered by a planter to the south, north, and west, respectively. ENVIRON observed the playgrounds (grassy play area and adjacent sandbox playground) and the interior garden areas that are located between Buildings B, C, and D, as depicted on Figure 7.

Three septic tank areas that service JCES (Septic Tanks 7, 8, and 9) were observed (see Figure 7). Septic Tank 7 is located in the northern end of the staff parking lot and is connected to three leach pits; Septic Tank 8 is located south of Building F and is connected to a leach field; and Septic Tank 9 is located south of the childcare trailer and is connected to one leach pit. Four monitoring wells (MW-1 through MW-4) are located in the vicinity of the septic systems. These monitoring wells were installed between March 28 and April 6, 2009 during an evaluation and upgrade of the existing septic system (GeoConcepts, 2009) as part of the WDR permit, and are monitored quarterly under oversight of the LARWQCB.

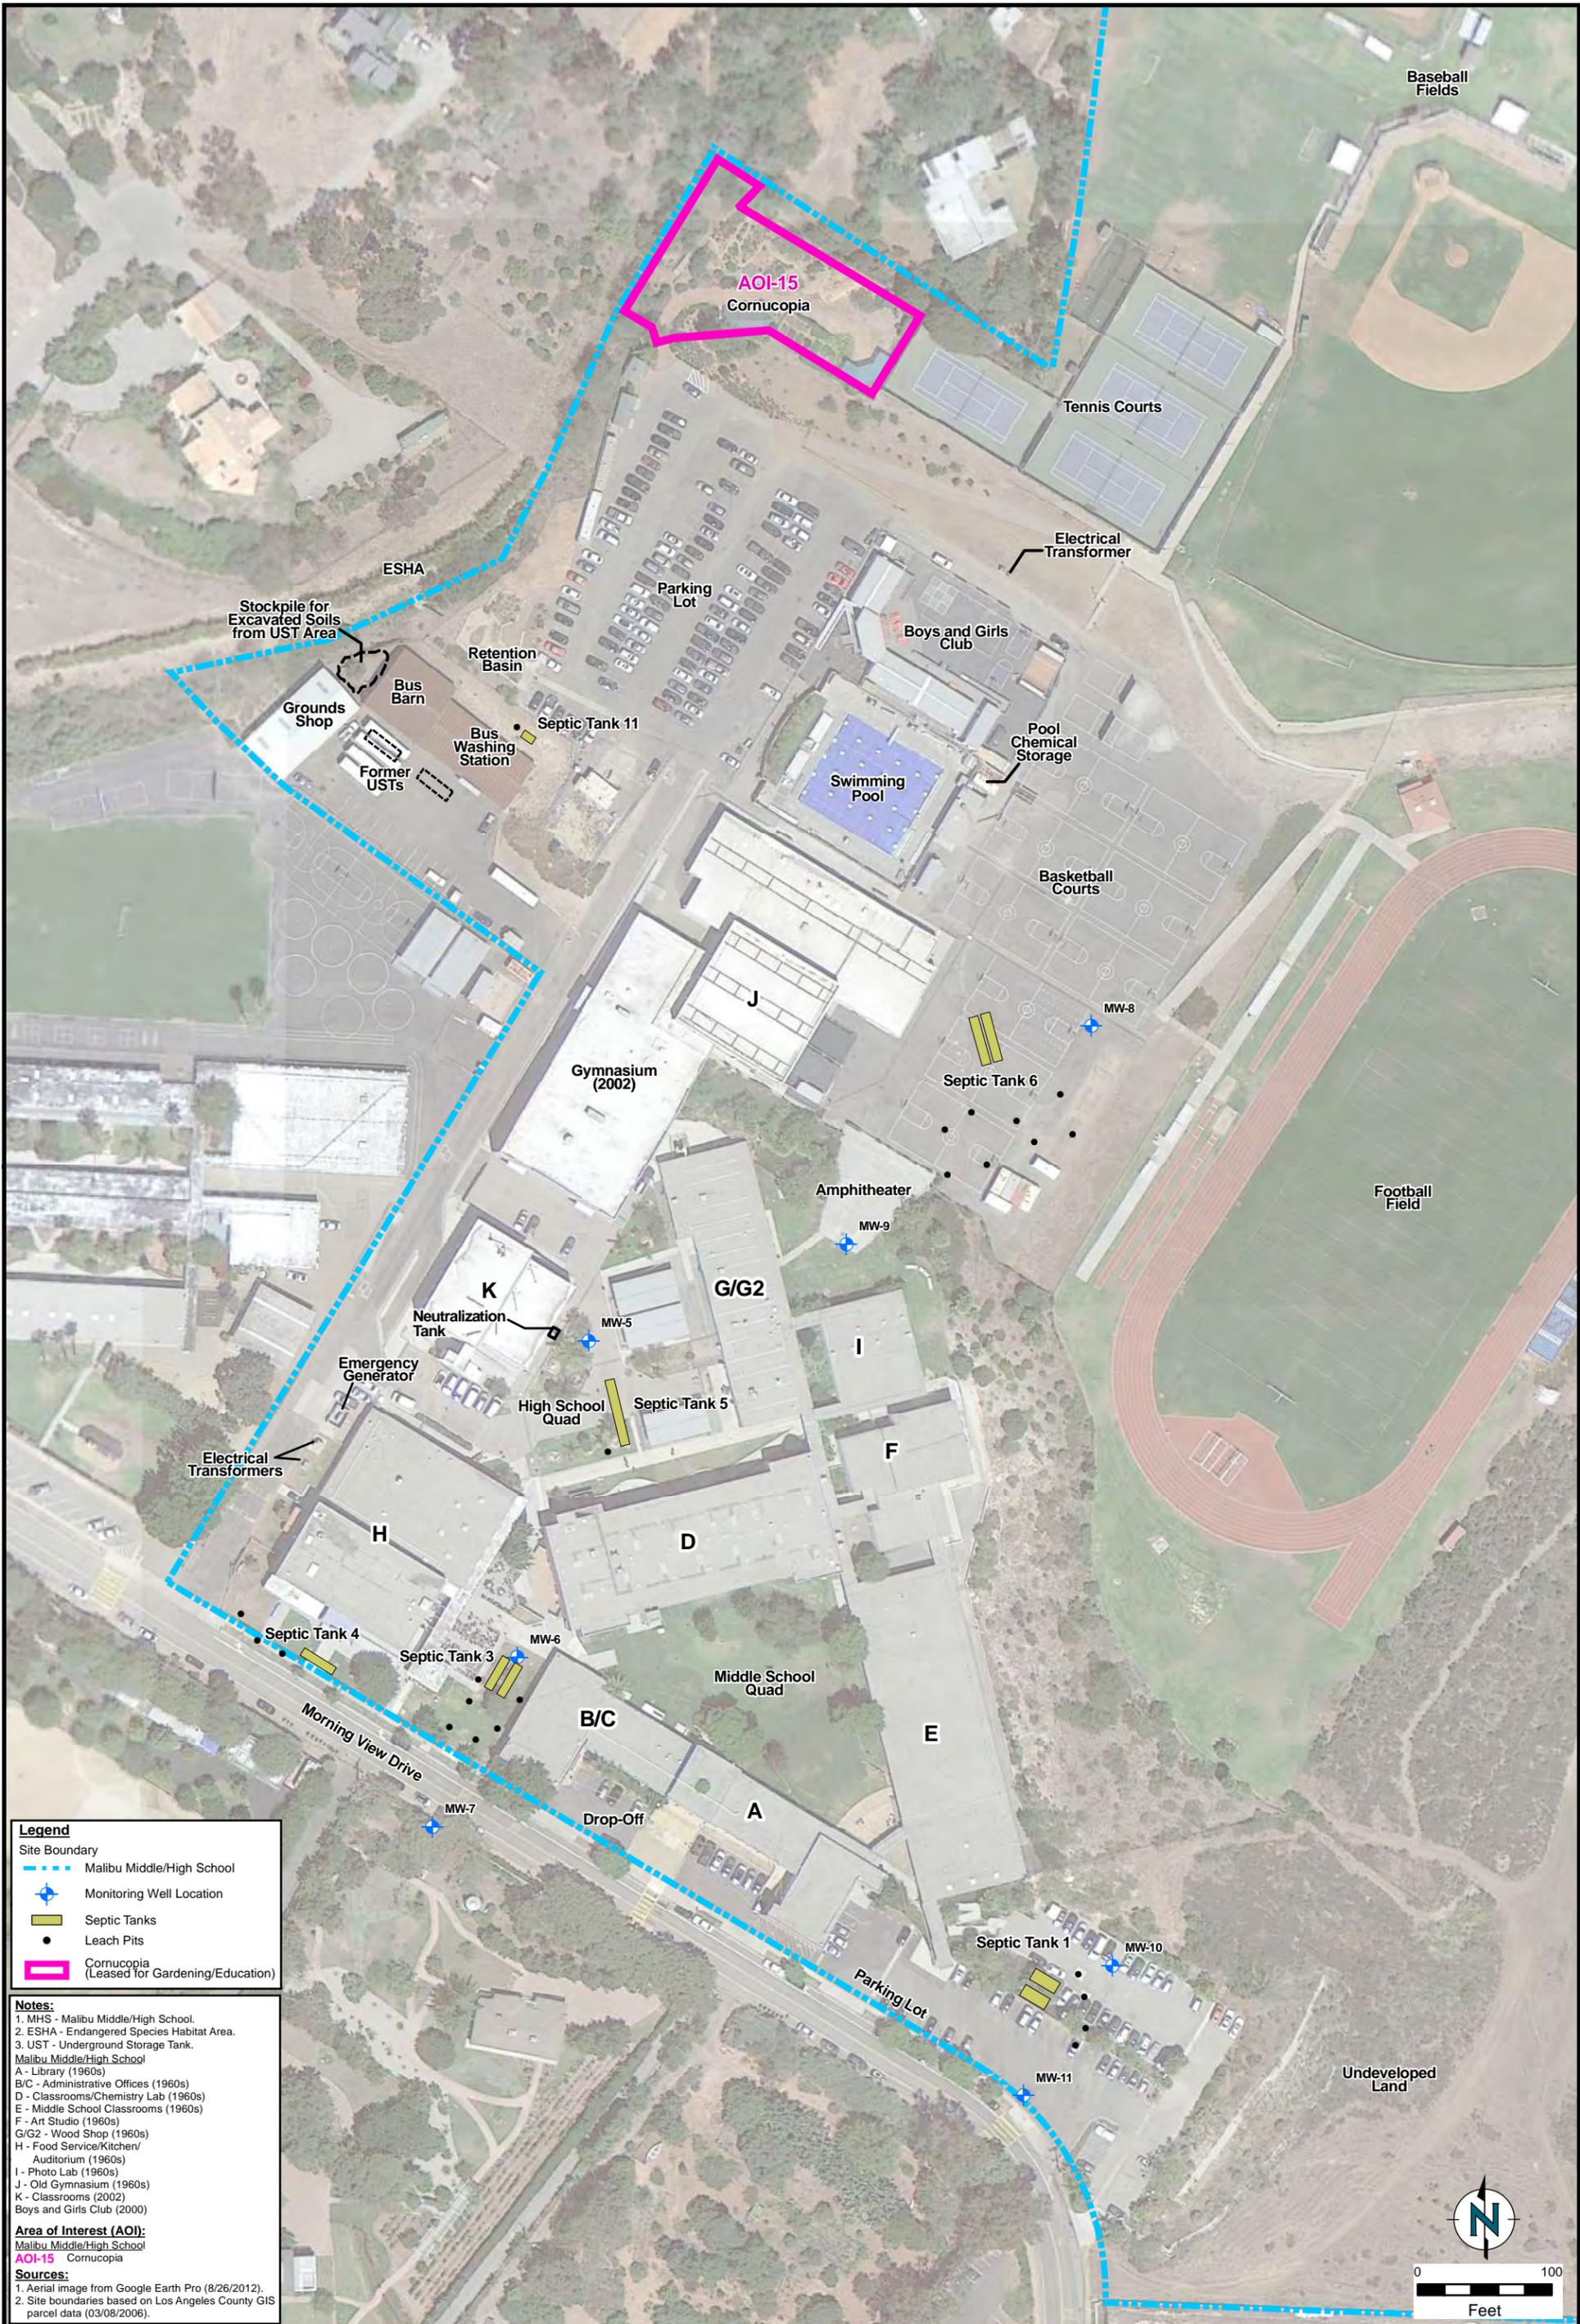
Path: Z:\01_Projects\Malibu High School\GIS\PEA Investigation\Figure 8 - MHS Detail - 2015-05-05.mxd

ENVIRON walked the entire school and observed both the exteriors and interiors of the buildings. Similarly to JCES, most buildings at MHS are bordered by an approximately 8- to 10-foot wide concrete walkway and a concrete and/or vinyl siding overhang. There are two main grassy areas: the Middle School Quad and the High School Quad, which are separated by Building D. An outdoor concrete amphitheater is located north of Building I and east of Building G. The basketball courts and the swimming pool are located north of the amphitheater, beyond which are the athletic fields (see Figure 8).

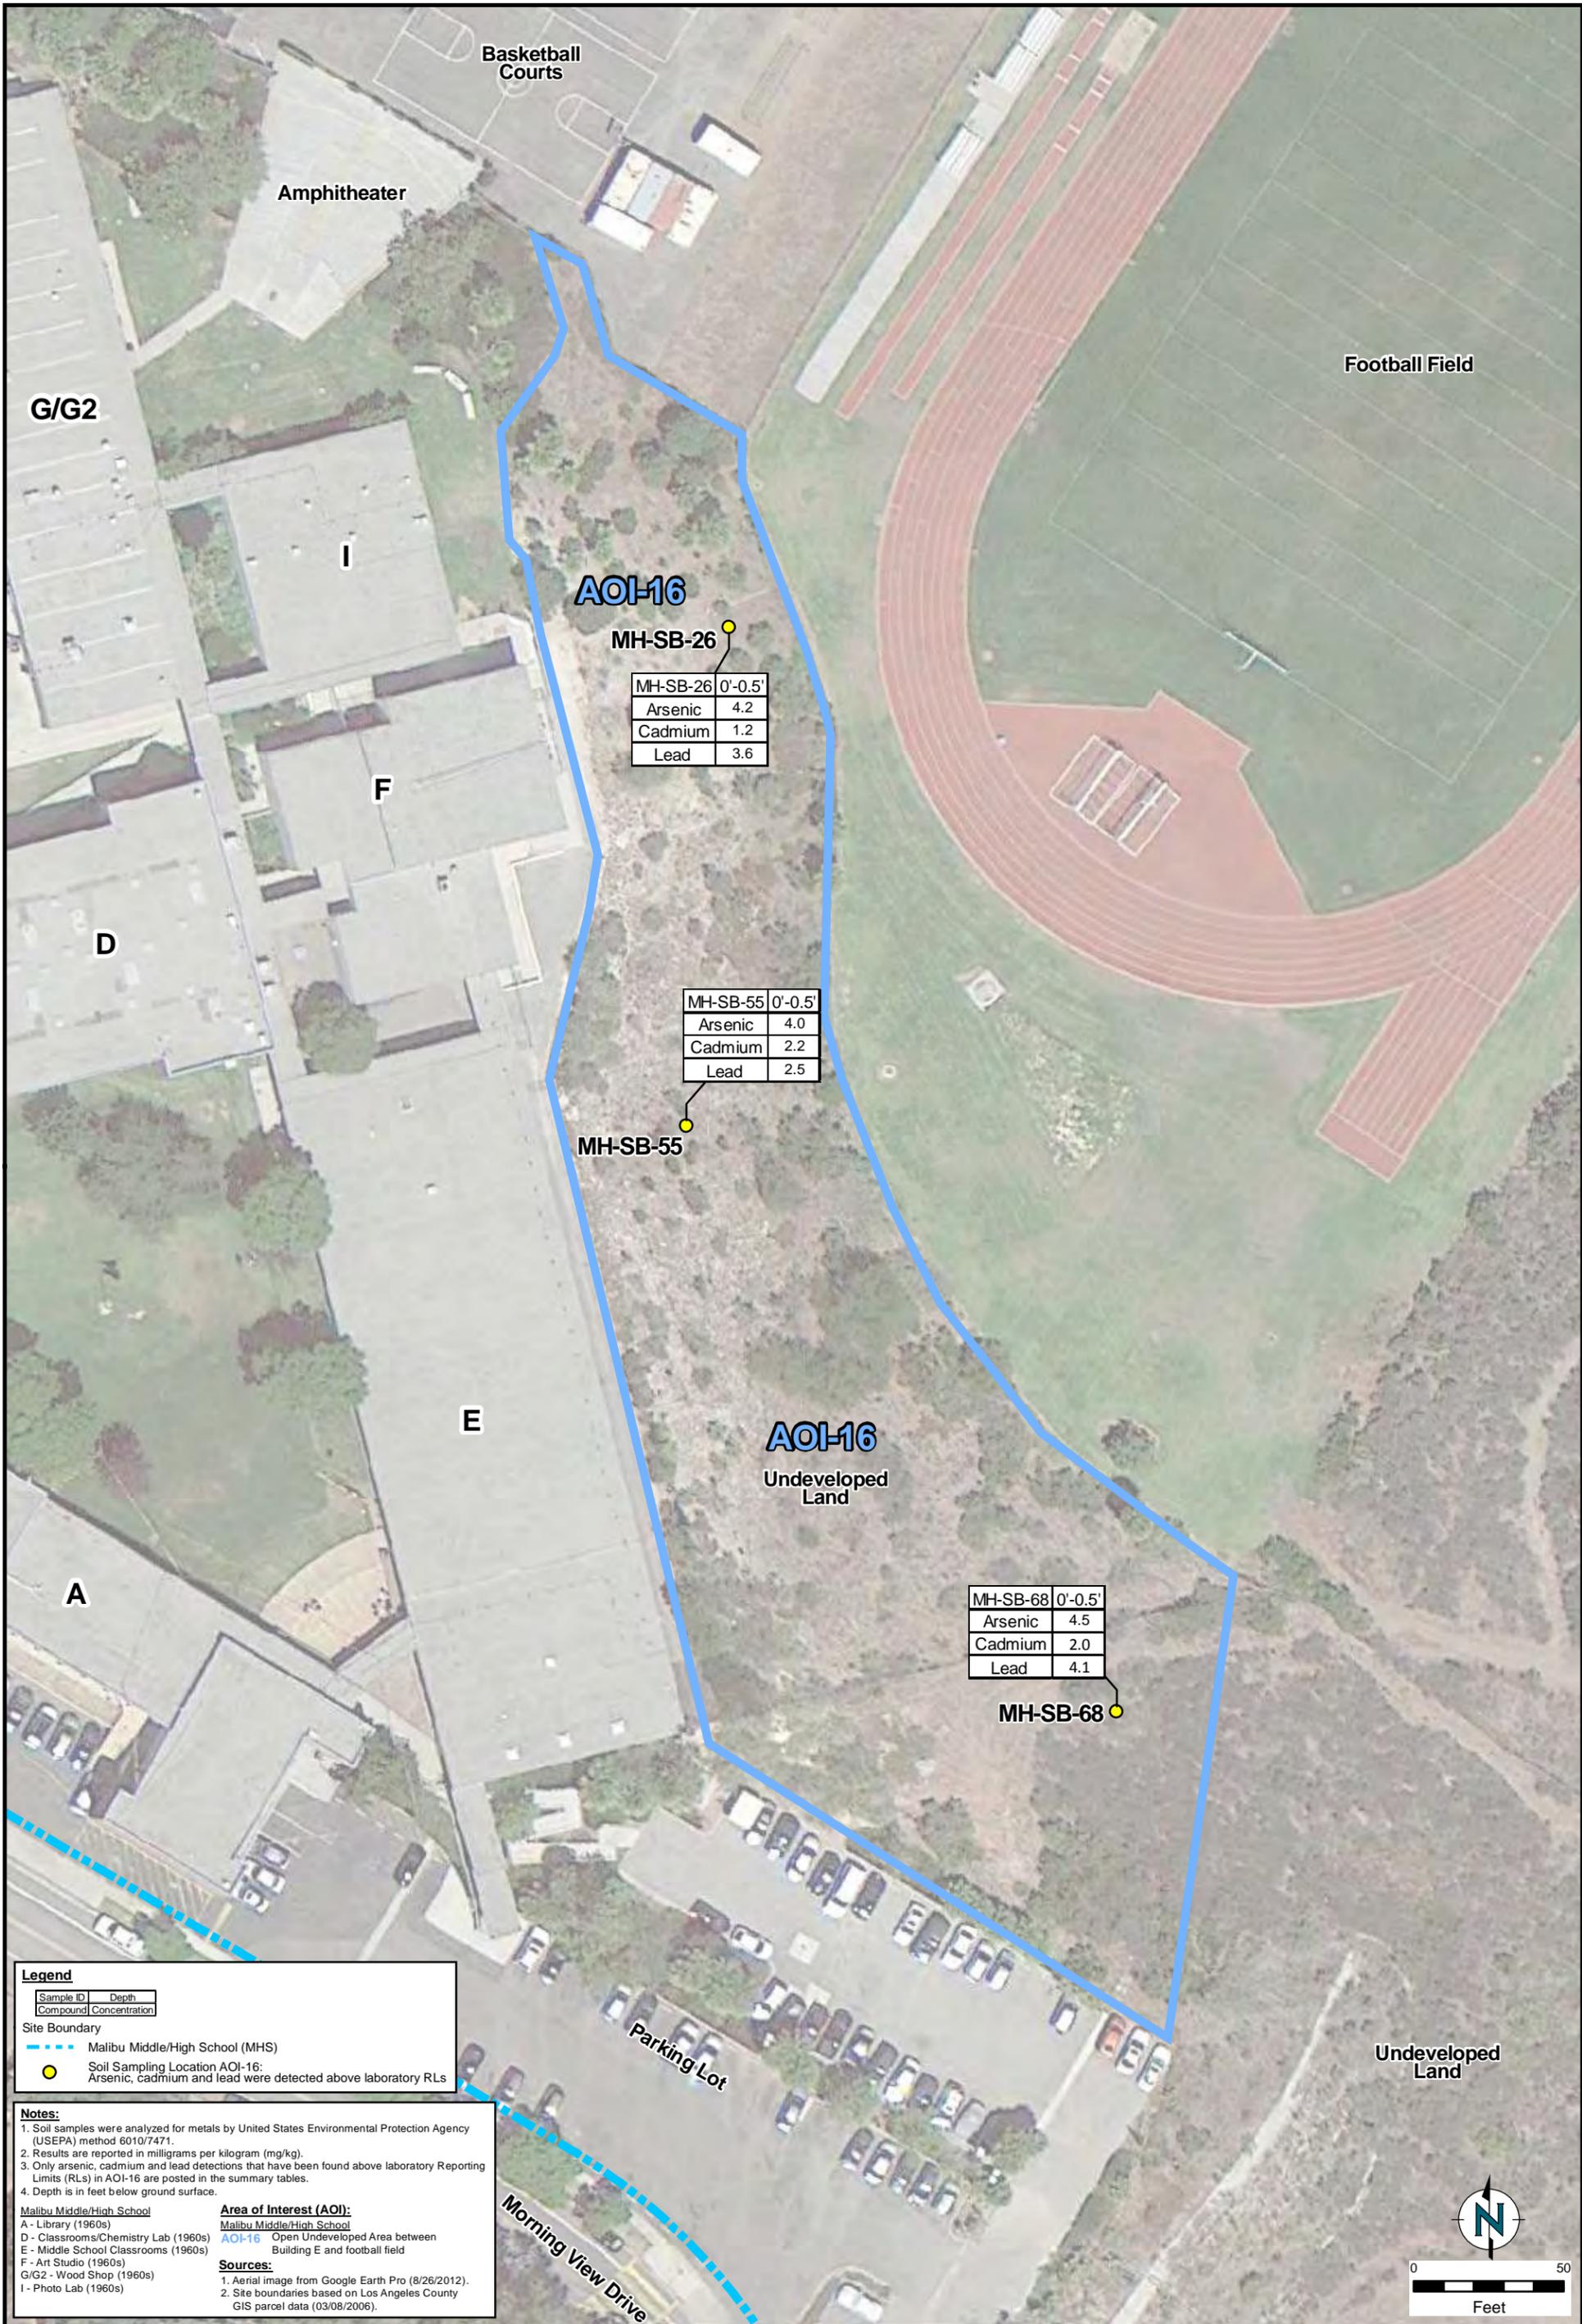
Path: Z:\01_Projects\Malibu High School\03_GIS\PEA Investigation\Figure 59 - Pesticides in Soil on MHS - AOI-16 - 2015-05-05.mxd

- Of the organochlorine pesticides, 4,4'-DDE was detected in one surface soil sample, MH-SB-55, at a concentration of 7.3 µg/kg. The 4,4-DDE detection is well below its USEPA residential RSL of 1,600 µg/kg. The organochlorine pesticide soil sampling results are presented in Table 18a and graphically depicted on Figure 59.
