Subject: Phase I Environmental Site Assessment
Jack Rabbit Trail, Beaumont, CA

Phase I Environmental Site Assessment Report

Jack Rabbit Trail,
Beaumont, CA

McAlister GeoScience
235 E. Broadway, Suite 1120
Long Beach, California 90802

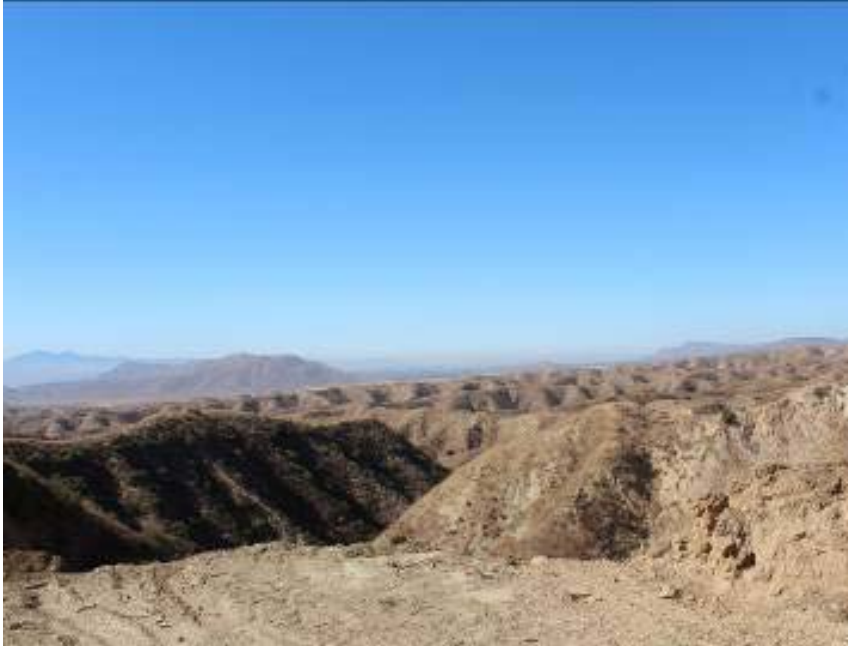
| <p>Photo: 7</p> <p>Description:</p> <p>Rolling hills and drainages on the Subject Property</p> <p>Orientation:</p> <p>Facing West</p> | |

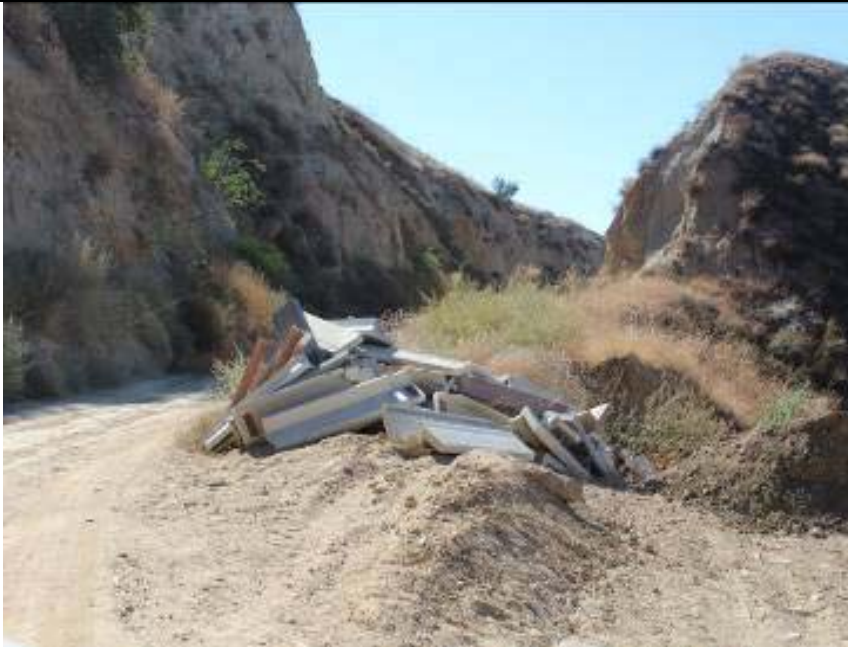
| <p>Photo: 8</p> <p>Description:</p> <p>Miscellaneous housing materials located off Jack Rabbit Trail on the eastern edge of the Subject Property.</p> <p>Orientation:</p> <p>Facing South.</p> | |

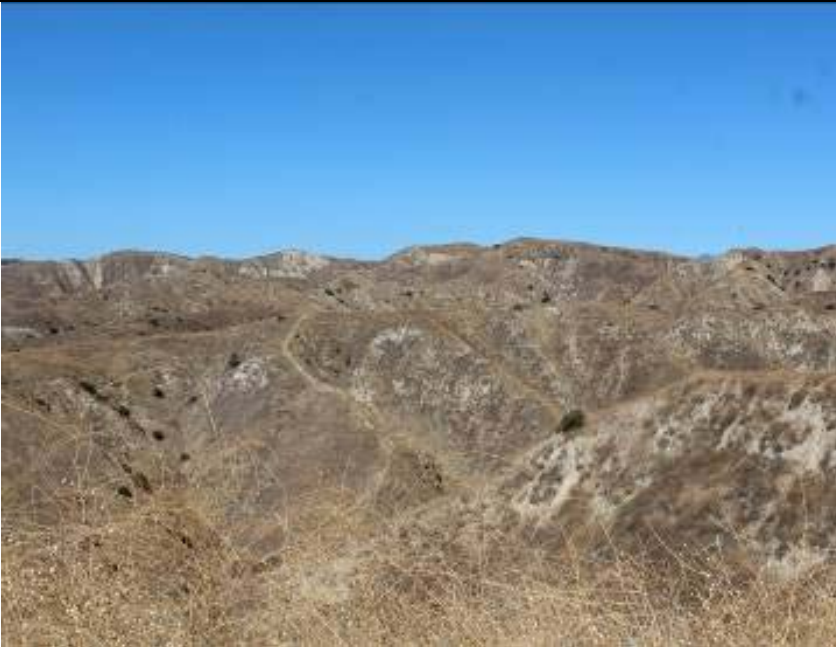
| <p>Photo: 10</p> <p>Description:</p> <p>Overview of Subject Property on the eastern edge showing steep slope hills and drainage patterns on the Subject Property.</p> <p>Orientation:</p> <p>Facing Northwest</p> | |

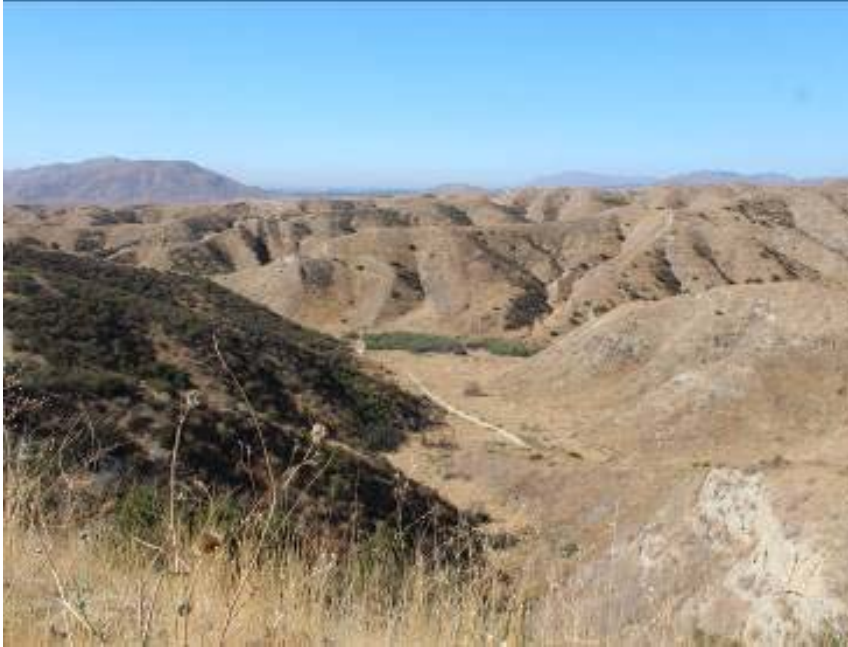
| <p>Photo: 13</p> <p>Description:</p> <p>Small canyon located on the southern edge of the Subject Property</p> <p>Orientation:</p> <p>Facing Down</p> | |

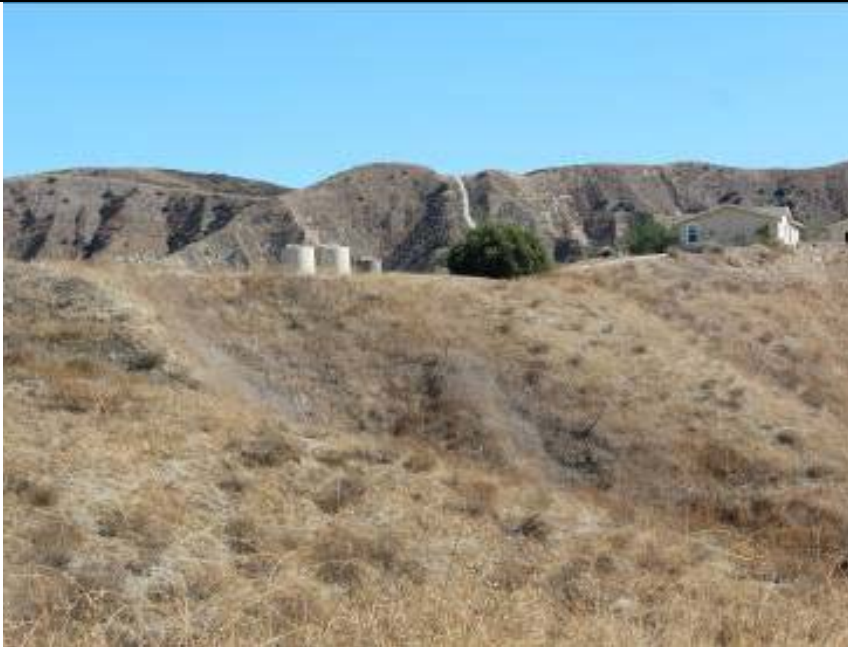
| <p>Photo: 14</p> <p>Description:</p> <p>Adjoining residential home with three Above Ground Storage Tanks, located across Jack Rabbit Trail.</p> <p>Orientation:</p> <p>Facing Northeast</p> | |

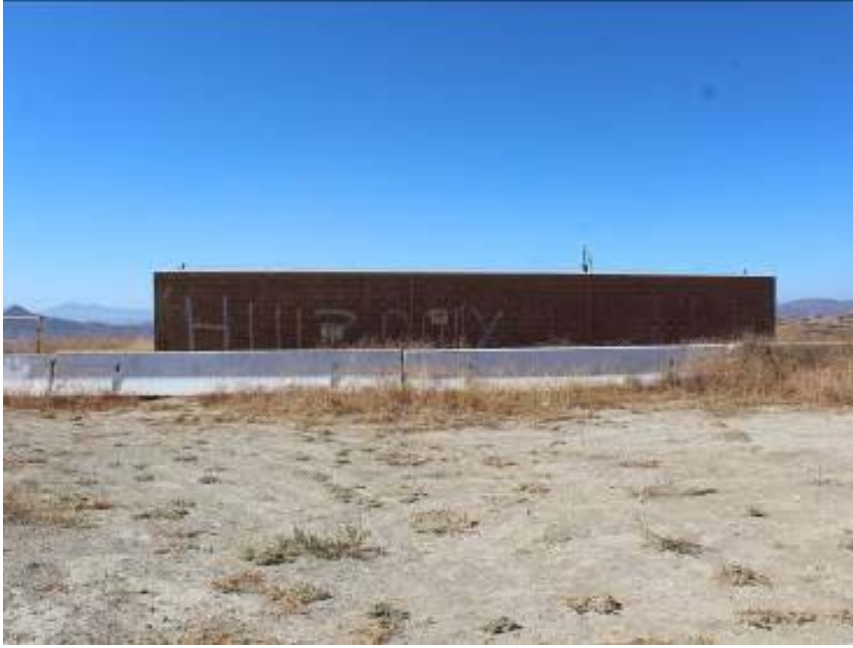
| <p>Photo: 15</p> <p>Description:</p> <p>Gas pipeline enclosure located adjoining the Subject Property on the southeast.</p> <p>Orientation:</p> <p>Facing Southwest</p> | |
