APPENDIX A

NOTICE OF PREPARATION AND RESPONSES TO NOTICE OF PREPARATION

Project Title: Mid-Valley Shopping Center (PLN190140)

Mid-Valley Shopping Center Design Approval EIR Notice of Preparation

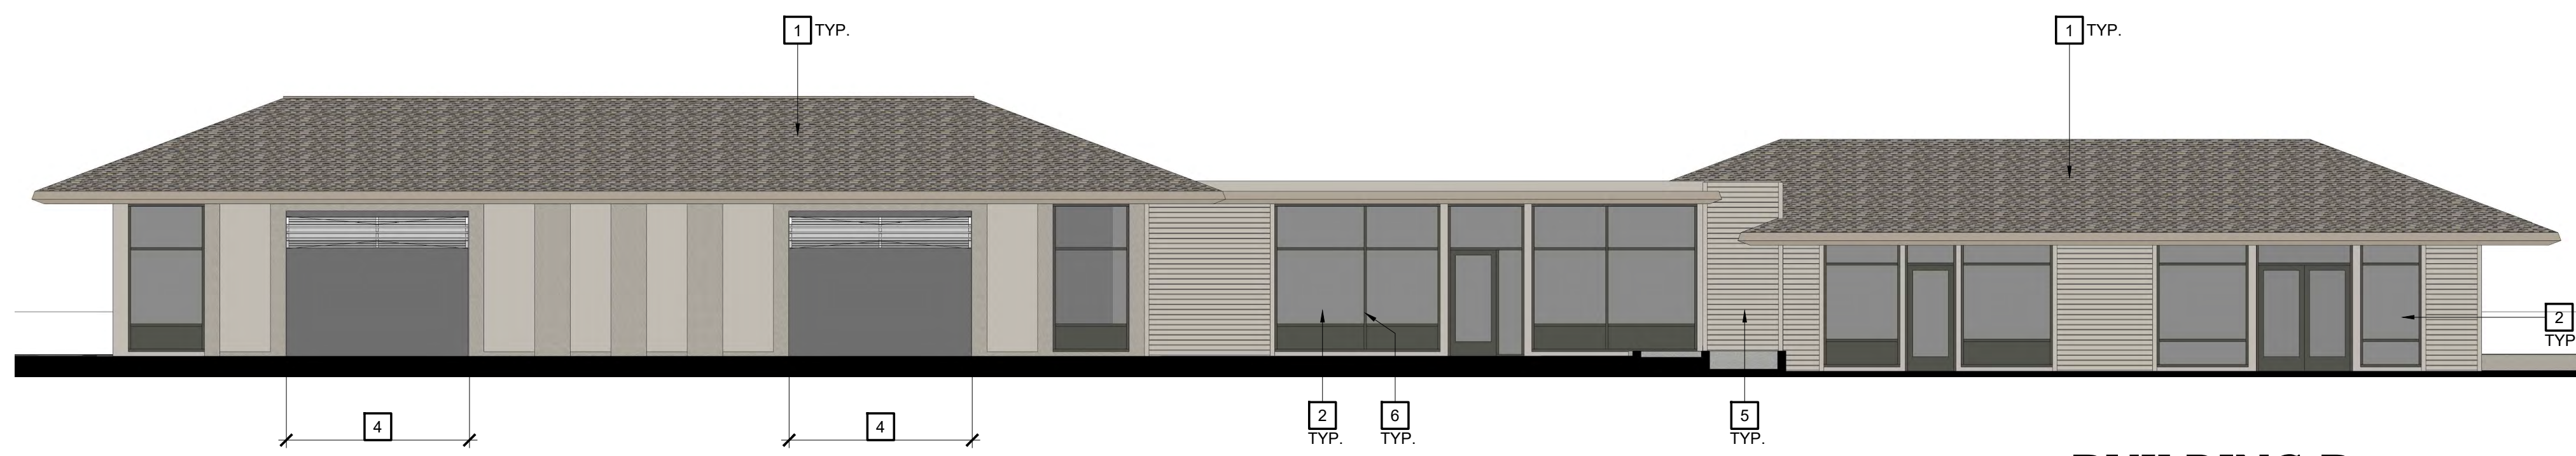
**BUILDING B
EXTERIOR ELEVATION**
SCALE: 1/8"=1'-0"

- 1 INDICATES EXISTING ROOF TO REMAIN. CONTRACTOR TO PROTECT FROM DAMAGE.
- 2 INDICATES EXISTING STOREFRONT GLAZING TO REMAIN. CONTRACTOR TO PROTECT FROM DAMAGE.

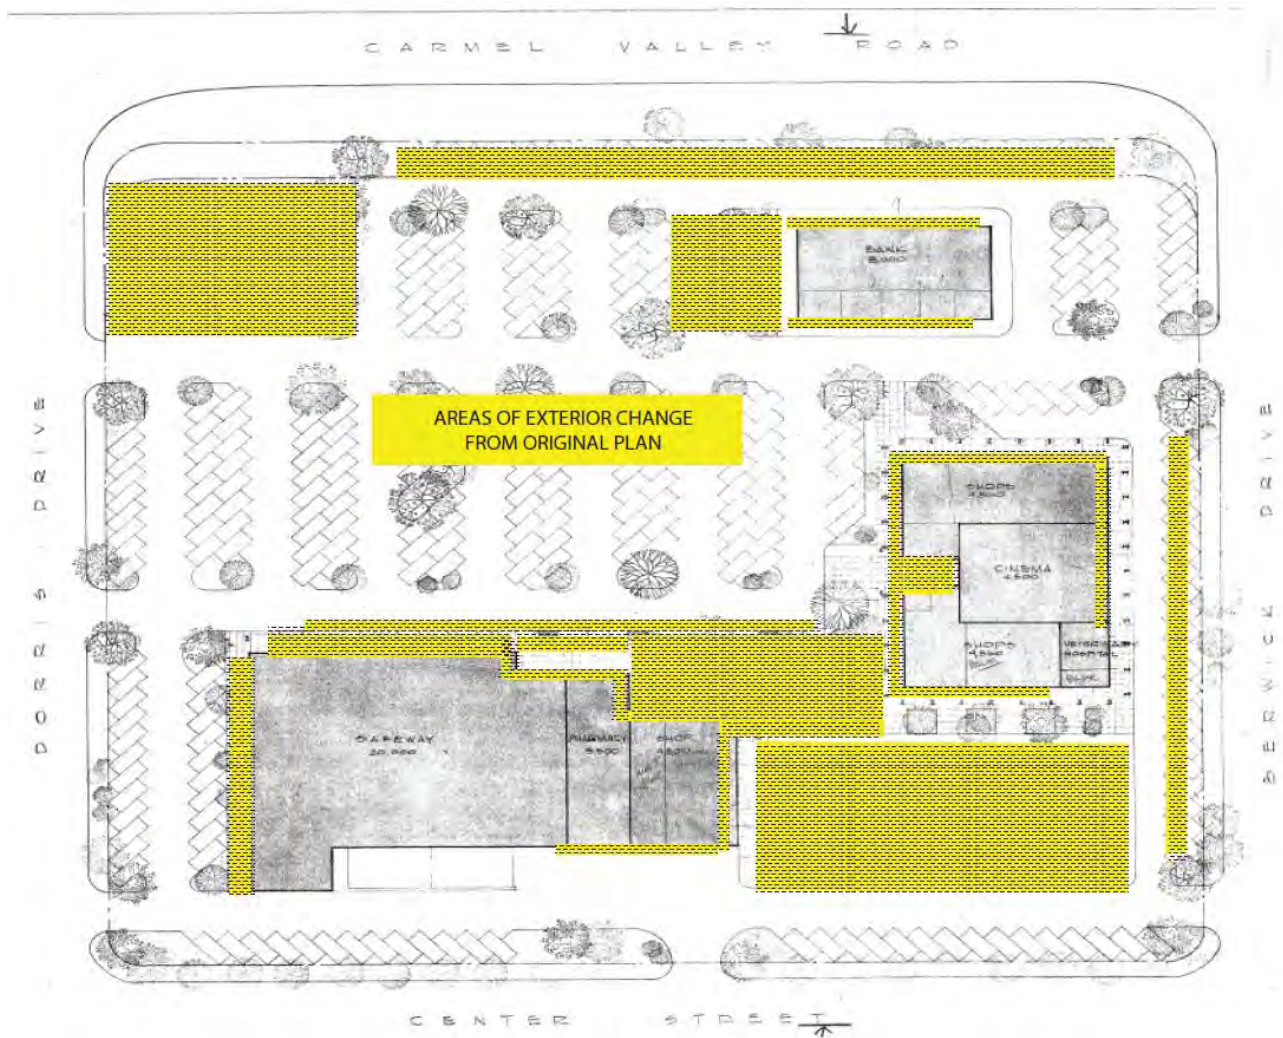
Figure 2: Integrity Exhibit

Alterations to exterior elevations and landscaping have altered nearly every feature on the original plan. See Figure 2, and the detailed analysis of buildings below.

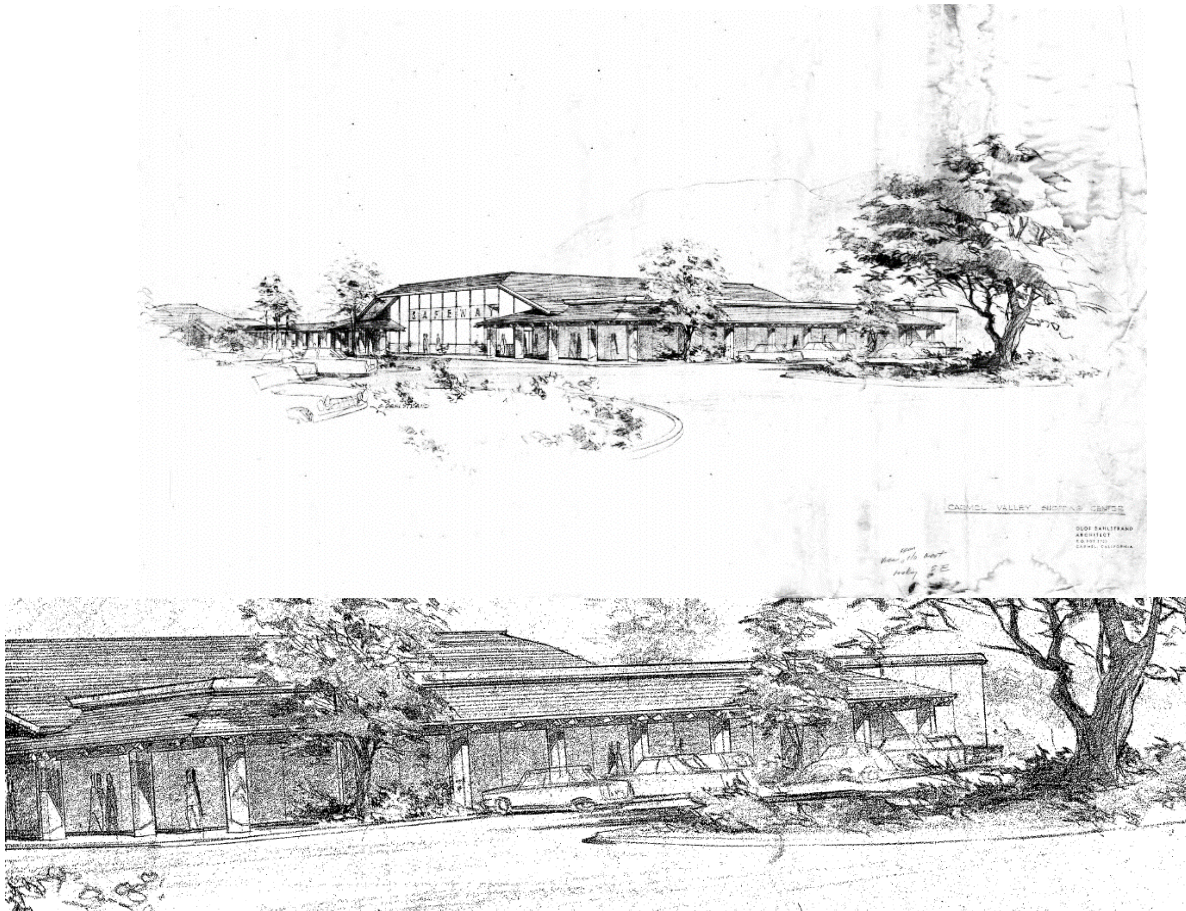
Figure 3. Two renderings of northwest corner of Safeway store, by Olaf Dahlstrand, 1965

Dahlstrand's original design for the front of the Safeway store called for a glass curtain wall extending from the eaves to a narrow strip of "glasweld" fiber cement panels at ground level. "SAFEGWAY" was written in neon cut-out letters (backed with fire-proof glasweld) mounted to the glass. The 1965 design drawings also show a stepped roof and covered arcade wrapping the west side of the store facing Dorris Drive. The effect was a central "lantern" of a glowing glass storefront framed by the low covered arcades sheltering visitors and inviting respite (Figure 3).

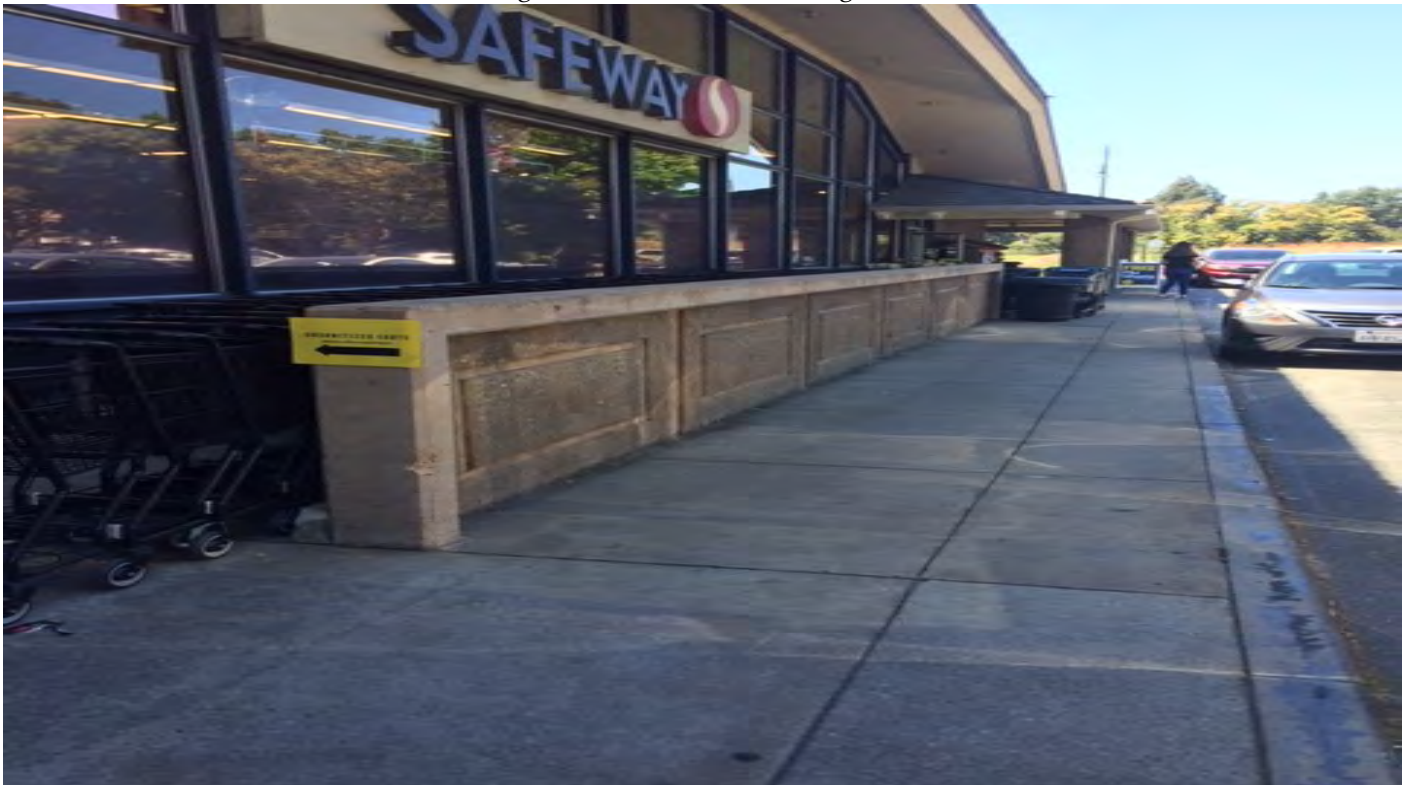
Figure 5. Concrete wall obscuring front elevation

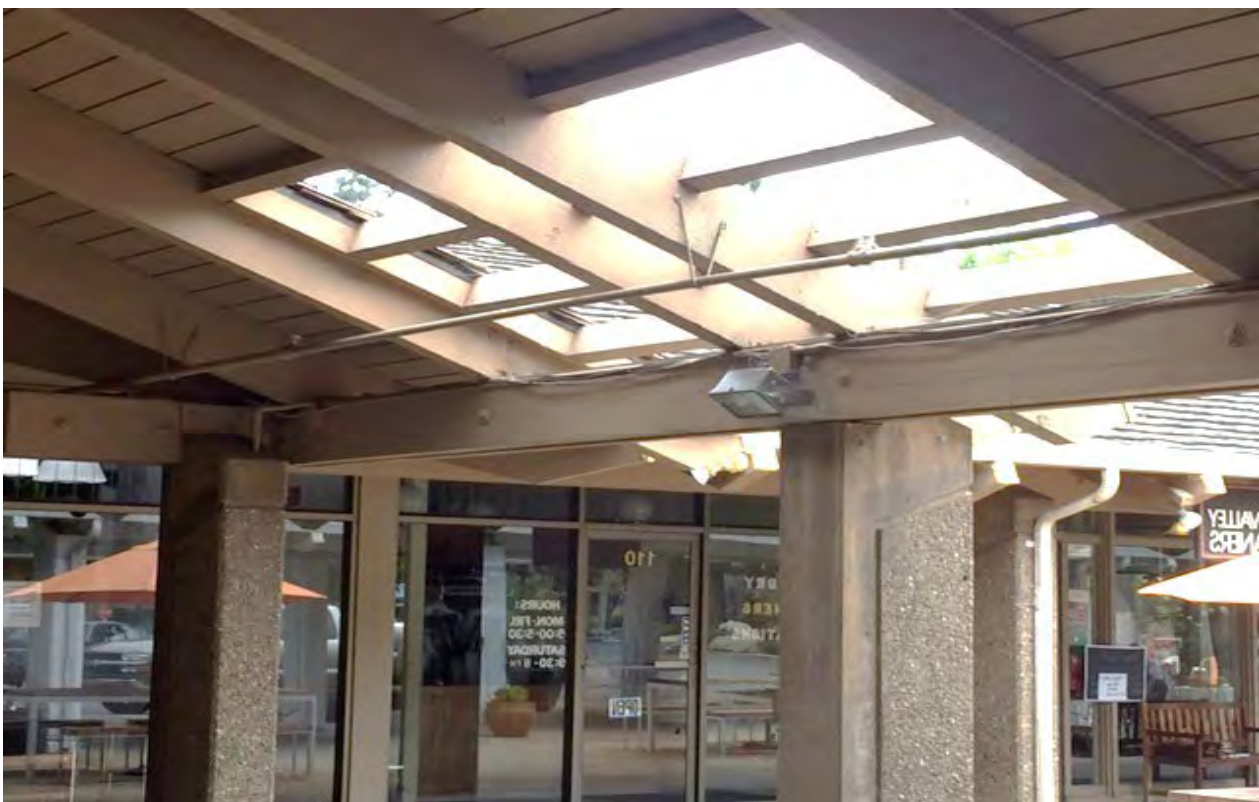
alterations include the partial infill of the glass curtain wall at the eastern entrance to the store (Figure 6), removal of portions of the arcade roof, and painting over of stained wood surfaces (Figure 7).

Figure 7. Removal of portion of arcade roof; painted-over stained wood surfaces

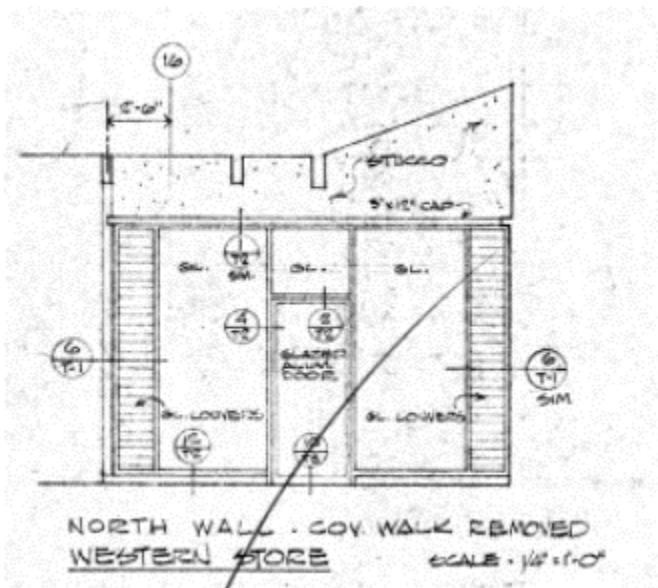
The rear-most section of this building was designed as a retail shop with a glass storefront, terminating in wood panels at the eaves. It now houses a dentist’s office and a café. This area is shown as glass storefront windows, framed in bronze metal, with clay block at the two edges and stucco above the glass on the original plans.

Figure 11. North elevation of Shop

The glass storefront windows have been replaced in an altered configuration, framed in silver aluminum. The stucco and clay block have been removed (Figure 11). This storefront has lost integrity of design, materials and workmanship.

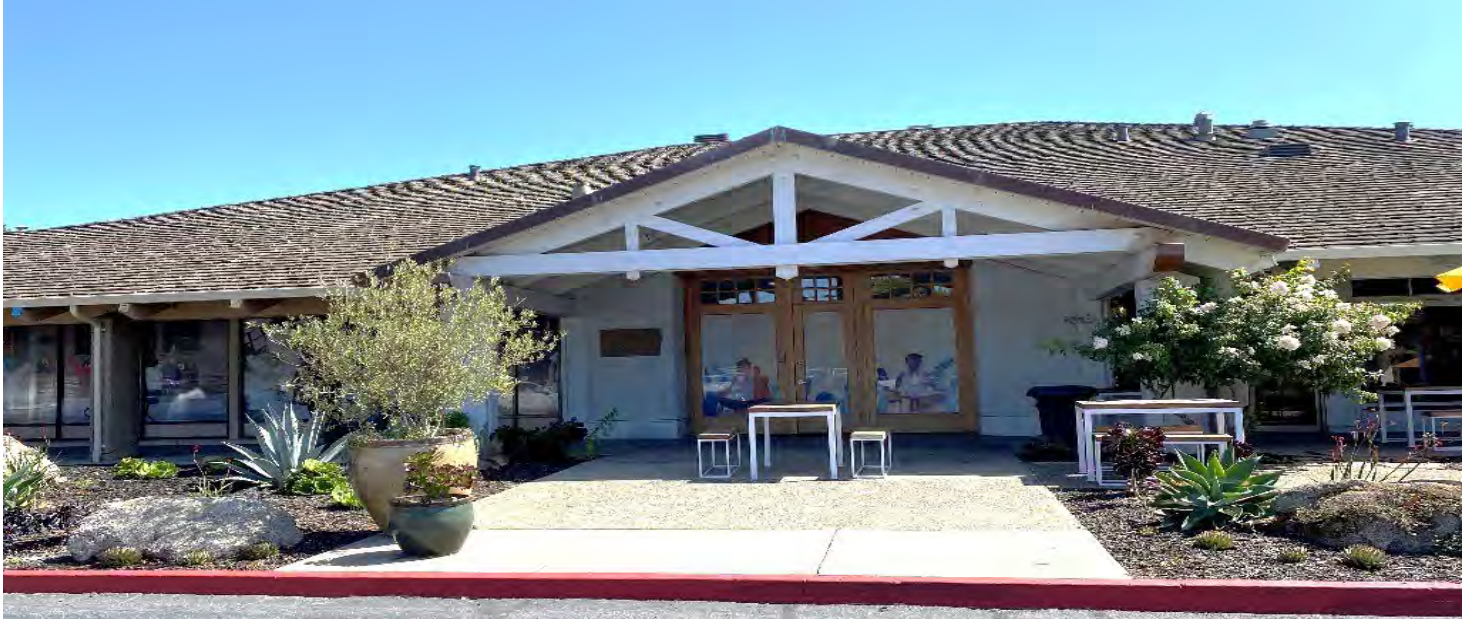
Figure 14. Cinema Building front in October 2020

The cinema closed in 1993 and the high central mass of the former cinema was split into two new tenant spaces: a skincare salon in the front and a self-storage facility in the back. A decorative truss has been added at the front of the gable (Figure 14). The former entrance to the cinema was entirely rebuilt: the recessed entrance was brought forward, the metal framed lobby doors were removed and new varnished birch framed doors were installed (Figure 16). The brown integrally colored concrete walls have been painted white and the decorative accents at the peak of the roof (stained redwood framing off-white inset panels) have been replaced with varnished vertical douglas fir. These alterations are a loss of integrity of design, workmanship, and materials.

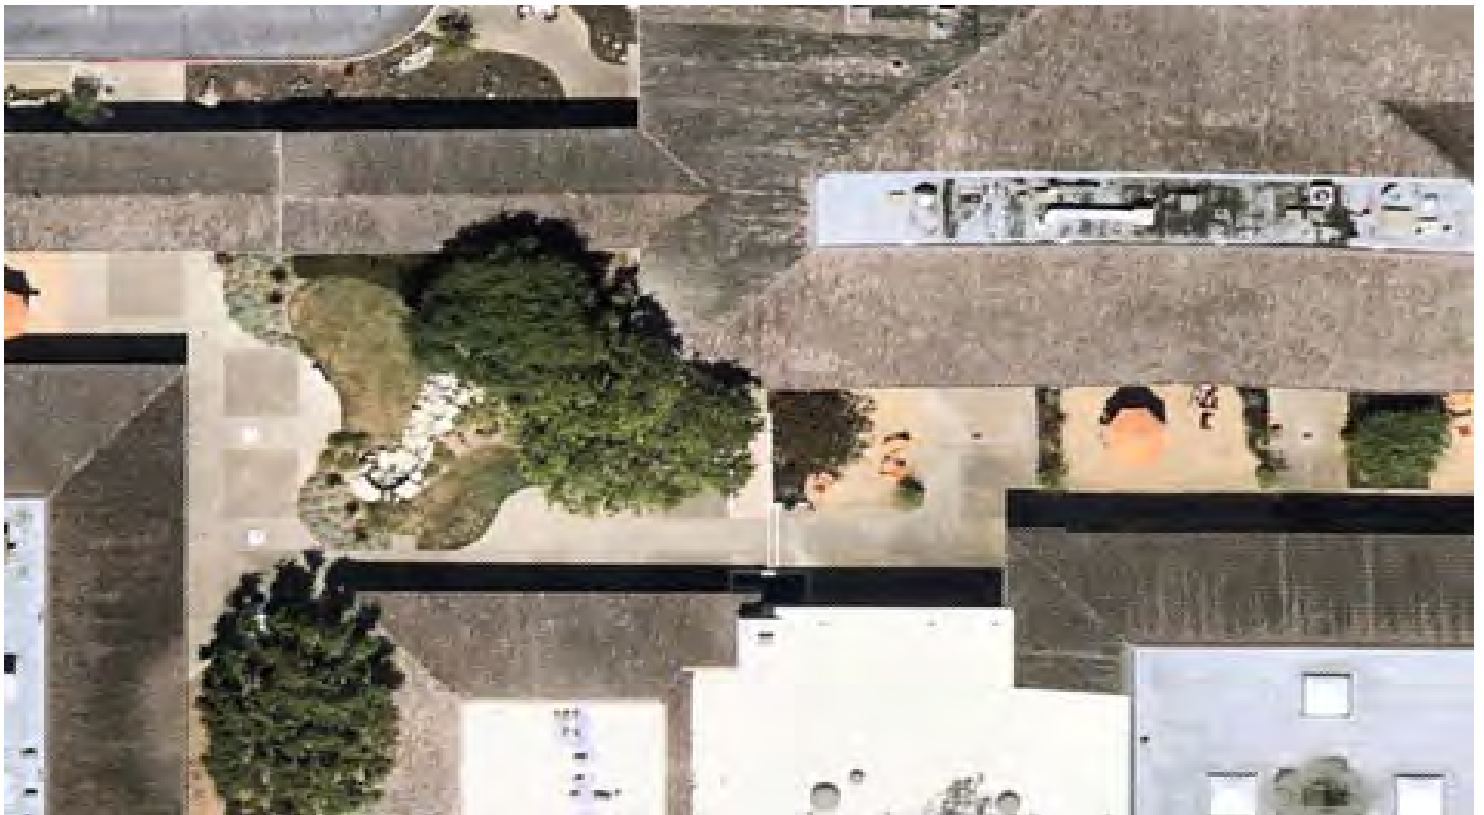
During the mid 1990's the Central Courtyard went through a second dramatic demolition and reconstruction into a new design. An elaborate water feature was constructed and newly installed grass areas, planters and modified concrete features were built removing many of the angular features of the original design, plantings and orientation and replacing them with soft curves, and flowing lines. Square planting beds were reduced in size to expand hardscape (Figure 19).

Figure 19. Existing conditions, 2020

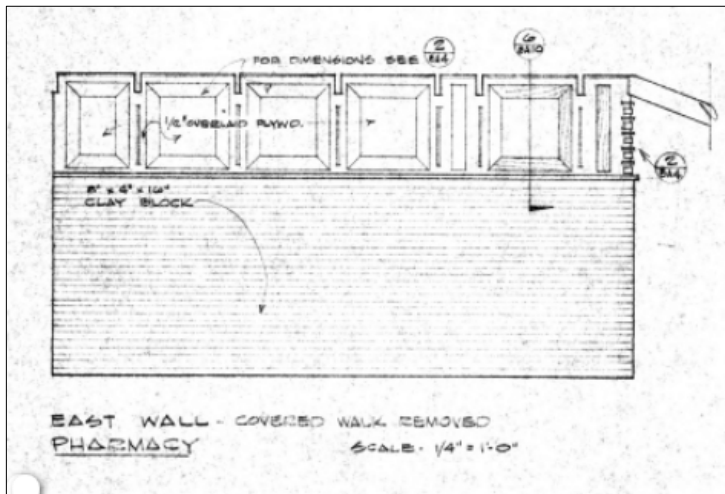
Figure 21. Olof Dahlstrand, Detail of the clerestory windows and clay-block, Steinmetz Pharmacy, Building 1, 22 October 1965. *Courtesy The Stanley Group.*
