# BIOLOGICAL RESOURCES REPORT

## YORBA LINDA BOULEVARD WIDENING PROJECT CITY OF YORBA LINDA, CALIFORNIA

LSA Project No. HNT1901.02

September 2020

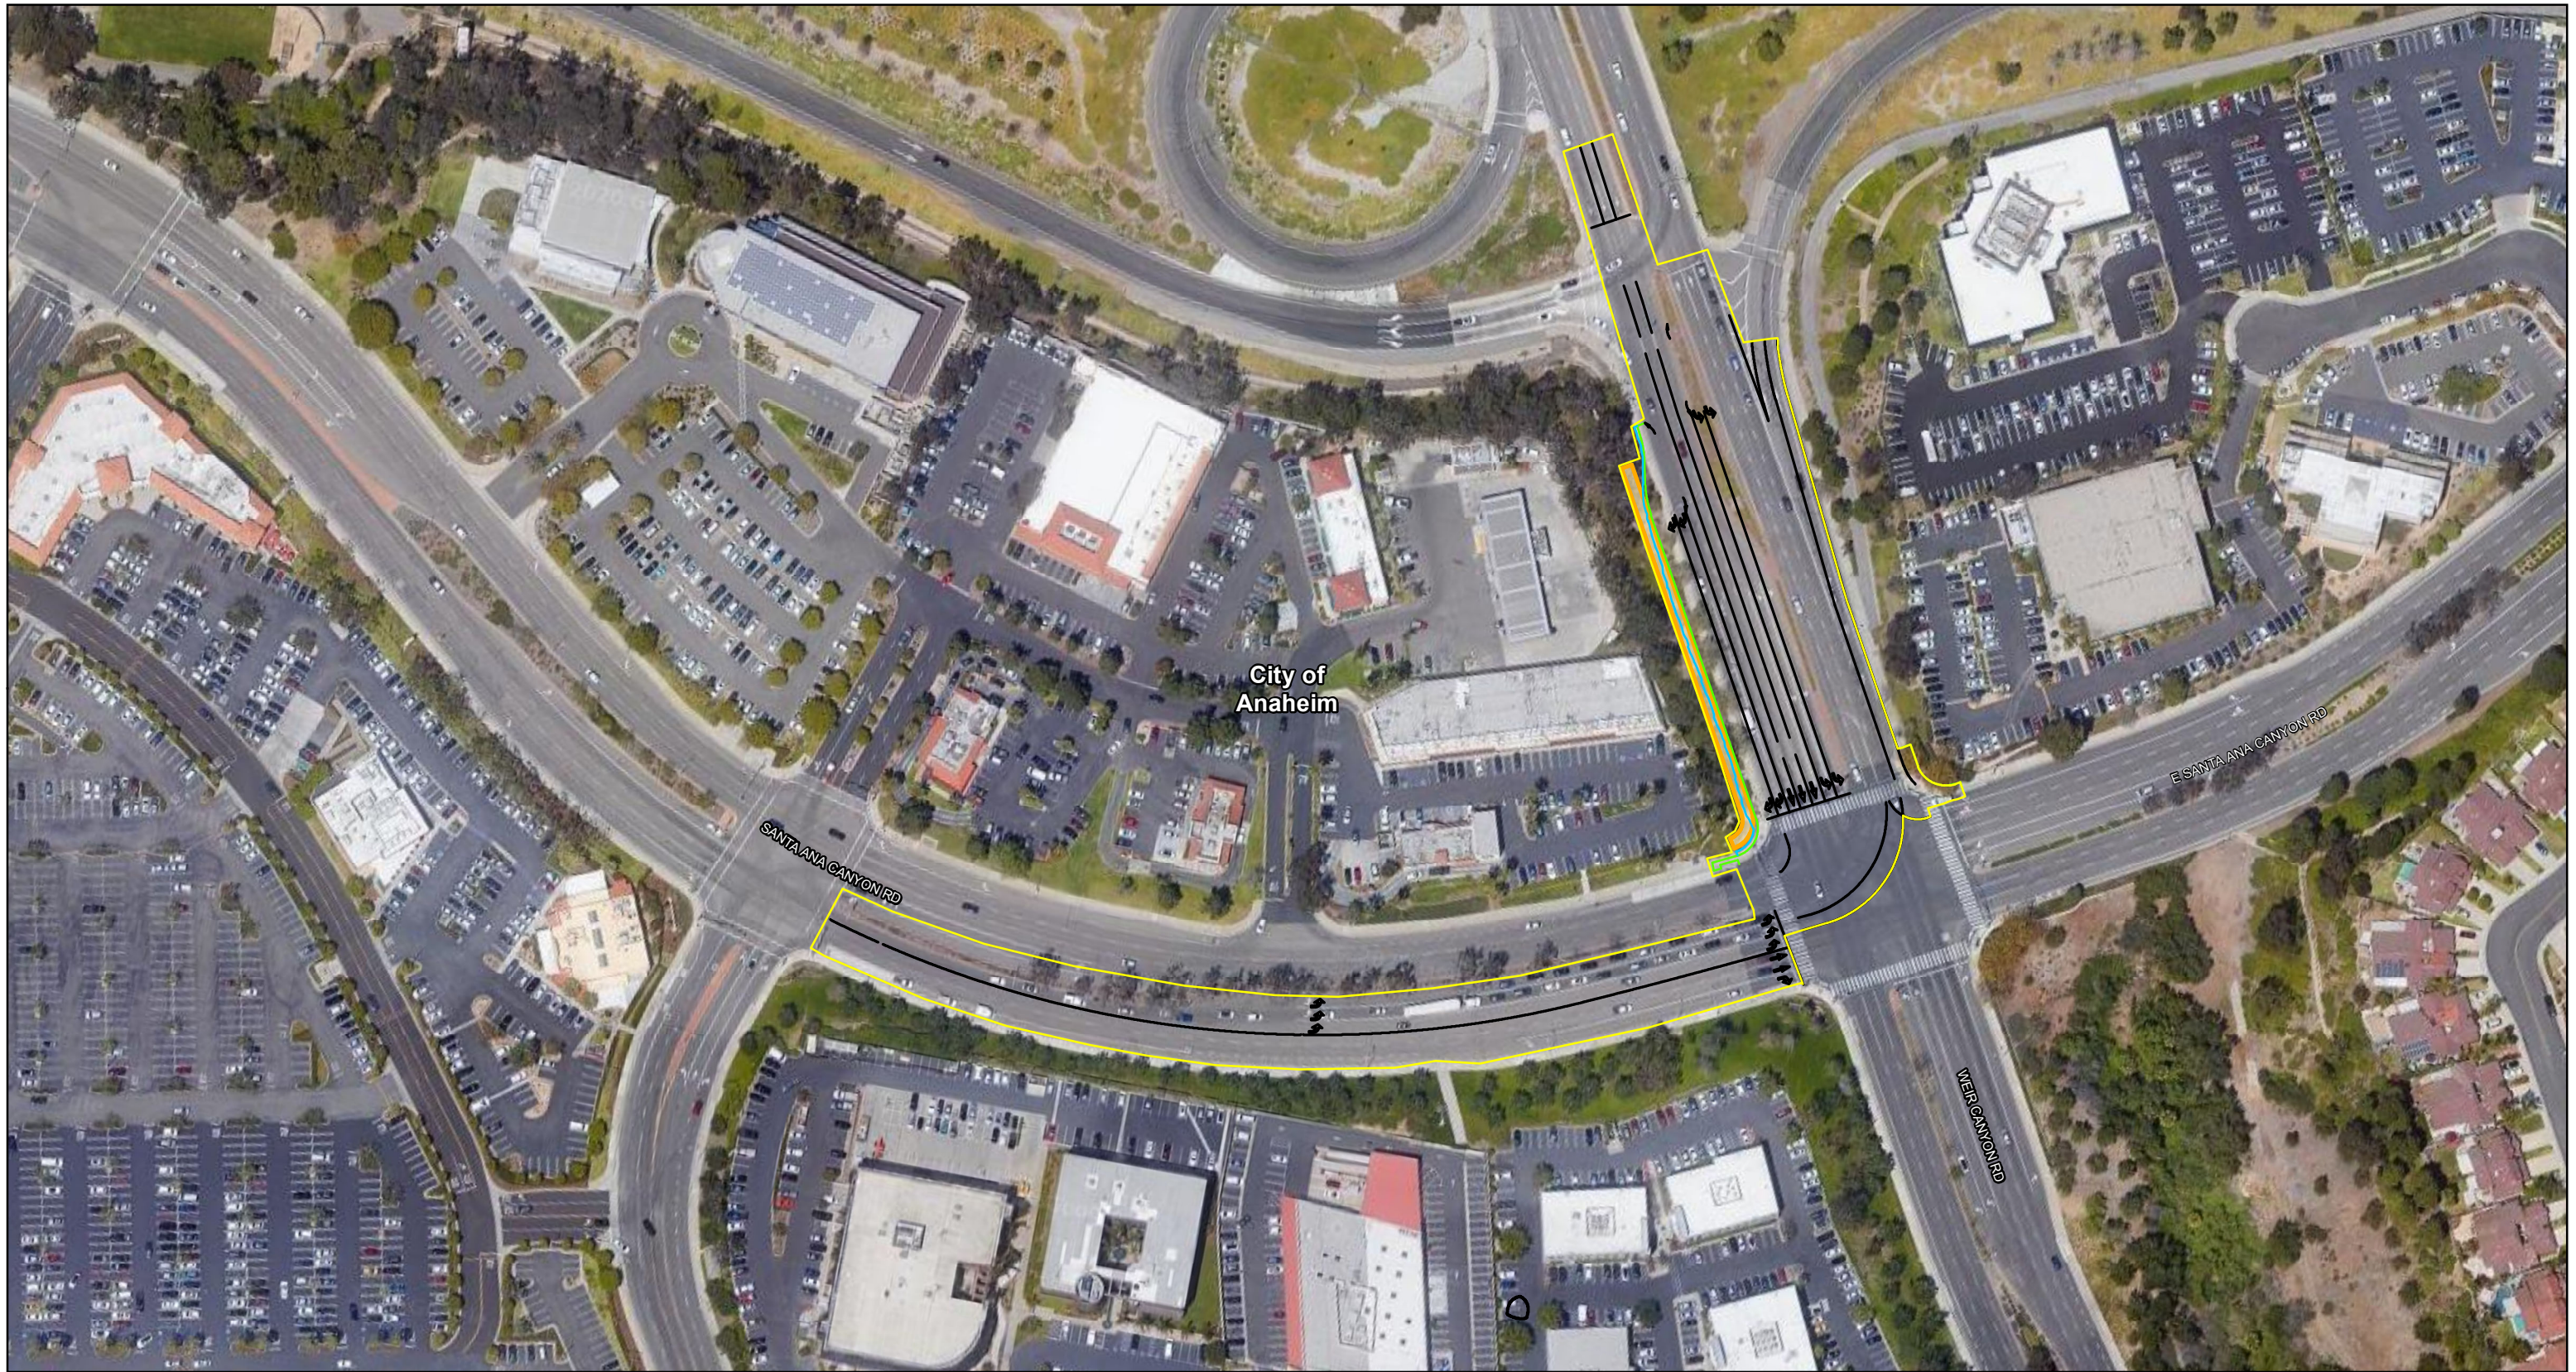
FIGURE 2  
Sheet 1 of 4

Yorba Linda Boulevard Widening Project  
Project Features

The City of Yorba Linda (City), as the Lead Agency under CEQA, in cooperation with the City of Anaheim, is proposing roadway improvements along Yorba Linda Boulevard as well as bicycle and pedestrian improvements along La Palma Avenue and Yorba Linda Boulevard. The proposed project would improve corridor operations and provide additional storage for turning movements, as the intersections within the proposed project limits have inadequate vehicle storage due to short turn pocket lengths. The proposed project limits and proposed improvements are shown in Figure 2 and described in further detail below.

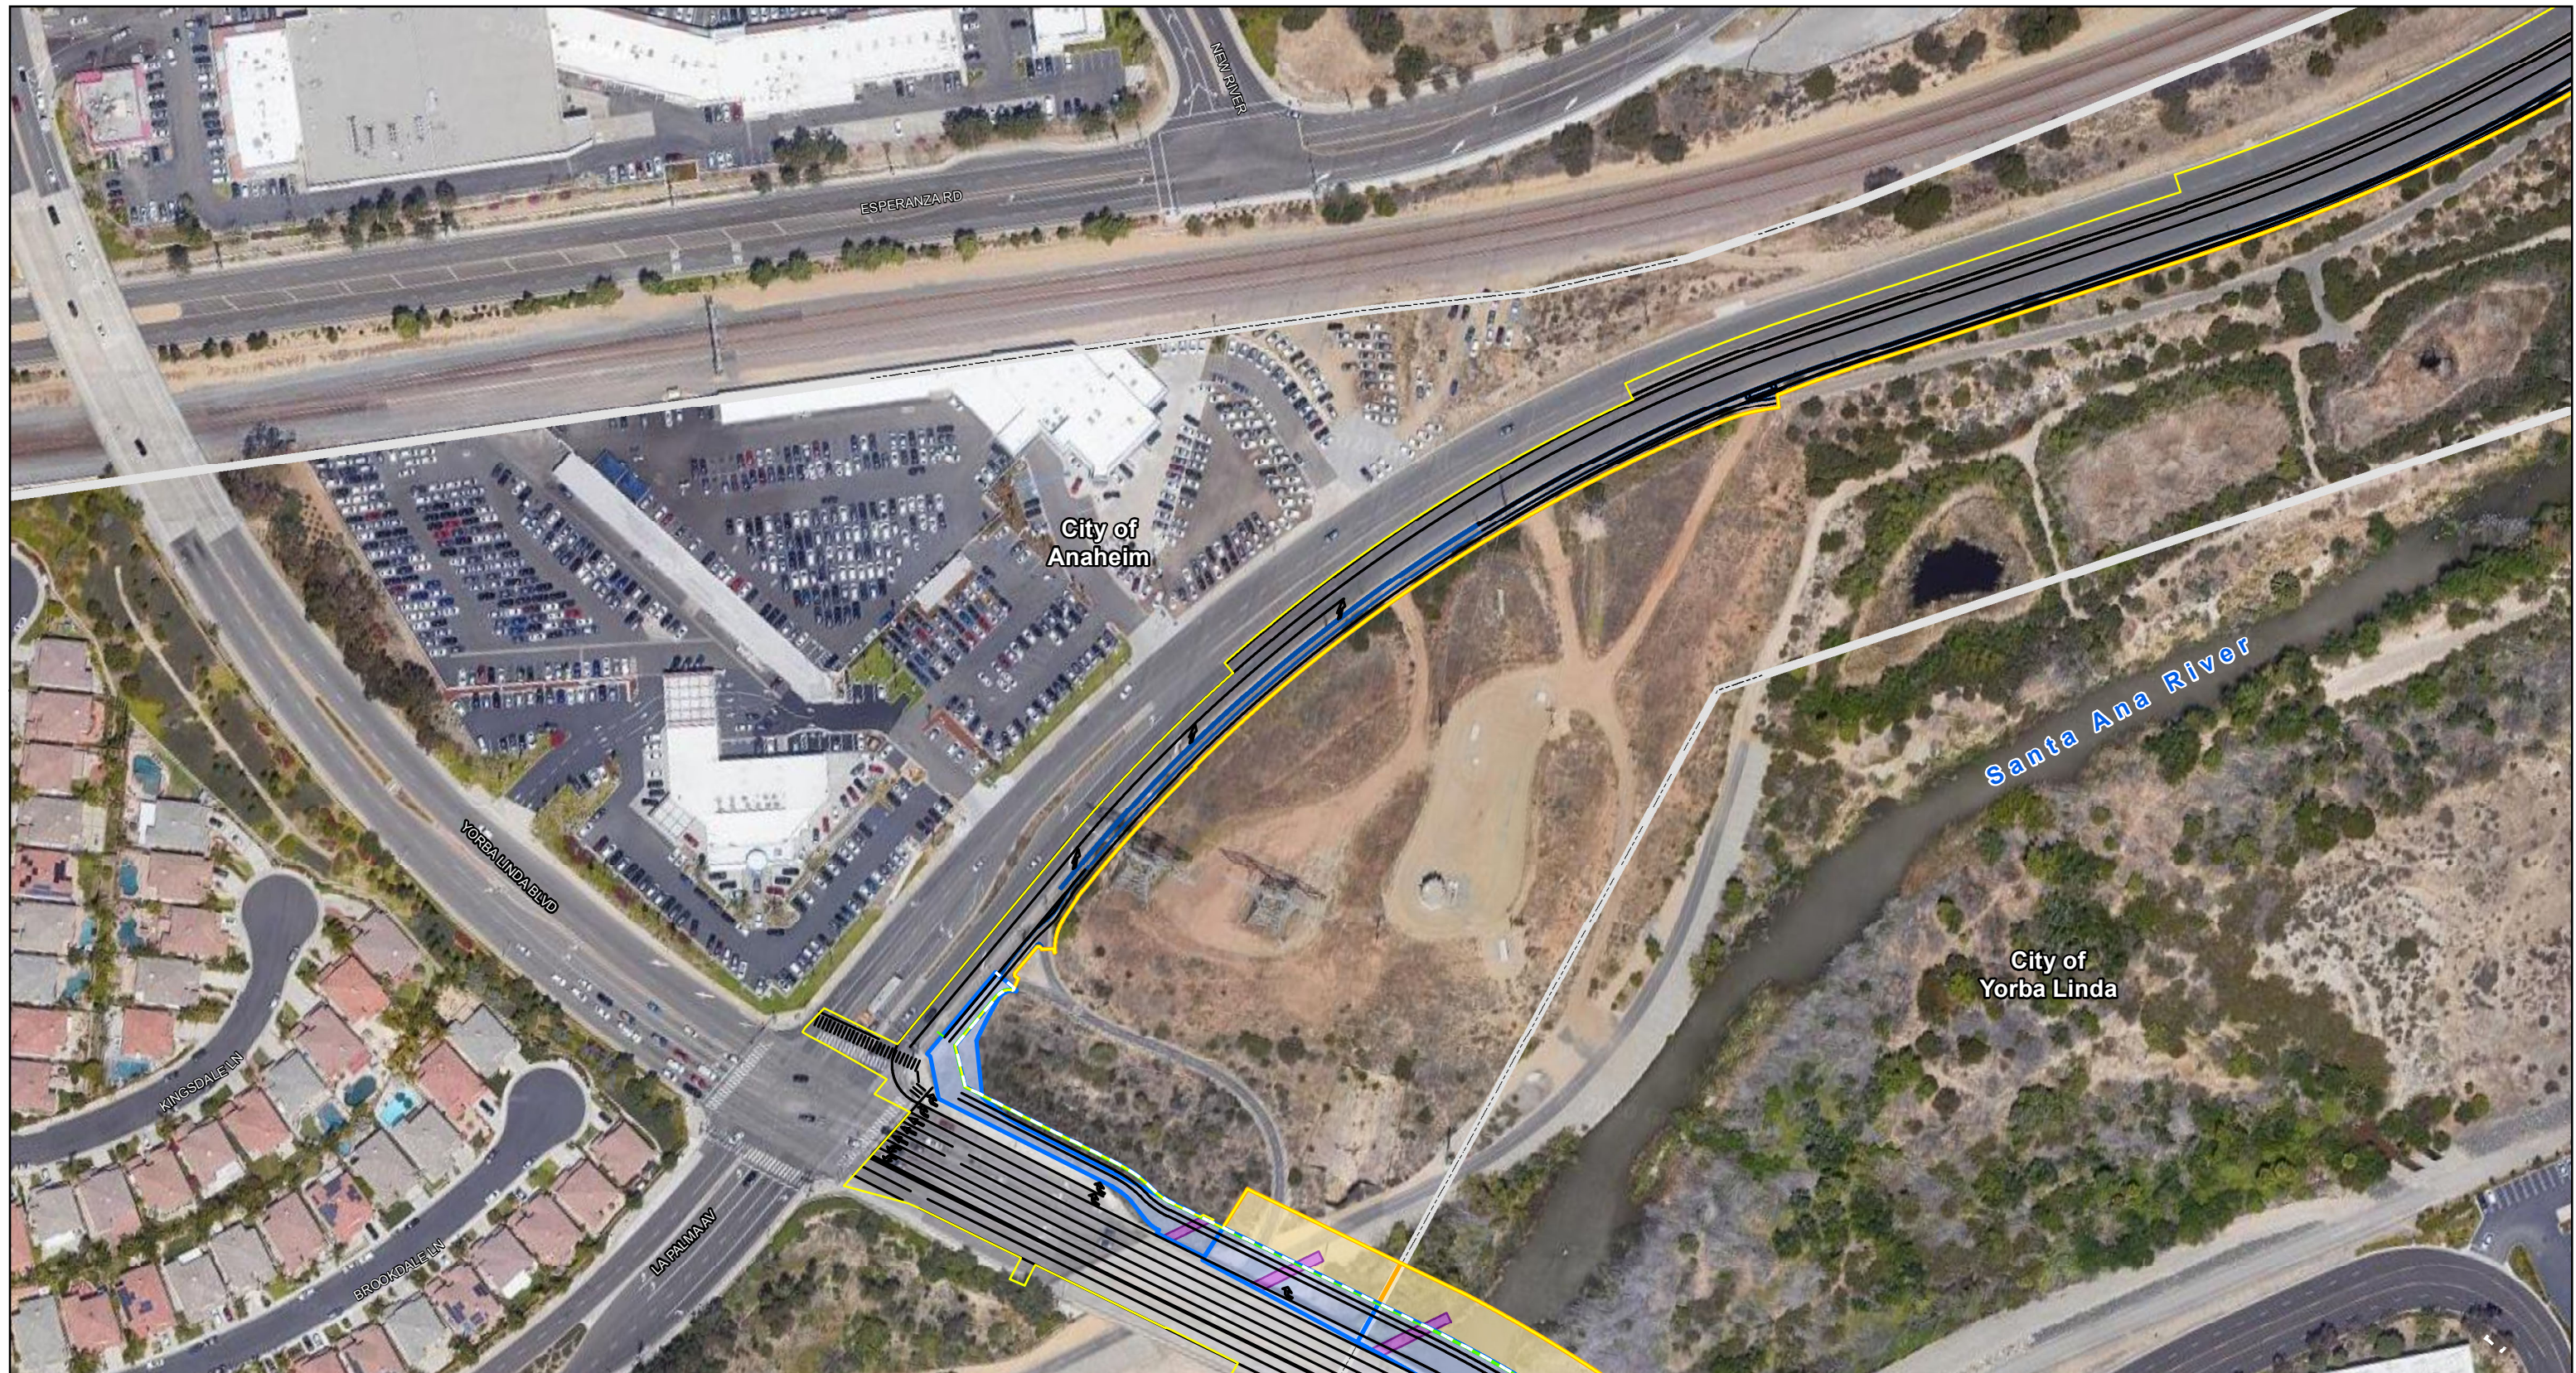
FIGURE 2  
Sheet 2 of 4

Yorba Linda Boulevard Widening Project  
Project Features

LSA has prepared this biological resources report for the proposed Yorba Linda Boulevard Widening Project (proposed project) located on the border between the cities of Yorba Linda and Anaheim along Yorba Linda Boulevard between La Palma Avenue and the State Route 91 (SR-91) westbound on-ramp and along South Weir Canyon Road between the SR-91 eastbound off-ramp and Santa Ana Canyon Road (see Figure 1). The City of Yorba Linda (City), as the Lead Agency under the California Environmental Quality Act (CEQA), in cooperation with the City of Anaheim, is proposing roadway improvements along Yorba Linda Boulevard as well as a Class I bike path along La Palma Avenue and Yorba Linda Boulevard, which includes the widening of the bridge over the Santa Ana River. The proposed bike path would also extend along La Palma Avenue and would connect with the existing Santa Ana River Trail. The proposed project would improve corridor operations and provide additional storage for turning movements, as the intersections within the proposed project limits have inadequate vehicle storage due to short turn pocket lengths. Improvements within the proposed project limits include intersection and lane reconfiguration, restriping, and roadway widening. The proposed project limits are shown in Figure 2.

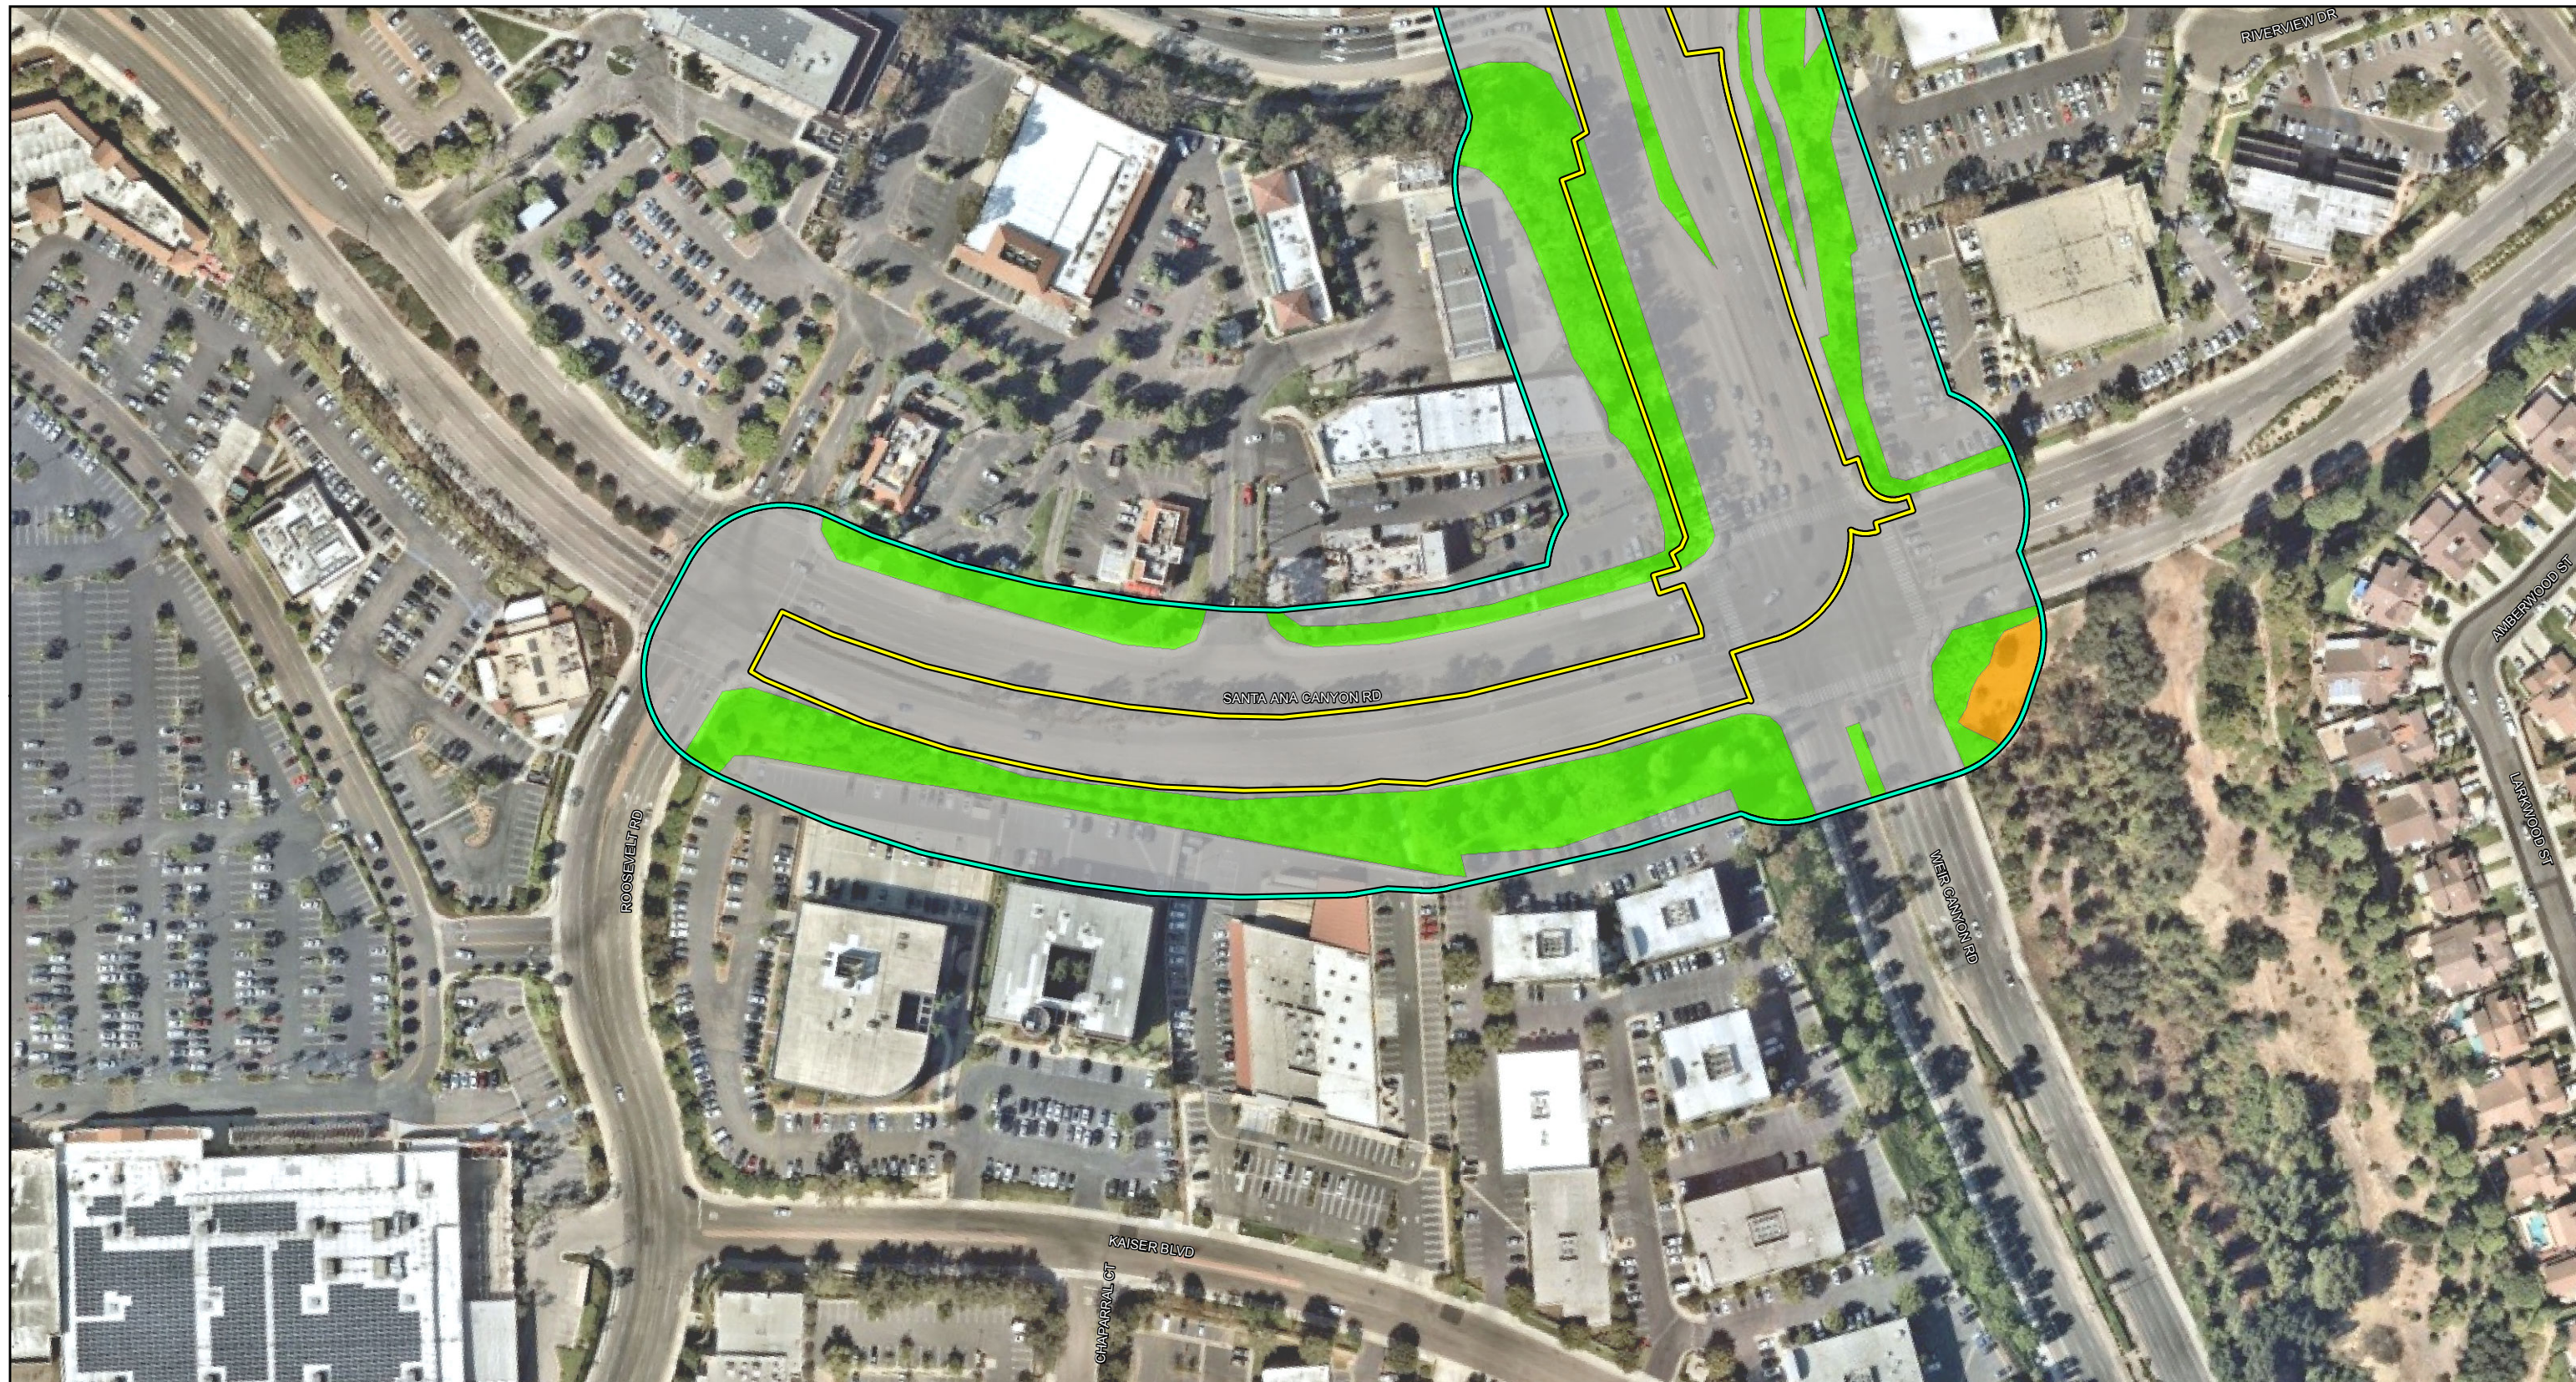
FIGURE 2  
Sheet 4 of 4

Yorba Linda Boulevard Widening Project  
Project Features

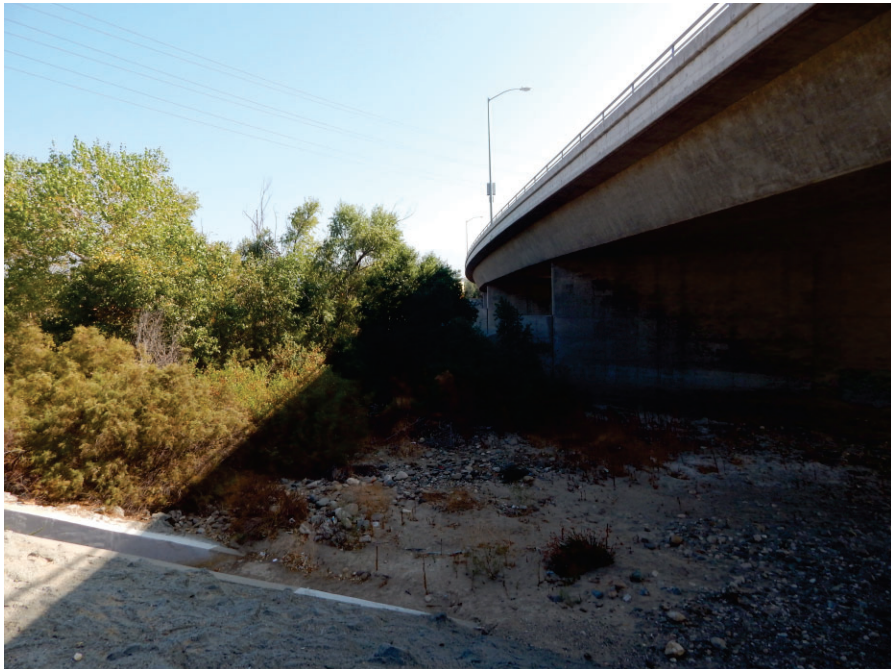
View of the pier walls and cottonwood-willow riparian forest on the east side of the Yorba Linda Boulevard bridge, looking south. The proposed project will require lengthening of the pier walls. November 7, 2019.

The widening of the bridge would require lengthening of the pier walls and replacement of the existing pier wall debris nosing further upstream. The bridge would be widened a maximum of 40 feet (ft). Depending on the pile type selected, either pile-driving or drilling equipment would be required in the river channel, and special foundation design detail will be needed to avoid any impacts to the existing underground utilities.

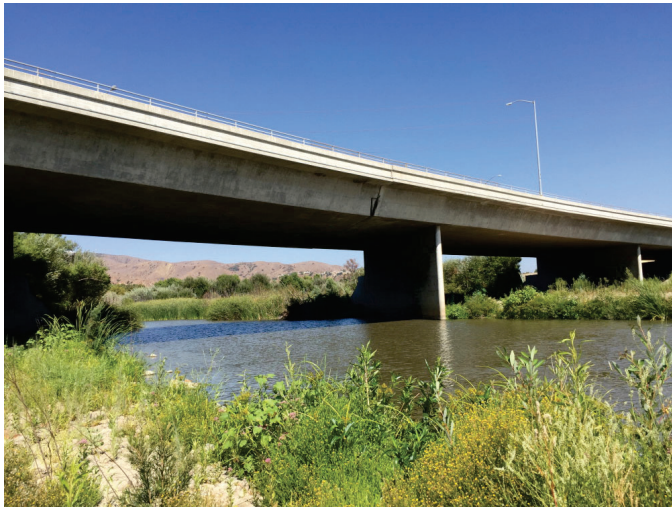
View looking east at the Yorba Linda Boulevard bridge over the Santa Ana River and the surrounding environment. The hinge containing bat roosting habitat suitable for maternity roosting is visible near the middle of the frame.

During the nighttime emergence survey, an estimated 159 bats were observed emerging from the Yorba Linda Boulevard bridge structure. The majority of bats exited the bridge on the western, or downstream, side. Based upon visual observation and analysis of the acoustic data collected during this survey, the bridge was occupied primarily by Mexican free-tailed bats (*Tadarida brasiliensis*), with some Yuma myotis bats (*Myotis yumanensis*) also present. Refer to Appendix E for further information regarding bats and the specific bat surveys conducted for the proposed project.

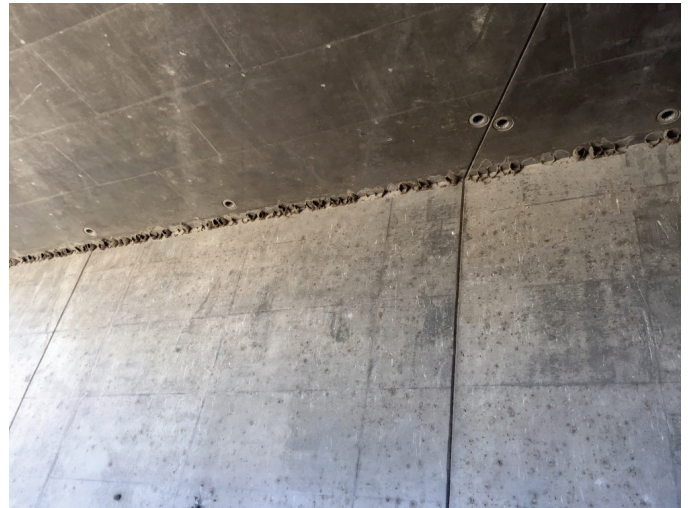
Representative view of cliff swallow nests and weep holes found at the Yorba Linda Boulevard Bridge. Both of these features provide suitable bat roosting habitat.

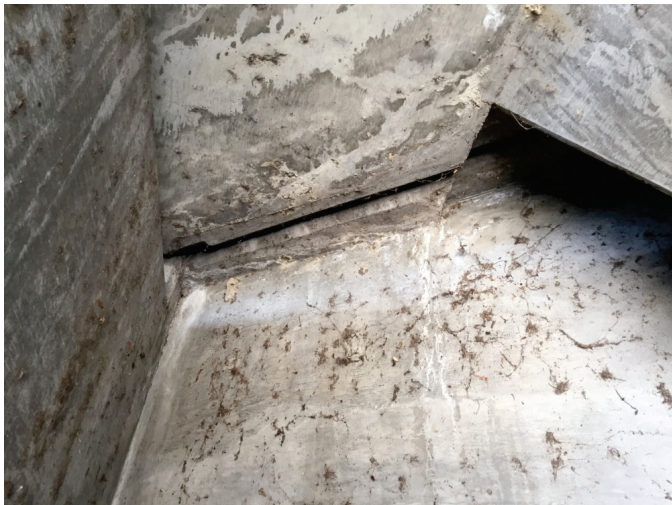
Representative view of crevices with potential bat roosting habitat that were observed at the north abutment of the Yorba Linda Boulevard Bridge.

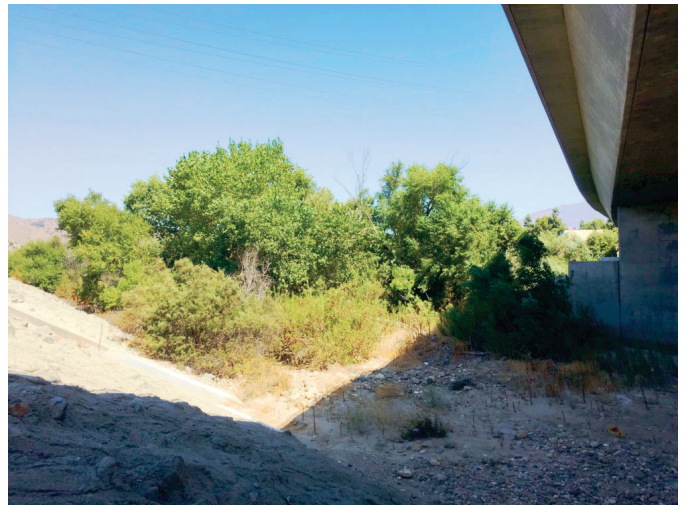
View looking south at the mature trees on the east side of the Yorba Linda Boulevard Bridge. These trees may be used by foliage-roosting bats for roosting.

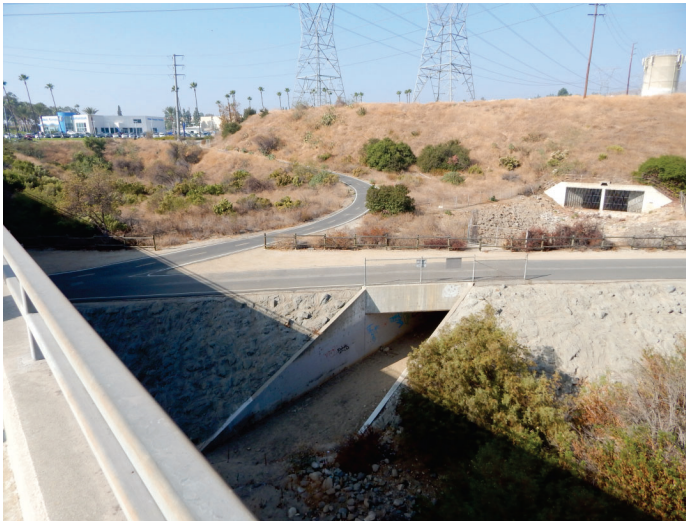
View of the tributary looking north from the Yorba Linda Boulevard bridge. November 7, 2019.

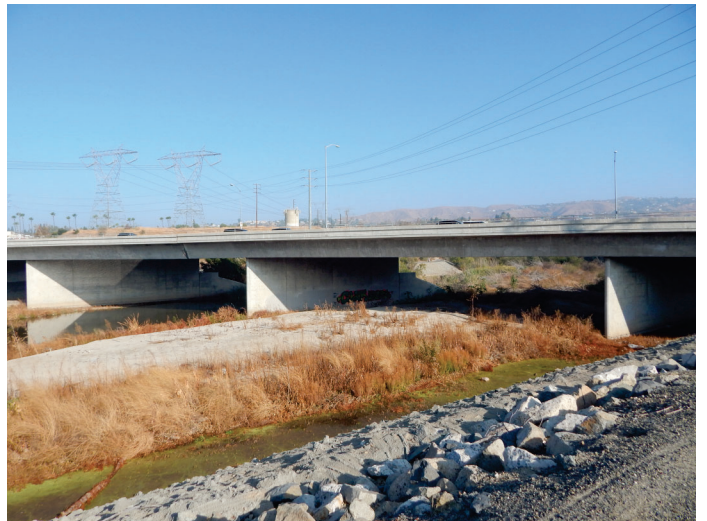
View of waters and wetland areas looking north toward the downstream side of the Yorba Linda Boulevard bridge. November 7, 2019.

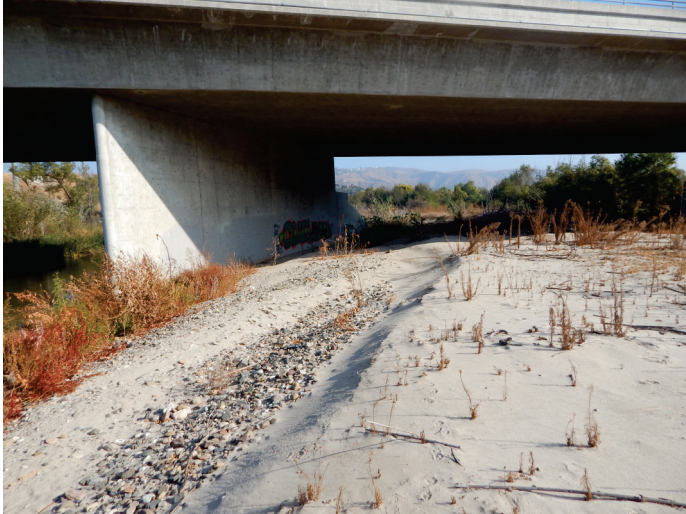
View of the ordinary high-water mark east of Yorba Linda boulevard, facing west. November 7, 2019.

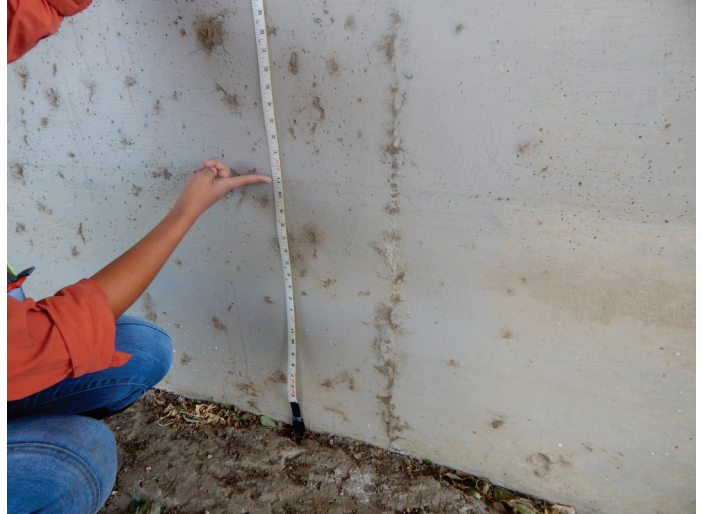
Water marks on the pier wall, showing the ordinary high-water mark. November 7, 2019.

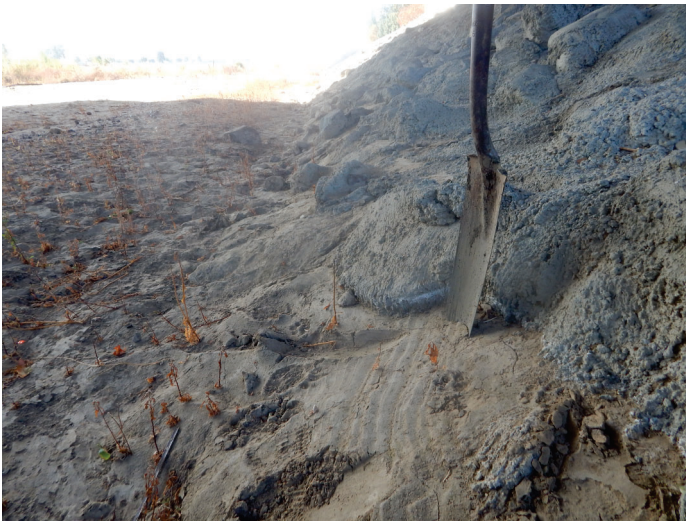
Sediment deposits showing the ordinary high-water mark. November 7, 2019.

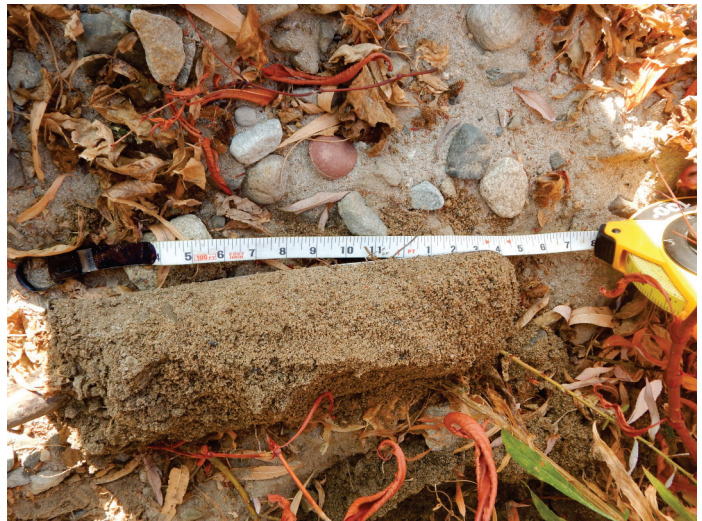
Sample Pit 1; soil type is coarse sand to cobble. The pit was dug in a problematic area. November 7, 2019.

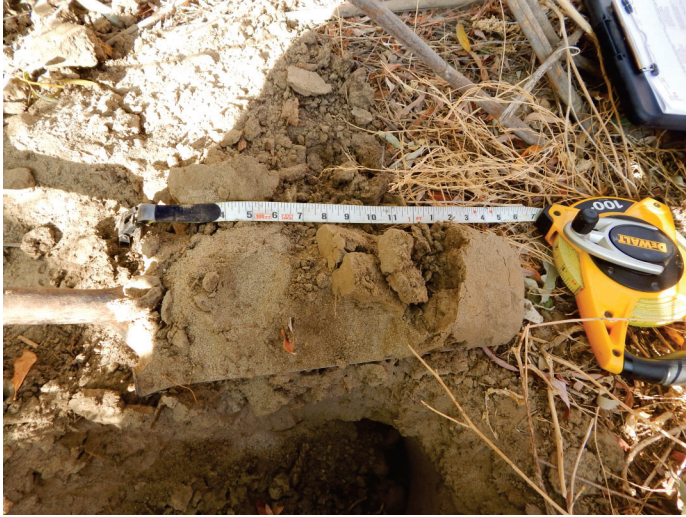
Sample Pit 2; soil type is sand to loamy fine sand, with sandy redox features present. November 7, 2019.

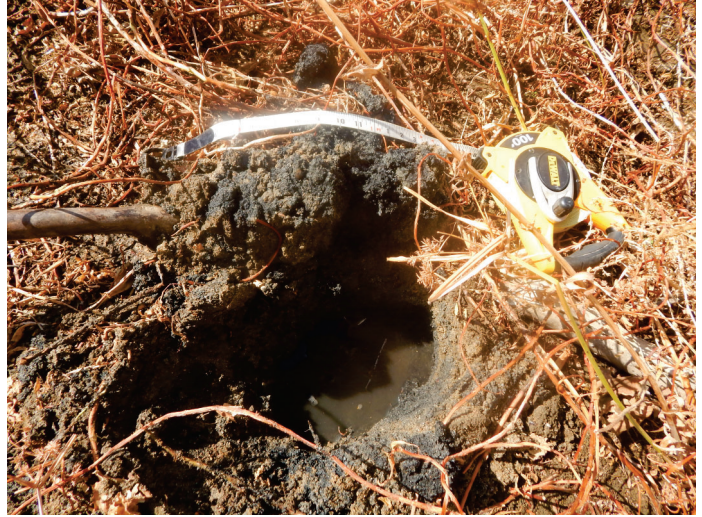
Sample Pit 5; soil type is sand to sandy clay loam and exhibited a hydrogen sulfide odor. Water table is present. November 7, 2019.

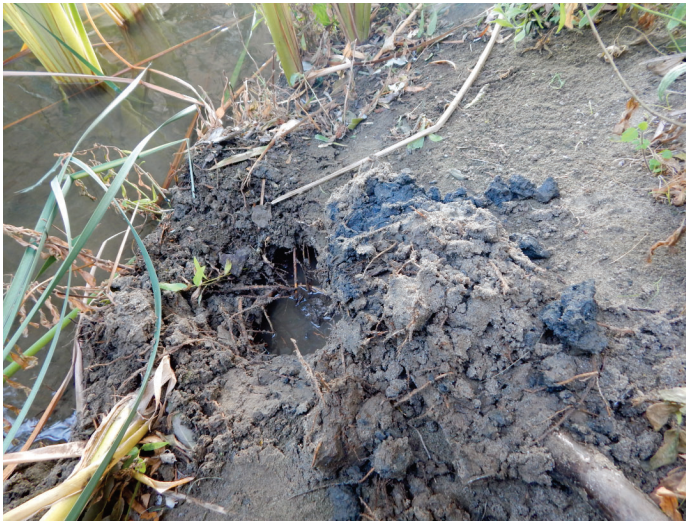
Sample Pit 9; soil type is sand to sandy clay loam and exhibited a hydrogen sulfide odor. Water table is present. November 7, 2019.

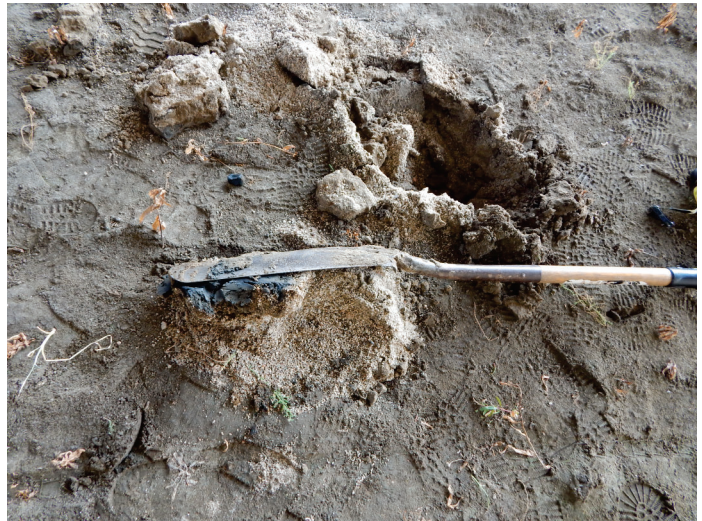
Sample Pit 10; soil type is coarse sand and clay. The pit was dug in a problematic area. November 7, 2019.
