## **PHASE I ENVIRONMENTAL SITE ASSESSMENT**

325 Yolanda Avenue & 2532 Santa Rosa Avenue  
Santa Rosa, Sonoma County, California 95407

AEI Project No. 387046

Client Provided Site Name: Yolanda

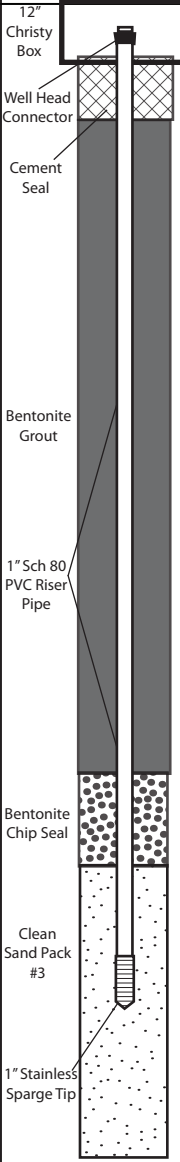
| Sparge Well Construction Detail | | | | | | | | | | Groundwater | Blows | Soil Sample ID | Depth (ft) | SAMPLE | Graphic Log | EQUIPMENT: 8" Hollow Stem Auger |

| Sparge Well Construction Detail | | | | | | | | | | Groundwater | Blows | Soil Sample ID | Depth (ft) | SAMPLE | Graphic Log | EQUIPMENT: 8" Hollow Stem Auger |
|--|--|--|--|--|--|--|--|--|--|---|---|---|---|---|--|---|
| <p>12" Christy Box<br/>Well Head Connector<br/>Cement Seal<br/>Bentonite Grout<br/>1" Sch 80 PVC Riser Pipe<br/>Bentonite Chip Seal<br/>Clean Sand Pack #3<br/>1" Stainless Sparge Tip</p> | | | | | | | | | | | | | | | | LOGGED BY: DLB      DATE: 12/19/13 |

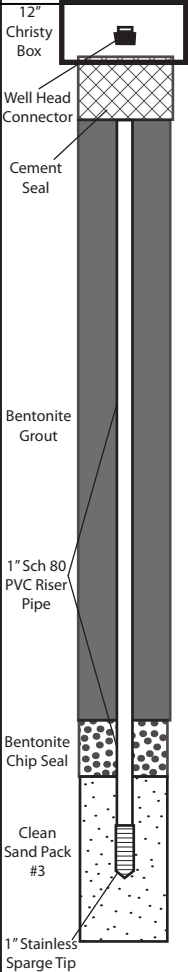
| Sparge Well Construction Detail | | | | | | | | | | Groundwater | Blows | Soil Sample ID | Depth (ft) | SAMPLE | Graphic Log | EQUIPMENT: 8" Hollow Stem Auger |

| Sparge Well Construction Detail | | | | | | | | | | Groundwater | Blows | Soil Sample ID | Depth (ft) | SAMPLE | Graphic Log | EQUIPMENT: 8" Hollow Stem Auger |
|--|--|--|--|--|--|--|---|---|--|---|---|---|---|---|--|---|
| <p>12" Christy Box<br/>Well Head Connector<br/>Cement Seal<br/>Bentonite Grout<br/>1" Sch 80 PVC Riser Pipe<br/>Bentonite Chip Seal<br/>Clean Sand Pack #3<br/>1" Stainless Sparge Tip</p> | | | | | | | | | | | | | | | | EQUIPMENT: 8" Hollow Stem Auger |

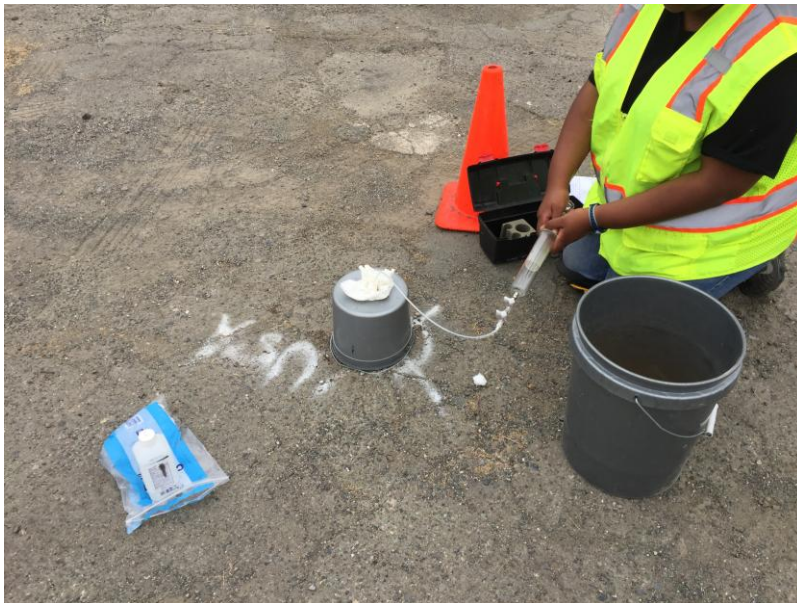
Photo 3: View collecting soil vapor sample in glass syringe, shroud and leak detection compound beneath connection

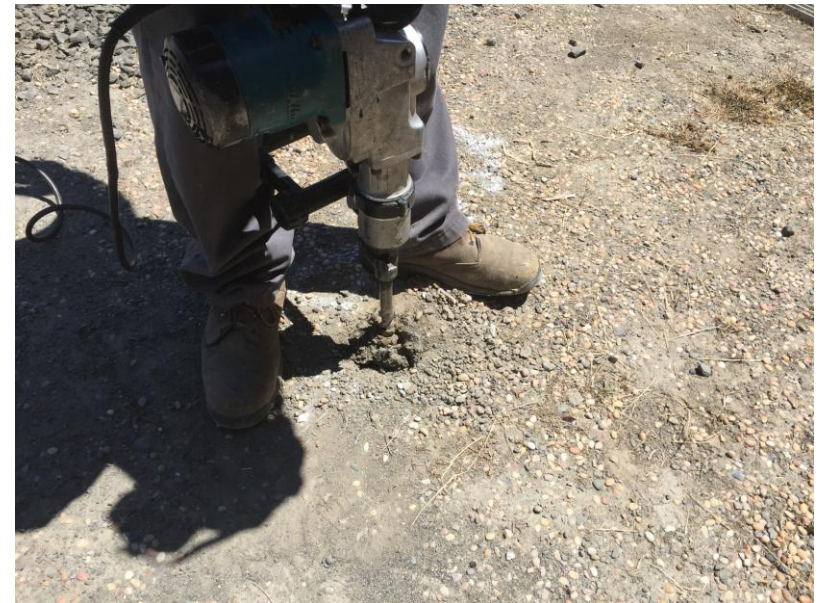
Photo 4: View removing upper 3 feet of hydrated BenSeal prior to completion of soil vapor probe with neat cement
