Department of Toxic Substances Control

EPA ID PROFILE

<u>Map</u>			
ID Number:	CAL000050356	Status:	INACTIVE
Name:	MAJOR DIESEL	Inactive Date:	12/14/2004 12:00:00 AM
County:	SONOMA	Record Entered:	10/5/1994 12:00:00 AM
NAICS:	811111	Last Updated:	12/21/2004 4:41:26 PM

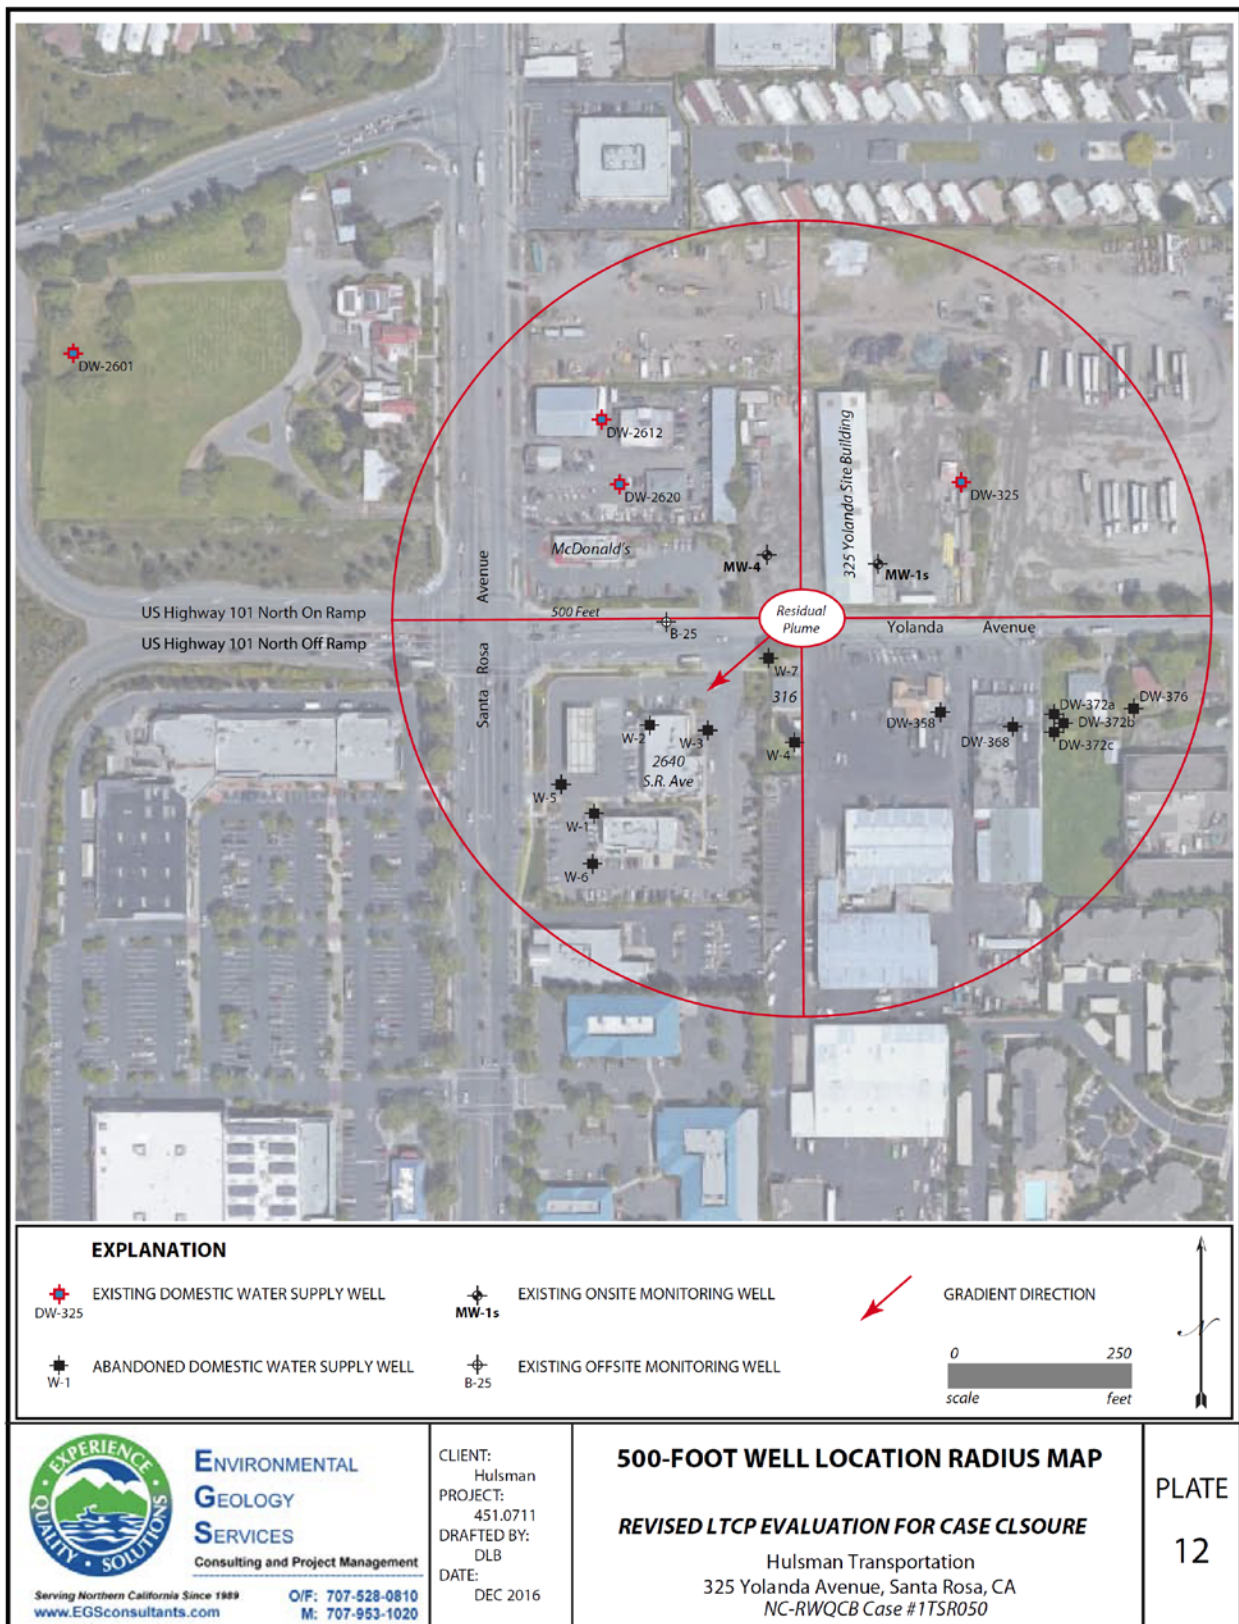
Figure 5- SRS showing location of existing and destroyed water supply wells near 2640 Santa Rosa Avenue

A figure showing the location of both W-7 and the replacement well W-4, as well as copies of the well destruction permits and Well Abandonment Reports are in Appendix D.

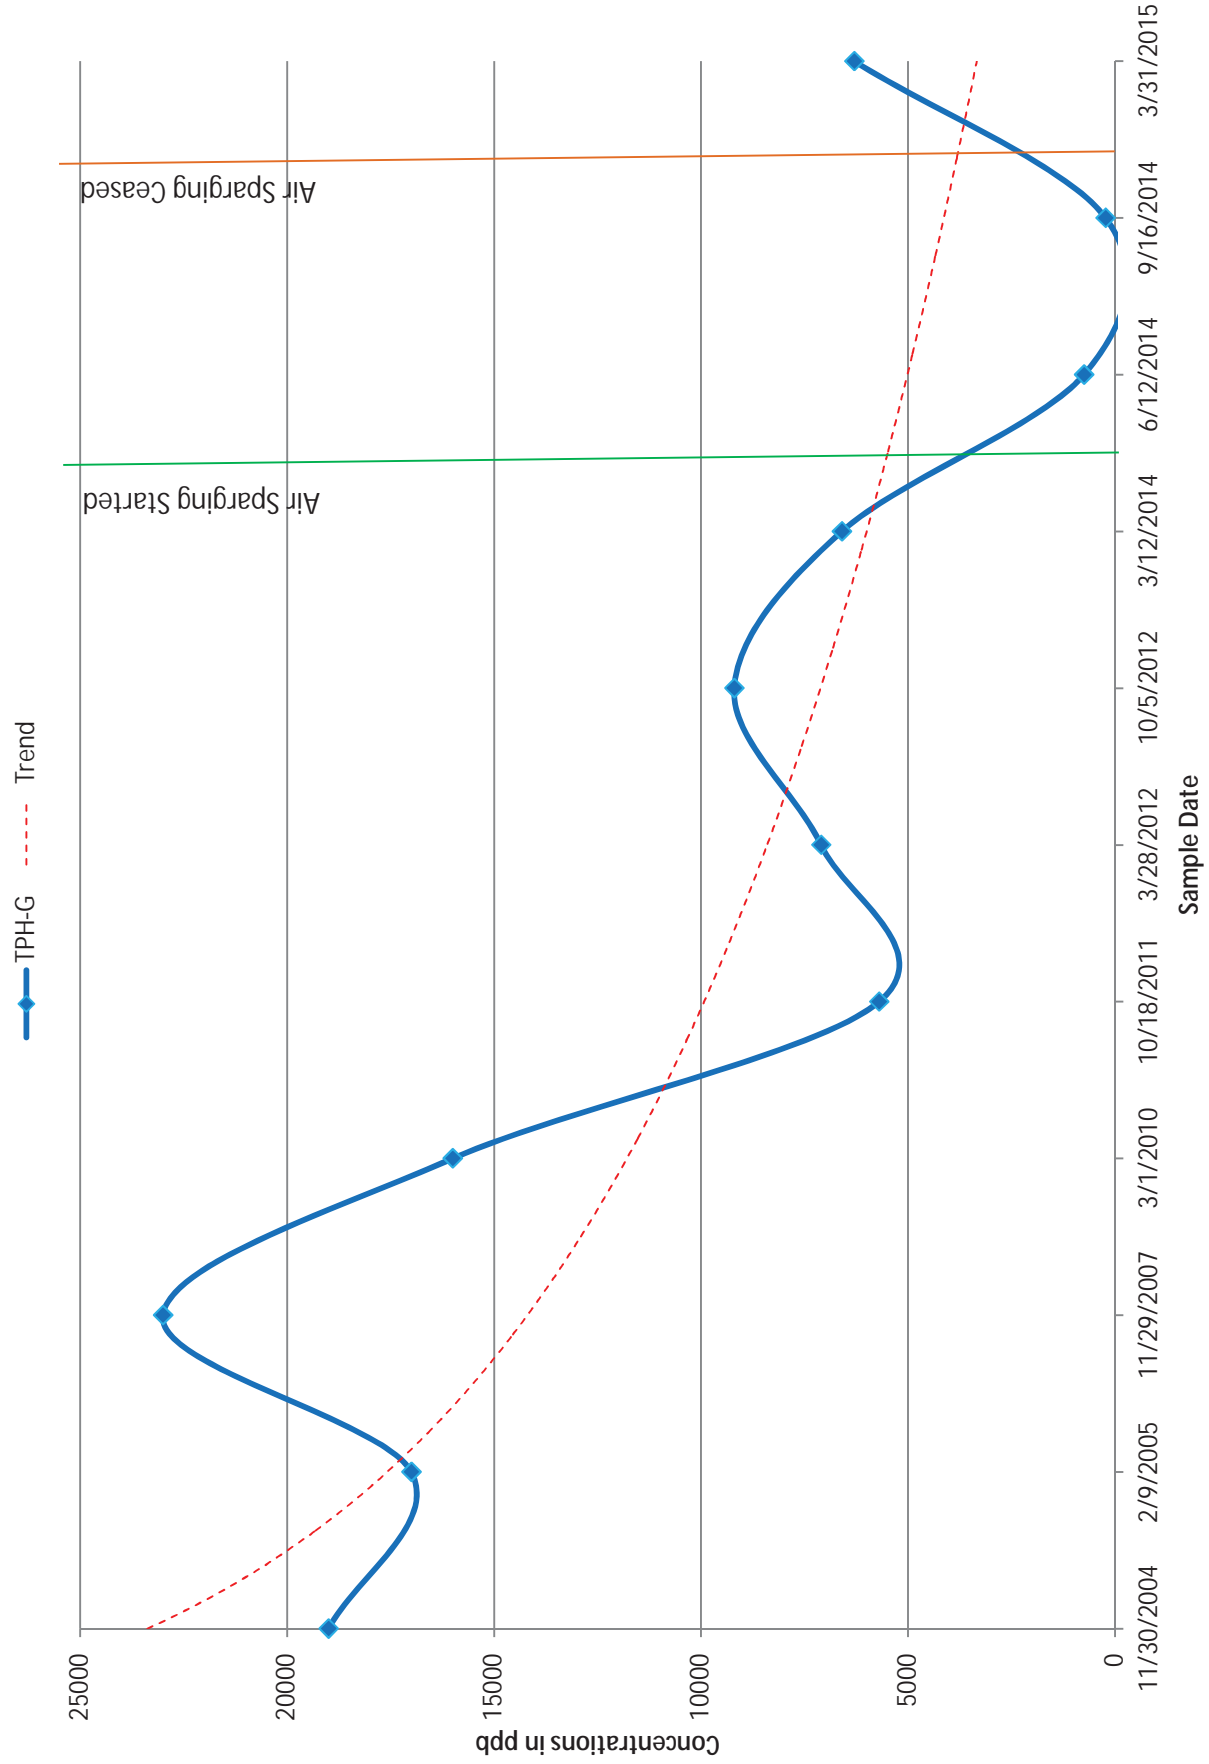
Chart 1: Historic Concentration Trend for TPH-G in MW-3s
